# Site Inspection Report

Site inspection of Kells Theatre which is access via an alley way from Kenlis Place. The existing property consists of a flat roof entrance foyer with male and female toilets. The main theatre appears to consist of an A-type slated roof which has steel rafters and piers to external walls. There is terraced seating which appeared to have a solid concrete slab supported on steel beams/columns. A link/fire escape corridor is provided to the left hand side of the theatre which has external fire exist doors through the adjoining Boys School site and also to the rear. A more recent rear extension appears to have been provided which has 300mm thick walls and raised concrete floors which are level with the stage. A modular building has been provided to the rear of the site to allow for additional toilets and changing facilities.

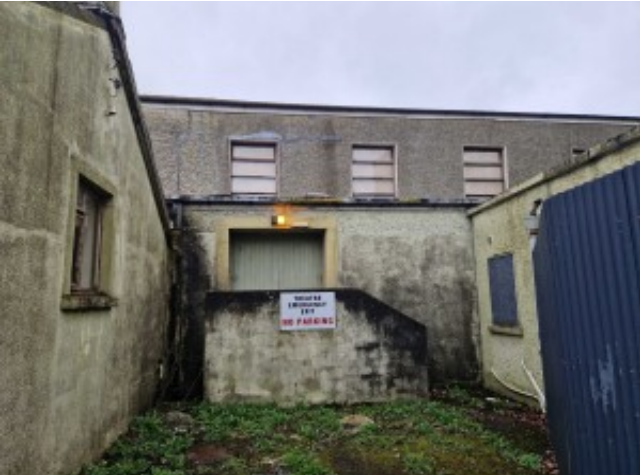
# 001 / 001

Side elevation of property with fire exit to adjoining lands which was previously the Boys School. Note repaired cracks to external wall of theatre.

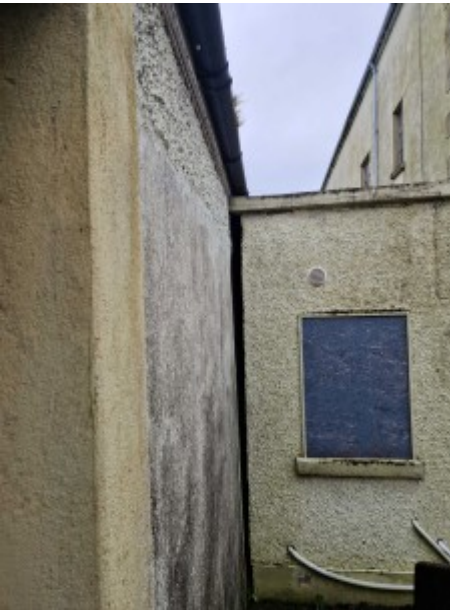
# 001 / 002

Junction of Kells Theatre and adjoining property which does not appear to be connected.

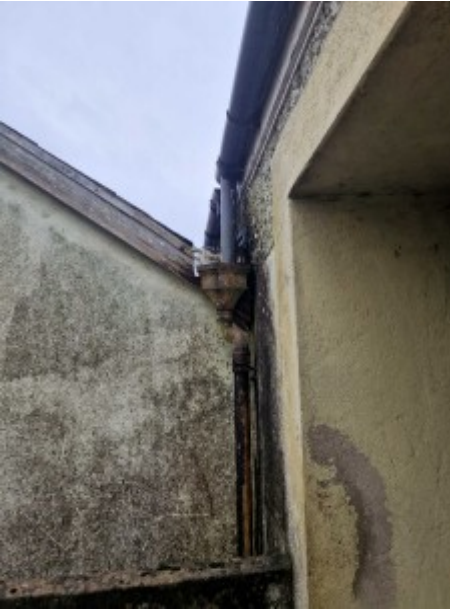
# 001 / 003

Downpipe connected to hopper of adjoining property which is leaking and staining walls.

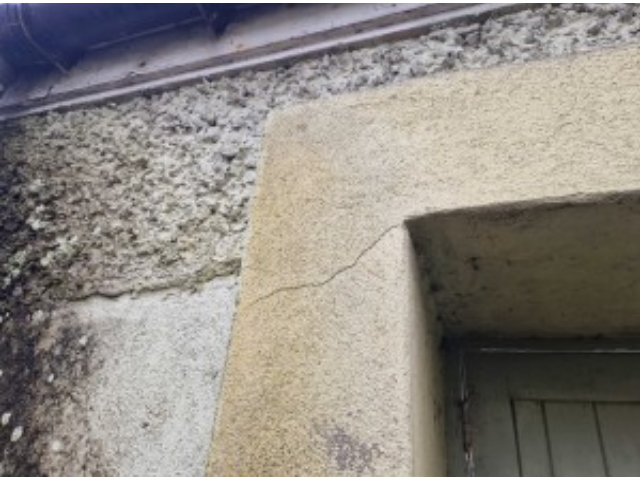
# 001 / 004

Hairline cracking of door head of fire escape.  
External wall 735mm thick.

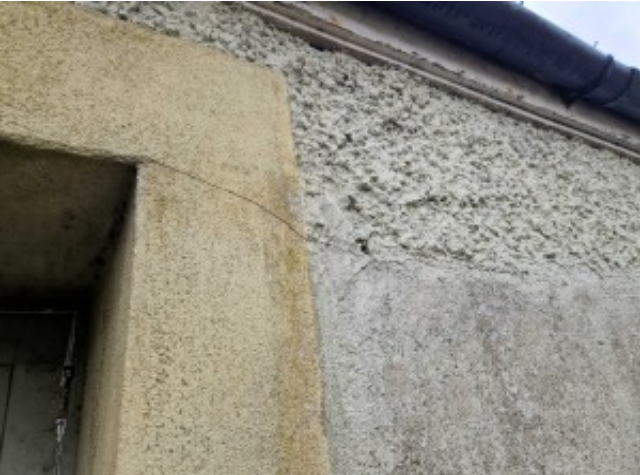
# 001 / 005

Hairline cracking of door head of fire escape.  
External wall 735mm thick.

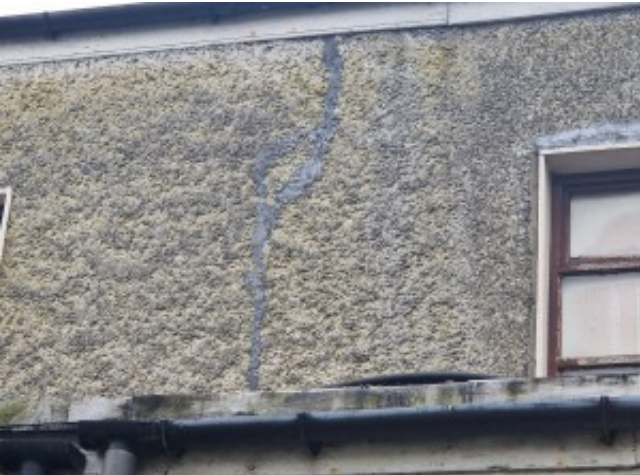
# 001 / 006

Close-up of historic crack to external wall of  
theatre which does not appear to have re-occured.

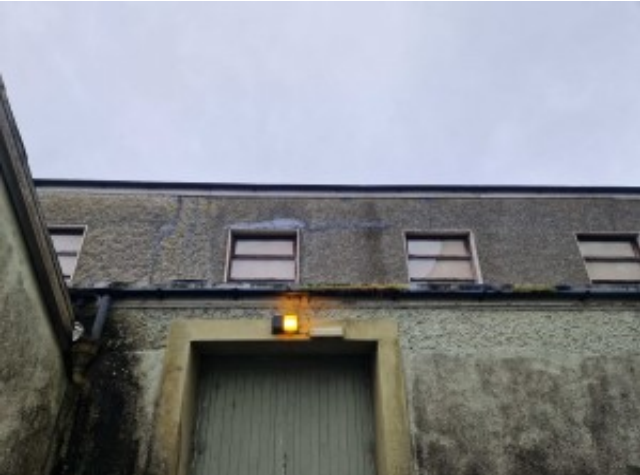
# 001 / 007

Historic crack to external wall of theatre which does not appear to have re-occured.

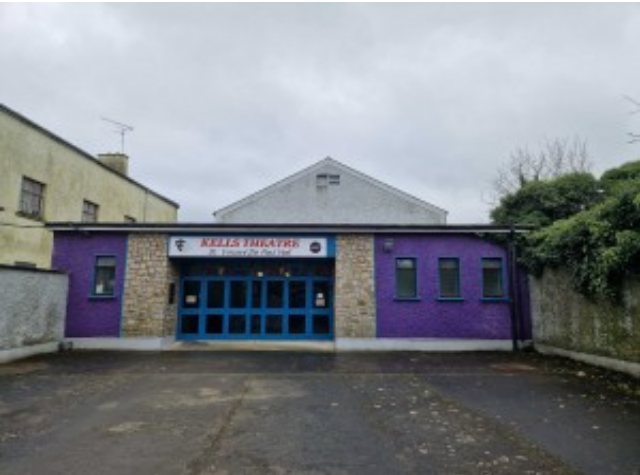
# 001 / 008

Main entrance to Theatre. Note flat roof covering to entrance hall and toilets with pitch roof structure to main theatre to rear.

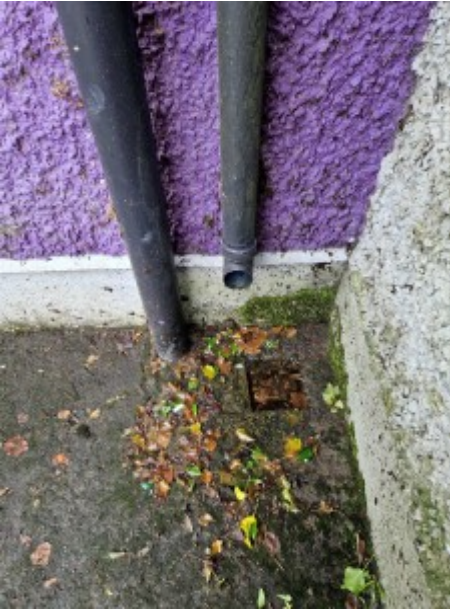
# 001 / 009

Comment  
Gullies blocked and require cleaning out and jetting to clear blockage.

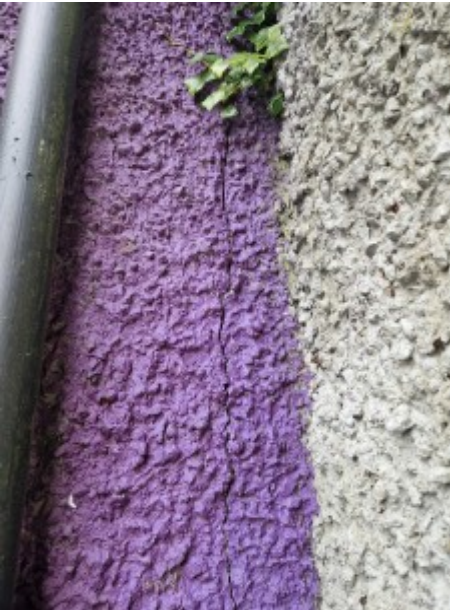
# 001 / 010

Comment  
Crack to front facade at junction of boundary wall.

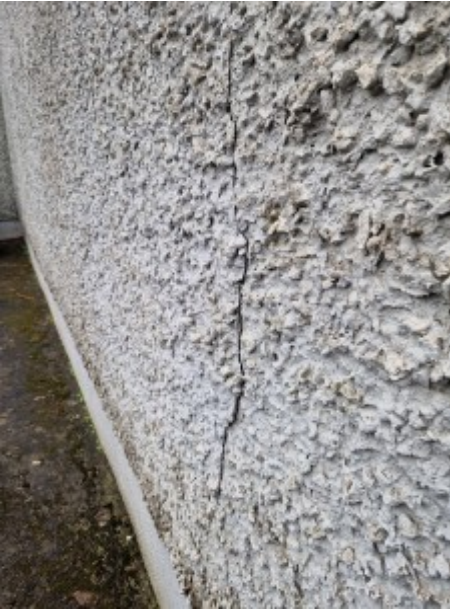
# 001 / 011

Comment  
Cracked and boast render to front left boundary wall

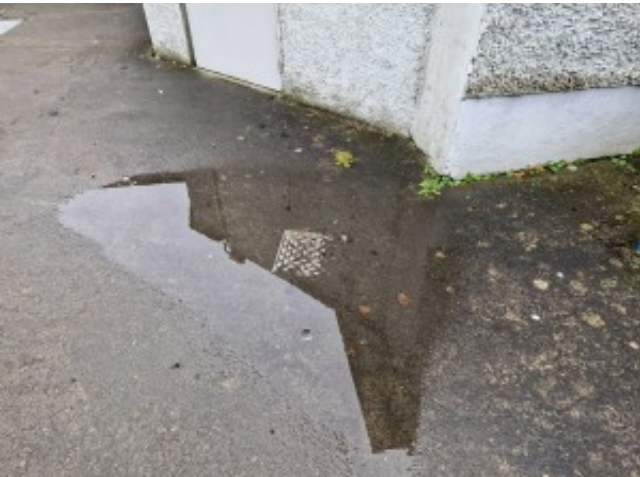
# 001 / 012

Comment  
Additional drainage gullies required to front yard due to pooling of water.

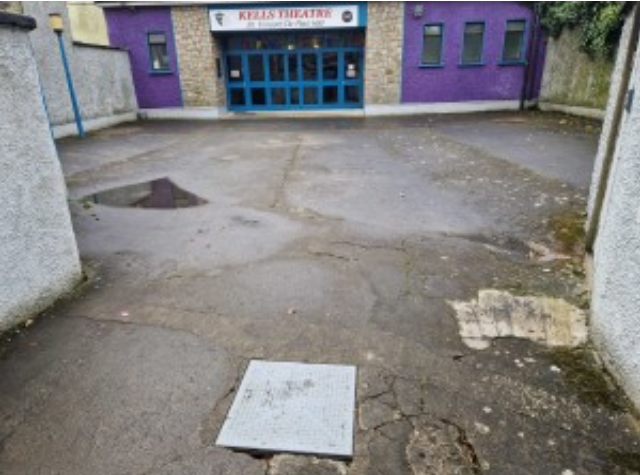
# 001 / 013

Comment  
Concrete to front of property in poor condition and requires replacement and recommended to provide a paved surface.

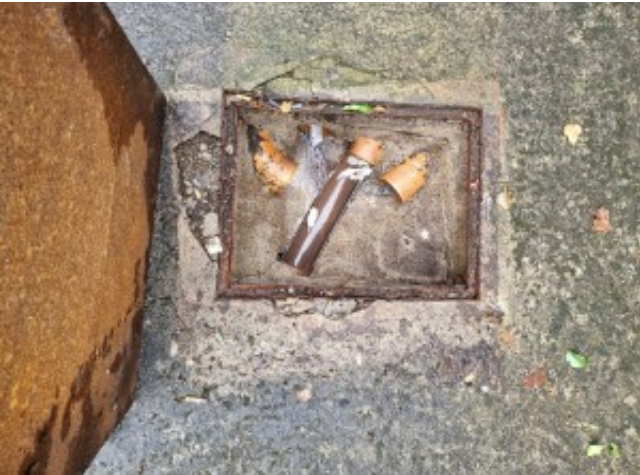
# 001 / 014

Comment  
Gaps at junction of pvc pipes and benching which may result of leaking into ground water.

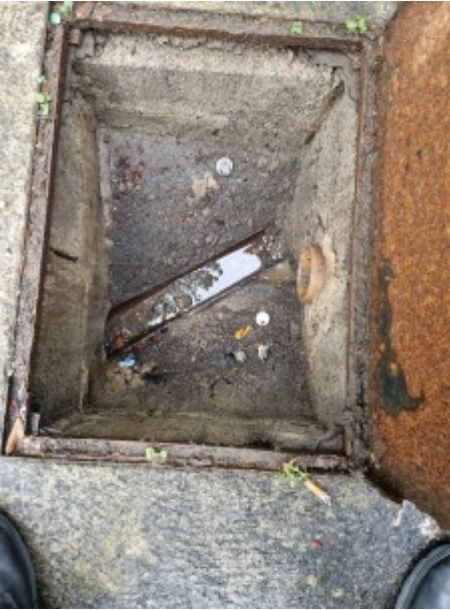
# 001 / 015

Effluent backing up in foul sewer, recommended to CCTV survey the underground services to determine condition.

4. New gutters and downpipes will be required to effectively collect and discharge roof water to gullies at ground level. The underground foul drains to rear show signs of previous blockages and these should be jetted out and CCTV surveyed to ensure pipework is in suitable condition with no defects present.

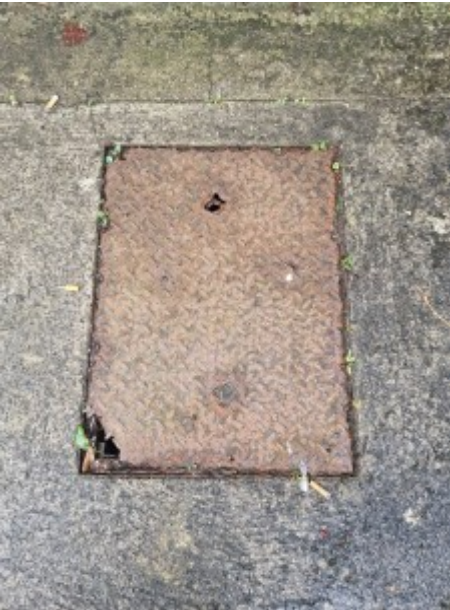
# 001 / 016

Manhole cover corroded and requires replacement.

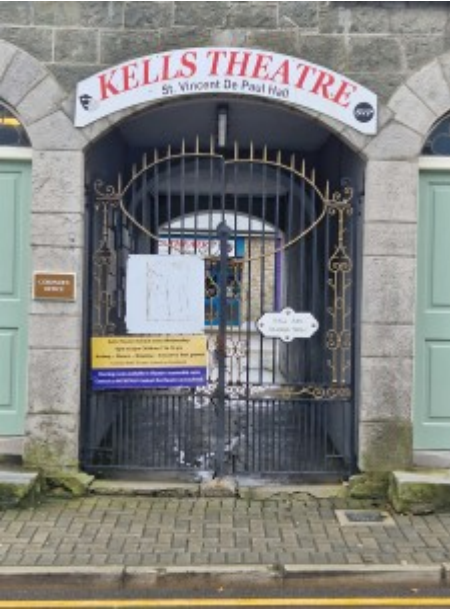
# 001 / 017

Entrance archway from Kenlis Place .

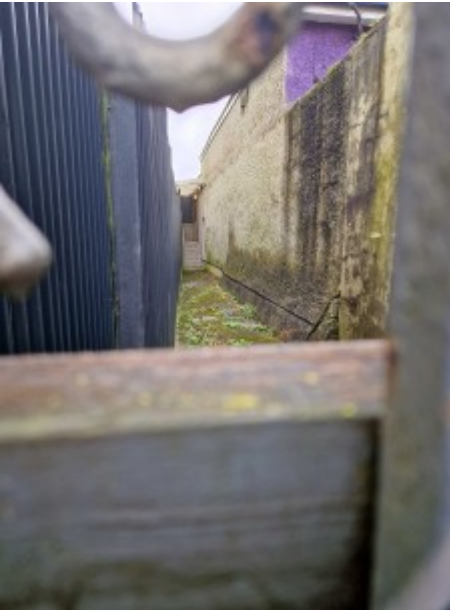
# 001 / 018

Fire escape exit from side of building through gate  
access to side of The Boy's School.

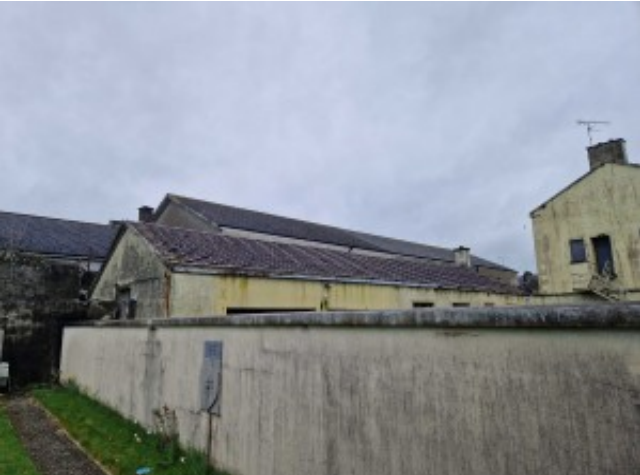
# 001 / 019

Comment  
Slate roof covering to main theatre, some slates appear to be of asbestos and will require testing if considering replacing.

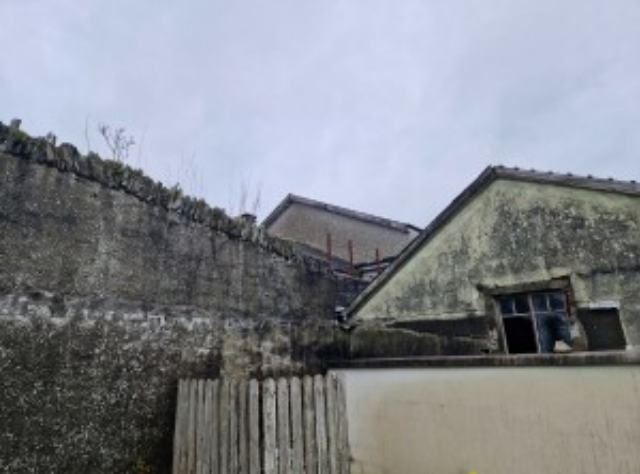
# 001 / 020

Comment  
Rear of property with timber fascia and soffit which requires replacement.

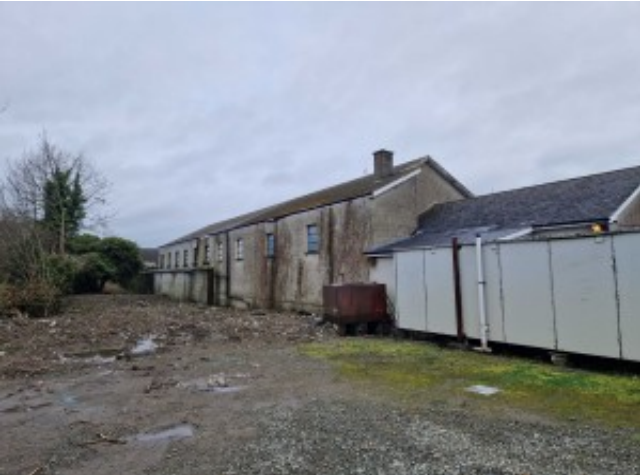
# 001 / 021

Western elevation from adjoining council site with section of site filled up. This filling may affect moisture levels to external walls. External gutters and downpipes in need of replacement with new surface water gullies installed to prevent long branch connections.

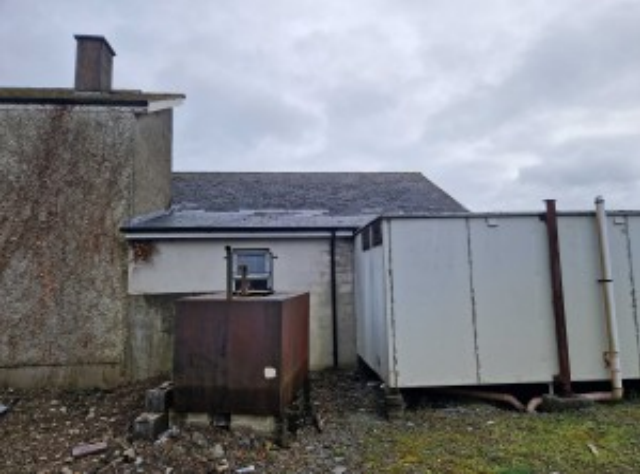
# 001 / 022

Comment  
A more recent extension to rear to link with modular building.

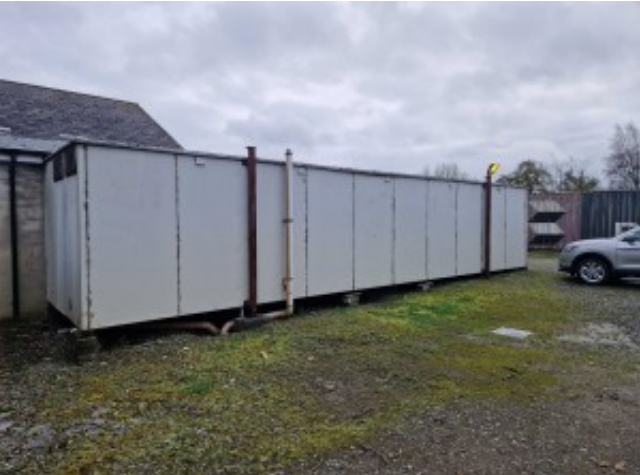
# 001 / 023

Modular building to rear of site which is used as changing area. This structure has some leaks evident and should be replaced in the near future.

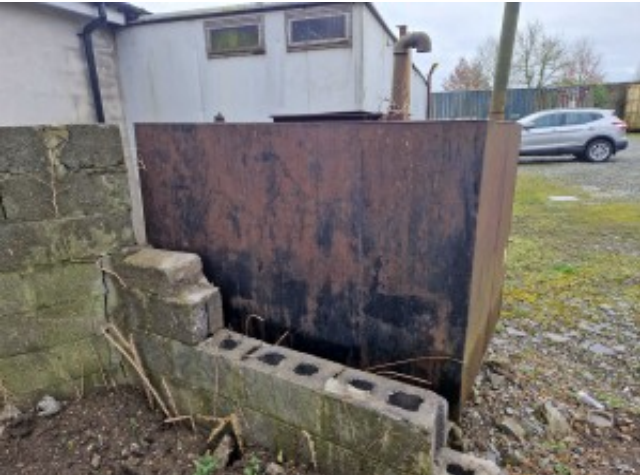
# 001 / 024

Oil storage tank with no bund provided and should be inspected to ensure it is not corroded.

5. The internal boiler house does not appear to be adequately fire stopped . Ideally it would be recommended to build an external boiler house/plant room and replace old oil storage tank.

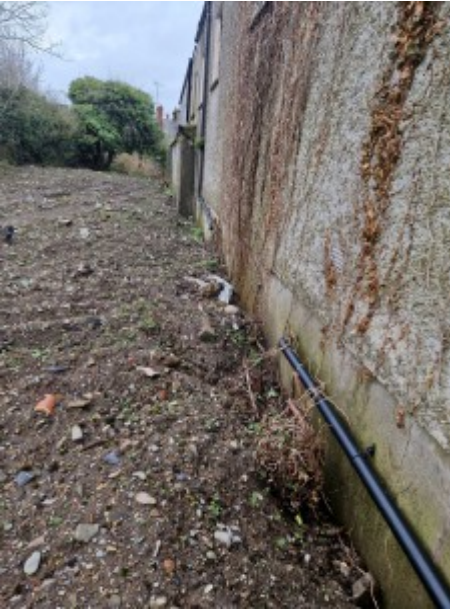
# 001 / 025

Damaged long branch connection for surface water pipe which requires replacement with additional surface water gullies installed. Recently installed fill material along this elevation.

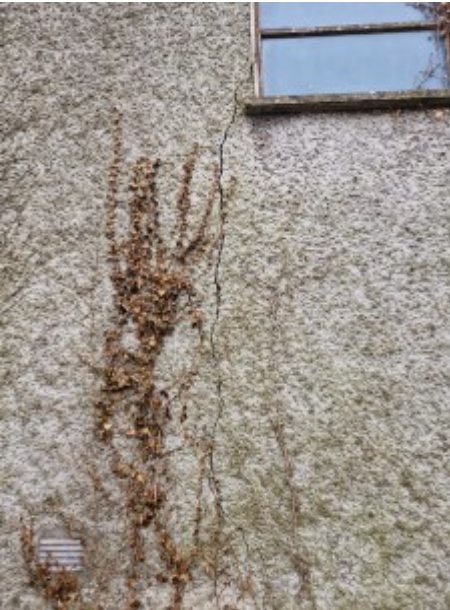
# 001 / 026

Vertical crack to western elevation.

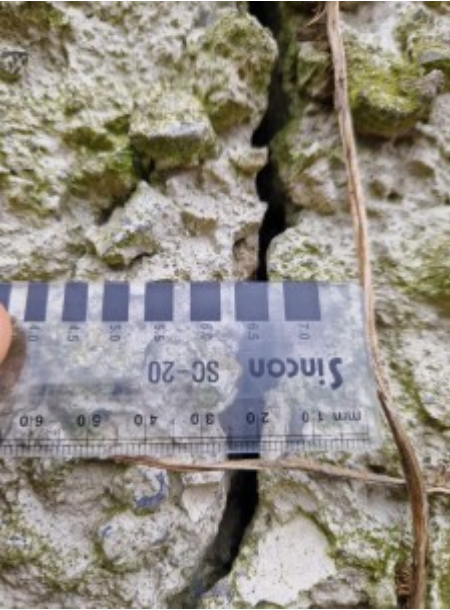
# 001 / 027

1. Cracking is evident to the external walls of the theatre and also to the rear extension. The most significant crack is to the western elevation which can be categorised as Category 3 (BRE Digest 251-Assessment of damaged in low-rise buildings) which are cracks between 5-15mm . Blockwork will require toothing out and rebuilding by blocklayer with remainder of cracks stitched with Ancon Heliber. It would be recommended to install a tell-tale crack monitor to ensure movement has ceased prior to repairing. The external ground level has been filled up along the western boundary which may increase the risk of rising damp. Additional drainage gullies are required along this facade to collect roof water as additional downpipes are required from new gutters. Section of stone boundary wall to rear eastern boundary to be re-built where bulging.

Close-up of crack which can be categorised as category 3 (BRE Digest 251-Assessment of damage in low rise buildings). These are cracks which will require some opening up and sticthing by a blocklayer. It would be recommended to install a tell-tale crack monitor on this crack to ensure movement has ceased prior to repairing.

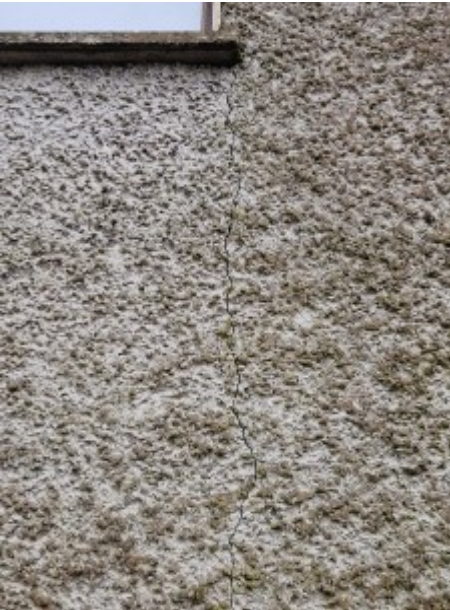
# 001 / 028

Vertical crack at third window from rear along the western elevation. This crack will require stitching with Ancon Helibar or similar repair system.

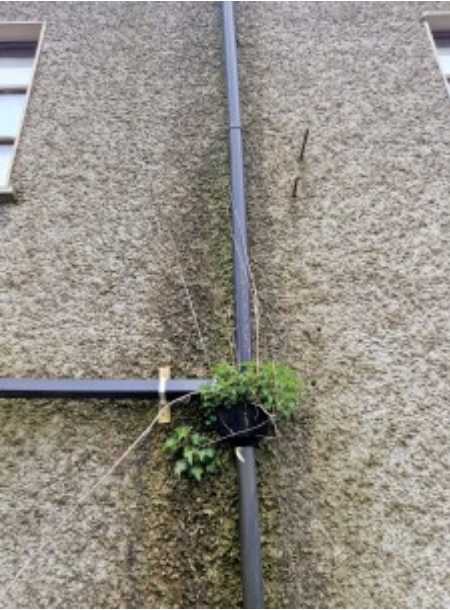
# 001 / 029

Staining of wall due to leaking downpipes.

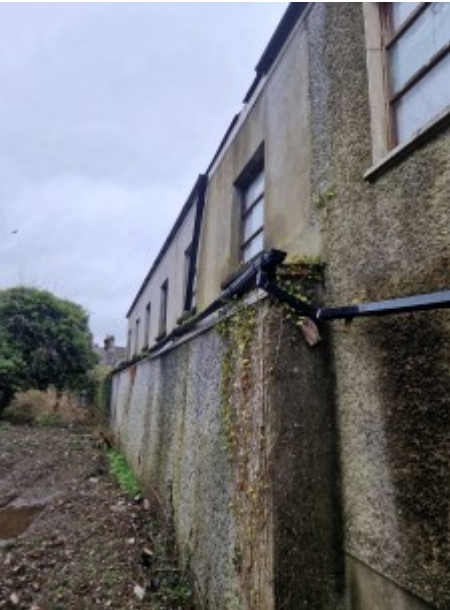
# 001 / 030

Damaged gutters and downpipes which require replacement.

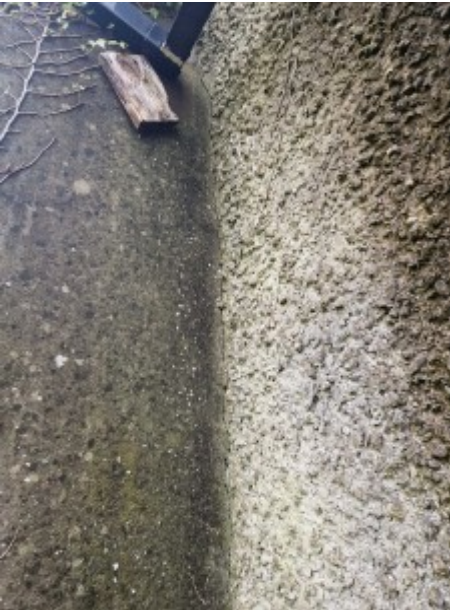
# 001 / 032

Side wall steps out which may indicate that building was constructed inside old stone boundary wall. Vertical crack at junction of wall step out.

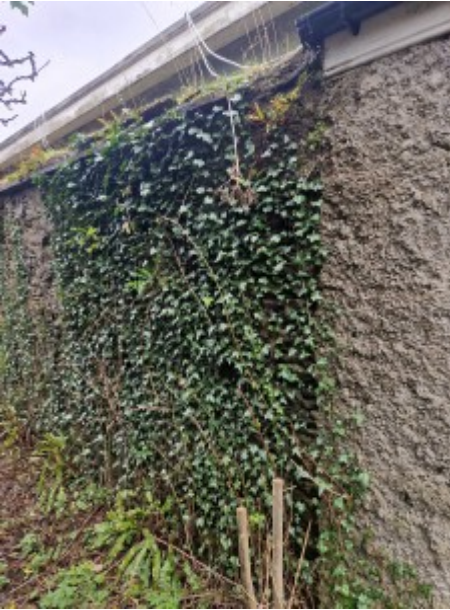
# 001 / 033

Old Stone boundary wall along flat roof section to front of theatre.

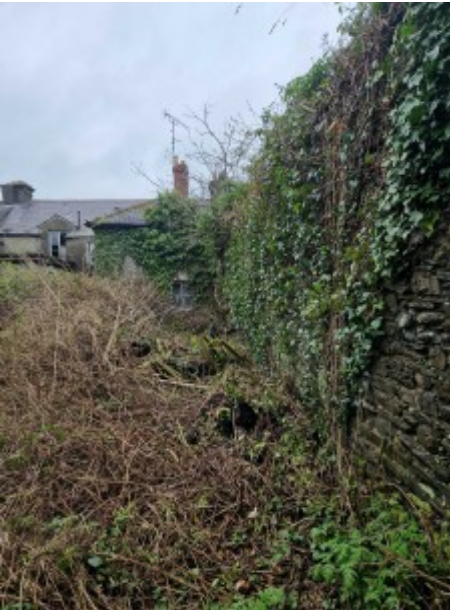
# 001 / 034

Vegitation on old stone boundary.

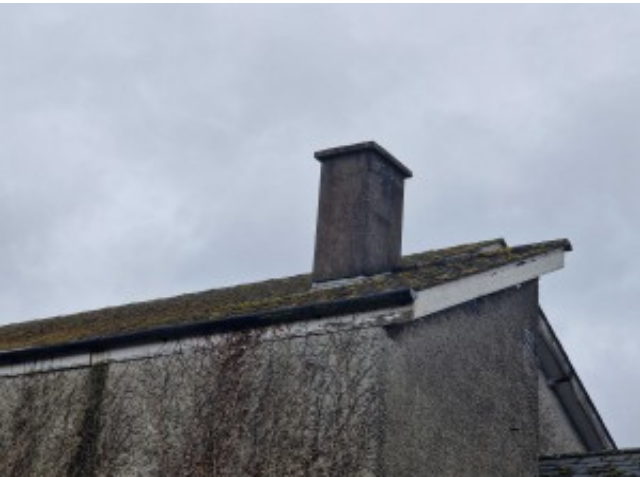
# 001 / 036

Chimney which serves oil boiler. Heavy moss growth on roof slates which may contain asbestos. Note timber fascia board which is in need of replacement.

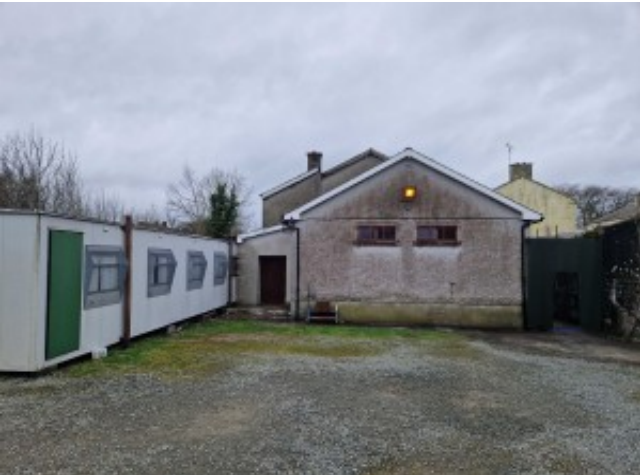
# 001 / 038

Rear elevation with modular building.

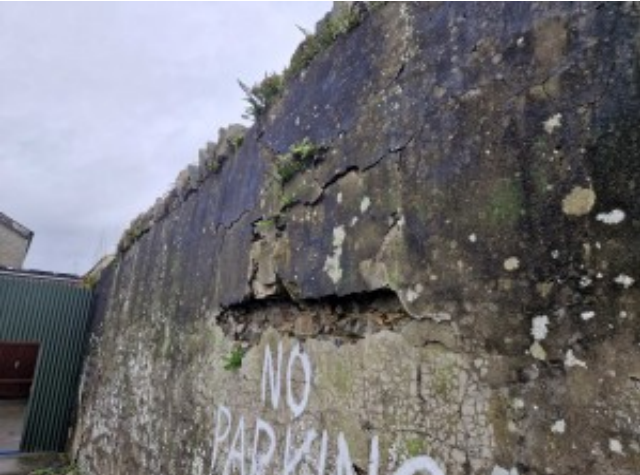
# 001 / 039

Damaged stone boundary wall to be partially rebuilt to Eastern Boundary to rear of site.

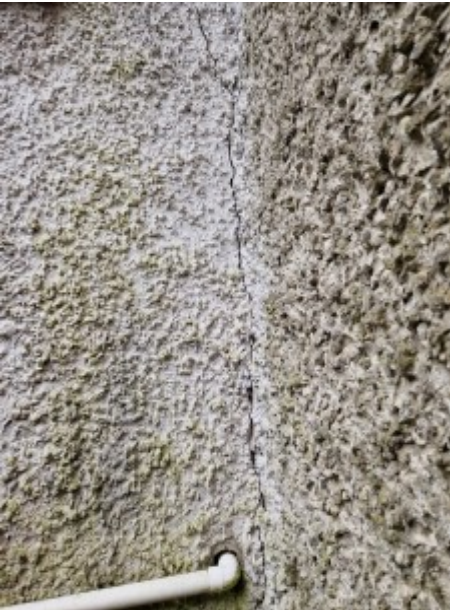
# 001 / 042

Vertical crack at junction of rear extension beside rear fire exit.

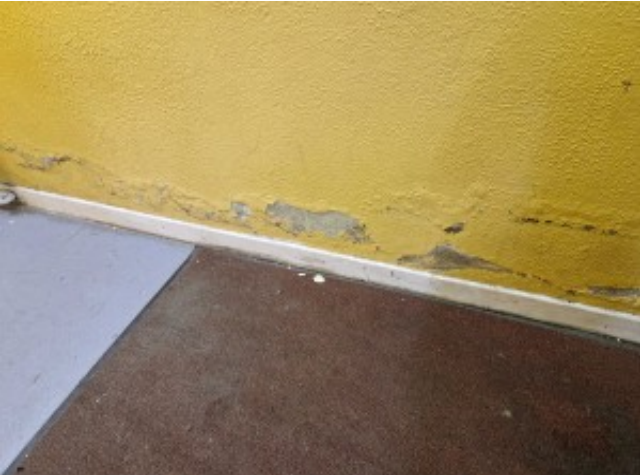
# 001 / 043

2. There is some rising damp evident to wall along eastern boundary which may be due to lack of damp proof course to walls.
3. There is significant moss growth on roof slates which may indicate that slates contain asbestos, slates should be tested if considering replacement. There is no visible signs of deflection of main roof structure however access should be provided to high level attic space to inspect roof timbers. There is a leak evident to the flat roof to the front over toilets. The roof timbers will require further inspection and roof deck, insulation, flashings and flat roof covering may require replacement.

Comment  
Evidence of rising damp to eastern boundary wall to rear of property.

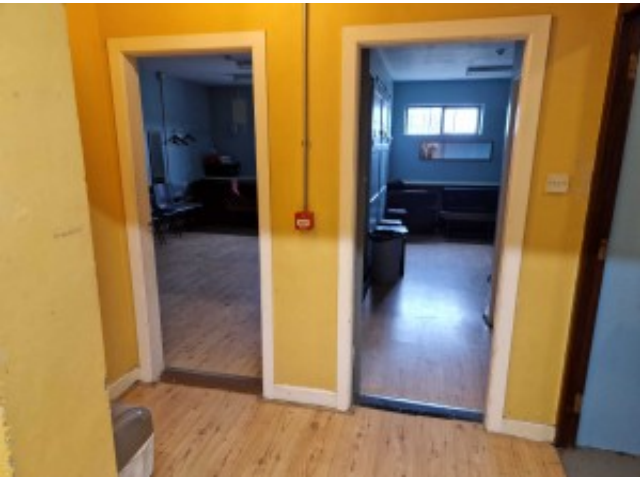
# 001 / 046

Comment  
Rear changing rooms to rear extension with concrete floors which are at same level as stage.

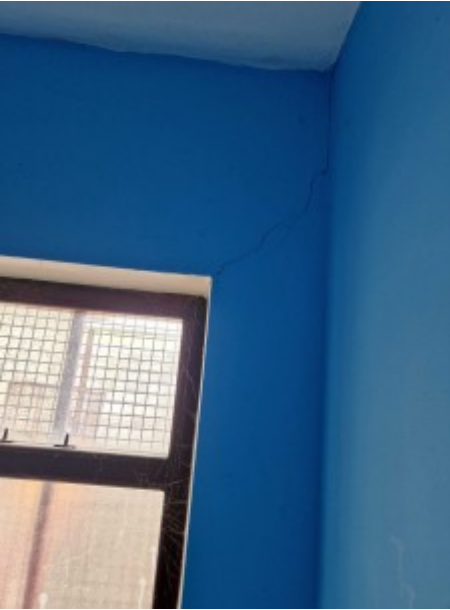
# 001 / 047

Crack internally to extension and external walls are approx 300mm wide which may be of cavity wall construction.

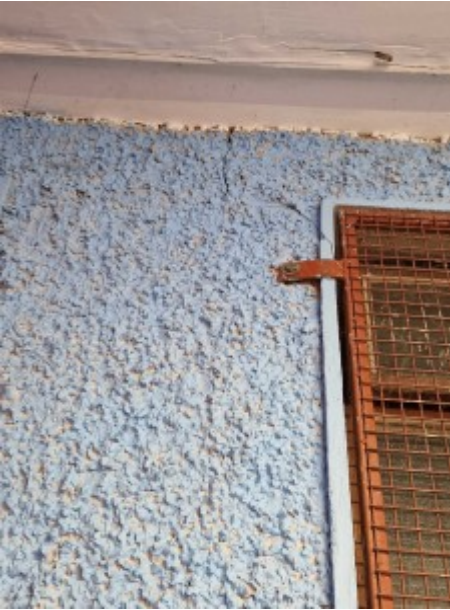
# 001 / 049

Crack to other side of extension which would indicate differential settlement of extension. Cracking appears to be historic and tell-tale crack monitor to be installed to ensure movement has ceased prior to filling.

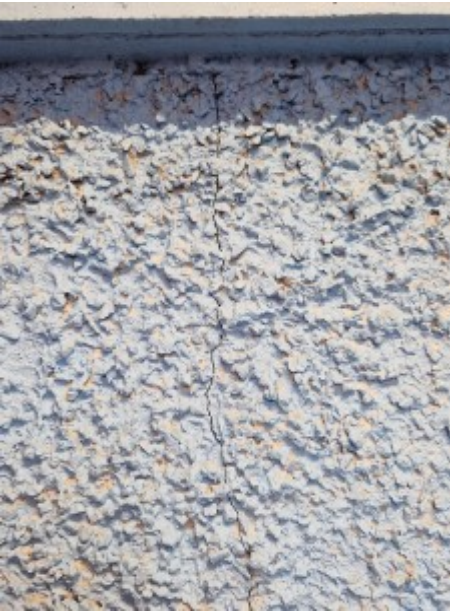
# 001 / 050

Crack extends below cill level.

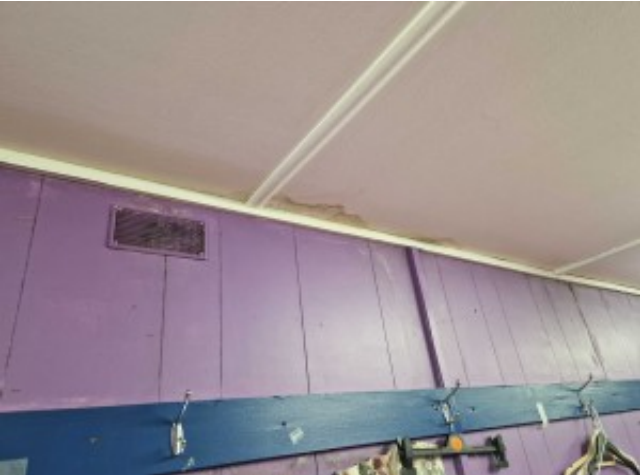
# 001 / 053

Comment  
Leaks to roof of modular unit.

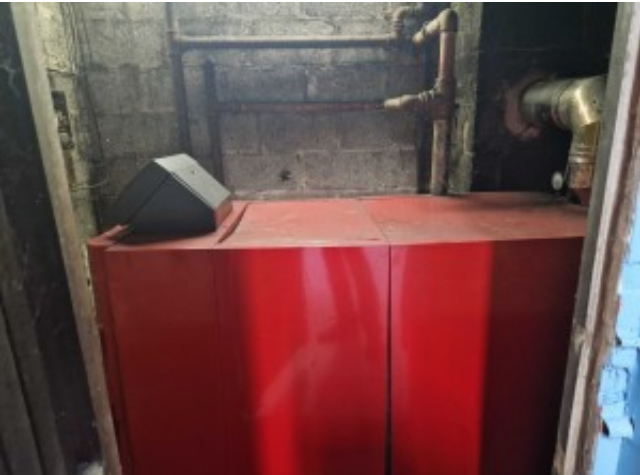
# 001 / 054

Comment  
Oil boiler to rear vented to escape corridor with no fire enclosure provided.  
This area should be fire sealed with fire doors fitted and area vented to external wall. Plumbing installation to be inspected by suitably qualified plumber.

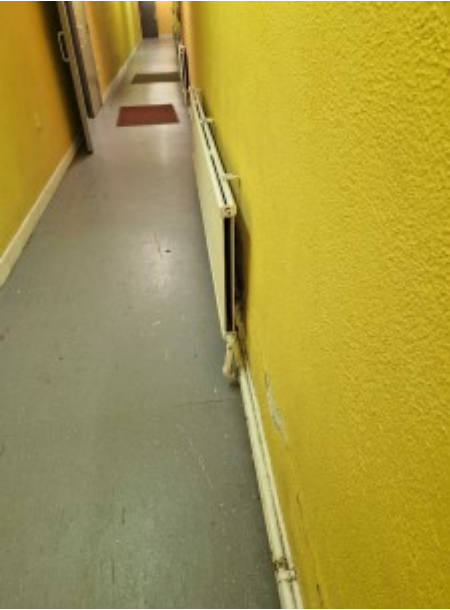
# 001 / 059

Comment  
Some heating pipework may be of old gun barrel pipework which is prone to leaks and should be replaced where possible. Plumbing installation to be inspected by suitably qualified plumber.

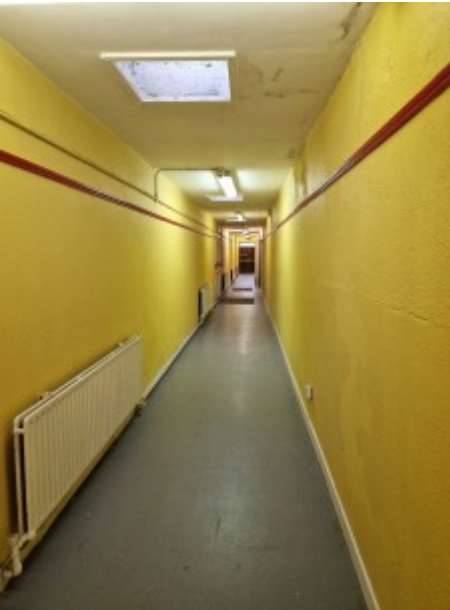
# 001 / 060

Comment  
Damp staining to ceiling of corridor which may indicate damaged flat roof covering and/or inadequate insulation.

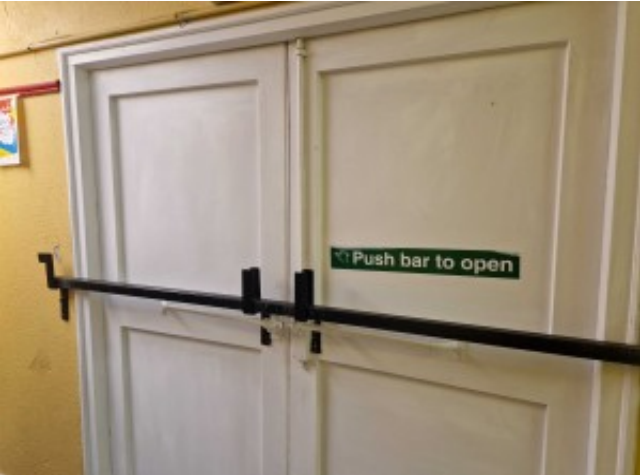
# 001 / 061

Fire exit to side circulation corridor. Steel security bars over fire exit doors which would not permitted under Part B (fire) of building regulations. Bars should be removed when property is in use.

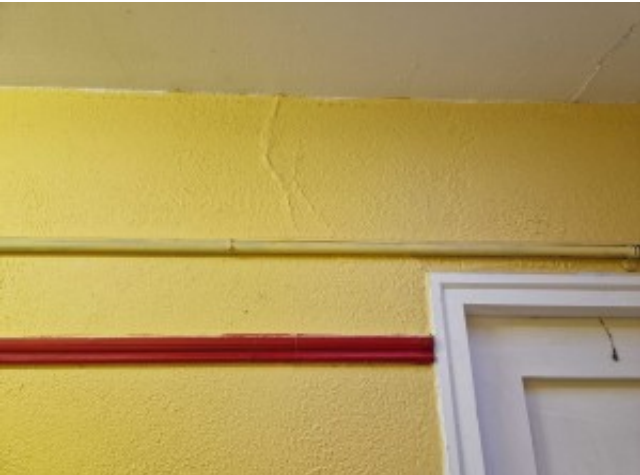
# 001 / 062

Historic cracking evident to external wall.

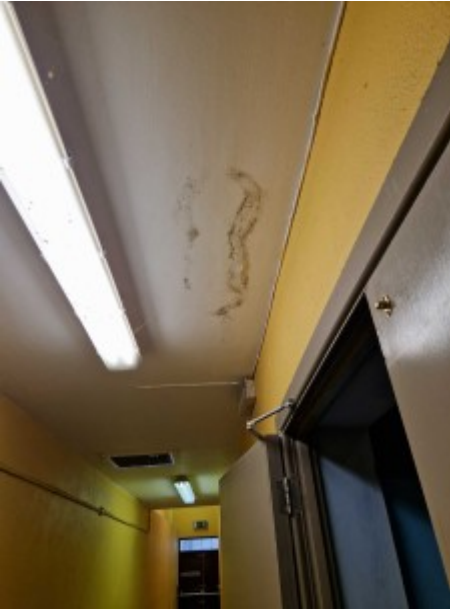
# 001 / 063

Comment  
Damp staining to ceiling of corridor which may indicate damaged flat roof covering and/or inadequate insulation.

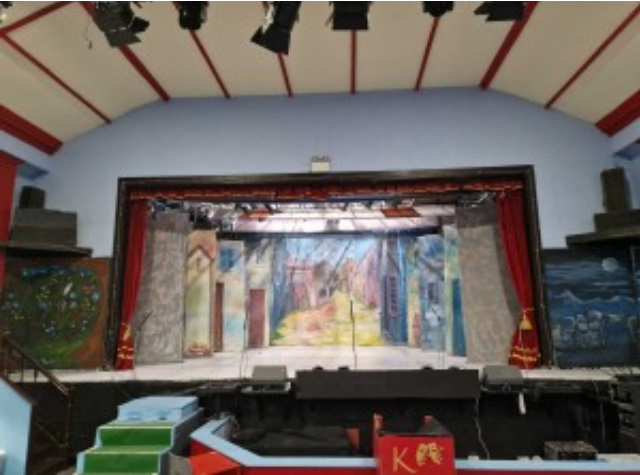
# 001 / 064

Comment  
Stage area and decorative ceiling to theatre.

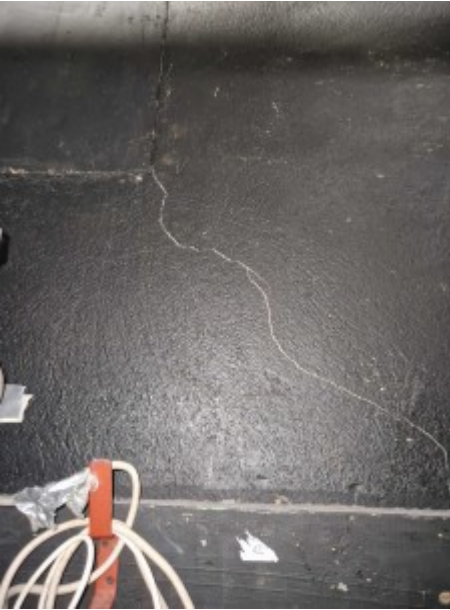
# 001 / 065

Comment  
Corresponding crack internally along western boundary wall at stage area.

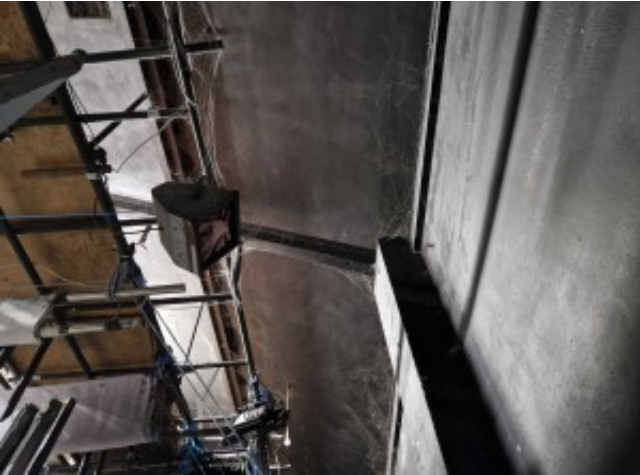
# 001 / 066

Comment  
Pitched roof of theatre appears to be of steel rafter with intermediate purlin. It is not possible to inspect roof timber and insulation and opening up works to be carried out to determine size and condition of roof timbers.

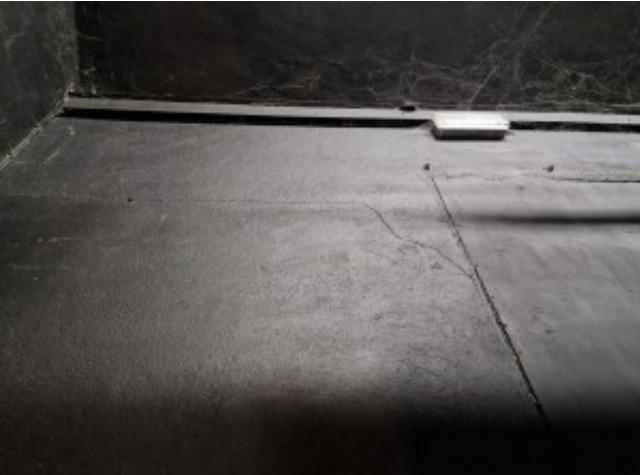
# 001 / 067

Comment  
Crack extends to roof level. Window openings have been sheeted internally.

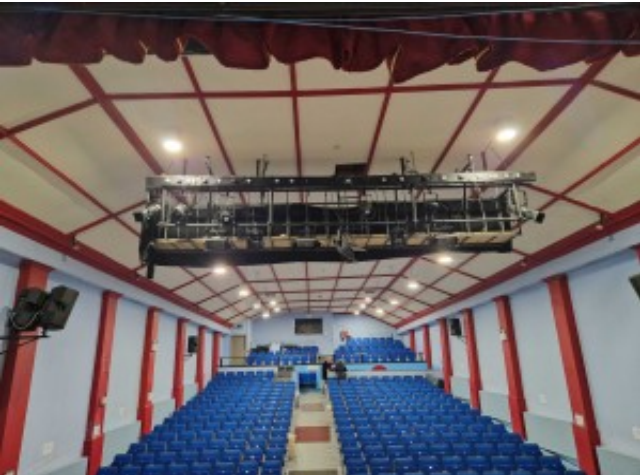
# 001 / 068

Comment  
Columns provided to external walls of theatre which may contain steel columns enclosed in blockwork.

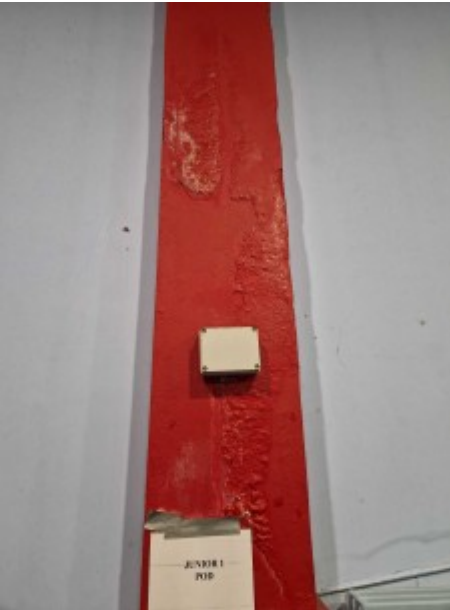
# 001 / 070

Damp penetration at columns internally which may be due to damaged and leaking gutters down external facade along the western boundary.

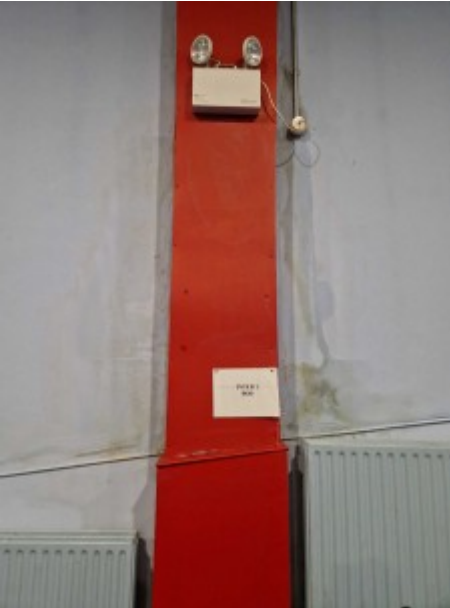
# 001 / 071

Comment  
Damp penetration at columns internally which may be due to damaged and leaking gutters down external facade along the western boundary.

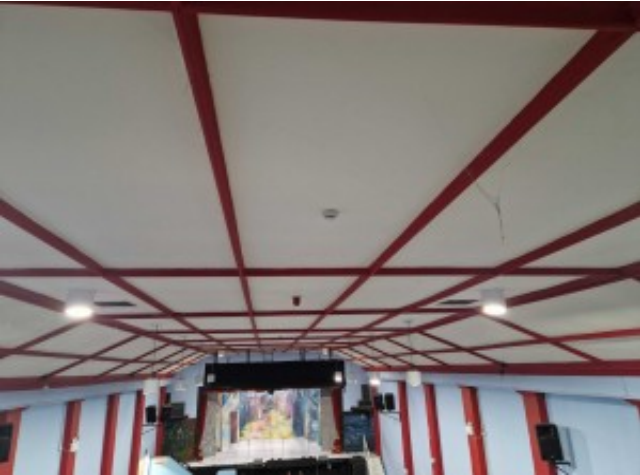
# 001 / 072

Comment  
No access obtained to high level attic space to inspect roof structure and insulation. No significant deflection observed externally to roof structure.

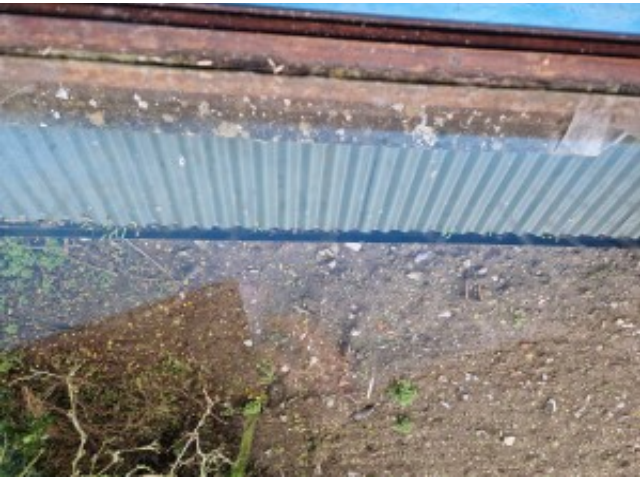
# 001 / 074

Comment  
Top of old stone boundary wall along western boundary covered in single skin sheeting to prevent damp penetration.

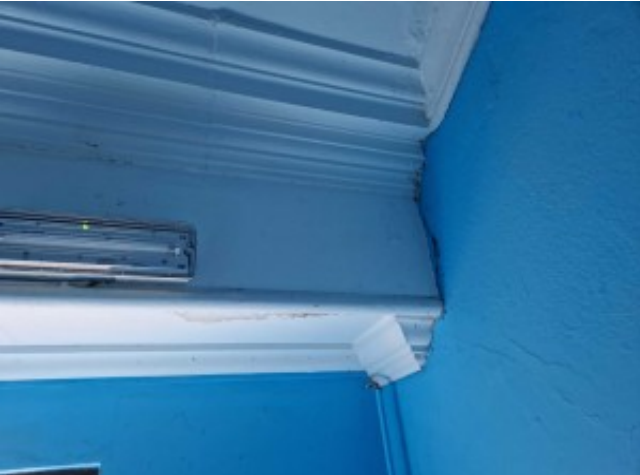
# 001 / 075

Comment  
Some damp staining to decorative coving

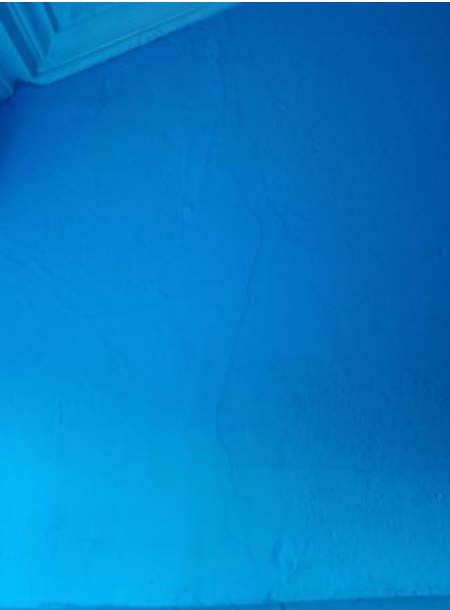
# 001 / 076

Comment  
Map cracking to internal wall. Boast render to be removed and crack stitched with Ancon Helibar and rendered.

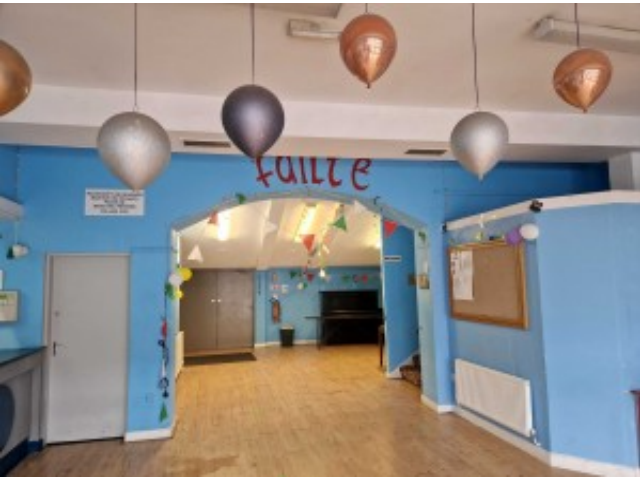
# 001 / 078

Comment  
Entrance foyer with flat roof structure over.

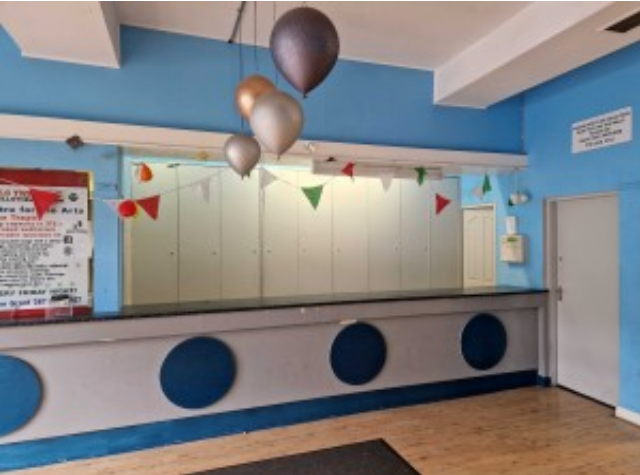
# 001 / 079

Comment  
Cloak/ticket desk with beams/structure over to support flat roof structure.

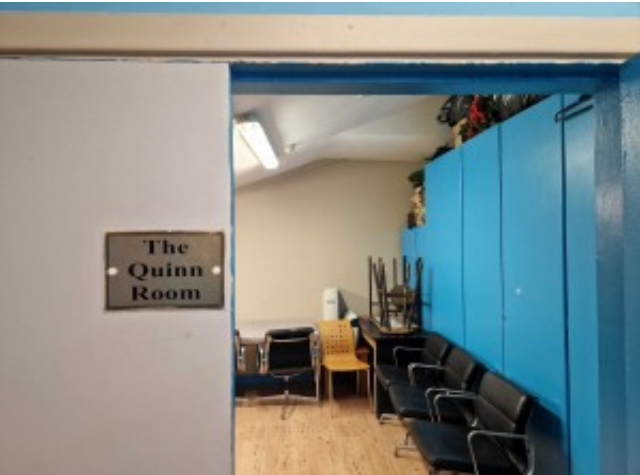
# 001 / 080

Comment  
Storage area under raked theatre seating.

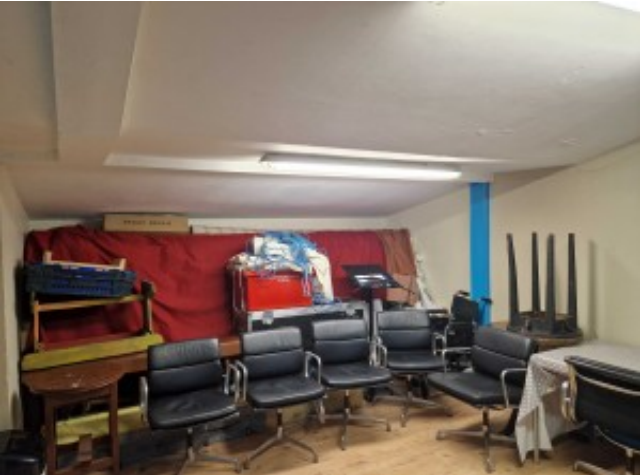
# 001 / 081

Comment  
Steel columns and beams evident to support raked theatre seating. Ceiling to be checked to ensure adequately fire rated.

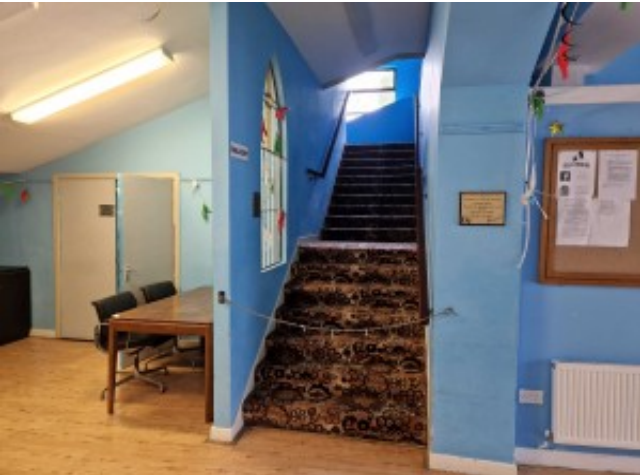
# 001 / 082

Comment  
Concrete stairs from toilets to theatre. Assumed alternative fire escape route.

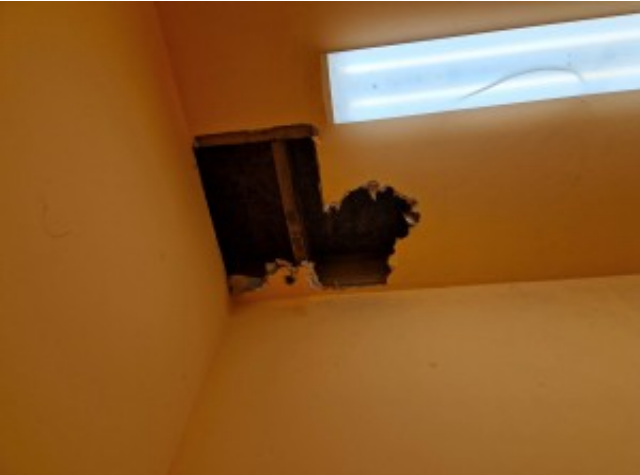
# 001 / 083

Hole in ceiling over female toilets which indicates timber joists with no insulation present. Flat roof covering, flashings and insulation to be checked.

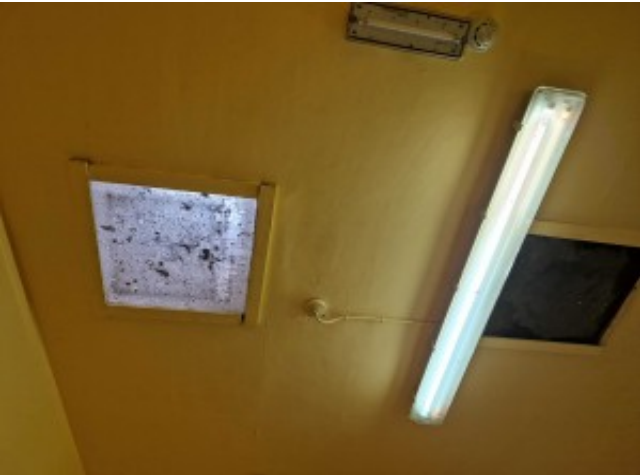
# 001 / 084

Comment  
Rooflight to toilet area.

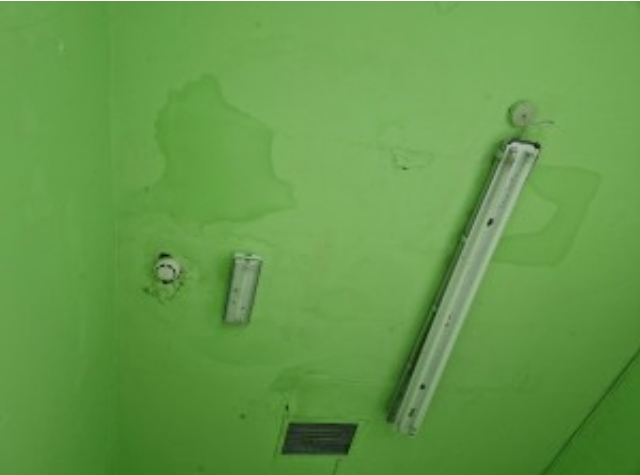
# 001 / 085

Comment  
Damp staining to ceiling of male toilets. Flat roof covering, flashings and insulation to be checked.
