## St Enda's Graiguecullen, Carlow Town

Client: Carlow County Council  
Project Title: St Endas  
Title of Document: Structural Survey Report

Date: 24/04/2026  
Document No: 26009-X-X-X-RP-TA-SE-9001  
Issue: Rev 0

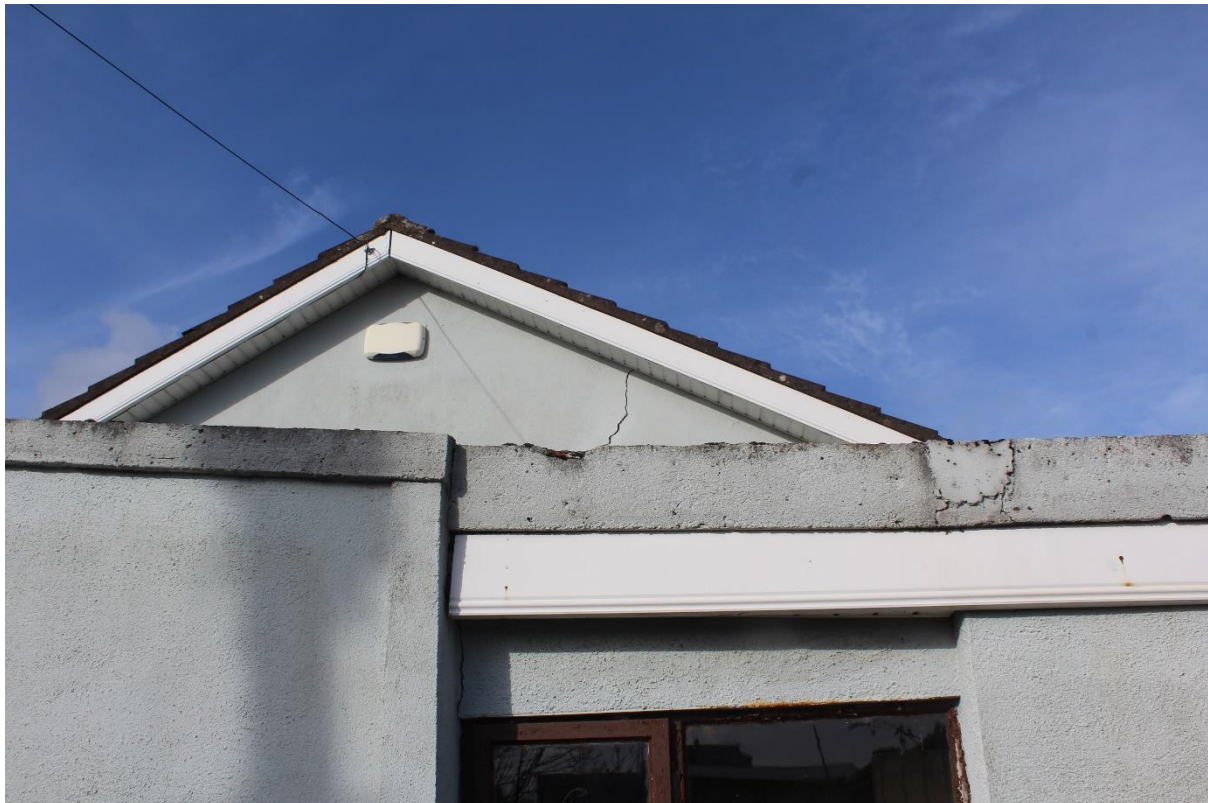
Structural Cracking was identified on both gable walls. The Structural cracking was also visible in the attic space on the Southern Gable. The structural cracking range between 4mm to 5mm in width. The structural cracks were larger in width at the top of the wall in comparison to the base of the wall. This would indicate the cracking is due to forces/movement at roof level rather than foundation level.

TA Group are of the opinion that the structural cracking is due to excessive loadings from the Roof, namely the roof purlins. See fig 1 to fig 6.

Fig 1 (Southern gable, above flat roof garage due for demolition).

1. Structural crack repair by means of helifix-bar to the joints of blockwork on each gable.
2. Introduction of a precast pad stone to at loading point from the purlin.
3. Increase Purlin size and or increased the number of supporting struts
4. Localised repair to roof membrane (replacement in full if budget requirements allow)

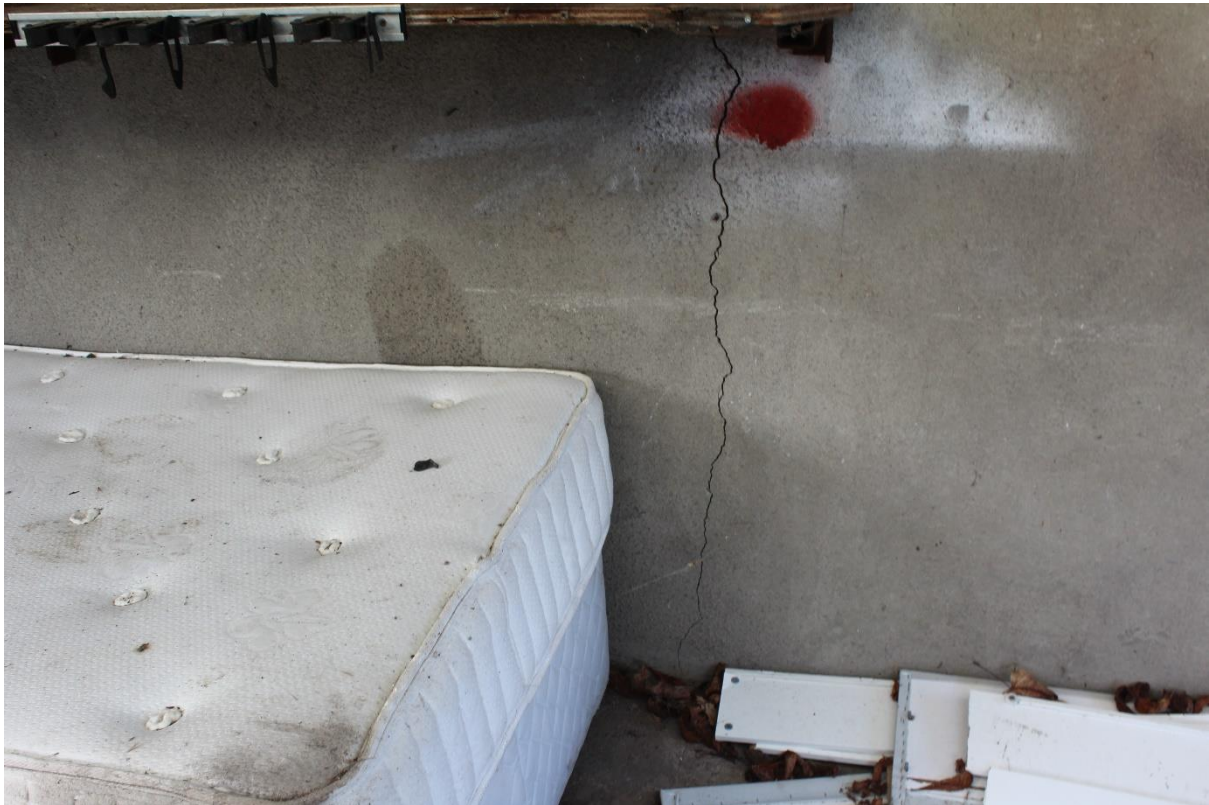
Fig 2 (Southern gable, taken from inside flat roof garage due for demolition)

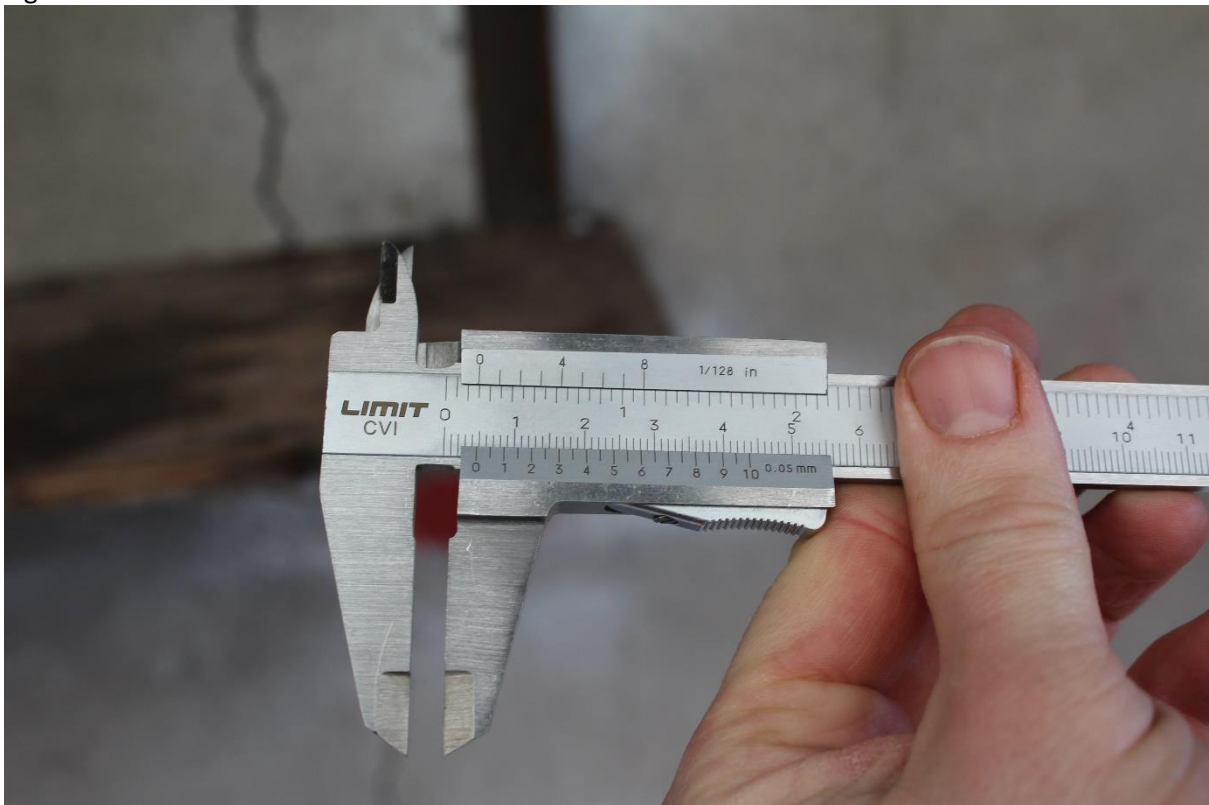
Fig 3 – Measurement of crack

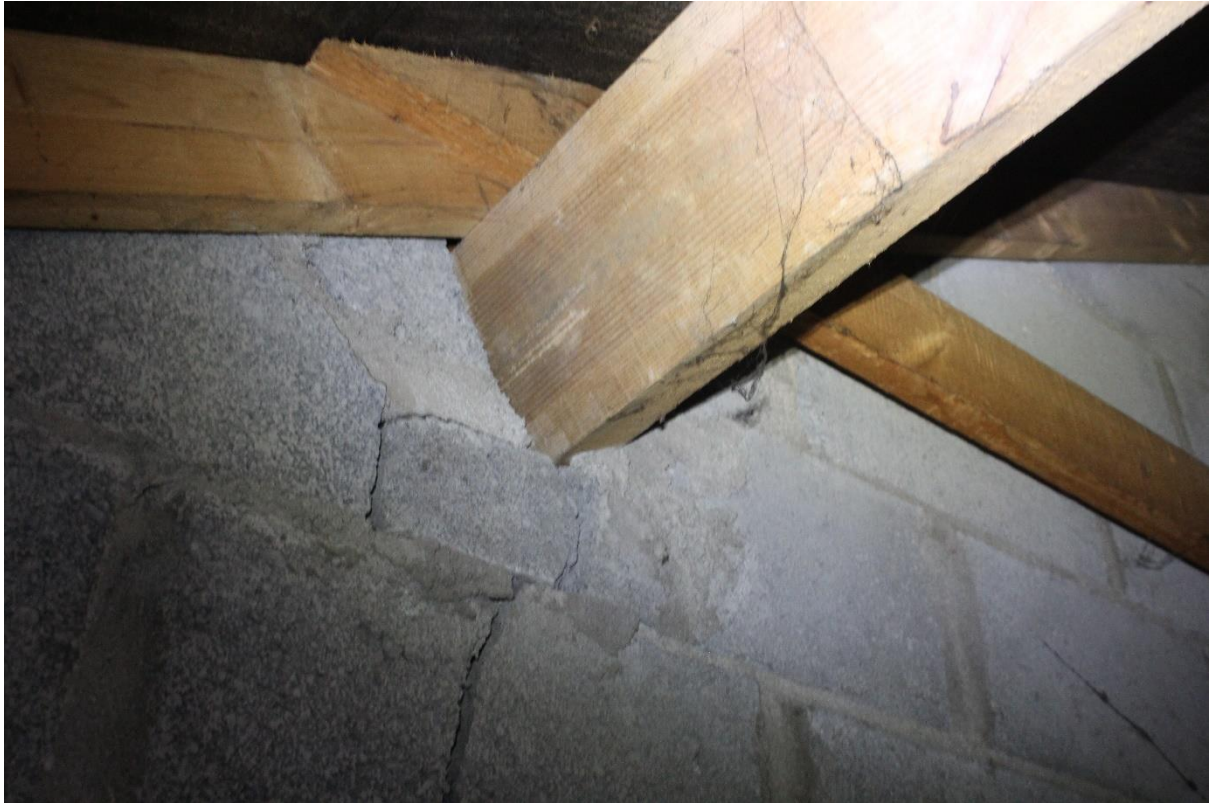
Fig 4 – Cracking to blockwork due to excessive loadings from purlin (southern gable)

The structural cracking to the gable walls is due to the lack of support to the Purlins and/or the under sizing of the purlins.

1. Double the number of Struts supporting the purlins. (See fig 7)
2. Double the number of Collar ties (See fig 7)
3. Use of helifix-bar to repair the inner leaf and outer leaf blockwork to each gable. The inclusion of a pad stone/bearing pad under each end of the purlin. (See fig 8&9)

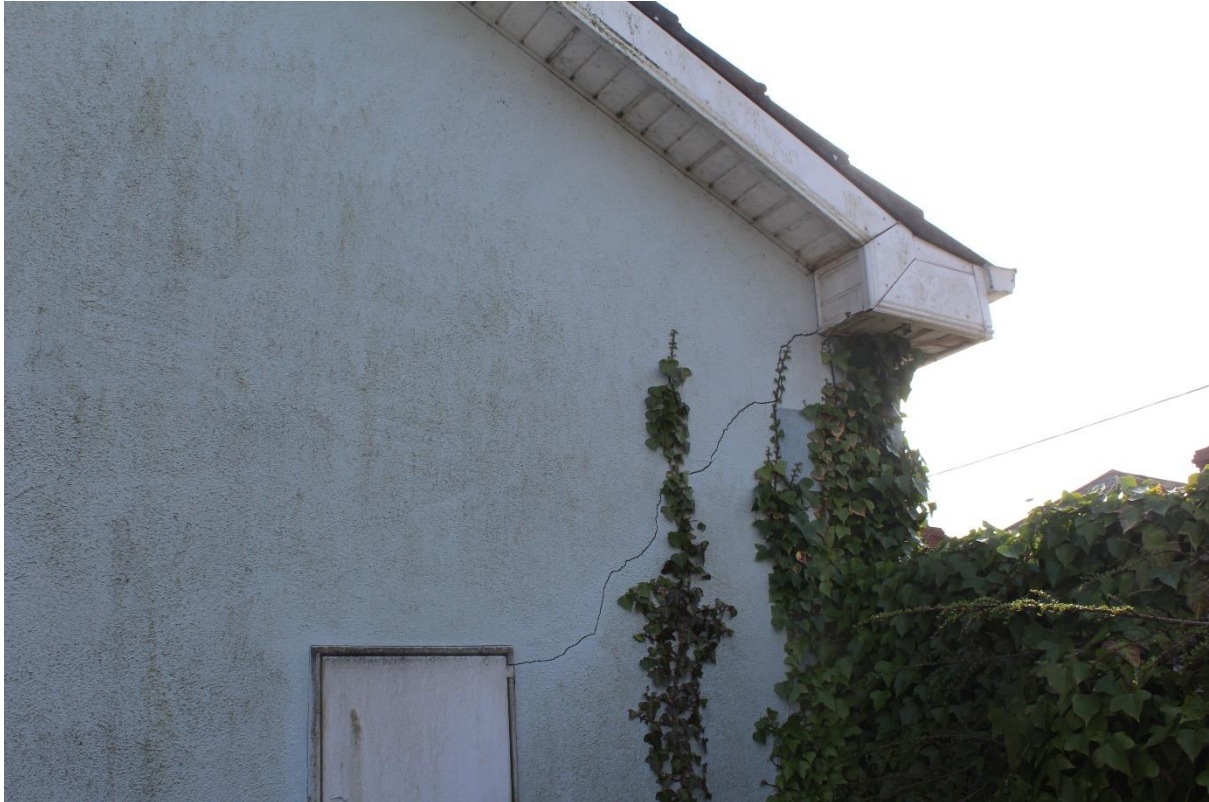
Fig 5 – Northern gable visible cracking externally

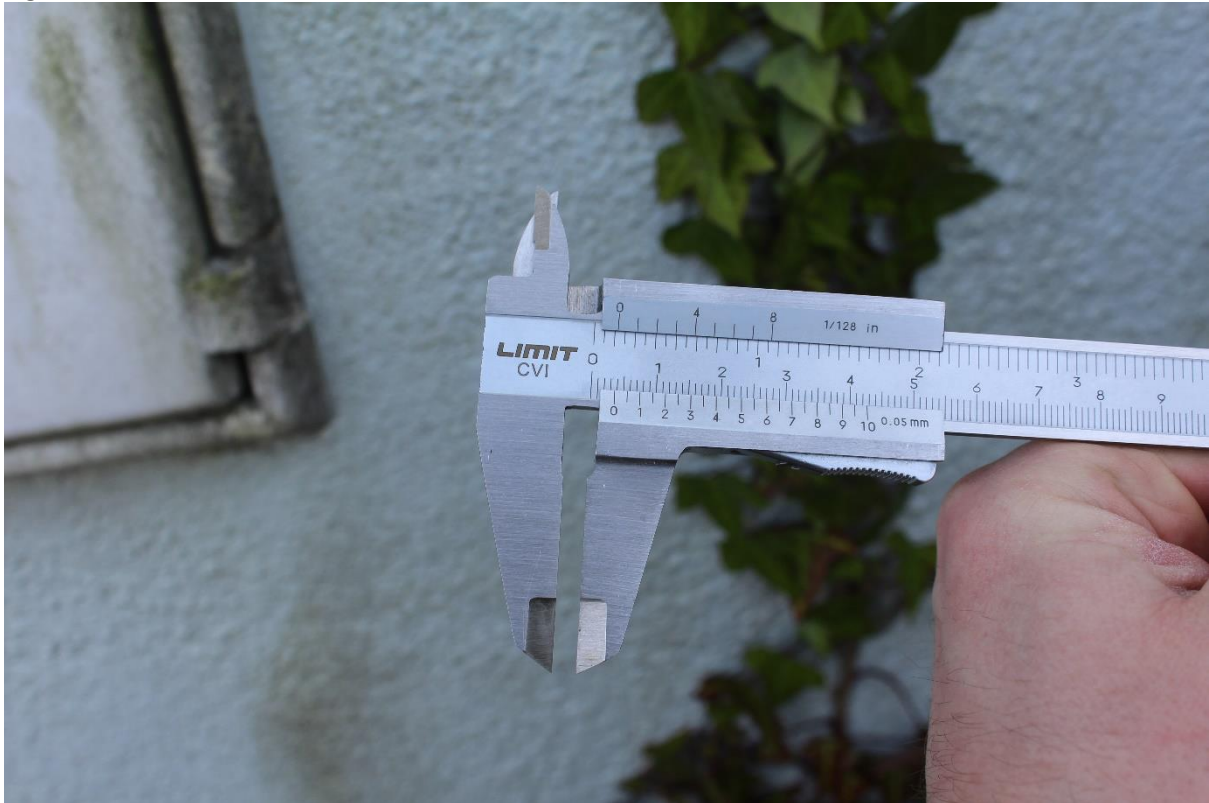
Fig 6 – Crack dimension

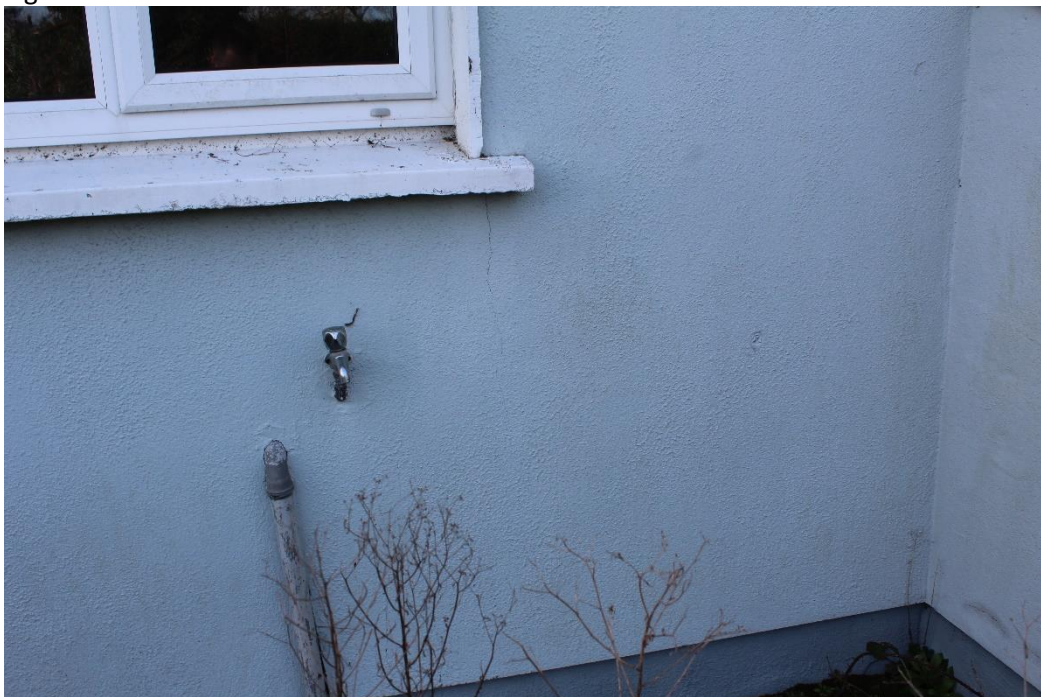
Fig 11

2. Localised settlement/movement cracking below window cills (see fig 11)
