# ASBESTOS REFURBISHMENT SURVEY REPORT

Old Guard Building

Finner Camp

| <b>Document Title</b> | Asbestos Refurbishment Report |

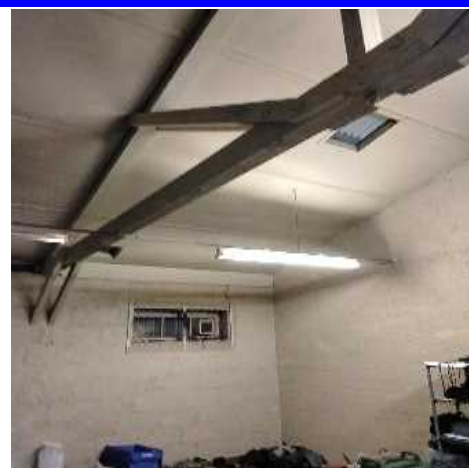
## Location Details : 150538 No Asbestos Found

Building/Area : Old Gaurd Building Finner Camp  
 Room/Section : Store room 1  
 Location : Walls, floor and ceiling  
 Description : Block, timber, concrete  
 Sample No. :  
 Confirmation :  
 Access : Full Access  
 Normal Use :  
 Recommendations :  
 Notes :

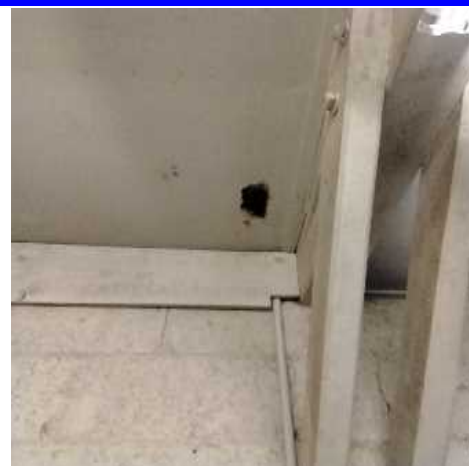
## Location Details : 150539 No Asbestos Found

Building/Area : Old Gaurd Building Finner Camp  
 Room/Section : Store room 1  
 Location : Above timber ceiling  
 Description : Galvanised metal roof  
 Sample No. :  
 Confirmation :  
 Access : Full Access  
 Normal Use :  
 Recommendations :  
 Notes :

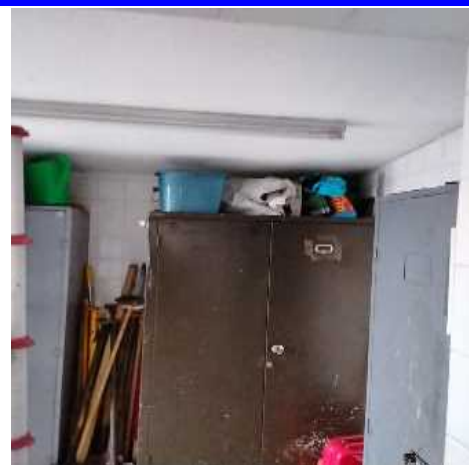
## Location Details : 150540 No Asbestos Found

Building/Area : Old Gaurd Building Finner Camp  
 Room/Section : Entrance to gardener shed  
 Location : Walls and ceiling  
 Description : Block, timber, concrete  
 Sample No. :  
 Confirmation :  
 Access : Full Access  
 Normal Use :  
 Recommendations :  
 Notes :

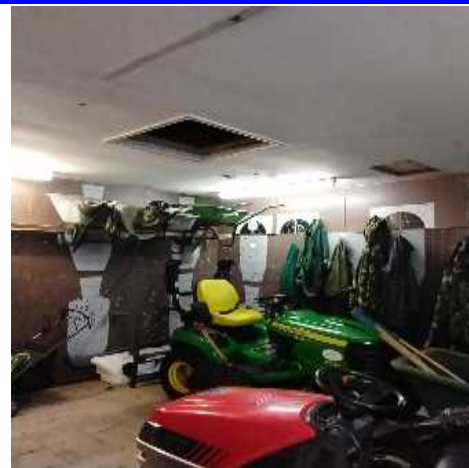
## Location Details : 150541 No Asbestos Found

Building/Area : Old Gaurd Building Finner Camp  
 Room/Section : Gardener shed  
 Location : Walls and ceiling  
 Description : Block, timber, concrete  
 Sample No. :  
 Confirmation :  
 Access : Full Access  
 Normal Use :  
 Recommendations :  
 Notes :

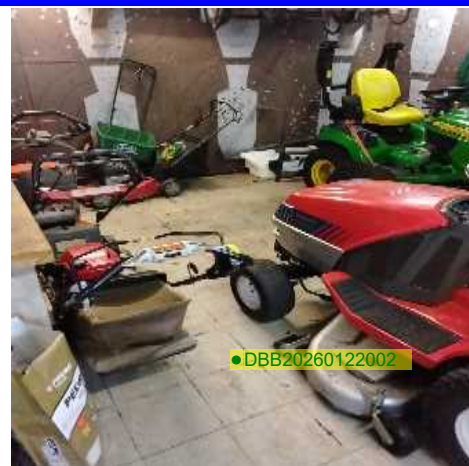
## Location Details : 150542 No Asbestos Found

Building/Area : Old Gaurd Building Finner Camp  
 Room/Section : Gardener shed  
 Location : Floor  
 Description : White floor tiles and adhesive  
 Sample No. : DBB20260122002  
 Confirmation : Sampled  
 Access : Full Access  
 Normal Use :  
 Recommendations :  
 Notes :

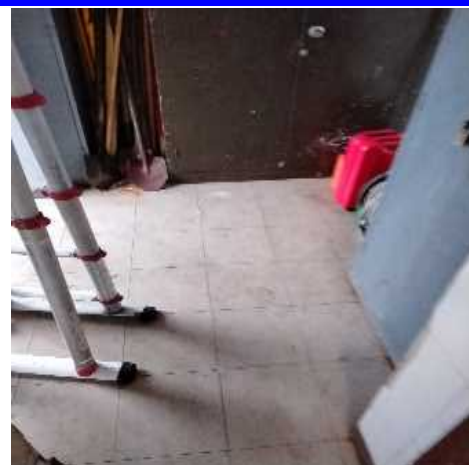
## Location Details : 150543 No Asbestos Found

Building/Area : Old Gaurd Building Finner Camp  
 Room/Section : Entrance to Gardener shed  
 Location : Floor  
 Description : White floor tiles and adhesive  
 Sample No. : DBB20260122002  
 Confirmation : Sampled  
 Access : Full Access  
 Normal Use :  
 Recommendations :  
 Notes :

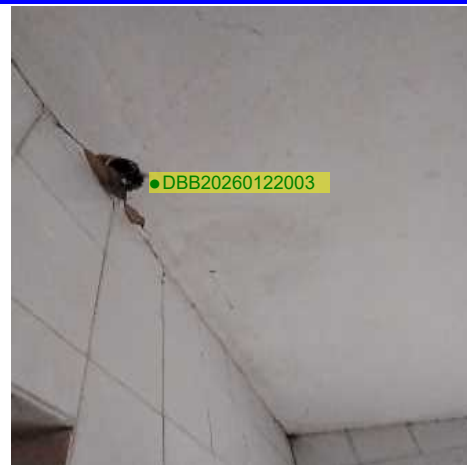
## Location Details : 150544 No Asbestos Found

Building/Area : Old Gaurd Building Finner Camp  
 Room/Section : All rooms  
 Location : Ceiling above plaster  
 Description : Felt  
 Sample No. : DBB20260122003  
 Confirmation : Sampled  
 Access : Full Access  
 Normal Use :  
 Recommendations :  
 Notes :

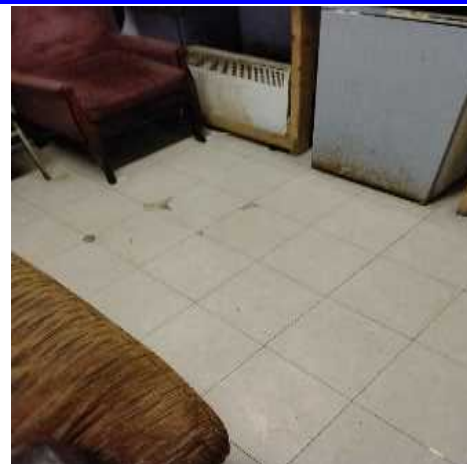
## Location Details : 150545 No Asbestos Found

Building/Area : Old Gaurd Building Finner Camp  
 Room/Section : Gardener shed break room  
 Location : Floor  
 Description : White floor tiles and adhesive  
 Sample No. : DBB20260122002  
 Confirmation : Sampled  
 Access : Full Access  
 Normal Use :  
 Recommendations :  
 Notes :

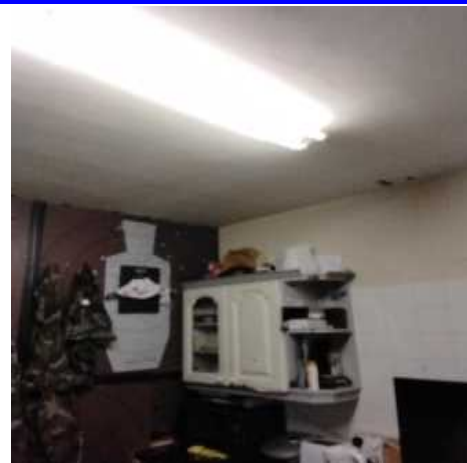
## Location Details : 150546 No Asbestos Found

Building/Area : Old Gaurd Building Finner Camp  
 Room/Section : Gardener shed break room  
 Location : Walls and ceiling  
 Description : Block, timber, concrete  
 Sample No. :  
 Confirmation :  
 Access : Full Access  
 Normal Use :  
 Recommendations :  
 Notes :

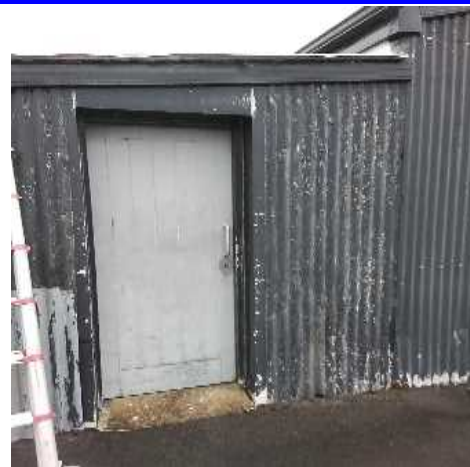
## Location Details : 150548 No Asbestos Found

Building/Area : Old Gaurd Building Finner Camp  
 Room/Section : Entrance to Gardener shed  
 Location : External cladding.  
 Description : Galbestos  
 Sample No. : DBB20260122010  
 Confirmation : Sampled  
 Access : Full Access  
 Normal Use :  
 Recommendations :  
 Notes :

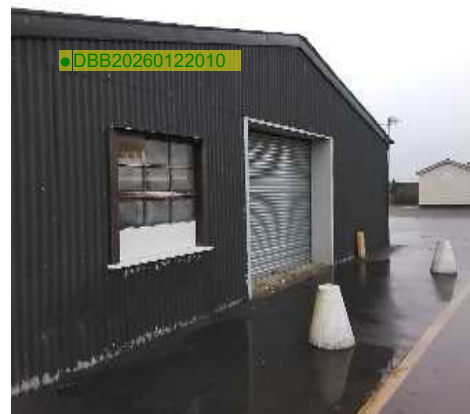
## Location Details : 150549 No Asbestos Found

Building/Area : Old Gaurd Building Finner Camp  
 Room/Section : Entrance to Gardener shed  
 Location : External cladding.  
 Description : Galbestos  
 Sample No. : DBB20260122010  
 Confirmation : Sampled  
 Access : Full Access  
 Normal Use :  
 Recommendations :  
 Notes :

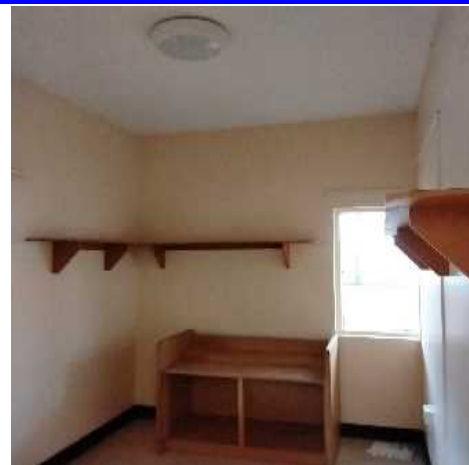
## Location Details : 150553 No Asbestos Found

Building/Area : Old Gaurd Building Finner Camp  
 Room/Section : Office 1  
 Location : Walls, and ceiling  
 Description : Block, plaster,  
 Sample No. :  
 Confirmation :  
 Access : Full Access  
 Normal Use :  
 Recommendations :  
 Notes :

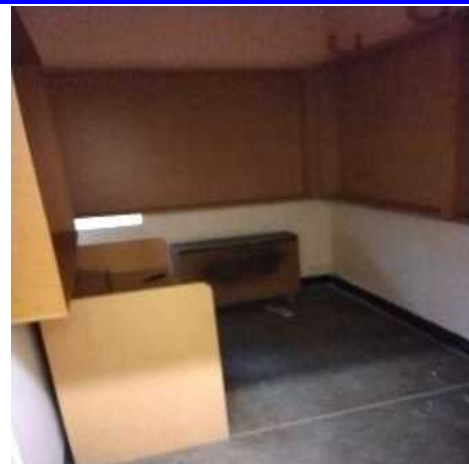
## Location Details : 150554 No Asbestos Found

Building/Area : Old Gaurd Building Finner Camp  
 Room/Section : Office 2  
 Location : Walls, floor, and ceiling  
 Description : Block, plaster,  
 Sample No. :  
 Confirmation :  
 Access : Full Access  
 Normal Use :  
 Recommendations :  
 Notes :

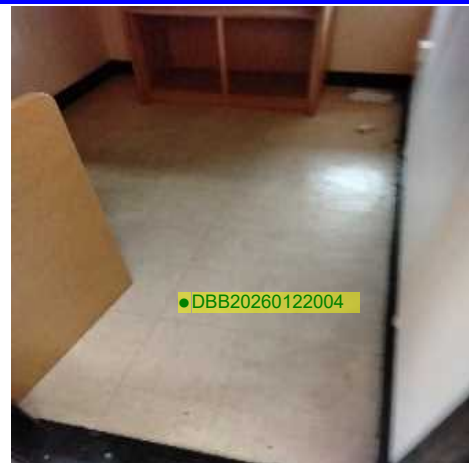
## Location Details : 150555 No Asbestos Found

Building/Area : Old Gaurd Building Finner Camp  
 Room/Section : Office 1  
 Location : Floor  
 Description : Beige vinyl tiles and adhesive  
 Sample No. : DBB20260122004  
 Confirmation : Sampled  
 Access : Full Access  
 Normal Use :  
 Recommendations :  
 Notes :

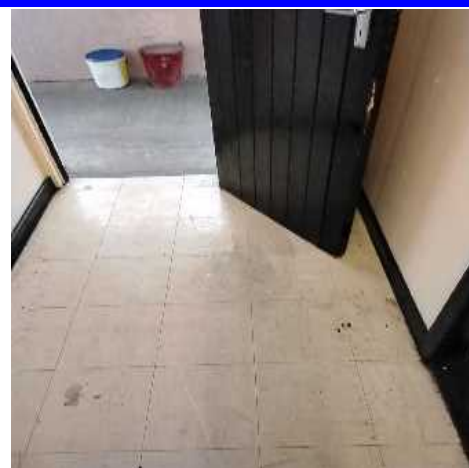
## Location Details : 150556 No Asbestos Found

Building/Area : Old Gaurd Building Finner Camp  
 Room/Section : Entrance to control room  
 Location : Floor  
 Description : Beige vinyl tiles and adhesive  
 Sample No. : DBB20260122004  
 Confirmation : Sampled  
 Access : Full Access  
 Normal Use :  
 Recommendations :  
 Notes :

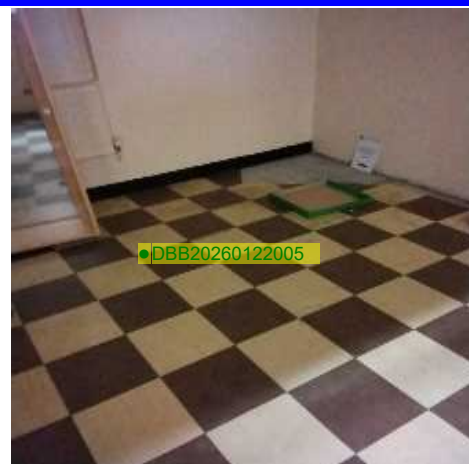
## Location Details : 150557 No Asbestos Found

Building/Area : Old Gaurd Building Finner Camp  
 Room/Section : Control room  
 Location : Floor  
 Description : Vinyl tiles and adhesive  
 Sample No. : DBB20260122005  
 Confirmation : Sampled  
 Access : Full Access  
 Normal Use :  
 Recommendations :  
 Notes :

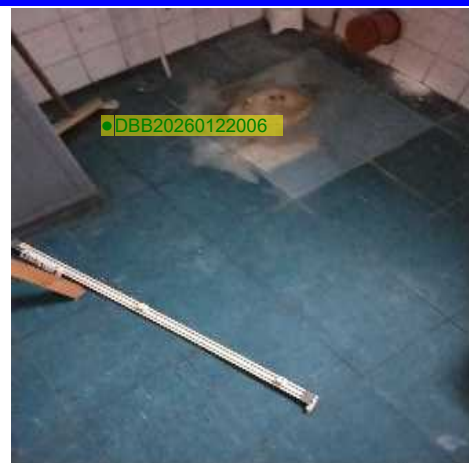
## Location Details : 150558 No Asbestos Found

Building/Area : Old Gaurd Building Finner Camp  
 Room/Section : Toilet  
 Location : Floor  
 Description : Blue vinyl tiles and adhesive  
 Sample No. : DBB20260122006  
 Confirmation : Sampled  
 Access : Full Access  
 Normal Use :  
 Recommendations :  
 Notes :

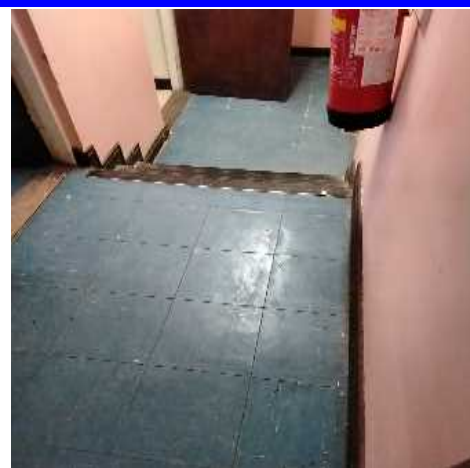
## Location Details : 150559 No Asbestos Found

Building/Area : Old Gaurd Building Finner Camp  
 Room/Section : Toilet corridor  
 Location : Floor  
 Description : Blue vinyl tiles and adhesive  
 Sample No. : DBB20260122006  
 Confirmation : Sampled  
 Access : Full Access  
 Normal Use :  
 Recommendations :  
 Notes :

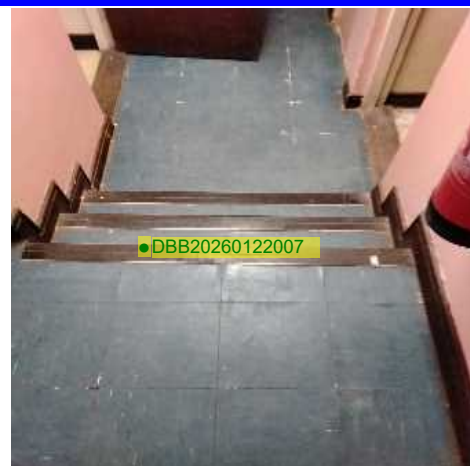
## Location Details : 150560 No Asbestos Found

Building/Area : Old Gaurd Building Finner Camp  
 Room/Section : Toilet corridor  
 Location : Steps  
 Description : Black nosing  
 Sample No. : DBB20260122007  
 Confirmation : Sampled  
 Access : Full Access  
 Normal Use :  
 Recommendations :  
 Notes :

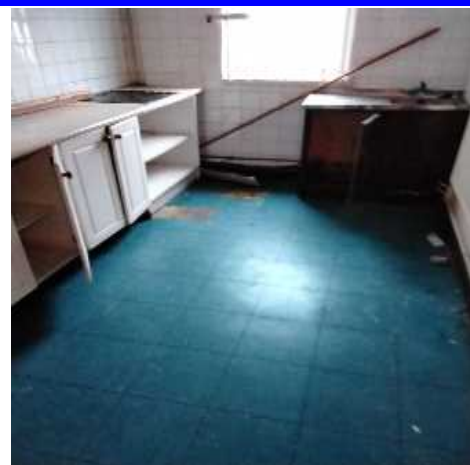
## Location Details : 150561 No Asbestos Found

Building/Area : Old Gaurd Building Finner Camp  
 Room/Section : Kitchen  
 Location : Floor  
 Description : Blue vinyl tiles and adhesive  
 Sample No. : DBB20260122006  
 Confirmation : Sampled  
 Access : Full Access  
 Normal Use :  
 Recommendations :  
 Notes :

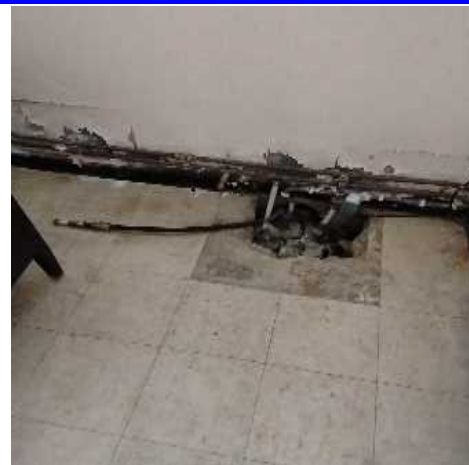
## Location Details : 150562 No Asbestos Found

Building/Area : Old Gaurd Building Finner Camp  
 Room/Section : Bedroom  
 Location : Floor  
 Description : Beige vinyl tiles and adhesive  
 Sample No. : DBB20260122004  
 Confirmation : Sampled  
 Access : Full Access  
 Normal Use :  
 Recommendations :  
 Notes :

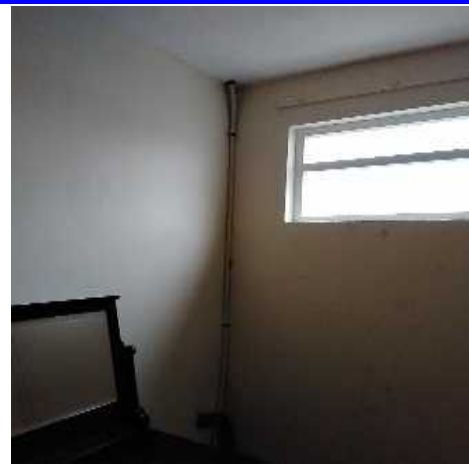
## Location Details : 150563 No Asbestos Found

Building/Area : Old Gaurd Building Finner Camp  
 Room/Section : Bedroom  
 Location : Walls and ceiling  
 Description : Block, plaster,  
 Sample No. :  
 Confirmation :  
 Access : Full Access  
 Normal Use :  
 Recommendations :  
 Notes :

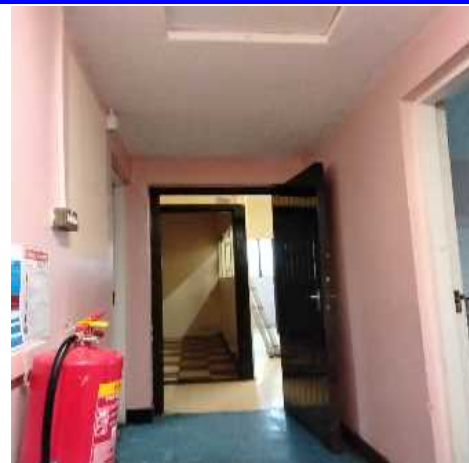
## Location Details : 150564 No Asbestos Found

Building/Area : Old Gaurd Building Finner Camp  
 Room/Section : Toilet corridor  
 Location : Walls, and ceiling  
 Description : Block, plaster,  
 Sample No. :  
 Confirmation :  
 Access : Full Access  
 Normal Use :  
 Recommendations :  
 Notes :

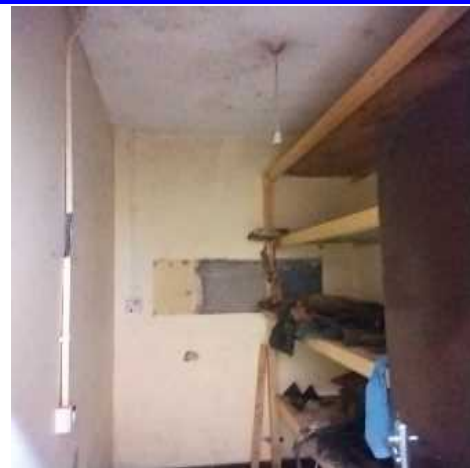
## Location Details : 150565 No Asbestos Found

Building/Area : Old Gaurd Building Finner Camp  
 Room/Section : Store room  
 Location : Walls, floor, and ceiling  
 Description : Block, plaster,  
 Sample No. :  
 Confirmation :  
 Access : Full Access  
 Normal Use :  
 Recommendations :  
 Notes :

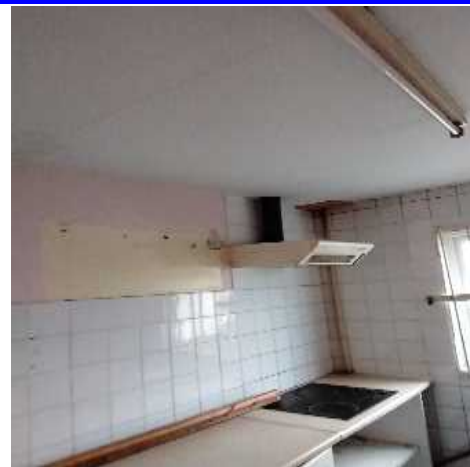
## Location Details : 150569 No Asbestos Found

Building/Area : Old Gaurd Building Finner Camp  
 Room/Section : Kitchen  
 Location : Walls, and ceiling  
 Description : Block, plaster,  
 Sample No. :  
 Confirmation :  
 Access : Full Access  
 Normal Use :  
 Recommendations :  
 Notes :

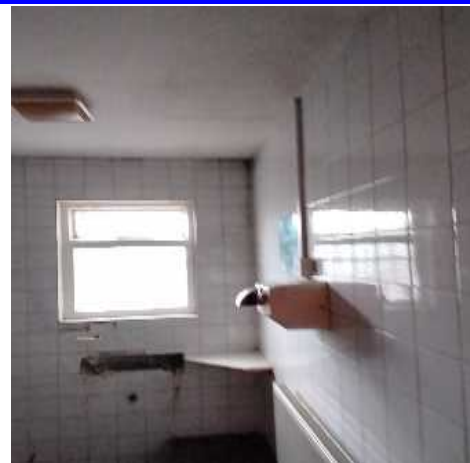
## Location Details : 150570 No Asbestos Found

Building/Area : Old Gaurd Building Finner Camp  
 Room/Section : Toilet  
 Location : Walls, and ceiling  
 Description : Block, plaster,  
 Sample No. :  
 Confirmation :  
 Access : Full Access  
 Normal Use :  
 Recommendations :  
 Notes :

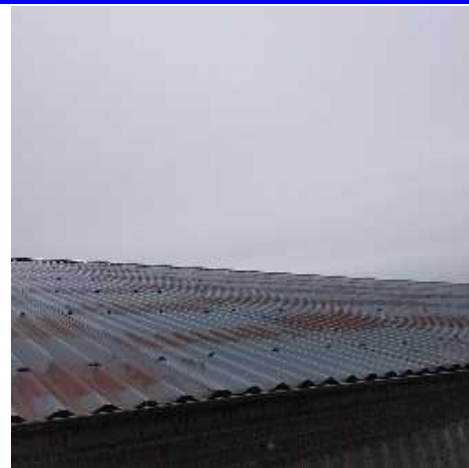
## Location Details : 150574 No Asbestos Found

Building/Area : Old Gaurd Building Finner Camp  
 Room/Section : Exterior  
 Location : Roof  
 Description : Metal  
 Sample No. :  
 Confirmation :  
 Access : Full Access  
 Normal Use :  
 Recommendations :  
 Notes :

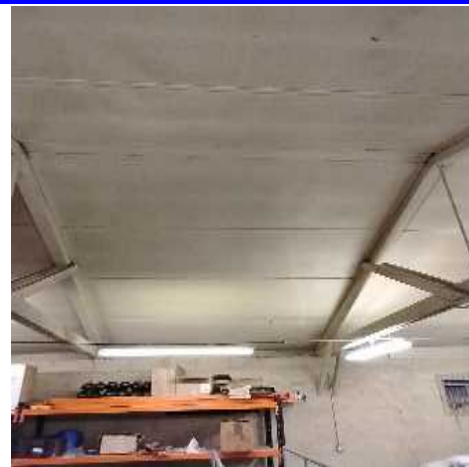
## Location Details : 150575 No Asbestos Found

Building/Area : Old Gaurd Building Finner Camp  
 Room/Section : Store room 2  
 Location : Above timber ceiling  
 Description : Galvanised metal roof  
 Sample No. :  
 Confirmation :  
 Access : Full Access  
 Normal Use :  
 Recommendations :  
 Notes :

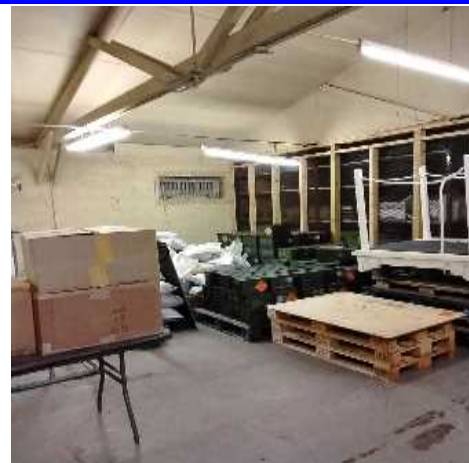
## Location Details : 150576 No Asbestos Found

Building/Area : Old Gaurd Building Finner Camp  
 Room/Section : Store room 2  
 Location : Walls, floor and ceiling  
 Description : Block, timber, concrete  
 Sample No. :  
 Confirmation :  
 Access : Full Access  
 Normal Use :  
 Recommendations :  
 Notes :

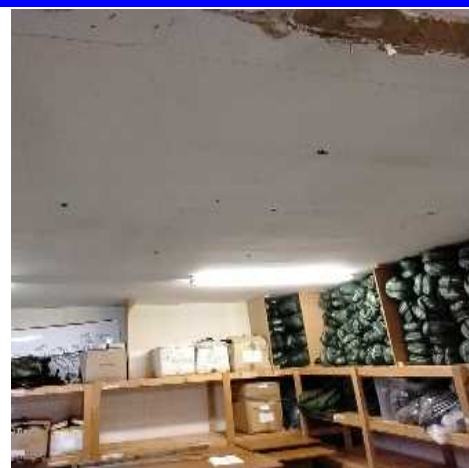
## Location Details : 150577 No Asbestos Found

Building/Area : Old Gaurd Building Finner Camp  
 Room/Section : Store room 3  
 Location : Walls, and ceiling  
 Description : Block, plaster  
 Sample No. :  
 Confirmation :  
 Access : Full Access  
 Normal Use :  
 Recommendations :  
 Notes :

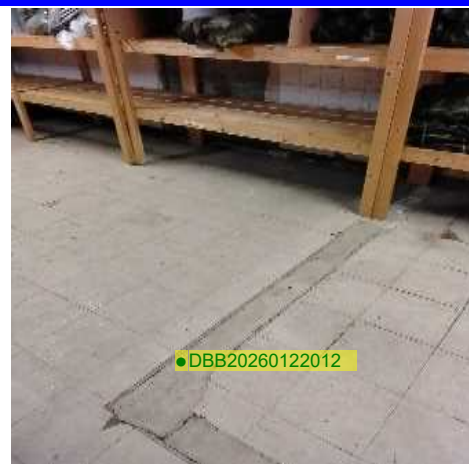
## Location Details : 150578 No Asbestos Found

Building/Area : Old Gaurd Building Finner Camp  
 Room/Section : Store 3  
 Location : Floor  
 Description : White floor tiles and bitumen  
 Sample No. : DBB20260122012  
 Confirmation : Sampled  
 Access : Full Access  
 Normal Use :  
 Recommendations :  
 Notes :

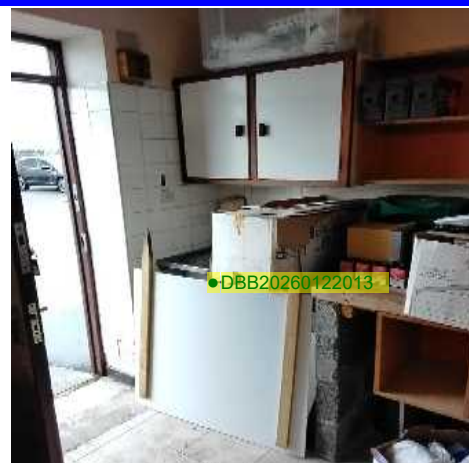
## Location Details : 150579 No Asbestos Found

Building/Area : Old Gaurd Building Finner Camp  
 Room/Section : Store 3  
 Location : Sink  
 Description : Bitumen pad  
 Sample No. : DBB20260122013  
 Confirmation : Sampled  
 Access : Full Access  
 Normal Use :  
 Recommendations :  
 Notes :
