# Management Asbestos Survey

| Site Address | Cappagh National Orthopaedic Hospital<br>Cappagh Road<br>Finglas West<br>Dublin 11 | | |
| Survey Dates | 2015, 2018 & 2024 | | |
| Issue Date | March, 2024 | | |

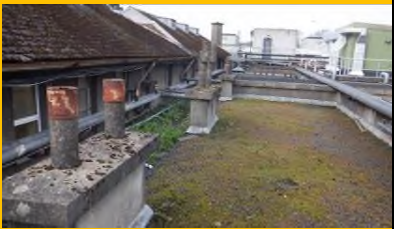
| Ref No. | Building/ Zone | Location Or Functional Space | Sample No. | Material Description, surface treatment and condition | Extent | Asbestos identified (presumed, strongly presumed or identified) | Product type | Condition | Surface treatment | Asbestos type | Material assessment score | Activity | Likelihood of disturbance | Exposure potential | Maintenance | Priority assessment score | Combined Assessment Score | Recommendation | Photo |
|---|---|---|---|---|---|---|---|---|---|---|---|---|---|---|---|---|---|---|---|
| 9. | Zone 1 | External Flat roof | | AC flue pipes from old chimneys | NQ | Chrysotile | 1 | 1 | 1 | 1 | 4 | 0 | 0 | 0 | 0 | 0 | 4 | Manage<br>Monitor<br>Label<br>Remove prior to works likely to cause disturbance. | |

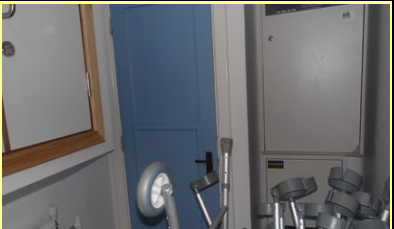
| Ref No. | Building/ Zone | Location Or Functional Space | Sample No. | Material Description, surface treatment and condition | Extent | Asbestos identified (presumed, strongly presumed or identified) | Product type | Condition | Surface treatment | Asbestos type | Material assessment score | Activity | Likelihood of disturbance | Exposure potential | Maintenance | Priority assessment score | Combined Assessment Score | Recommendation | Photo |
|---|---|---|---|---|---|---|---|---|---|---|---|---|---|---|---|---|---|---|---|
| 22. | Zone 1 | Ground floor Old Phone Booth 007 | | | | Presumed asbestos | | | | | | | | | | | | Investigate prior to works likely to cause disturbance. | |

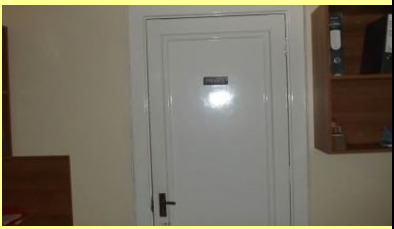
| Ref No. | Building/ Zone | Location Or Functional Space | Sample No. | Material Description, surface treatment and condition | Extent | Asbestos identified (presumed, strongly presumed or identified) | Product type | Condition | Surface treatment | Asbestos type | Material assessment score | Activity | Likelihood of disturbance | Exposure potential | Maintenance | Priority assessment score | Combined Assessment Score | Recommendation | Photo |
|---|---|---|---|---|---|---|---|---|---|---|---|---|---|---|---|---|---|---|---|
| 25. | Zone 1 | Ground floor Physio Office | | | | Presumed asbestos | | | | | | | | | | | | Investigate prior to works likely to cause disturbance. | |

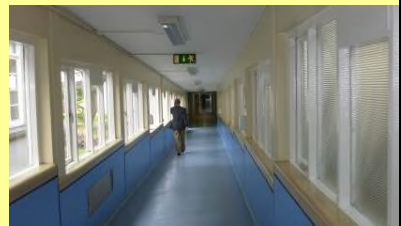
| Ref No. | Building/ Zone | Location Or Functional Space | Sample No. | Material Description, surface treatment and condition | Extent | Asbestos identified (presumed, strongly presumed or identified) | Product type | Condition | Surface treatment | Asbestos type | Material assessment score | Activity | Likelihood of disturbance | Exposure potential | Maintenance | Priority assessment score | Combined Assessment Score | Recommendation | Photo |
|---|---|---|---|---|---|---|---|---|---|---|---|---|---|---|---|---|---|---|---|
| 171. | Zone 1 | Ground Floor Main Corridor | | Concealed heaters in wall void under windows | | Presumed asbestos linings | | | | | | | | | | | | Investigate prior to works likely to cause disturbance | |

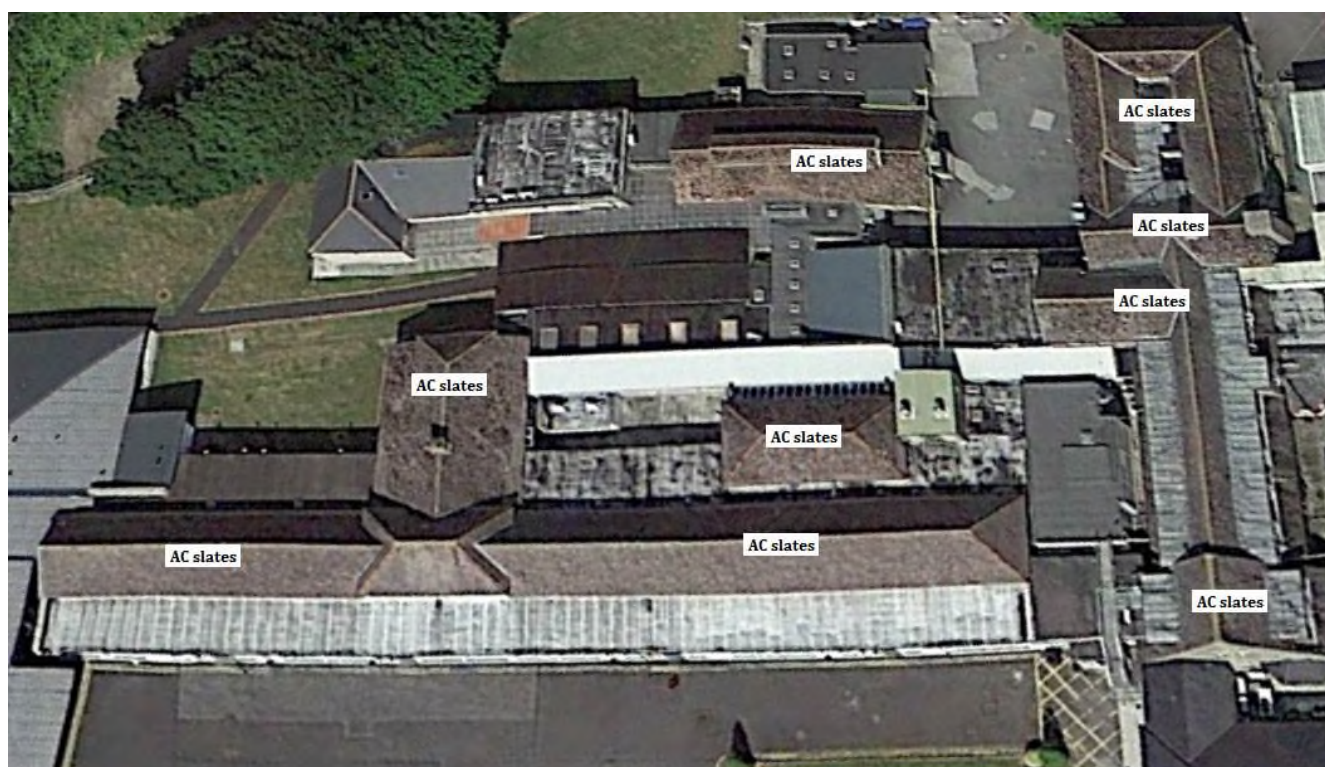
Asbestos Cement (AC) Slates

| Ref No. | Confirmed asbestos |
|---|---|
| 8, 10 | <p>The red external roof slates contain asbestos. The slates are in fair condition generally and may remain in place, labelled and managed.</p> <p>The external effects of moss and lichen growth are delaminating the surface of the slates with visible loose and dead moss containing asbestos fibres evident on adjacent roofs and in the valleys.</p> <p>This moss which becomes airborne when dry has been identified on the ground around the buildings.</p> <p>The roof slates may remain in place and managed and a preventative maintenance /remediation programme put in place to control the spread of dry moss and monitor the condition of the slate surfaces.</p> |

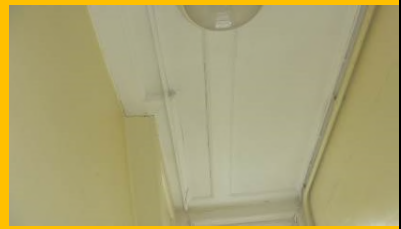
| Ref No. | Building/ Zone | Location Or Functional Space | Sample No. | Material Description, surface treatment and condition | Extent | Asbestos identified (presumed, strongly presumed or identified) | Product type | Condition | Surface treatment | Asbestos type | Material assessment score | Activity | Likelihood of disturbance | Exposure potential | Maintenance | Priority assessment score | Combined Assessment Score | Recommendation/ Comments | Photo |
|---|---|---|---|---|---|---|---|---|---|---|---|---|---|---|---|---|---|---|---|
| 29. | Zone 2 | Admin 1 <sup>st</sup> floor WC 211 | | AC sheeting to ceiling and walls | | Chrysotile | 1 | 0 | 1 | 1 | 3 | 1 | 1 | 3 | 0 | 5 | 8 | Manage Label Monitor | |

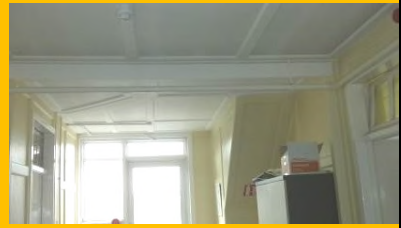
| Ref No. | Building/ Zone | Location Or Functional Space | Sample No. | Material Description, surface treatment and condition | Extent | Asbestos identified (presumed, strongly presumed or identified) | Product type | Condition | Surface treatment | Asbestos type | Material assessment score | Activity | Likelihood of disturbance | Exposure potential | Maintenance | Priority assessment score | Combined Assessment Score | Recommendation/ Comments | Photo |
|---|---|---|---|---|---|---|---|---|---|---|---|---|---|---|---|---|---|---|---|
| 30. | Zone 2 | Admin 1 <sup>st</sup> floor Corridor 210 | | AC sheeting to ceiling and walls | | Chrysotile | 1 | 0 | 1 | 1 | 3 | 1 | 1 | 3 | 0 | 5 | 8 | Manage Label Monitor | |

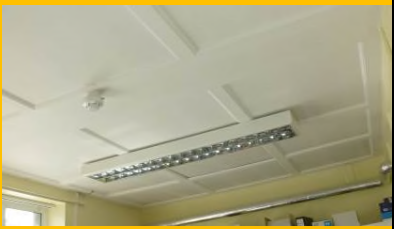
| Ref No. | Building/ Zone | Location Or Functional Space | Sample No. | Material Description, surface treatment and condition | Extent | Asbestos identified (presumed, strongly presumed or identified) | Product type | Condition | Surface treatment | Asbestos type | Material assessment score | Activity | Likelihood of disturbance | Exposure potential | Maintenance | Priority assessment score | Combined Assessment Score | Recommendation/ Comments | Photo |
|---|---|---|---|---|---|---|---|---|---|---|---|---|---|---|---|---|---|---|---|
| 33. | Zone 2 | Admin 1 <sup>st</sup> floor Financial Accountant | | AC sheeting to ceiling | | Chrysotile | 1 | 0 | 1 | 1 | 3 | 1 | 1 | 3 | 0 | 5 | 8 | Manage Label Monitor | |

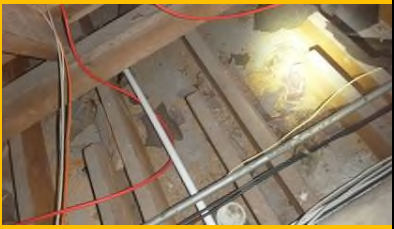
| Ref No. | Building/ Zone | Location Or Functional Space | Sample No. | Material Description, surface treatment and condition | Extent | Asbestos identified (presumed, strongly presumed or identified) | Product type | Condition | Surface treatment | Asbestos type | Material assessment score | Activity | Likelihood of disturbance | Exposure potential | Maintenance | Priority assessment score | Combined Assessment Score | Recommendation/ Comments | Photo |
|---|---|---|---|---|---|---|---|---|---|---|---|---|---|---|---|---|---|---|---|
| 43. | Zone 2 | Admin 1 <sup>st</sup> floor Corridor Attic | 15208 05 | AC debris on ceiling | | Chrysotile | 1 | 2 | 1 | 1 | 5 | 0 | 1 | 0 | 1 | 2 | 7 | Environmental cleaning of areas prior to works likely to cause disturbance. | |

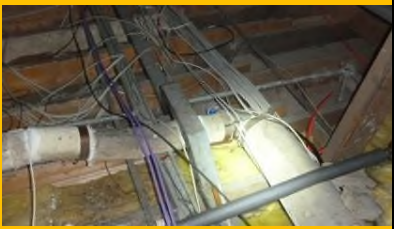
| Ref No. | Building/ Zone | Location Or Functional Space | Sample No. | Material Description, surface treatment and condition | Extent | Asbestos identified (presumed, strongly presumed or identified) | Product type | Condition | Surface treatment | Asbestos type | Material assessment score | Activity | Likelihood of disturbance | Exposure potential | Maintenance | Priority assessment score | Combined Assessment Score | Recommendation/ Comments | Photo |
|---|---|---|---|---|---|---|---|---|---|---|---|---|---|---|---|---|---|---|---|
| 45. | Zone 2 | Admin 1 <sup>st</sup> floor Corridor Attic | | Thermal insulation to pipework. Fibrous in areas with residues on ceiling. | 10 LM apprx. | Crocidolite and chrysotile | 3 | 3 | 3 | 3 | 12 | 0 | 2 | 0 | 1 | 3 | 15 | Remedial encapsulation and environmental cleaning required. | |

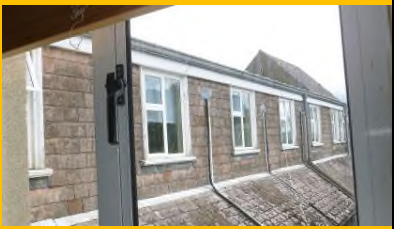
| Ref No. | Building/ Zone | Location Or Functional Space | Sample No. | Material Description, surface treatment and condition | Extent | Asbestos identified (presumed, strongly presumed or identified) | Product type | Condition | Surface treatment | Asbestos type | Material assessment score | Activity | Likelihood of disturbance | Exposure potential | Maintenance | Priority assessment score | Combined Assessment Score | Recommendation/ Comments | Photo |
|---|---|---|---|---|---|---|---|---|---|---|---|---|---|---|---|---|---|---|---|
| 49. | Zone 2 | External | | AC slates to roof and sides | NQ | Chrysotile | 1 | 2 | 1 | 1 | 5 | 0 | 1 | 0 | 0 | 1 | 6 | Manage Label Monitor | |

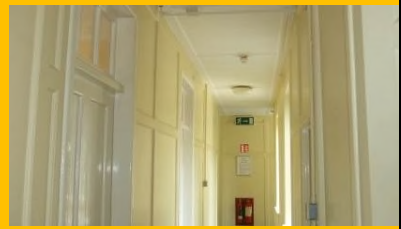
| Ref No. | Building/ Zone | Location Or Functional Space | Sample No. | Material Description, surface treatment and condition | Extent | Asbestos identified (presumed, strongly presumed or identified) | Product type | Condition | Surface treatment | Asbestos type | Material assessment score | Activity | Likelihood of disturbance | Exposure potential | Maintenance | Priority assessment score | Combined Assessment Score | Recommendation/ Comments | Photo |
|---|---|---|---|---|---|---|---|---|---|---|---|---|---|---|---|---|---|---|---|
| 53. | Zone 2 | Admin 1 <sup>st</sup> floor Corridor 229 | | AC sheeting to ceiling and walls | NQ | Chrysotile | 1 | 0 | 1 | 1 | 3 | 1 | 1 | 3 | 0 | 5 | 8 | Manage Label Monitor | |

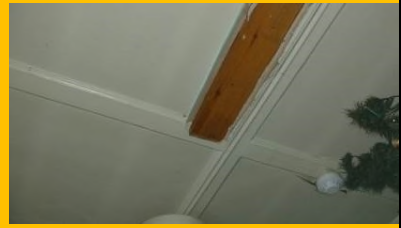
| Ref No. | Building/ Zone | Location Or Functional Space | Sample No. | Material Description, surface treatment and condition | Extent | Asbestos identified (presumed, strongly presumed or identified) | Product type | Condition | Surface treatment | Asbestos type | Material assessment score | Activity | Likelihood of disturbance | Exposure potential | Maintenance | Priority assessment score | Combined Assessment Score | Recommendation/ Comments | Photo |
|---|---|---|---|---|---|---|---|---|---|---|---|---|---|---|---|---|---|---|---|
| 54. | Zone 2 | Admin 1 <sup>st</sup> floor Store room 224 | | AC sheeting to ceiling and walls | NQ | Chrysotile | 1 | 0 | 1 | 1 | 3 | 1 | 1 | 3 | 0 | 5 | 8 | Manage Label Monitor | |

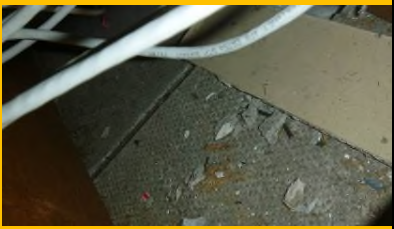
| Ref No. | Building/ Zone | Location Or Functional Space | Sample No. | Material Description, surface treatment and condition | Extent | Asbestos identified (presumed, strongly presumed or identified) | Product type | Condition | Surface treatment | Asbestos type | Material assessment score | Activity | Likelihood of disturbance | Exposure potential | Maintenance | Priority assessment score | Combined Assessment Score | Recommendation/ Comments | Photo |
|---|---|---|---|---|---|---|---|---|---|---|---|---|---|---|---|---|---|---|---|
| 57. | Zone 2 | Admin 1 <sup>st</sup> floor Attic void | 1520809 | AC debris on ceiling | NQ | Chrysotile | 1 | 2 | 1 | 1 | 5 | 0 | 1 | 0 | 1 | 2 | 7 | Environmental cleaning of areas prior to works likely to cause disturbance. | |

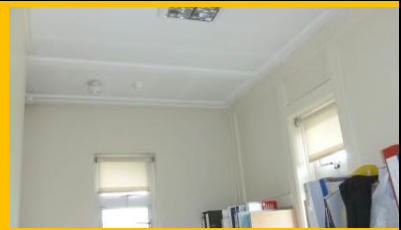
| Ref No. | Building/ Zone | Location Or Functional Space | Sample No. | Material Description, surface treatment and condition | Extent | Asbestos identified (presumed, strongly presumed or identified) | Product type | Condition | Surface treatment | Asbestos type | Material assessment score | Activity | Likelihood of disturbance | Exposure potential | Maintenance | Priority assessment score | Combined Assessment Score | Recommendation/ Comments | Photo |
|---|---|---|---|---|---|---|---|---|---|---|---|---|---|---|---|---|---|---|---|
| 62. | Zone 2 | Admin 1 <sup>st</sup> floor Office 231 | | AC sheeting to ceiling and walls | NQ | Chrysotile | 1 | 0 | 1 | 1 | 3 | 1 | 1 | 3 | 0 | 5 | 8 | Manage Label Monitor | |

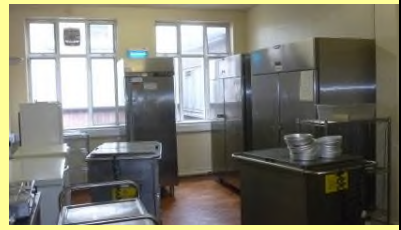
| Ref No. | Building/ Zone | Location Or Functional Space | Sample No. | Material Description, surface treatment and condition | Extent | Asbestos identified (presumed, strongly presumed or identified) | Product type | Condition | Surface treatment | Asbestos type | Material assessment score | Activity | Likelihood of disturbance | Exposure potential | Maintenance | Priority assessment score | Combined Assessment Score | Recommendation/ Comments | Photo |
|---|---|---|---|---|---|---|---|---|---|---|---|---|---|---|---|---|---|---|---|
| 63. | Zone 2 | Ground Floor Kitchen 144 | | Original AC ceilings presumed over plaster board throughout | | Chrysotile | | | | | | | | | | | | Investigate prior to work likely to cause disturbance. | |

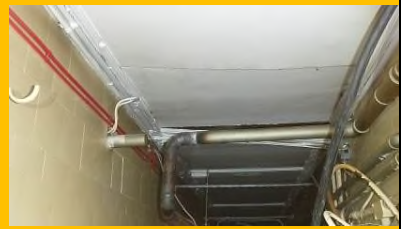
| Ref No. | Building/ Zone | Location Or Functional Space | Sample No. | Material Description, surface treatment and condition | Extent | Asbestos identified (presumed, strongly presumed or identified) | Product type | Condition | Surface treatment | Asbestos type | Material assessment score | Activity | Likelihood of disturbance | Exposure potential | Maintenance | Priority assessment score | Combined Assessment Score | Recommendation/ Comments | Photo |
|---|---|---|---|---|---|---|---|---|---|---|---|---|---|---|---|---|---|---|---|
| 69. | Zone 2 | Ground Floor Kitchen Corridor Ceiling voids | | AC sheeting to ceiling over drop ceiling | NQ | Chrysotile | 1 | 0 | 1 | 1 | 3 | 0 | 1 | 0 | 0 | 1 | 4 | Manage Label Monitor | |

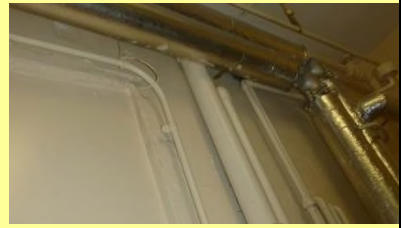
| Ref No. | Building/ Zone | Location Or Functional Space | Sample No. | Material Description, surface treatment and condition | Extent | Asbestos identified (presumed, strongly presumed or identified) | Product type | Condition | Surface treatment | Asbestos type | Material assessment score | Activity | Likelihood of disturbance | Exposure potential | Maintenance | Priority assessment score | Combined Assessment Score | Recommendation/ Comments | Photo |
|---|---|---|---|---|---|---|---|---|---|---|---|---|---|---|---|---|---|---|---|
| 70. | Zone 2 | Ground Floor Kitchen Wash-up 145 | | Old pipework runs | | Presumed Asbestos | | | | | | | | | | | | Investigation and sampling prior to any works likely to cause disturbance. | |

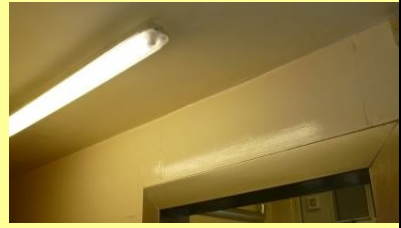
| Ref No. | Building/ Zone | Location Or Functional Space | Sample No. | Material Description, surface treatment and condition | Extent | Asbestos identified (presumed, strongly presumed or identified) | Product type | Condition | Surface treatment | Asbestos type | Material assessment score | Activity | Likelihood of disturbance | Exposure potential | Maintenance | Priority assessment score | Combined Assessment Score | Recommendation/ Comments | Photo |
|---|---|---|---|---|---|---|---|---|---|---|---|---|---|---|---|---|---|---|---|
| 71. | Zone 2 | Ground Floor Kitchen Corridor 150 | | Panels over doors to rooms | | Presumed Asbestos | | | | | | | | | | | | Investigation and sampling prior to any works likely to cause disturbance. | |

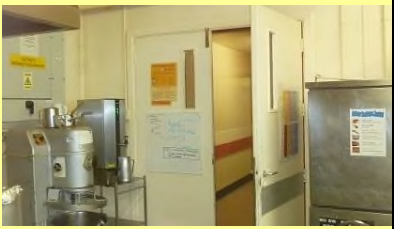
| Ref No. | Building/ Zone | Location Or Functional Space | Sample No. | Material Description, surface treatment and condition | Extent | Asbestos identified (presumed, strongly presumed or identified) | Product type | Condition | Surface treatment | Asbestos type | Material assessment score | Activity | Likelihood of disturbance | Exposure potential | Maintenance | Priority assessment score | Combined Assessment Score | Recommendation/ Comments | Photo |
|---|---|---|---|---|---|---|---|---|---|---|---|---|---|---|---|---|---|---|---|
| 77. | Zone 2 | Ground Floor Kitchen 160 | | Integral area of fire doors | | Presumed Asbestos | | | | | | | | | | | | Investigate prior to works likely to cause disturbance. | |

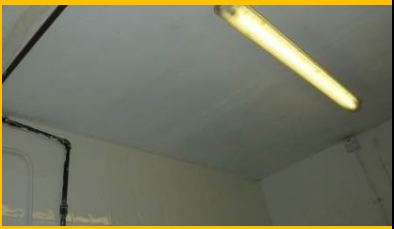
| Ref No. | Building/ Zone | Location Or Functional Space | Sample No. | Material Description, surface treatment and condition | Extent | Asbestos identified (presumed, strongly presumed or identified) | Product type | Condition | Surface treatment | Asbestos type | Material assessment score | Activity | Likelihood of disturbance | Exposure potential | Maintenance | Priority assessment score | Combined Assessment Score | Recommendation/ Comments | Photo |
|---|---|---|---|---|---|---|---|---|---|---|---|---|---|---|---|---|---|---|---|
| 81. | Zone 2 | Yard Stores 1 154 | | AC sheeting | | New drop ceiling under old AC sheeting. | 1 | 0 | 1 | 1 | 3 | 0 | 1 | 1 | 0 | 2 | 5 | Manage Label Monitor | |

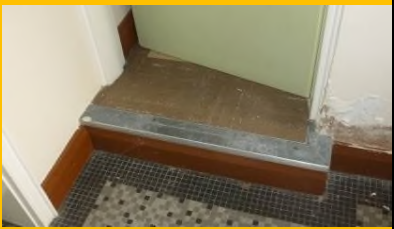
| Ref No. | Building/ Zone | Location Or Functional Space | Sample No. | Material Description, surface treatment and condition | Extent | Asbestos identified (presumed, strongly presumed or identified) | Product type | Condition | Surface treatment | Asbestos type | Material assessment score | Activity | Likelihood of disturbance | Exposure potential | Maintenance | Priority assessment score | Combined Assessment Score | Recommendation/ Comments | Photo |
|---|---|---|---|---|---|---|---|---|---|---|---|---|---|---|---|---|---|---|---|
| 57. | Zone 4 | Convent Ground Floor Chapel Sacristy hall 030 | 1520117 | VFT and adhesive.<br><br>Black thread nosing to step | | Chrysotile | 1 | 1 | 0 | 1 | 3 | 0 | 1 | 1 | 0 | 2 | 5 | Manage Label monitor | |
