## Technical Note

<b>Project title</b>	University Hospital Kerry (UHK) - Flue Chimney Condition Assessment & Recommendations
<b>Job number</b>	306730-00
<b>File reference</b>	306730-ARUP-ZZ-XX-TN-S-0001
<b>cc</b>	F O'Sullivan, M Minarro, J Hynes
<b>Prepared by</b>	Feargal O'Sullivan
<b>Date</b>	12 February 2026
<b>Subject</b>	Flue Chimney Condition Assessment & Recommendations Based on Drone Photographic Survey

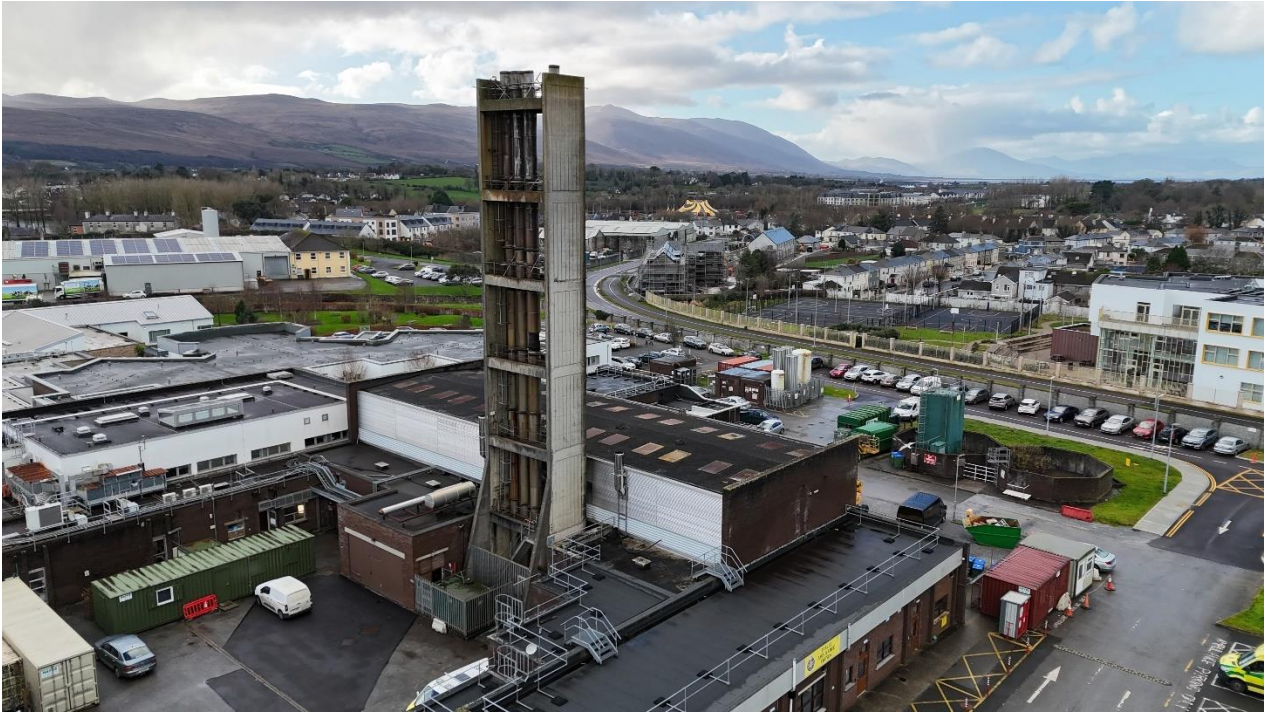
The chimney structure is believed to have been constructed as part of the original hospital build in the late-1970s / early 1980s. It is used to support exhaust flue stacks from the boiler house located at its base. The structure comprises two reinforced concrete (RC) wall panels connected by RC beams at six levels. The chimney is approximately 31m high, with a base footprint of approximately 6m × 6m, reducing to approximately 6m × 3m close to the second platform level, approximately 10m above ground level. Refer to Figure 1 below.

**Figure 1 - Exhaust Flue Chimney**

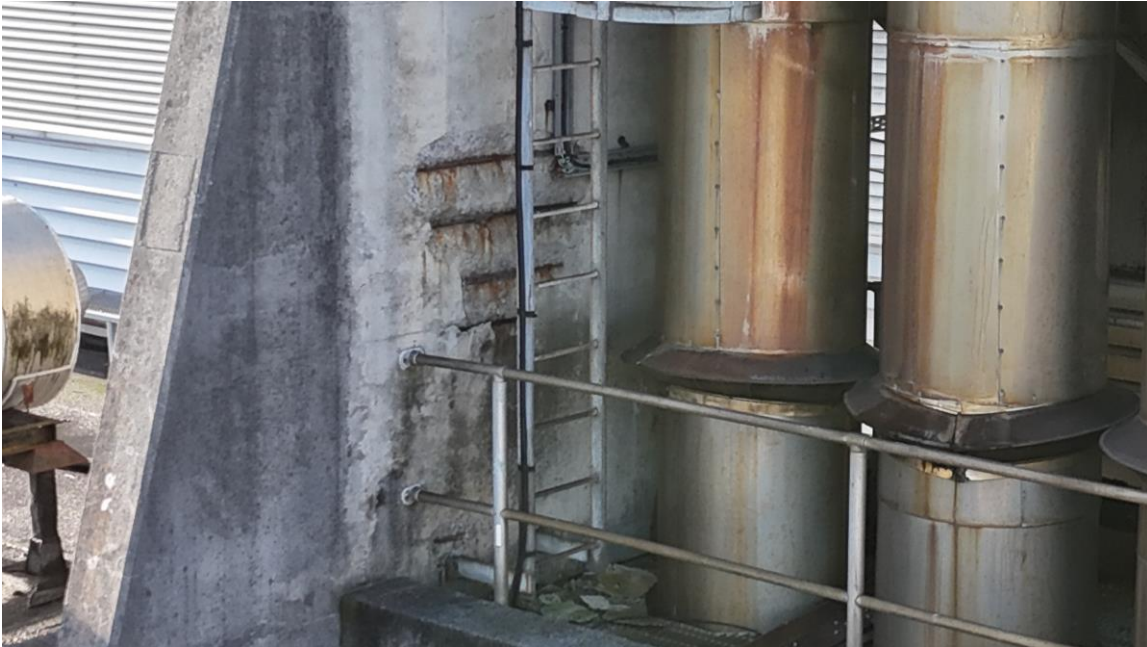
The drone survey photographs indicate that the concrete structure is exhibiting significant deterioration, with multiple areas of damage and disrepair identified. The primary defect observed throughout the structure is concrete spalling caused by corroding reinforcement. Figure 2 presents a particularly severe example of this deterioration near the base of the structure, where a large area of concrete has spalled away with the concrete debris visible on the platform grating below. Similarly, Figure 3 shows comparable deterioration at high-level on the structure, where reinforcement is exposed at numerous locations within the rebates of the decorative fluting in the outer concrete face. The recurring presence of exposed reinforcement within these rebates suggests that the original concrete cover may have been insufficient at these locations. The reinforcement has corroded and expanded over time causing the concrete cover to spall and fall off, as observed in Figure 3.

Figure 2 - Spalling concrete and exposed, corroding reinforcement at first platform level

- **Concrete Repairs:** Extensive concrete repair works are recommended to address the ongoing issues of reinforcement corrosion and resultant concrete spalling. To determine the full extent of the required repairs, a detailed close-up inspection of the structure should be

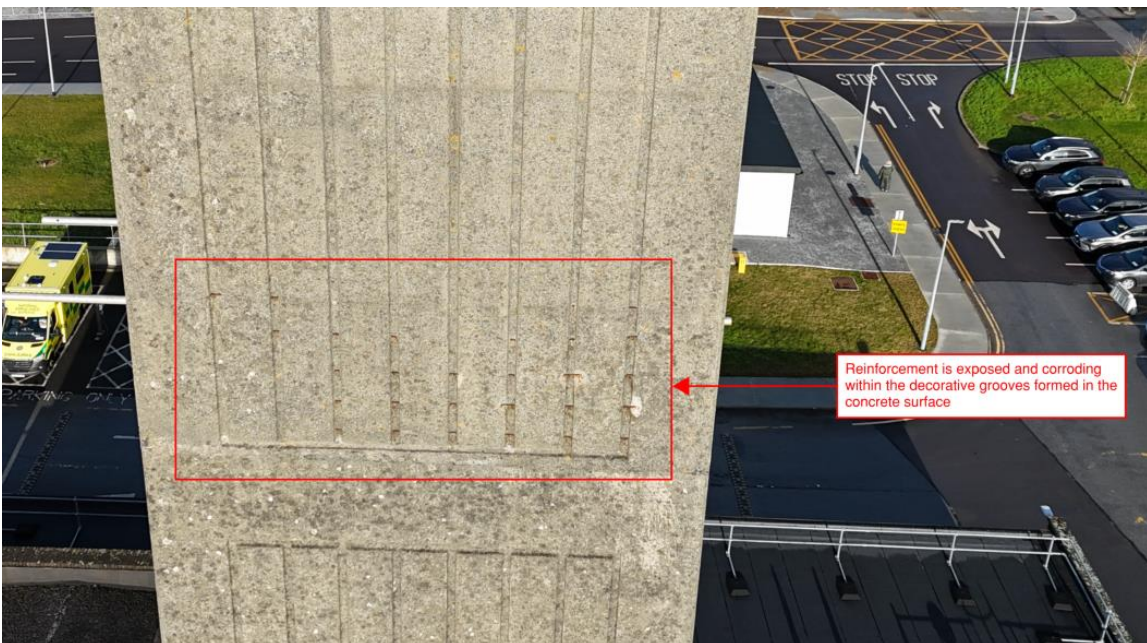
Figure 3 - Exposed corroding rebar visible in grooves in concrete wall on southern elevation

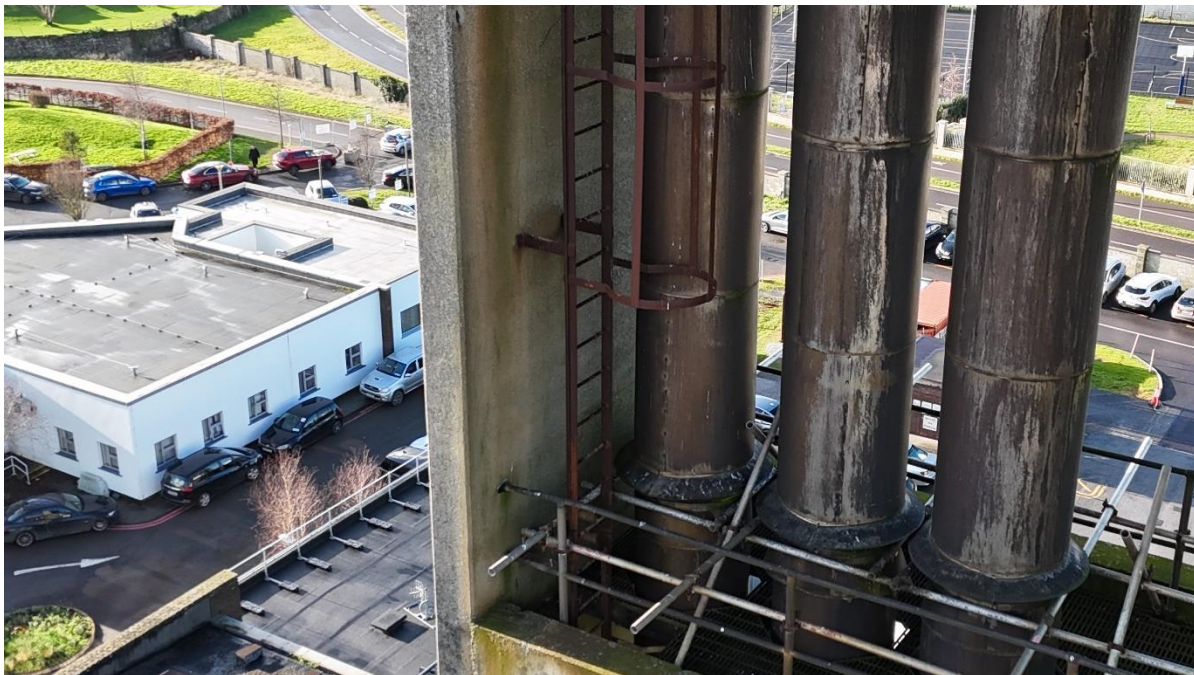
The condition of the access ladder and handrails was assessed insofar as possible from the drone survey photographs. In general, these elements appear to be in poor condition, with most of the steelwork showing signs of corrosion, particularly at high level. The condition of the fixings to the reinforced concrete (rc) structure could not be assessed in detail from the drone photographs. However, in several images the anchor bolts appear discoloured, indicating that corrosion is likely present.

The design of the access ladder does not appear to comply with EN ISO 14122-4, which sets out contemporary requirements for vertical access ladders. Based on the available drone imagery, aspects of the existing ladder arrangement appear inconsistent with these requirements. In particular, the continuous straight vertical ladder arrangement may exceed the recommended climb heights between rest platforms, and the gap between the bottom hoop of the cage and the top of the handrail may be greater than that permitted by the standard. While the ladder arrangement may have been compliant when originally installed, any repairs or modifications to the existing ladders, or their replacement with new ladders should account for the current standards.

Figure 4 - Access ladder & handrail

- **Access Ladder Upgrade:** The existing access ladders present several safety concerns, including corroded fixings, corroded surfaces, and potential non-compliance with current access ladder standards. It is therefore recommended that should the chimney structure be retained that the ladders are upgraded or replaced to provide safe access for personnel for future inspections and maintenance of the structure and lighting protection system etc.

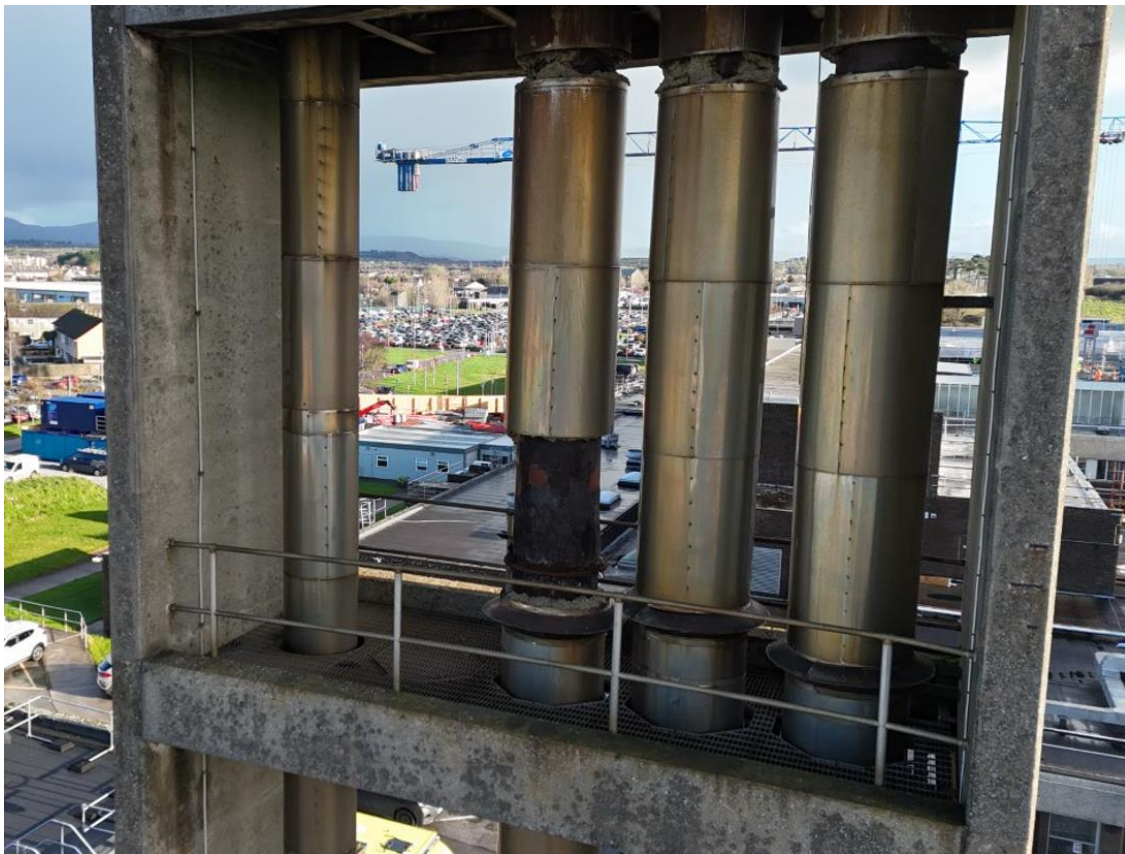
The flue stacks are understood to be redundant and have not been maintained for several years. Consequently, they are in a poor state of repair. As shown in Figure 5, sections of the external cladding are missing, exposing the underlying steel pipework, which is severely corroded. The remaining cladding was observed to be loose and partially detached in several areas.

This loose cladding poses a risk of becoming dislodged during high winds and could strike a roof, vehicle, or person in the immediate vicinity of the structure. Temporary scaffolding was observed to be fitted to the upper three platform levels of the structure. Although not known for certain, it appeared that the scaffolding was installed in an attempt to provide additional restraint to the flue stacks and cladding, to reduce the risks of elements getting dislodged by high winds.

**Figure 5 - Flue stacks supported within chimney. Extensive rust visible on central flue where cladding is missing.**

- **Removal of Redundant Flue Stacks:** The exhaust flue stacks supported by the structure are understood to be redundant. It is therefore not considered appropriate to undertake remedial works to the flues. Instead, it is recommended that the flue stacks are fully removed to eliminate the risk of loose or deteriorated components detaching and falling onto roofs, vehicles, or personnel below.

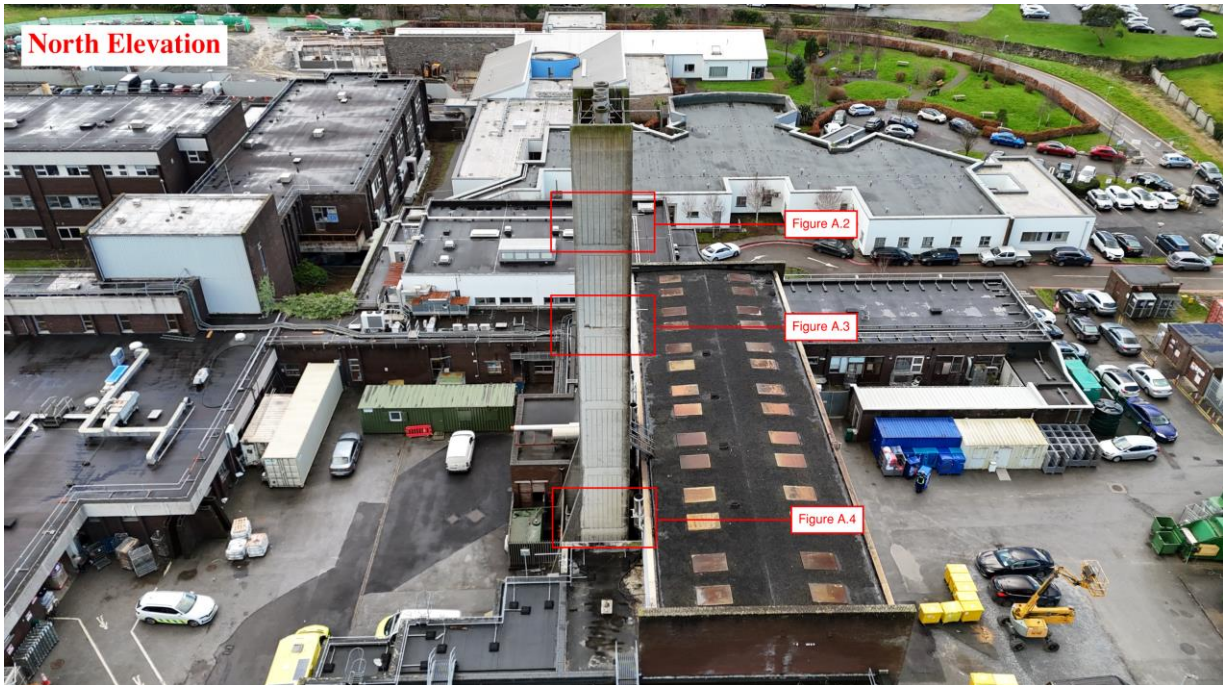
Figure A. 1 – North elevation of existing chimney

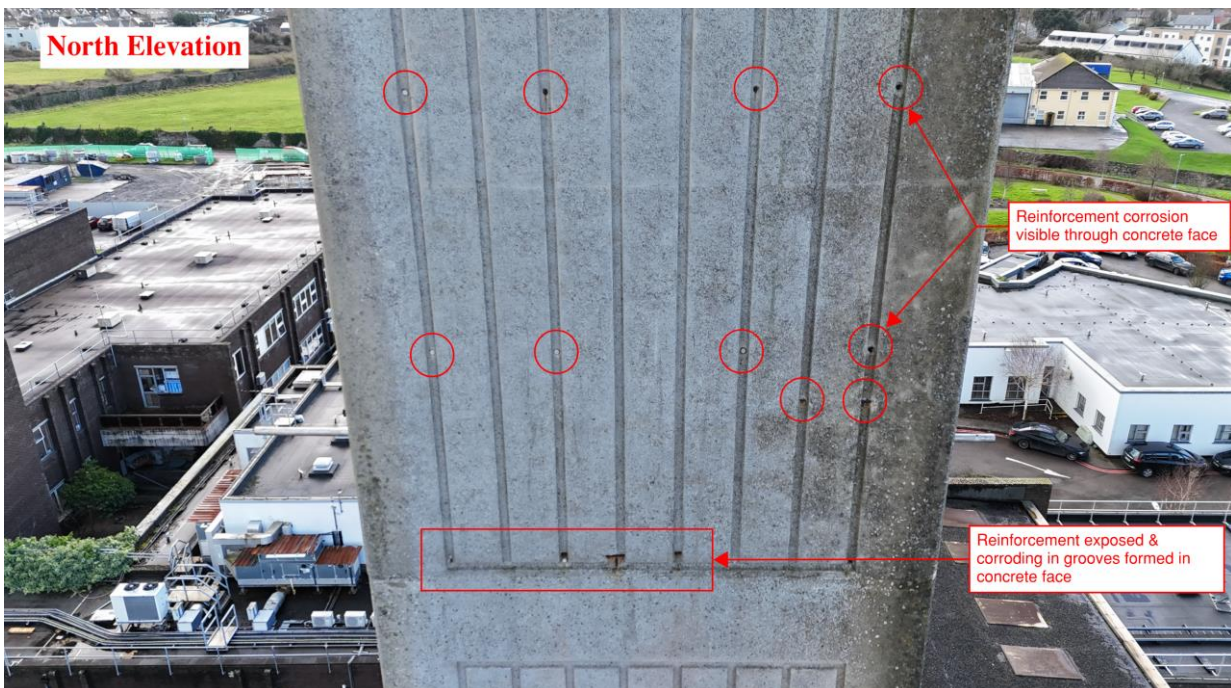
Figure A. 2 - Concrete defects on north wall of chimney

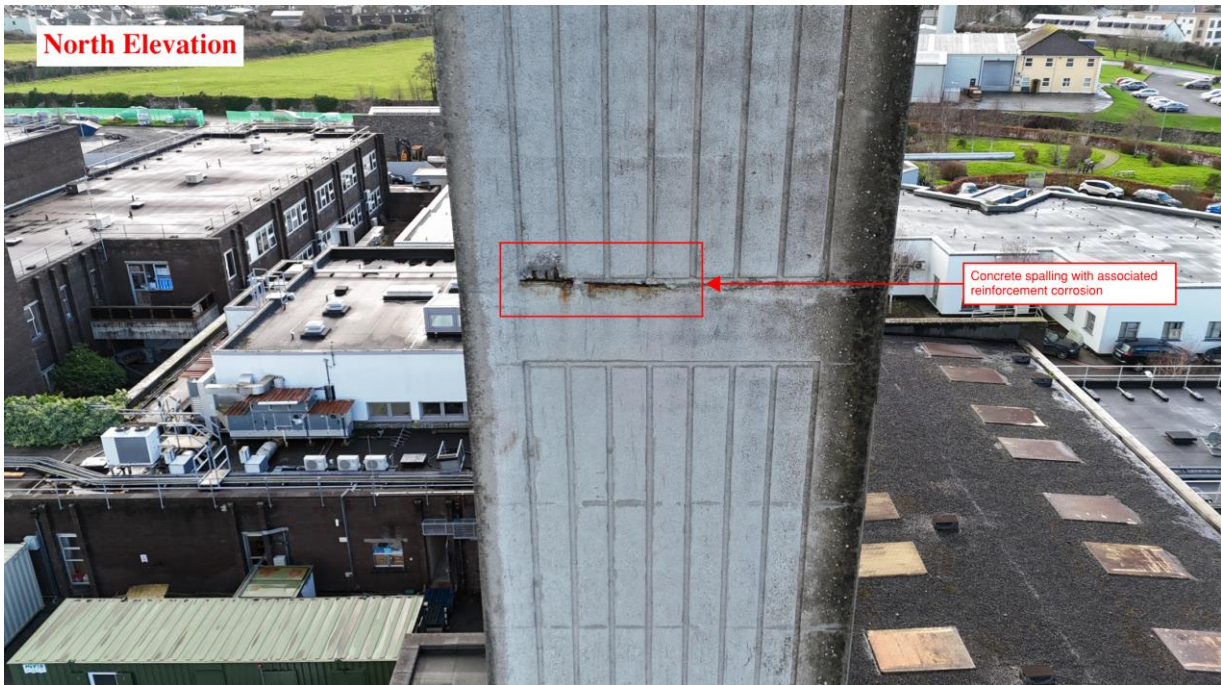
Figure A. 3 - Concrete defects on north wall of chimney

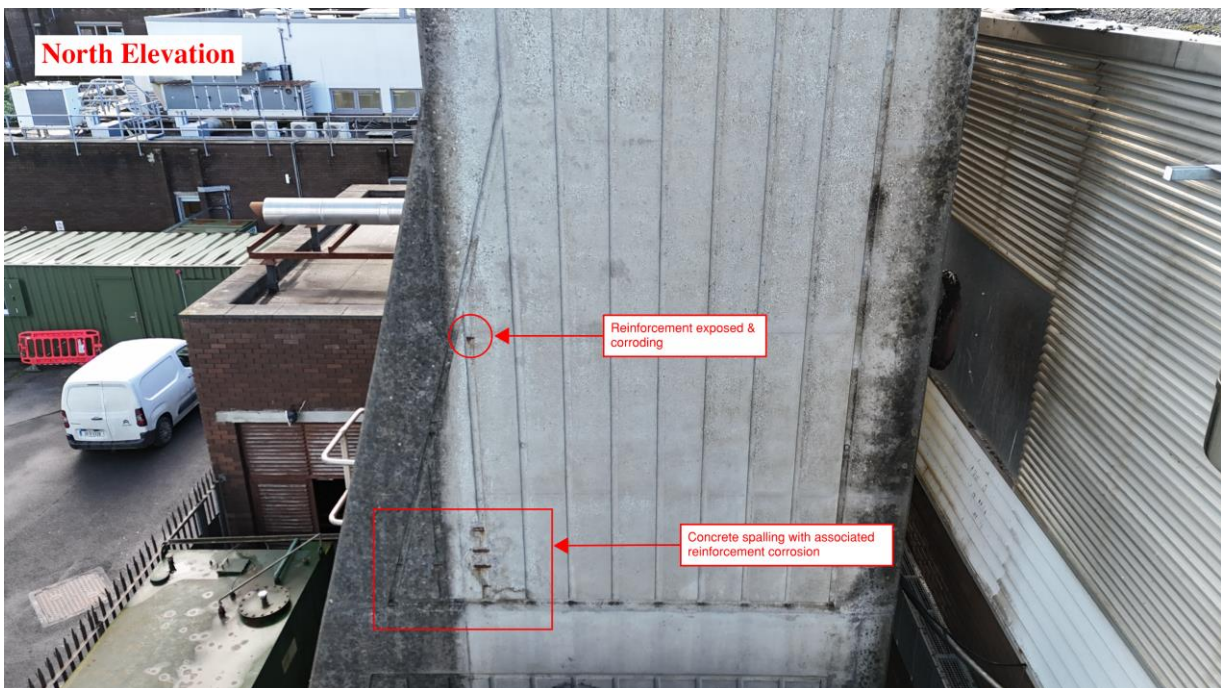
Figure A. 4 - Concrete defects on north wall of chimney

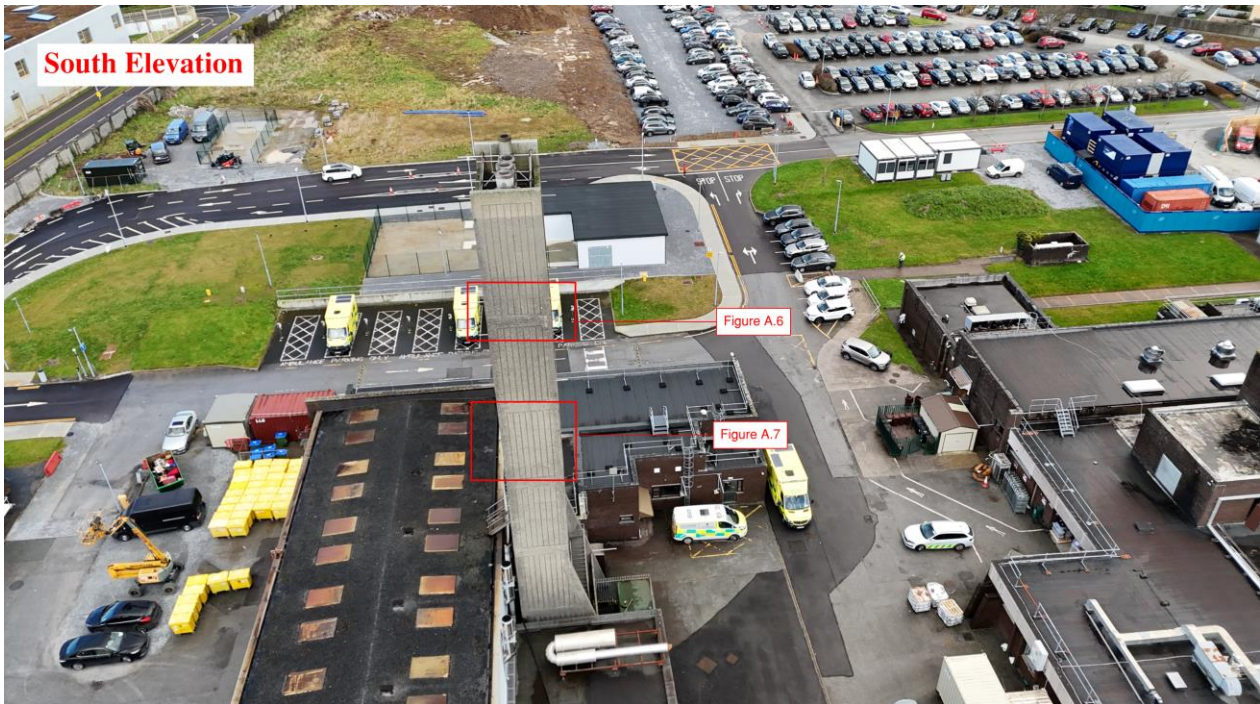
Figure A. 5 - Chimney south elevation

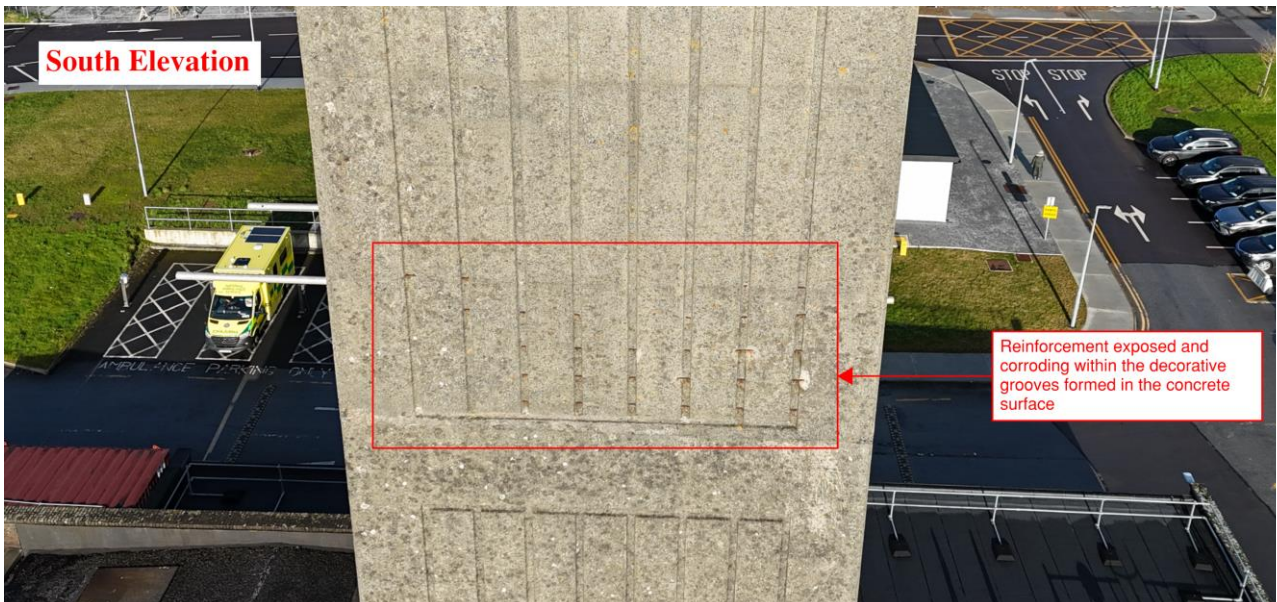
Figure A. 6 - Concrete defects on south wall

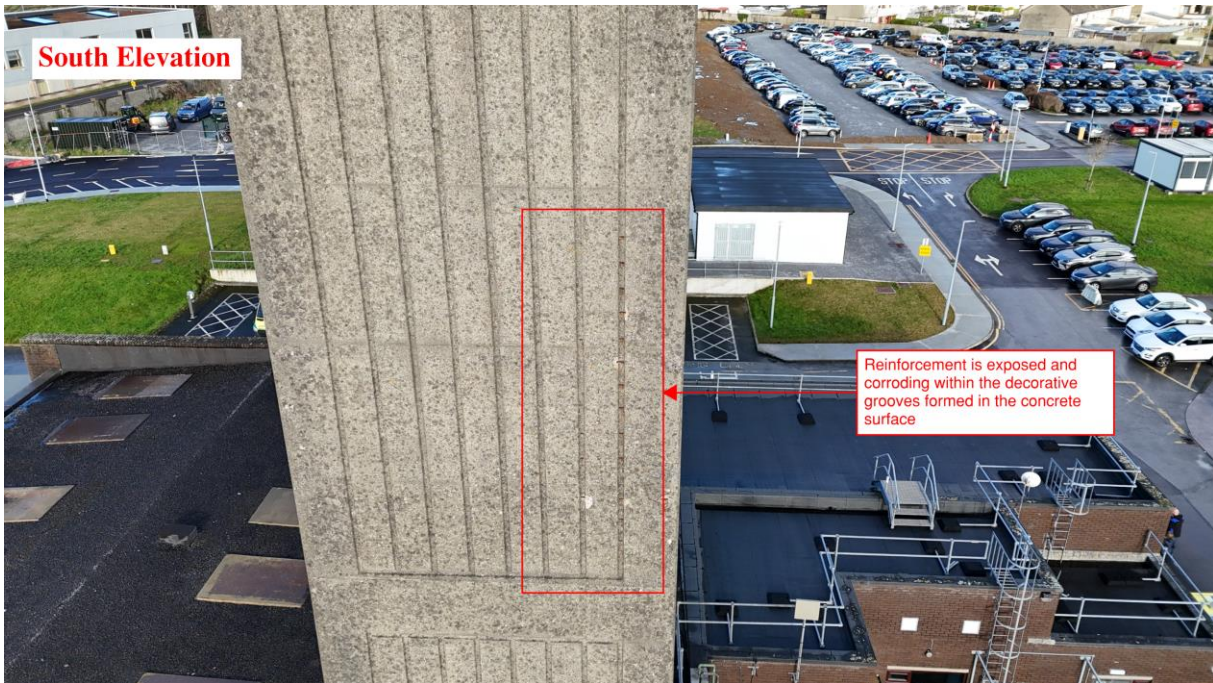
Figure A. 7 - Concrete defects on south wall

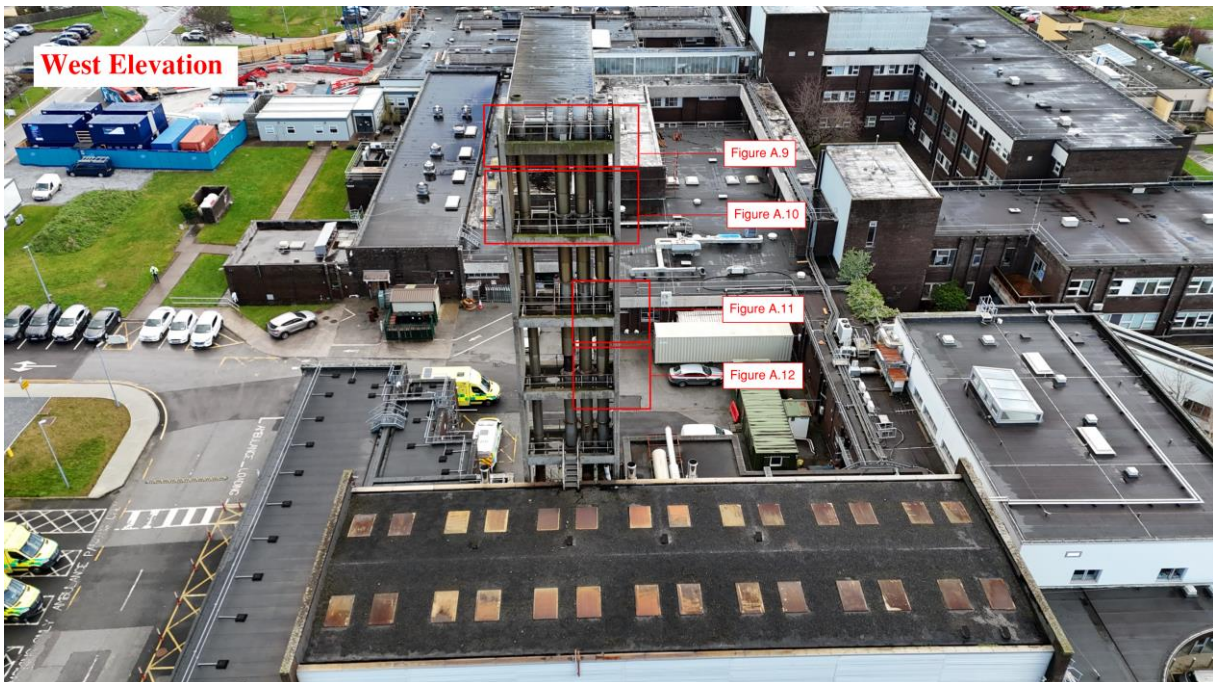
Figure A. 8 - Chimney west elevation

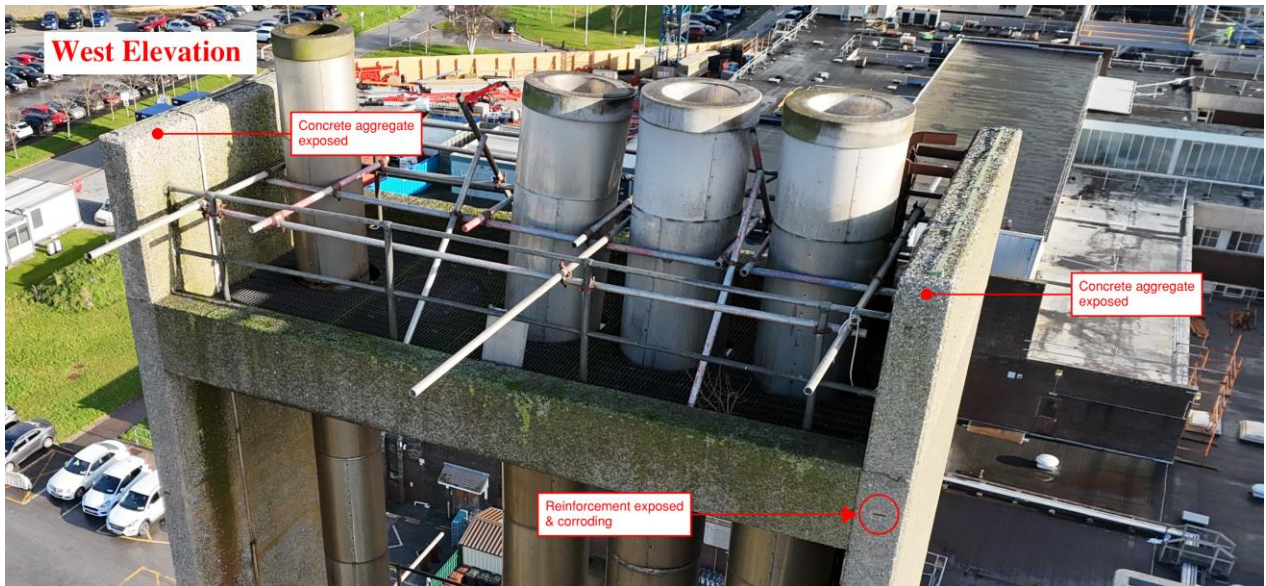
Figure A. 9 - - Concrete defects on west elevation

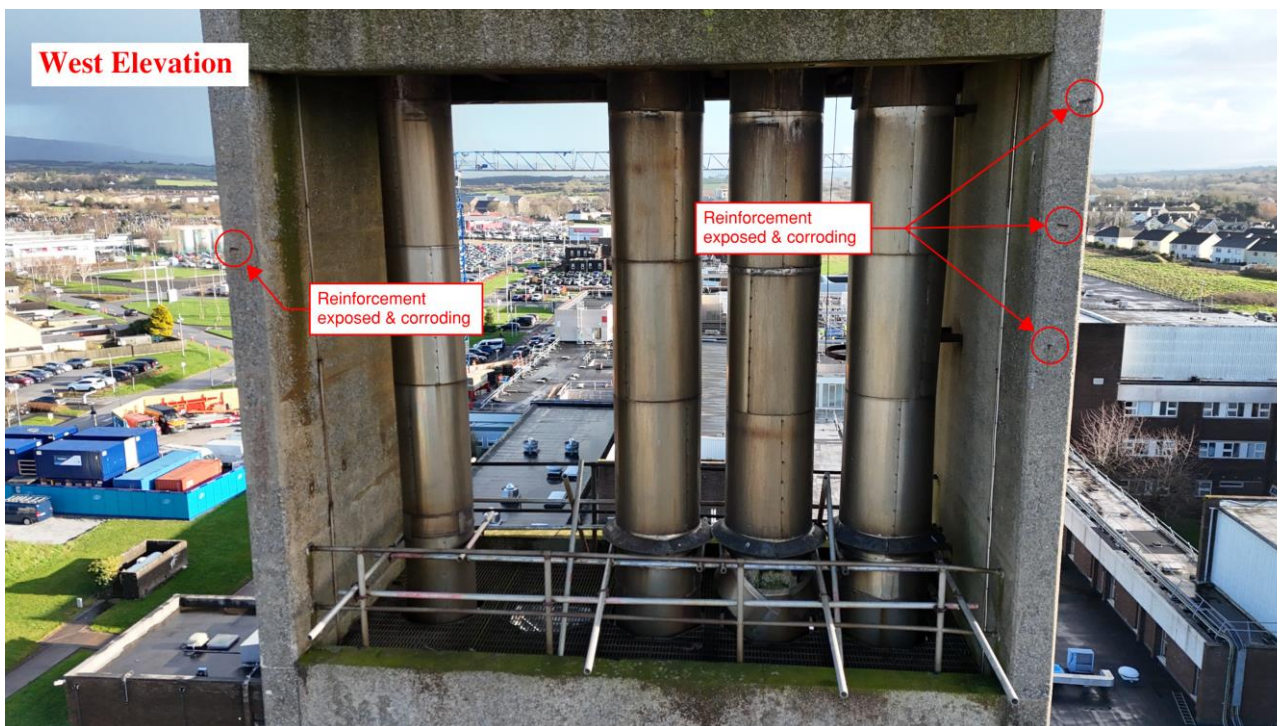
Figure A. 10 - Concrete defects on west elevation

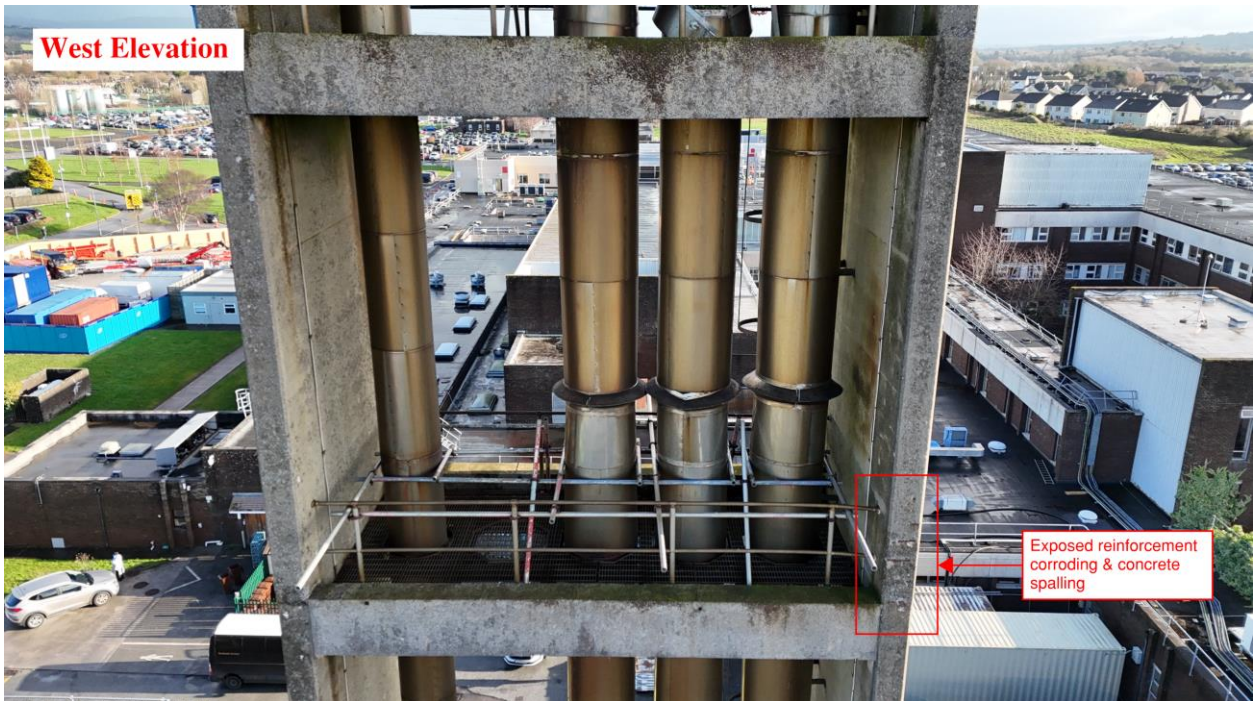
Figure A. 11 - Concrete defects on west elevation

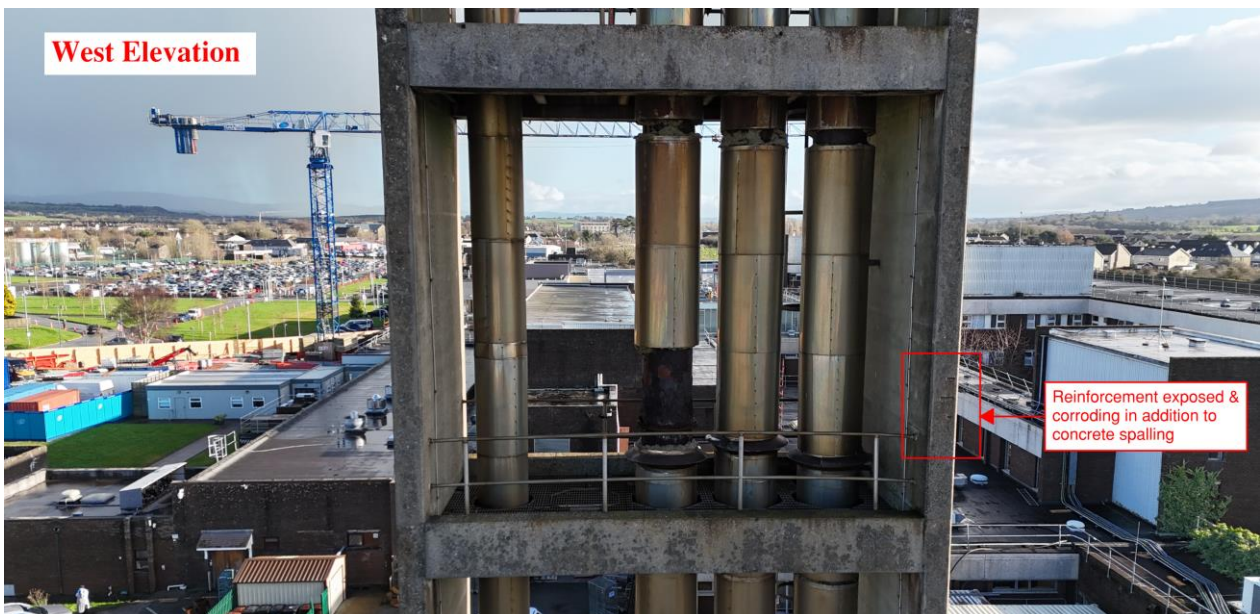
Figure A. 12 - Concrete defects on west elevation

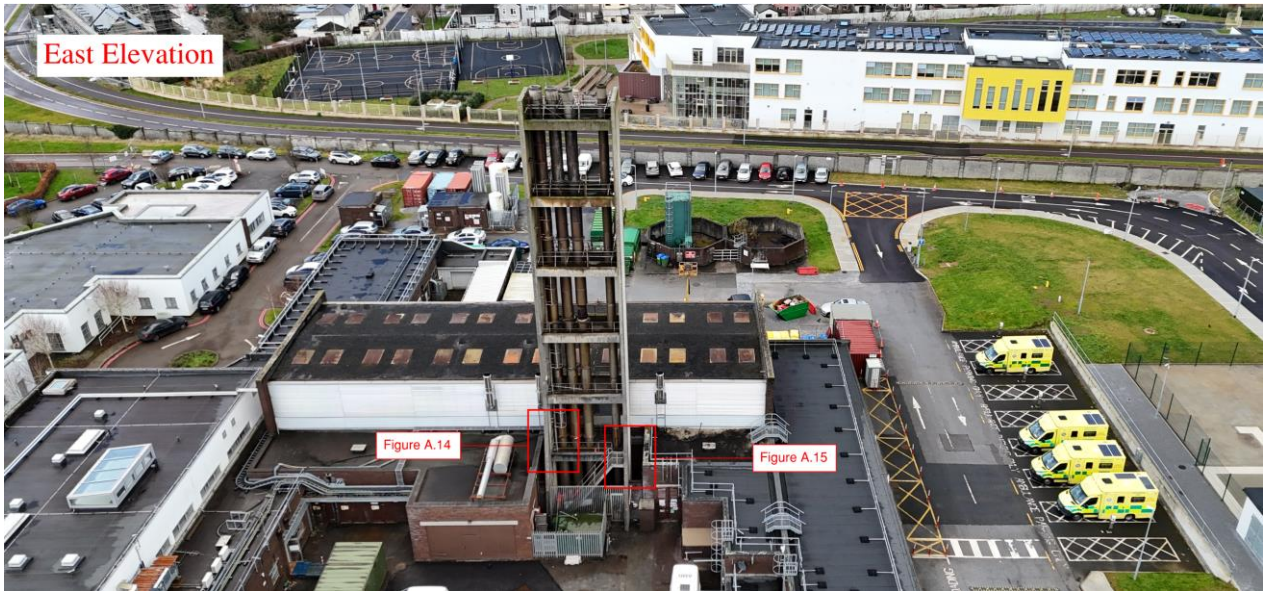
Figure A. 13 - East chimney elevation

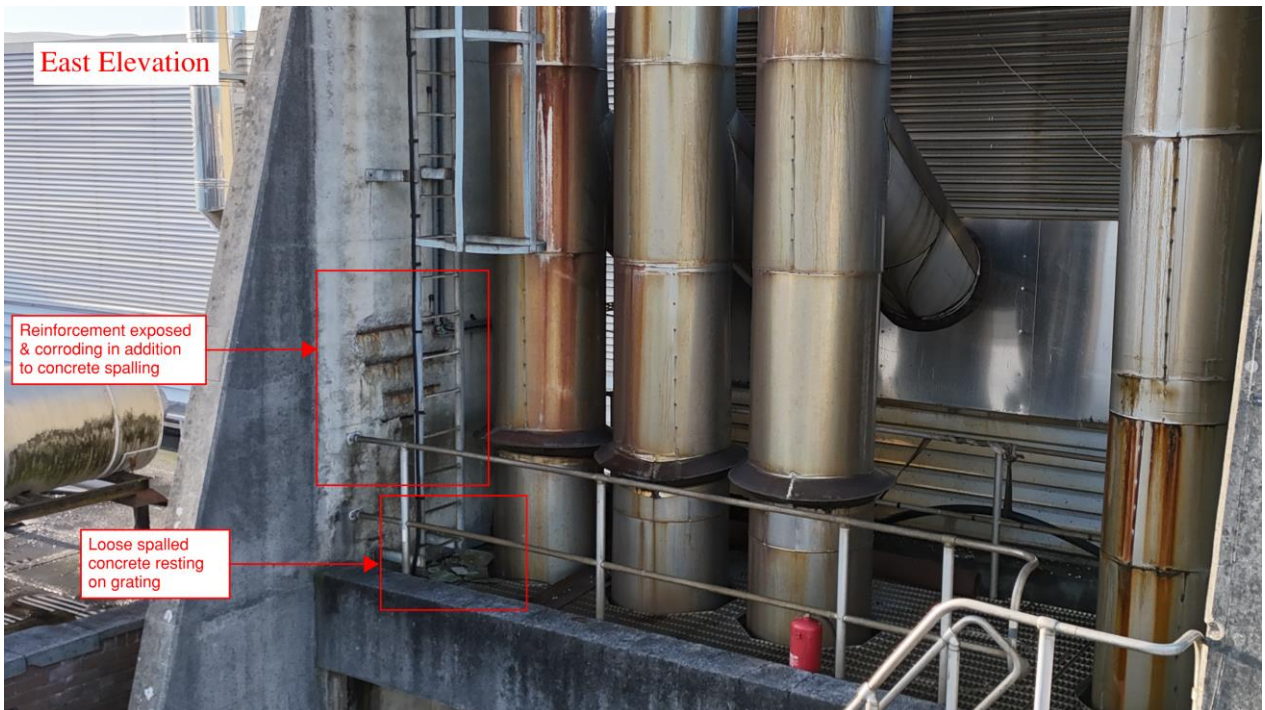
Figure A. 14 - Concrete defects on east elevation

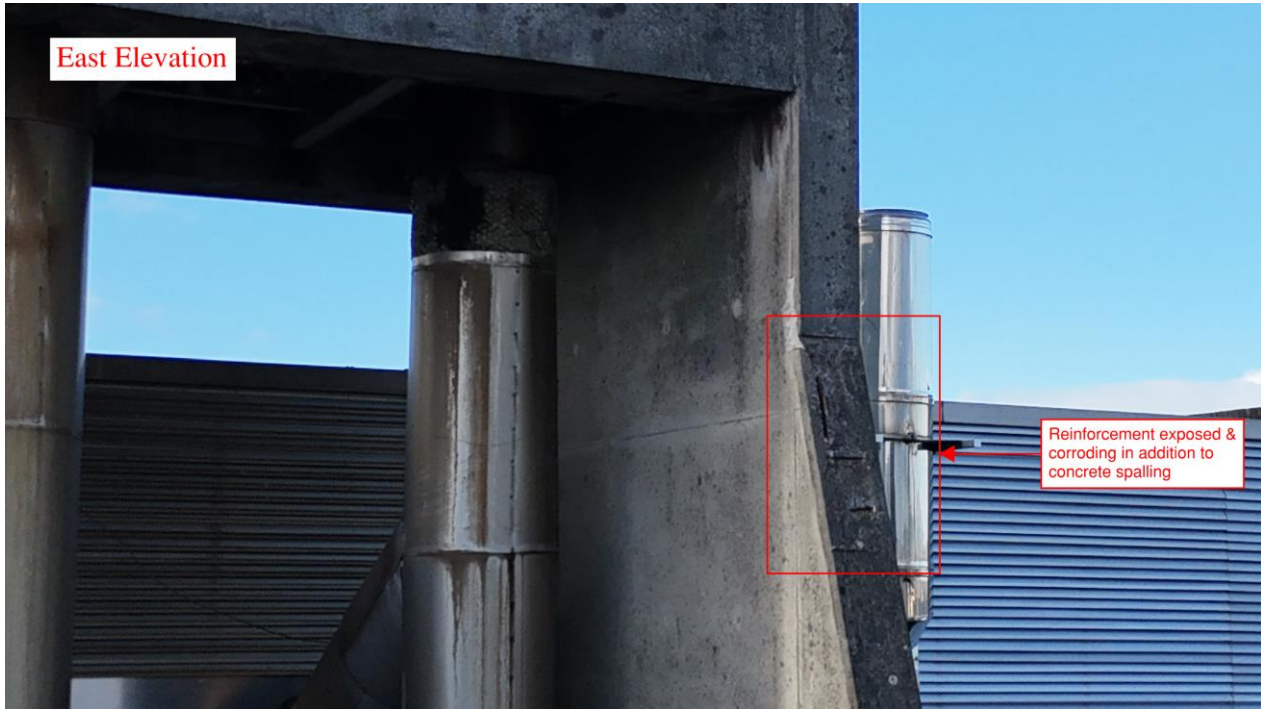
Figure A. 15 - Concrete defects on east elevation
