File Note

Project title: University Hospital Kerry (UHK) – Flue Chimney Demolition
Job number 603143-22
File reference
cc Paul Reynolds, Paul McEvoy
Prepared by: E O’Connor, J Collins, P Hegarty, R O’Neill, K O’Shea, J Purcell
Date 14 Oct 2022
Subject Arup Site Survey – Summary of Findings - 26 Sept 2022

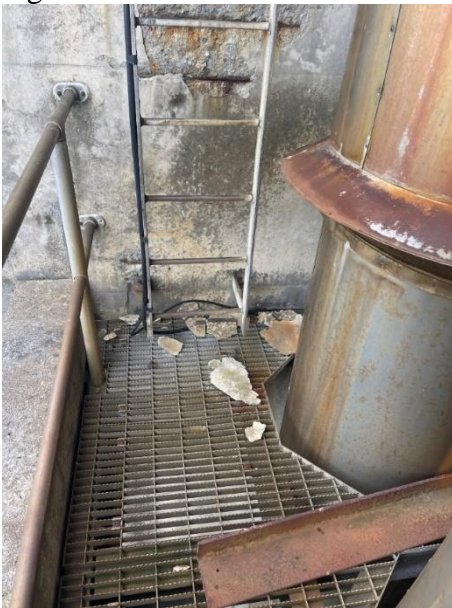
The structural survey could only be carried out from Ground Level and the First landing level of the structure as access to the upper levels was via a ladder fixed to the concrete structure and whose condition and the condition of its connection to the concrete was unknown. There is an area of significant spalling at the first landing with evidence of a recent concrete spall sitting on the steel grating. There is also evidence of other areas of the structure where the reinforcement can be seen protruding from the concrete, these areas will worsen in time and the concrete will spall. As the upper levels of the structure were not safely accessible due to the visible spalling at the access ladder connection at the lower platform, see Figure 3, there may be more significant spalling which is not visible from the lower levels. Due to the large area of recent spalling noted the area around the structure should be cordoned off as falling concrete could bounce away from the structure and cause injury or damage. We noted some cracking in concrete beams which will lead to water ingress and corrosion of the reinforcement and eventually spalling will occur.

Figure 1: Image showing spalled concrete on the steel walkway

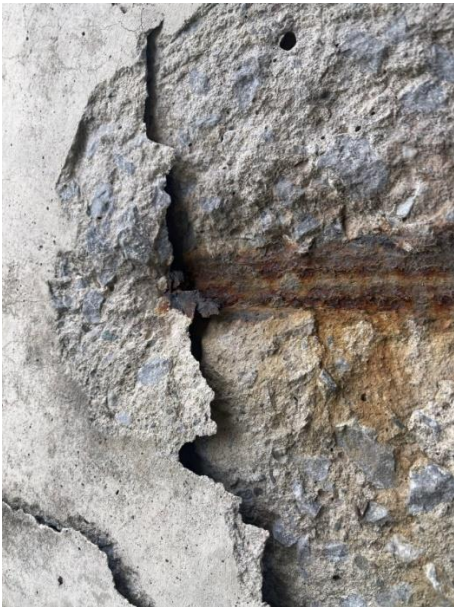
Figure 2: Image shows loose concrete

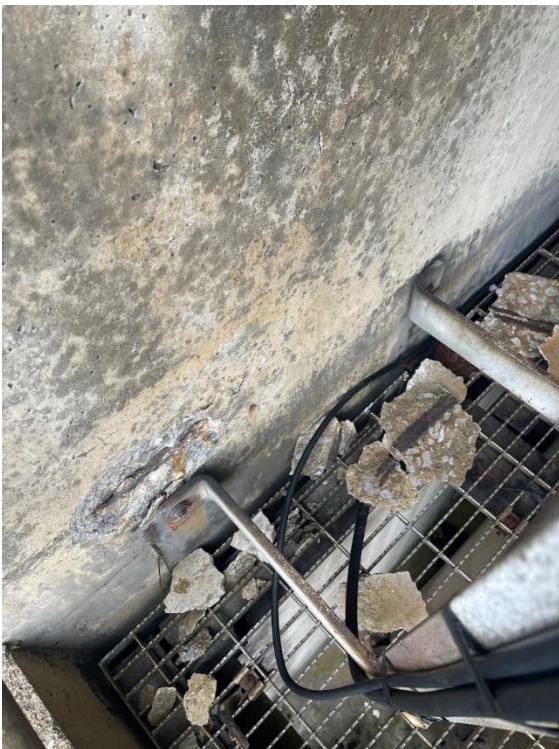
Figure 3: Image shows spalled concrete at the access ladder connection

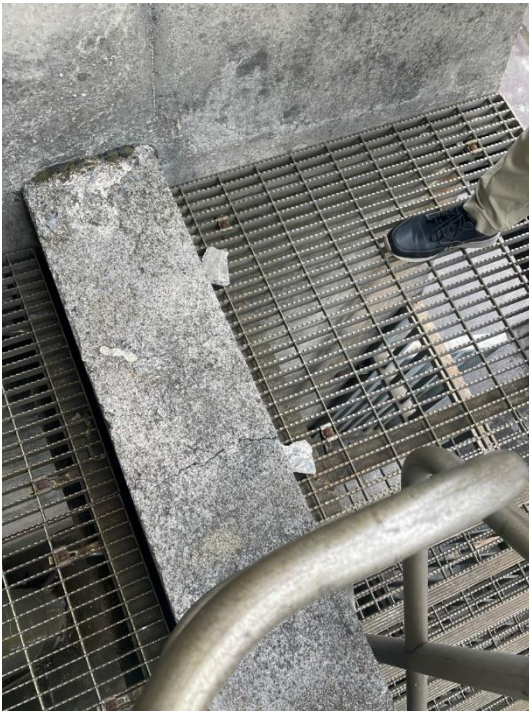
Figure 4: Image showing piece of fallen concrete and a crack in concrete beam
