# COMMISSIONERS OF IRISH LIGHTS

18<sup>th</sup> June 2019

## **Muglins Boat Landing Inspection Report**

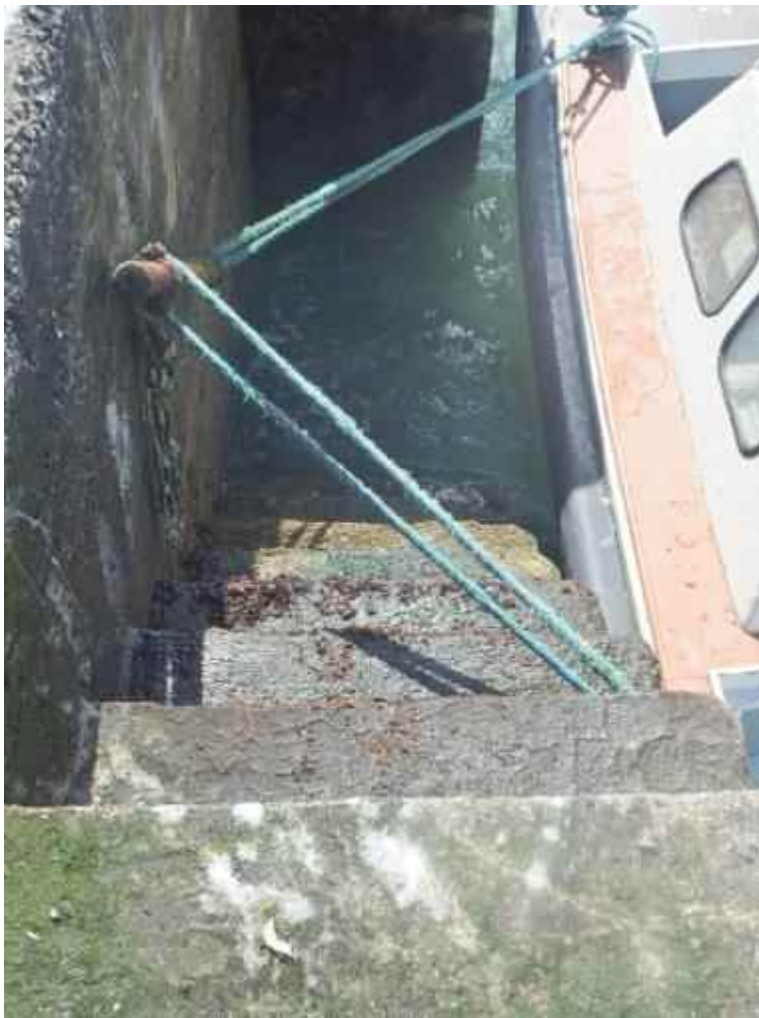
Entire steps back in 2017 – handrail now missing.

- Concrete repairs made to side of landing below the water line (This has got worse since the reports made in 2016 & 2017)
- Handrail in need of replacement (Outstanding from last report) – Handrail gone entirely

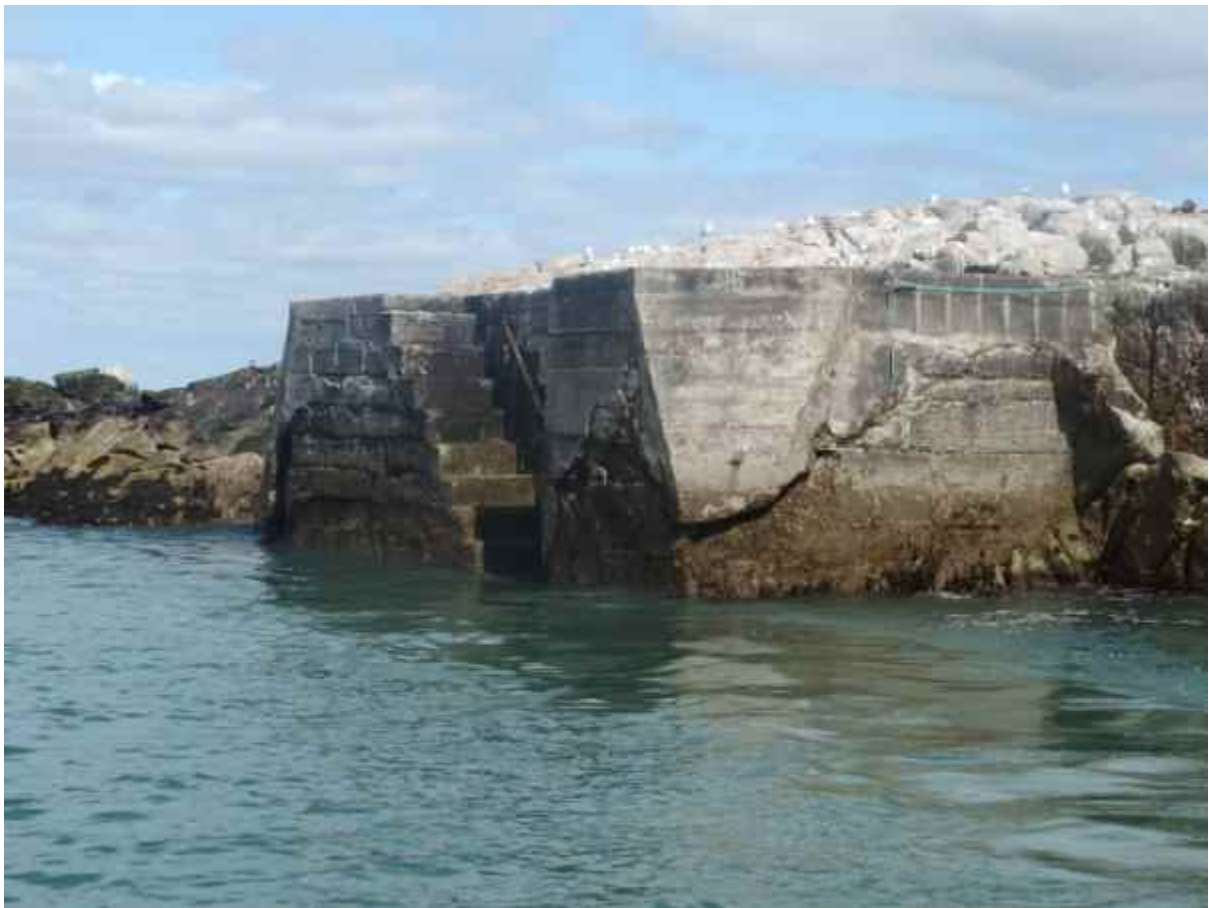
Concrete cracking and missing on side of landing below waterline
