CLIENT: LAOIS OFFALY ETB

PROJECT: CLONASLEE VOCATIONAL SCHOOL

DRAWING: ROOF AND FASCIA/SOFFIT REPAIRS DRAWN BY: CF

DRAWING No: TD9001

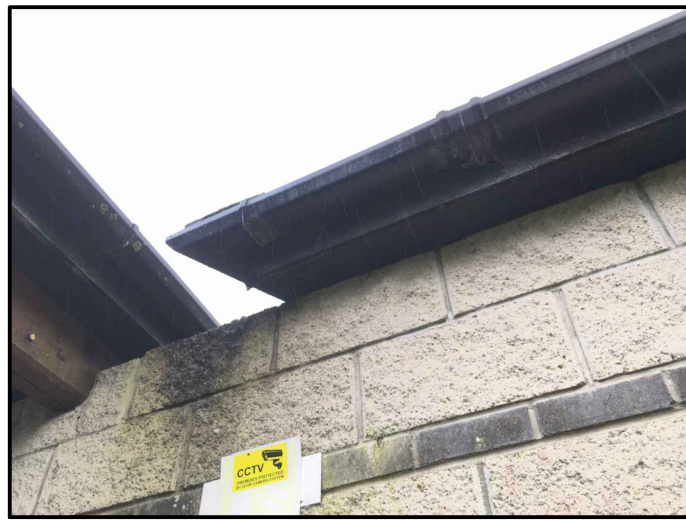
Photo Ref 01  
Gutters to be replaced as necessary

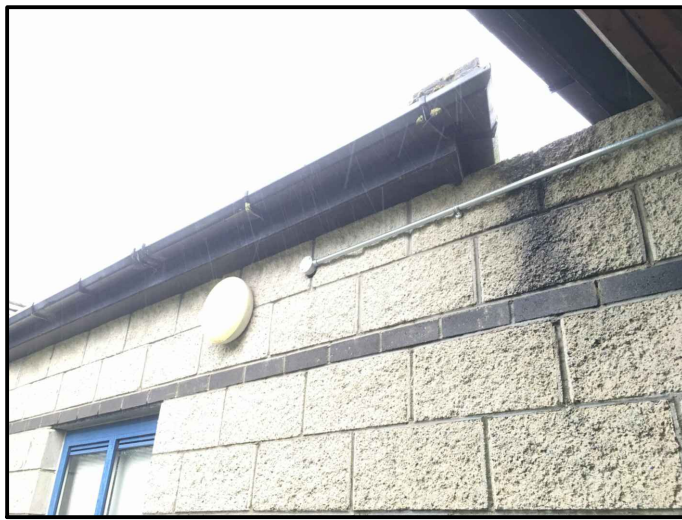
Photo Ref 02  
Gutters to be replaced as necessary

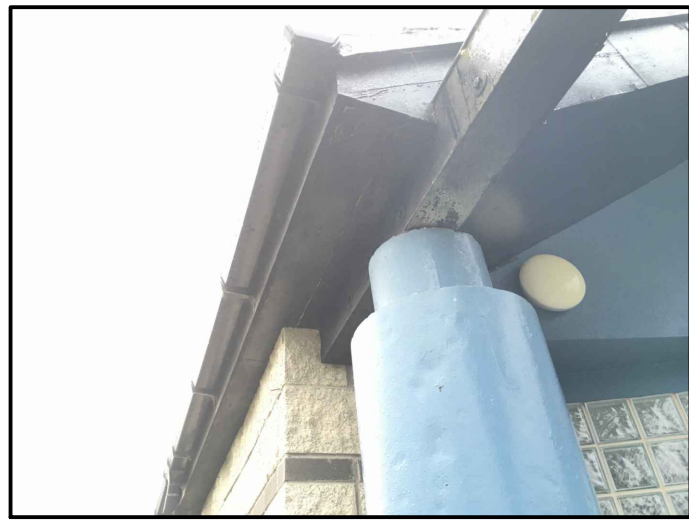
Photo Ref 03  
Entrance Canopy - Timbers to be replaced

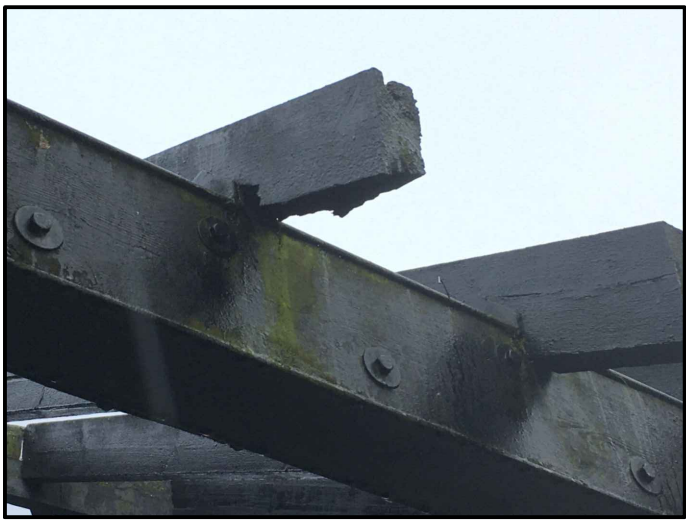
Photo Ref 03  
Entrance Canopy - Timbers to be replaced

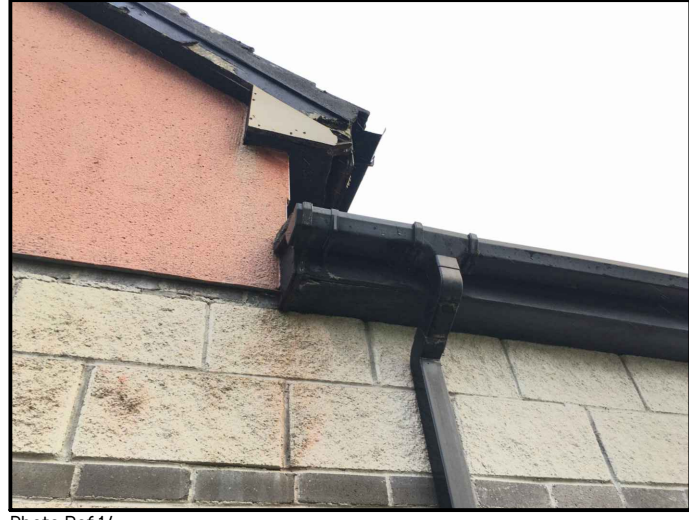
Photo Ref 14  
Roof Barge & Eaves to be repaired.

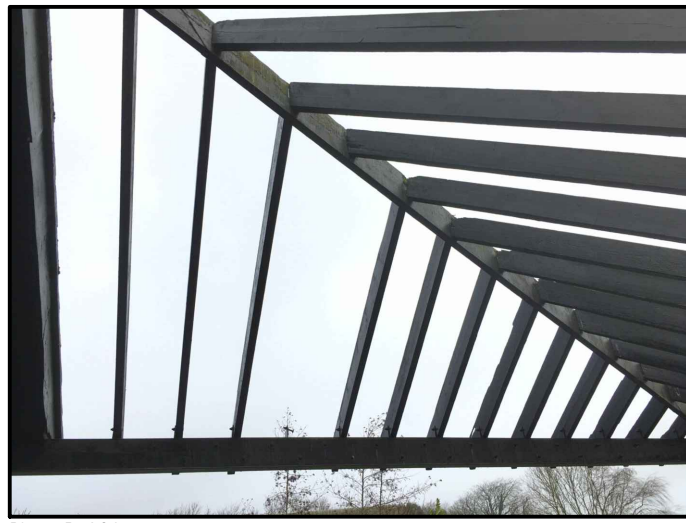
Photo Ref 04  
Entrance Canopy -  
Option A - Timbers replaced with a new Tile roof on felt, battens and structural timbers.  
Option B - Timbers to be replaced with timber effect plastic lengths. Giving the same visual effect of existing canopy

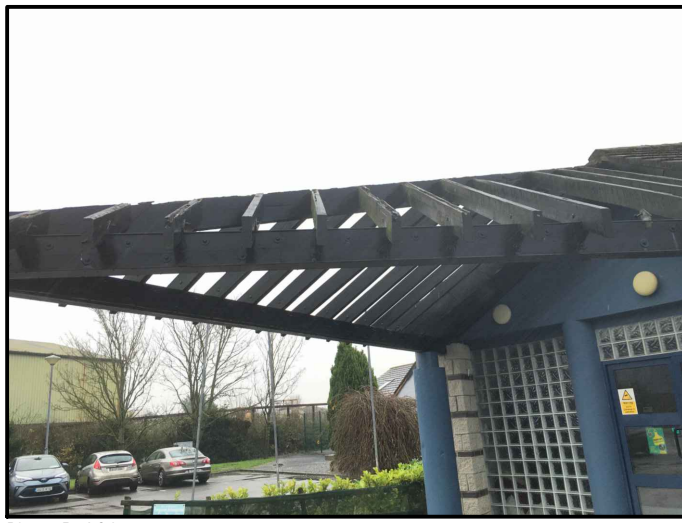
Photo Ref 04  
Entrance Canopy -  
Option A - Timbers replaced with a new Tile roof on felt, battens and structural timbers.  
Option B - Timbers to be replaced with timber effect plastic lengths. Giving the same visual effect of existing canopy

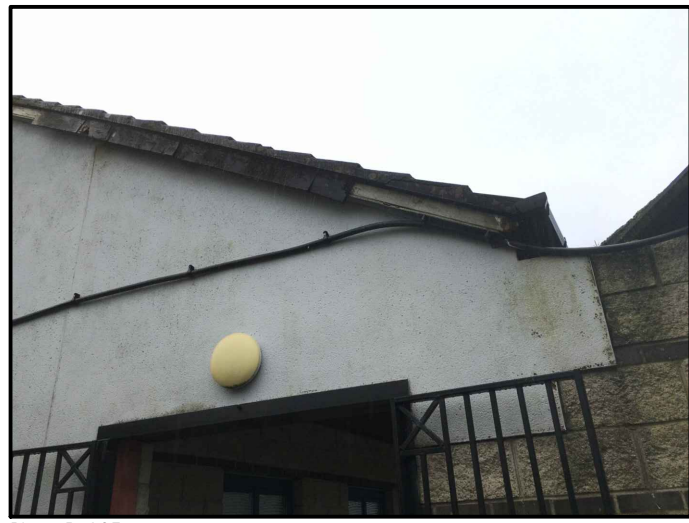
Photo Ref 05  
Roof Barge to be repaired as per detail 02.

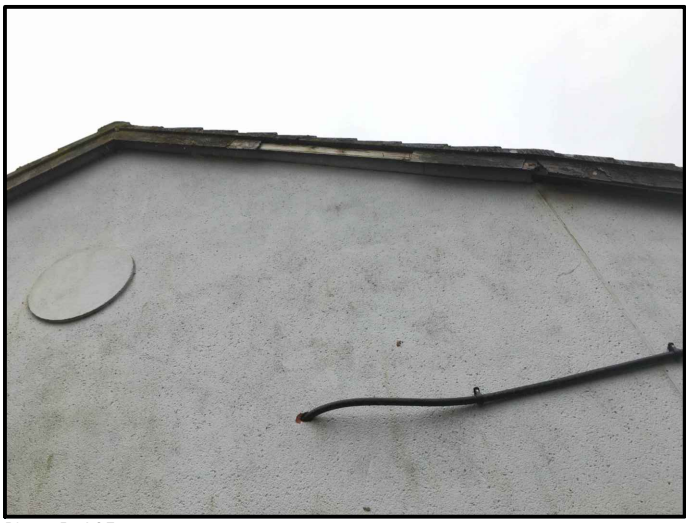
Photo Ref 05  
Roof Barge to be repaired as per detail 02.

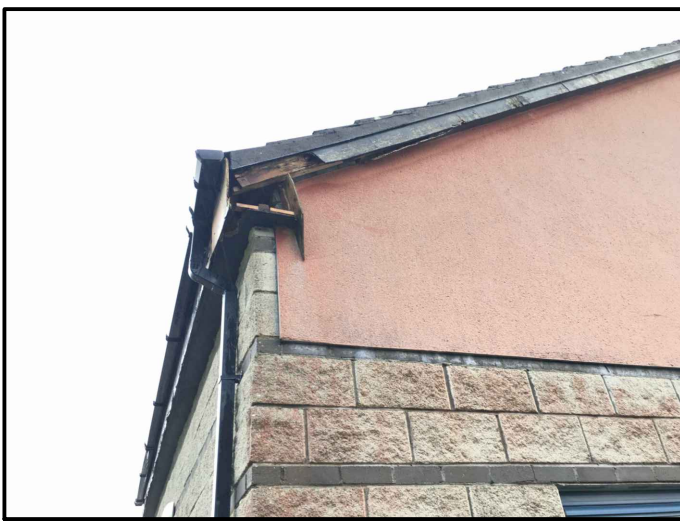
Photo Ref 15  
Roof Barge & Eaves to be repaired.

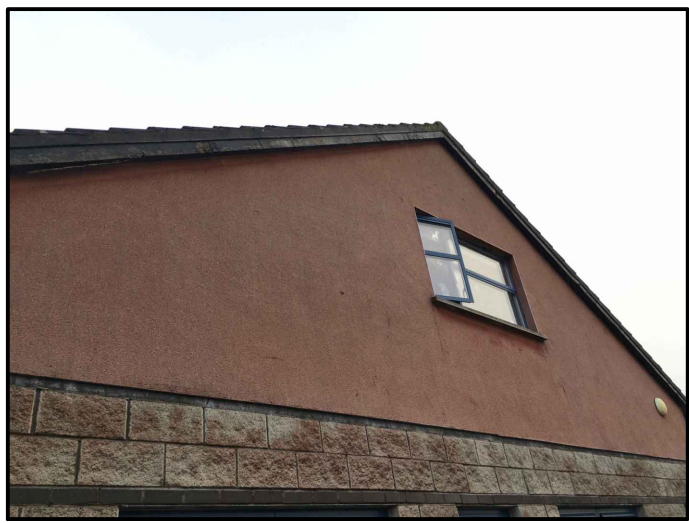
Photo Ref 15  
Roof Barge to be repaired as per detail 02.

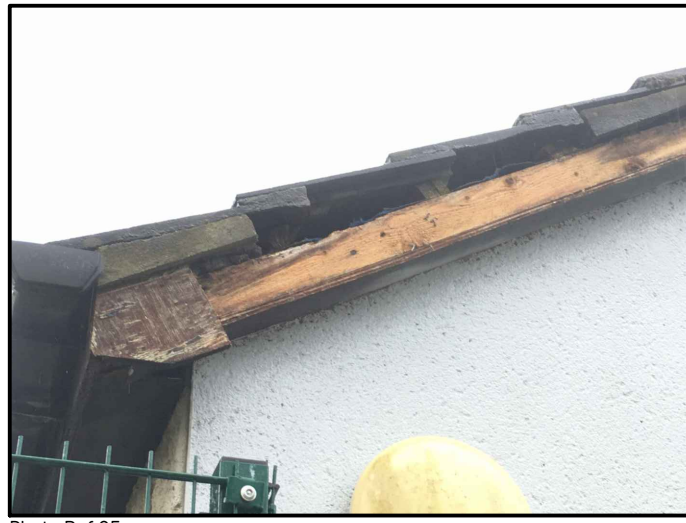
Photo Ref 05  
Roof Barge to be repaired as per detail 02.

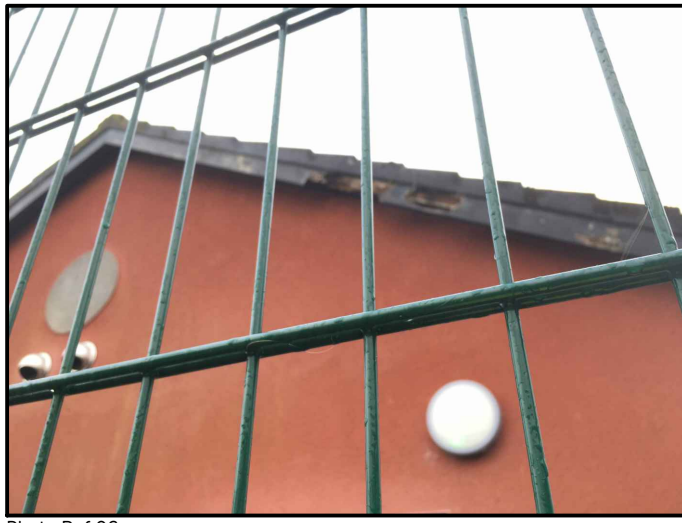
Photo Ref 06  
Roof Barge to be repaired as per detail 02.

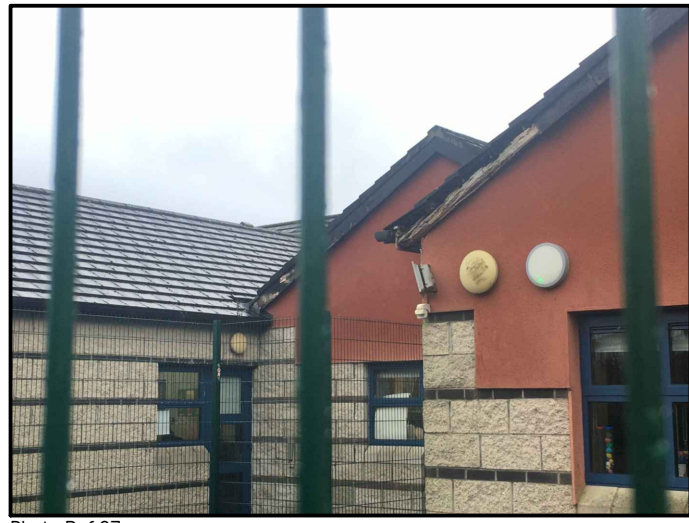
Photo Ref 07  
Roof Barge to be repaired as per detail 02.

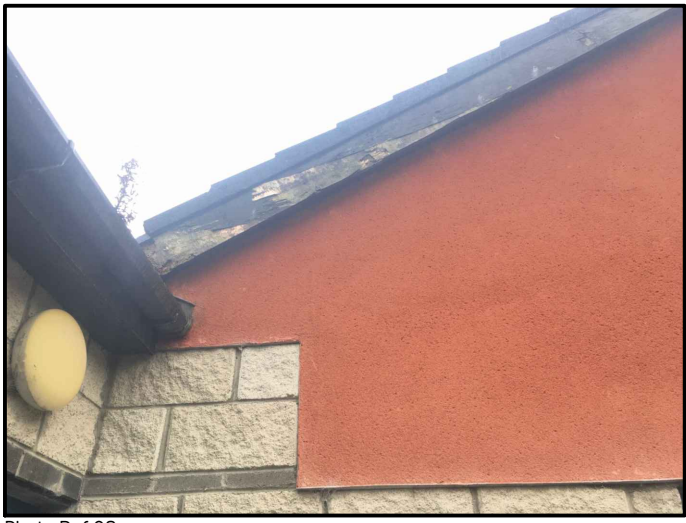
Photo Ref 08  
Roof Barge to be repaired as per detail 02.

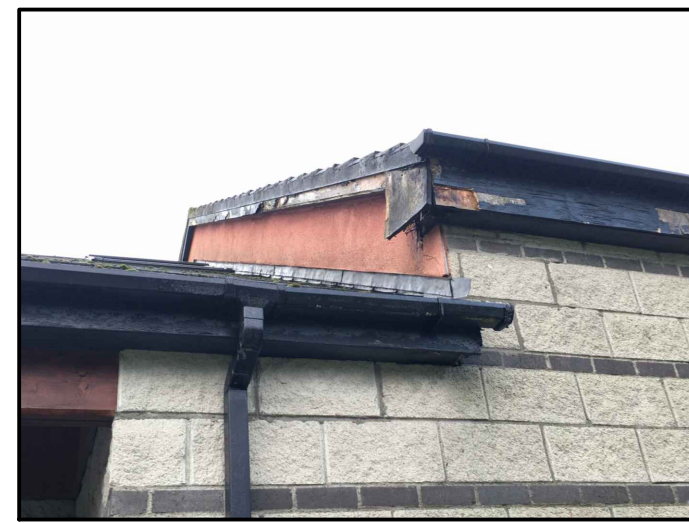
Photo Ref 16  
Roof Barge & Eaves to be repaired.

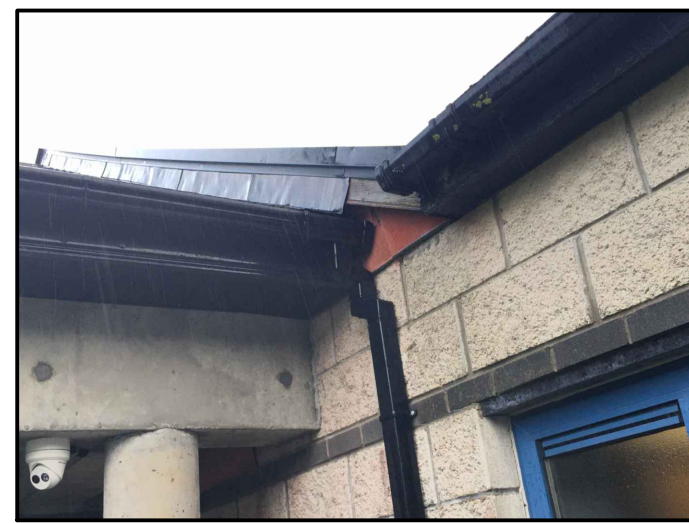
Photo Ref 17  
Roof Barge & Eaves to be repaired.

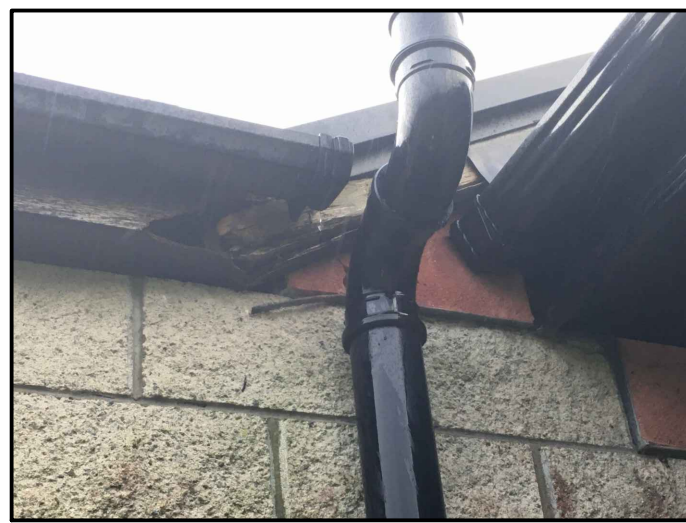
Photo Ref 18  
Roof Barge & Eaves to be repaired.

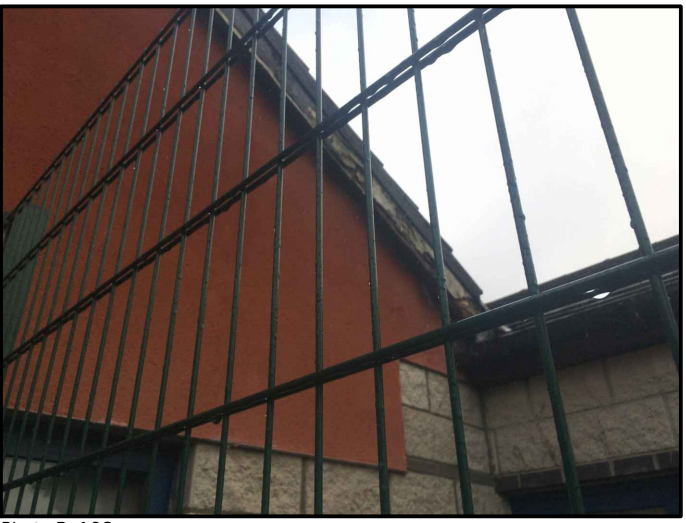
Photo Ref 09  
Roof Barge to be repaired as per detail 02.

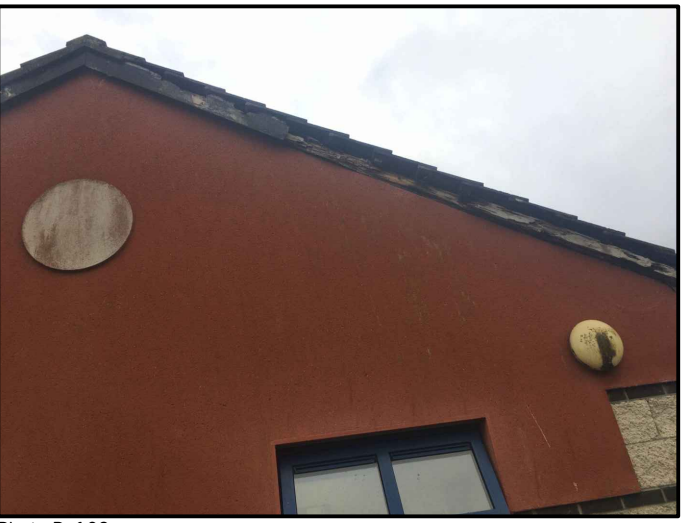
Photo Ref 09  
Roof Barge to be repaired as per detail 02.

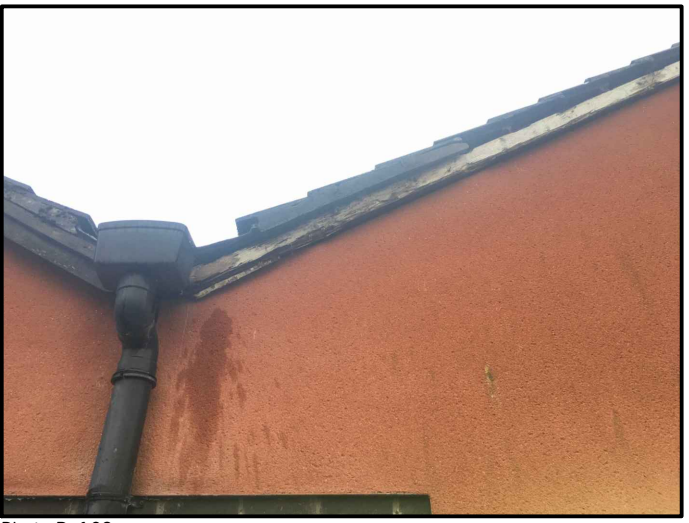
Photo Ref 09  
Roof Barge to be repaired as per detail 02.

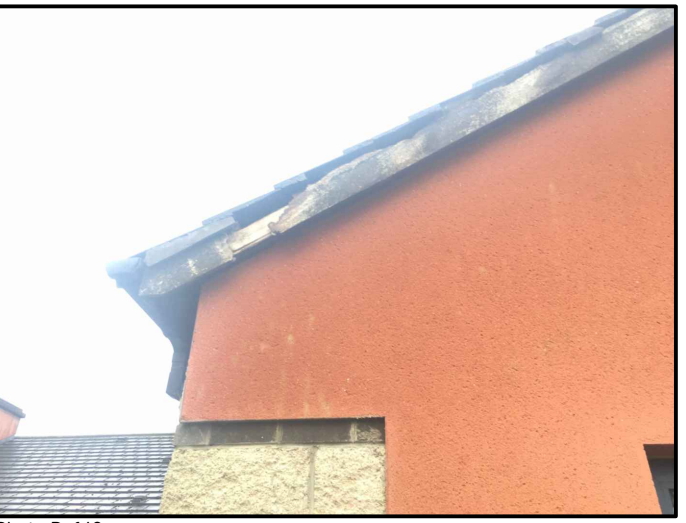
Photo Ref 10  
Roof Barge to be repaired as per detail 02.

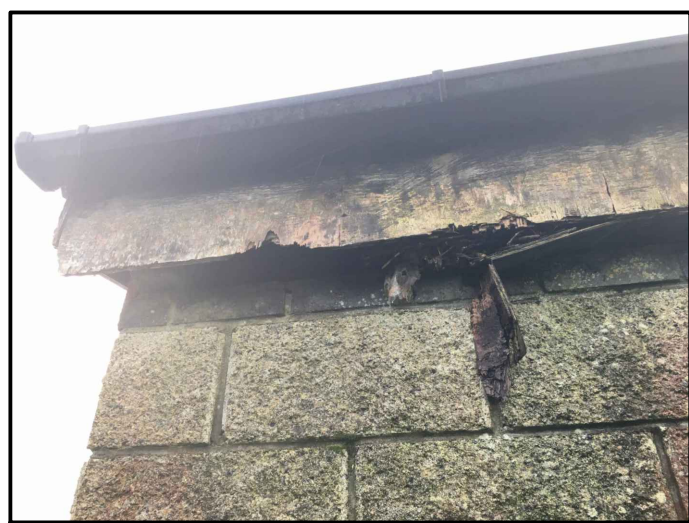
Photo Ref 19  
Roof Eaves to be repaired as per detail 01.

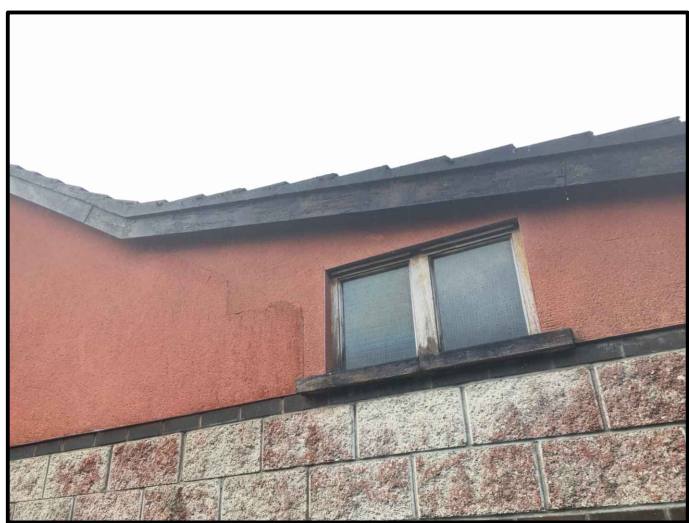
Photo Ref 20  
Roof Barge to be repaired as per detail 02.

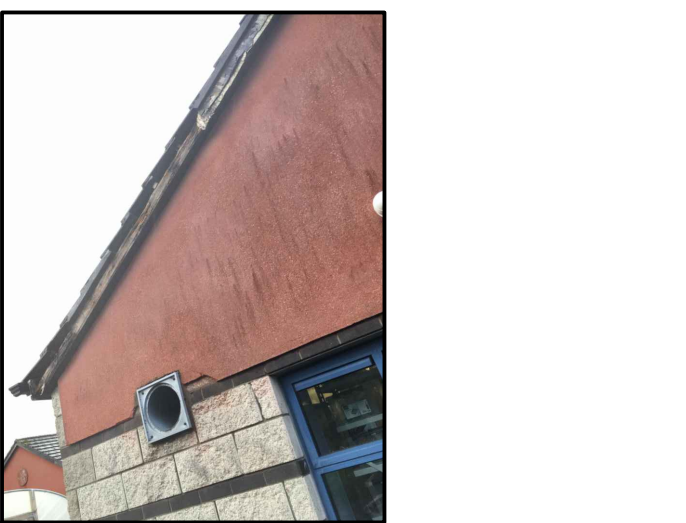
Photo Ref 21  
Roof Barge to be repaired as per detail 02.

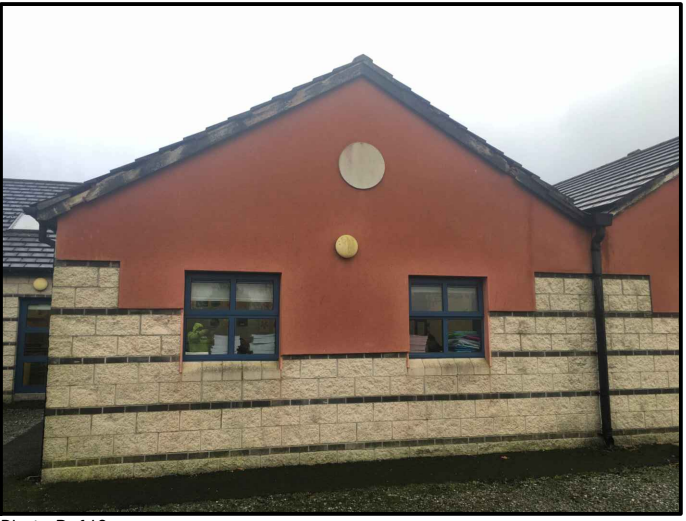
Photo Ref 10  
Roof Barge to be repaired as per detail 02.

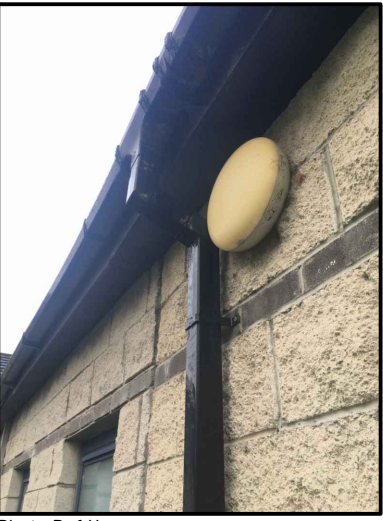
Photo Ref 11  
Gutters to be replaced/repairs as necessary

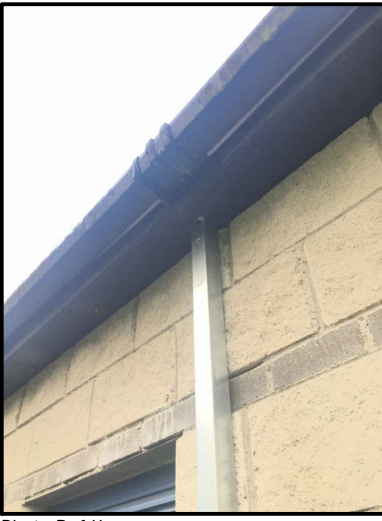
Photo Ref 11  
Gutters to be replaced/repairs as necessary

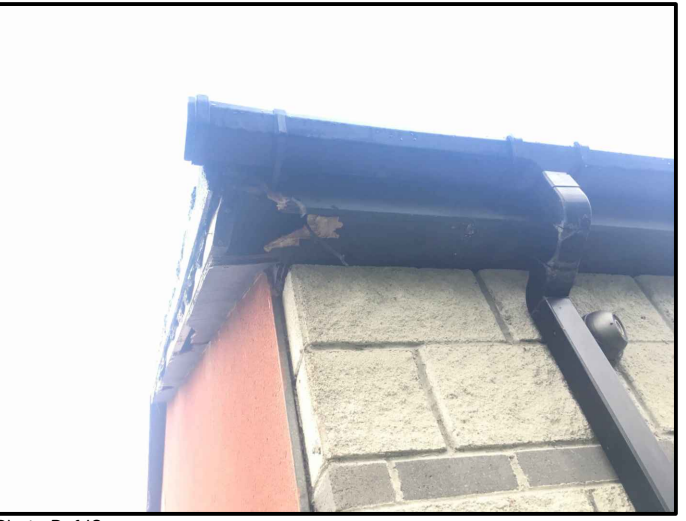
Photo Ref 12  
Roof Eaves to be repaired as per detail 01.

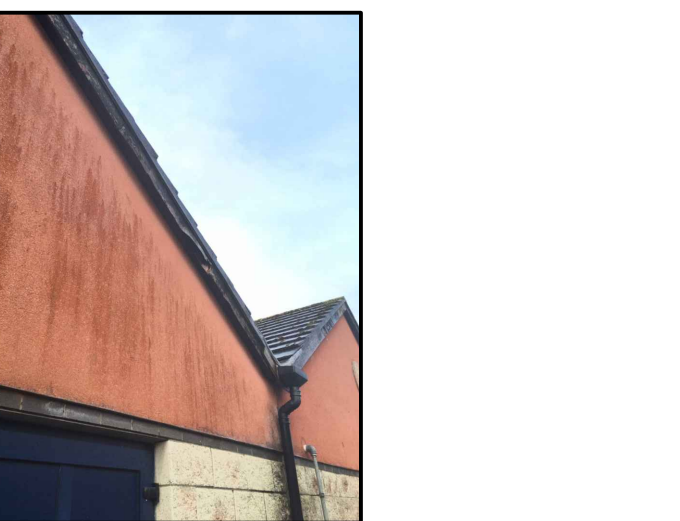
Photo Ref 21  
Roof Barge to be repaired as per detail 02.

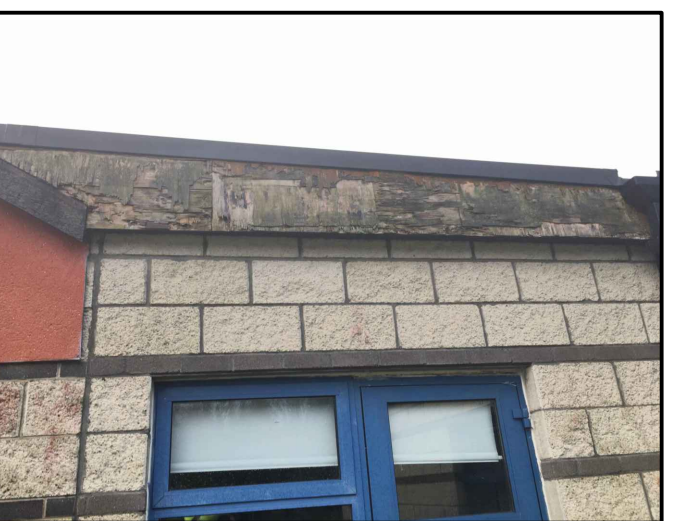
Photo Ref 22  
Roof Eaves to be repaired as per detail 01.

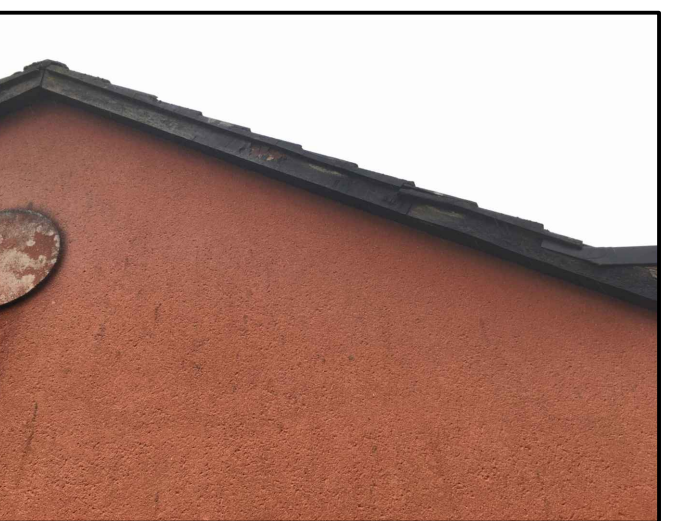
Photo Ref 23  
Roof Barge to be repaired as per detail 02.

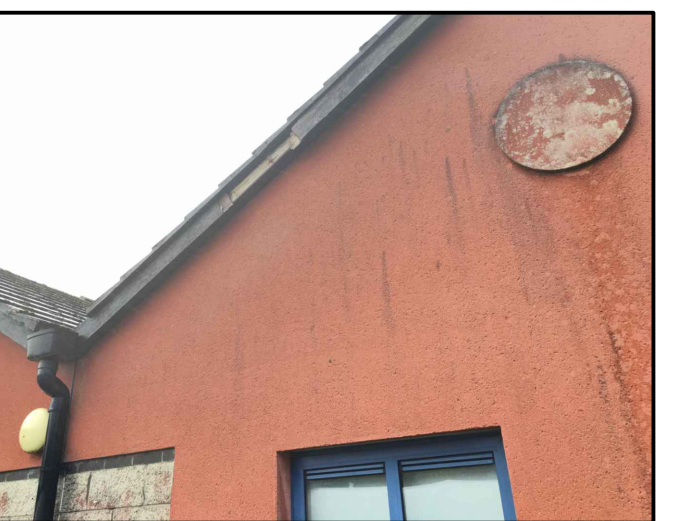
Photo Ref 23  
Roof Barge to be repaired as per detail 02.

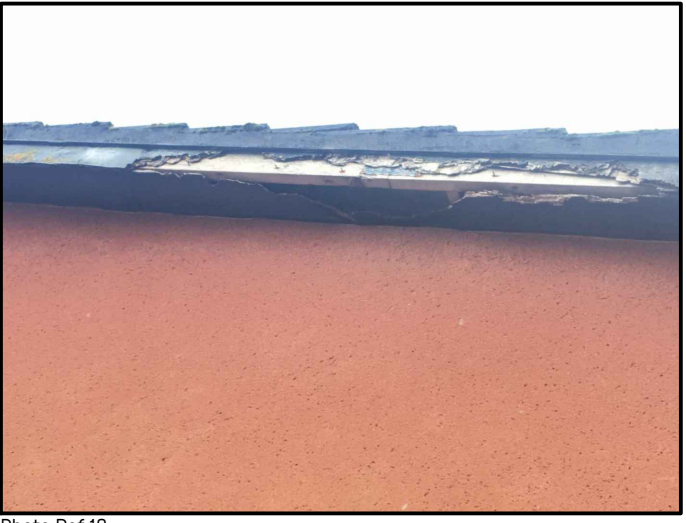
Photo Ref 12  
Roof Barge to be repaired as per detail 02.

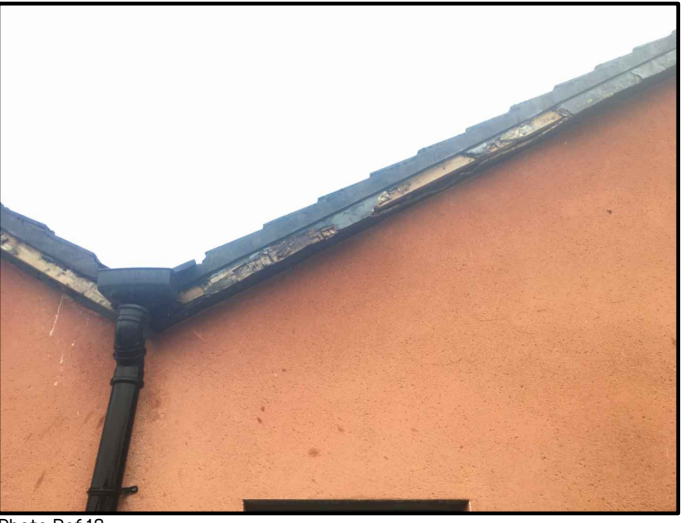
Photo Ref 12  
Roof Barge to be repaired as per detail 02.

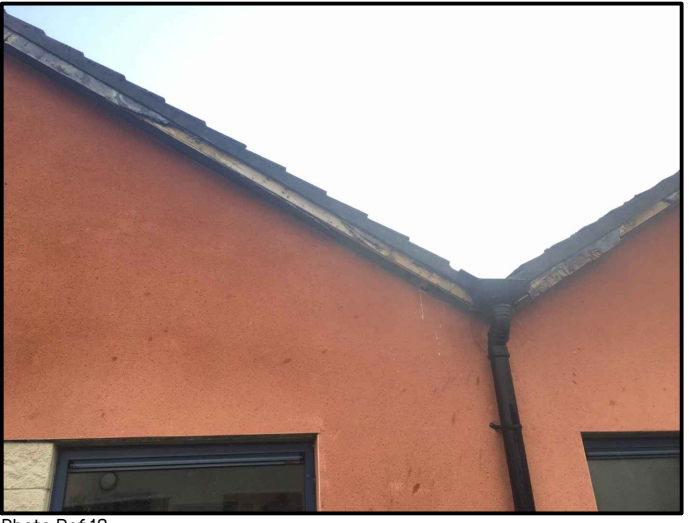
Photo Ref 13  
Roof Barge to be repaired as per detail 02.

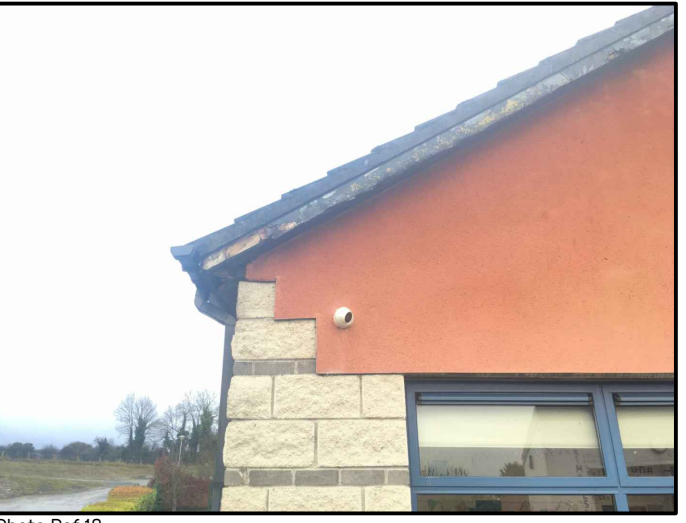
Photo Ref 13  
Roof Barge to be repaired as per detail 02.

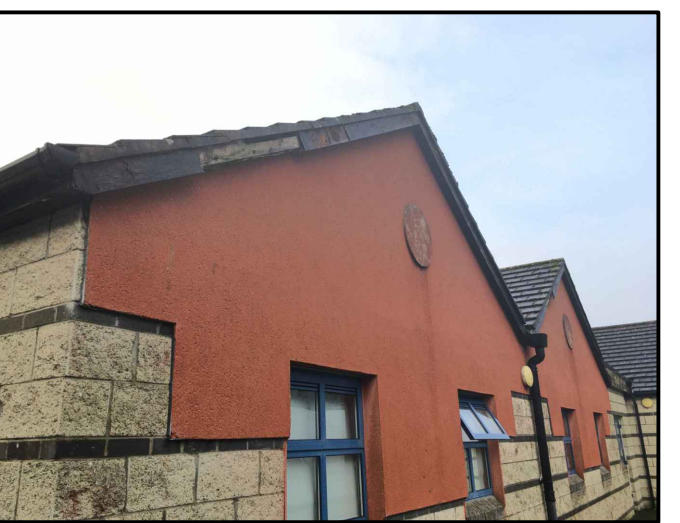
Photo Ref 24  
Roof Barge to be repaired as per detail 02.

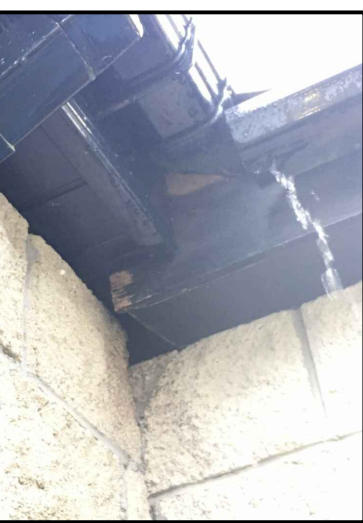
Photo Ref 25  
Gutters to be replaced as necessary

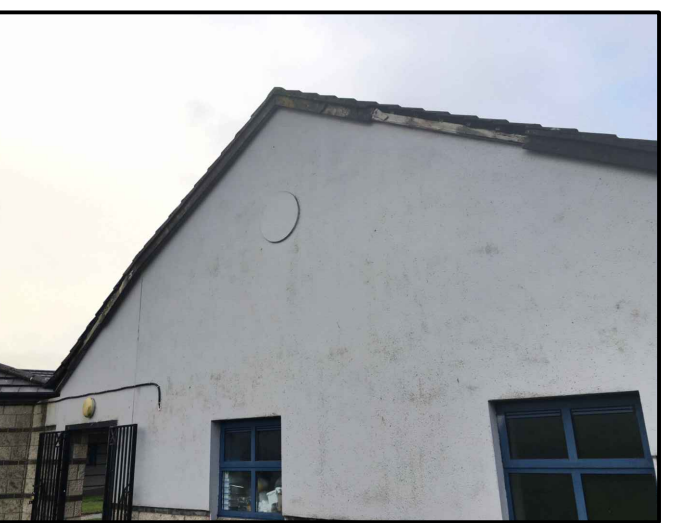
Photo Ref 26  
Roof Barge to be repaired as per detail 02.

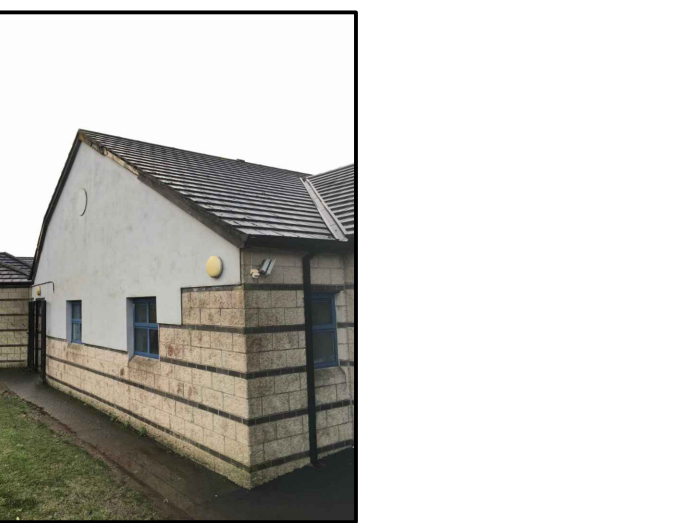
Photo Ref 26  
Roof Barge to be repaired as per detail 02.
