Kinsale Regional Museum

Old Courthouse, Market Square, Kinsale, Co. Cork. P17 D962

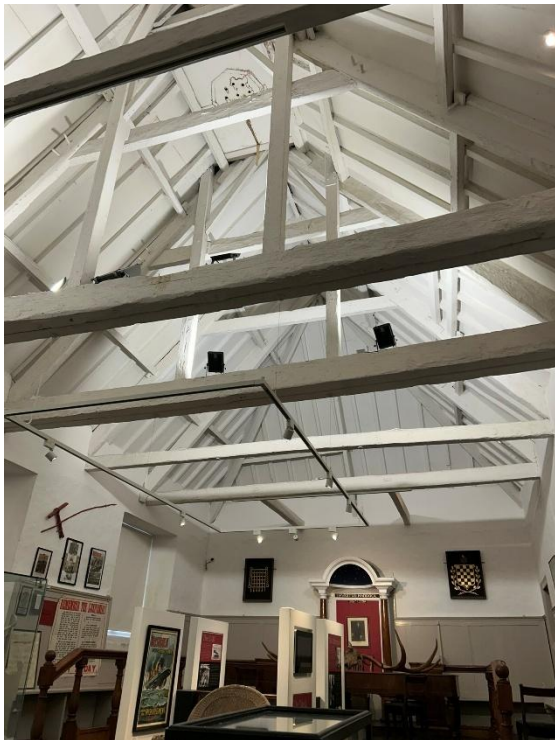
Figure 1: View of First Floor Exhibition Space

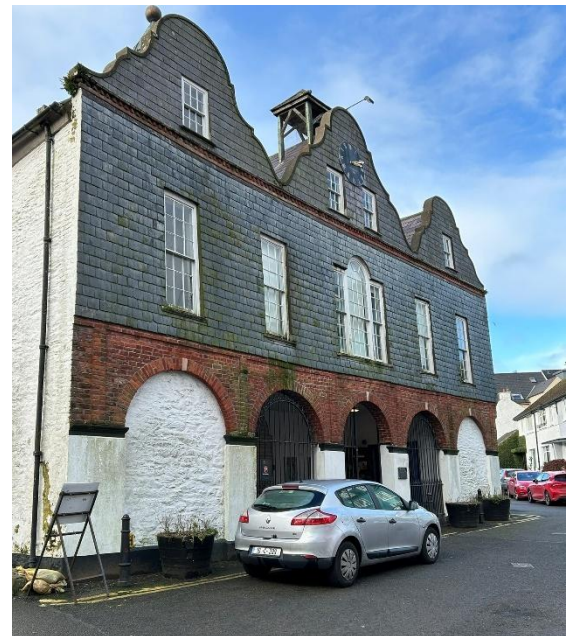
Figure 4: Recent photograph of the Museum

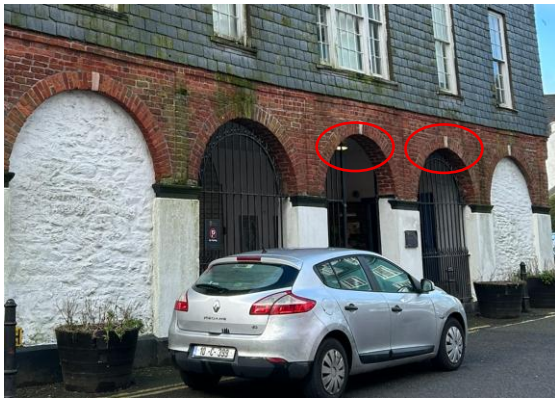
Figure 5: Location of subject cracks highlighted

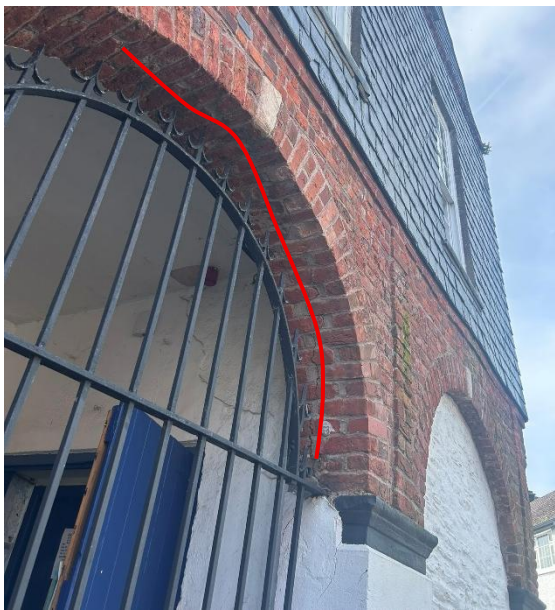
Figure 6: Detail of subject crack highlighted

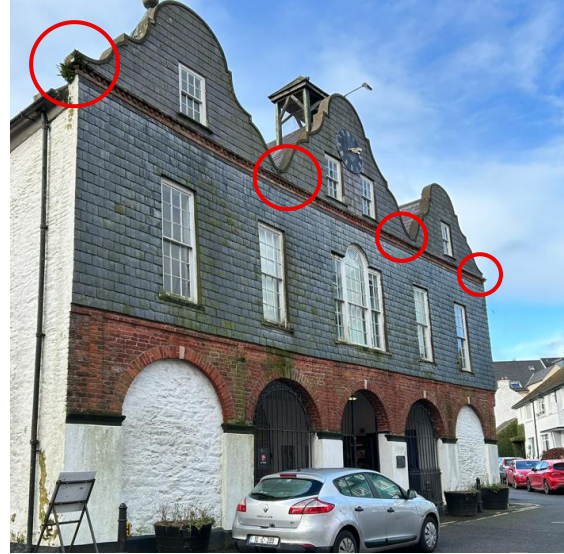
Figure 7: Locations of vegetation growth highlighted

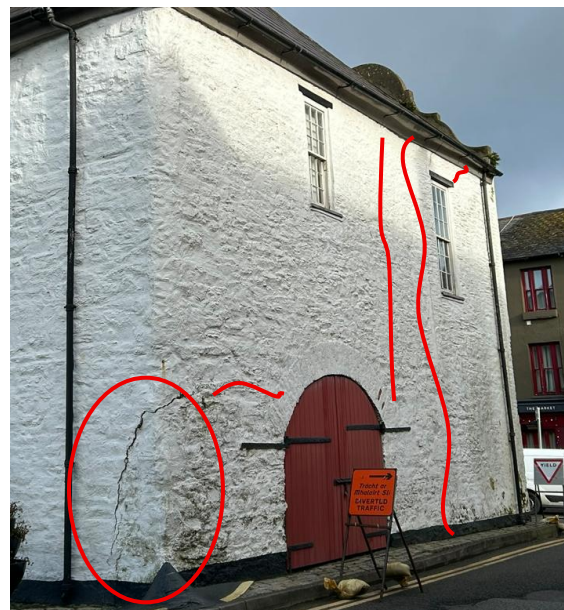
Figure 8: Location of subject cracks highlighted

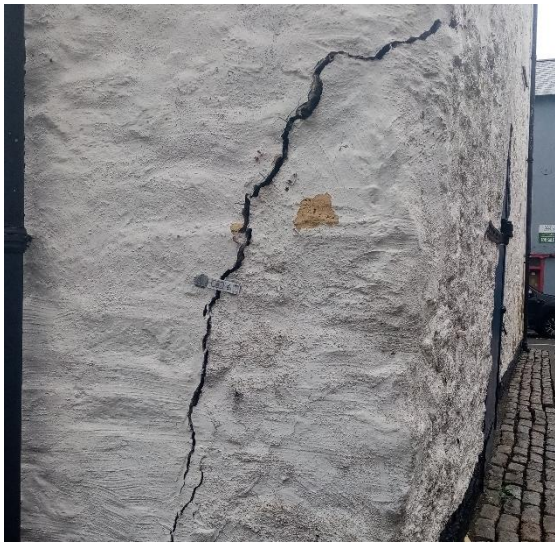
Figure 9: Detail of crack on southern corner

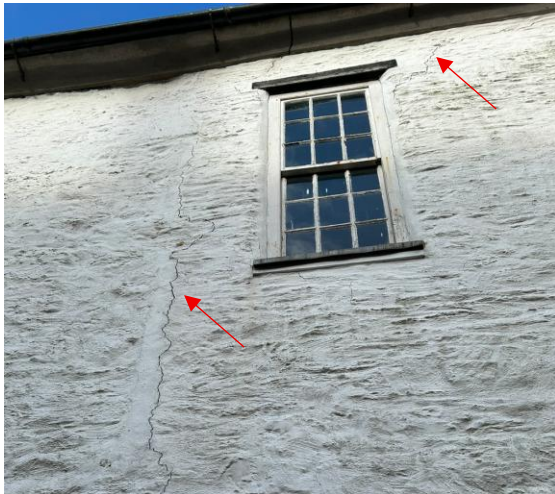
Figure 10: Detail of cracking on southeastern elevation

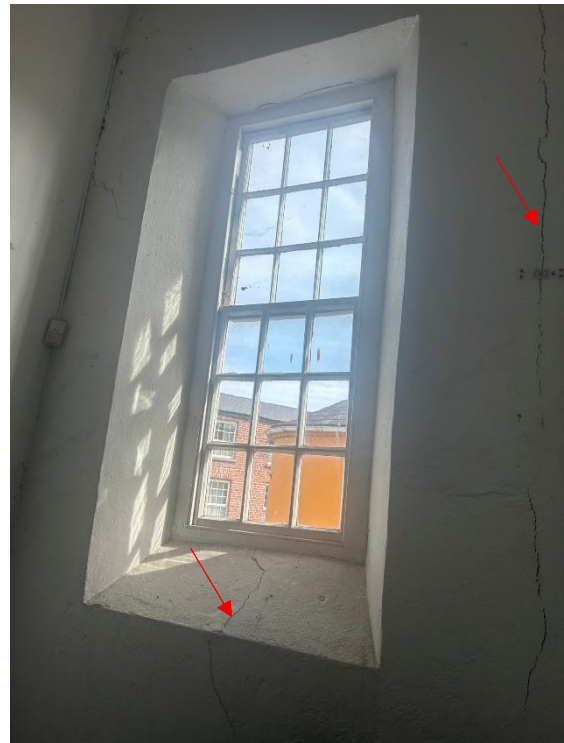
Figure 11: Internal cracks which correspond to the external cracks

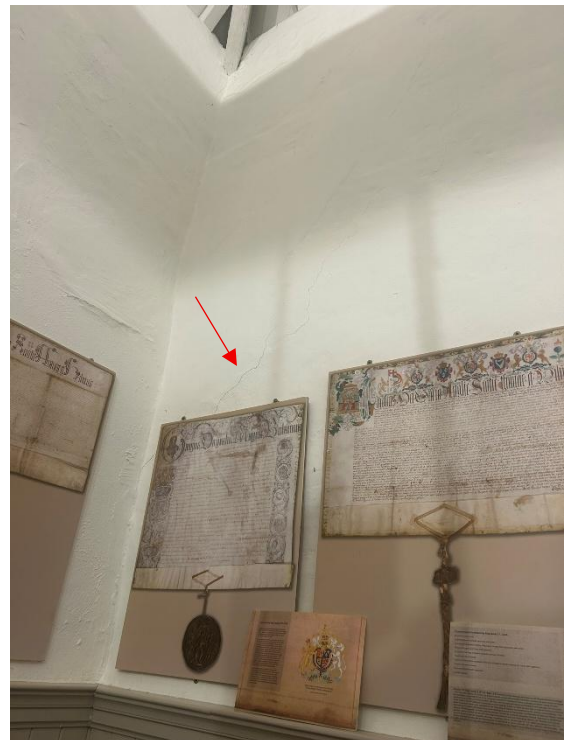
Figure 12: Internal cracks which correspond to the external cracks

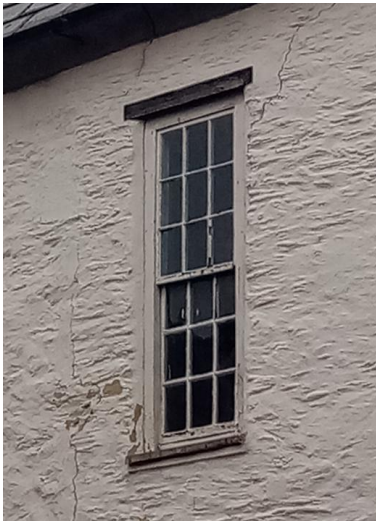
Figure 13: A window on the southeastern elevation in poor repair

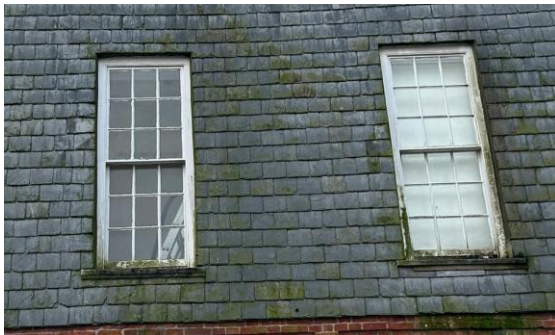
Figure 14: Window on the northeastern elevation with suspected OPC reveals

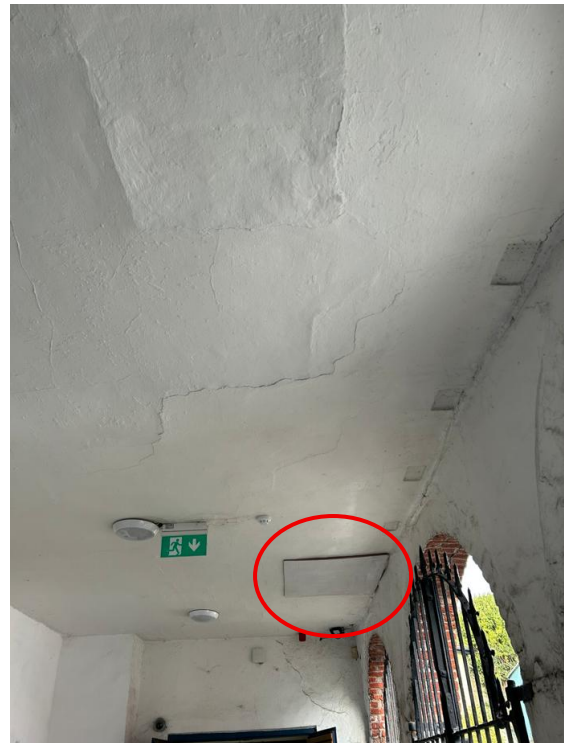
Figure 15: View of Ground Floor Arcade looking Northwest - note vents on RHS.

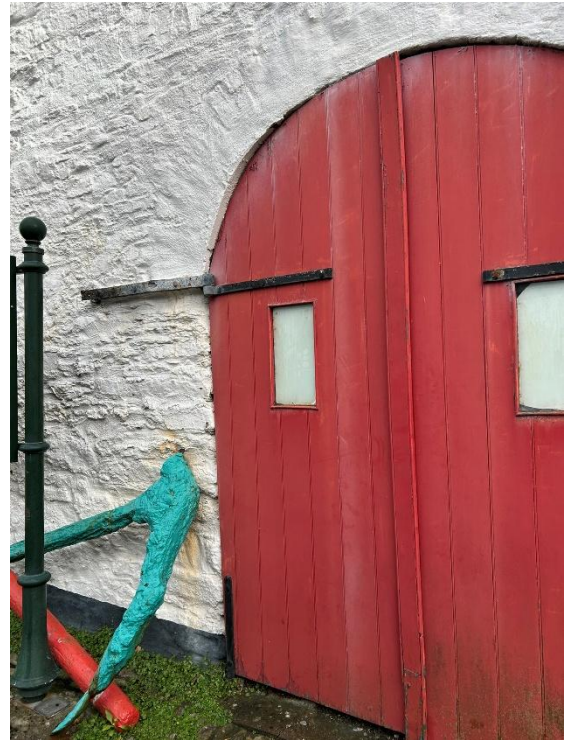
Figure 22: View of Fire Doors and wrought iron hinges

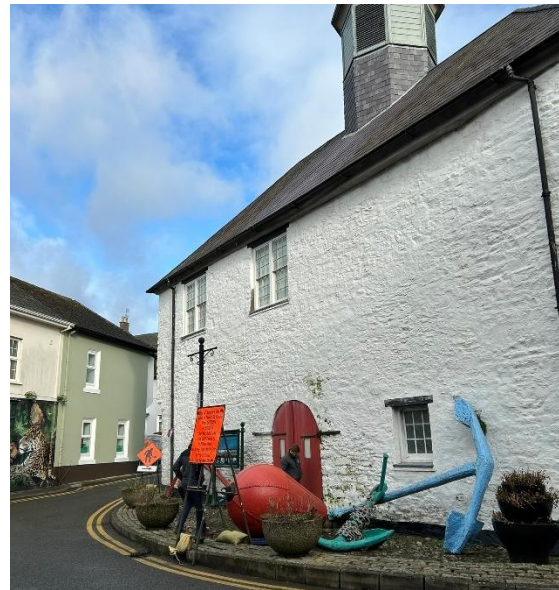
Figure 25: View of southwestern elevation where there is evidence of a broken gutter as observed on a wet day

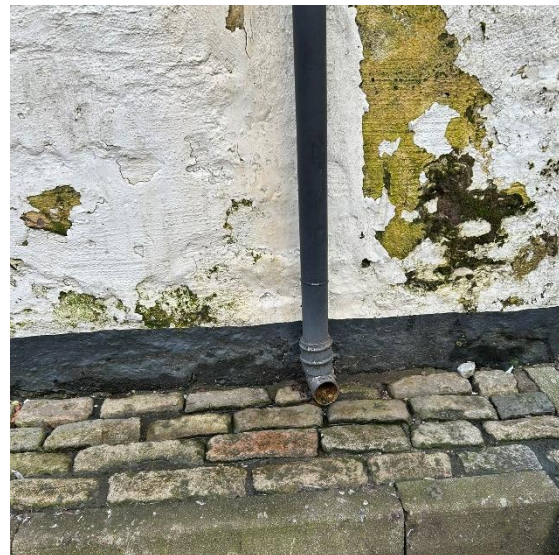
Figure 26: Detail of existing downpipe discharging above ground on eastern corner.
