# Asbestos Management Survey

Quay National School, Creggs Rd,  
Quignamanger, Ballina, Co. Mayo, F26  
YX95

N2203354

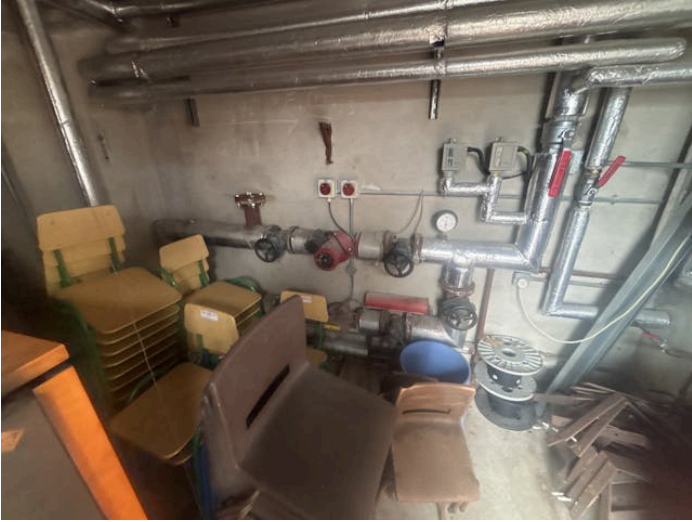
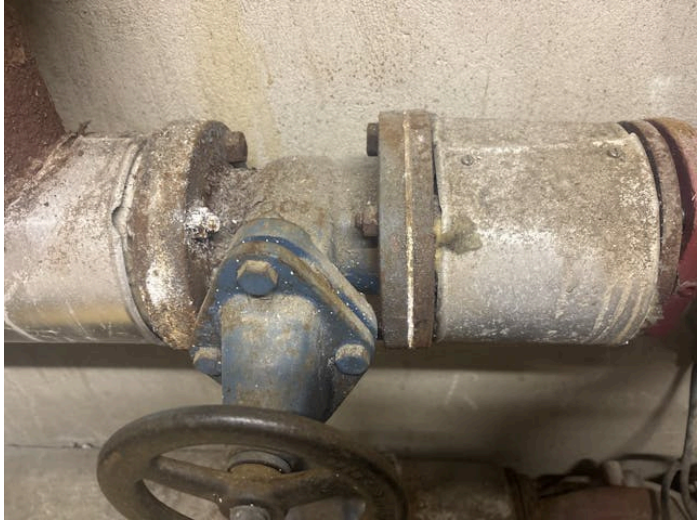
## Main Building > External > Boiler House > Gaskets

| Location | Boiler House | Item | Gaskets |
| Material | Gasket seal | Extent | Approx 14 No. total |
| Strategy / Sample Id | Sample / S104 | Fibre Type | Chrysotile |

| Product Type (or Debris from Product) | 2 | Extent of Damage / Deterioration | 1 |
| Material Score | 5 / Low | | |

| Recommendation | Manage in situ. Removal by trained operatives is required if gaskets are to be disturbed or removed during any future works. | | |

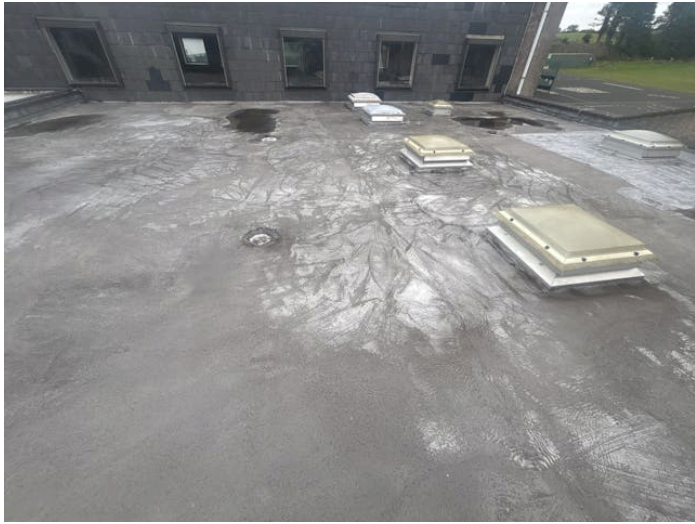
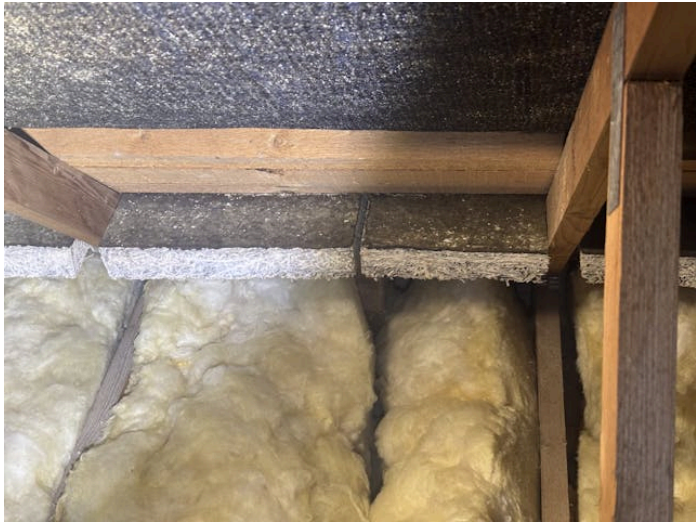
## Main Building > External > External Fixtures > Bitumen Felt

| Strategy / Sample Id | Sample / S101 | Fibre Type | Chrysotile |
| General Comments | Bitumen felt located on top of timber straw board and under new asphalt external finish. | | |

| Material Score | 4 / Very Low | | |

| Recommendation | Manage in situ. Any works carried out to repair or remove current flat roof should be by trained operatives. | | |

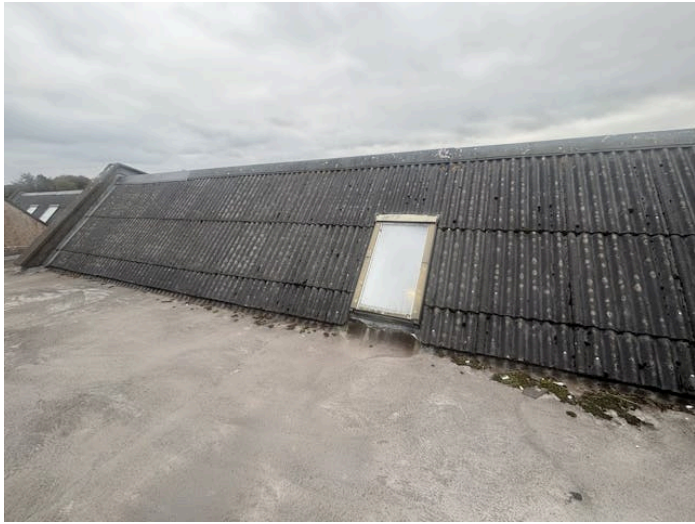
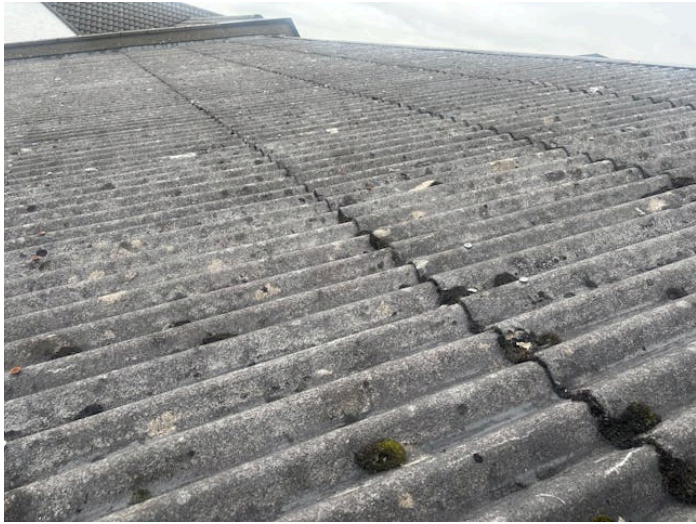
## Main Building > External > External Fixtures (R1) > Cement sheeting

| Strategy / Sample Id | Sample / S102 | Fibre Type | Amosite and Chrysotile |
| General Comments | Numerous areas of severe deterioration of sheeting across the roof. | | |

| Material Score | 6 / Low | | |

| Assessment Parameter | Score | Examples of score variables |
|---|---|---|
| Total Sum | 31 | <p><b>Judgment on state of roof:</b></p> <p>Roof is in poor condition throughout with numerous areas of deterioration exposing fibrous edges and large amounts of debris located on flat roof area.</p> <p>*This information should be considered alongside the asbestos data sheet on the previous page.</p> |

| Recommendation | Remove by trained operatives. | | |

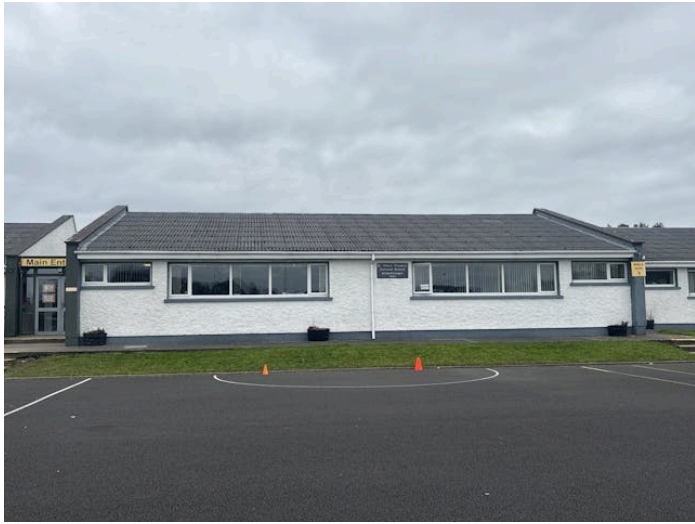
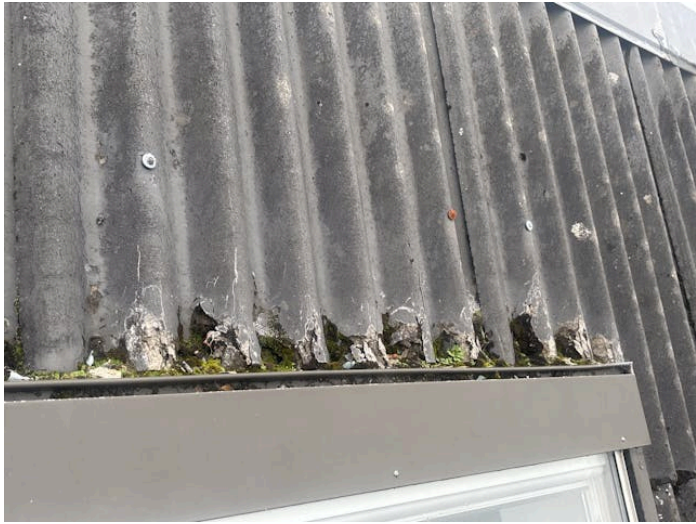
| Location | External Fixtures (R2) | Item | Cement sheeting |

| Strategy / Sample Id | Strongly Presume / S102 | Presumed Fibre Type | Amosite and Chrysotile |
| General Comments | Numerous areas of severe deterioration of sheeting across the roof. | | |

| Product Type (or Debris from Product) | 1 | Extent of Damage / Deterioration | 3 |

| Assessment Parameter | Score | Examples of score variables |
|---|---|---|
| Total Sum | 31 | <p><b>Judgment on state of roof:</b></p> <p>Roof is in poor condition throughout with numerous areas of deterioration exposing fibrous edges and large amounts of debris located on flat roof area.</p> <p>*This information should be considered alongside the asbestos data sheet on the previous page.</p> |

| Recommendation | Remove by trained operatives. | | |

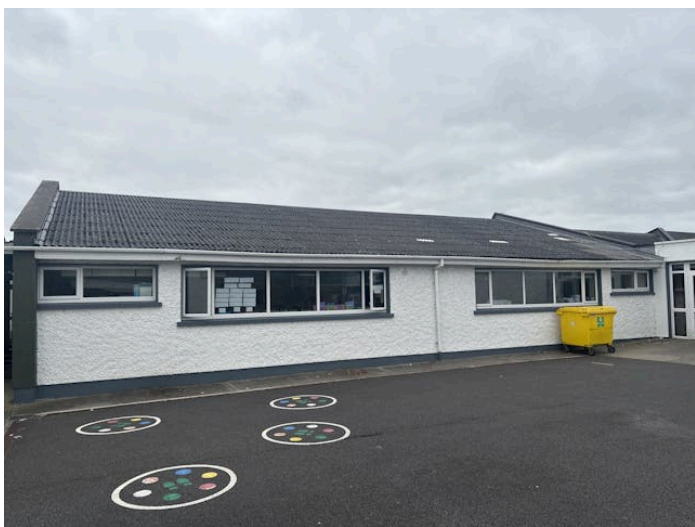
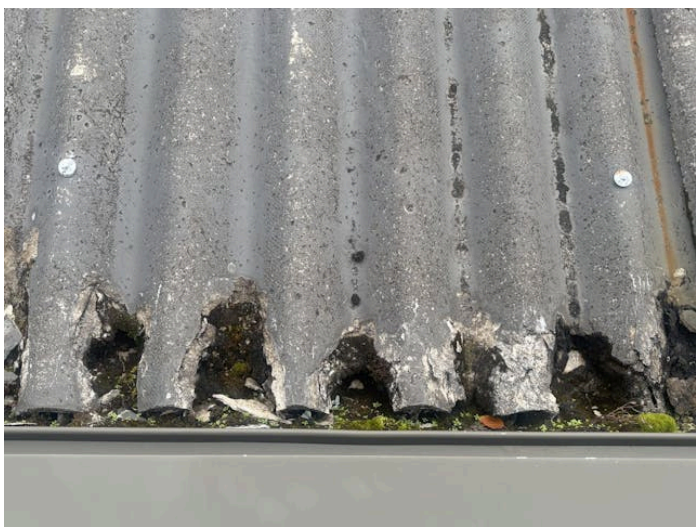
| Location | External Fixtures (R3) | Item | Cement sheeting |

| Strategy / Sample Id | Strongly Presume / S102 | Presumed Fibre Type | Amosite and Chrysotile |
| General Comments | Numerous areas of severe deterioration of sheeting across the roof. | | |

| Product Type (or Debris from Product) | 1 | Extent of Damage / Deterioration | 3 |

| Assessment Parameter | Score | Examples of score variables |
|---|---|---|
| Total Sum | 31 | <p><b>Judgment on state of roof:</b></p> <p>Roof is in poor condition throughout with numerous areas of deterioration exposing fibrous edges and large amounts of debris located on flat roof area.</p> <p>*This information should be considered alongside the asbestos data sheet on the previous page.</p> |

| Recommendation | Remove by trained operatives. | | |

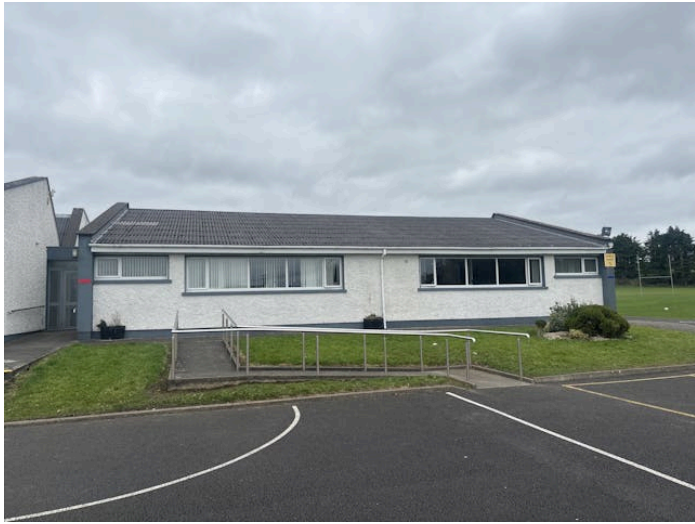
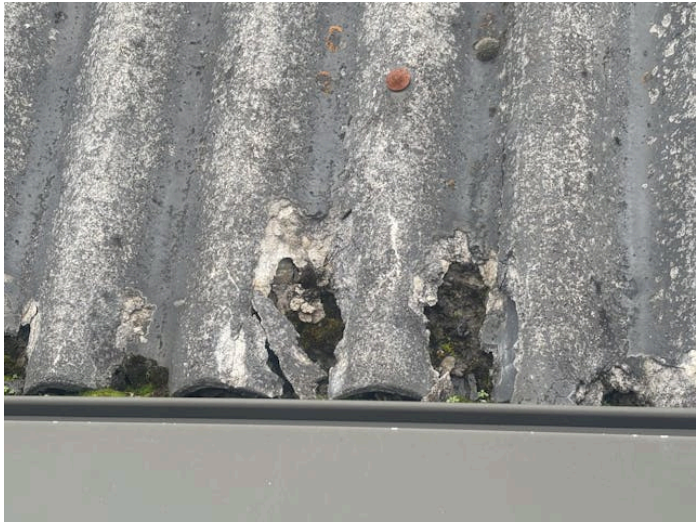
| Location | External Fixtures (R4) | Item | Cement sheeting |

| Strategy / Sample Id | Strongly Presume / S102 | Presumed Fibre Type | Amosite and Chrysotile |
| General Comments | Numerous areas of severe deterioration of sheeting across the roof. | | |

| Product Type (or Debris from Product) | 1 | Extent of Damage / Deterioration | 3 |

| Assessment Parameter | Score | Examples of score variables |
|---|---|---|
| Total Sum | 31 | <p><b>Judgment on state of roof:</b></p> <p>Roof is in poor condition throughout with numerous areas of deterioration exposing fibrous edges and large amounts of debris located on flat roof area.</p> <p>*This information should be considered alongside the asbestos data sheet on the previous page.</p> |

| Recommendation | Remove by trained operatives. | | |

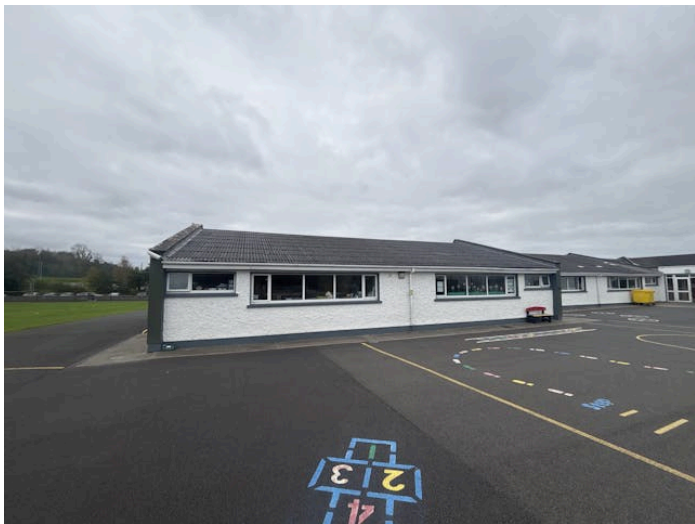
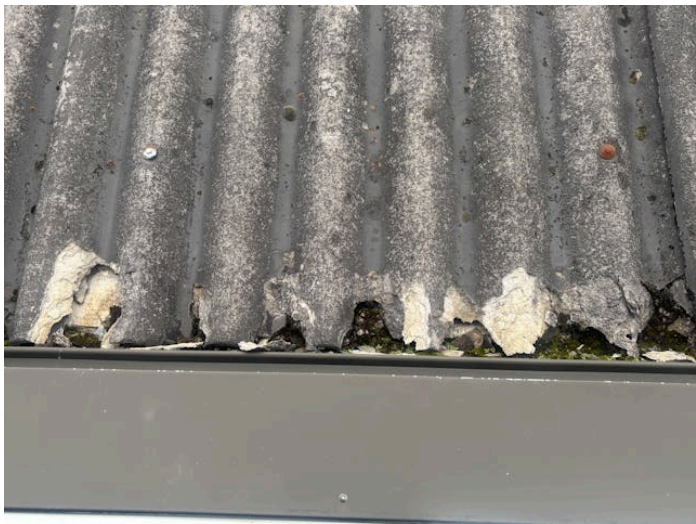
| Location | External Fixtures (R5) | Item | Cement sheeting |

| Strategy / Sample Id | Strongly Presume / S102 | Presumed Fibre Type | Amosite and Chrysotile |
| General Comments | Numerous areas of severe deterioration of sheeting across the roof. | | |

| Product Type (or Debris from Product) | 1 | Extent of Damage / Deterioration | 3 |

| Assessment Parameter | Score | Examples of score variables |
|---|---|---|
| Total Sum | 31 | <p><b>Judgment on state of roof:</b><br/>Roof is in poor condition throughout with numerous areas of deterioration exposing fibrous edges and large amounts of debris located on flat roof area.</p> <p>*This information should be considered alongside the asbestos data sheet on the previous page.</p> |

| Recommendation | Remove by trained operatives. | | |

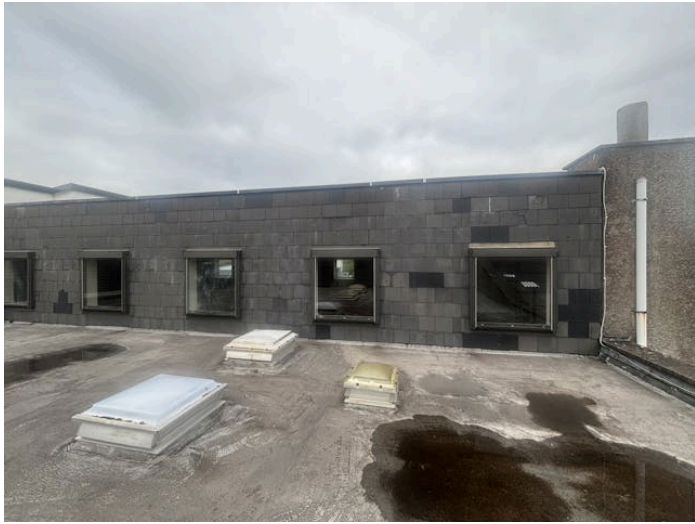
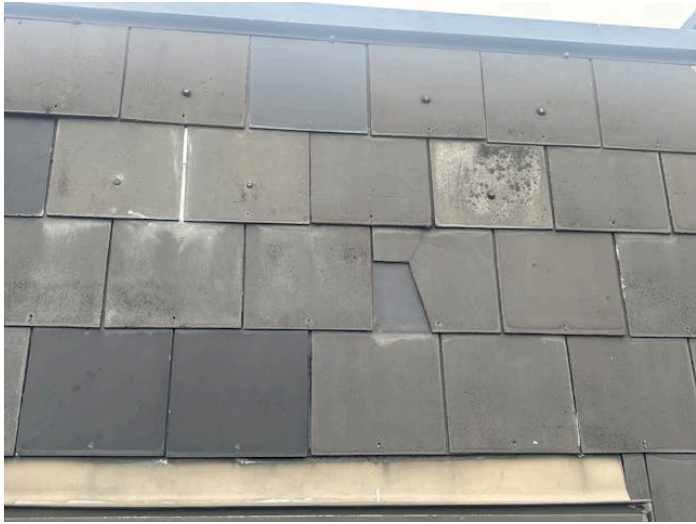
| Strategy / Sample Id | Sample / S103 | Fibre Type | Amosite and Chrysotile |
| General Comments | Numerous areas of minor damage throughout fascia should be monitored for further more significant damage. | | |

| Product Type (or Debris from Product) | 1 | Extent of Damage / Deterioration | 2 |

| Recommendation | Manage in situ for signs of deterioration | | |

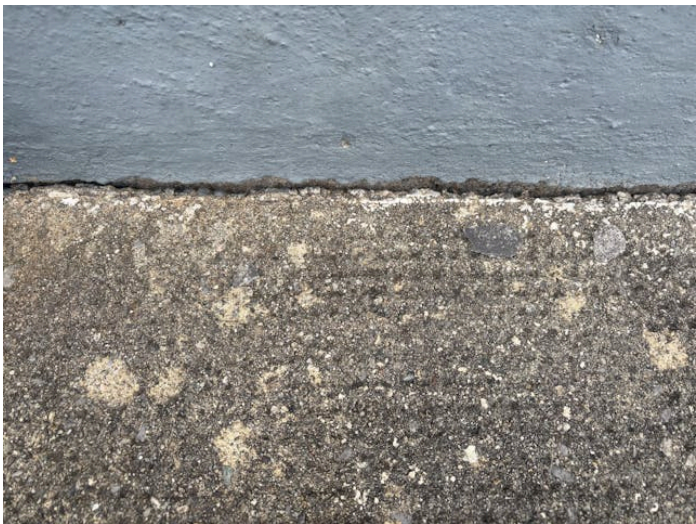
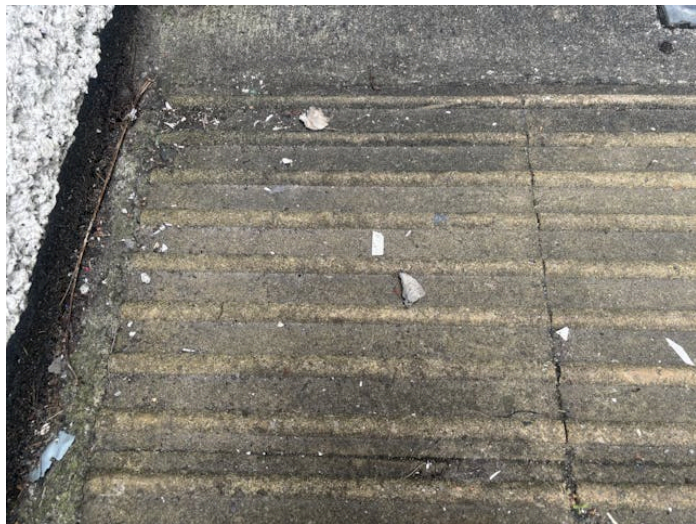
| Strategy / Sample Id | Strongly Presume / S102 | Presumed Fibre Type | Amosite and Chrysotile |

| Product Type (or Debris from Product) | 1 | Extent of Damage / Deterioration | 3 |

| Recommendation | Emergency environmental clean is required of immediate areas surrounding the school and flat roof areas to prevent further debris being displaced on to ground level surrounding areas. | | |

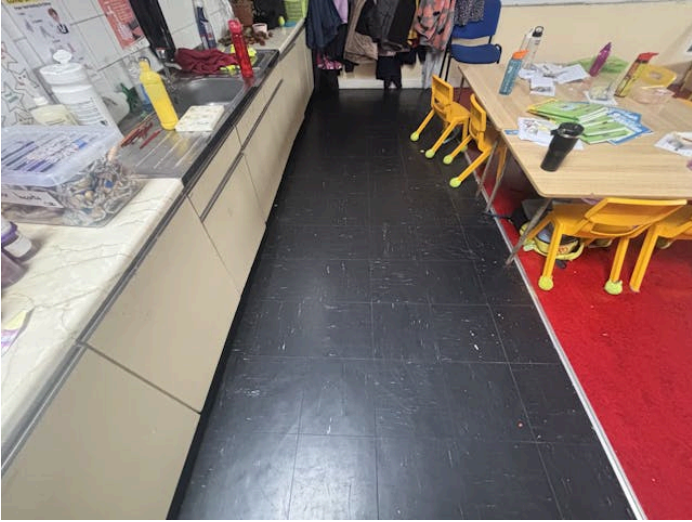
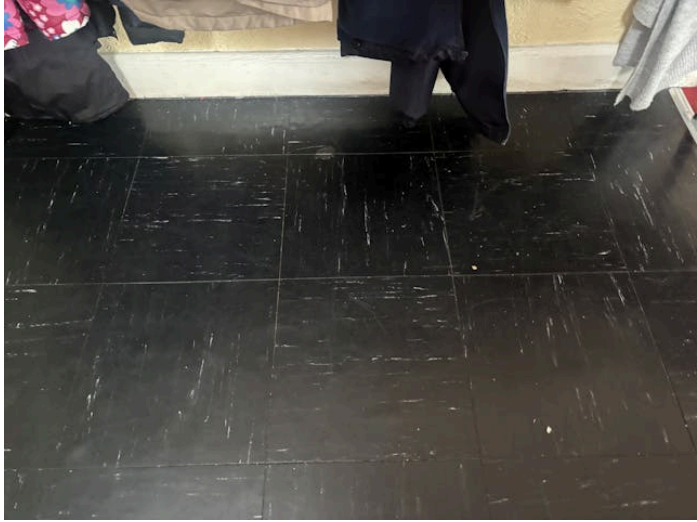
| Location | Classrooms | Item | Vinyl tiles |

| Strategy / Sample Id | Strongly Presume / S105 | Presumed Fibre Type | NADIS |

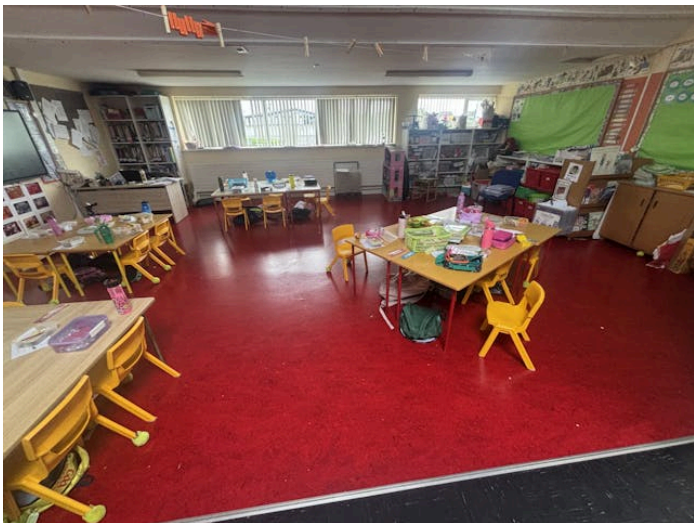
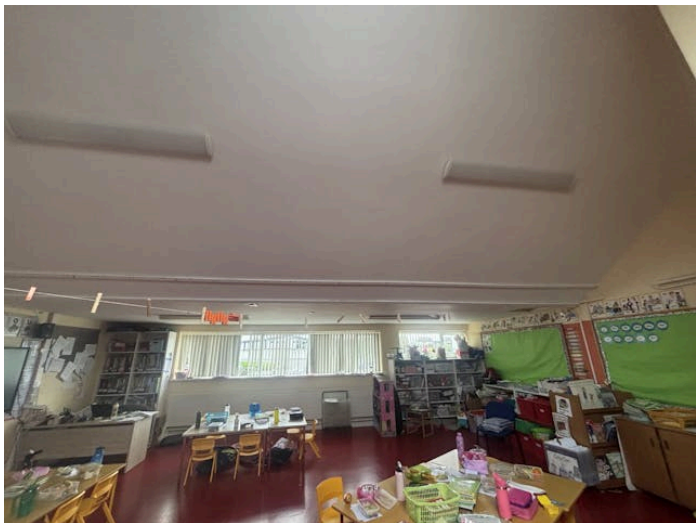
Main Building > Ground Floor > Classrooms > Location Notes

| Location Notes | <p>Vinyl flooring over concrete subfloor. Solid walls throughout. Smooth plasterboard ceilings. Non ACM vinyl tiles located at the front of the room.</p> <p>All classrooms were not accessible on the day for invasive inspection. Classrooms are presumed to be of similar structure based on visual inspections.</p> | | |
| General Comments | No ACM's identified | | |

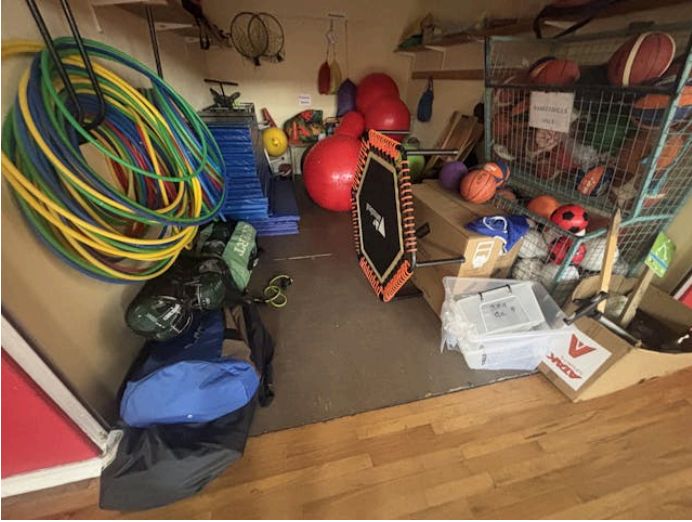
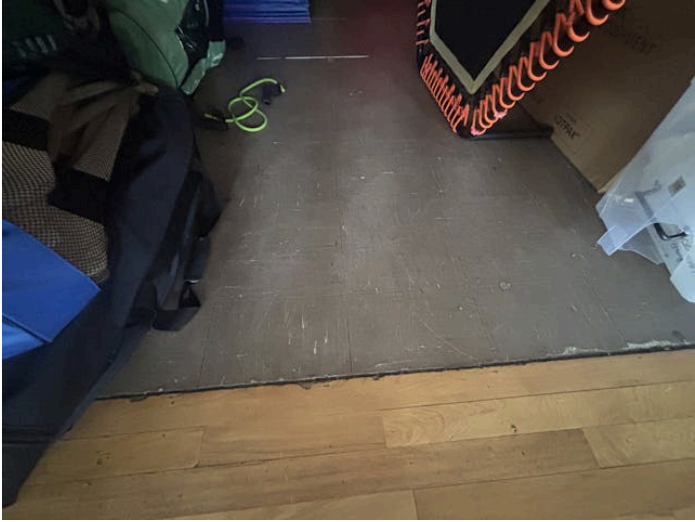
| Location | Gymnasium | Item | Vinyl tiles |

| Strategy / Sample Id | Sample / S105 | Fibre Type | NADIS |

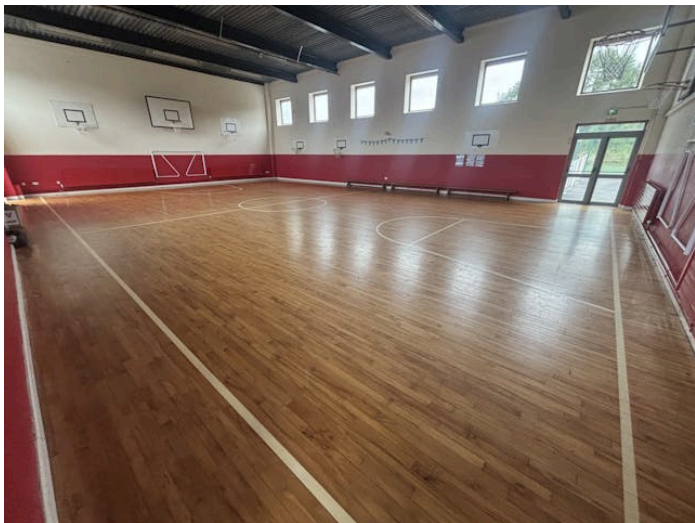
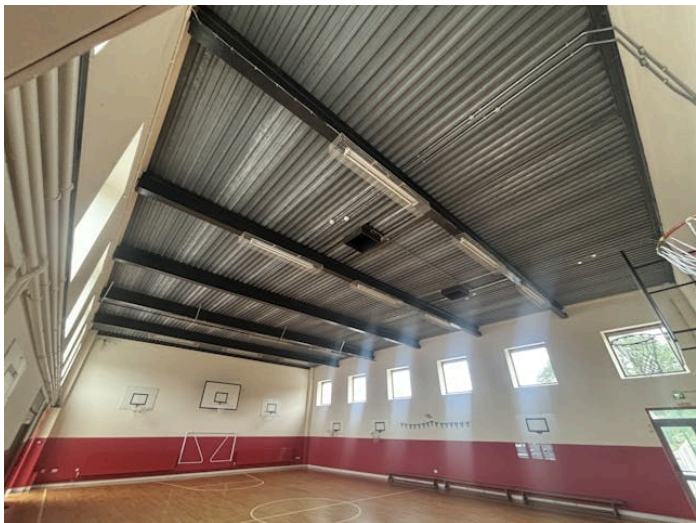
Main Building > Ground Floor > Gymnasium > Location Notes

| Location Notes | Timber flooring. Solid walls throughout. Metal deck roof ceiling. Side storage area with vinyl tiles on concrete subfloor (sample taken for analysis). | | |
| General Comments | No ACM's identified | | |

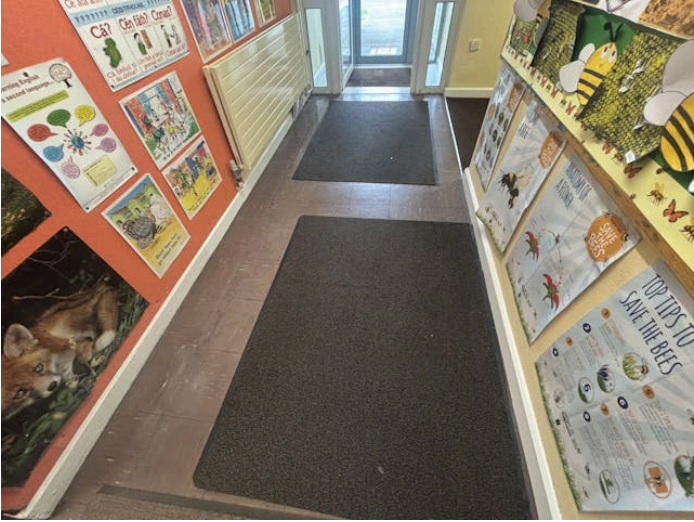
| Location | Hallways | Item | Vinyl tiles |

| Strategy / Sample Id | Strongly Presume / S105 | Presumed Fibre Type | NADIS |

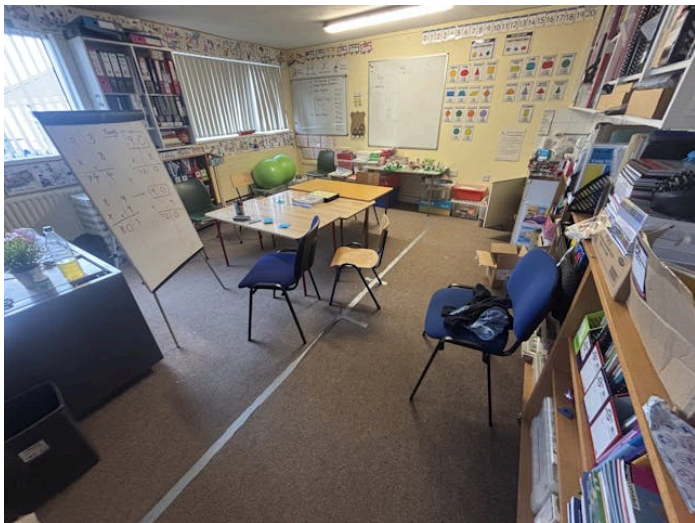
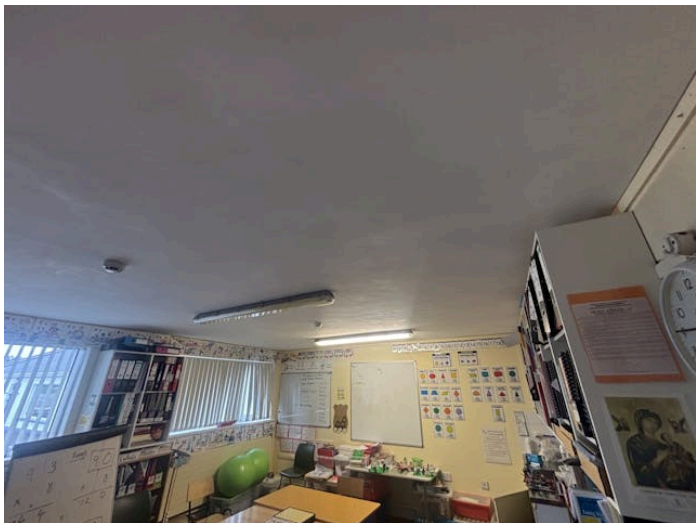
Main Building > Ground Floor > Small classrooms > Location Notes

| Location Notes | <p>Carpet flooring over concrete subfloor. Solid walls throughout. Smooth plasterboard ceilings.</p> <p>All classrooms were not accessible on the day for invasive inspection. Classrooms are presumed to be of similar structure based on visual inspections.</p> | | |
| General Comments | No ACM's identified | | |
