**Project Name:** Shannon Valley House Connections 08-01-25  
**Project Description:** CCTV Survey  
**Project Number:** CES 11740  
**Project Status:** Complete  
**Project Date:** 08/01/2026

Project Name Shannon Valley House Connections 08-01-25 Project Number CES 11740 Project Date 08/01/2026

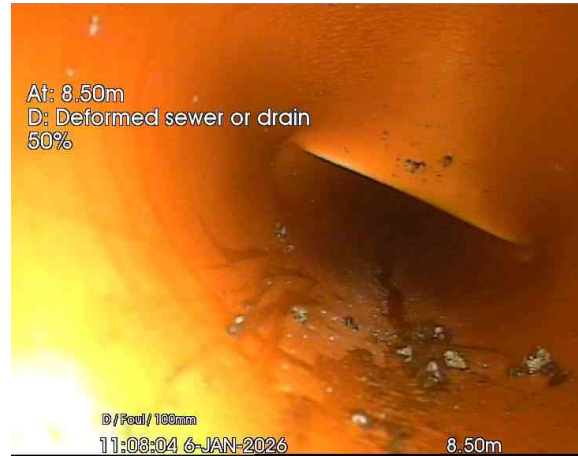
2, 00:00:18, 8.50 m  
 Deformed sewer or drain, 50%

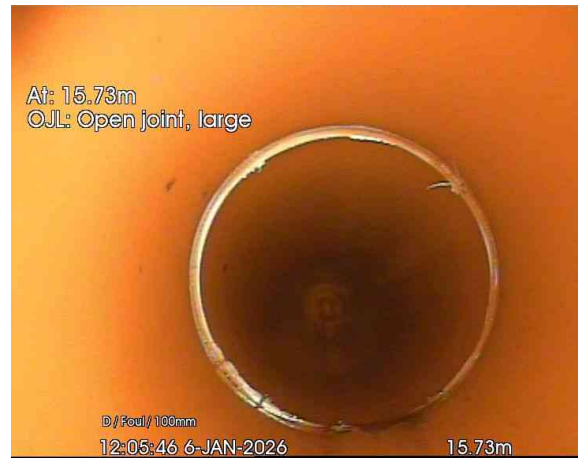
2, 00:00:29, 15.73 m  
 Open joint, large

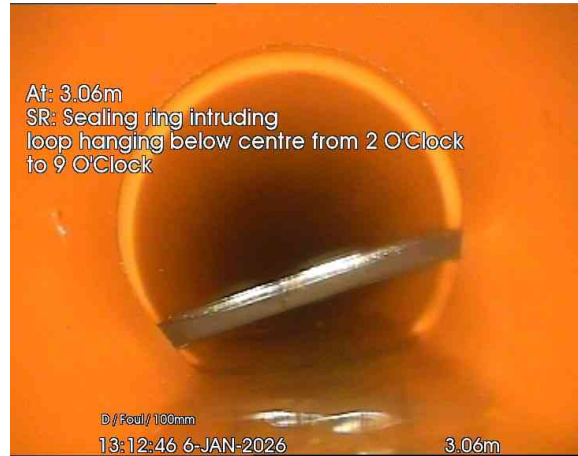
2, 00:00:08, 3.06 m  
 Sealing ring intruding, loop hanging below centre from 2 o'clock to 9 o'clock

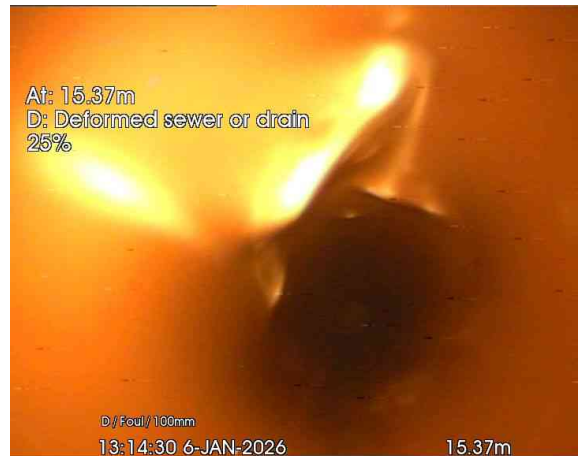
4, 00:01:18, 15.37 m  
 Deformed sewer or drain, 25%

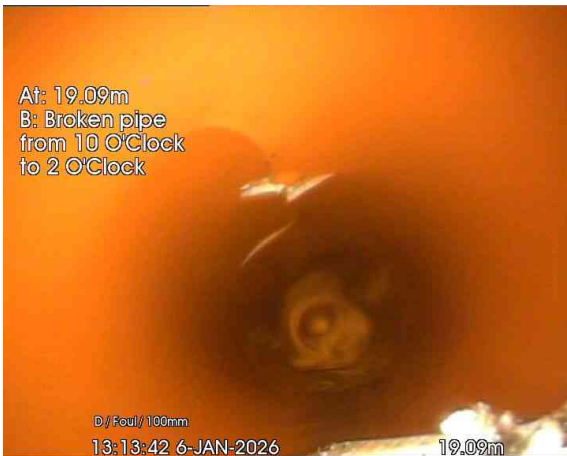
7, 00:00:46, 19.09 m  
 Broken pipe from 10 o'clock to 2 o'clock

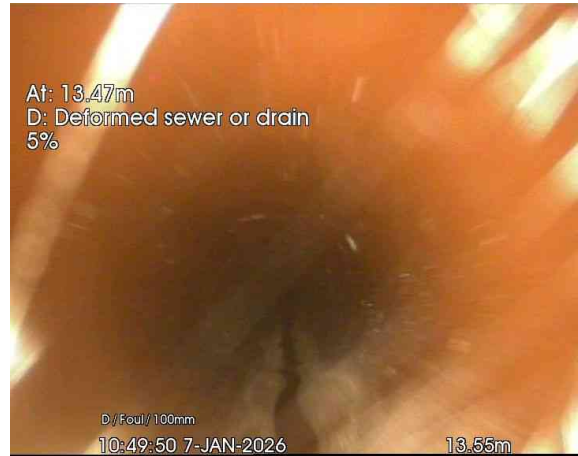
2, 00:00:27, 13.57 m  
 Deformed sewer or drain, 5%
