Project Name: Shannon Valley Foul Water 10-11-25
Project Description: CCTV Survey
Project Number: CES 11659
Project Status: Complete
Project Date: 10/11/2025
Inspection Standard: MSCC5 Sewers & Drainage GB (SRM5 Scoring)

Project Name: Shannon Valley Foul Water 10-11-25
Project Number: CES 11659
Project Date: 10/11/2025

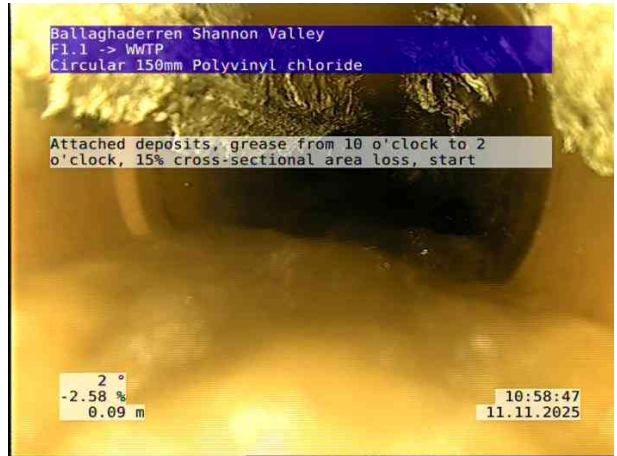
0.09	S01 DEG	Attached deposits, grease from 10 o'clock to 2 o'clock, 15% cross-sectional area loss, start	00:00:10	2	
	0.20	LR	Line deviates right	00:00:17

2, 00:00:10, 0.09 m
 Attached deposits, grease from 10 o'clock to 2 o'clock, 15% cross-sectional area loss, start

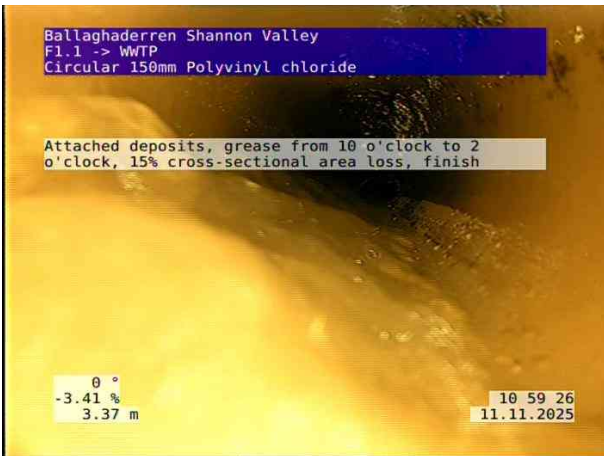
3.37	F01 DEG	Attached deposits, grease from 10 o'clock to 2 o'clock, 15% cross-sectional area loss, finish	00:00:37	3	3
	5.74	D	Deformed sewer or drain, 5%	00:01:09	4	1 / 2

3, 00:00:37, 3.37 m
 Attached deposits, grease from 10 o'clock to 2 o'clock, 15% cross-sectional area loss, finish

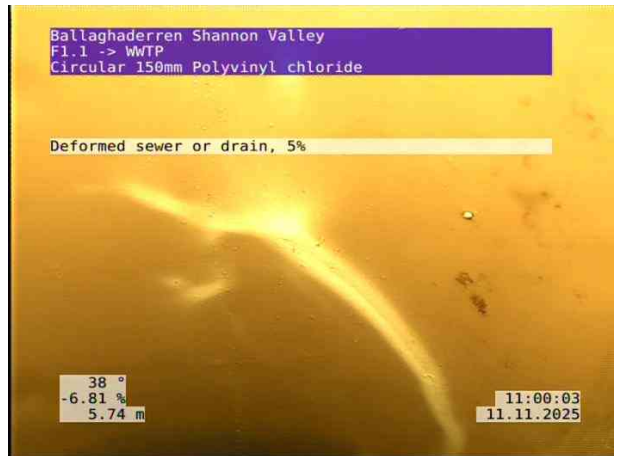
4, 00:01:09, 5.74 m
 Deformed sewer or drain, 5%

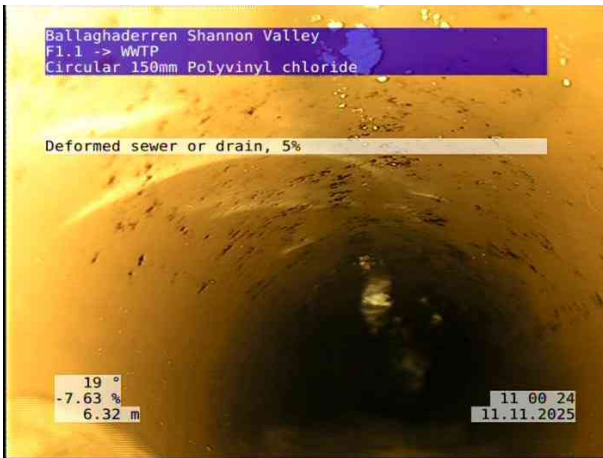
5, 00:01:28, 6.32 m
 Deformed sewer or drain, 5%

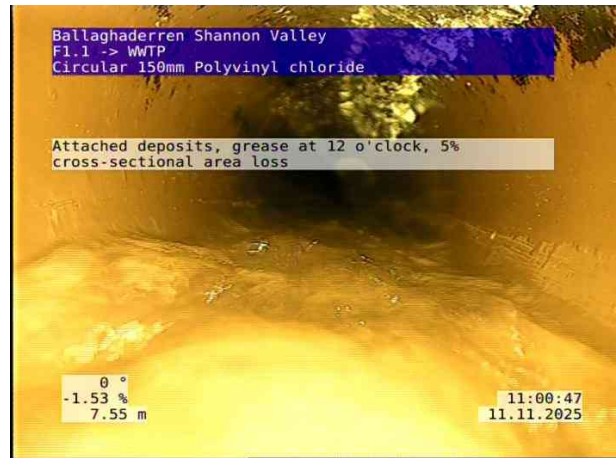
6, 00:01:40, 7.55 m
 Attached deposits, grease at 12 o'clock, 5% cross-sectional area loss

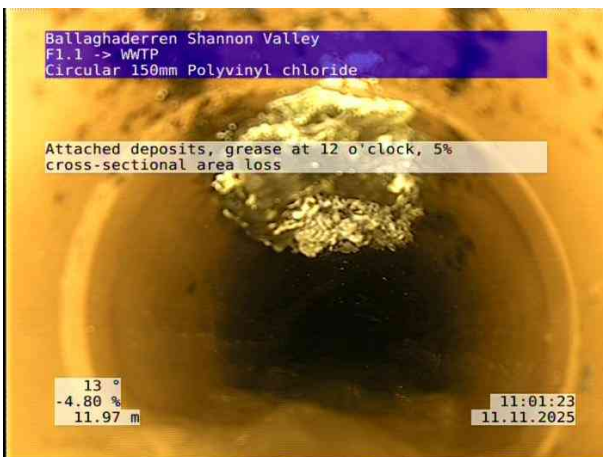
7, 00:02:08, 11.97 m
 Attached deposits, grease at 12 o'clock, 5% cross-sectional area loss

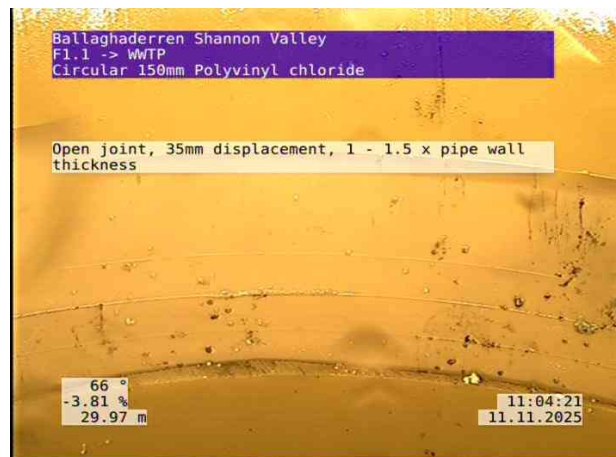
8, 00:03:58, 29.97 m
 Open joint, 35mm displacement, 1 - 1.5 x pipe wall thickness

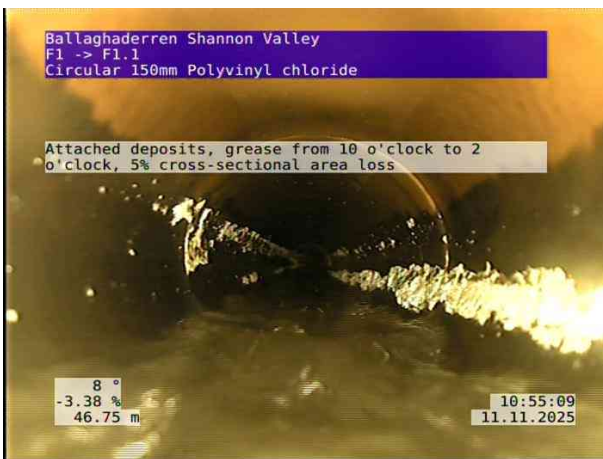
<table><tr> <td>0.00</td> <td>MH</td> <td>Start node, manhole, reference: F1</td> <td>00:00:00</td> <td>1</td> <td></td> </tr><tr> <td>46.75</td> <td>DEG</td> <td>Attached deposits, grease from 10 o'clock to 2 o'clock, 5% cross-sectional area loss</td> <td>00:05:21</td> <td>7</td> <td>3</td> </tr></table>

7, 00:05:21, 46.75 m
 Attached deposits, grease from 10 o'clock to 2 o'clock, 5% cross-sectional area loss

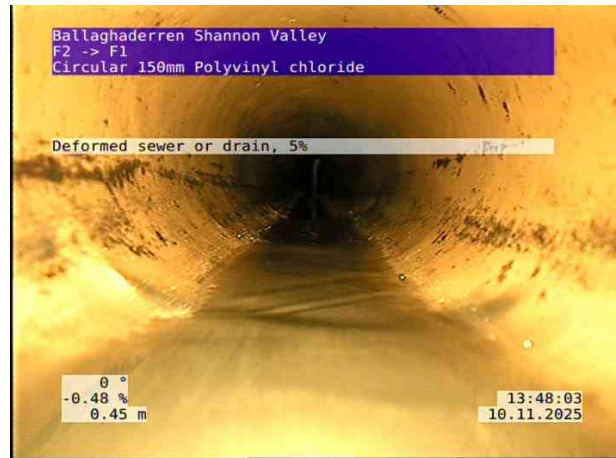
2, 00:00:16, 0.45 m
 Deformed sewer or drain, 5%

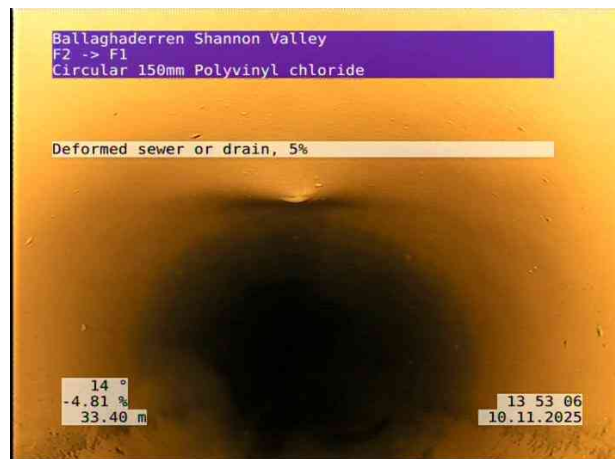
8, 00:04:48, 33.40 m
 Deformed sewer or drain, 5%

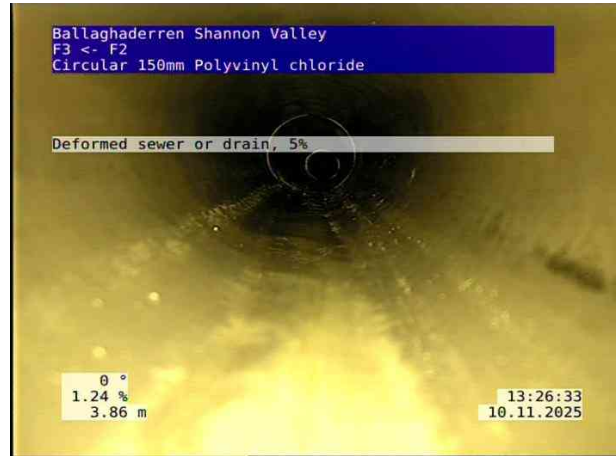
2, 00:00:41, 3.86 m
 Deformed sewer or drain, 5%

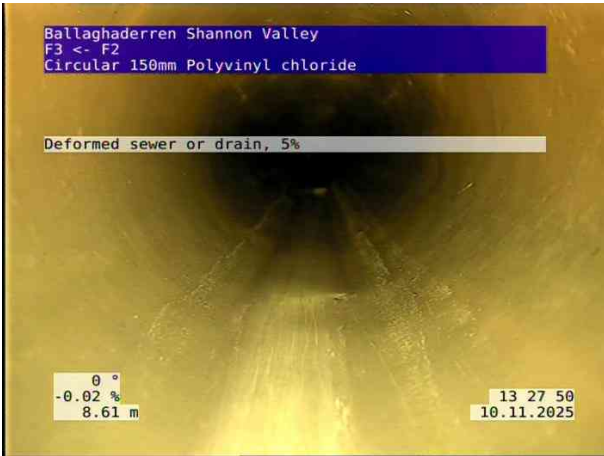
5, 00:01:45, 8.61 m
 Deformed sewer or drain, 5%

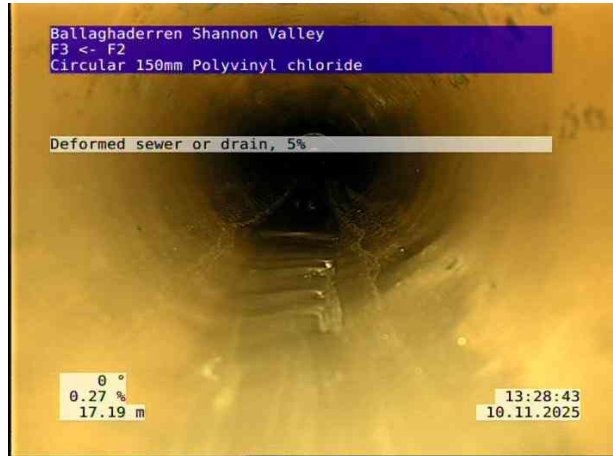
6, 00:02:35, 17.19 m
 Deformed sewer or drain, 5%

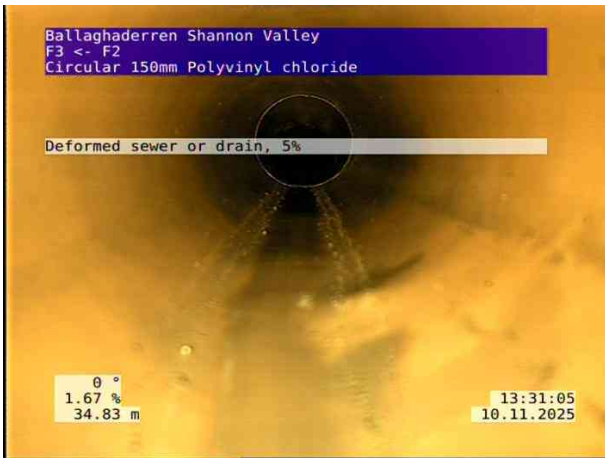
9, 00:04:44, 34.83 m
 Deformed sewer or drain, 5%

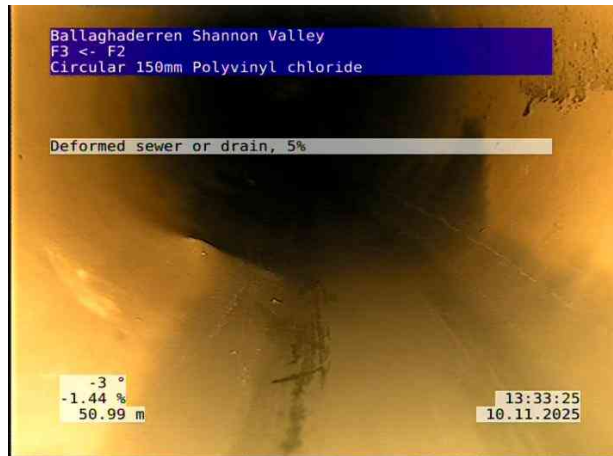
12, 00:06:52, 51.00 m
 Deformed sewer or drain, 5%

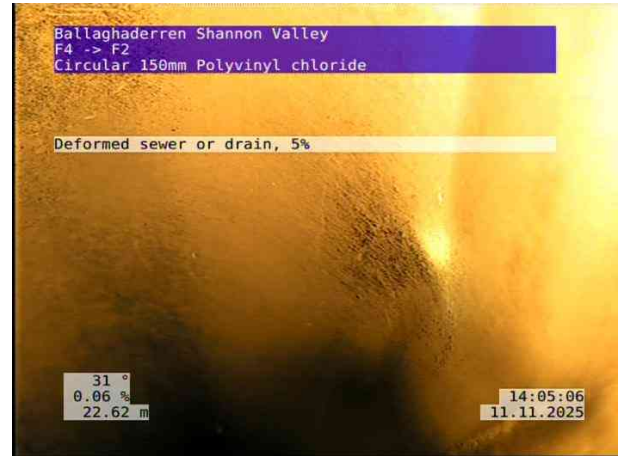
6, 00:02:53, 22.62 m
 Deformed sewer or drain, 5%

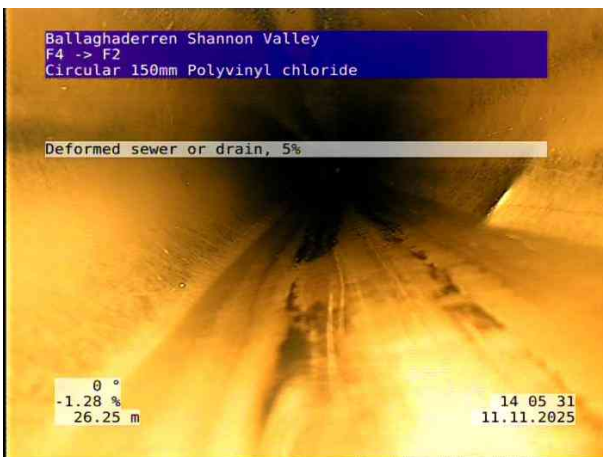
7, 00:03:14, 26.25 m
 Deformed sewer or drain, 5%

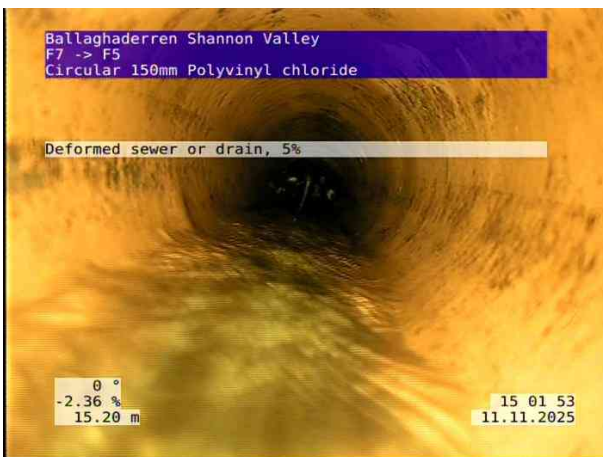
3, 00:03:09, 15.20 m
 Deformed sewer or drain, 5%

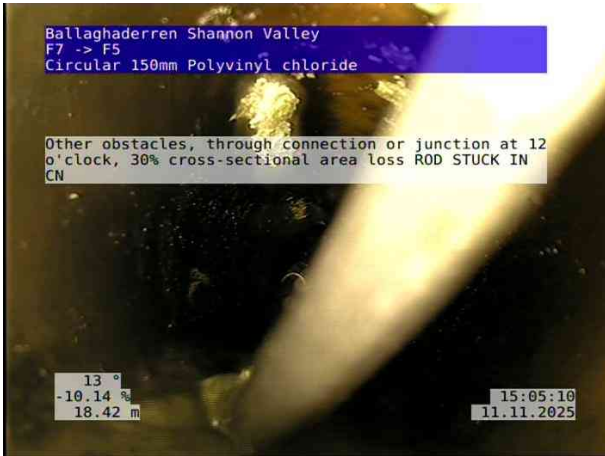
5, 00:04:16, 18.42 m

Other obstacles, through connection or junction at 12 o'clock, 30% cross-sectional area loss, ROD STUCK IN CN

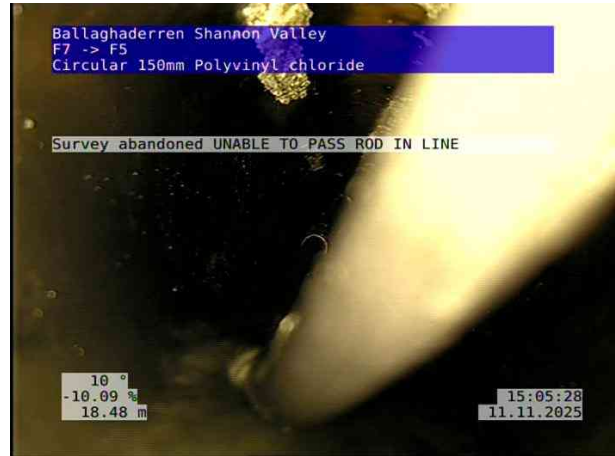
6, 00:04:21, 18.48 m

Survey abandoned, UNABLE TO PASS ROD IN LINE
