Project Name: Shannon Valley Surface Water 10-11-25
Project Description: CCTV Survey
Project Number: CES 11659
Project Status: Complete
Project Date: 10/11/2025
Inspection Standard: MSCC5 Sewers & Drainage GB (SRM5 Scoring)

Section Inspection - 11/11/2025 - S1.1X

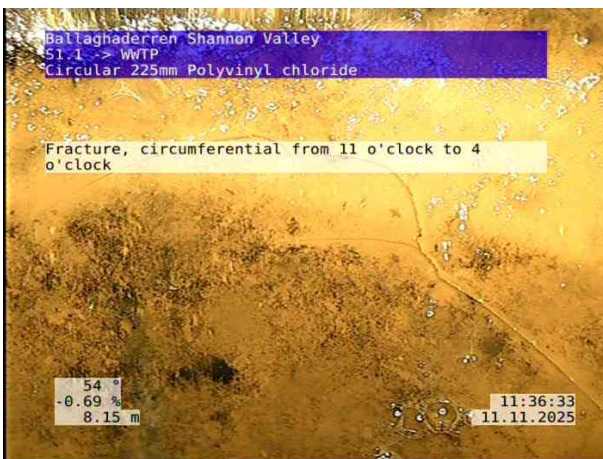
3, 00:02:27, 8.15 m
 Fracture, circumferential from 11 o'clock to 4 o'clock

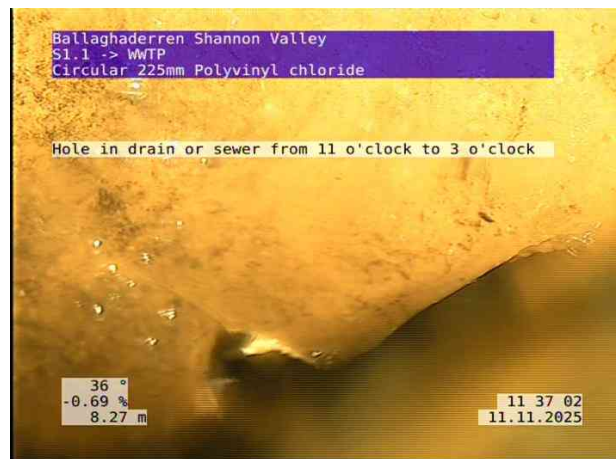
Item No.	PLR	Grade	Description
1	S1.1X	5	Hole in drain or sewer from 11 o'clock to 3 o'clock
4	S2X	3	Multiple defects
7	S7X	4	Hole in drain or sewer from 10 o'clock to 11 o'clock
9	S7.1X	4	Multiple defects

4, 00:02:48, 8.27 m
 Hole in drain or sewer from 11 o'clock to 3 o'clock

- Grade 3: Best practice suggests consideration should be given to repairs in the medium term.
Grade 4: Best practice suggests consideration should be given to repairs to avoid a potential collapse.
Grade 5: Best practice suggests that this pipe is at risk of collapse at any time. Urgent consideration should be given to repairs to avoid total failure.

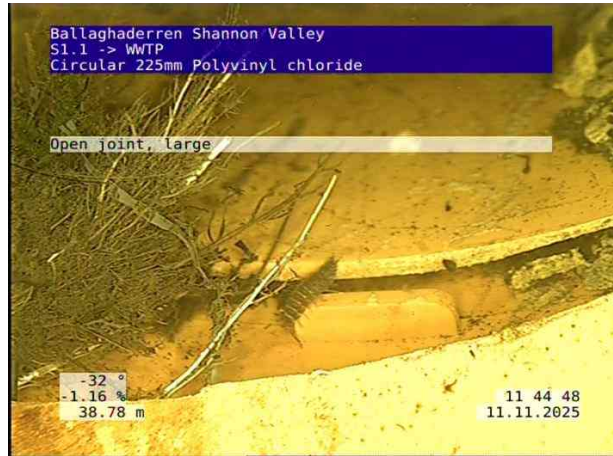
6, 00:10:18, 38.78 m
 Open joint, large

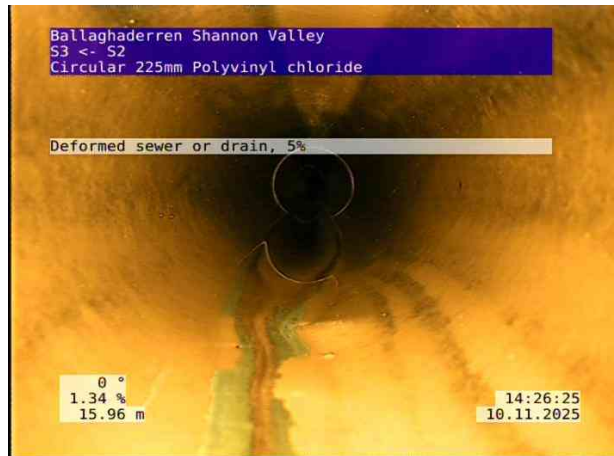
4, 00:02:08, 15.96 m
 Deformed sewer or drain, 5%

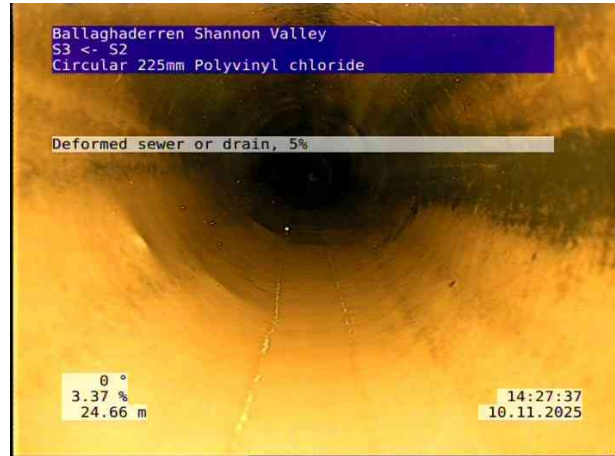
6, 00:03:09, 24.66 m
 Deformed sewer or drain, 5%

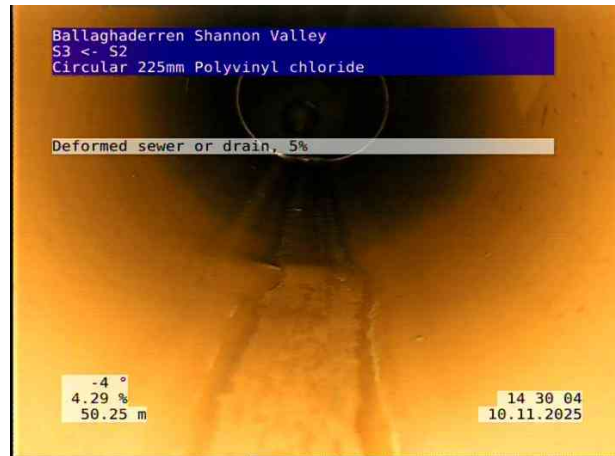
8, 00:05:29, 50.25 m
 Deformed sewer or drain, 5%

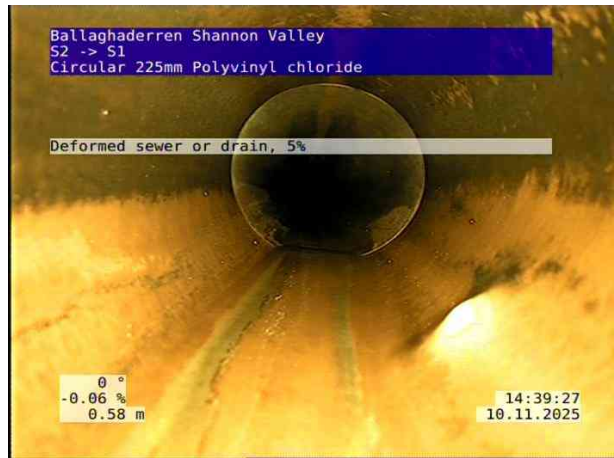
2, 00:00:21, 0.58 m
 Deformed sewer or drain, 5%

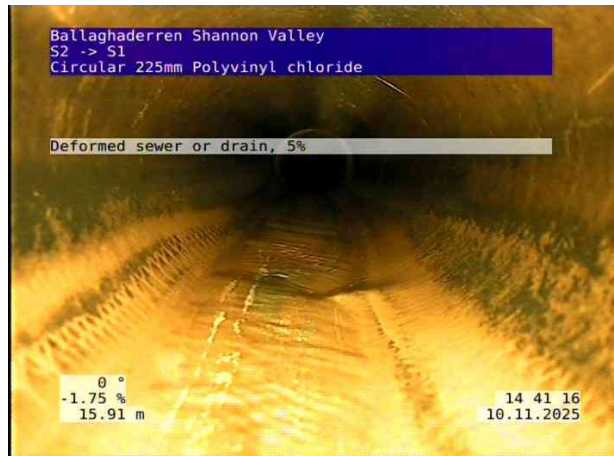
4, 00:02:00, 15.91 m
 Deformed sewer or drain, 5%

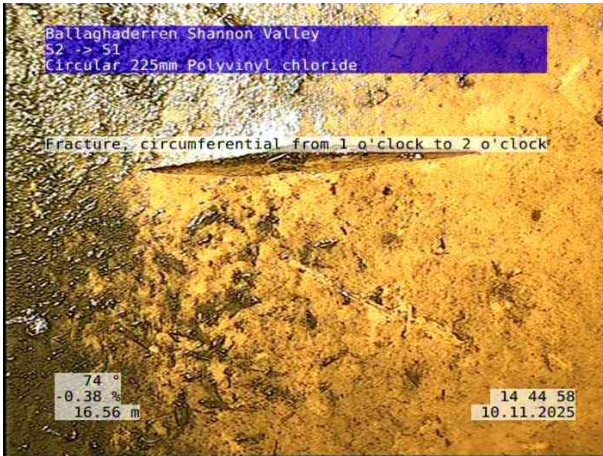
5, 00:04:54, 16.56 m
 Fracture, circumferential from 1 o'clock to 2 o'clock

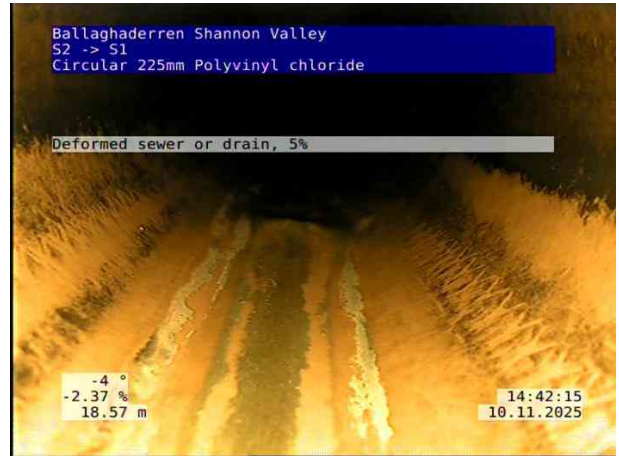
6, 00:02:52, 18.57 m
 Deformed sewer or drain, 5%

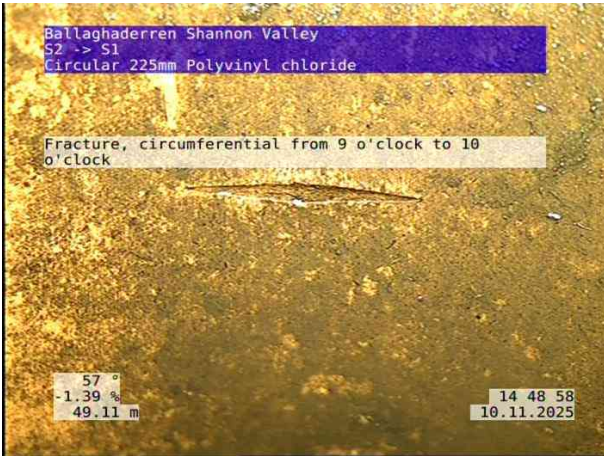
9, 00:08:28, 49.11 m
 Fracture, circumferential from 9 o'clock to 10 o'clock

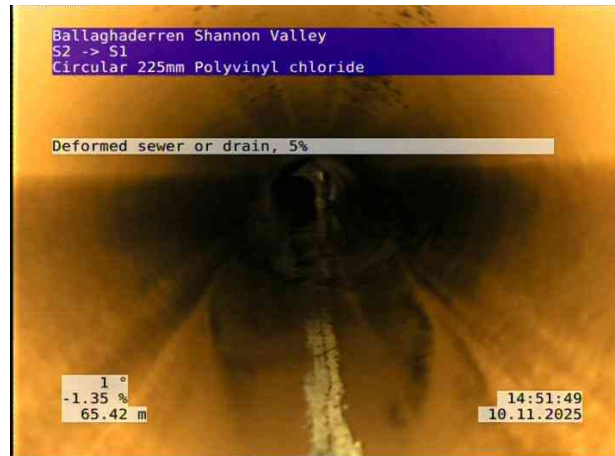
12, 00:11:03, 65.42 m
 Deformed sewer or drain, 5%

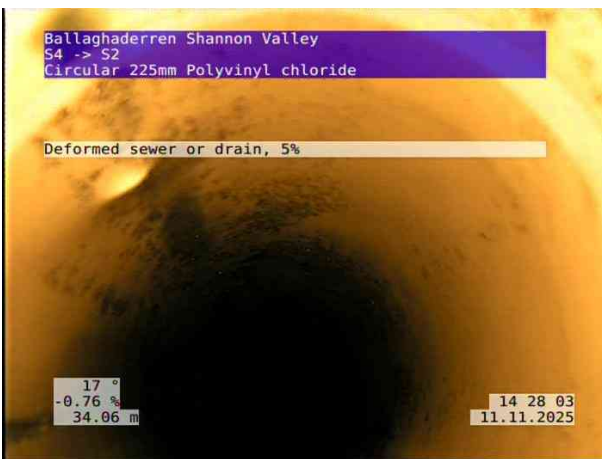
7, 00:04:15, 34.07 m
 Deformed sewer or drain, 5%

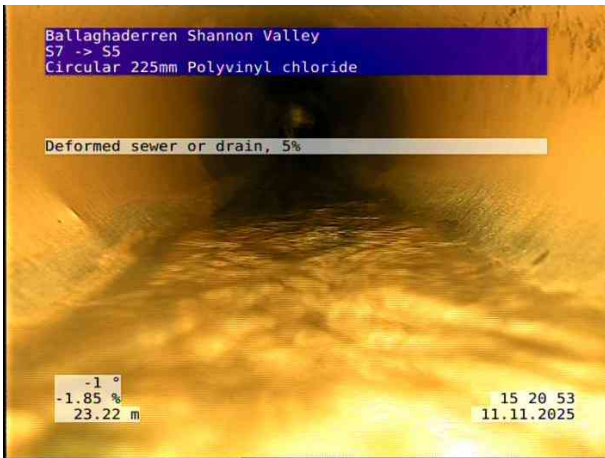
5, 00:02:48, 23.22 m
Deformed sewer or drain, 5%

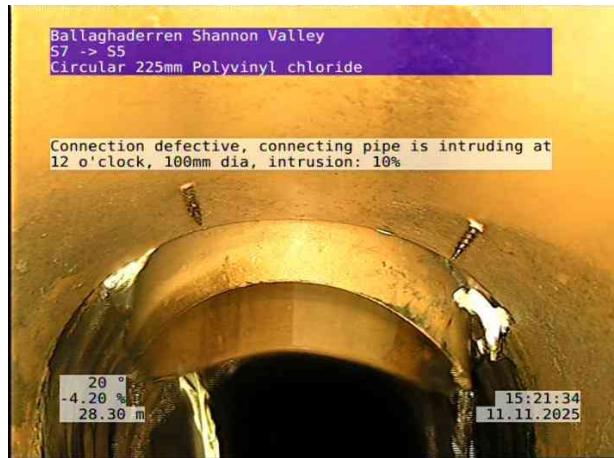
Item No.	PLR	Grade	Description
7	S7X	3	Connection defective, connecting pipe is intruding at 12 o'clock, 100mm dia, intrusion: 10%
10	S8X	3	Deformed sewer or drain, 10%

6, 00:03:17, 28.30 m
Connection defective, connecting pipe is intruding at 12 o'clock, 100mm dia, intrusion: 10%

- Grade 3: Best practice suggests consideration should be given to maintenance activities in the medium term.
Grade 4: Best practice suggests consideration should be given to maintenance activity to avoid potential blockages.
Grade 5: Best practice suggests that this pipe is at a high risk of backing up or causing flooding.

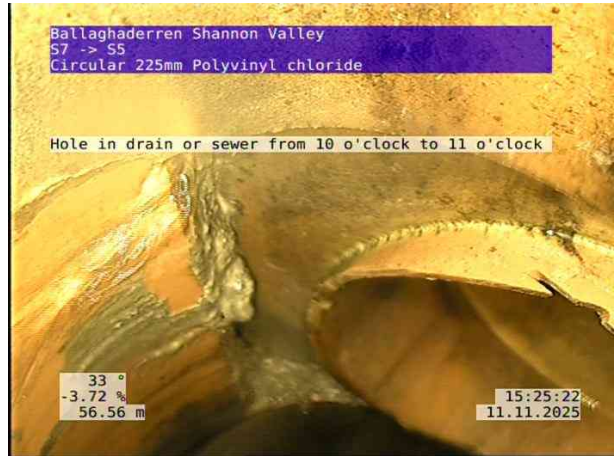
10, 00:06:29, 56.56 m
 Hole in drain or sewer from 10 o'clock to 11 o'clock

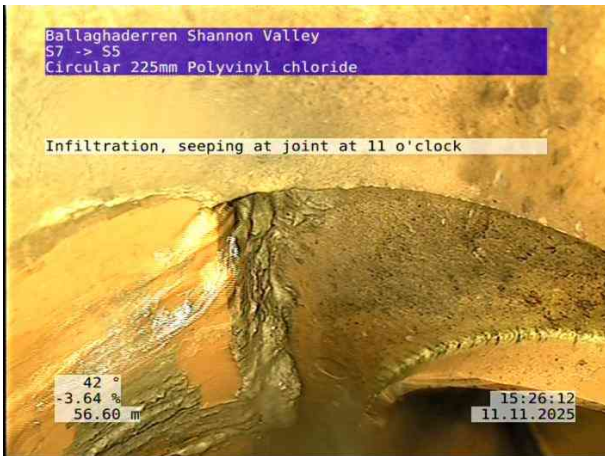
11, 00:06:39, 56.60 m
 Infiltration, seeping at joint at 11 o'clock

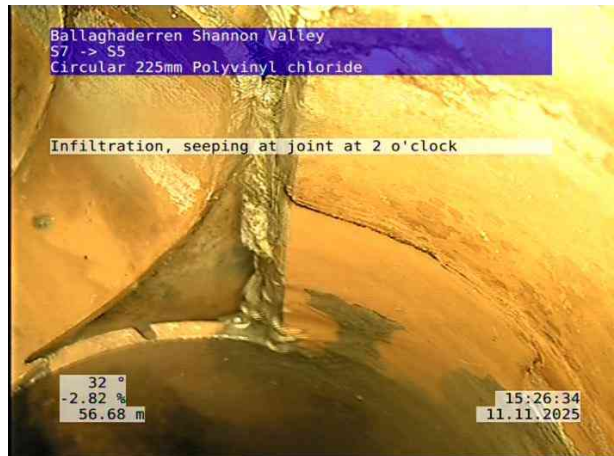
12, 00:06:53, 56.68 m
 Infiltration, seeping at joint at 2 o'clock

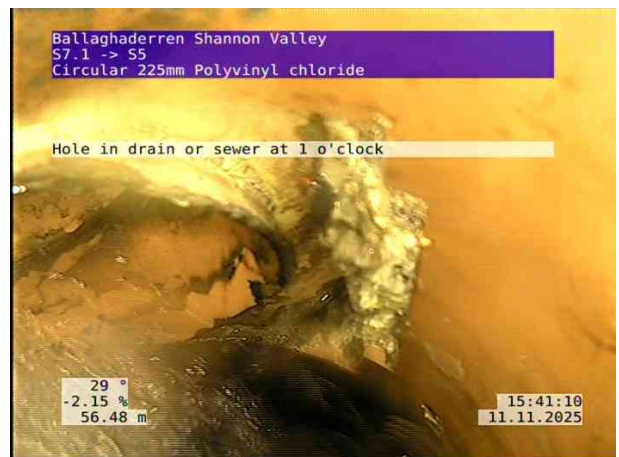
8, 00:06:39, 56.48 m
 Hole in drain or sewer at 1 o'clock

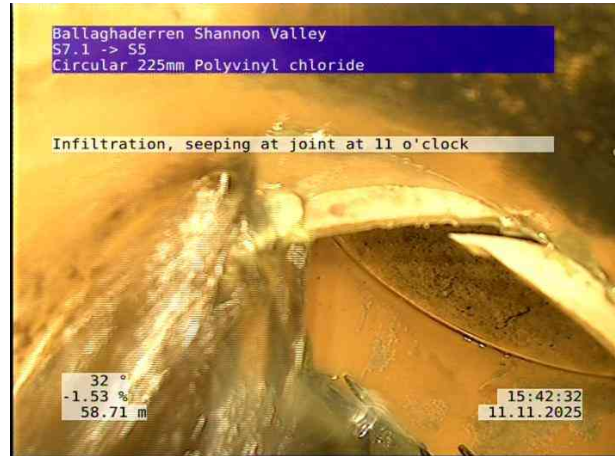
10, 00:07:20, 58.71 m
 Infiltration, seeping at joint at 11 o'clock

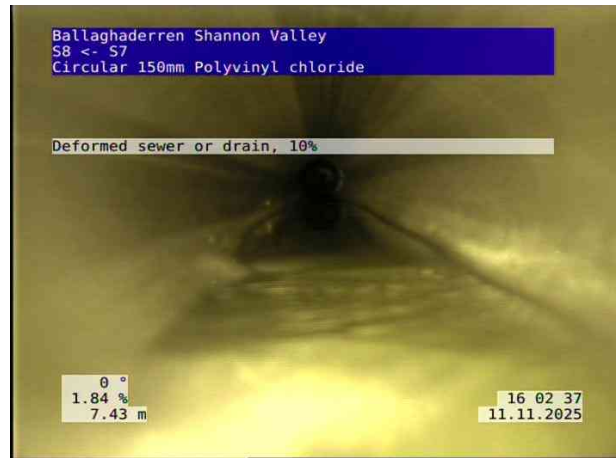
2, 00:01:50, 7.43 m
 Deformed sewer or drain, 10%

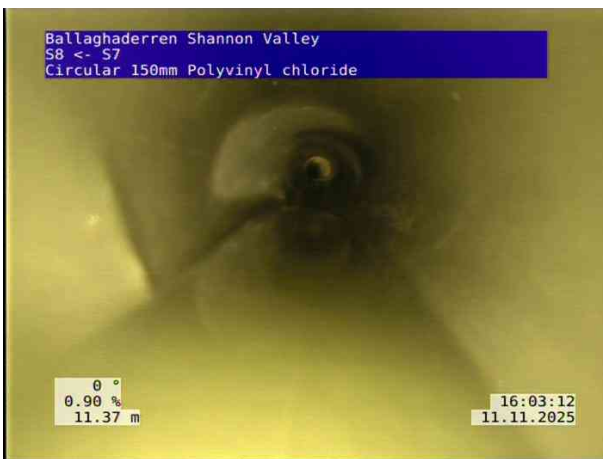
3, 00:02:18, 11.40 m
 Deformed sewer or drain, 5%
