# ASBESTOS SURVEY REPORT

**Client:** MCLA

**Location:** CBS, Basin View, Dublin 8.

**Date of Survey:** 23/03/2026

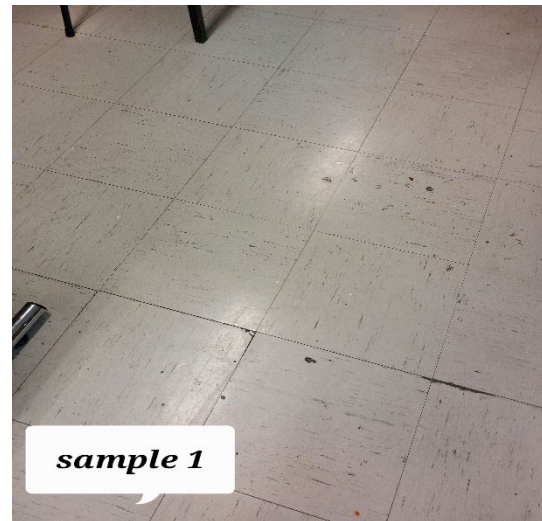
#### Sample 1.

| Sample no. | Location | Material | Asbestos Type NADIS |
|---|---|---|---|
| 1. | Science lab. | Vinyl floor tile and glue. | <b>CHRYSTILE</b> |

The lab results show that Asbestos was detected in the sample.

**CHRYSTILE**

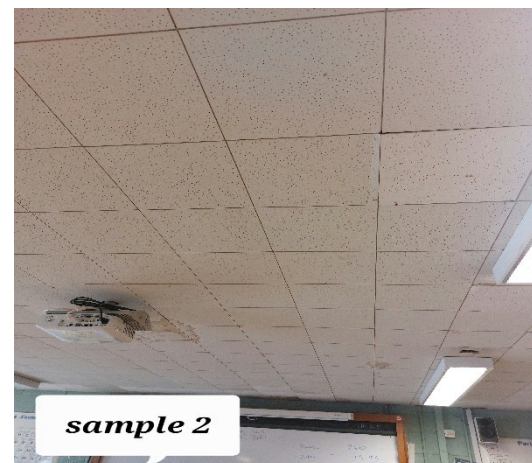
### Ceiling tile.

A sample was taken here of the ceiling tile in the science lab.

The lab results show that Asbestos was not detected in the sample.

**NADIS**

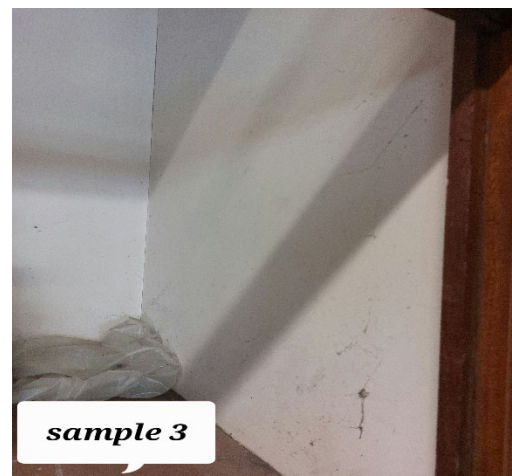
### Fume hood lining wall.

| Sample no. | Location | Material | Asbestos Type NADIS |
|---|---|---|---|
| 3. | Science lab. | Fume hood wall lining. | <b>CHRYSTILE</b> |

A sample was taken here of the Cement product in the fume hood in the science lab.

Asbestos was detected in the sample.

**CHRYSTILE**

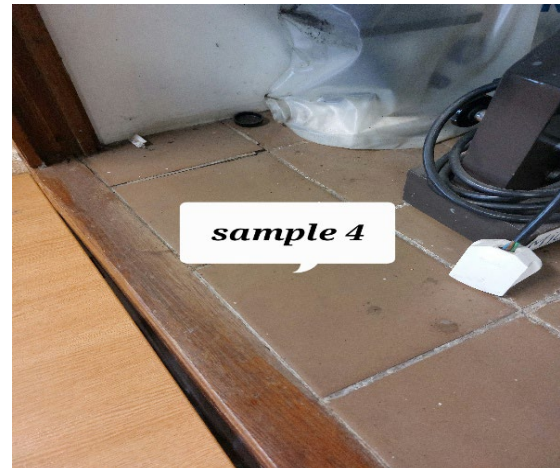
**Ceramic tile and adhesive.**

A sample was taken here of the ceramic tile and adhesive in the fume hood in the science lab.

The lab results show that Asbestos was not detected in the sample.

**NADIS**

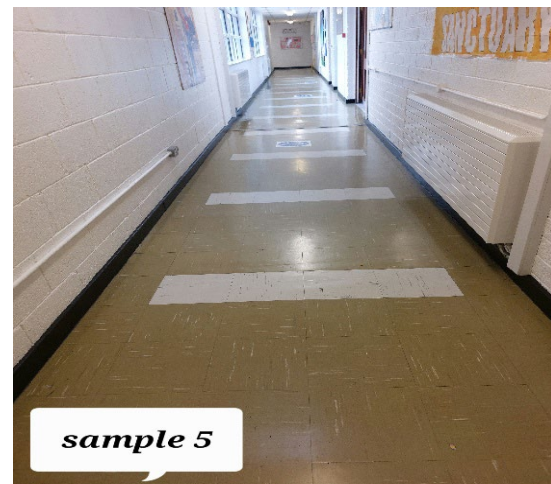
**Vinyl floor tile and glue.**

| Sample no. | Location | Material | Asbestos Type NADIS |
|---|---|---|---|
| 5. | Upstairs hall floor. | Vinyl floor tile and glue. | <b>CHRYSTILE</b> |

A sample was taken of the vinyl floor tile and glue in the upstairs hall.

The lab results show that Asbestos was detected in the sample.

**CHRYSTILE**

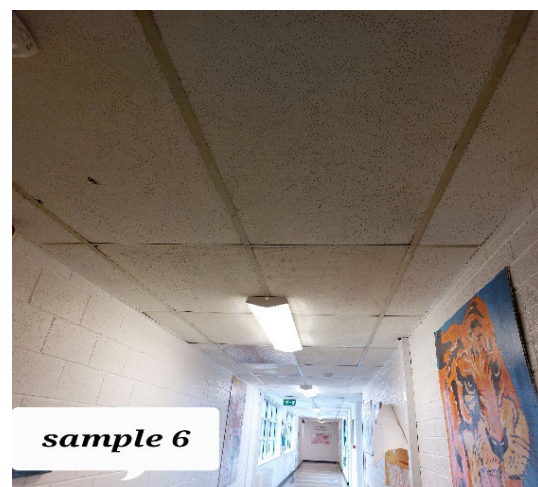
**Ceiling tile.**

A sample was taken of the ceiling tile in the upstairs hall.

The lab results show that Asbestos was not detected in the sample.

**NADIS**

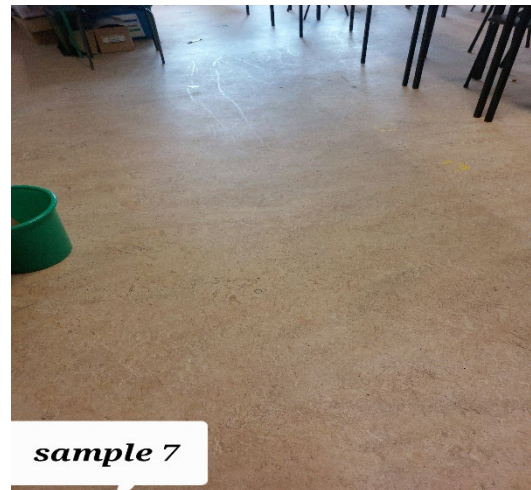
**Vinyl floor tile and glue.**

A sample was taken of the vinyl floor tile and glue in room 50.

The lab results show that Asbestos was not detected in the sample.

**NADIS**

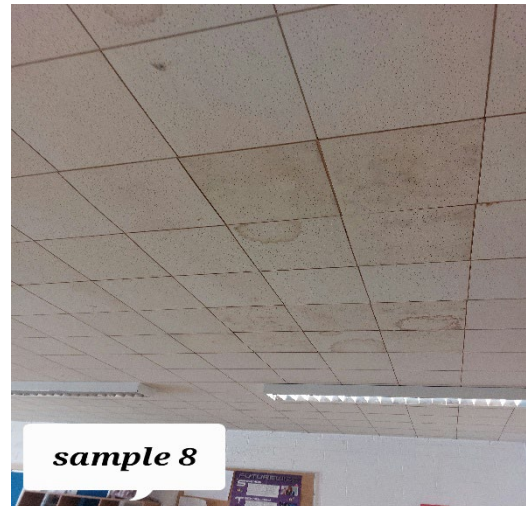
**Ceiling tile.**

A sample was taken of the ceiling tile in room 50.

The lab results show that Asbestos was not detected in the sample.

**NADIS**

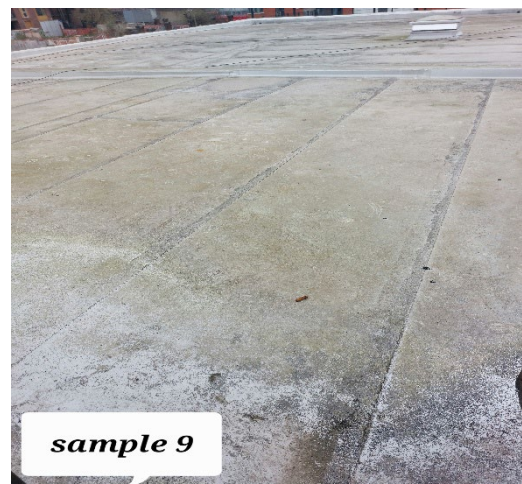
**Bitumen felt.**

A sample was taken of the bitumen felt on the main roof.

The lab results show that Asbestos was not detected in the sample.

**NADIS**

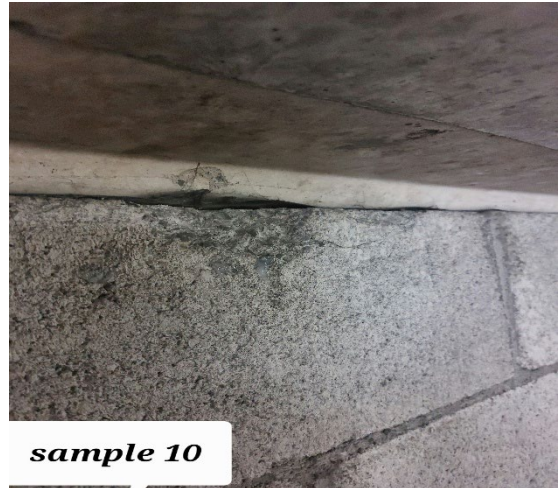
**Damp proof PVC/Bitumen product.**

A sample was taken of the PVC damp proof in the attic.

The lab results show that Asbestos was not detected in the sample.

**NADIS**

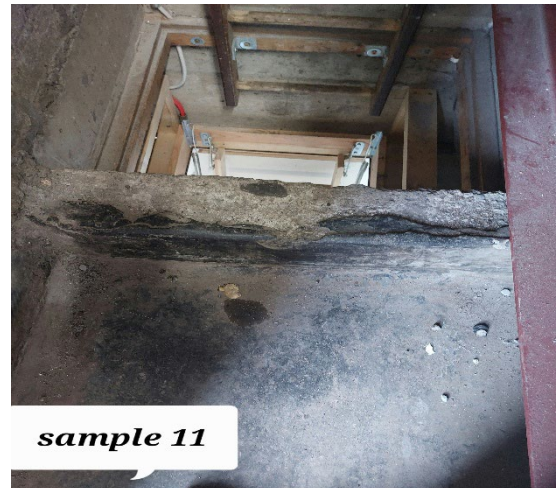
**Bitumen risen.**

A sample was taken of the bitumen risen on the attic floor.

The lab results show that Asbestos was not detected in the sample.

**NADIS**

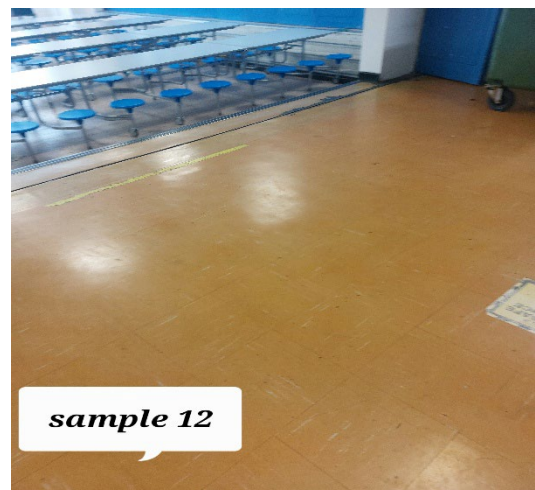
**Vinyl floor tile and glue.**

| Sample no. | Location | Material | Asbestos Type NADIS |
|---|---|---|---|
| 12. | Downstairs canteen. | Vinyl floor tile and glue. | <b>CHRYSTILE</b> |

A sample was taken of the vinyl floor tile and glue on the canteen floor.

The lab results show that Asbestos was detected in the sample.

**CHRYSTILE**

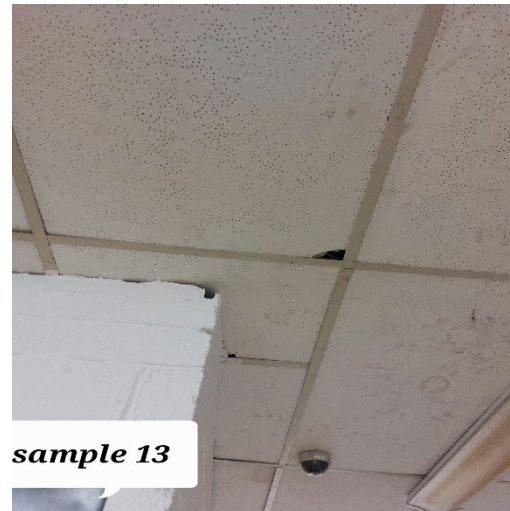
**Ceiling tile.**

A sample was taken of the ceiling tile in the down stairs hall.

The lab results show that Asbestos was not detected in the sample.

**NADIS**

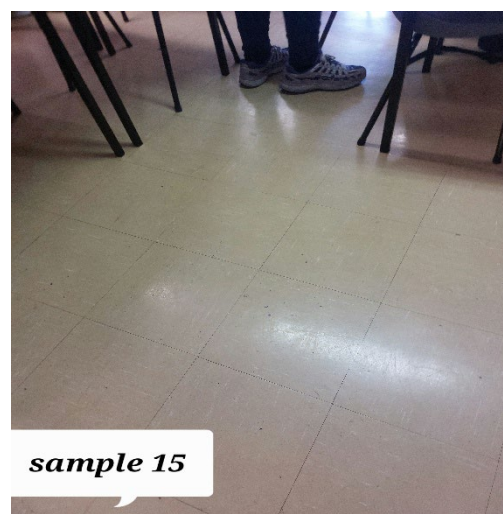
**Vinyl floor tile and glue.**

| Sample no. | Location | Material | Asbestos Type NADIS |
|---|---|---|---|
| 15. | Irish classroom. | Vinyl floor tile and glue. | <b>CHRYSTILE</b> |

A sample was taken of the vinyl floor tile and glue in the Irish classroom.

The lab results show that Asbestos was detected in the sample.

**CHRYSTILE**

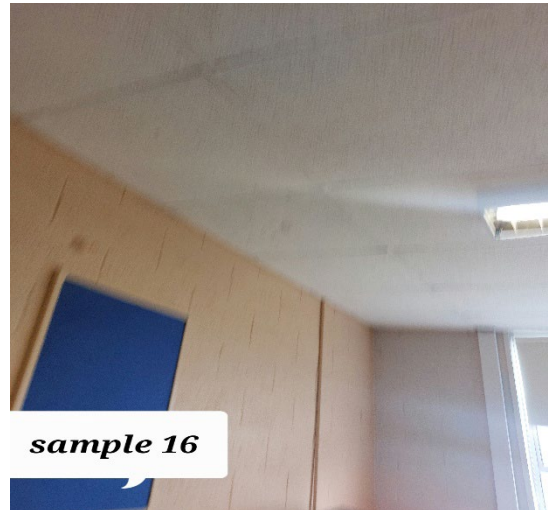
**Ceiling tile.**

A sample was taken of the ceiling tile in the Irish classroom.

The lab results show that Asbestos was not detected in the sample.

**NADIS**

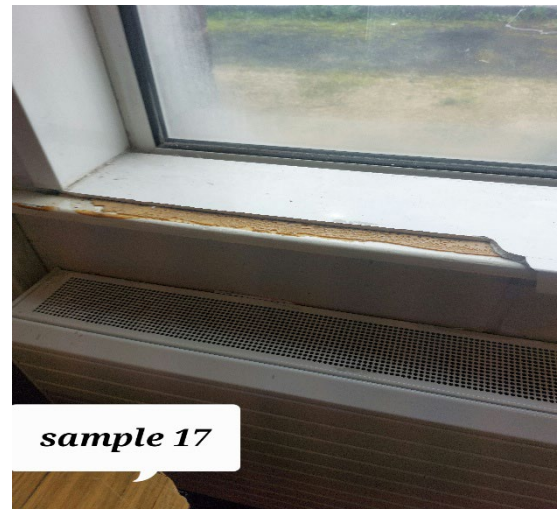
**PVC window board and glue.**

A sample was taken of the pvc window board and glue in the Irish classroom.

The lab results show that Asbestos was not detected in the sample.

**NADIS**

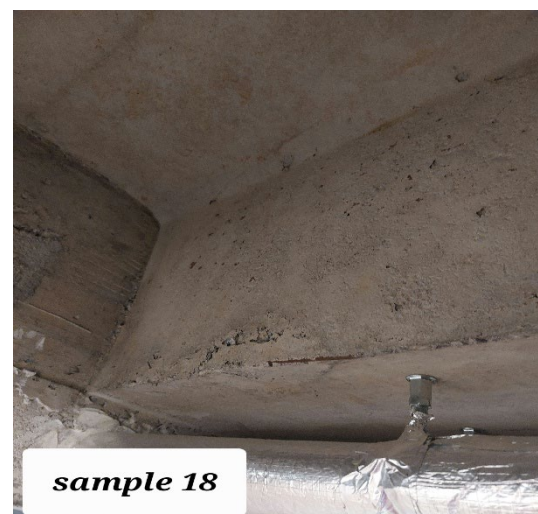
A sample was taken of the cement product underside of science lab floor.

The lab results show that Asbestos was not detected in the sample.

**NADIS**

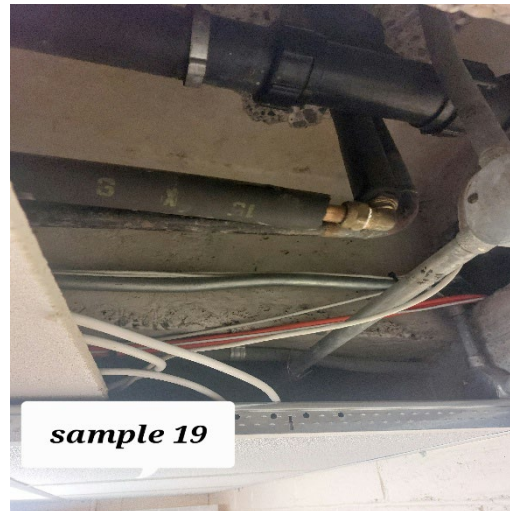
**Pipe lagging.**

A sample was taken of the pipe lagging underside of science lab floor.

The lab results show that Asbestos was not detected in the sample.

**NADIS**

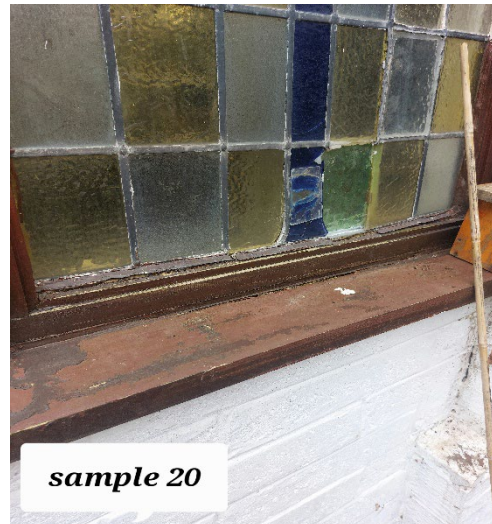
**Mastic/Putty.**

A sample was taken of the mastic/putty in the porch linking the hallways.

The lab results show that Asbestos was not detected in the sample.

**NADIS**
