## Boyne Bridge

ID: OY-R401-001.00

### Inventory and Principal Inspection Report

DATE: 28 JANUARY 2015

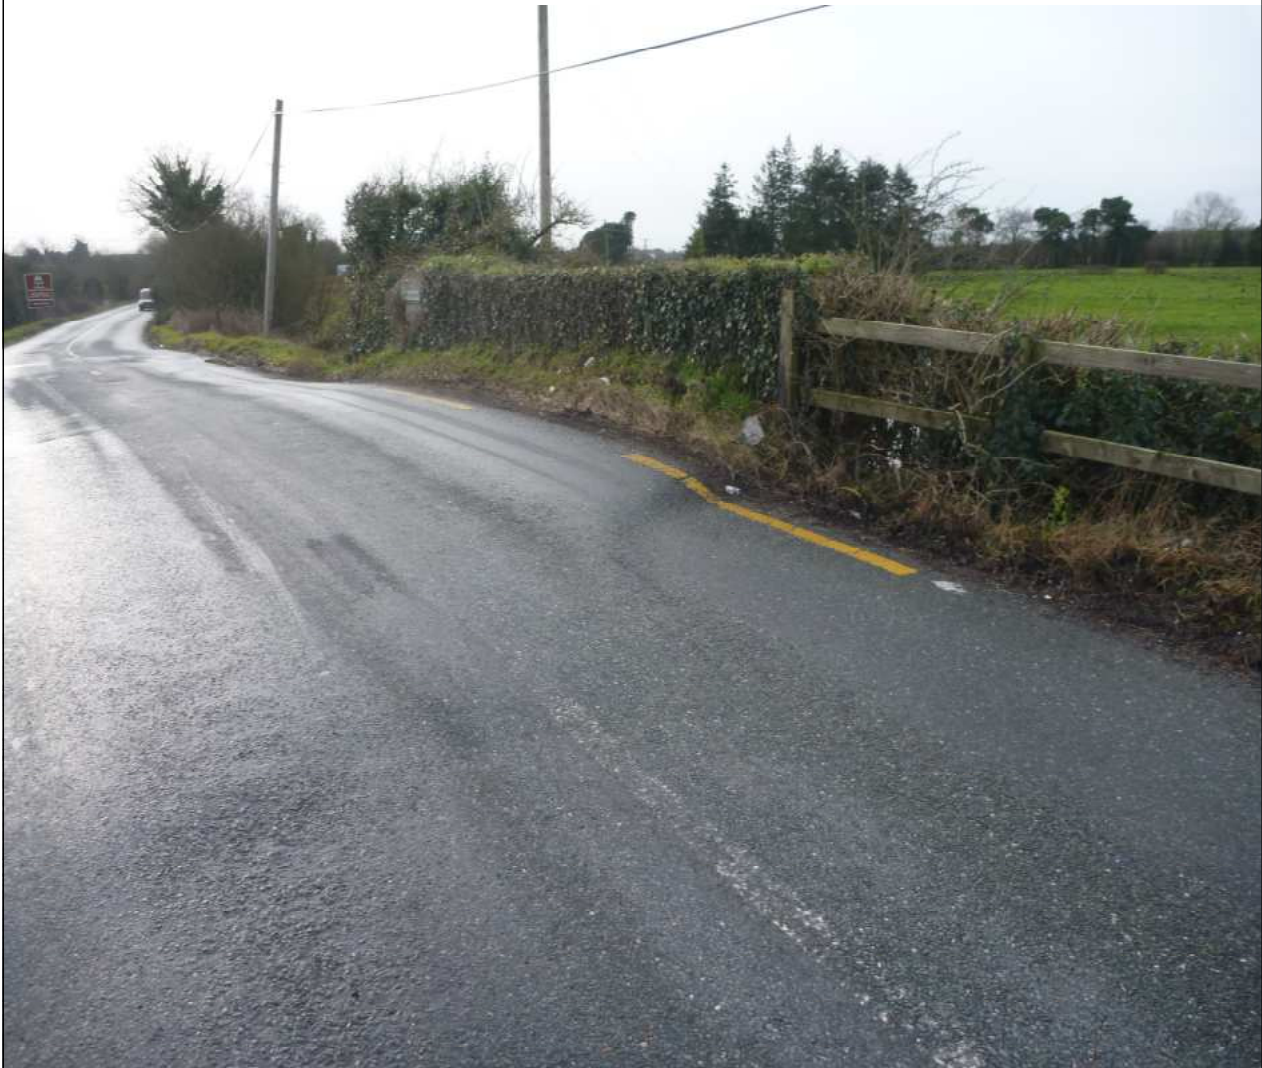
**OY-R401-001.00 Boyne Bridge****Component No. 1 Bridge surface**

Consider vertical alignment at this location.  
There is a large depression in road surface at North West.

Condition/Mainten. 3 / N

| No | Component | | | | Repair Work | | | | |
|---|---|---|---|---|---|---|---|---|---|
| | 1 Bridge surface<br>Z : Other repair work<br>Consider vertical alignment at<br>this location.<br>There is a large depression in<br>road surface at North West. | 3 | N | N | | | | | 5 |

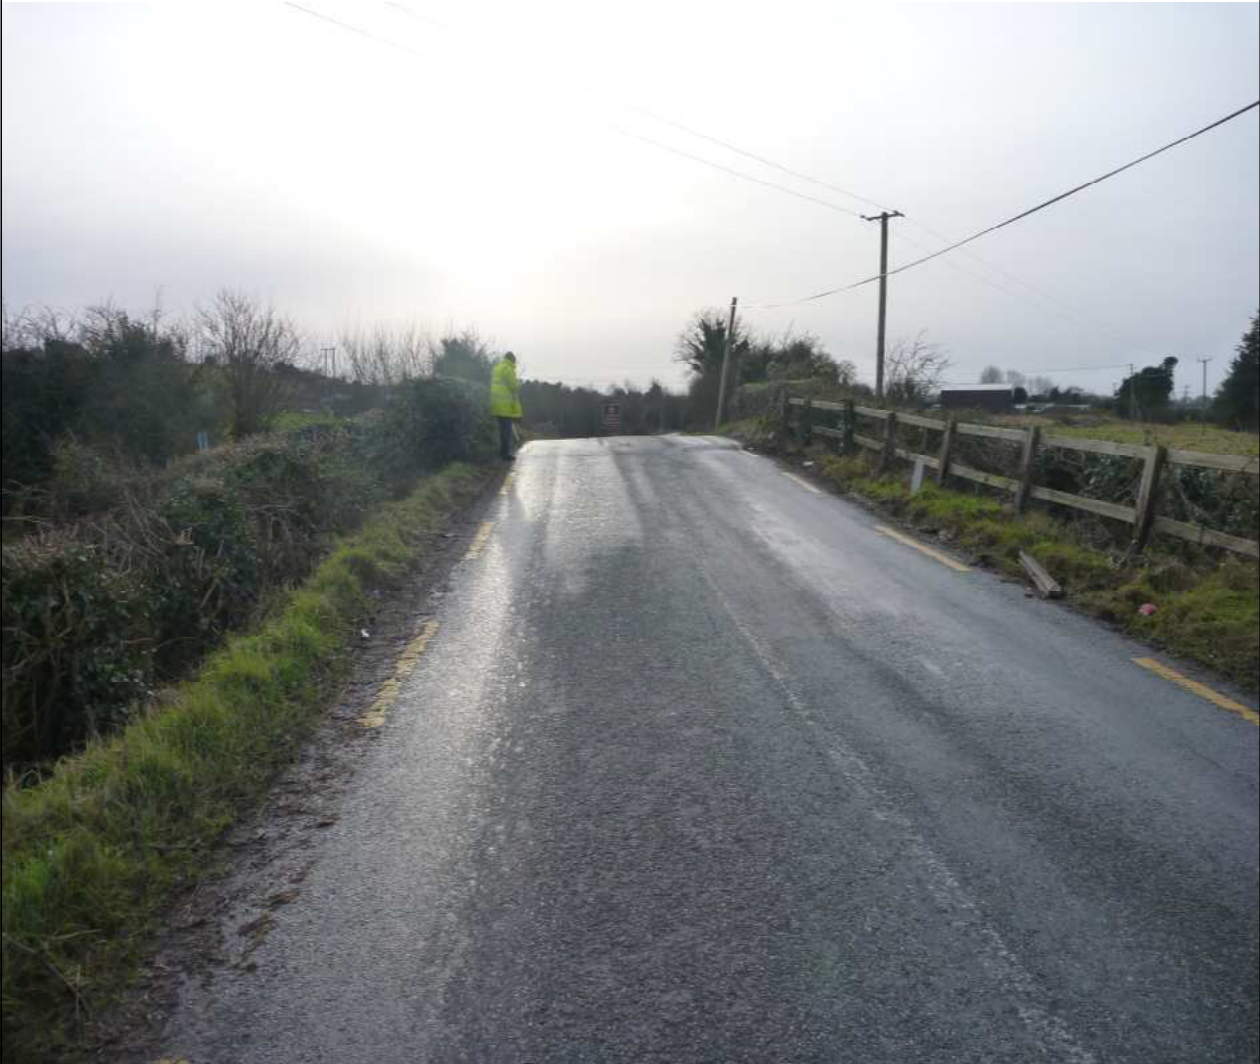
**OY-R401-001.00 Boyne Bridge****Component No. 1 Bridge surface**

Consider vertical alignment at this location.  
There is a large depression in road surface at North West.

Condition/Mainten. 3 / N

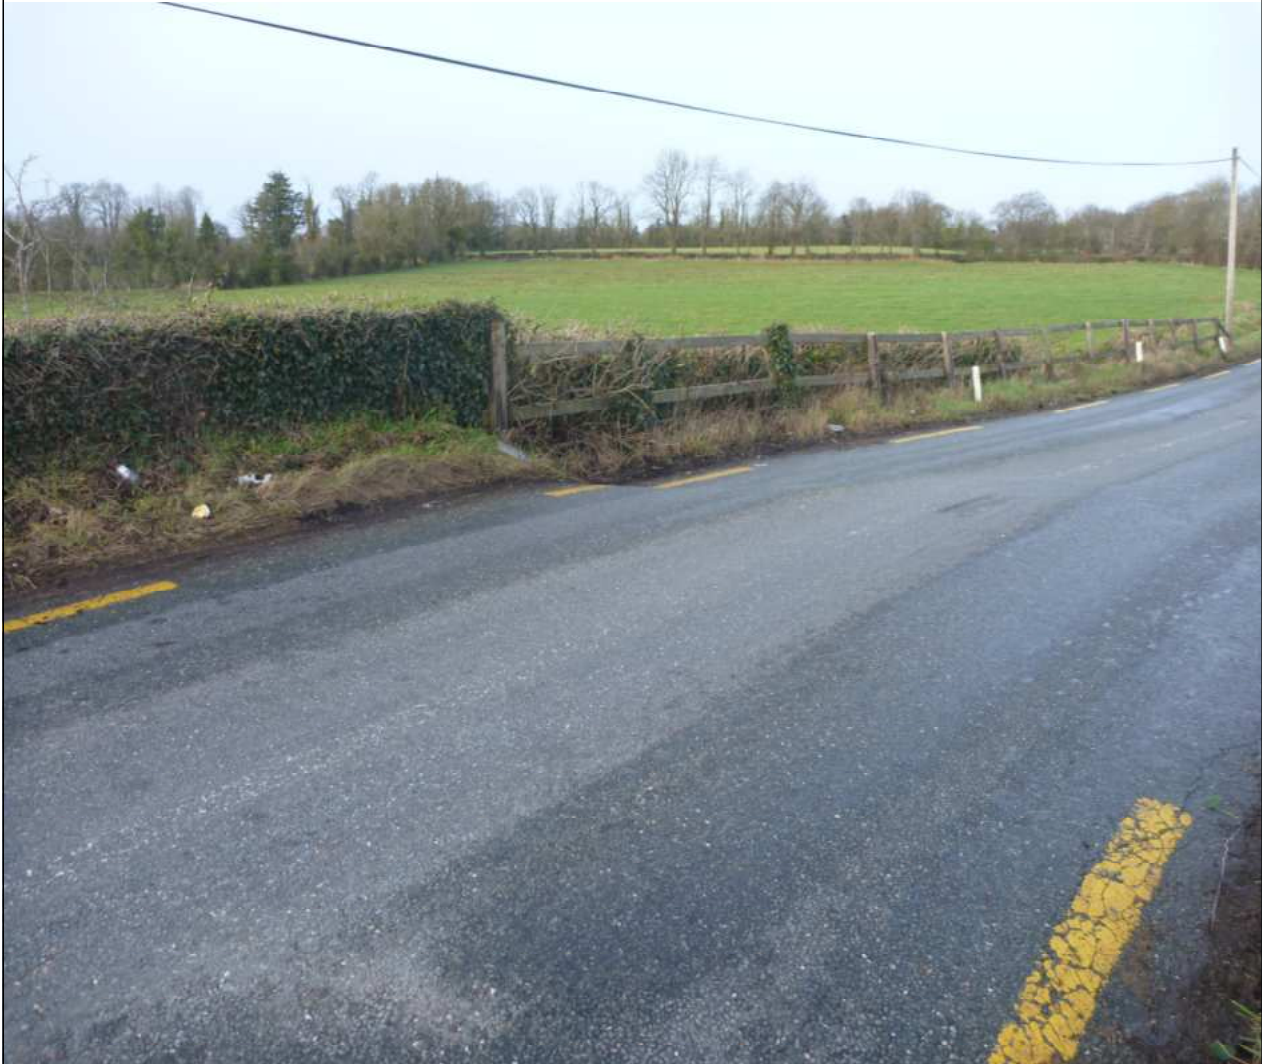
**OY-R401-001.00 Boyne Bridge****Component No. 1 Bridge surface**

Consider vertical alignment at this location.  
There is a large depression in road surface at North West.  
Condition/Mainten. 3 / N

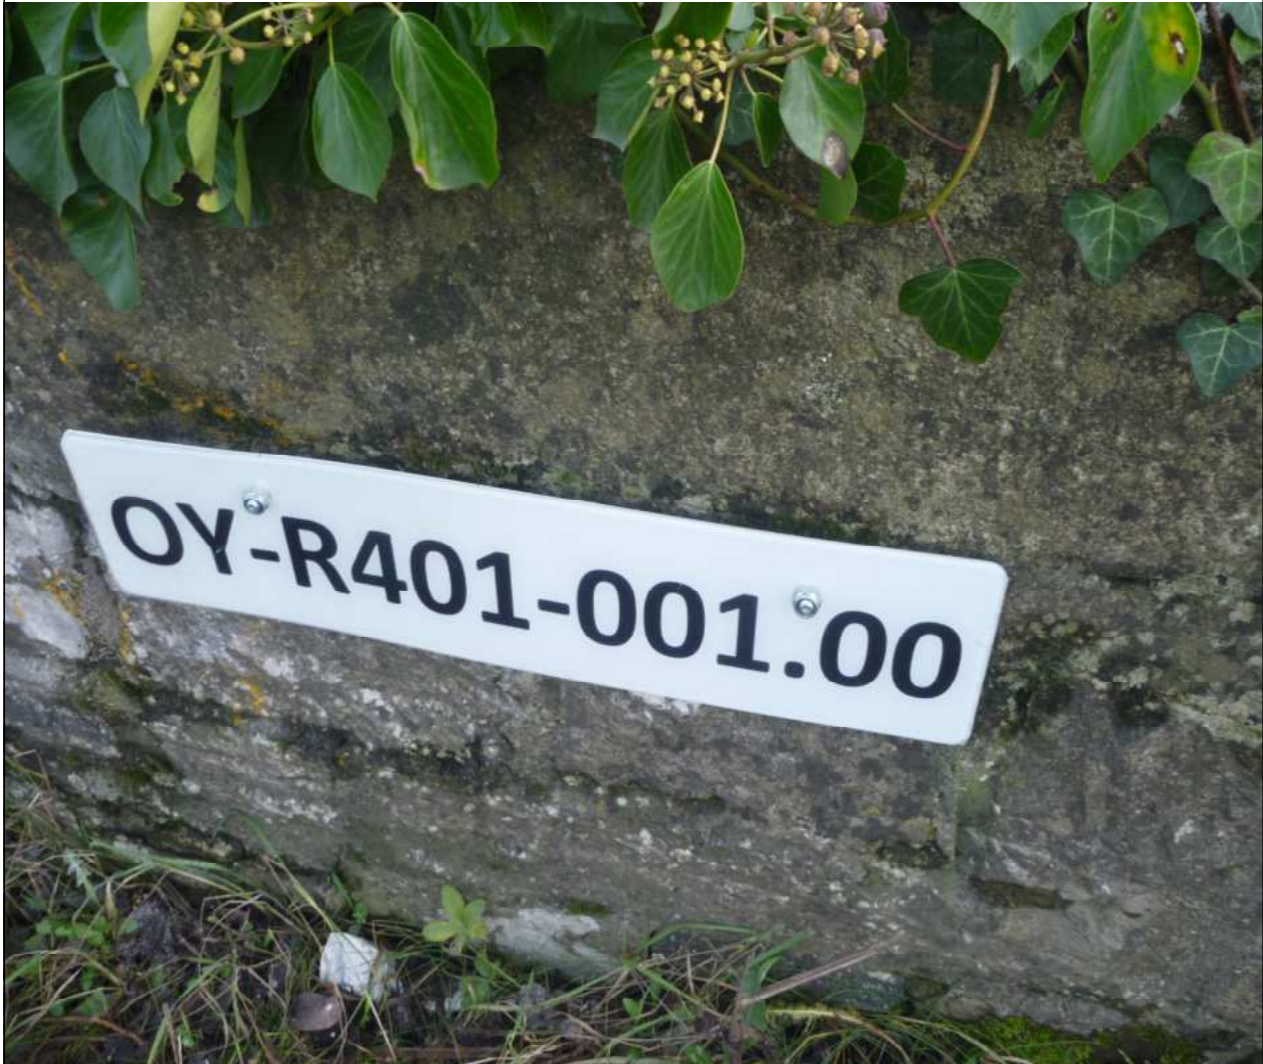
| <b>Component No.</b> | <b>1</b> | <b>Bridge surface</b> |

| Consider vertical alignment at this location.<br>There is a large depression in road surface at North West.<br>Condition/Mainten.                    3 / N | | |

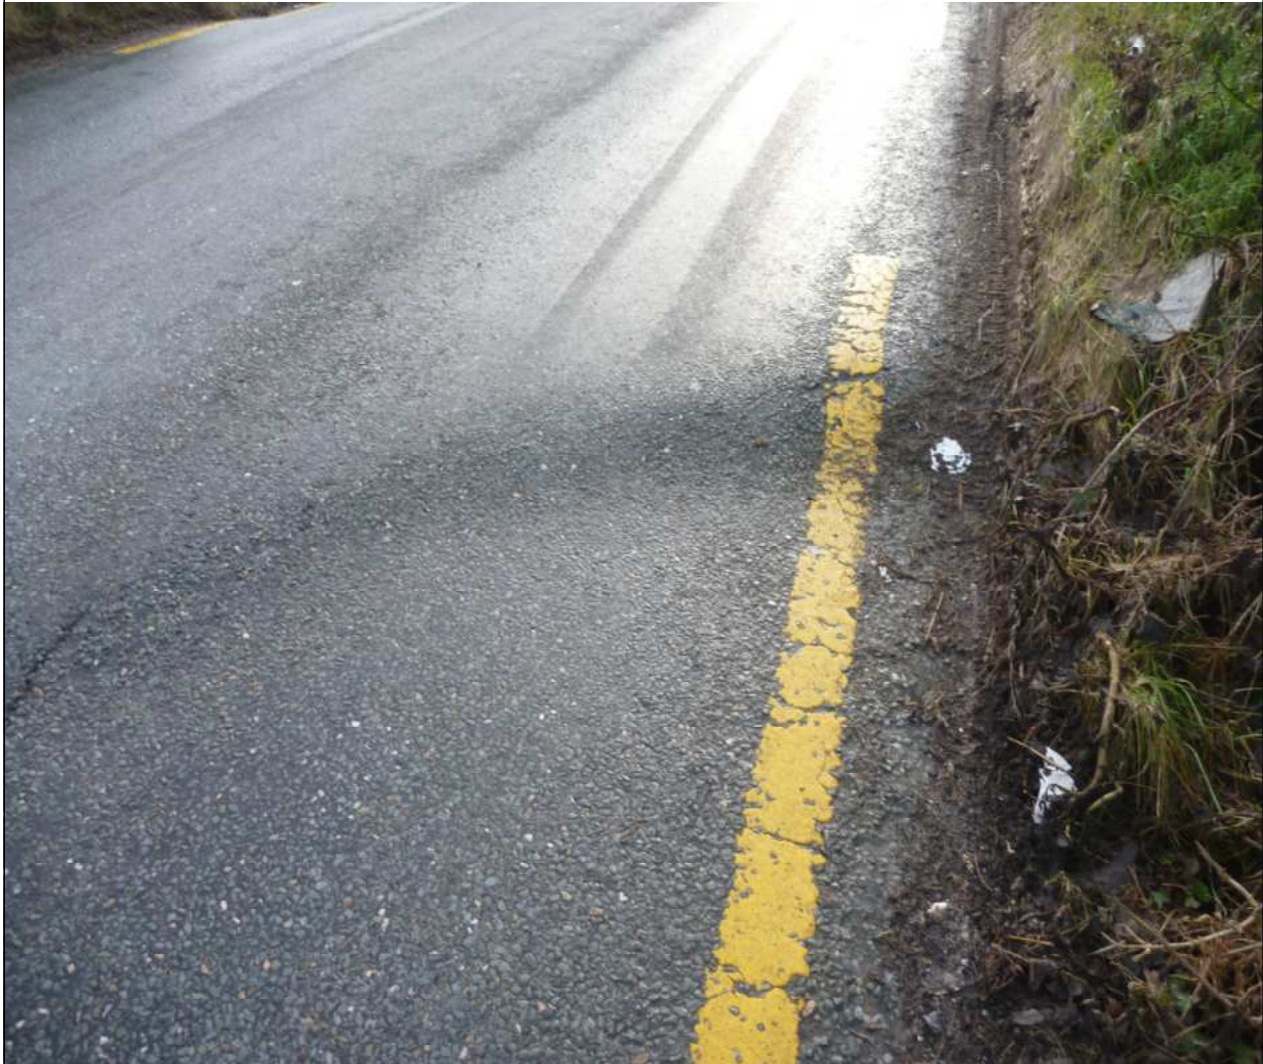
| <b>Component No.</b> | <b>1</b> | <b>Bridge surface</b> |

| Consider vertical alignment at this location.<br>There is a large depression in road surface at North West.<br>Condition/Mainten.            3 / N | | |

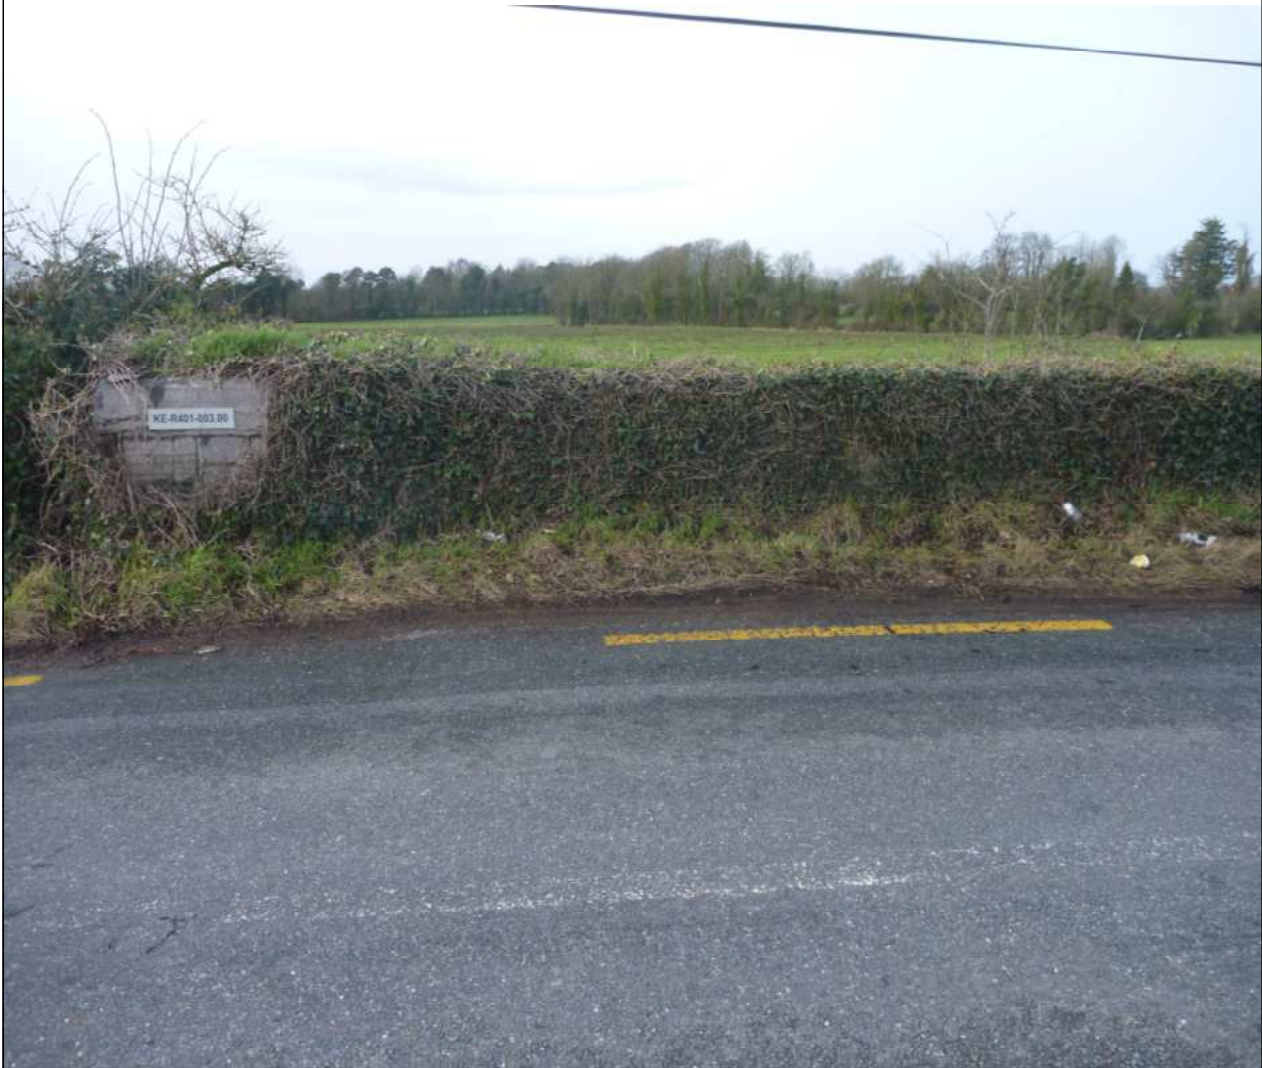
| Component No. | 4 | Parapets/Safety barrier |

Not visible due to vegetation.

Condition/Mainten.        ? /

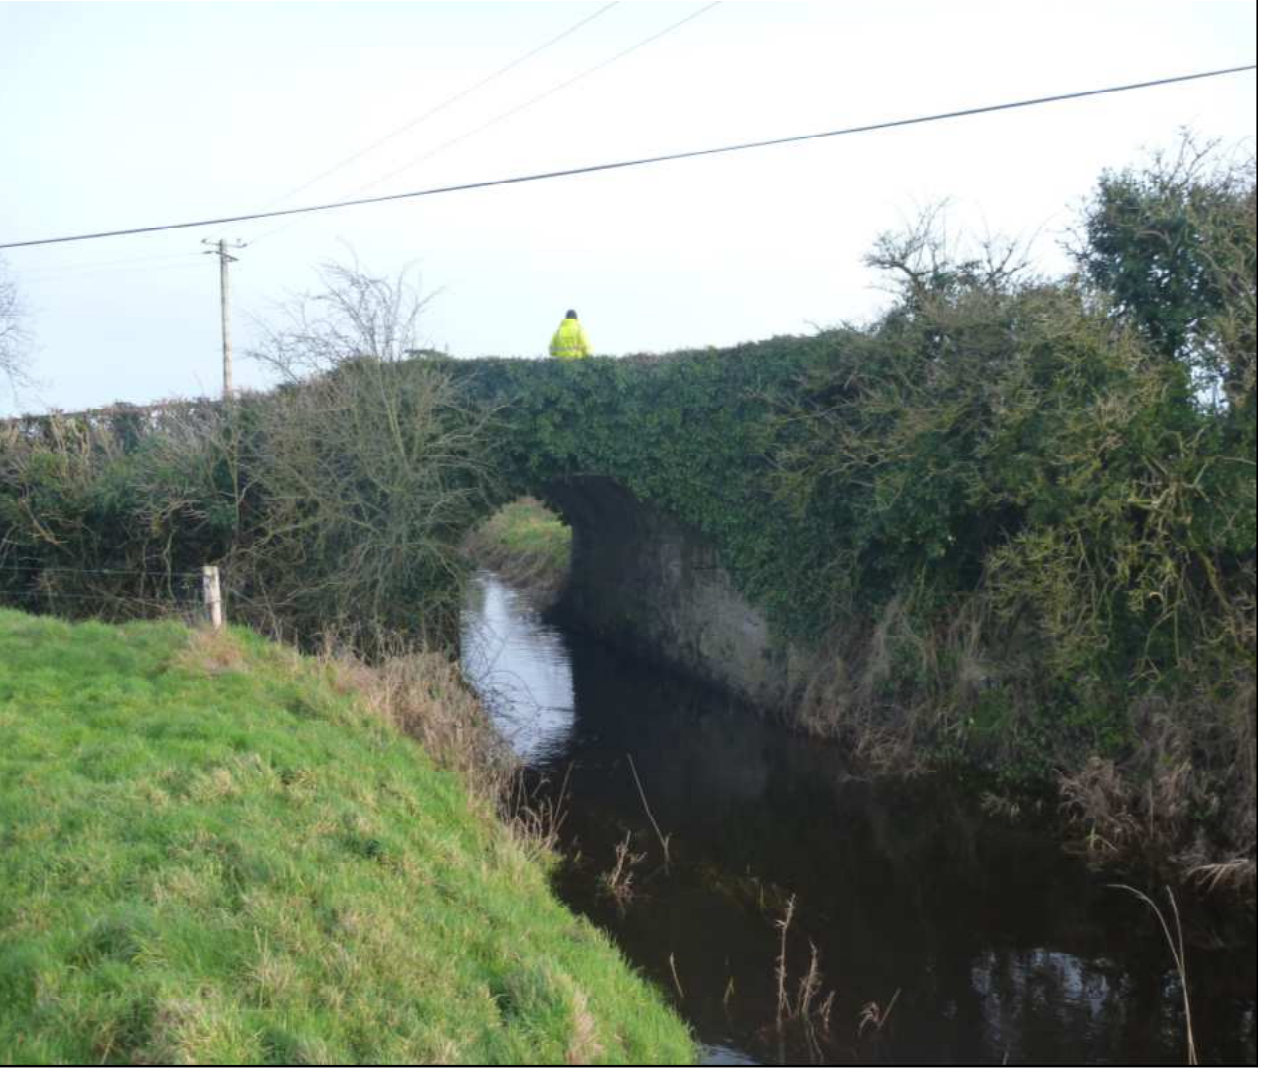
| <b>Component No.</b> | <b>5</b> | <b>Embankments/Revetments</b> |

| Vegetation. | | |
| Condition/Mainten. | 1 | / Y |

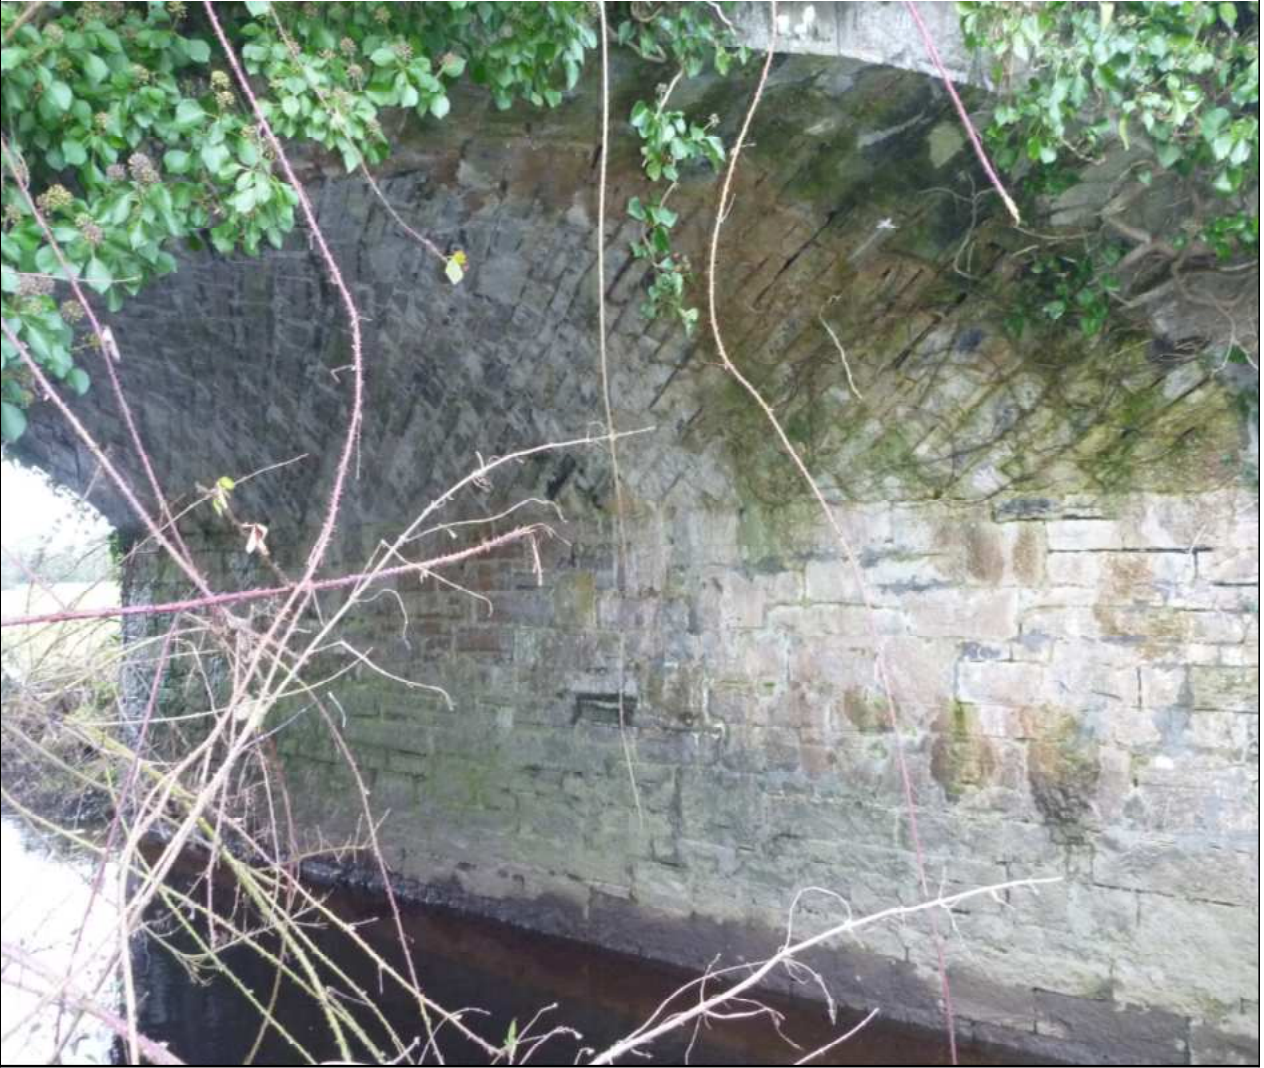
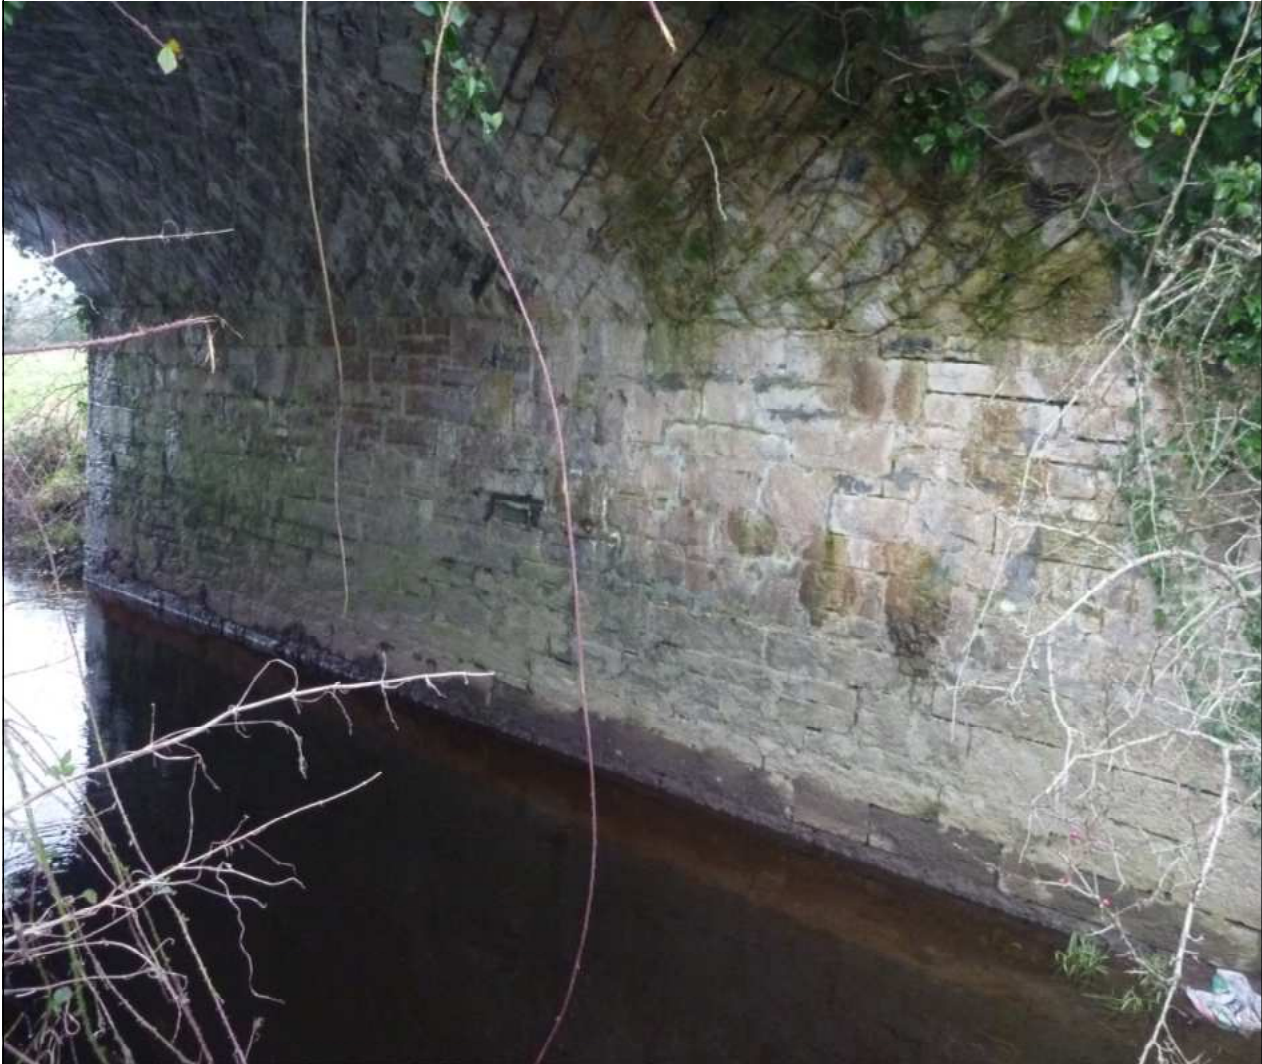
| <b>Component No.</b> | <b>7</b> | <b>Abutments</b> |

| No | Component | | | | Repair Work | | | | |
|---|---|---|---|---|---|---|---|---|---|
| | 7 Abutments<br>D : Masonry repointing<br>Loss of masonry pointing | 2 | N | N | | | | | 2 |

| <b>Condition/Mainten.</b> | <b>2 / N</b> | |

| No | Component | | | | Repair Work | | | | |
|---|---|---|---|---|---|---|---|---|---|
| | | | | | D | 10 | 2018 | 1250 | |

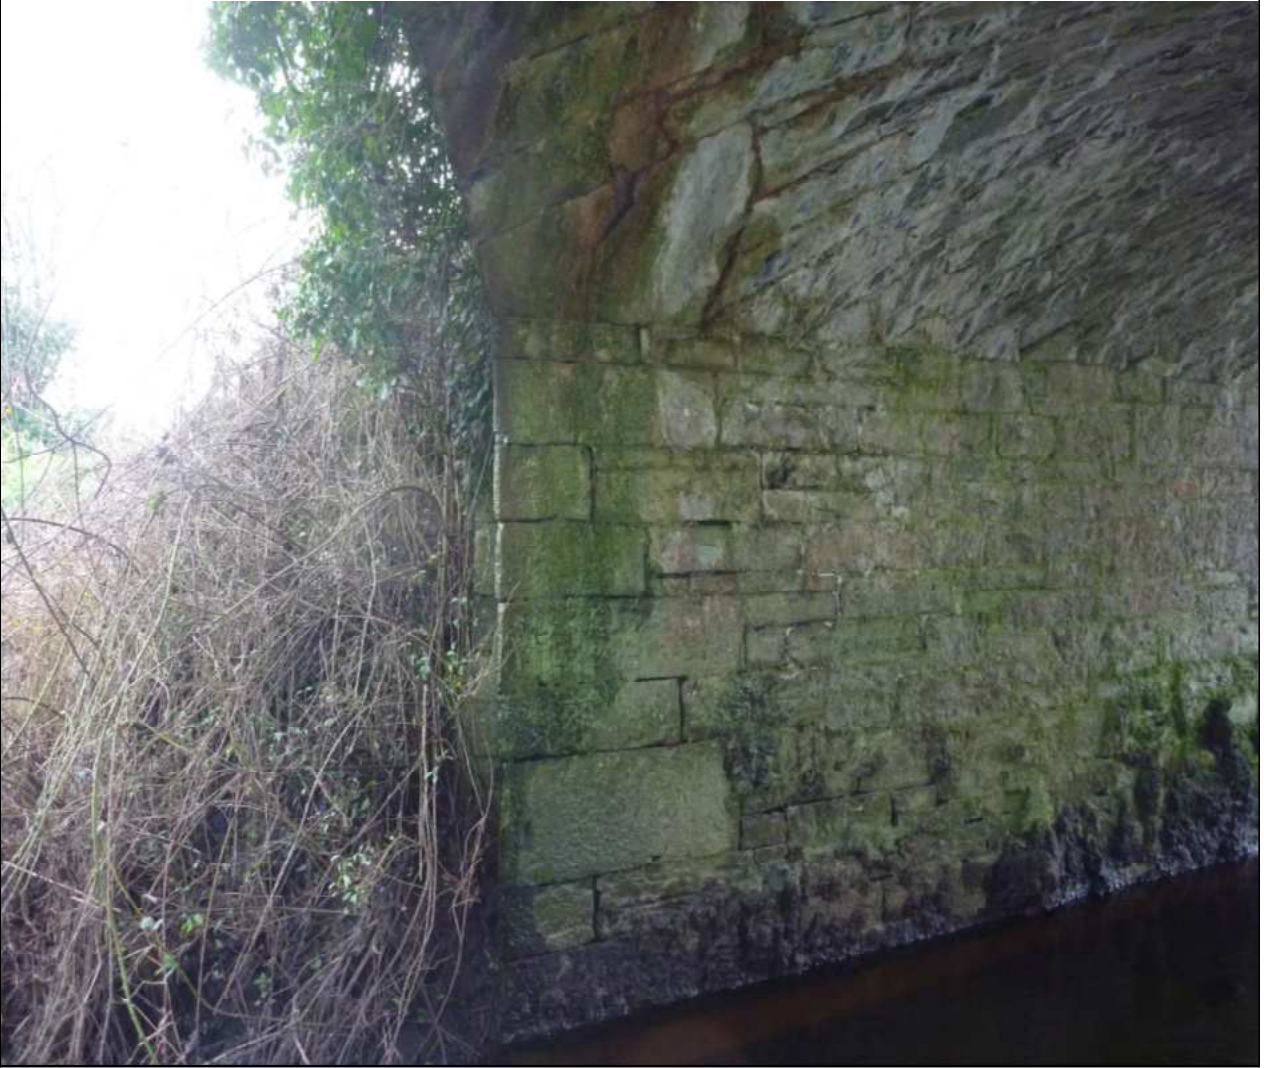
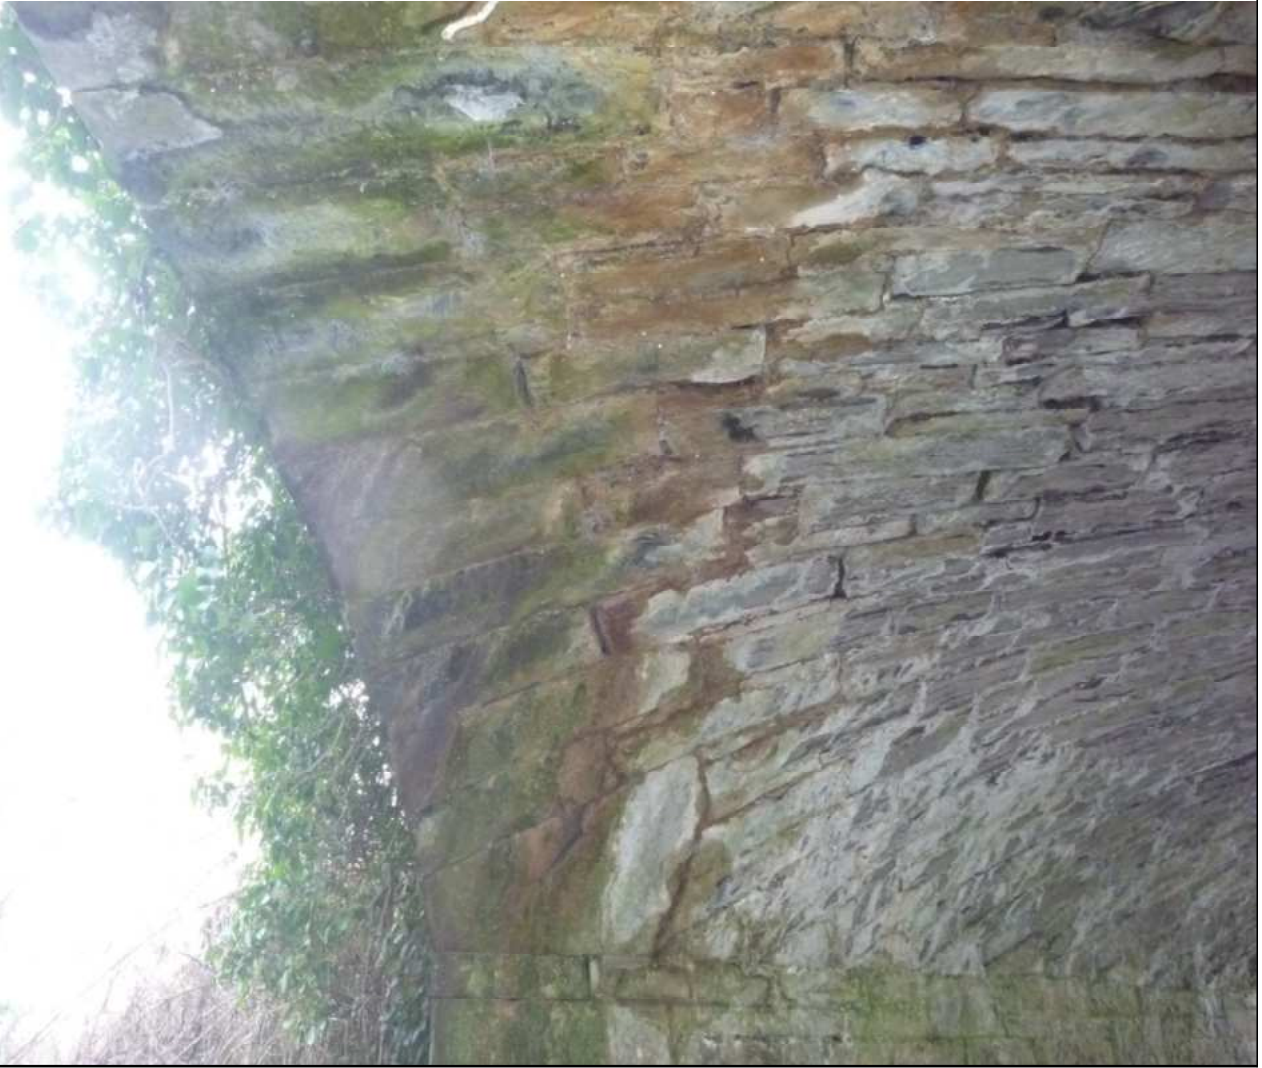
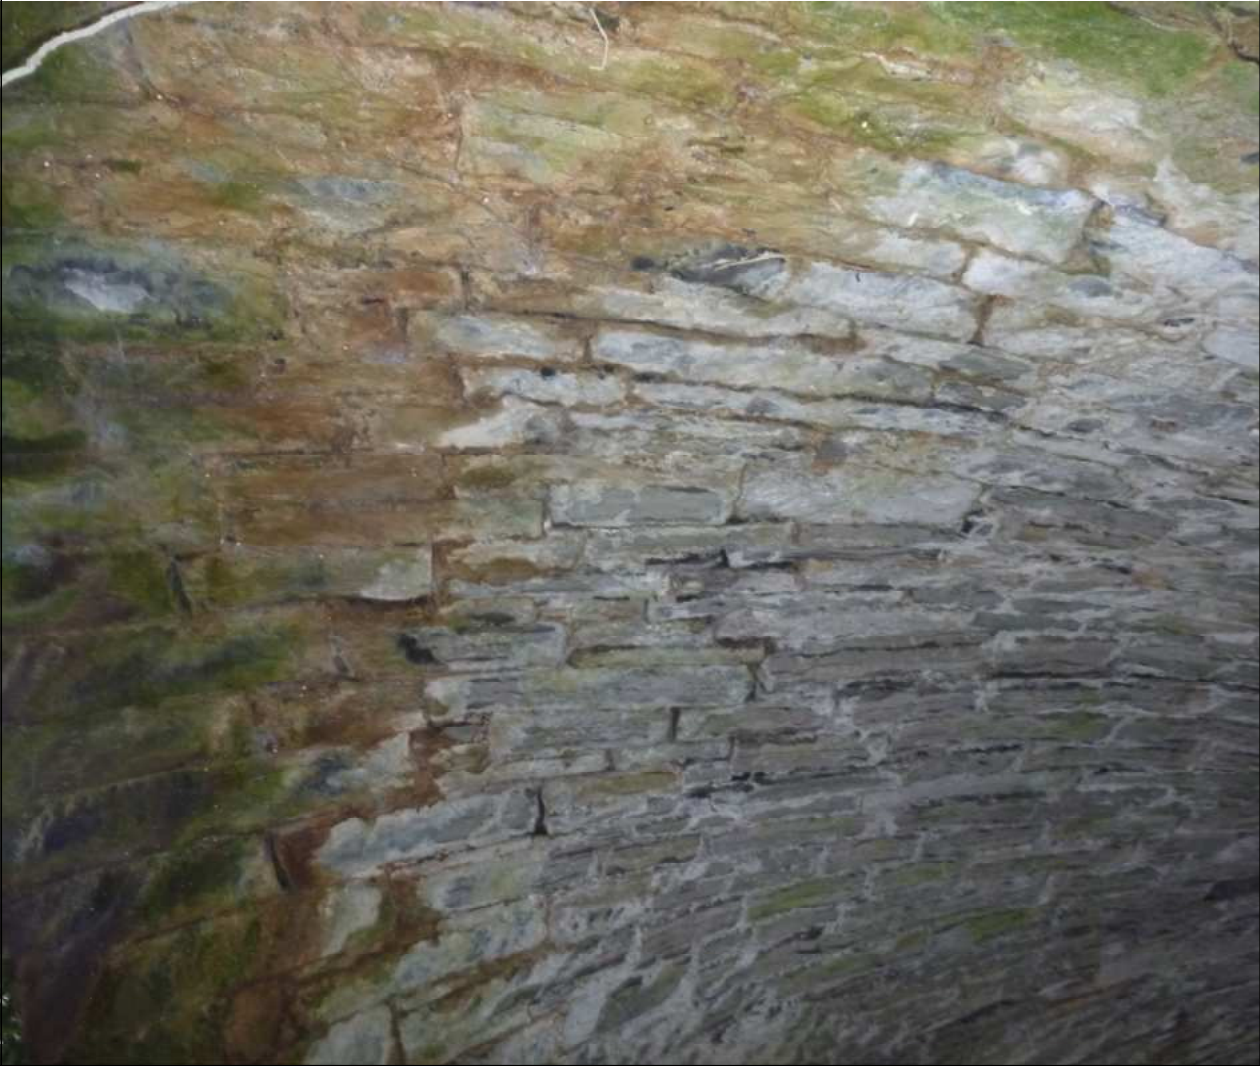
| <b>Component No.</b> | <b>10</b> | <b>Deck/slab/arch barrel</b> |

| No | Component | | | | Repair Work | | | | |
|---|---|---|---|---|---|---|---|---|---|
| | 10 Deck/slab/arch barrel<br>D : Masonry repointing<br>Loss of masonry pointing | 2 | N | N | | | | | 3 |

| <b>Condition/Mainten.</b> | <b>2 / N</b> | |

| No | Component | | | | Repair Work | | | | |
|---|---|---|---|---|---|---|---|---|---|
| | | | | | D | 10 | 2018 | 1850 | |

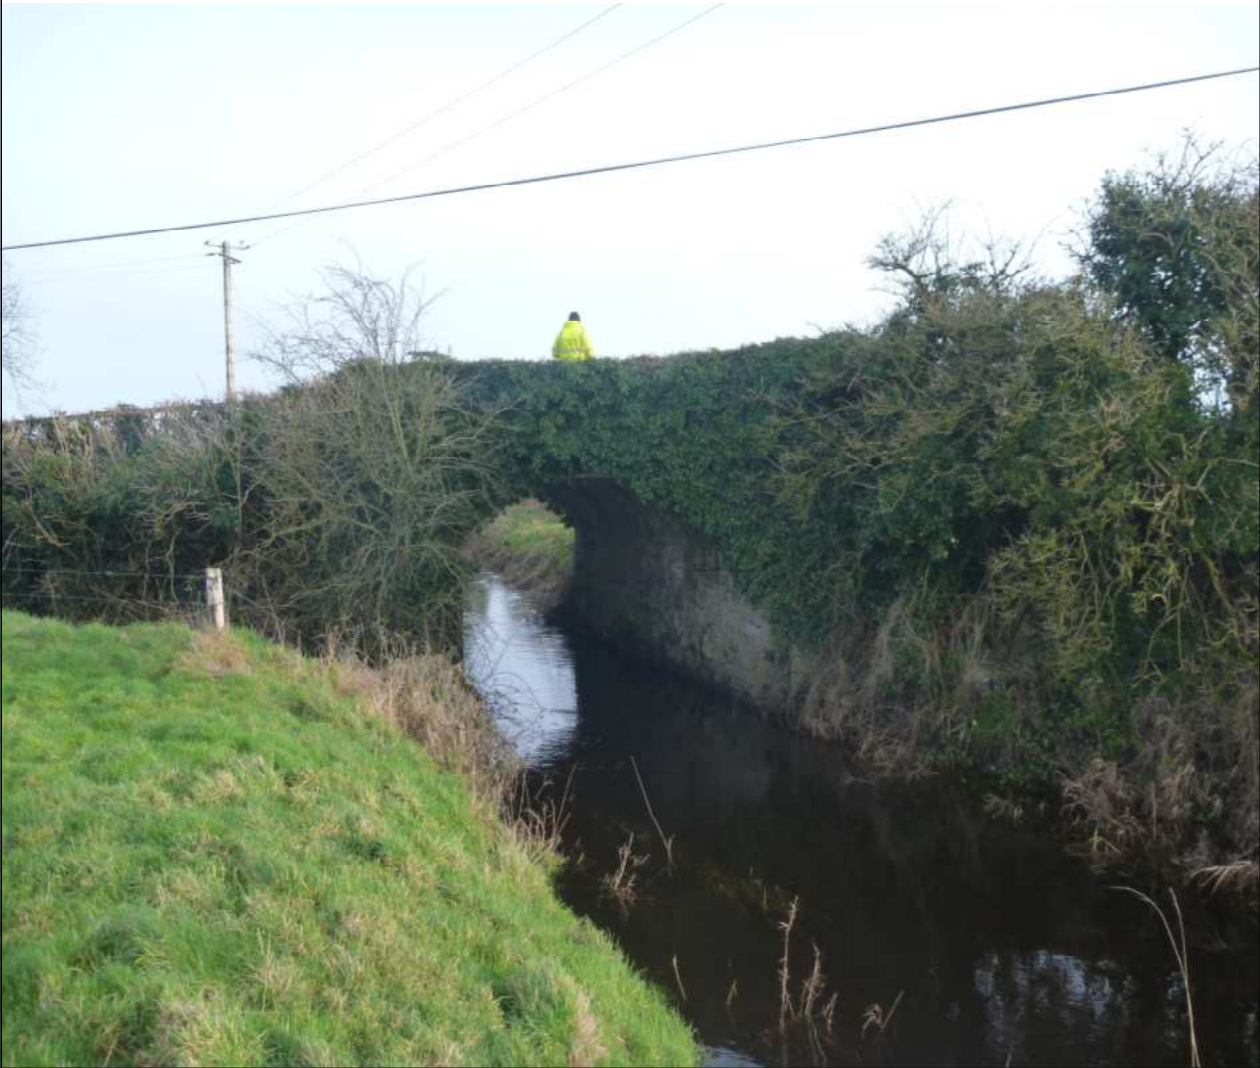
| Component No. | 14 | Structure in general |

| Condition/Mainten. | 2 | / |
