## SURVEY, SAMPLING AND ASSESSMENT FOR ASBESTOS CONTAINING MATERIALS

Scoil Mhuire  
Buncrana  
Co. Donegal

LCETB

Report Date: 29/4/2019

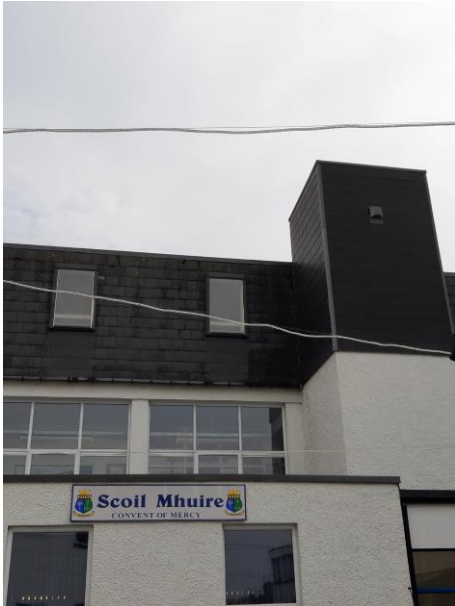
2.1.1 Slates to external walls of the main building

Material Assessment Score: 3, Priority Assessment Score: 1.

The material assessment score for the slates is 3 indicating a low risk of fibre release if not interfered with. The priority assessment score is high, scoring 1 indicating that the slates will be interfered with during refurbishment works.

**Slates to external walls**

**Recommendation:** The asbestos containing materials will be disturbed during the proposed works and should be removed under controlled conditions by a specialist asbestos contractor.

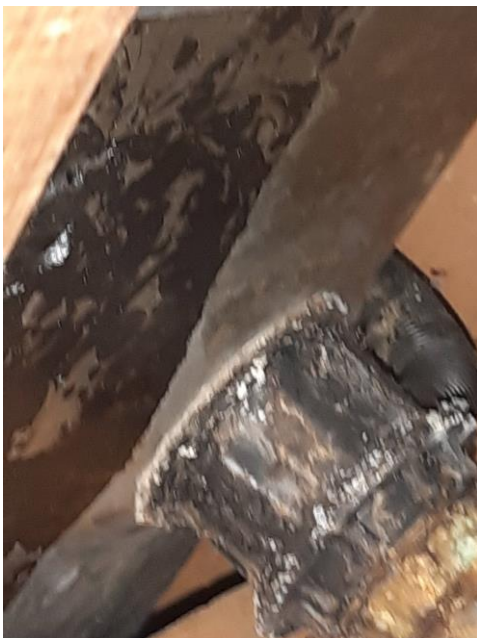
2.1.2 Heat pads to sink units in the Home Economics Room

Material Assessment Score: 3, Priority Assessment Score: 1

The material assessment score for the heatpads is 4 indicating a low risk of fibre release if not interfered with. The priority assessment score is high, scoring 1 indicating that the heat pads will be interfered with during refurbishment works

**Heat pads to sink units**
