**Client:**  
Beaumont Hospital,  
P.O. Box 1297,  
Beaumont Road,  
Dublin 9.

**Title:**  
Asbestos Survey of Beaumont Hospital

**Report ref.** ACS 2-170

**Date :** 29<sup>th</sup> July 2002

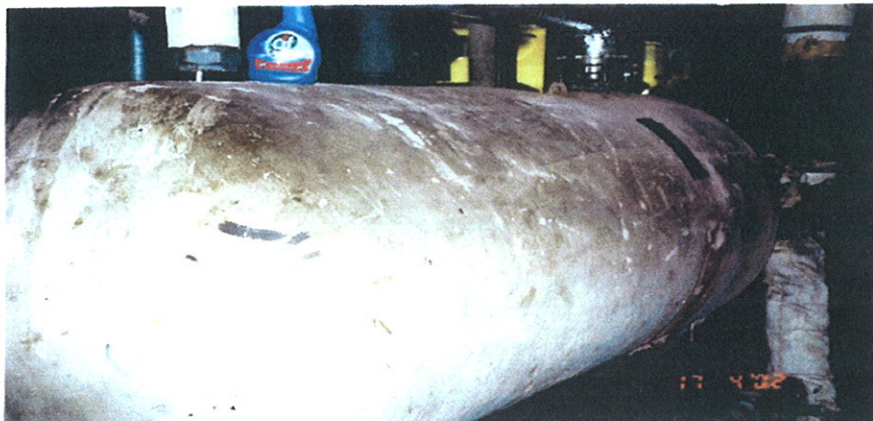
None were found during the survey. Plate 2 shows a calorifier with fibreglass lagging in the H 1 plant room.

**Plate 2 - Calorifier Lagging in H 1 Plant Room.**

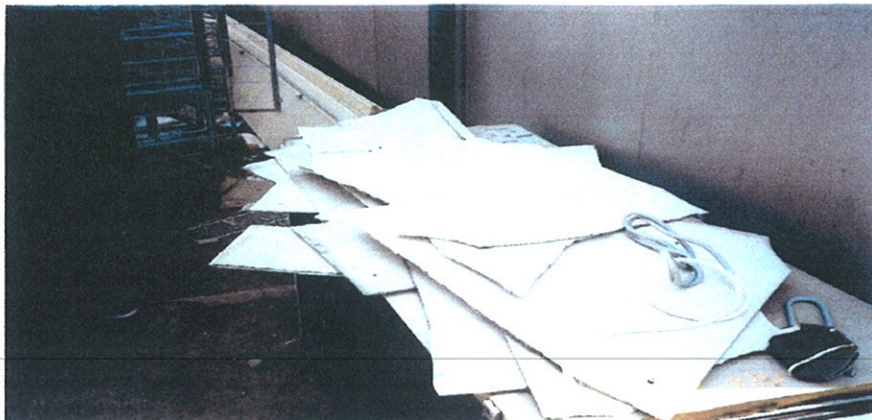
**Plate 3 - Broken Asbestos Cement Cladding.**

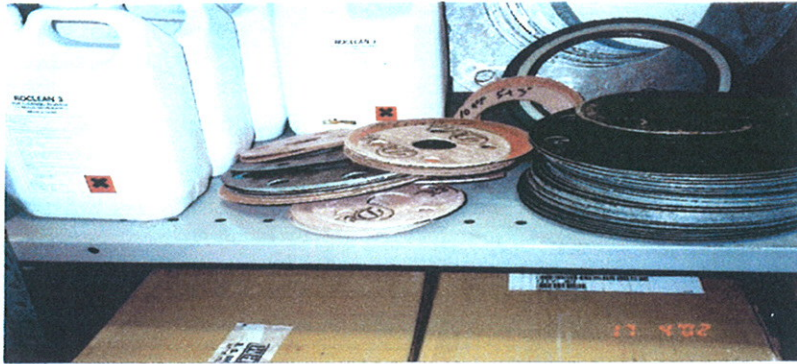
Plates 4 and 30 shows asbestos gaskets in the Technical Services Stores and a plant room respectively. Asbestos gaskets are entombed in use, but staff using them should be made aware of the asbestos content and it is recommended that a code of practice be implemented for those handling asbestos gaskets. It is also recommended that if possible, asbestos free substitutes are found. Plates 5 and 6 shows large, blue asbestos gaskets and webbing in an upper flue duct beside the boiler house. These have been present since first installed and should be labeled and inspected annually. It is recommended that the H.S.A. be consulted if this gasket or webbing has to be repaired or replaced. Plate 7 shows asbestos rope seal between the flanges of the metal ducting in the V3 plant room. These sources are entombed and can be safely left in place. The same can be said of the rope seals (if present) in the Northlight windows (Plate 9). Plate 8 shows asbestos rope insulation on the exhaust pipes of the older generator. These can also be left in place but should be labeled and inspected on an annual basis. Their removal would require the services of a specialist contractor. Finally, Plate 10 shows a welder's jacket in the filter's workshop. This was shown to contain white asbestos but under normal use it will not emit hazardous fibres.

**Plate 4 - Asbestos Gasket Materials in Technical Services Stores.**

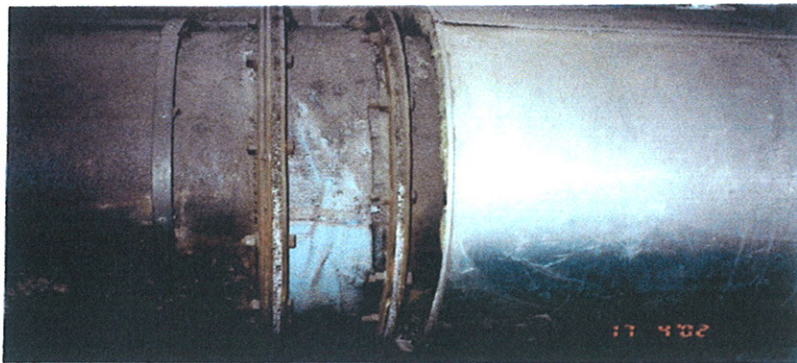
**Plate 5 - Asbestos Webbing and Gasket on Lower Flue Duct.**

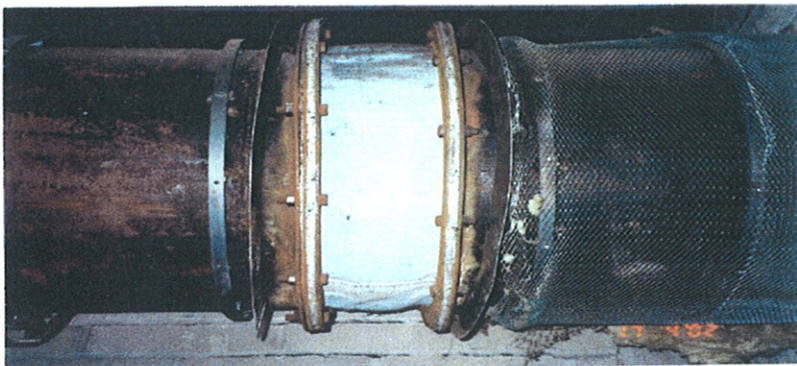
**Plate 6 - Webbing and Gasket on Upper Flue Duct.**

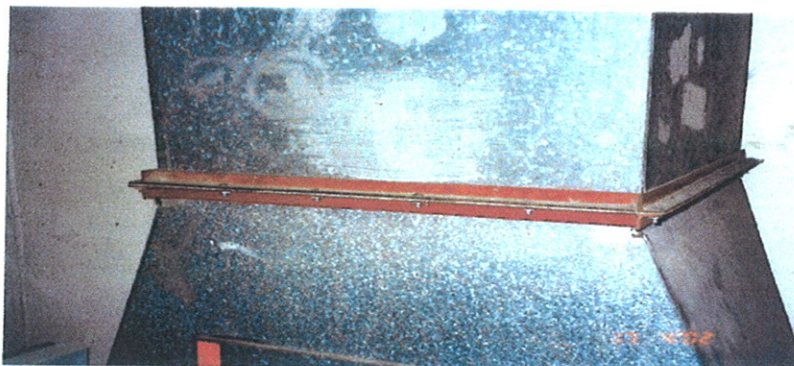
**Plate 7- Asbestos Rope Seal on Duct Flange in Plant Room V 3.**

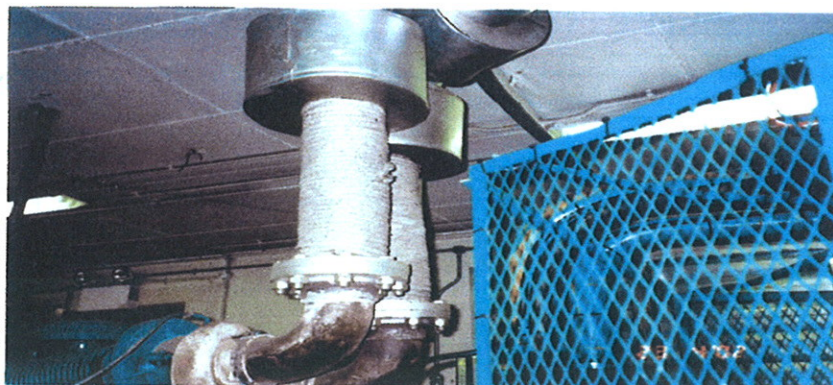
**Plate 8 - Asbestos Rope Insulation on Older Generator Exhaust.**

To: Holmes  
contractor  
remove

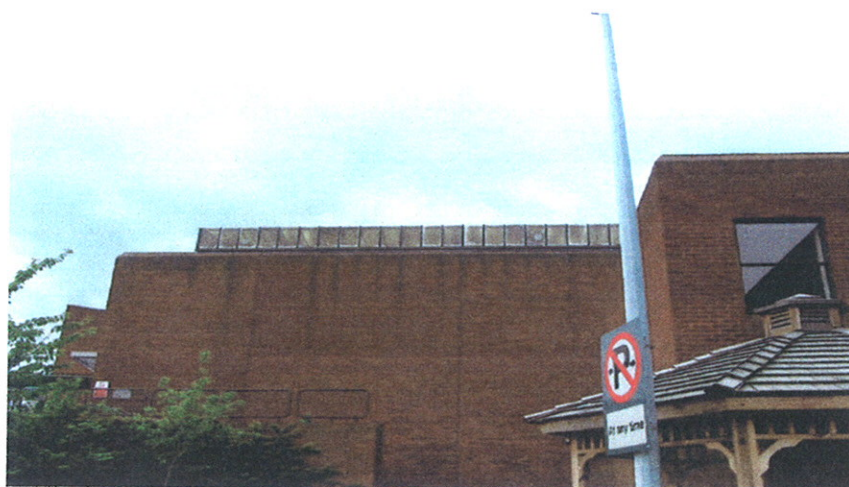
**Plate 9 – Possible Northlight Windows at Entrance**

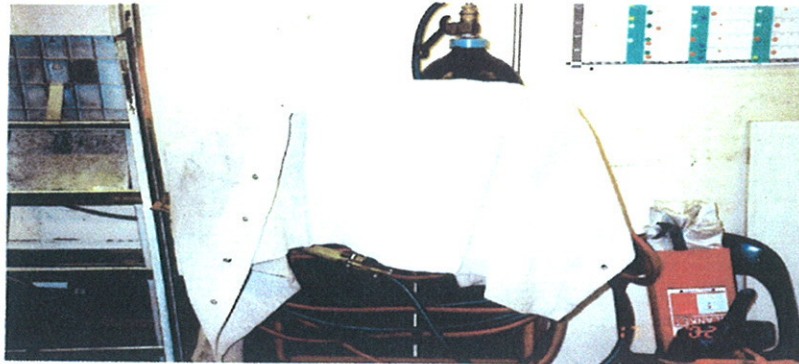
**Plate 10 - Welders Jacket in Filter's Workshop.**

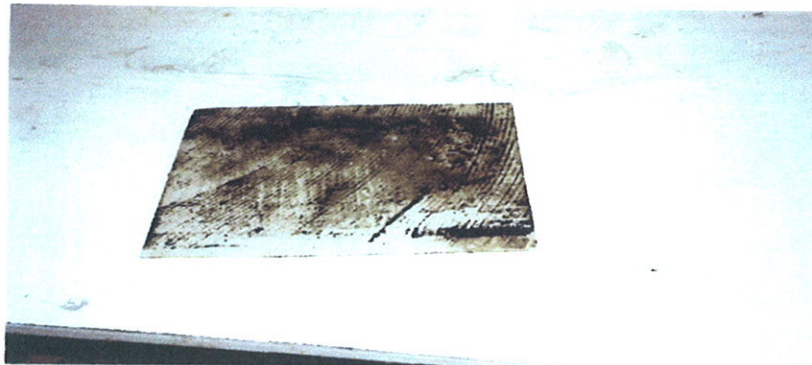
Older floor tiles are known to contain white asbestos, as is the more frequently encountered bitumen adhesive. Plate 11 shows a typical floor tile with such an adhesive. These are perfectly safe in use but, on account of the bitumen being present, the tile is classed as an asbestos containing material and must be disposed of as asbestos waste.

**Plate 11 - Floor Tile with Bitumen Adhesive.**

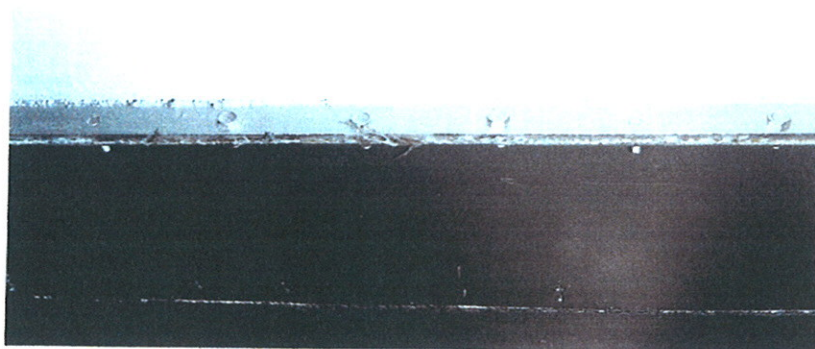
Plate 12 shows a non asbestos seal on the boiler flue duct and Plate 13 shows rubberised paint on the metal roof of the Turf Hopper.

**Plate 12 - Rope Seal on Boiler Flue Duct.**

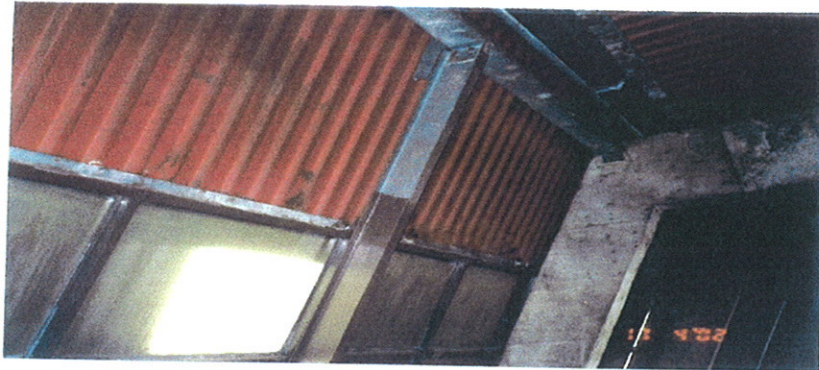
**Plate 13 - Rubberised Paint on Metal Roof on Turf Hopper.**

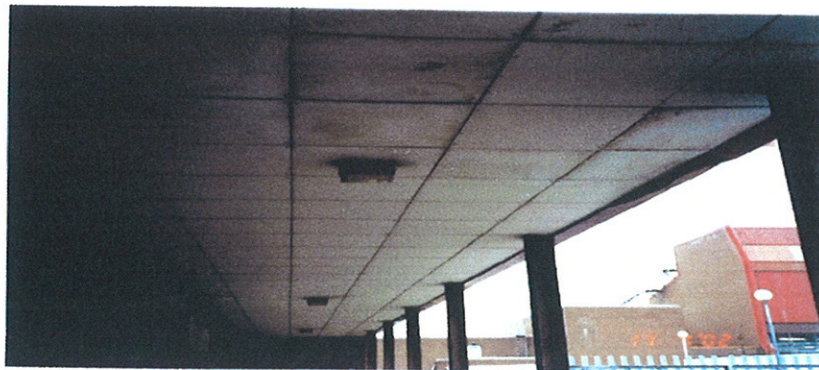
**Plate 14 - Supalux Tiles in Walkway Duct.**

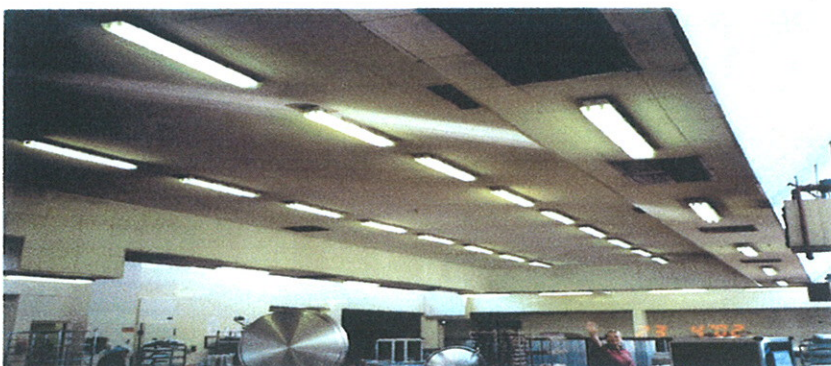
**Plate 24 - Ceiling Tiles in Main Kitchen**

In all instances the tiles were identified as supalux. It is understood the kitchen is to be refurbished in the near future. This will involve the removal of a large number of tiles To ensure that none of these contain asbestos a significant proportion i.e. 25%, should be checked prior to demolition.

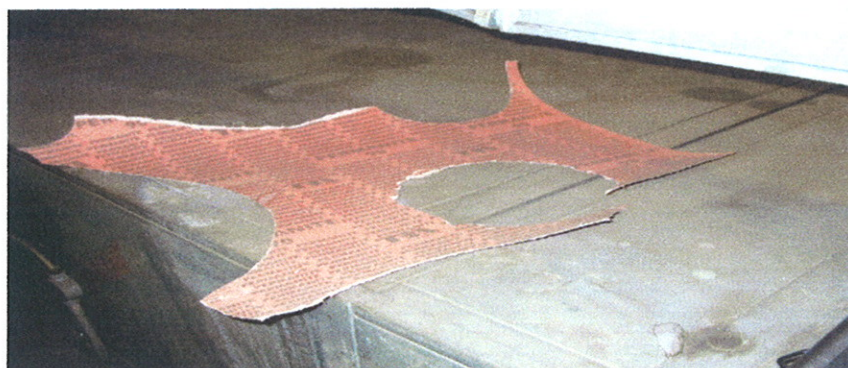
**Plate 30- Gasket Sheet in Plant Room.**

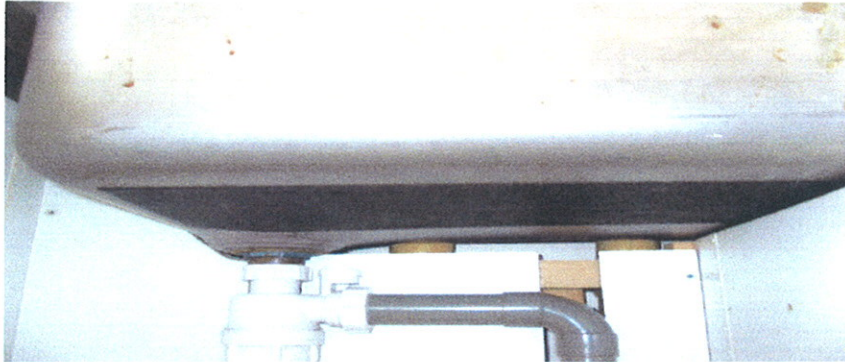
Plate 31 shows a typical stainless steel sink with a felt patch containing white asbestos. The fibres are firmly bound in the matrix posing minimum risk and they can be left in place without further attention.

**Plate 31- Felt Patch on Stainless Steel Sink.**

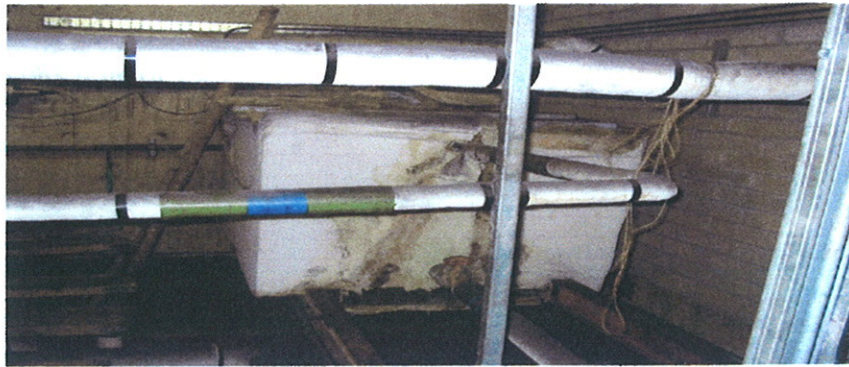
- (a) Plate 32 shows the roof top tank room with fibreglass insulation.
- (b) Plate 36 shows the lift hoist room. It is possible that the lift motors may contain asbestos brakes and clutches but this will only be of concern to the lift company's service engineers.
- (c) Plate 37 shows a typical ceiling void in the second floor Whitworth Ward with fibreglass insulation on the pipe work.

**Plate 32- Roof Top Tank Room with Fibreglass Insulation.**
