# ASBESTOS MANAGEMENT SURVEY REPORT

Blood Science Facility,

Pathology Block 6,

Beaumont Hospital

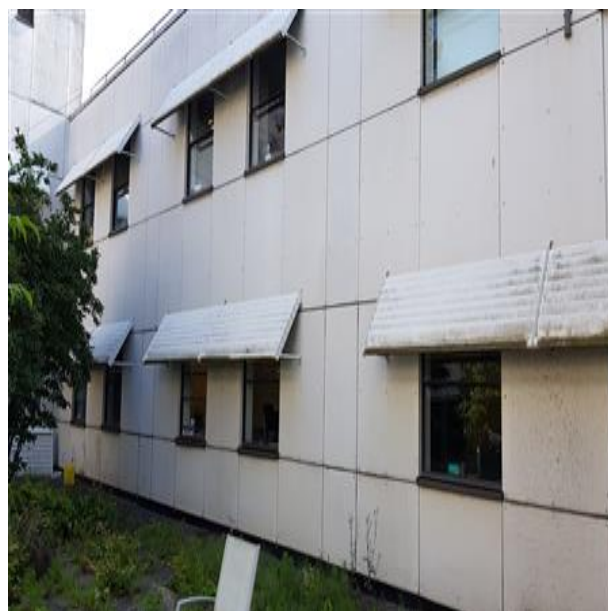
Condition : Good condition

#### Recommended Action

Please refer to the company's asbestos management plan for an explanation of this recommendation.

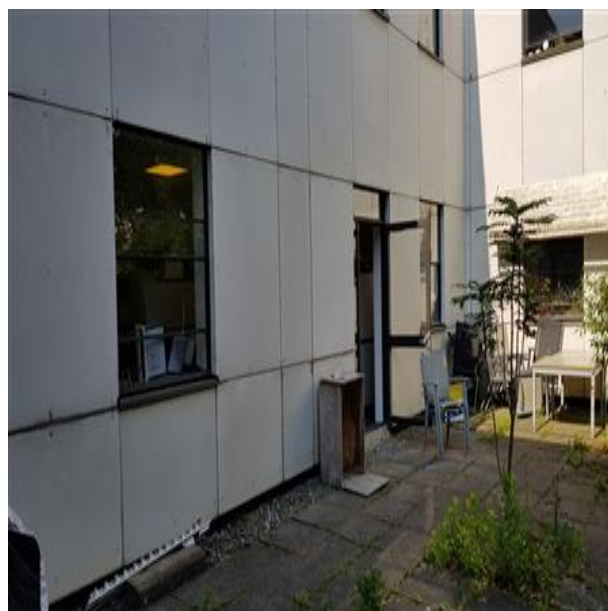
Condition : Good condition

#### Recommended Action

Please refer to the company's asbestos management plan for an explanation of this recommendation.

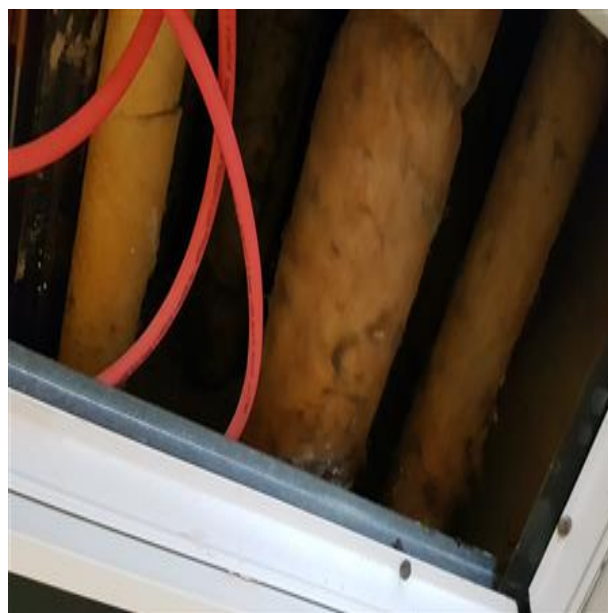
Condition : Very Low

#### Recommended Action

Please refer to the company's asbestos management plan for an explanation of this recommendation.

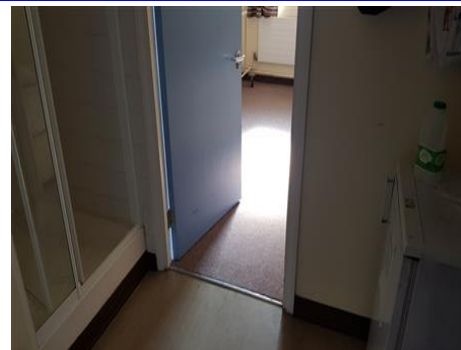
## Location Details 295909 No Asbestos Found

; No ACM's identified in this area. A more detailed survey will be required prior to any refurbishment or demolition works.

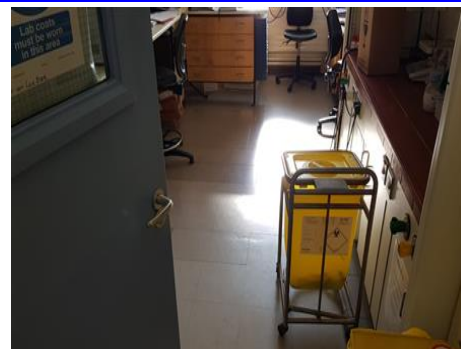
## Location Details 295910 No Asbestos Found

mushroom Floor tiles and bitumen adhesive; No ACM's identified in this area. A more detailed survey will be required prior to any refurbishment or demolition works.

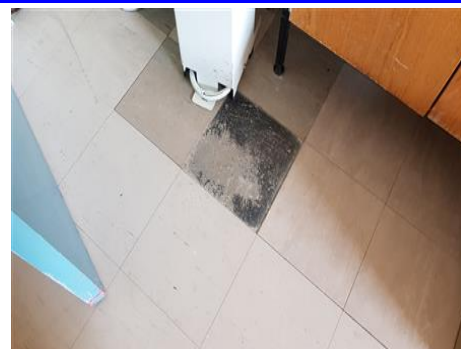
## Location Details 295911 No Asbestos Found

mushroom Floor tiles and bitumen adhesive; No ACM's identified in this area. A more detailed survey will be required prior to any refurbishment or demolition works.
