## **Type 3 Refurbishment/Demolition ASBESTOS SURVEY**

**C.T.I The Mall  
Clonmel,  
Tipperary**

**Upgrade of water controls in bathrooms**

**Survey Ref No: 10/16/200 ASB**

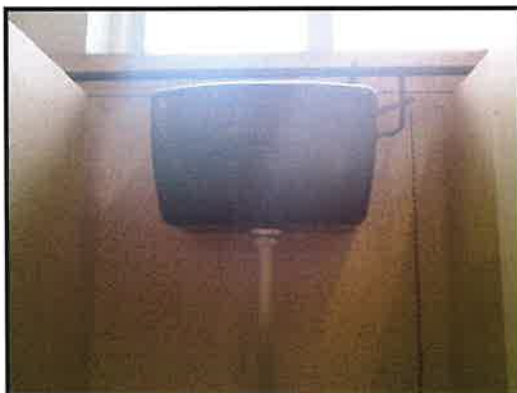
**SAMPLE REF NO:** S01

| Sample Ref. Nr. | Floor | Location | Description | Asbestos Type | Extent / Amount | Recommended Action |
|---|---|---|---|---|---|---|
| S01 | Ground | Male Toilets | Toilet Cistern | Amosite | 7 No. | Remove |

| <b>USE OF MATERIAL:</b> | Toilet Cistern | | | <b>ACCESSIBILITY ASSESSMENT:</b> | | | |
| <b>LOCATION</b> | Male Toilets | | | <b>EXTENT / QUANTITY:</b> | 7 No. | | |
| | CHRYSTOLITE: | 1 | | | LOW DAMAGE | 1 | ✓ |
| | AMOSITE: | 2 | ✓ | | MEDIUM DAMAGE | 2 | |
| | UNSEALED LAGGING / SPRAY COATING | 3 | | | VERY LOW RISK | 1 - 4 | ✓ |

| Site Ref | Lab Ref | Description | Analysis Result | Classification |
|---|---|---|---|---|
| 1. S01 | NI012308 | Male Toilets - Toilet cistern | Amosite | Reinforced Composite |

| <b>PRODUCT TYPE (tick)</b> | ASBESTOS REINFORCED COMPOSITES | 1 | ✓ | <b>RECOMMENDED ACTION (tick)</b> | REMOVE | | ✓ |

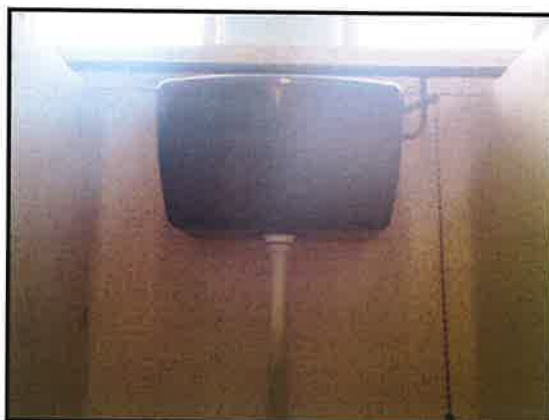
**SAMPLE REF NO:** S02

| Sample Ref. Nr. | Floor | Location | Description | Asbestos Type | Extent / Amount | Recommended Action |
|---|---|---|---|---|---|---|
| S02 | 1 <sup>st</sup> floor | Female Toilets | Toilet cisterns | Amosite | 8 No. | Remove |

| <b>USE OF MATERIAL:</b> | Toilet Cistern | | | <b>ACCESSIBILITY ASSESSMENT:</b> | | | |
| <b>LOCATION</b> | Female Toilets | | | <b>EXTENT / QUANTITY:</b> | 8 No. | | |
| | CHRYSTOTILE: | 1 | | | LOW DAMAGE | 1 | ✓ |
| | AMOSITE: | 2 | ✓ | | MEDIUM DAMAGE | 2 | |
| | UNSEALED LAGGING / SPRAY COATING | 3 | | | VERY LOW RISK | 1 - 4 | ✓ |

| Site Ref | Lab Ref | Description | Analysis Result | Classification |
|---|---|---|---|---|
| 2. S02 | NI012309 | Female Toilets - Toilet cistern | Amosite | Reinforced Composite |

| <b>PRODUCT TYPE (tick)</b> | ASBESTOS REINFORCED COMPOSITES | 1 | ✓ | <b>RECOMMENDED ACTION (tick)</b> | REMOVE | | ✓ |

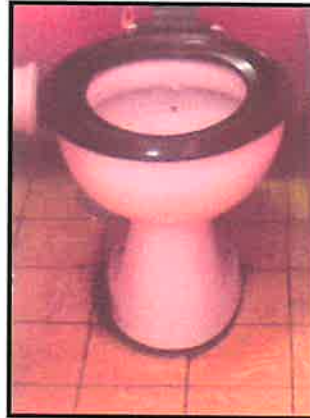
**SAMPLE REF NO:** S03

| <b>USE OF MATERIAL:</b> | Toilet Seat | | | <b>ACCESSIBILITY ASSESSMENT:</b> | | | |
| <b>ASBESTOS TYPE (tick)</b> | NON ASBESTOS | 0 | ✓ | <b>EXTENT OF DAMAGE / DETERIORATION (tick)</b> | GOOD CONDITION | 0 | |

| Site Ref | Lab Ref | Description | Analysis Result | Classification |
|---|---|---|---|---|
| 3. S03 | NI012310 | Male Toilets - Toilet seat | No Asbestos Detected | Not Applicable |
