# ASBESTOS REFURBISHMENT SURVEY REPORT

Tipperary FET College Roscrea

46108

| <b>Document Title</b> | Asbestos Refurbishment Report |

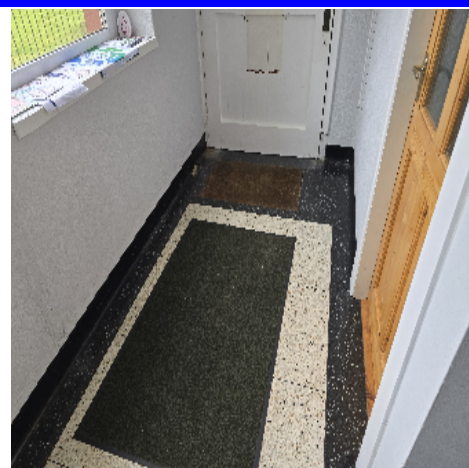
## Location Details : 158985 No Asbestos Found

Building/Area : Roscrea ETB  
Room/Section : Entrance  
Location : Floor Walls and Ceilings  
Description : Terazzo Floor Block Walls PB Ceilings  
Sample No. :  
Confirmation :  
Access : Full Access  
Normal Use : Access  
Recommendations :  
Notes :

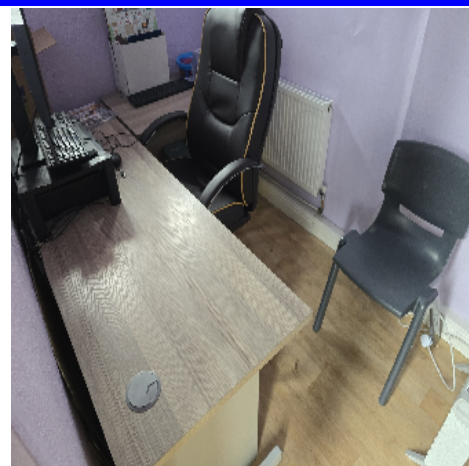
## Location Details : 158986 No Asbestos Found

Building/Area : Roscrea ETB  
Room/Section : Office  
Location : Floor Walls and Ceilings  
Description : Lino over Terazzo Floor Block Walls PB Ceilings  
Sample No. :  
Confirmation :  
Access : Full Access  
Normal Use : Access  
Recommendations :  
Notes :

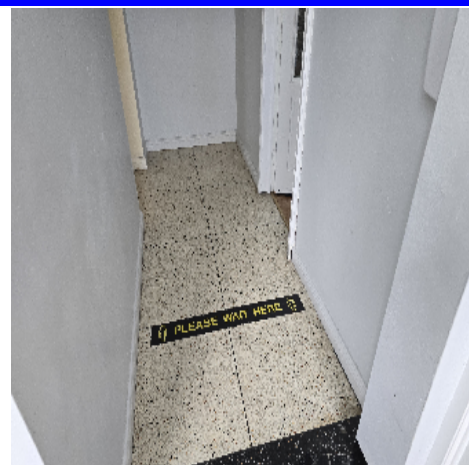
## Location Details : 158987 No Asbestos Found

Building/Area : Roscrea ETB  
Room/Section : Lobby  
Location : Floor Walls and Ceilings  
Description : Terazzo Floor Block Walls PB Ceilings  
Sample No. :  
Confirmation :  
Access : Full Access  
Normal Use : Access  
Recommendations :  
Notes :

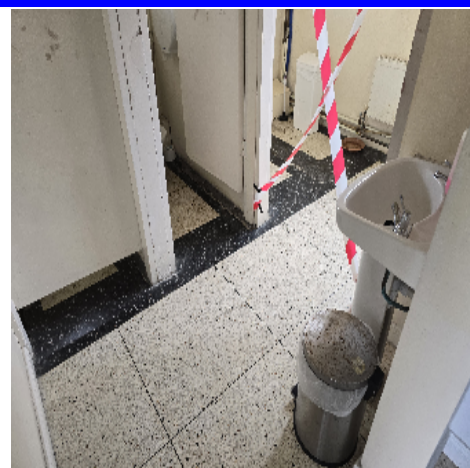
## Location Details : 158988 No Asbestos Found

Building/Area : Roscrea ETB  
Room/Section : Toilets  
Location : Floor Walls and Ceilings  
Description : Terazzo Floor Block Walls PB Ceilings  
Sample No. :  
Confirmation :  
Access : Full Access  
Normal Use : Access  
Recommendations :  
Notes :

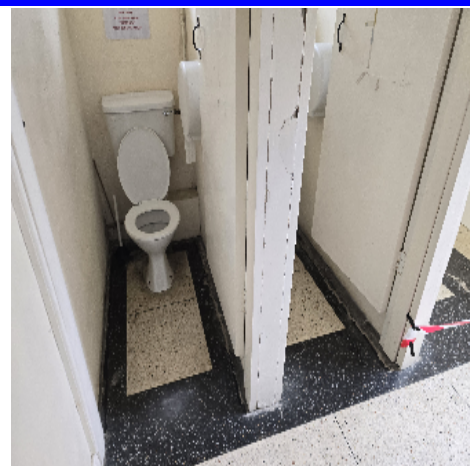
## Location Details : 158989 No Asbestos Found

Building/Area : Roscrea ETB  
Room/Section : Toilets  
Location : Floor Walls and Ceilings  
Description : Terazzo Floor Block Walls PB Ceilings  
Sample No. :  
Confirmation :  
Access : Full Access  
Normal Use : Access  
Recommendations :  
Notes :

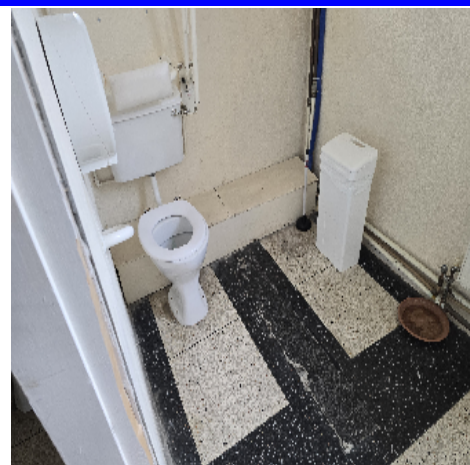
## Location Details : 158990 No Asbestos Found

Building/Area : Roscrea ETB  
Room/Section : Toilets  
Location : Floor Walls and Ceilings  
Description : Terazzo Floor Block Walls PB Ceilings  
Sample No. :  
Confirmation :  
Access : Full Access  
Normal Use : Access  
Recommendations :  
Notes :

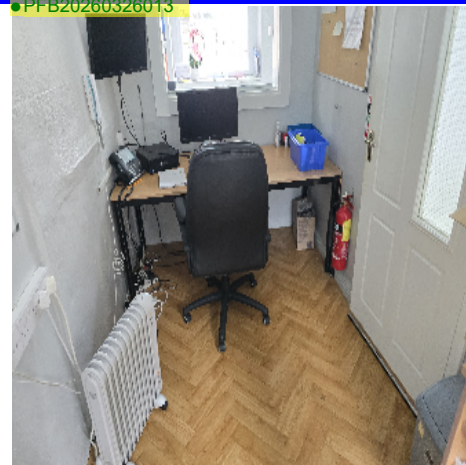
## Location Details : 158991 No Asbestos Found

Building/Area : Roscrea ETB  
Room/Section : Office  
Location : Floor  
Description : Lino  
Sample No. : PFB20260326013  
Confirmation :  
Access : Full Access  
Normal Use : Access  
Recommendations :  
Notes :

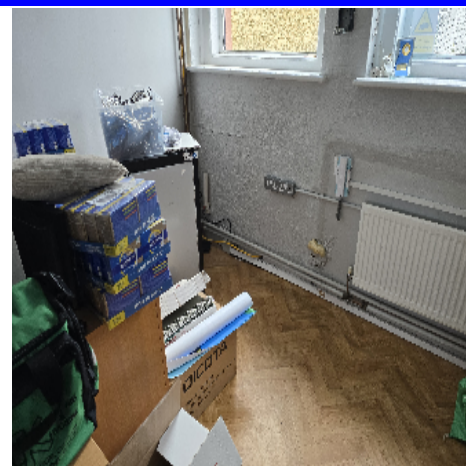
## Location Details : 158992 No Asbestos Found

Building/Area : Roscrea ETB  
Room/Section : Office  
Location : Floor Walls and Ceilings  
Description : Lino over Terazzo Floor Block Walls PB Ceilings  
Sample No. :  
Confirmation :  
Access : Full Access  
Normal Use : Access  
Recommendations :  
Notes :

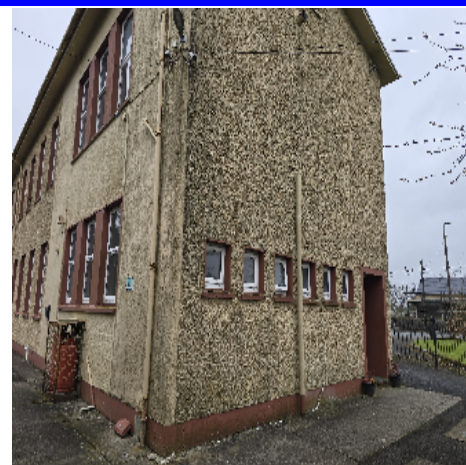
## Location Details : 158993 No Asbestos Found

Building/Area : Roscrea ETB  
Room/Section : External Facade  
Location : Walls and roof  
Description : PVC Windows rendered walls  
Sample No. :  
Confirmation :  
Access : Full Access  
Normal Use : Access  
Recommendations :  
Notes :
