# SKIBBEREEN STEAM MILL

## INFORMATION PACK

## INSPECTION REPORT

### Re: The Old Steam Mill, Skibbereen, Co. Cork.

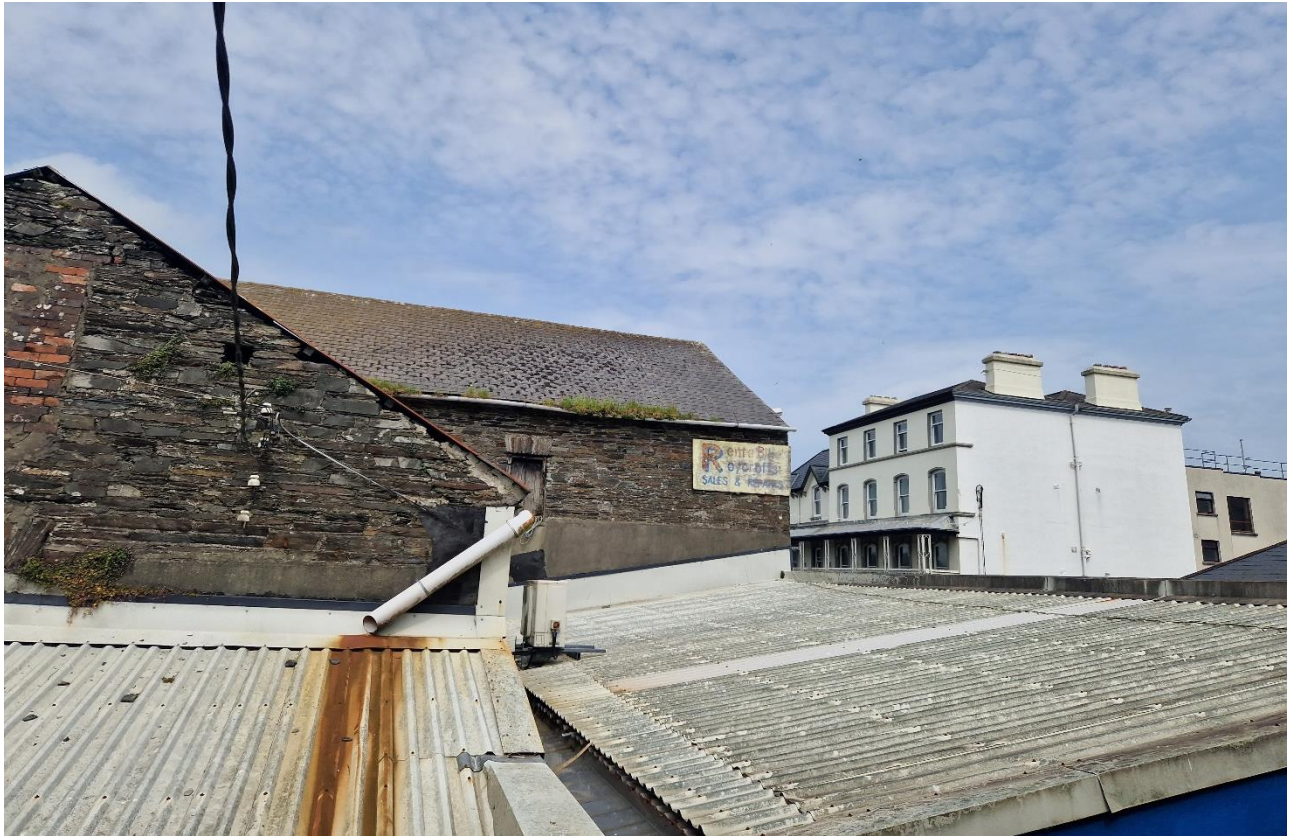
The guttering at the south is full of vegetation, which allows water to spill down the face of the building and actively decays the timber girder ends.

*Figure 1. Highlights the heavy vegetation growing from the gutter, causing water to cascade down the face of the building.*

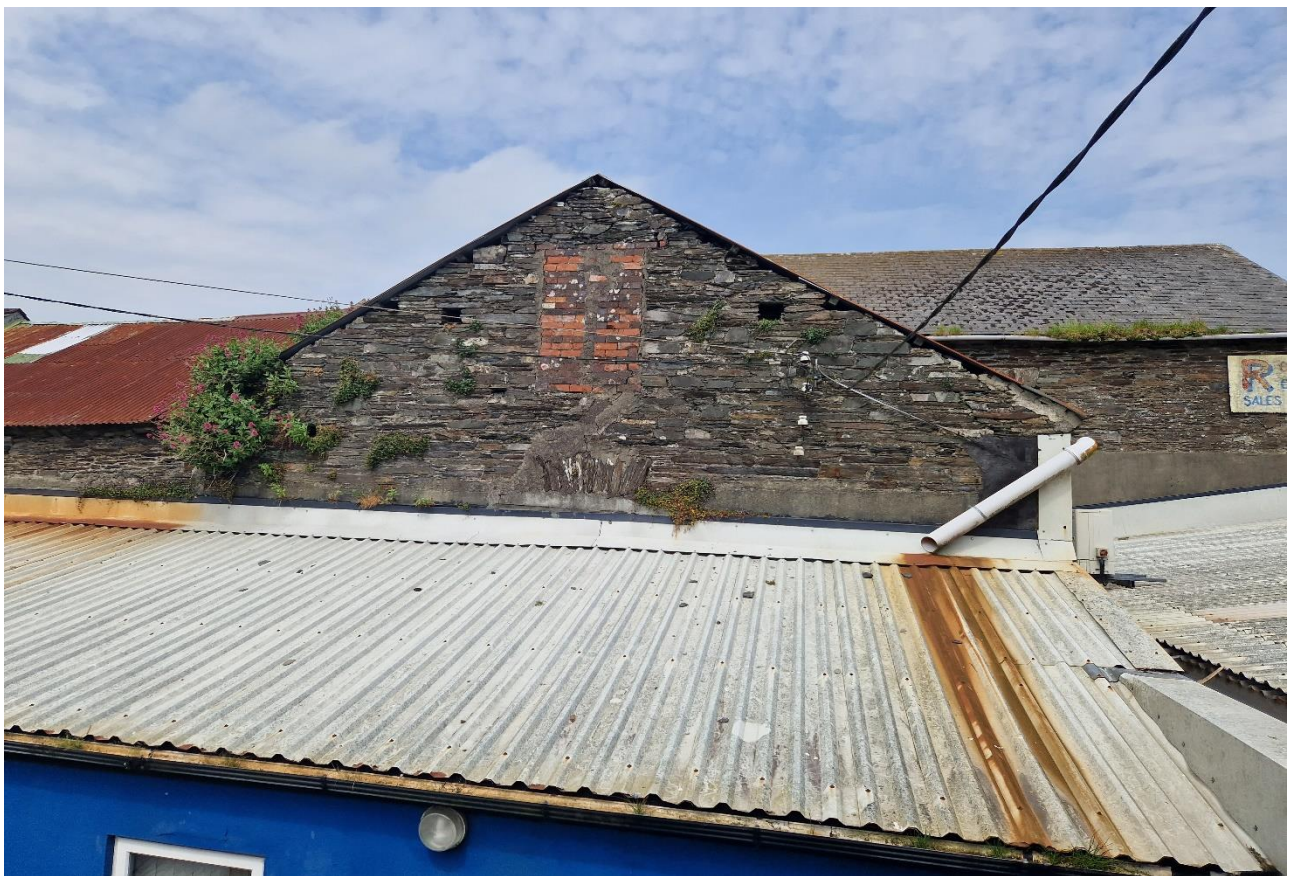
*Figure 2. This highlights the poor condition of the south-facing gable.*

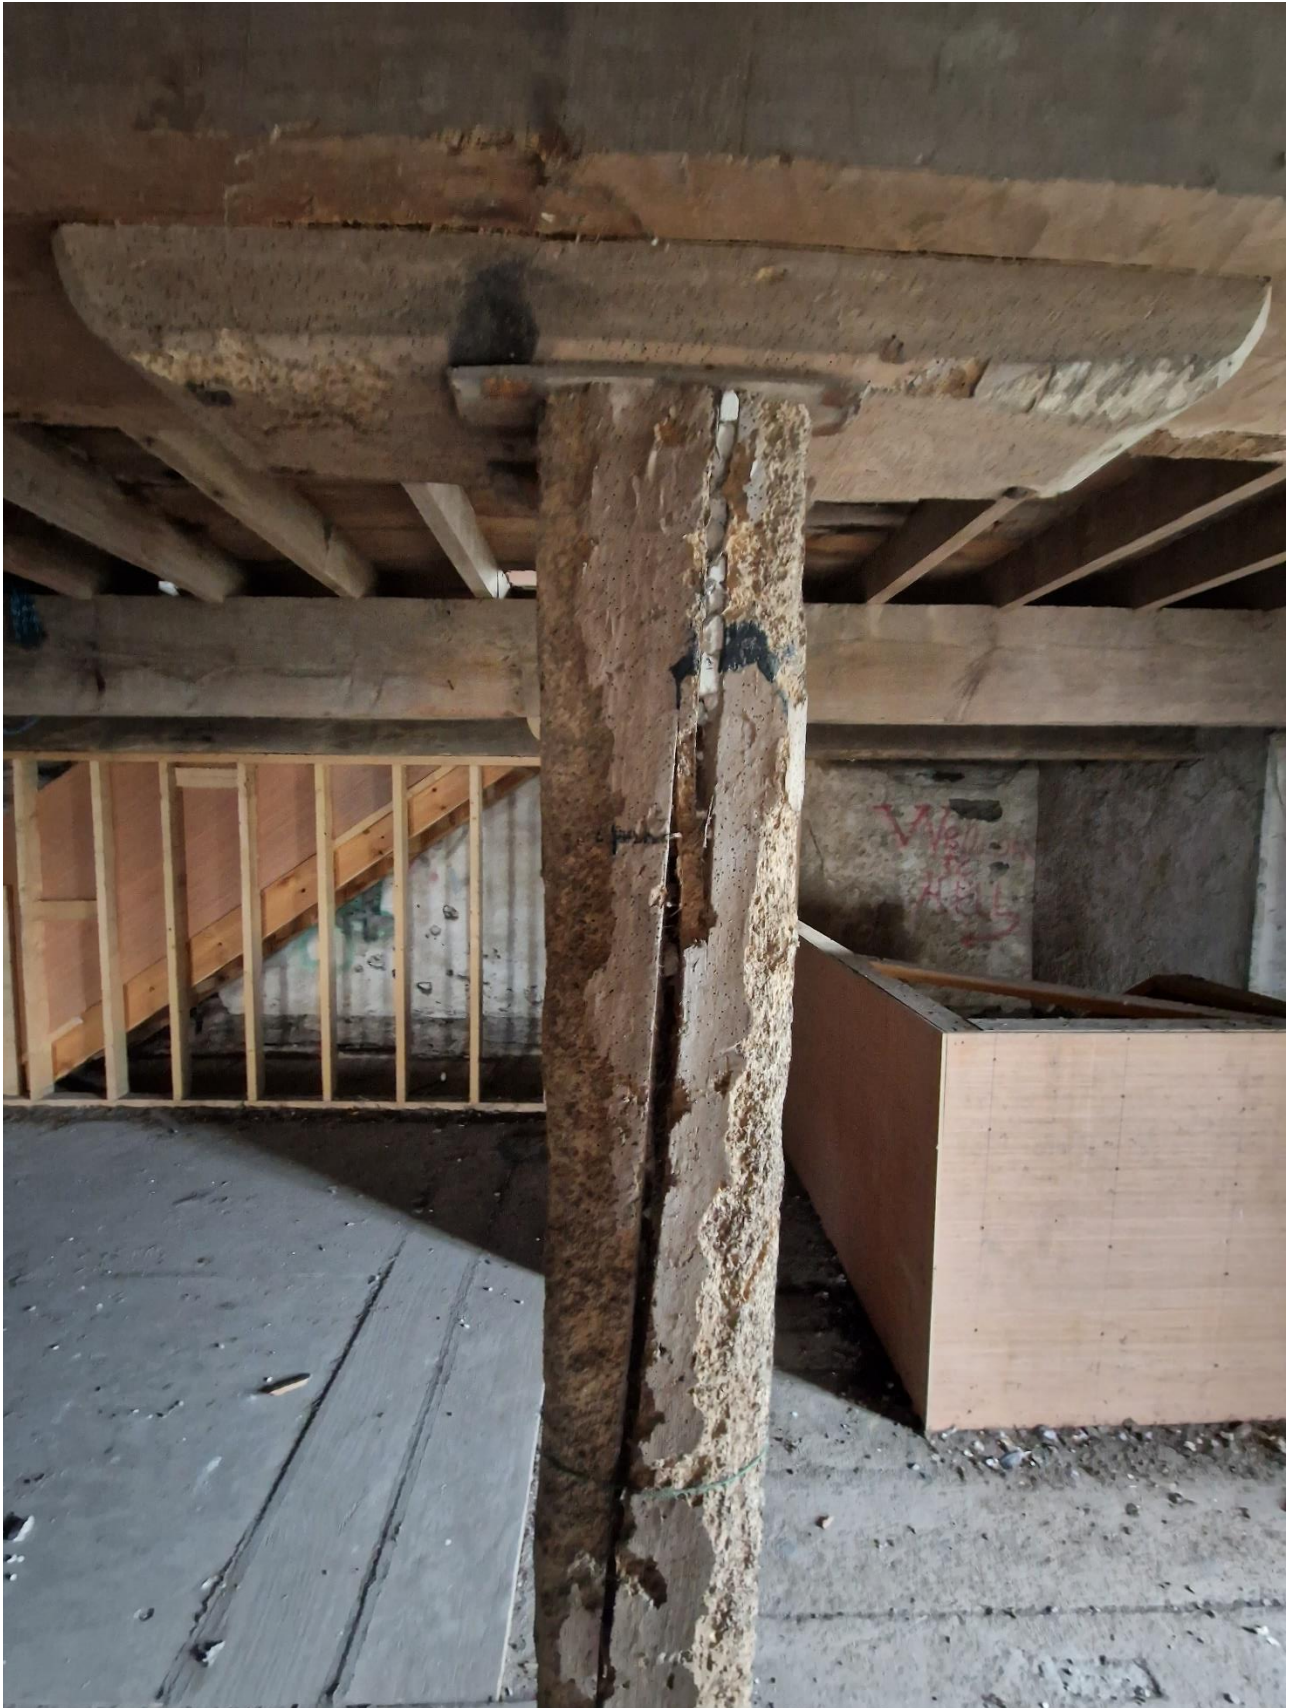
Many Samson Posts (breaking the span of the girders) have heavy decay from woodworm but all have enough healthy remaining timber to be retained. The base of the posts in contact with the ground has heavier decay and can be supplemented in the short term.

*Figure 3. Shows heavy surface deterioration from active woodworm infestation. There is currently enough remaining timber for this post.*

The posts made from unconverted timber (log) should be replaced when appropriate.

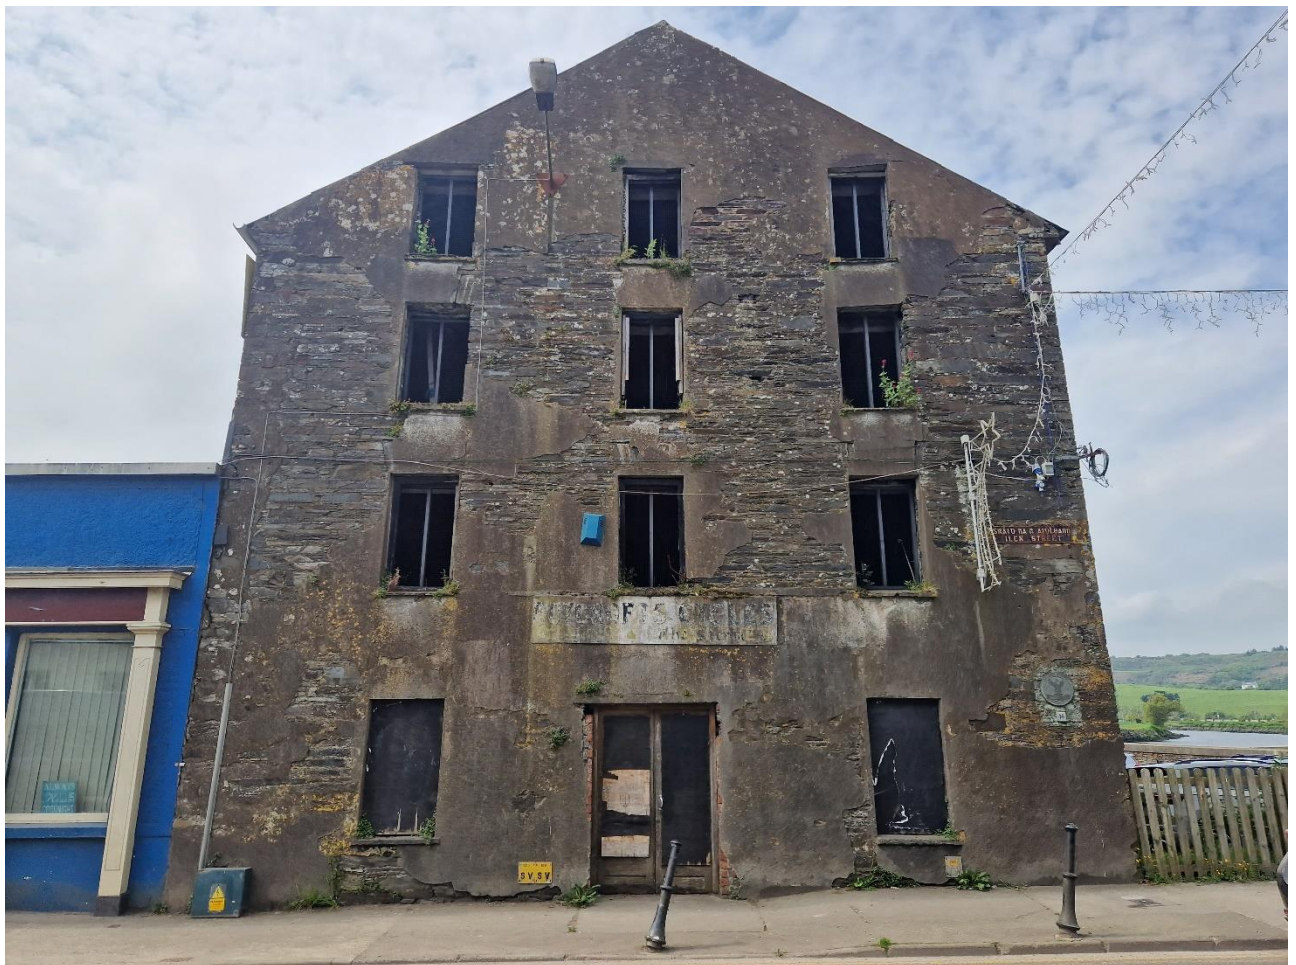
We have recorded that the majority of the timber lintels have heavy decay present and should be replaced as per the engineers' detail. We noted some healthy lintels along the north elevation, which can be retained.

*Figure 4. Shows the main gable fronted elevation of the building. Note that as there are no windows present, water penetrates and decays the lintels. Most lintels on this elevation have decay present.*

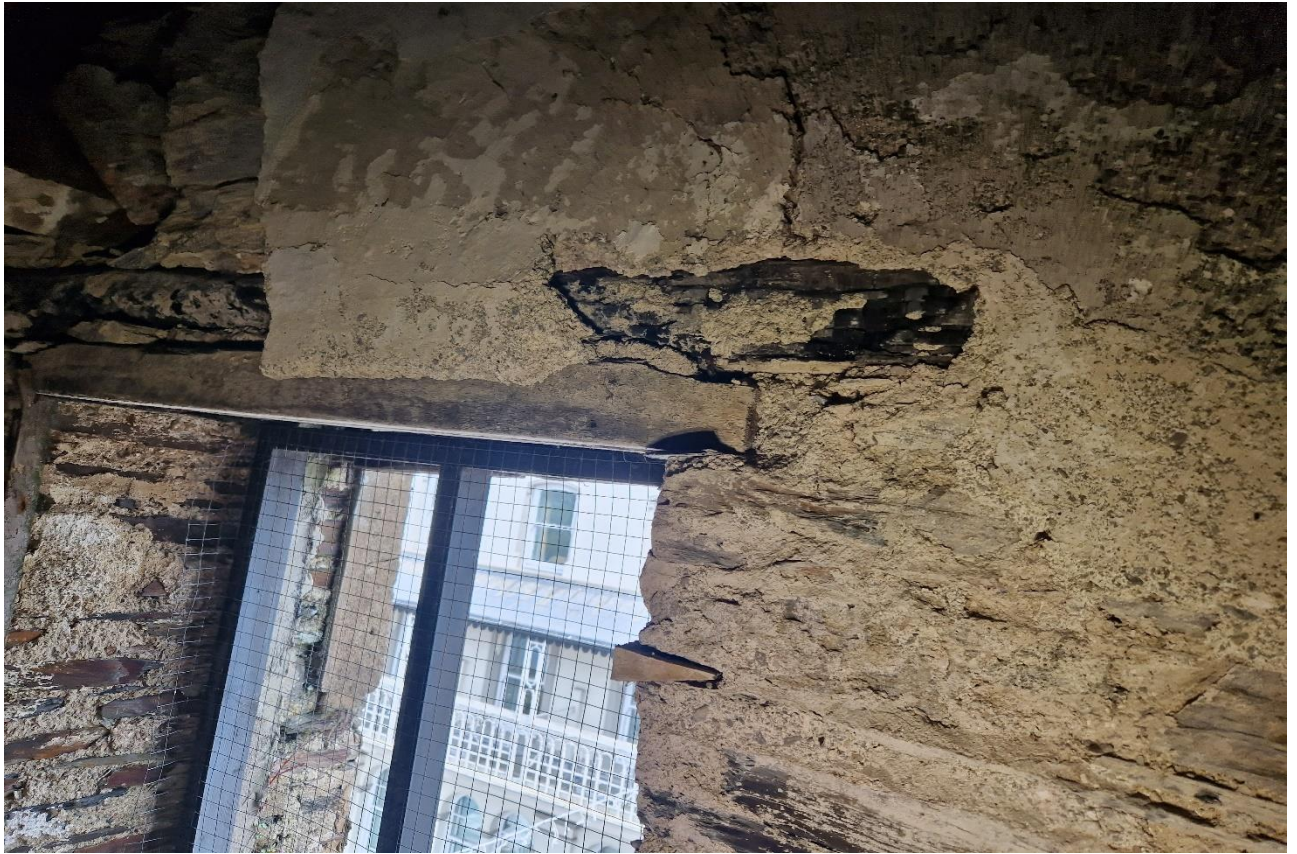
*Figure 5. Shows a double lintel at the third-floor level. Note the upper lintel has fire damage.*

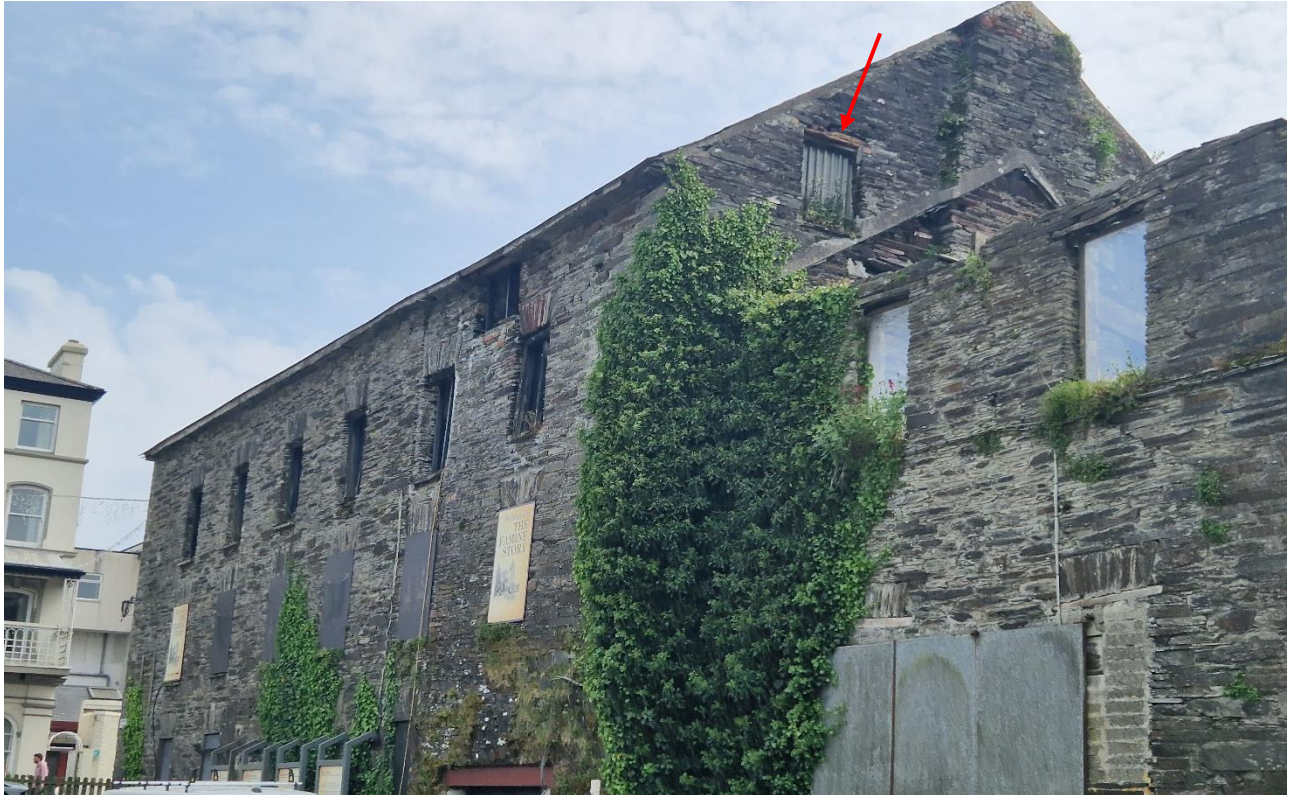
Two internal lintels between the main mill and the south annexe have failed, resulting in structural movement. The timber lintel on the west gable on the north side is in poor condition, and failure is forthcoming.

*Figure 6. It highlights the poor condition of the exposed lintel on the north of the west gable that should be replaced.*

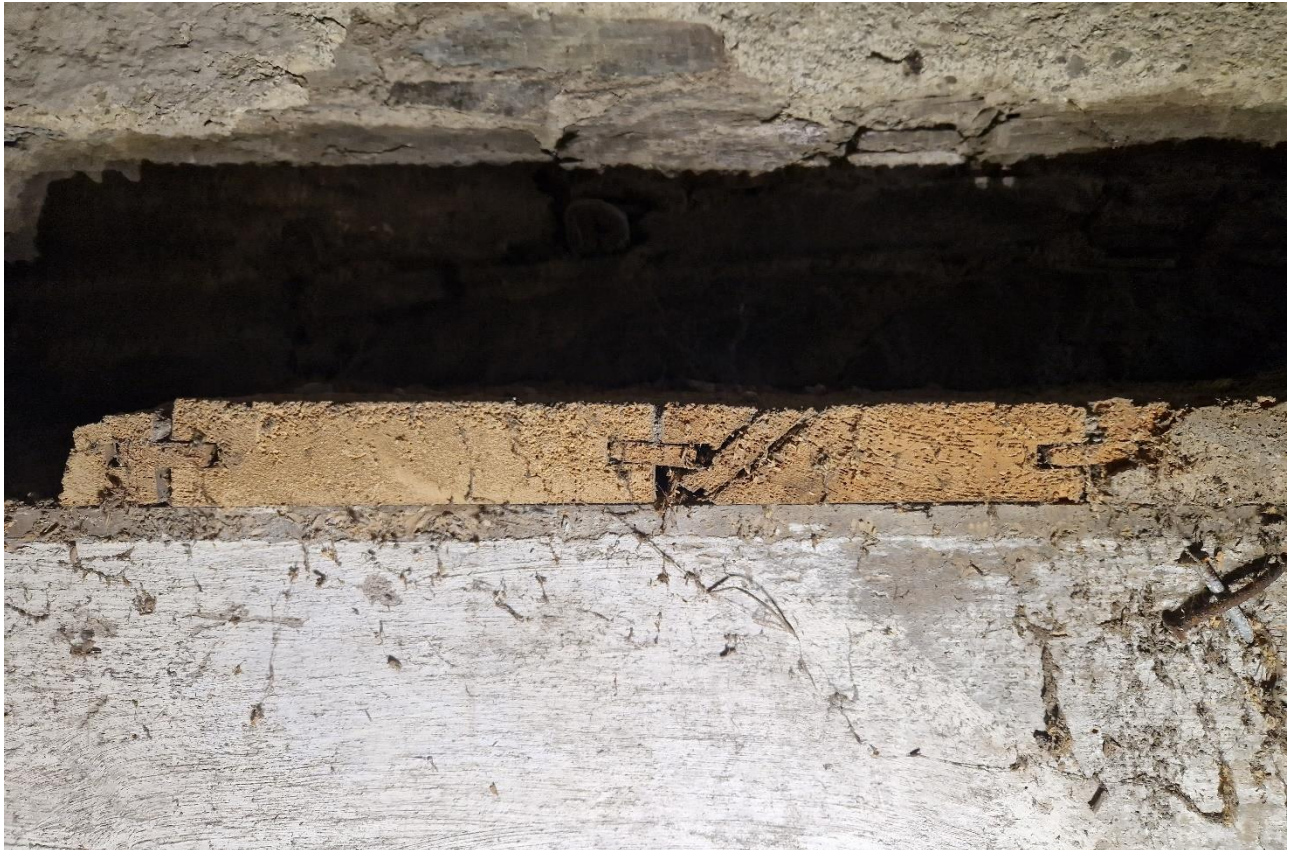
*Figure 7. Shows a section through the 'heavy' section floorboards. Note the heavy tunnelling from furniture beetle.*

We suggest that all light floorboards be entirely replaced and that the vast majority of the heavy boards be retained (subject to review on proposed loading).

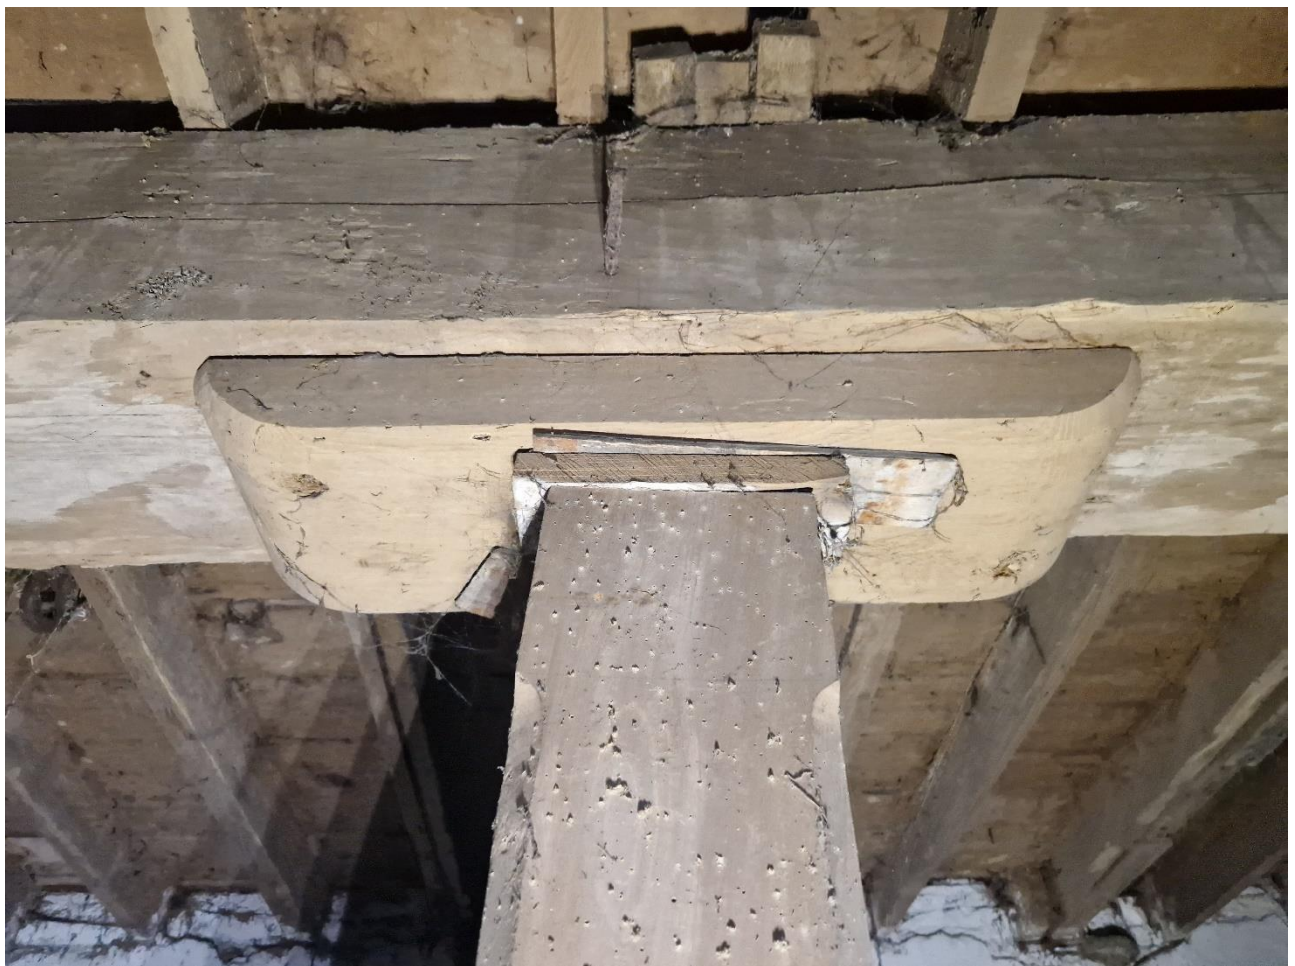
Several posts have heavy decay, but in our view, there is enough healthy timber remaining to be retained.

Some posts installed later are poor, and the posts in contact with the ground floor have heavier decay present.

*Figure 8. Shows a typical post arrangement.*

Allow for the cutting back of all badly decayed posts and the fitting of a steel shoe/base plate detail to the bottom of the remaining section.

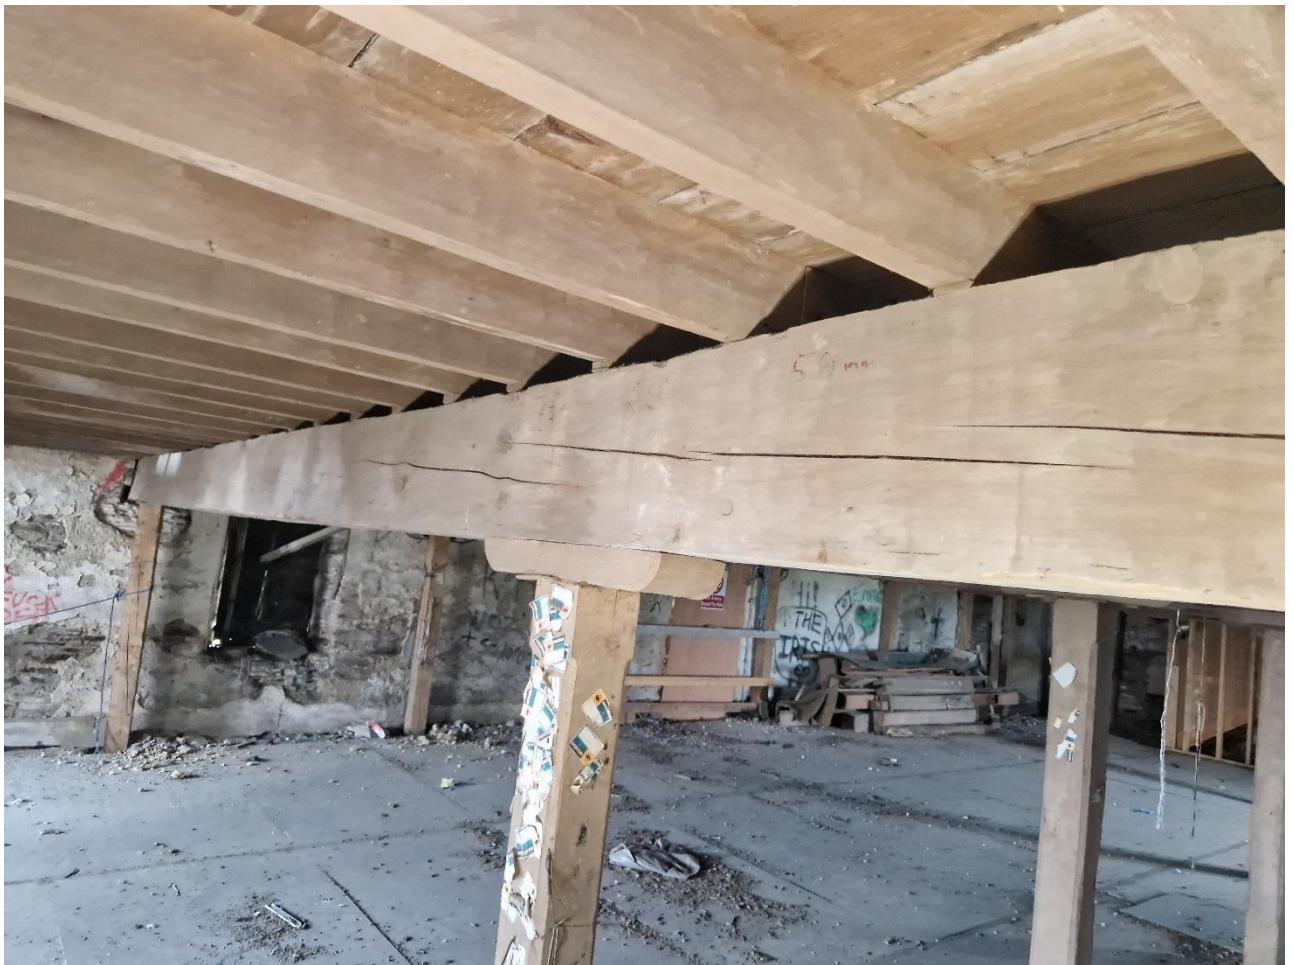
The timber girders are in reasonable overall condition, with some minor deflection noted. The main span of the girders are healthy, all with signs of active woodworm. We do not have concerns about significant deterioration as a result of the beetle attack.

The bearing ends vary in condition, and several are healthy. A number of the bearing ends have heavy decay and require a steel splice detail. Some have dose present from being in contact with damp masonry over a long period of timber with more actively decaying due to water penetration.

*Figure 9. Shows a typical girder. Note the shake in the timber along the grain. This has little weakening of the timber section.*

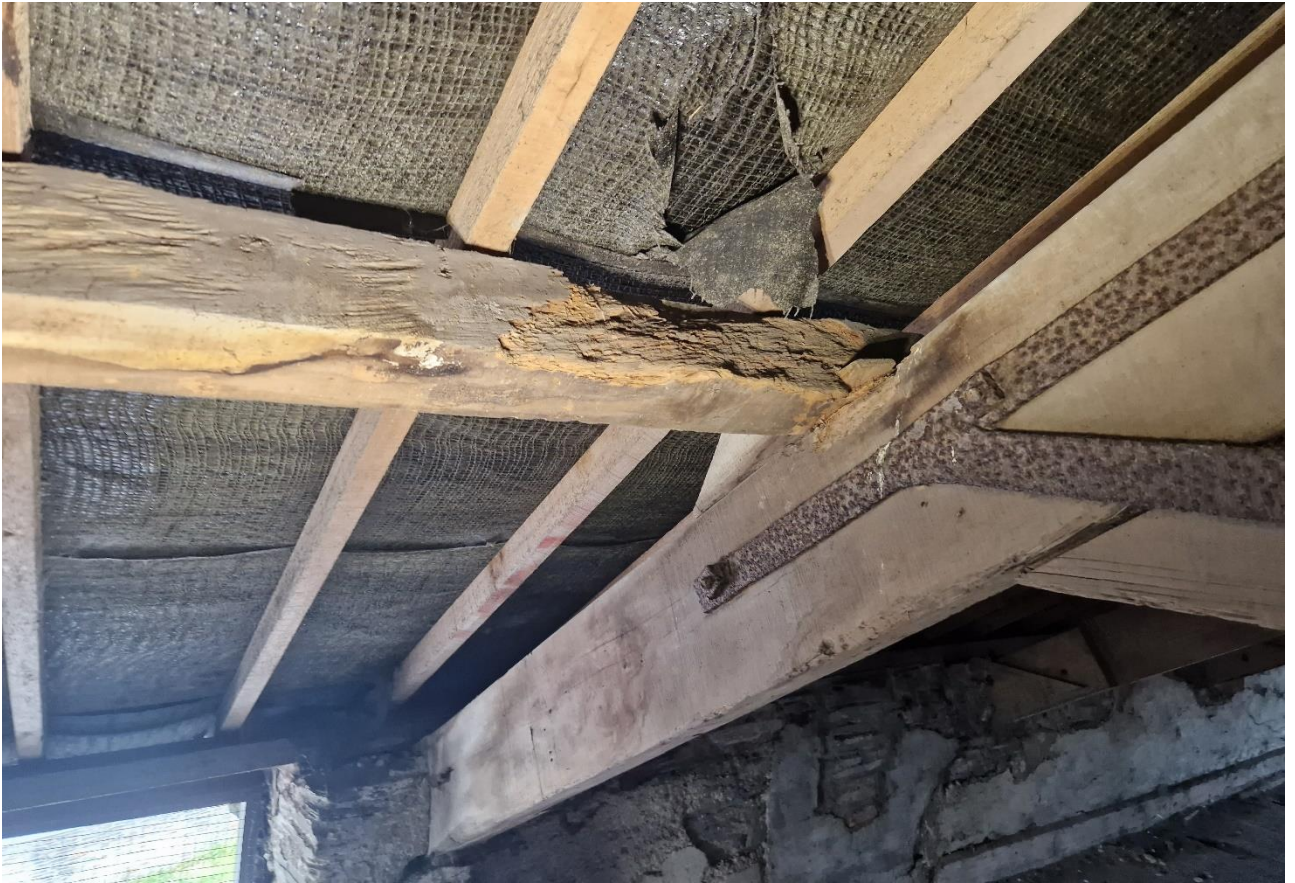
The trusses are off-plumb along the centre of the truss, which is most notable at the front (east) of the building. The purlin embedded in the front gable wall shows that it has moved at some point, which should be considered part of any repair.

*Figure 11. Shows deterioration of a purlin connection.*

Allow two of the purlin connections to be improved as part of any roofing repair work.

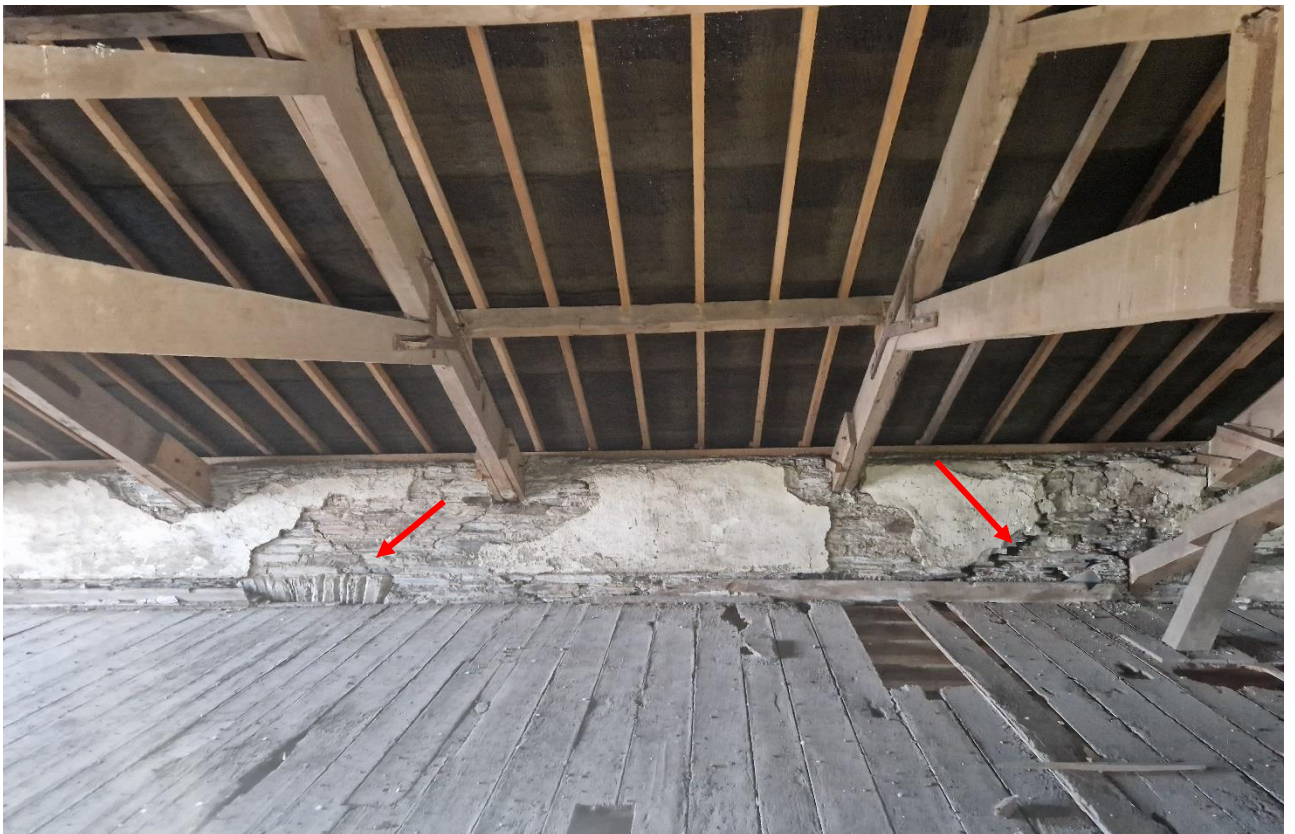
*Figure 12. Shows a broad view of the roof detail. Note the masonry deflection where the lintel/arch failed.*

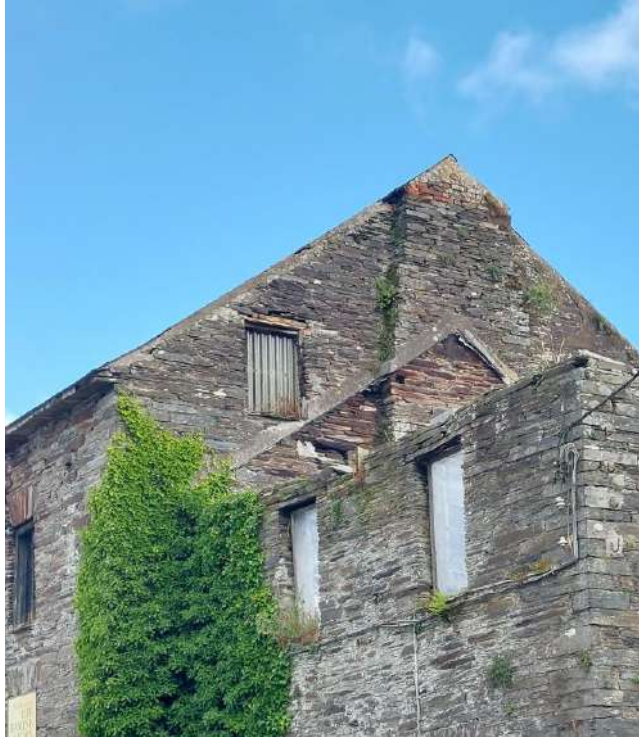
*Fig 3.17: West elevation: eroded joints and cracking visible to north west corner, along with a significant amount of ivy growth.*

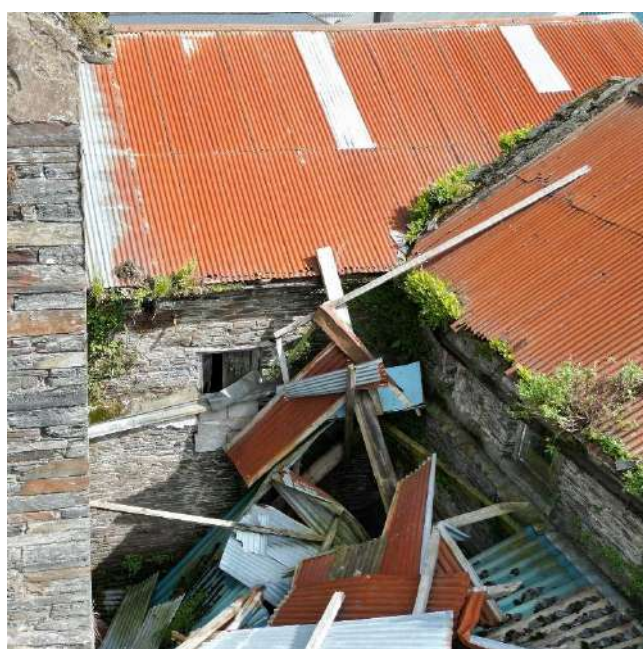
*Fig 3.23: West wall of south annex with adjoining failed roof structure*

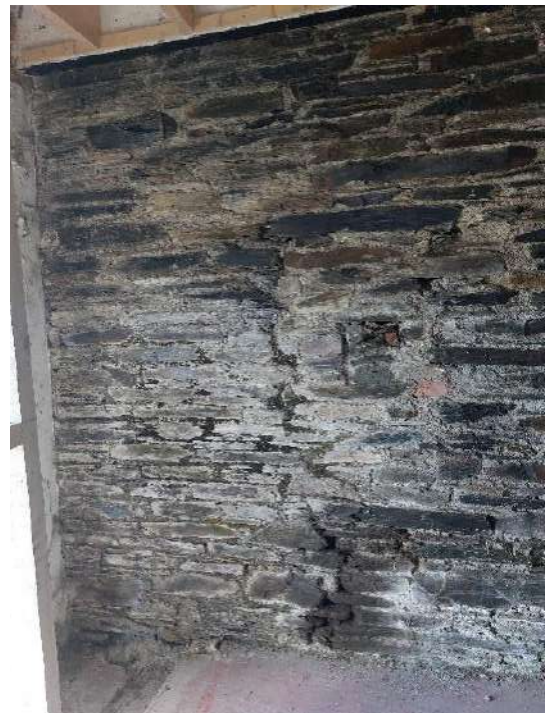
*Fig 3.52: Some cracking visible to partition wall between main volume and west room.*

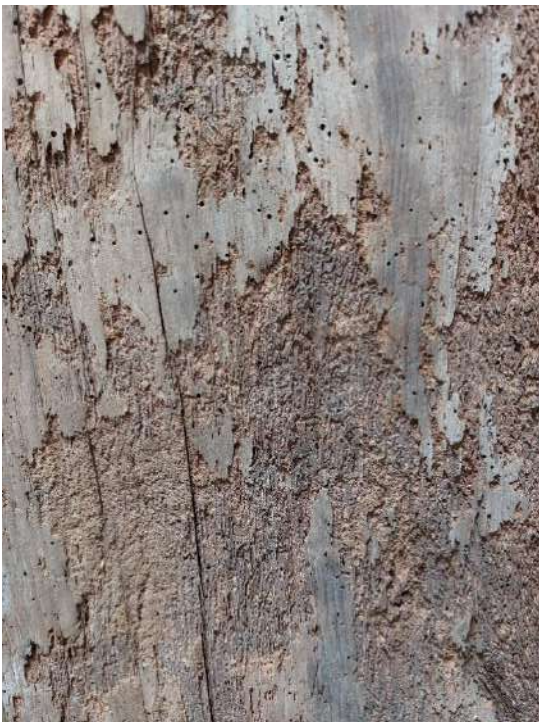
*Fig 3.70 Detail of woodworm damage to beam*

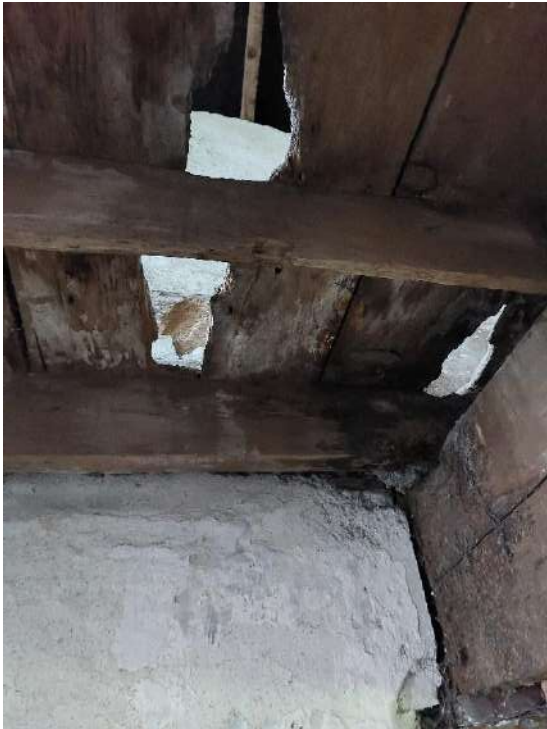
*Fig 3.71: Boards forming ceiling very heavily decayed.*

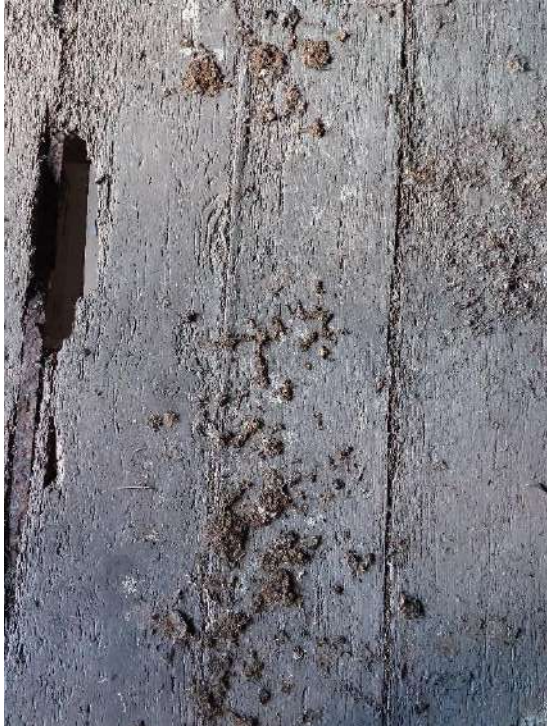
*Fig 3.80: Heavy decay to timber floorboards*

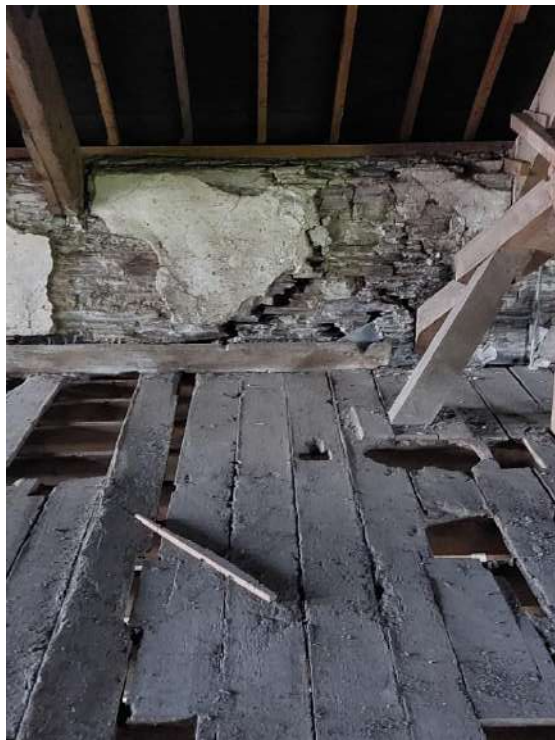
*Fig 3.81: View of cracking to south wall which appears to be associated with the south annex.*

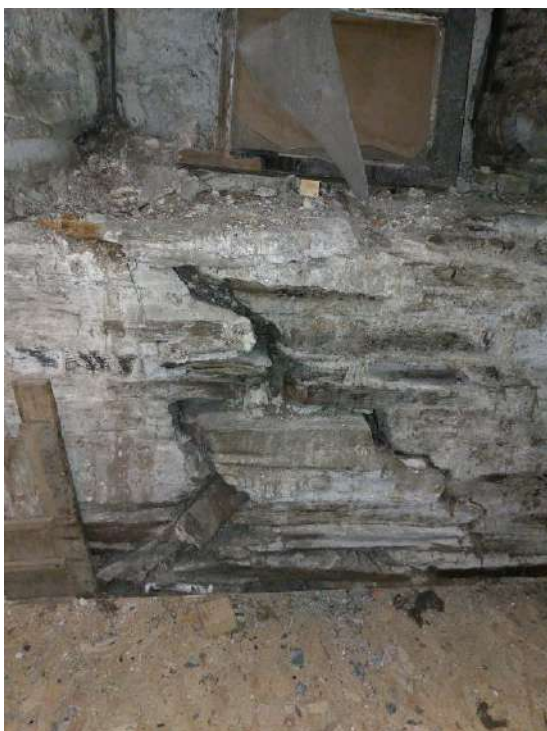
*Fig 3.93. Cracking to south gable wall between openings*

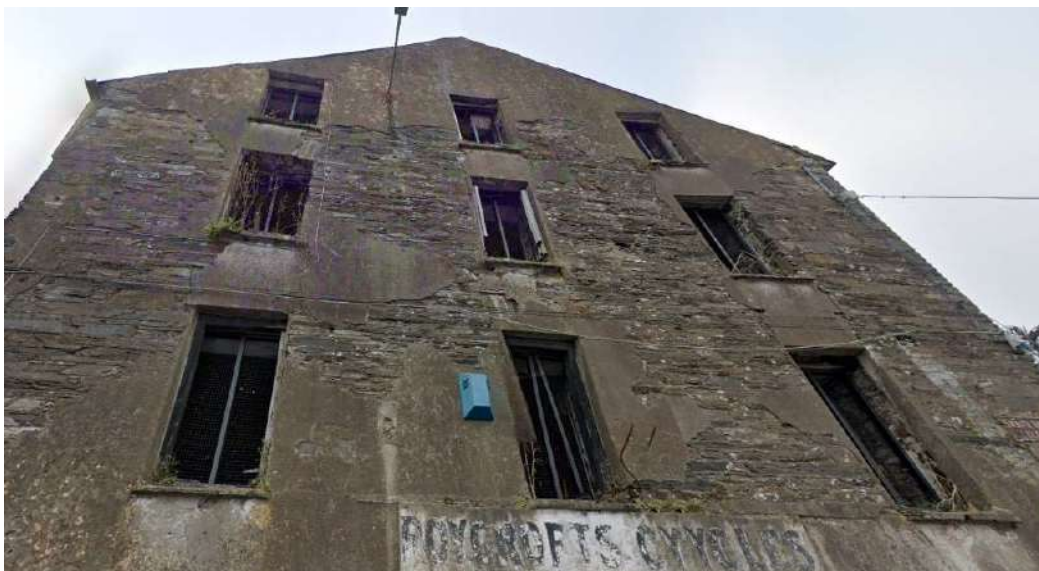
*Photo 7 – Eastern gable out of plumb*

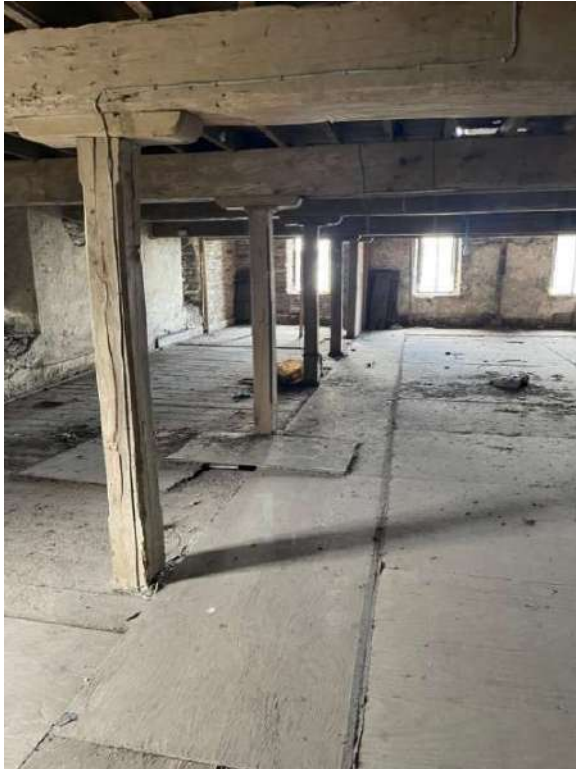
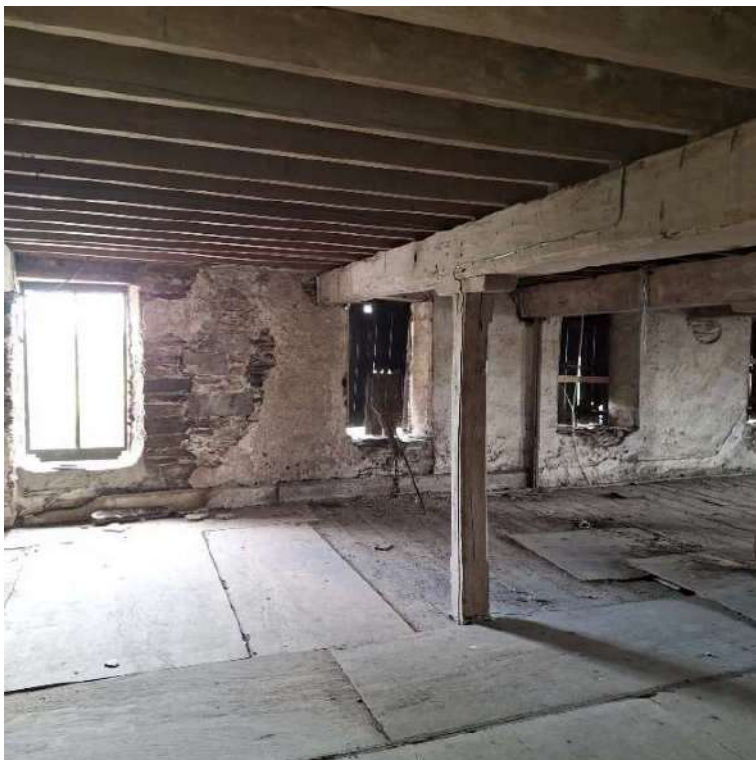
On the second floor the floorboards are 90% failure and in poor condition. The floor joists are in poor condition, especially where they abut the walls and these need to be replaced. The beams and columns are in good condition.

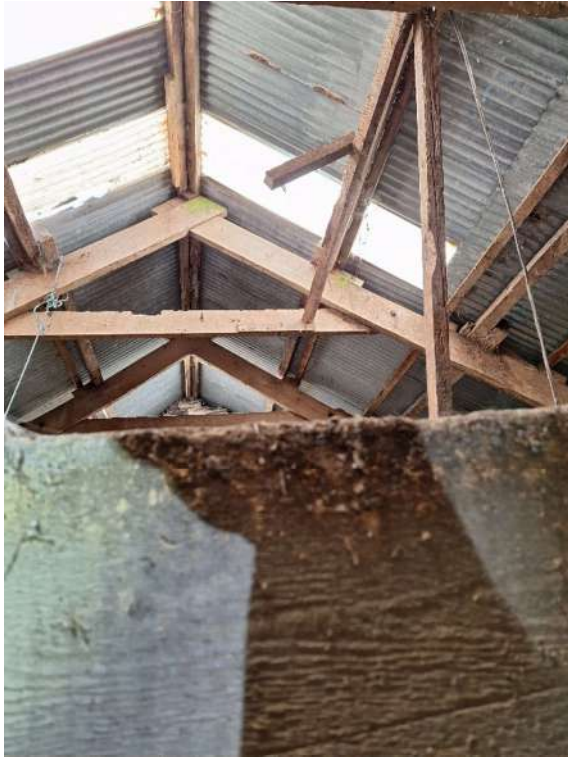
The annex to the south of the building is in much poorer condition than the main warehouse. The corrugated steel roof is in poor condition and needs to be replaced. Approximately 50% of the roof truss is in poor condition due to damp and decay and will need to be replaced in its entirety. This was not visible externally.

*Photo 17 – Corrugated roof and timber truss*

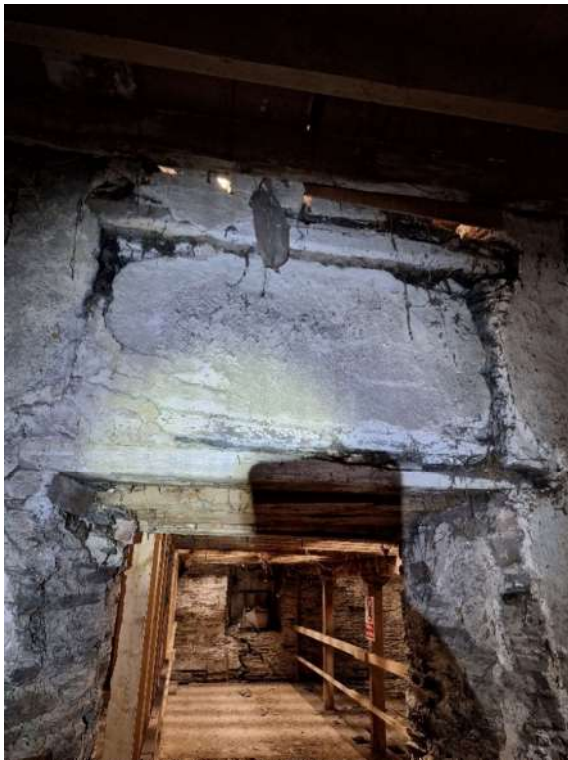
The external walls are generally in good condition. The east facing wall is in good condition and the gable wall to the south is in good condition. However, there is major structural failure due to failure of one of the timber lintels to the south wall of the annex. The west facing wall is in bad condition and will have to be replaced in its entirety.

*Photo 18 – Failed lintel*

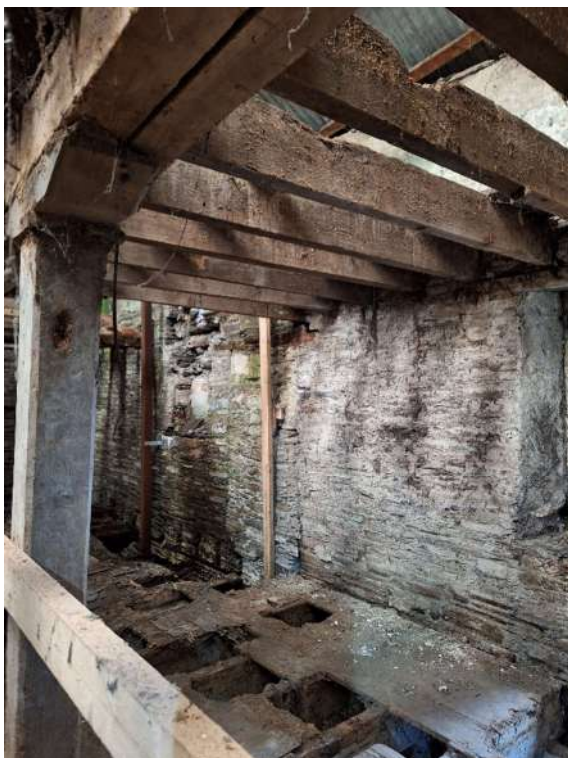
*Photo 19 – West facing wall requiring replacement*
