# **Underwater Inspection Report**

## **Knightstown Breakwaters**

### **Mooring Inspection**

### **April 2026**

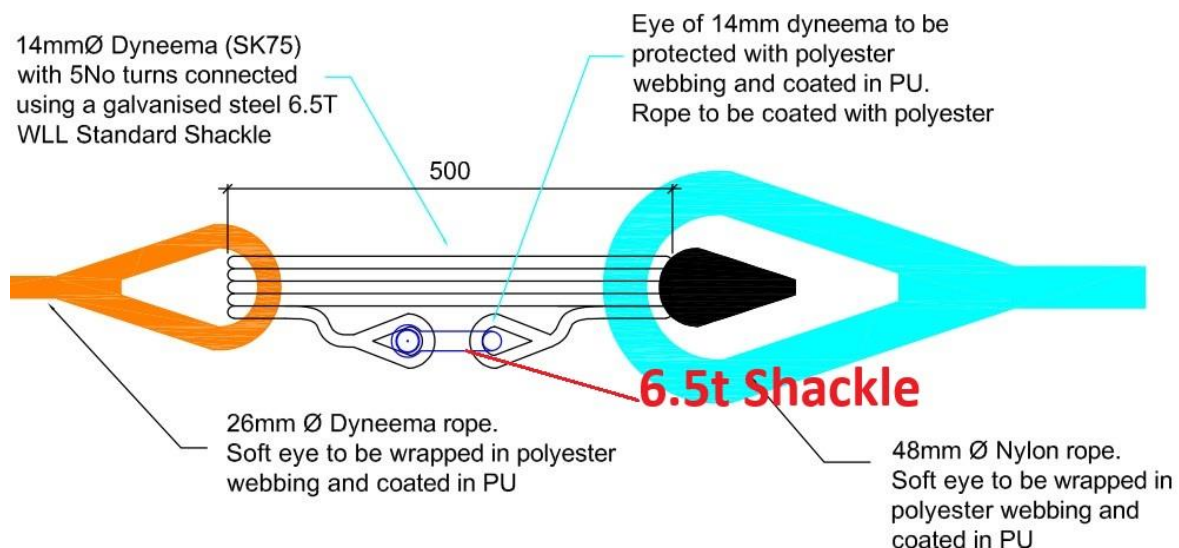
A significant development is the deteriorating condition of the 6.5t shackles connecting the eyes of the 14mm Dyneema whip.

Figure 3 Diagrammatic illustration showing location of 6.5t shackle

At least fifty percent of the shackles on leg b and leg c were buried and not accessible To the working diver with another twenty percent with with in excess of ninety percent wear to the shackle. The dyneema whip between both eyes appeared to be in fair - good condition with heavy growth.

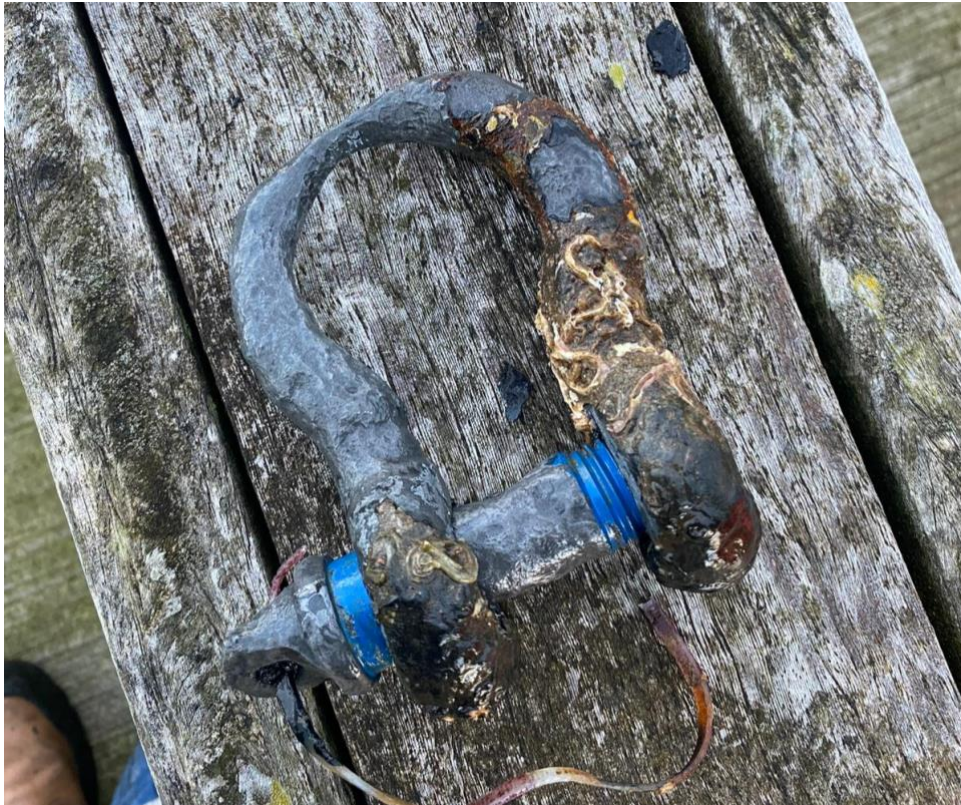
Figure 4 Example of 6.5t shackle with 90% depletion i

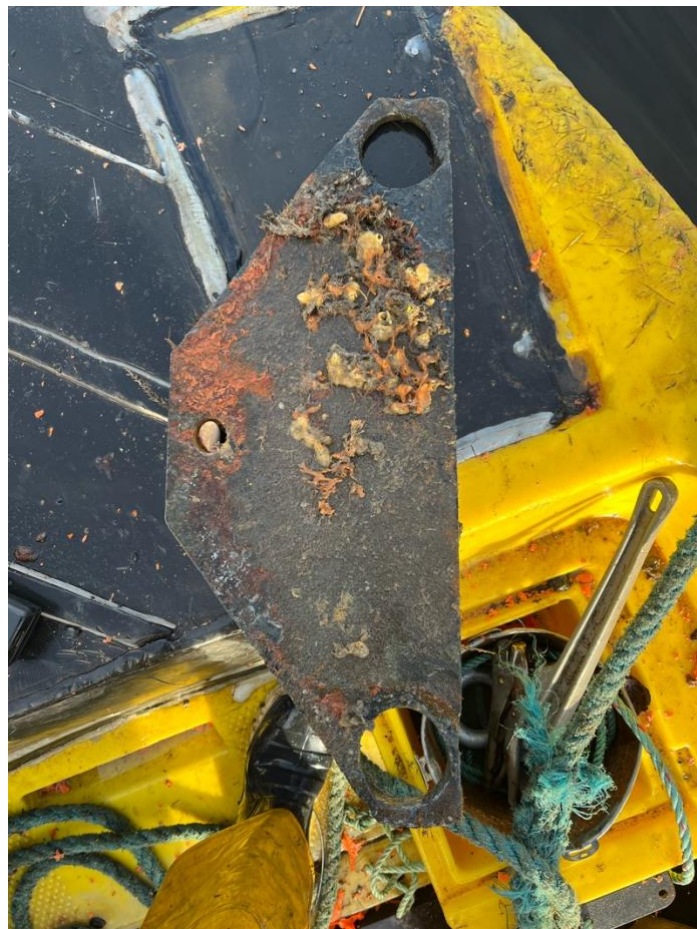
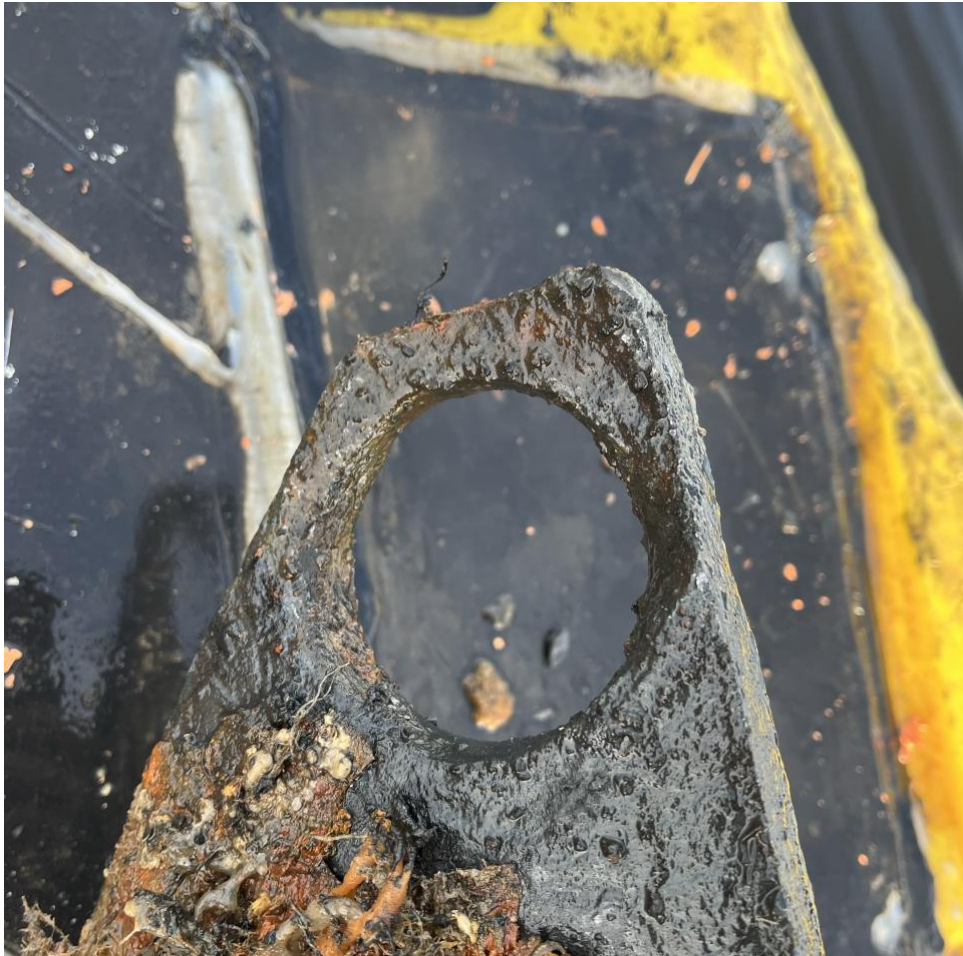
Figure 5 And 6 angel weight plate and evidence of elongation

The angel weight plates are experiencing significant deterioration. There is heavy elongation of the holes in the plates, which is likely due to repeated point loading from shackles. This elongation, combined with accelerating wear on both the plates and the shackles, indicates that the structural integrity of the angel plates is being compromised. The damage is further evidenced by the deformation visible in Figures 5 and 6, which show how the plates have been affected over time. Continuous use and heavy loading are contributing to this wear, making it a critical area for maintenance and monitoring.

Additionally, it should be noted that the holes in the angel weight plates are positioned too close to the edge. This lack of sufficient material around the holes leaves inadequate room for natural wear, which not only compromises the plate integrity but also accelerates the wear on the shackles themselves. As a result, the combined effect of hole placement and heavy loading is exacerbating the overall deterioration of both components.
