**Windows Restoration Works at Ormonde College,  
Ormonde Road, Kilkenny for Kilkenny and Carlow Education and  
Training Board**

**WINDOW CONDITION SURVEY AND SCHEDULE OF  
WORKS**

**August 2024**

**Job No. 23085**

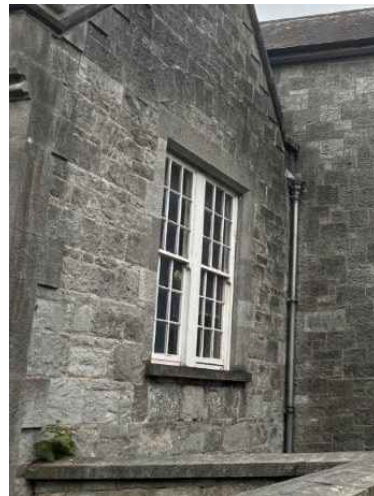
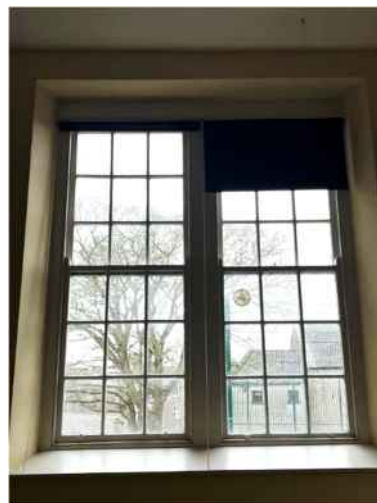
G01 (1no window)

**Condition:** Glazing putty is cracked; paint to frame and sashes is flaking/missing in areas; decay in frame and sash at cill; gaps around frame.

**Recommendations:** Replace decayed sections of timber cill and bottom rail; re-use existing glazing and re-putty all glazing; strip, prime, undercoat and repaint frame and sashes, internally and externally; re-draught-proof with new draught seals; adjust sash cords & weights and replace where necessary; maintain and clean all ironmongery, reinstate lime mortar seal to gap around window frame.

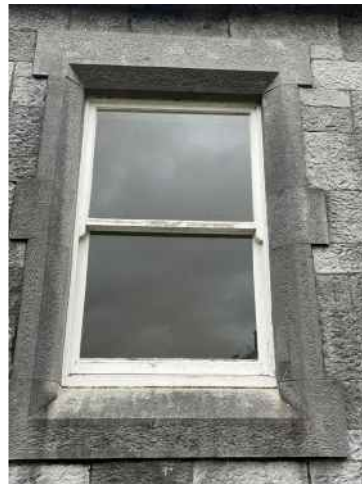
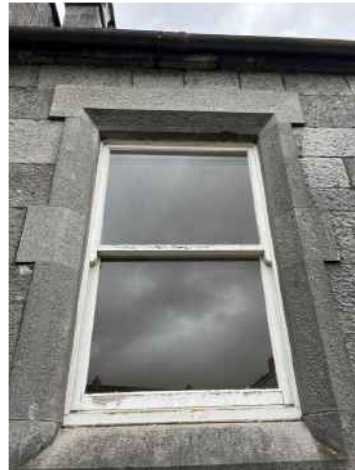
G02 and G03 (2no windows)

**Condition:** Glazing putty is cracked; paint to frame and sashes is flaking/missing in areas; previously repaired with decay in frame and sash at cill; lime mortar pointing around frames poor.

**Recommendations:** Replace decayed sections of timber cill and bottom rail; re-use existing glazing and re-putty all glazing; strip, prime, undercoat and repaint frame and sashes, internally and externally; re-draught-proof with new draught seals; adjust sash cords & weights and replace where necessary; maintain and clean all ironmongery, reinstate with new lime mortar seal to gap around window frame.

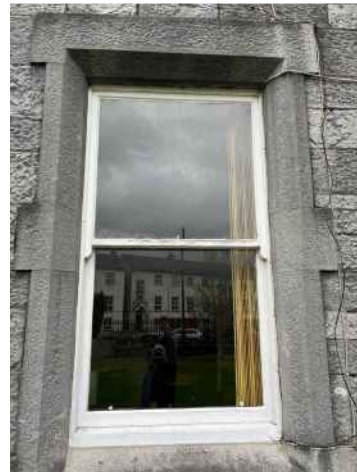
**Condition:** Glazing putty is cracked and missing in areas; paint to frame and sashes is flaking/missing in areas; significant decay in some frames and sashes at cill; ironmongery poor in some areas.

**Note:** Electrical cables penetrate corner of window frame.

**Recommendations:** Replace decayed sections of timber cill and frame; re-use existing glazing and re-putty all glazing; strip, prime, undercoat and repaint frame and sashes, internally and externally; re-draught-proof with new draught seals; adjust sash cords & weights and replace where necessary; maintain and clean all ironmongery and replace where damaged; reinstate with new lime mortar seal to gap around window frame.

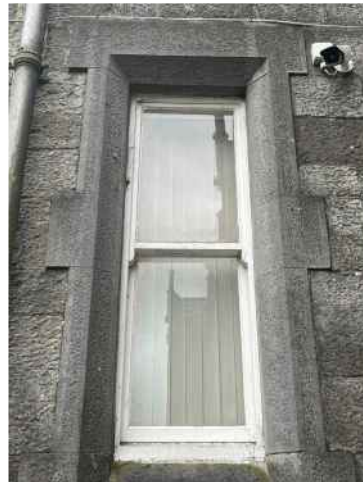
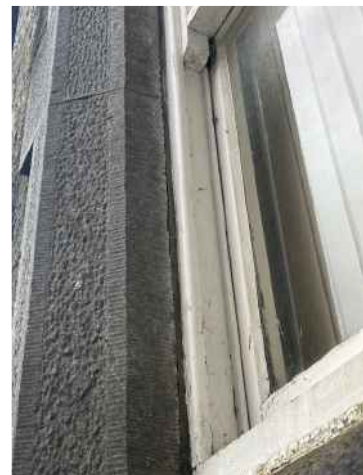
G09 (1no window)

**Type:** 1 over 1 timber-framed, single-glazed, vertical sliding sashes, painted white.**Condition:** Glazing putty is reasonably good; paint to frame and sashes also good; no obvious decay to frame and sashes; ironmongery good.**Recommendations:** Re-use existing glazing and re-putty all glazing; clean and repaint frame and sashes, internally and externally; re-draught-proof with new draught seals; adjust sash cords & weights and replace where necessary; maintain and clean all ironmongery and replace where necessary; reinstate new lime mortar seal to gap around window frame.

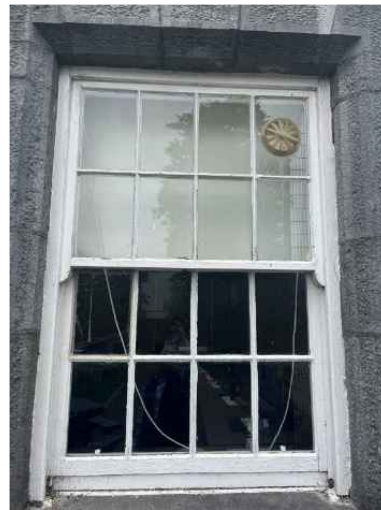
Window G46

**Condition:** Glazing putty is cracked; paint to frame and sashes is flaking/missing; decay in frame and sash at cill; corrosion of nails to frame cover slips (G47), gaps around frame.

**Recommendations:** Replace decayed sections of timber cill and bottom rail; re-use existing glazing and re-putty all glazing; strip, prime, undercoat and repaint frame and sashes, internally and externally; re-seal and draught-proof with new draught seals; adjust sash cords & weights and replace where necessary; maintain and clean all ironmongery, reinstate lime mortar seal to gap around window frame.

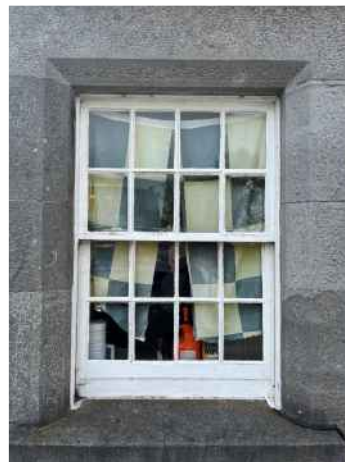
G13 and G14 (2no windows)

**Condition:** Glazing putty is cracked and missing in areas; paint to frame and sashes is flaking/missing; decay in frame and sash at cill; mid-rail detaching from frame; lime mortar seal around frame cracked.

**Note:** Electrical cable penetrates corner of G14 window frame.

**Recommendations:** Replace decayed sections of timber cill and bottom rail; re-use existing glazing and re-putty all glazing; strip, prime, undercoat and repaint frame and sashes, internally and externally; re-seal and draught-proof with new draught seals; adjust sash cords & weights and replace where necessary; maintain and clean all ironmongery, reinstate lime mortar seal to gap around window frame.

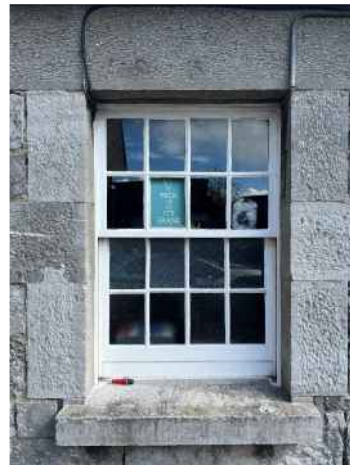
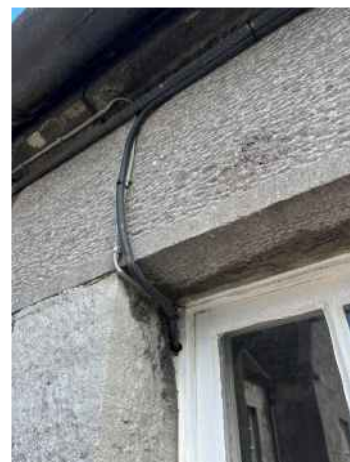
G15 (1no window)

**Condition:** Glazing putty is cracked and missing in areas; one damaged glass pane; paint to frame and sashes is flaking/missing; decay in frame and sash at cill; mid-rail detaching from frame; lime mortar seal around frame cracked.

**Note:** Electrical cables penetrate the two top corners of the window frame.

**Recommendations:** Replace decayed sections of timber cill and bottom rail; re-use existing glazing and re-putty all glazing; replace cracked glass pane; strip, prime, undercoat and repaint frame and sashes, internally and externally; re-seal and draught-proof with new draught seals; adjust sash cords & weights and replace where necessary; maintain and clean all ironmongery, reinstate lime mortar seal to gap around window frame.

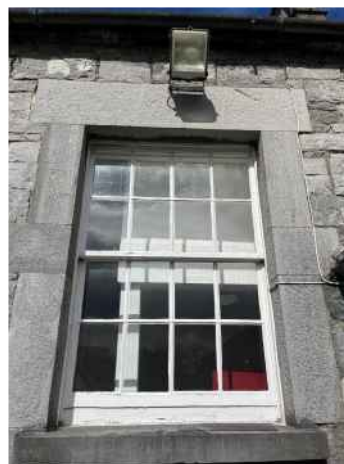
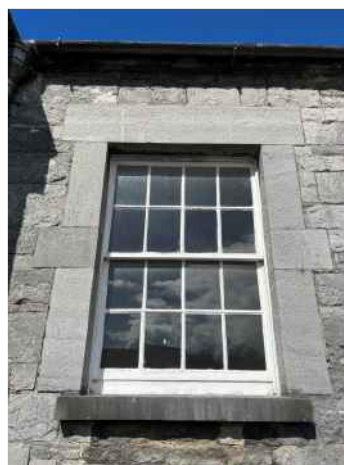
G16 and G18 (2no windows)

**Type:** 8 over 8 timber-frame, single-glazed, vertical sliding sashes, painted white.**Condition:** Glazing putty is cracked and missing in areas; cracked glass pane to G16; paint to frame and sashes is flaking/missing; decay in frame at cill (G16).**Recommendations:** Replace decayed sections of timber cill; replace cracked glass pane and re-using existing glazing, re-putty all glazing; strip, prime, undercoat and repaint frame and sashes, internally and externally; re-seal and draught-proof with new draught seals; adjust sash cords & weights and replace where necessary; maintain and clean all ironmongery, reinstate lime mortar seal to gap around window frame.**Note:** Electrical cable penetrates corner of G16 window frame.

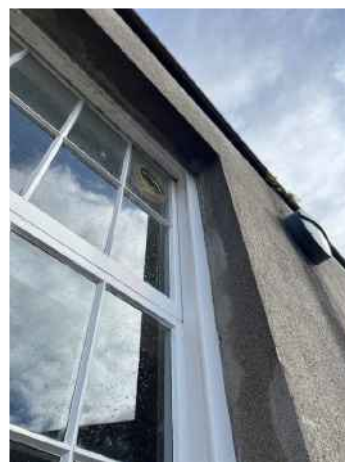
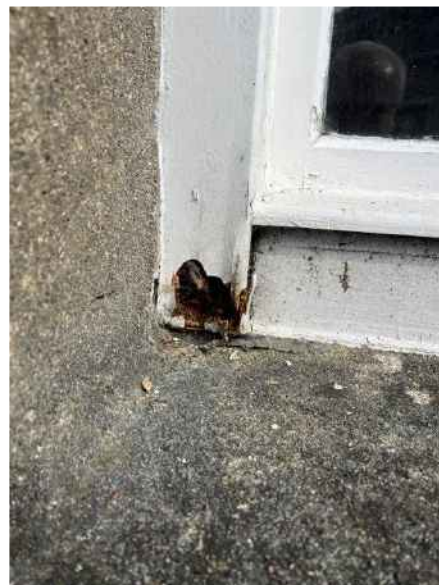
**Condition:** Relatively modern replacement/reconfiguration of original window fittings, possibly with some original sashes; poorly constructed; in very poor condition with decay in frame and sash at cill level and bottom rail of top sash; glazing putty is cracked; cracked glass panes to some windows (3no total); paint to frame and sashes is flaking/missing; lime mortar seal around frame poor.

**Recommendations:** Replace window with new timber frame window to match original windows elsewhere in the building, retaining existing sashes sash, frames repaired as necessary, with new ironmongery, weights and chords; re-using existing glazing with new putty; painted with primer, undercoat and white finish coats, internally and externally; reinstated with lime mortar seal to gap around window frame.

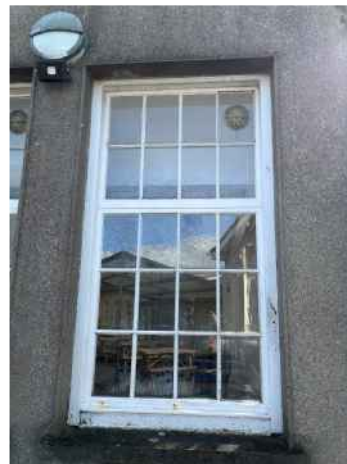
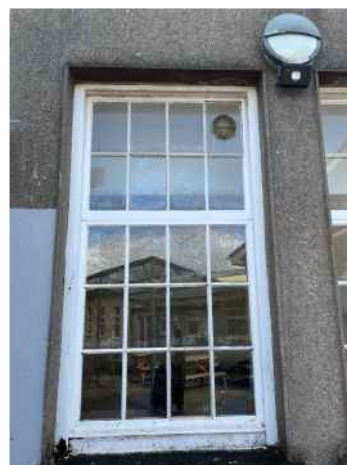
G28 and G29 (2no windows)

**Condition:** Relatively modern replacement/reconfiguration of original window fitting, possibly with some original sashes; poorly constructed; in very poor condition with decay in frame and sash at cill level; glazing putty is cracked; some cracked glazing panes; paint to frame and sashes is flaking/missing; lime mortar seal around frame poor.

**Recommendations:** Replace window with new timber frame window to match original windows elsewhere in the building, retaining existing sashes, sash frames repaired as necessary, with new ironmongery, weights and chords; re-using existing glazing with new putty; painted with primer, undercoat and white finish coats, internally and externally; reinstated with lime mortar seal to gap around window frame.

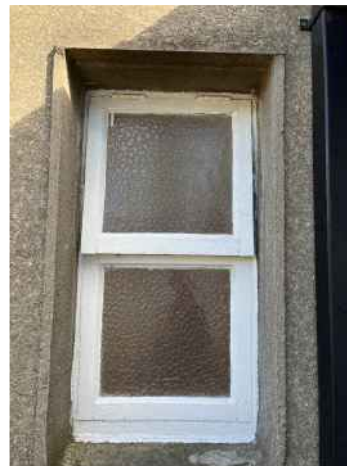
G34 and G35 (2no windows)

**Condition:** Relatively good condition with no obvious decay to frames; some cracking of putty; paint to frame and sashes in good condition.

**Recommendations:** Re-use existing glazing and re-putty all glazing; strip, prime, undercoat and repaint frame and sashes, internally and externally; re-seal and draught-proof with new draught seals; maintain and clean all ironmongery and replace where damaged; retain windows in-situ.

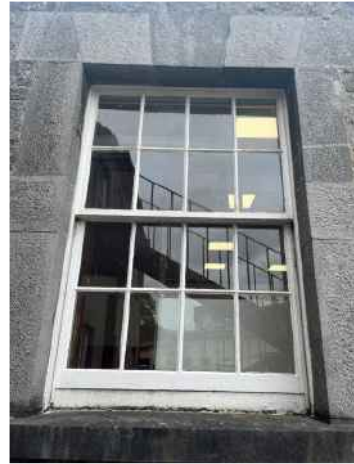
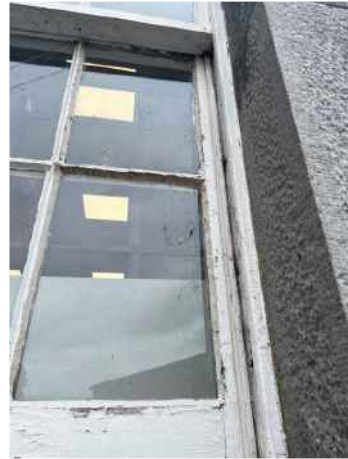
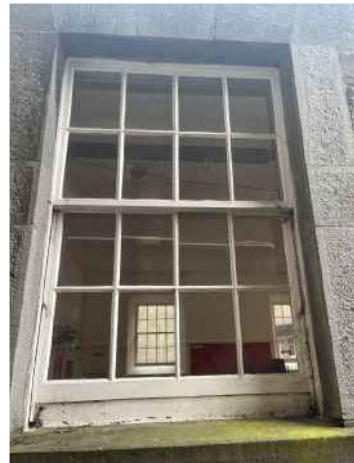
**Condition:** Glazing putty is poor in areas of previous repairs with cracking to older putty; some cracked glass panes in all windows; paint to frame and sashes is flaking/missing; some decay to frame and bottom rail at cill level; small hole at base of one window frame from former service penetration; large gaps around frames.

**Recommendations:** Repair decayed sections of timber frame and sash rails; seal hole in frame; replace 4no broken glass panes and elsewhere re-use existing glazing and re-putty all glazing; strip, prime, undercoat and repaint frame and sashes, internally and externally; re-seal and draught-proof with new draught seals; adjust sash cords & weights and replace where necessary; maintain and clean all ironmongery; reinstate lime mortar seal to gap around window frame.

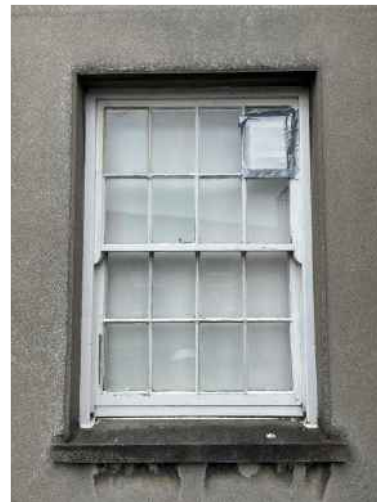
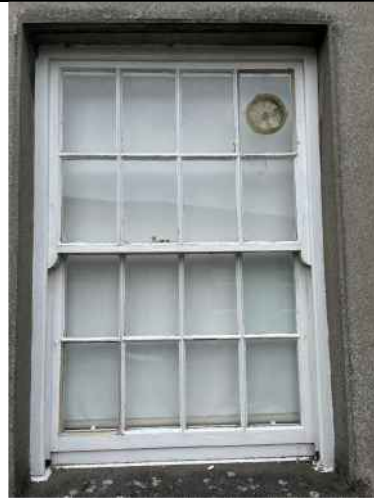
G41, G42, G43, G44 and G45 (5no windows)

**Condition:** Glazing putty is poor in areas of previous repairs with cracking to older putty with sections missing; paint to frame and sashes is flaking/missing; some minor decay to frame and bottom rail at cill level.

**Recommendations:** Repair decayed sections of timber frame and sash rails where necessary; re-use existing glazing and re-putty all glazing; strip, prime, undercoat and repaint frame and sashes, internally and externally; re-seal and draught-proof with new draught seals; adjust sash cords & weights and replace where necessary; maintain and clean all ironmongery.

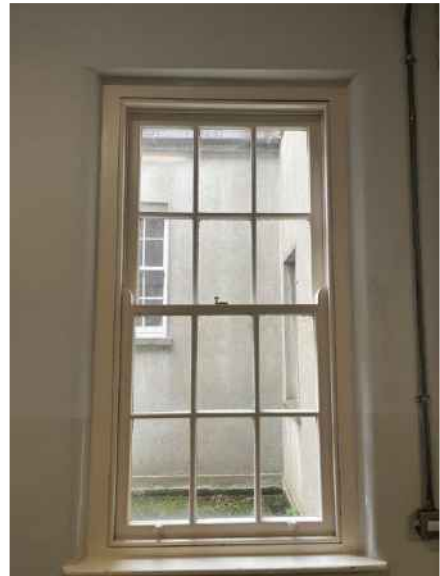
G53 (2no windows and door with boarded up fanlight over)

**Condition:** Generally in very poor condition; significant decay of timber frame; glazing putty is cracking in areas; paint is poor with peeling/cracking in areas (leaking rainwater gutter over window causing significant wetting of window frame).

**Note:** Rainwater gutter over window to be repaired.

**Recommendations:** Repair decayed sections of timber frame; re-use existing glazing and re-putty all glazing; strip, prime, undercoat and repaint frame, internally and externally.

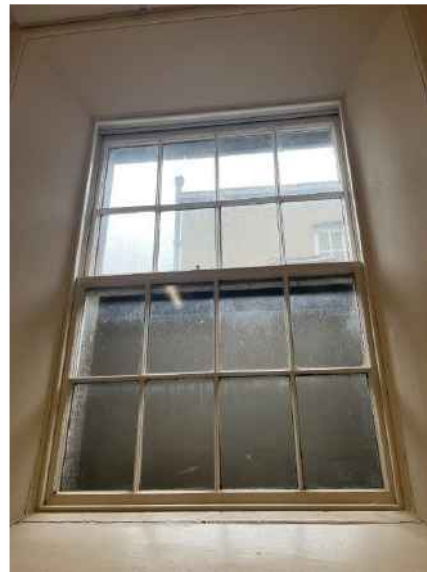
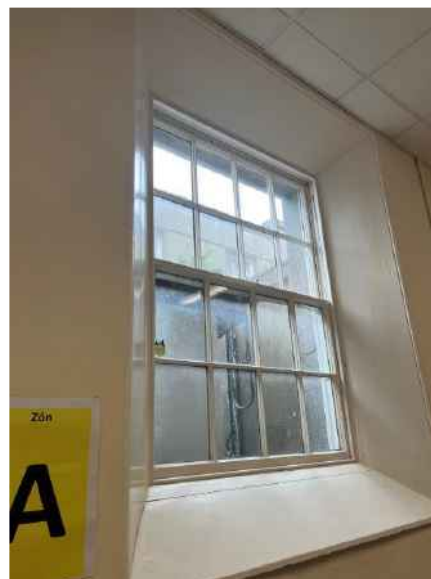
G66 and G67 (2no windows)

**Condition:** Generally in good condition; glazing putty is cracking in areas; paint is good; no obvious decay to frame and bottom rail at cill level.

**Recommendations:** Re-use existing glazing and re-putty all glazing; strip, prime, undercoat and repaint frame and sashes, internally and externally; re-seal and draught-proof with new draught seals; adjust sash cords & weights and replace where necessary; maintain and clean all ironmongery and replace where damaged; retain windows in-situ.

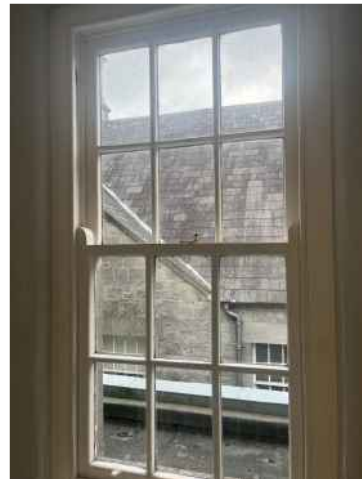
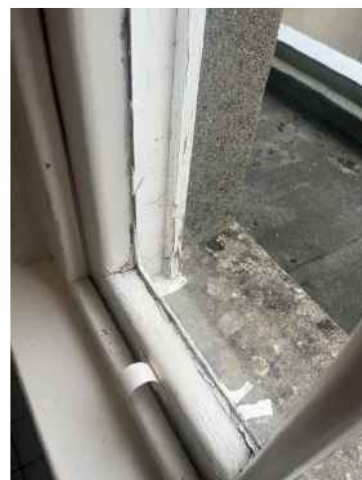
F16, F17, F18 and F19 (4no windows)

**Condition:** Generally in good condition; glazing putty is cracking in areas; paint is good; some minor decay to frames at cill level to some windows.

**Recommendations:** Repair timber frames where decayed; re-use existing glazing and re-putty all glazing; strip, prime, undercoat and repaint frame and sashes, internally and externally; re-seal and draught-proof with new draught seals; adjust sash cords & weights and replace where necessary; maintain and clean all ironmongery and replace where damaged; retain windows in-situ.

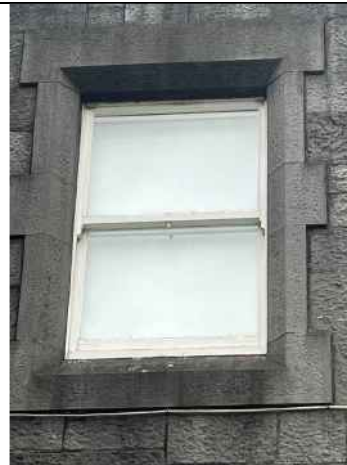
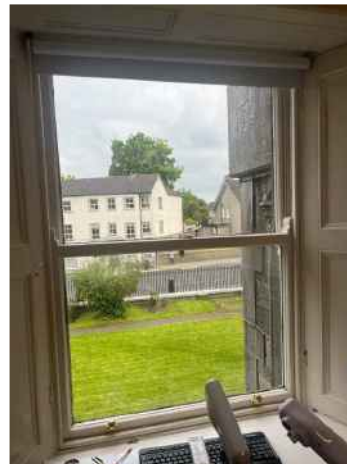
F22, F23, F24, F25 and F26 (5no windows)

**Condition:** Glazing putty is cracked; paint to frame and sashes is flaking/missing in areas; significant deterioration of frame with decay in frame and bottom sash rail at cill; lime mortar pointing around frames poor; one cracked glass pane.

**Recommendations:** Replace decayed sections of timber cill and bottom rail; replace cracked glass pane to one window and elsewhere, re-use existing glazing and re-putty all glazing; strip, prime, undercoat and repaint frame and sashes, internally and externally; re-seal and draught-proof with new draught seals; adjust sash cords & weights and replace where necessary; maintain and clean all ironmongery, reinstate with new lime mortar seal to gap around window frame.

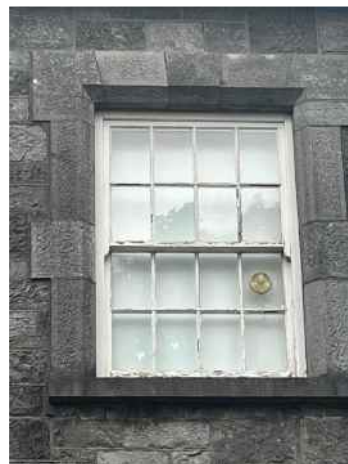
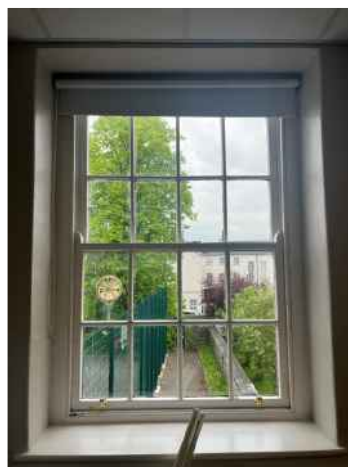
F28 and F29 (2no windows)

**Condition:** Glazing putty is cracked; paint to frame and sashes is flaking/missing; some slight deterioration of frame and sash at cill; previous repairs in poor condition.

**Recommendations:** Repair decayed sections of timber frames; re-use existing glazing and re-putty all glazing; strip, prime, undercoat and repaint frame and sashes, internally and externally; re-seal and draught-proof with new draught seals; adjust sash cords & weights and replace where necessary; maintain and clean all ironmongery.
