**Avoca - Tigroney 850 Adit**  
**Ground Support Rehabilitation**  
**Follow up visit**  
**August 2025**

**Prepared By:** Joe Burke,  
Associate Principal Geotechnical Engineer, LTMS Limited

**Date:** 4<sup>th</sup> September 2025

**Ref. P25028**

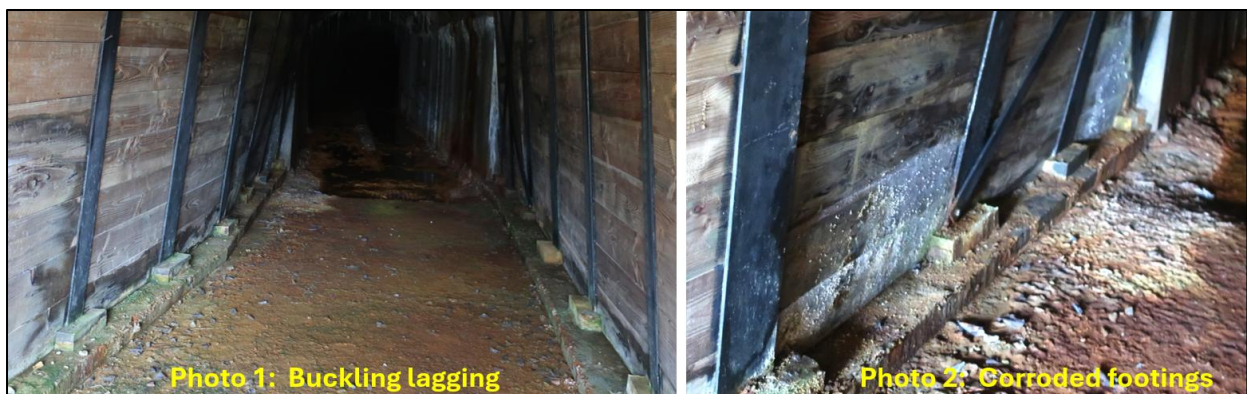
*The bulging of some of the steel arches with offsets and displacements of the timber lagging in sections of the north sidewall continues, photo 1.*

*The leaking water and suspected overflow from the adit itself are causing severe corrosion of the steel footings particularly the retaining nuts, photo 2.*

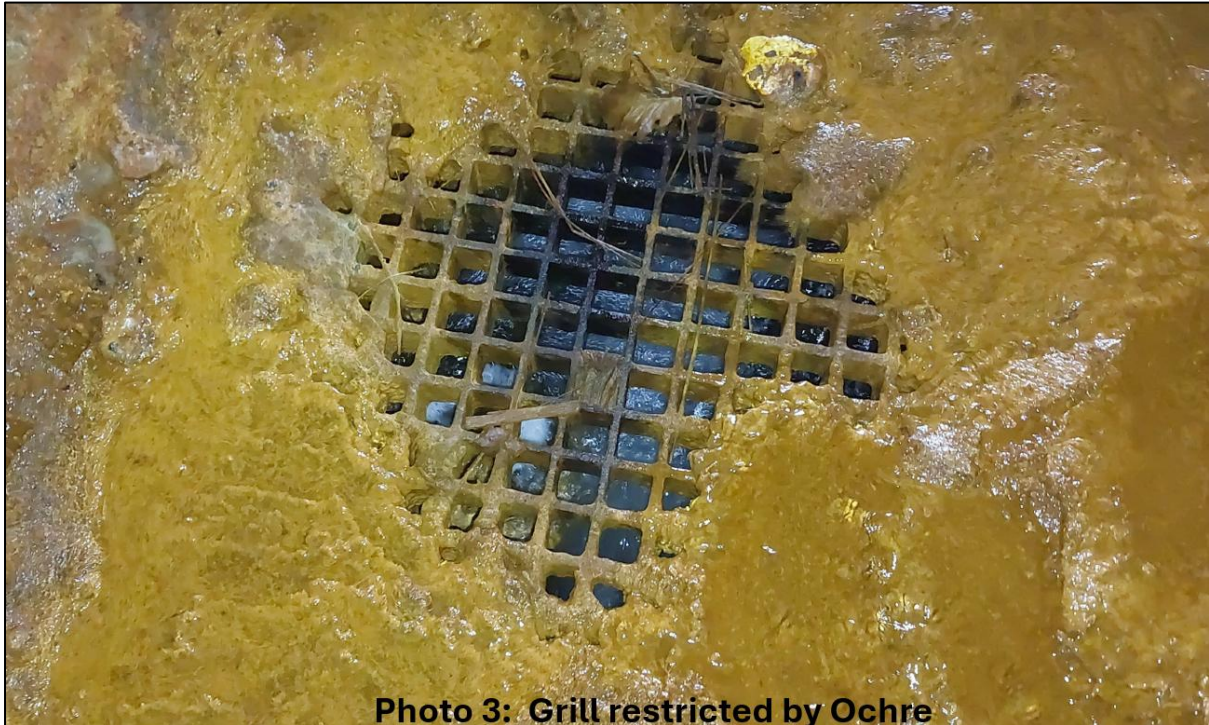
**Photo 3: Grill restricted by Ochre**

*The grill allowing the piped water flow to the Deep adit level is significantly reduced in area by an encrusted ochre covering, photo 3.*

*This restriction causes the acid rich water to overflow at times contributing to the corrosion of the steel arches.*

*It is suspected that water pressure is building up during periods of heavy precipitation and exerting pressure on the timbers and steel frame. This action will continue with failure of the lagging and steel frame displacement as saturation of the backfilled area occurs.*

*As an immediate measure It is recommended that*

- 1. The grill be cleaned to allow the full flow into the lower Deep Adit.*
- 2. A sandbag barricade (0.5m high) be constructed before the timbered area to prevent overflow into the front Zone 1.*
- 3. A series of small diameter holes be drilled into the lower sidewalls to allow drainage and relieve any hydrostatic pressures.*

*Longer term it would be advisable to insert drainage pipes in the backfill to channel the water to the outside on the north side and construct an impervious wall behind the steel arches.*

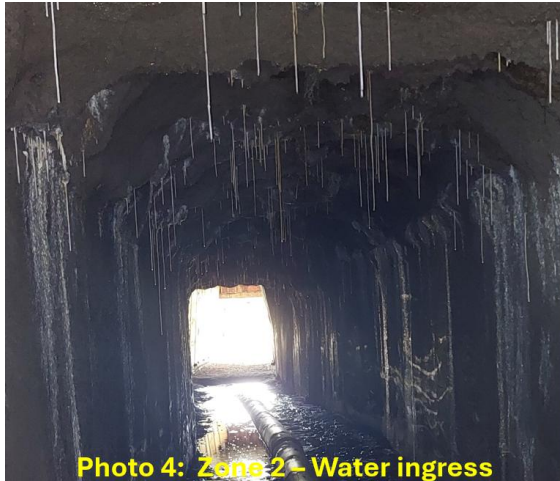
**Photo 4: Zone 2 – Water ingress**

*There has been a significant increase in wet conditions in this zone with the entire roof and walls now damp and covered in small stalactites, photo 4.*

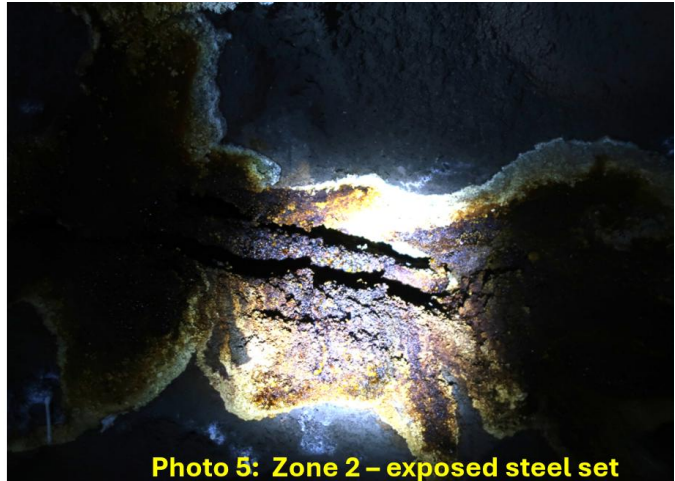
**Photo 5: Zone 2 – exposed steel set**

*The steelwork where exposed had some small local iron staining on the cross beams but now shows severe corrosion, photo 5.*

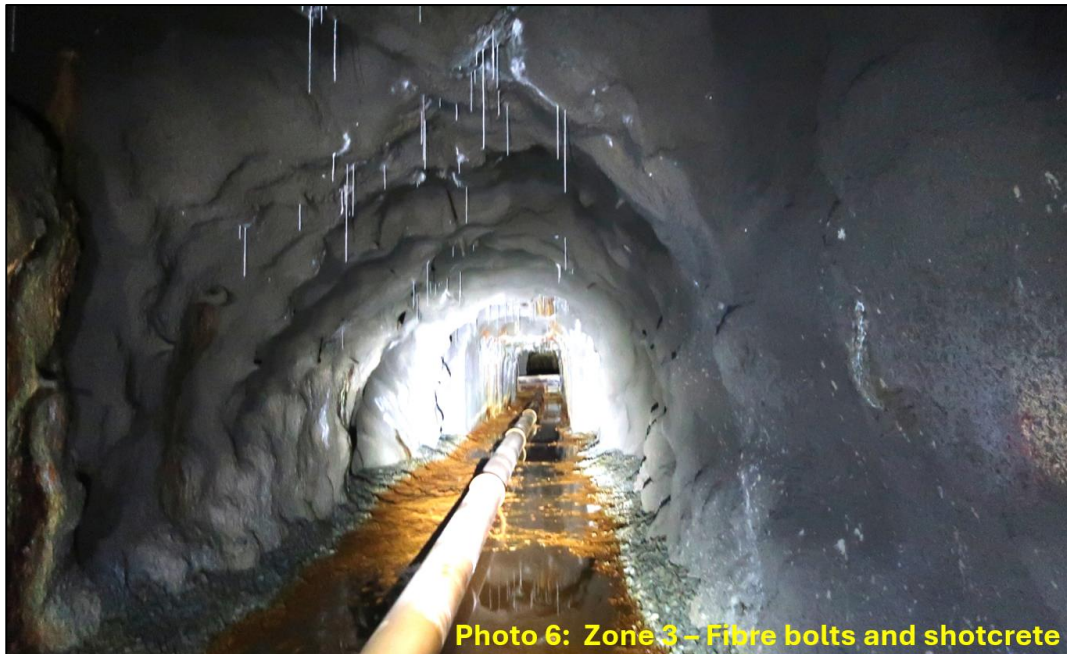
*The drain holes installed show no flows and have dried out with only occasional damp patches showing, photo 6.*

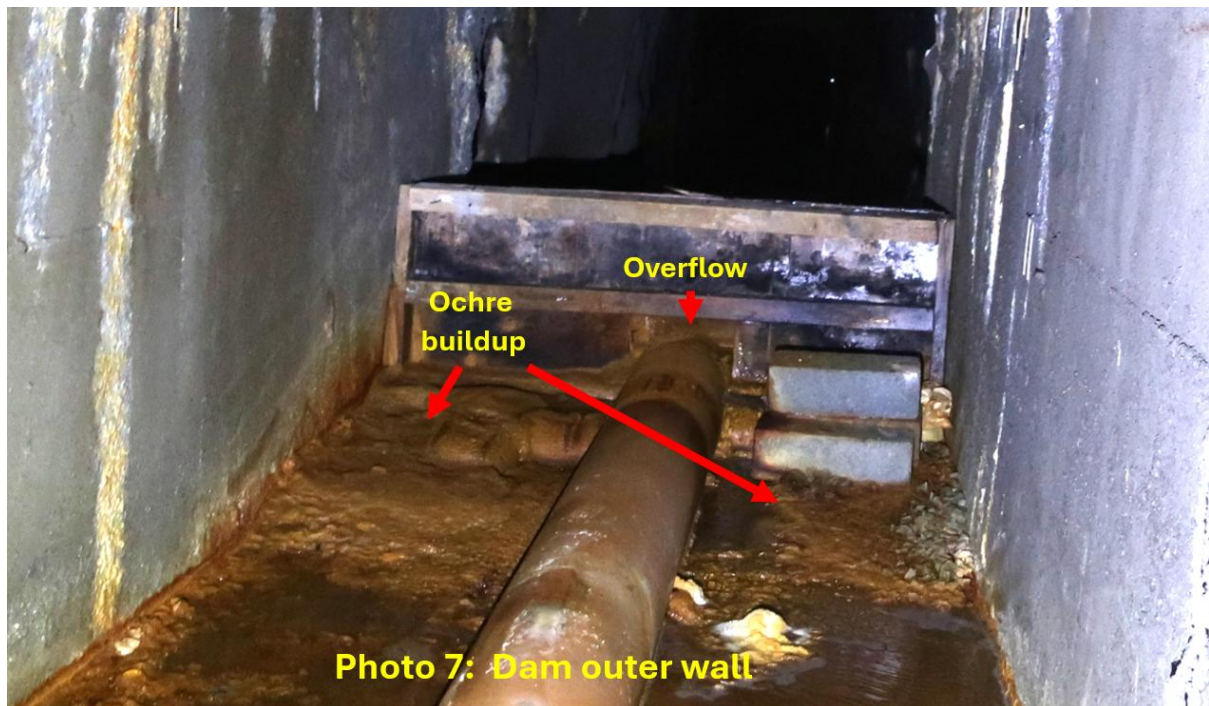
*The overflow exits through the hole cut for the outflow pipe, photo 7. A large amount of ochre is building up indicating a regular overflow of the pipe.*

*Over time it is likely that the timber frame will deteriorate with a buildup of ochre between the sandbag dam and timber wall rotting the structure as it becomes the principal means of restraining a rising head of water behind.*

*Consideration should be given to replacing the timber frame with a designed wall anchored to the sidewalls.*

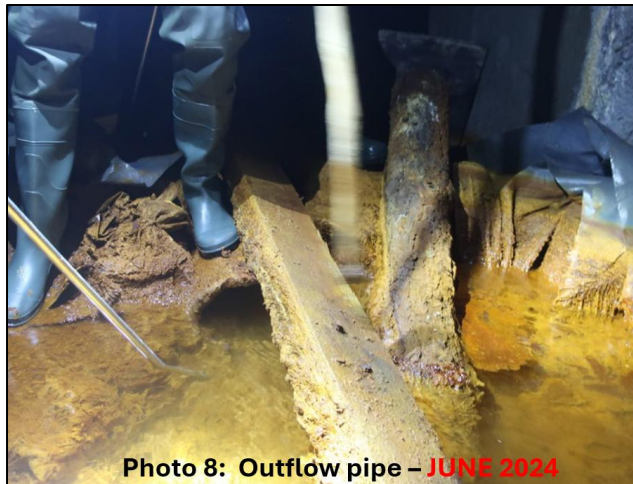
Photo 8: Outflow pipe – JUNE 2024

*The outflow pipe is now submerged having been at approximately 55% of the pipe diameter capacity in June 2024, up from 40% capacity in 2023 (photos 8 & 9).*

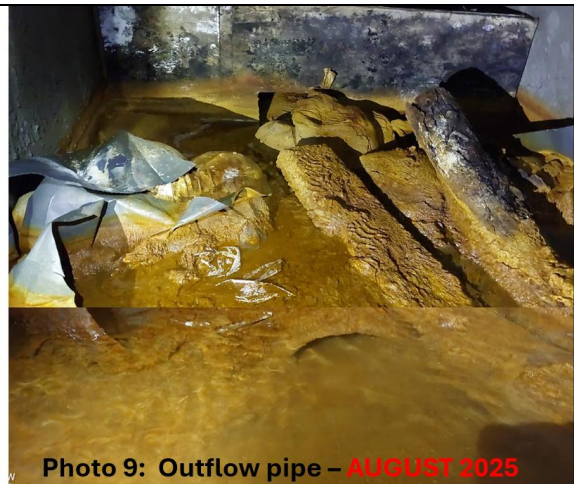
Photo 9: Outflow pipe – AUGUST 2025

*There has been a very noticeable increase in ochre buildup on floors behind the dam and in the pipe itself.*

*There has been an increase in timber beams being washed down from further up the adit that are obstructing the outflow.*

*It is suggested that maintenance work be carried out on the sandbag dam and outflow pipe, principally to remove the debris, clean out the ochre build-up and install a mesh screen to prevent smaller loose timbers blocking the pipe.*

*Due to an increase in water levels (unsure if this is seasonal) the sandbag dam should be raised to prevent the overflow on the adit floor.*

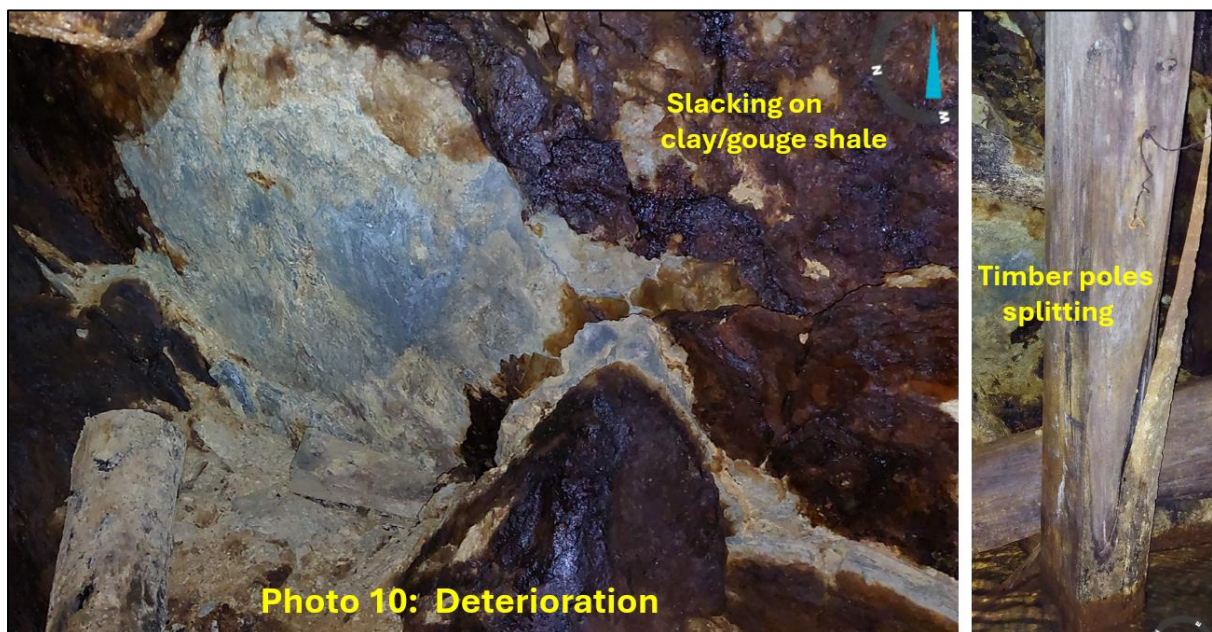
There is evidence of slackening of the shale rock pillars along clay/gauge filled contacts with some small-scale failures and pole cracking, photo 10.

In some areas the loose rock is supported by bolts that must now be considered ineffective. Although the area is currently accessible it should be considered unstable and traversed quickly.

*To ensure safe and continuous access a support regime should be installed including scaling to solid rock, shotcrete to close joints and give surface bonding and bolting to secure wedges and large blocks of loose.*

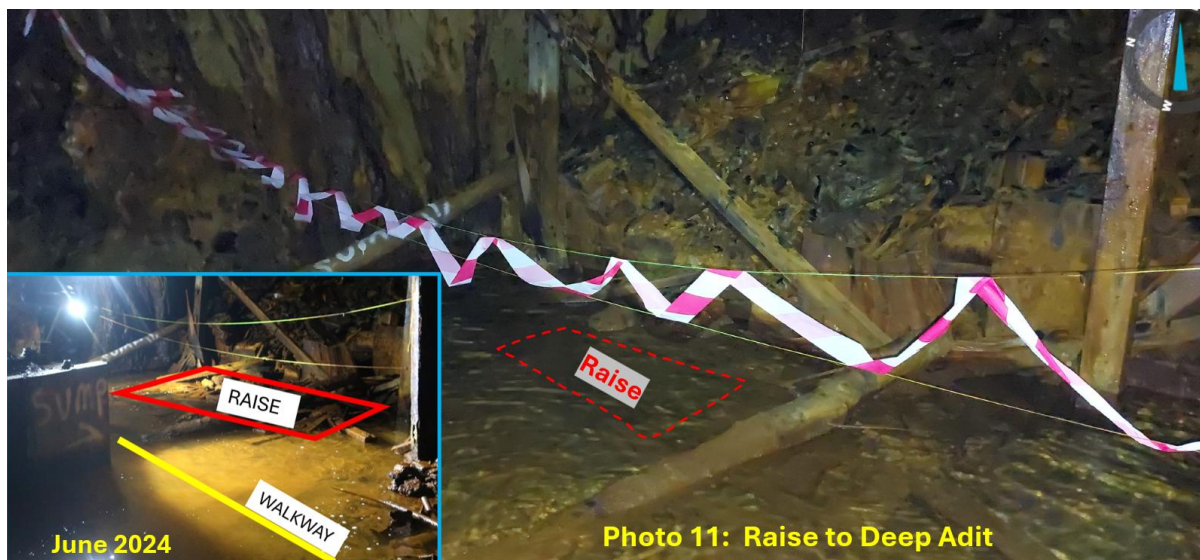
As a temporary measure the area was marked off with reflective tape, photo 11.

*The marking of the area with painting 'SUMP' or tape is not sufficient to prevent unintentional access.*

*It is strongly recommended that the launder be removed and placed in front of the void and a timber barricade be constructed and marked to restrict any access.*
