# Inspection and Survey of Sheet Pile Wall and Marina Piles at An Daingean FHC, Dingle, Co. Kerry

Submitted: April. 2025

This report contains the findings of an underwater inspection carried out at Dingle Harbour Fisheries Centre between 20<sup>th</sup> and 22<sup>nd</sup> March 2025.

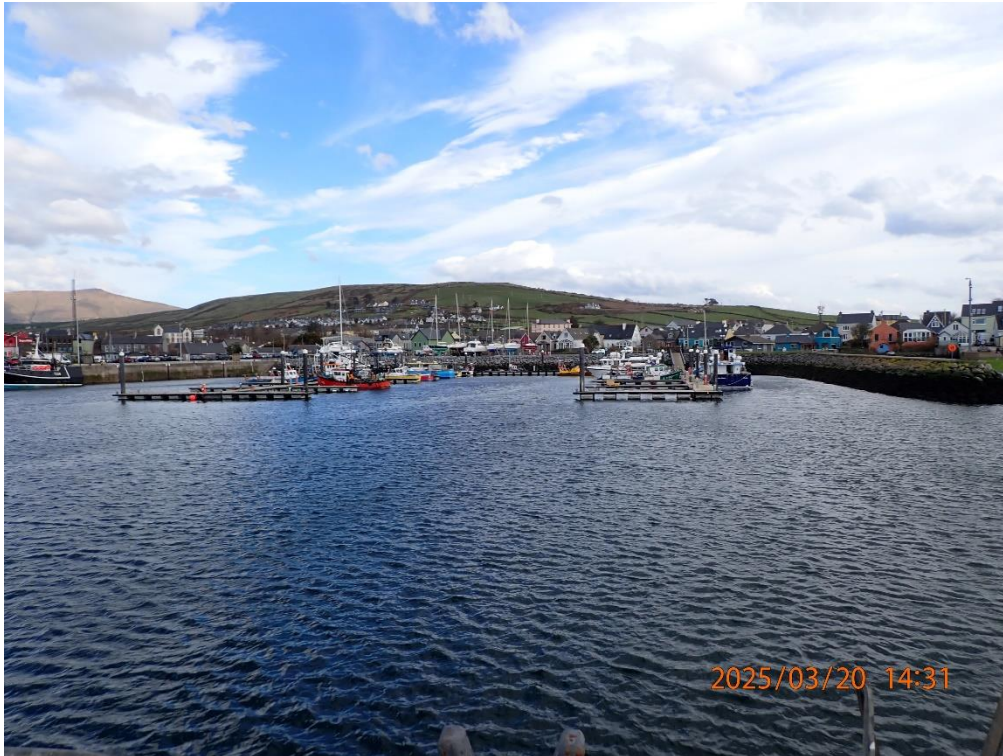
All 20 piles have anodes attached, 11 of these have 2 anodes each. The depletion of these anodes was noted to be typically 10% on each pile. CP meter readings were carried out on all piles and all readings fell within expected ranges of 0.930v and 1.057v. UT meter readings were also recorded for candidate piles.

Photograph 3: Marina A viewed from the Main Pier

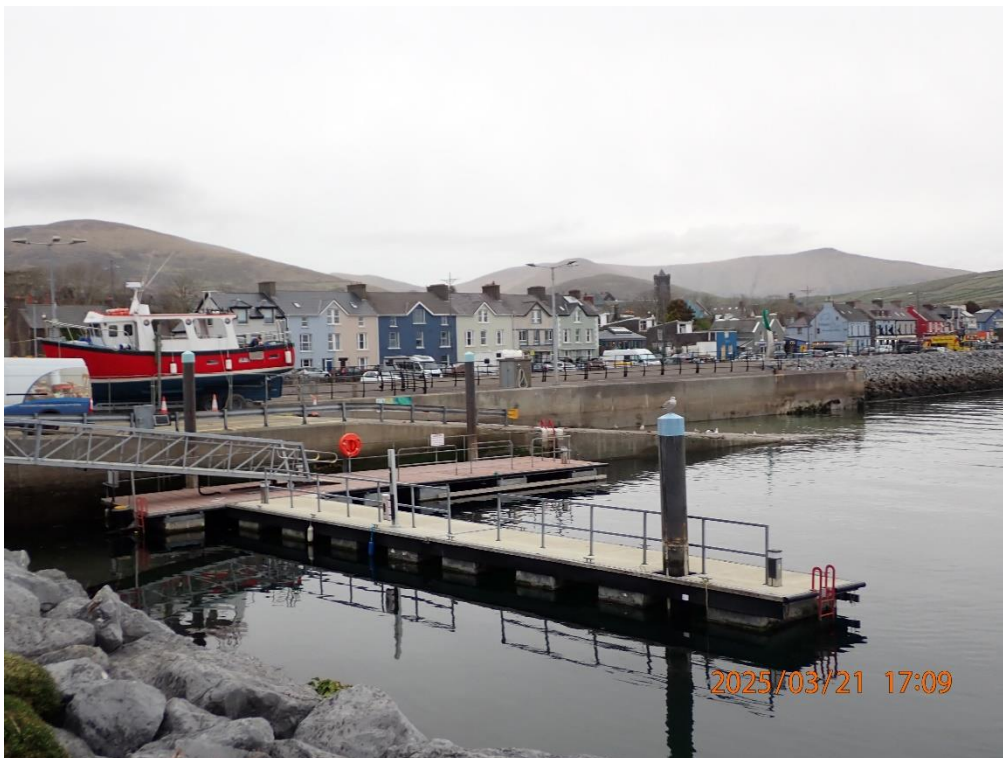
All 3 Piles have 1 anode attached. the depletion of these anodes was noted to be 10%.

Photograph 4: Marina B viewed from the west shore

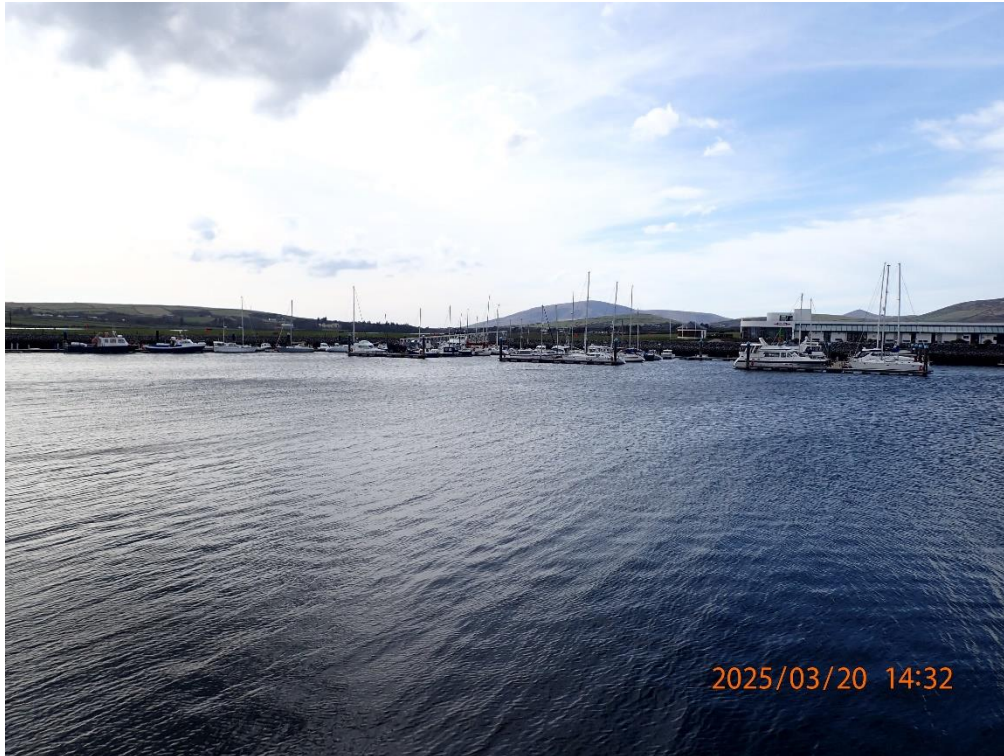
All 17 Piles have 1 anode each attached. The depletion of these anodes was noted to be 10% on all 17 piles. CP meter readings were carried out on all piles and all readings fell within acceptable ranges of 0.95v and 1.036v.

Photograph 5: Marina C viewed from the Main Pier

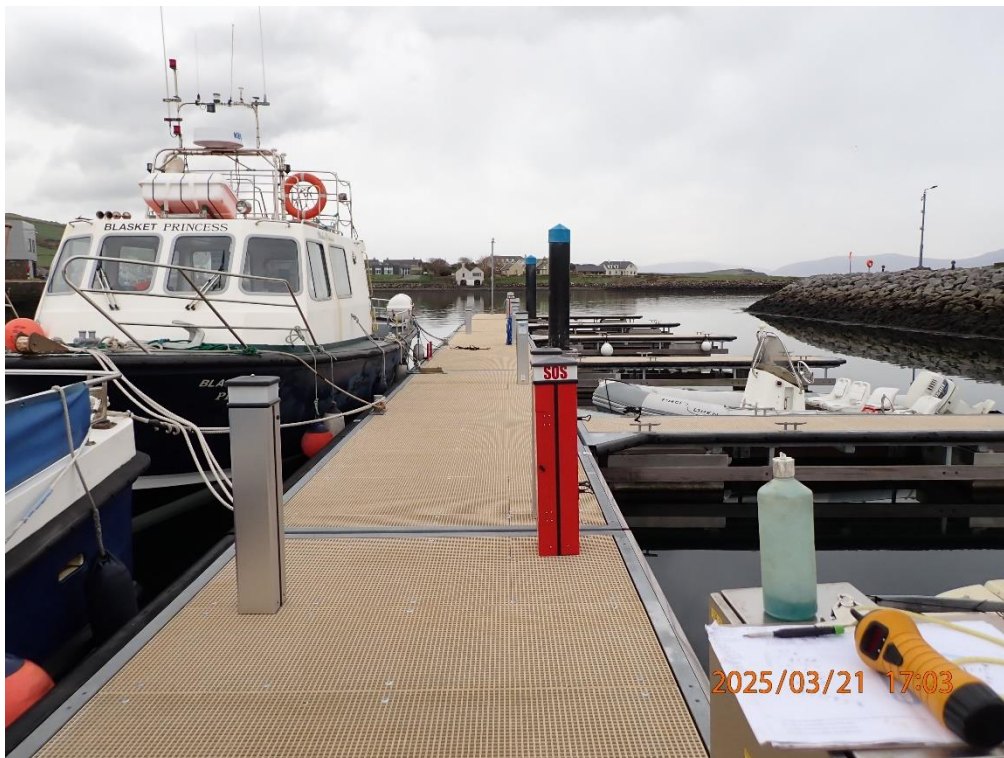
The piles showed evidence of having been treated with a protective coating since the last inspection.

Photograph 6: Marina D viewed from its west end looking east

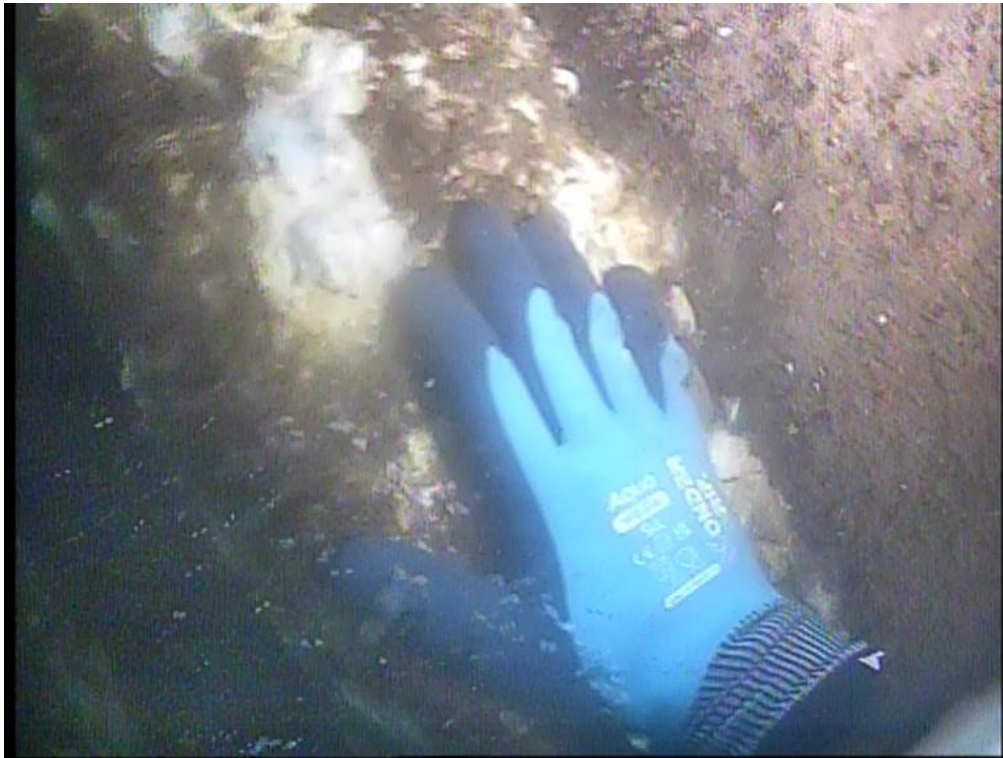
With one exception, CP readings were consistent throughout the structure between Ch 50 to Ch 210, ranging from 0.857v to 1.035v. However, readings as low as 0.270v were recorded between Ch 30 and Ch 50. This is where the sheet piles begin. It is relatively shallow in comparison to the main section of the quay wall and as a result shorter anodes (0.7m) have been installed. The shorter anodes generally will result in lower voltage readings, any reading lower than 0.5v is typical of what is expected on an unprotected structure, so it appears that this initial section of sheet pile wall is significantly under protected. Larger anodes (1.40m) were present throughout the structure from Ch 57 and were secured at both top and bottom brackets. Anodes showed typical depletion of about 10%.

Photograph 9: Typical anode

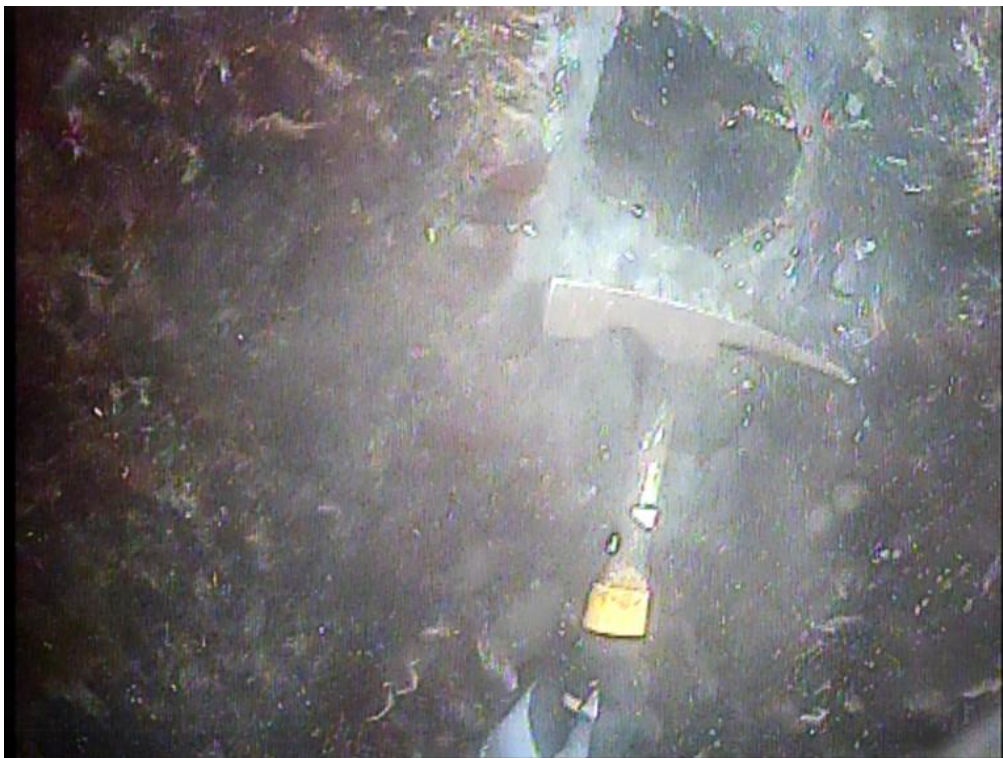
Five voids were noted throughout the sheet pile wall structure between Ch 167 and Ch 198, these voids were relatively consistent in both size and elevation. They were between 50mm wide x 80mm high and 120mm wide x 330mm high and were up to in excess of 1.00m in penetration. They were all located between 4.40m and 5.50m below the deck level. Clean angular stone was noted behind the piles where visible. Considerable suction was noted to each void at the time of the inspection, see photographs 10 to 14.

Photograph 10: Void at Ch 67

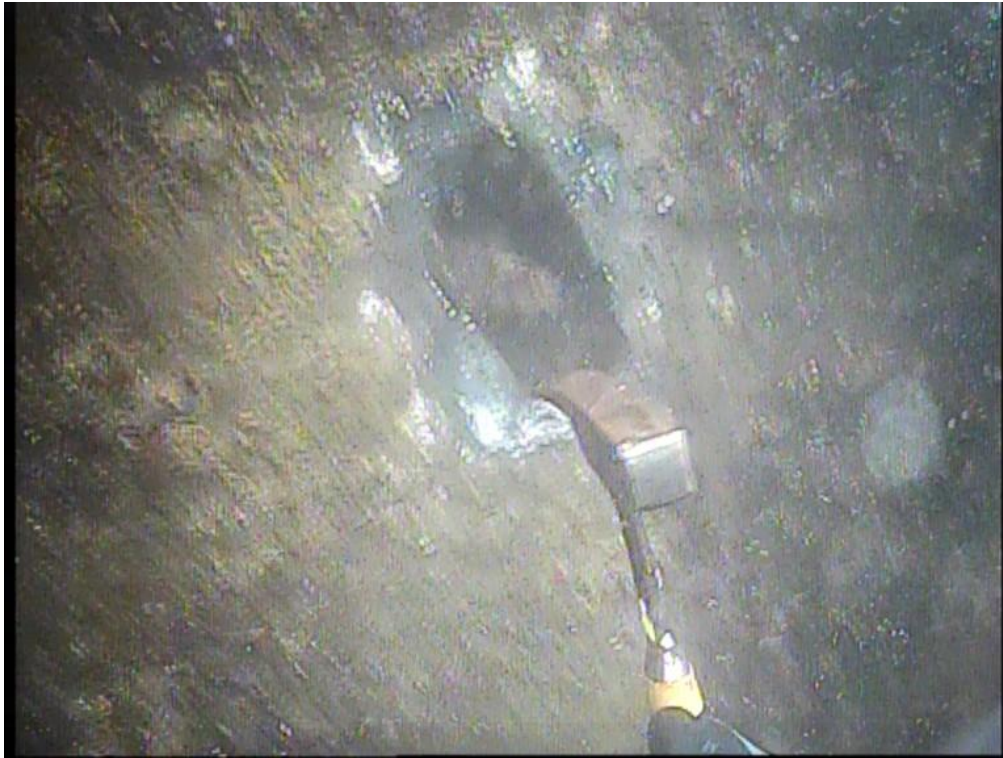
Photograph 11: Void at Ch 178

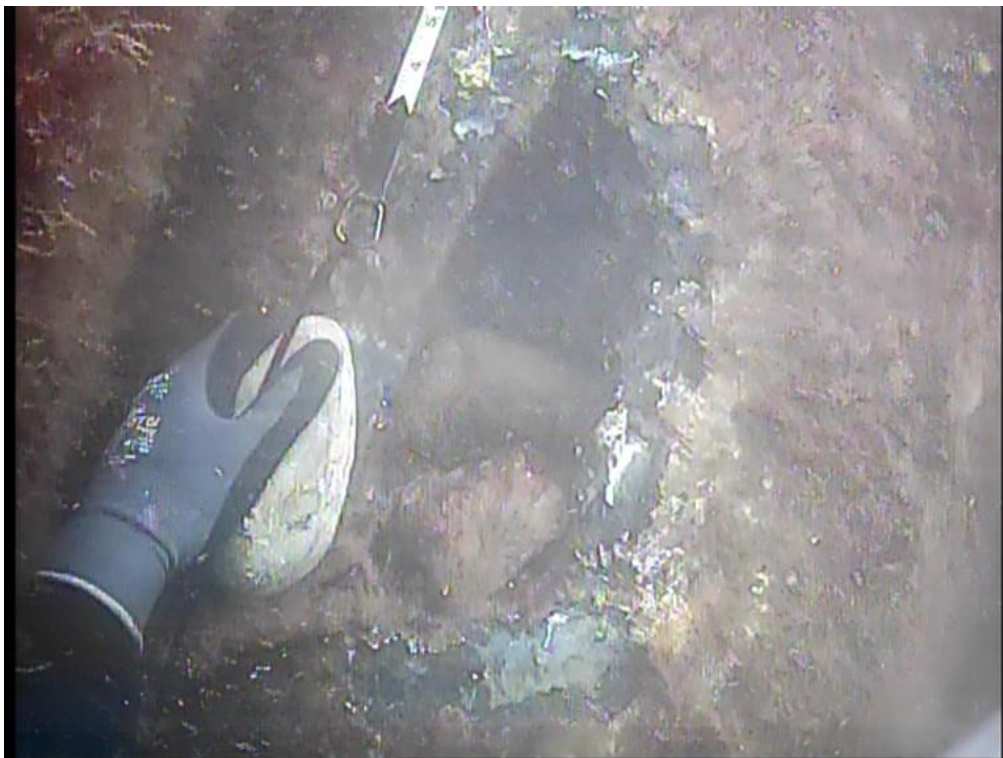
Photograph 12: Void at Ch 187

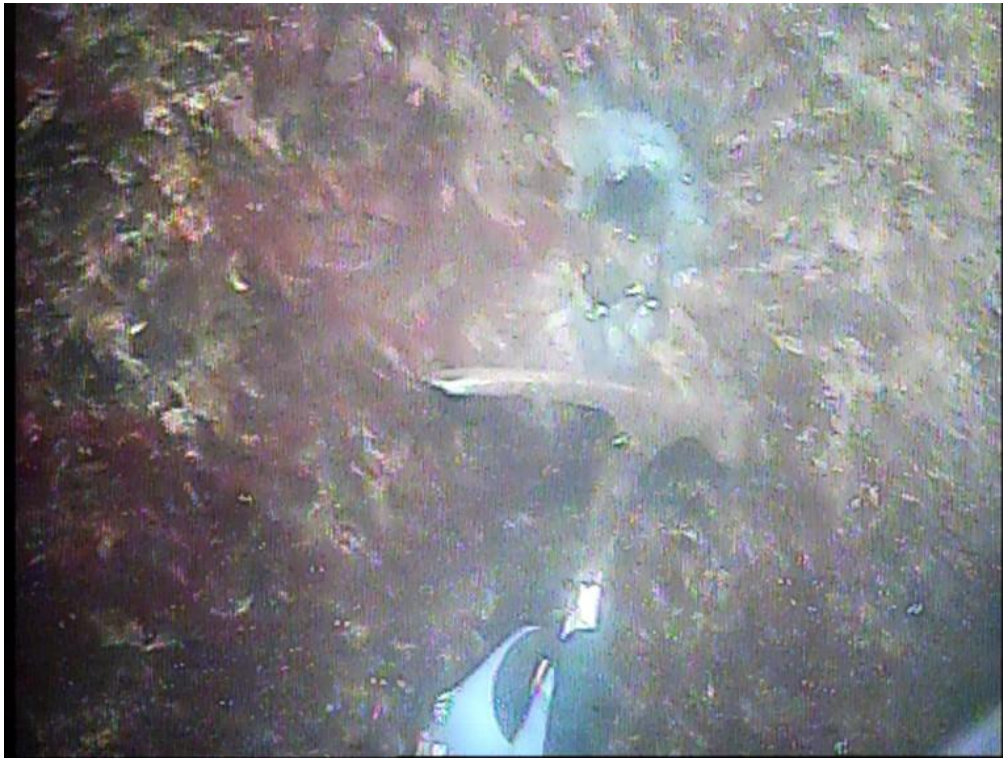
Photograph 13: Void at Ch 190

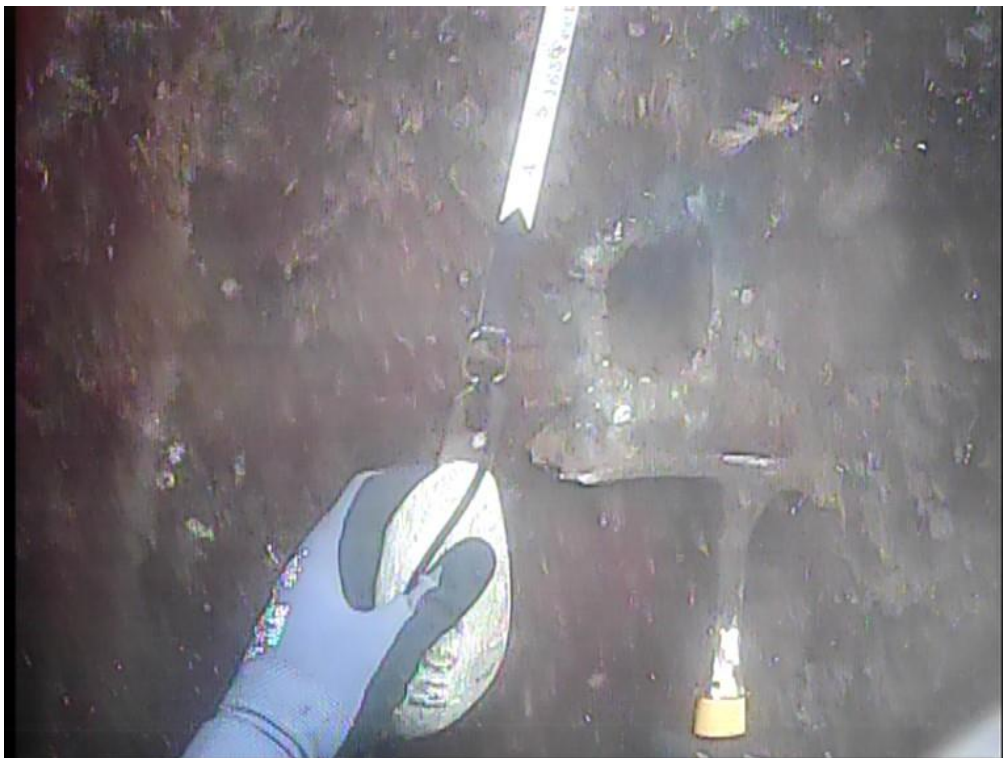
Photograph 14: Void at Ch 198

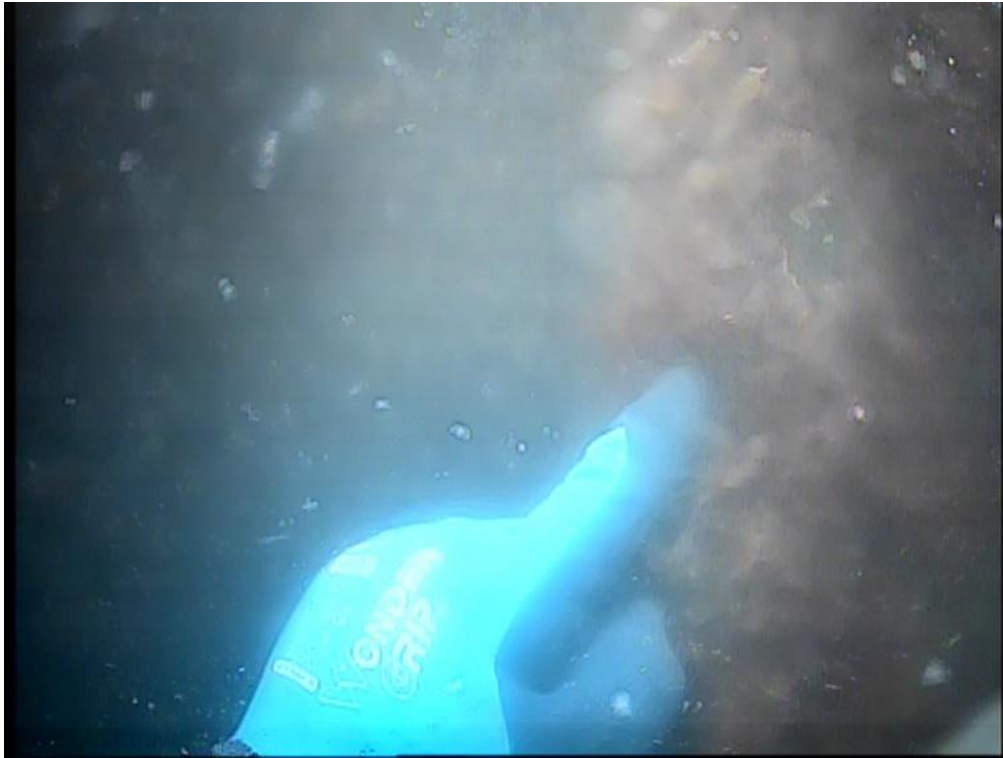
The bottom 1.00m appeared to be missing from the fender situated at Ch. 87. The rubbing strip extended down beyond the timber section, see photograph 15.

Photograph 15: Defect to fender at Ch 87

Consideration should be given to addressing issues raised with the fenders on the east pier.

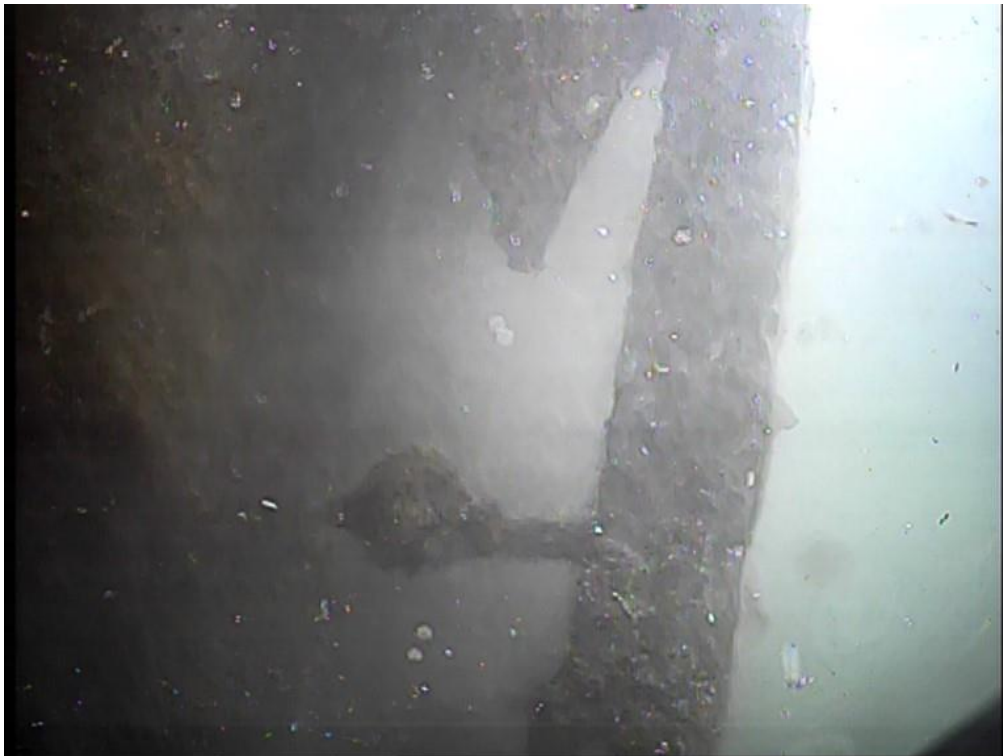
Section loss was noted to the bottom 1.50m of the fender at Ch. 106, see photograph 16.

Photograph 16: Defect to fender at Ch 106

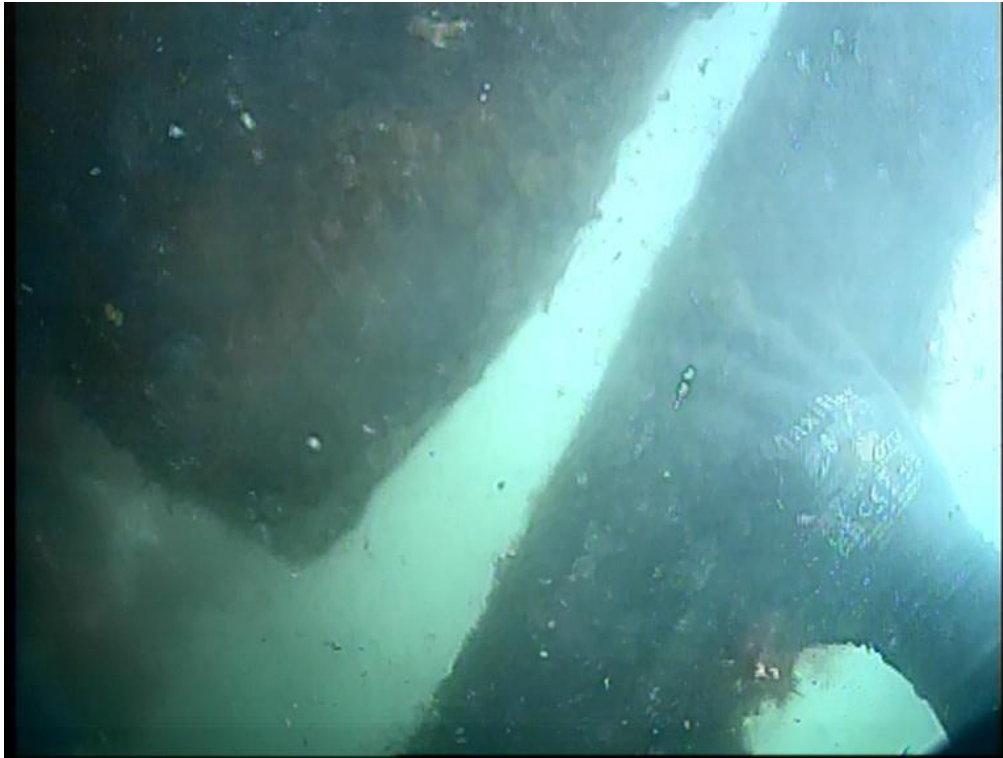
The bottom rubbing strip was loose and extended down past the timber section by 0.45m at Ch. 125, see photograph 17.

Photograph 17: Defect to fender at Ch 125

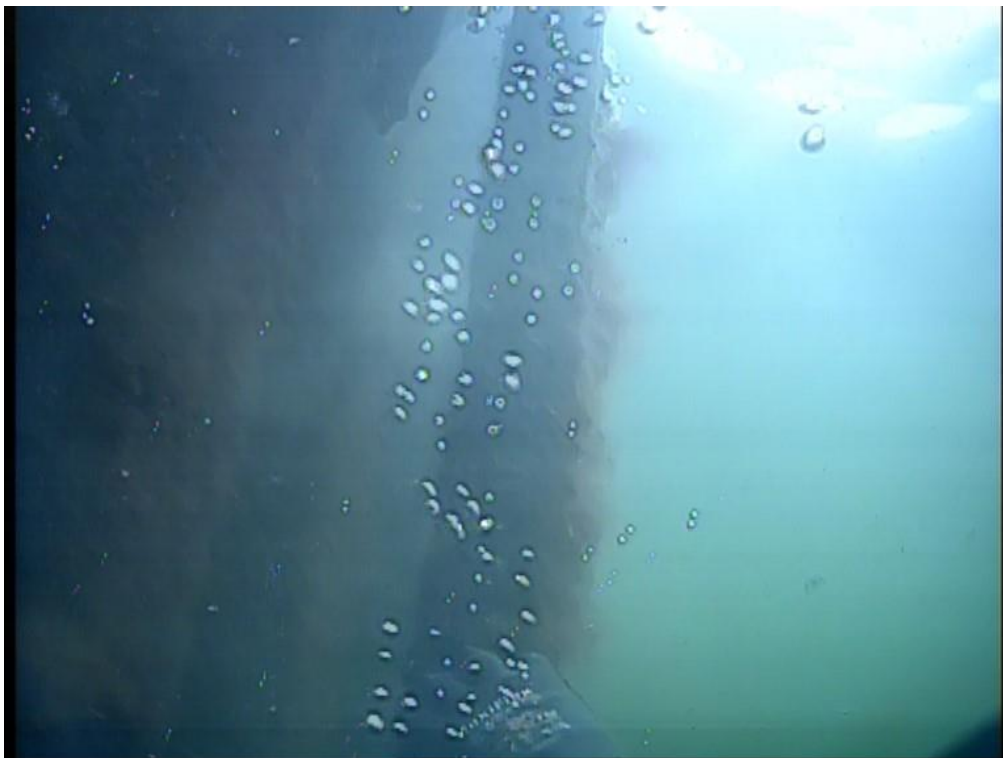
Upto 1.50m of timber was missing from the bottom of the fender at Ch. 129, see photograph 18.

Photograph 18: Defect to fender at Ch 129

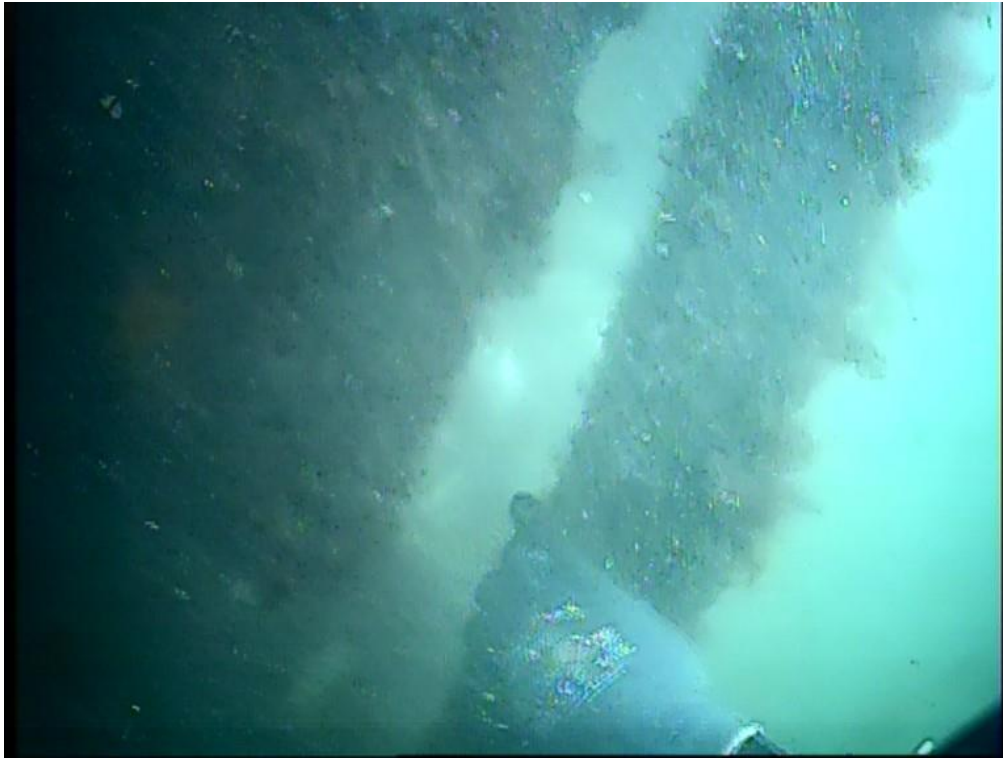
The bottom 1.70m of fender material appears to be missing on the fender at Ch. 133, see photograph 19.

Photograph 19: Defect to fender at Ch 133

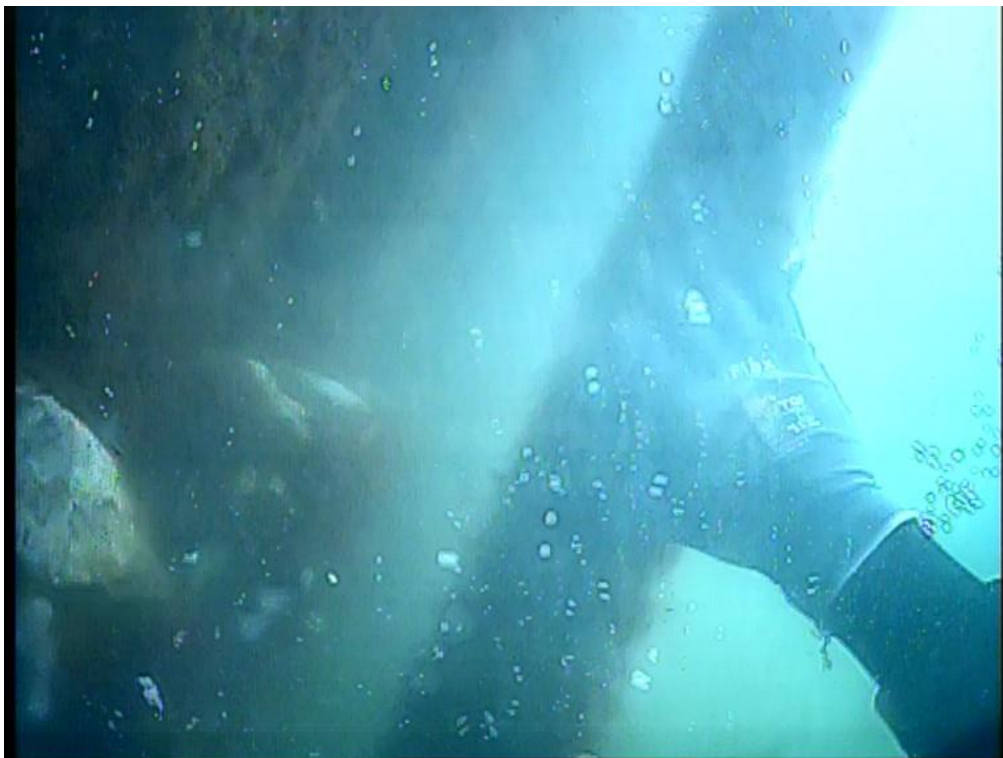
The bottom 1.80m of the fender at Ch. 141 seems to be missing, see photograph 20 and the bottom 1.80m of the fender at Ch. 148 appears to be damaged and exhibits exposed steel bolts, see photograph 21.

Photograph 20: Defect to fender at Ch 141

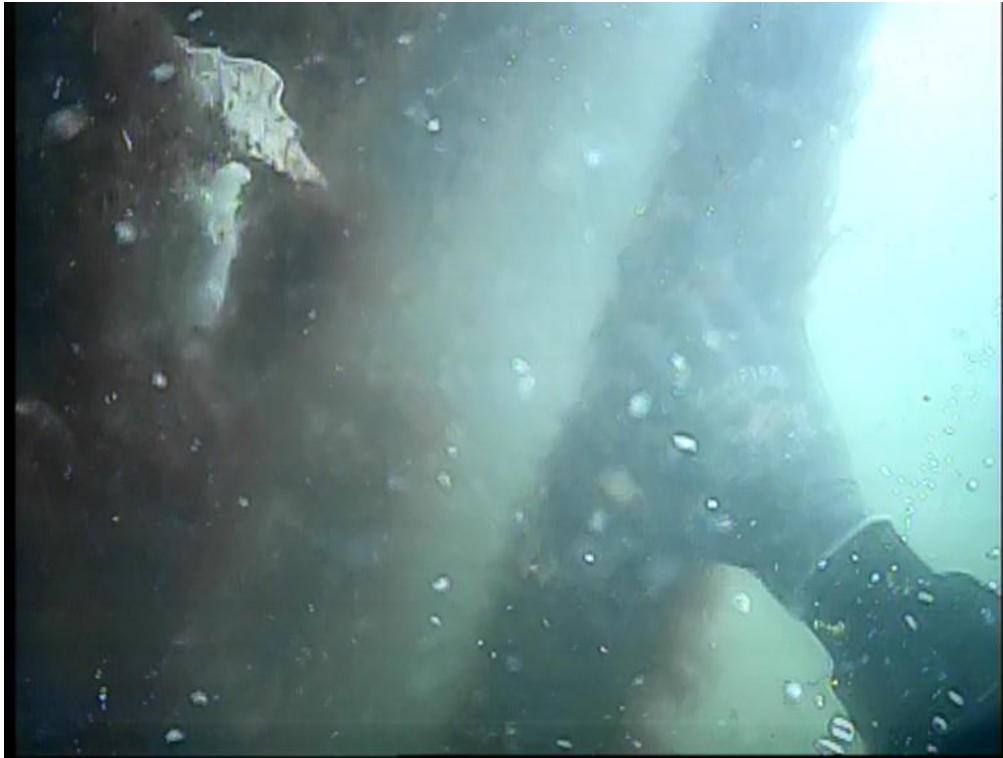
Photograph 21: Defect to fender at Ch 148

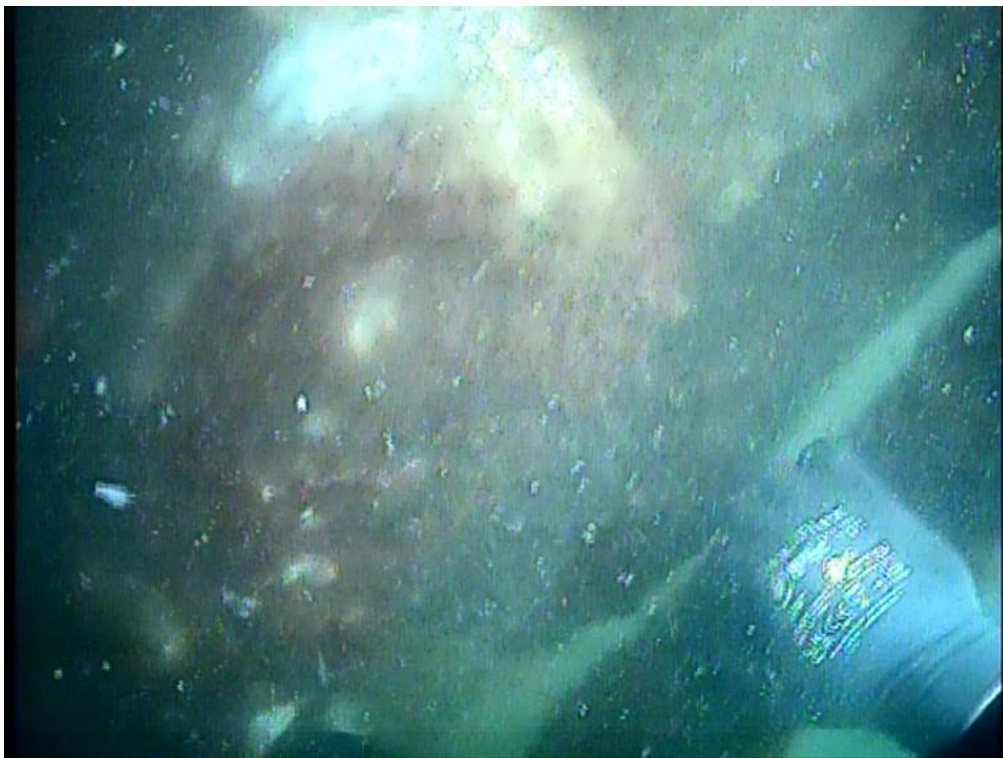
The bottom 1.20m of the fender at Ch. 160 appears to have upto 60% section loss, see photograph 22.

Photograph 22: Defect to fender at Ch 160

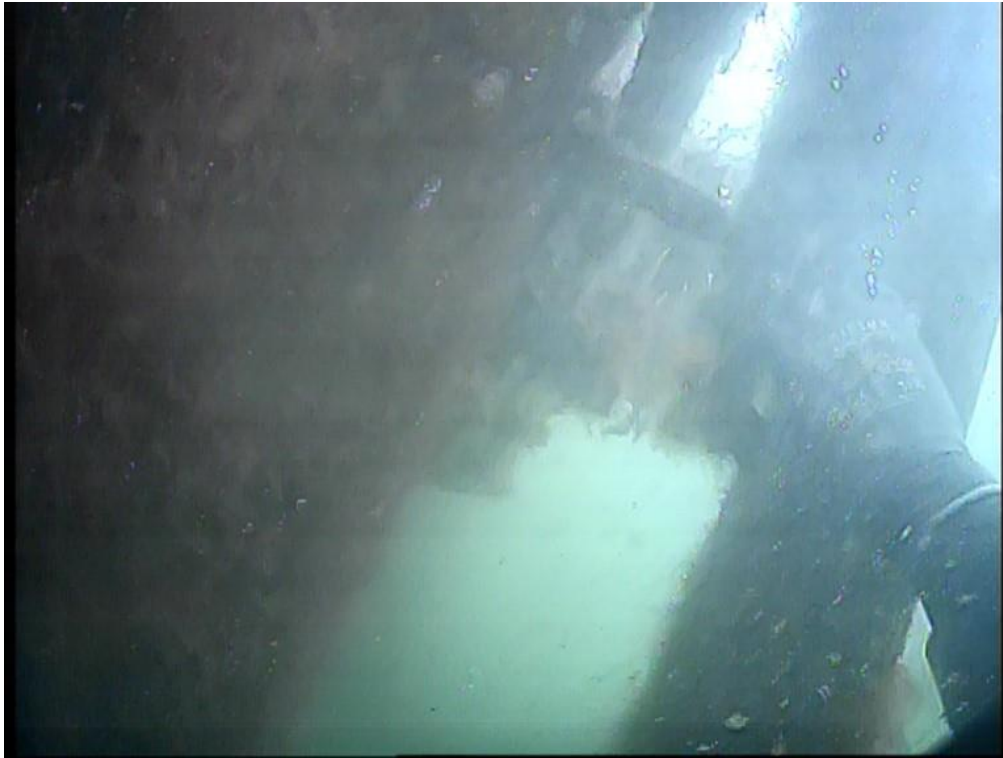
Damaged or missing timber was noted to the bottom 1.20m of the fender at Ch. 163, see photograph 23.

Photograph 23: Defect to fender at Ch 163

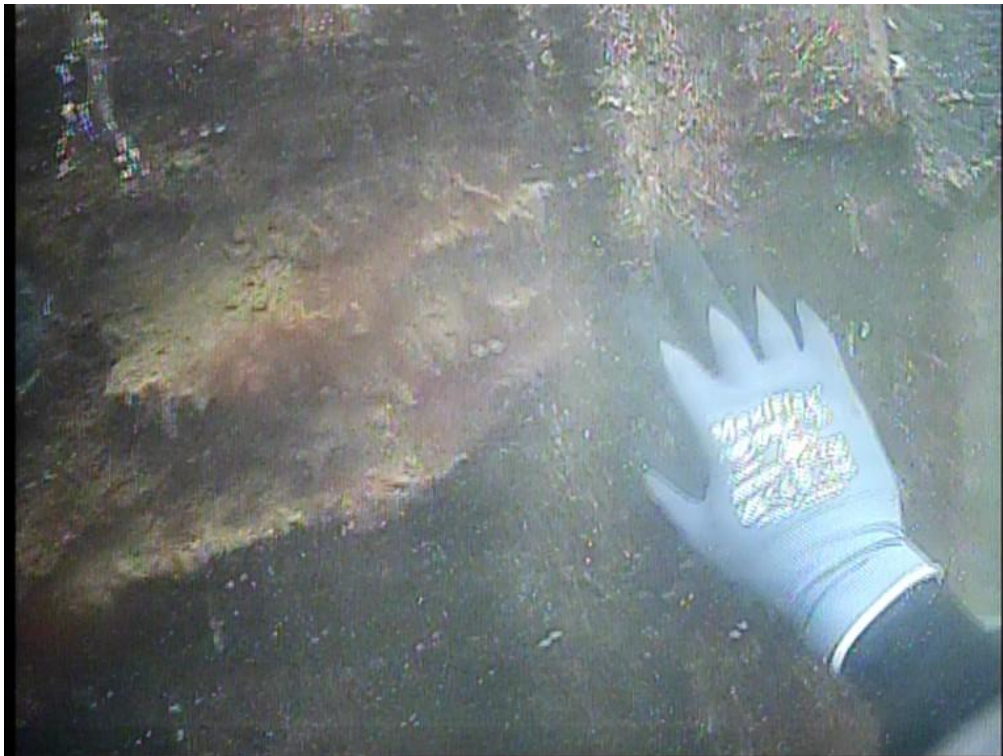
The bottom cross member of the fender at Ch. 167 exhibited upto 40% section loss, see photograph 24.

Photograph 24: Defect to the fender cross member at Ch 167

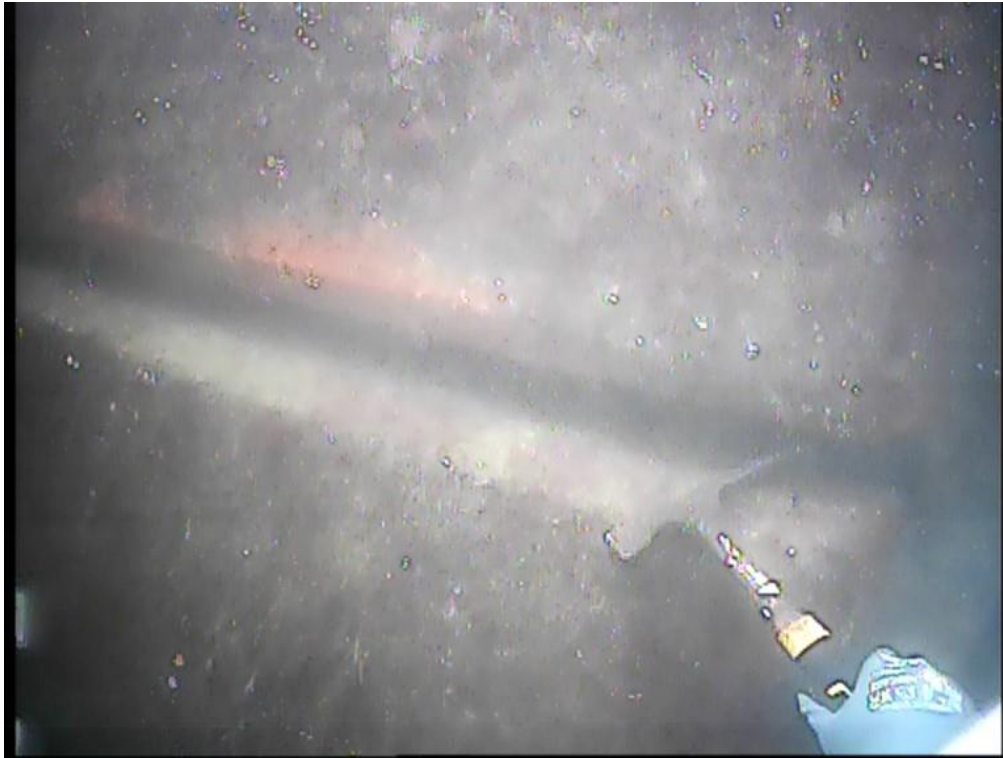
The construction of the pier changed to a concrete facade at Ch. 203, see photograph 25. No significant defects were noted to the remainder of the structure.

Photograph 25: Change in construction at Ch 203
