# Main Pier Sheet Pile Condition Survey at Daingean FHC, Co. Kerry

## Condition Survey Report

| <b>Document No.</b> | IBM0558/EM/R | | | | | |

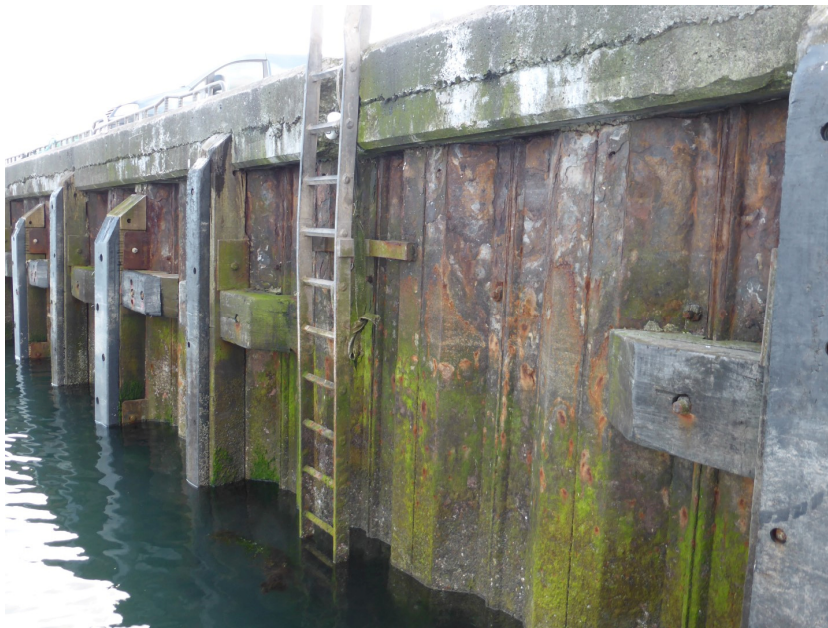
**Plate 4 – Corrosion of sheet piles in Splash zone**

The sheet pile wall exhibits widespread corrosion in the splash zone extending downwards from the crown of the piles over an approximate height of 1.8m (Plate4).

Inspection identified typical degradation with 'blistered' and corroded steel and some loss of steel thickness when compared to areas where the pile was intact. It should be noted however that the deviation of thicknesses encountered (between the visually corroded and intact areas) was minor.

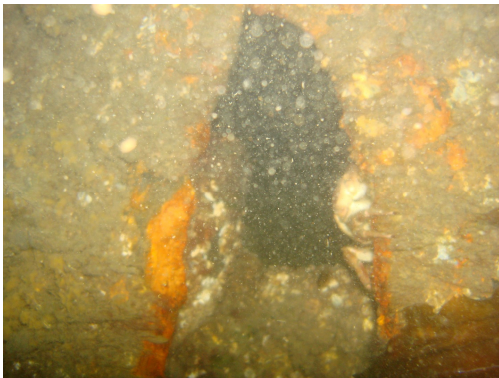
**Plate 5 – Hole in sheet pile wall at CH15m**

- Single hole identified in the permanently immersed zone at CH15m (150mm wide x 450mm ht). (Plate 5)
- Small holes in intertidal zone (4Nr) believed to be formed at CH0m, CH160m and CH170m.
- 2 Larger holes at approx CH40m in the splash zone (Plate 6)

While holes are typically significant: the encountered holes are small and are suitable for localised repairs are not of major concern.

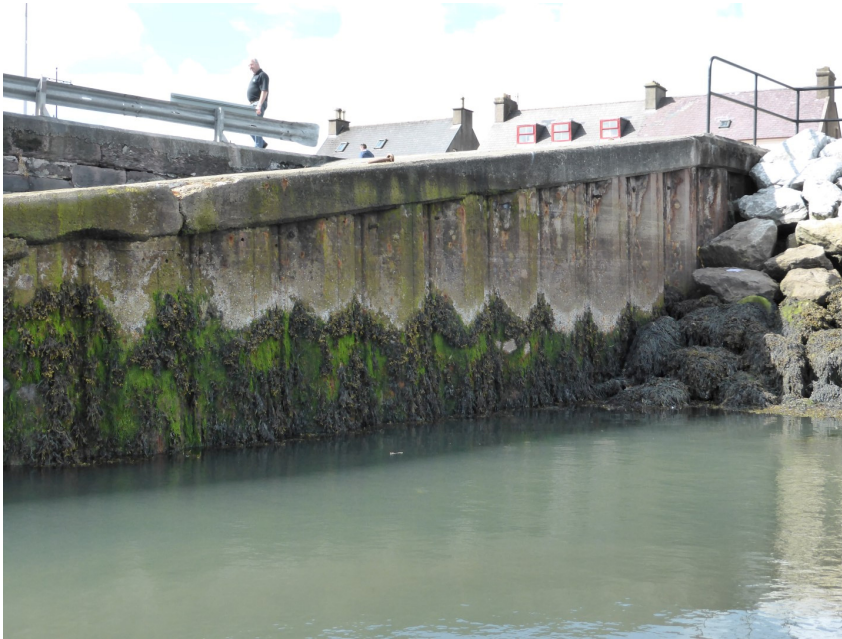
**Plate 7 – Typical view on Punt slipway sheet pile wall**

Also, like the main sheet pile wall surface corrosion is also firmly adhered to the surface of the pile and is providing a level of protection to the intact steel behind. Indeed it should be noted that the piles were extremely difficult to prepare for thickness testing (removing surface corrosion to bare steel behind by hand methods). A typical view of current condition is shown in Plate 7.

As noted the condition of these piles is largely typical of the condition encountered on the splash zone of the main pier sheet piles however the readings obtained indicate a lower loss of wall thickness.

The surface corrosion remains firmly adhered to the piles providing some ongoing protection. Furthermore it should be noted that the exposed length of pile is limited as the structure is abutted by the adjacent rock armour revetment. For this reason significant deflection or structural failure is unlikely.

Given the above it is suggested to monitor these piles to determine any ongoing deterioration prior to conducting any repairs. The current condition does not present any current integrity concerns and this element of the structure is unlikely to require maintenance/remedial works for 3 to 5 years.

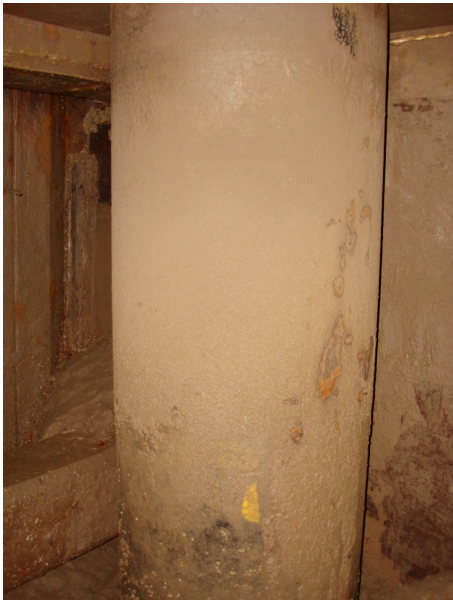
**Plate 8 – Typical view on tubular steel bearing pile**

Although readings obtained indicate (for the record nominal wall thickness) ongoing corrosion equal to the upper level of that expected for temporal climates it should be noted that no visual evidence of significant corrosion was encountered during the survey. Pending confirmation of the installed nominal wall thickness and thus the rate of any corrosion, it is considered that the piles are in reasonable condition for their age. (Plate 8)

As noted within section 4.2 the thickness readings obtained are generally higher than that expected for exposure on a single side, however if the pile is not plugged and water and oxygen are allowing corrosion from the inside, then the majority of readings encountered are inline with that expected for steel elements in temporal climates however;

- Multiple readings of almost twice this rate were noted in row Bb and row H. It may be possible that these piles have a thinner wall thickness however this remains to be confirmed.
- Readings of up to 4mm loss were also noted on further individual piles.

In this respect an approach centred on monitoring and proactive management (with maintenance/repairs conducted as identified) is likely to be the most prudent and cost effective approach to ensure the piles remain in good condition and fit for purpose.

In particular, the condition of piles: Bb1, Bb3, C4, E4, F1, G4, H2, H3, H4, J1 and J4 should be monitored and checked for residual thickness against the results baseline of this survey to determine the level of deterioration over time. This could be considered at a 3 to 5 year interval.

If/when required maintenance may be in the form of cleaning and application of a proprietary paint coating system or surface coating. It should be noted that as the piles dry out at low water sacrificial anodes fixed to the piles would not be appropriate and installation on the seabed with connections to the piles may not be possible given the varying bed levels and conditions and the limited space between piles and structural bracing elements.

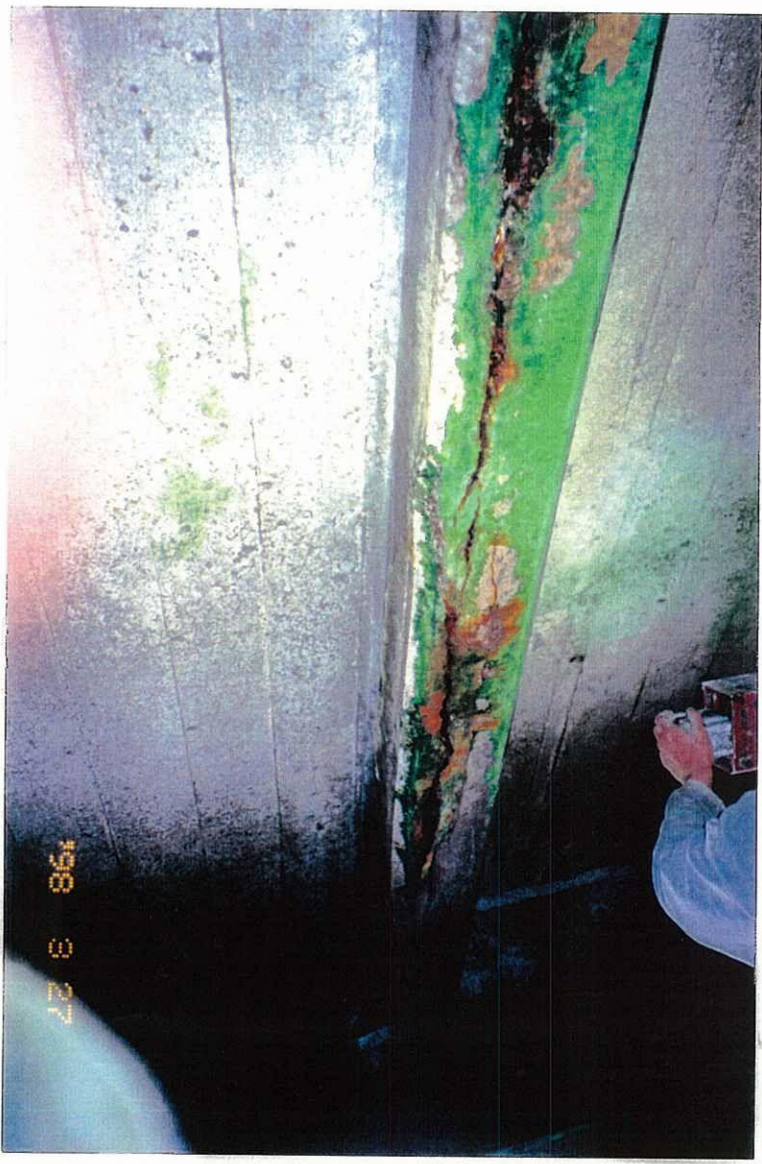
P.5. - TYPICAL DETERIORATION /  
SECONDARY BEAMS

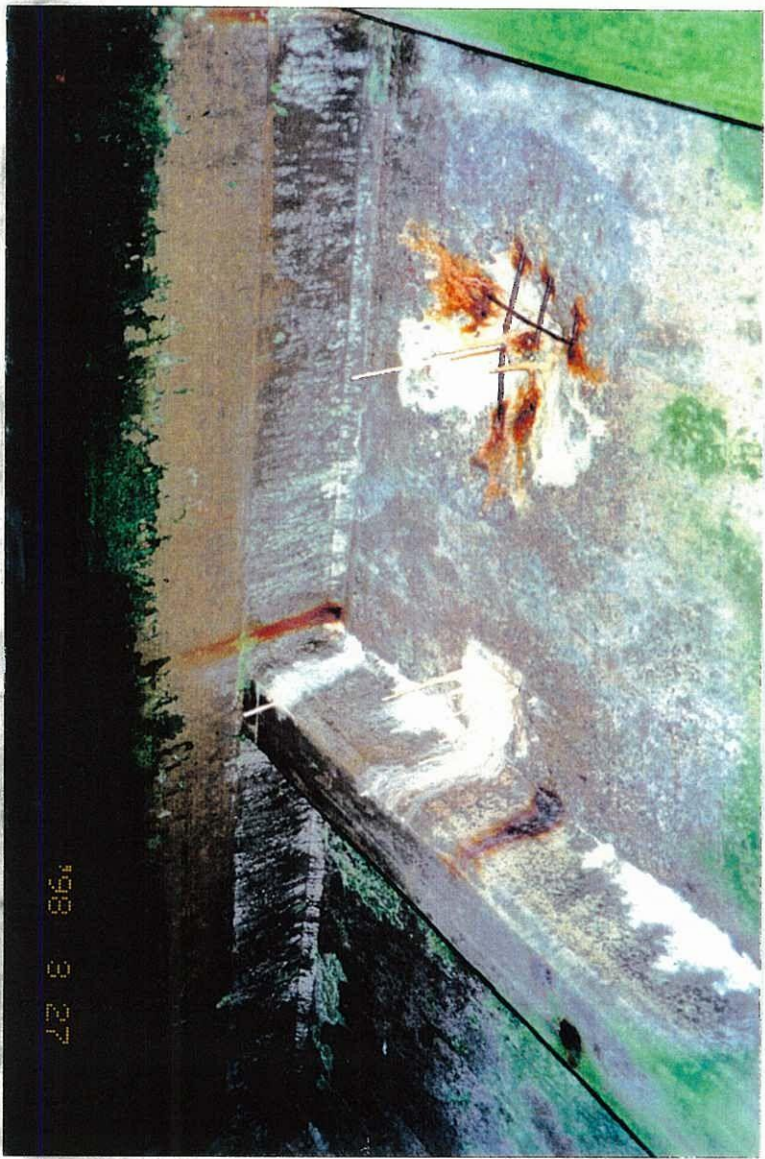
P.6. - SLAB DETERIORATION

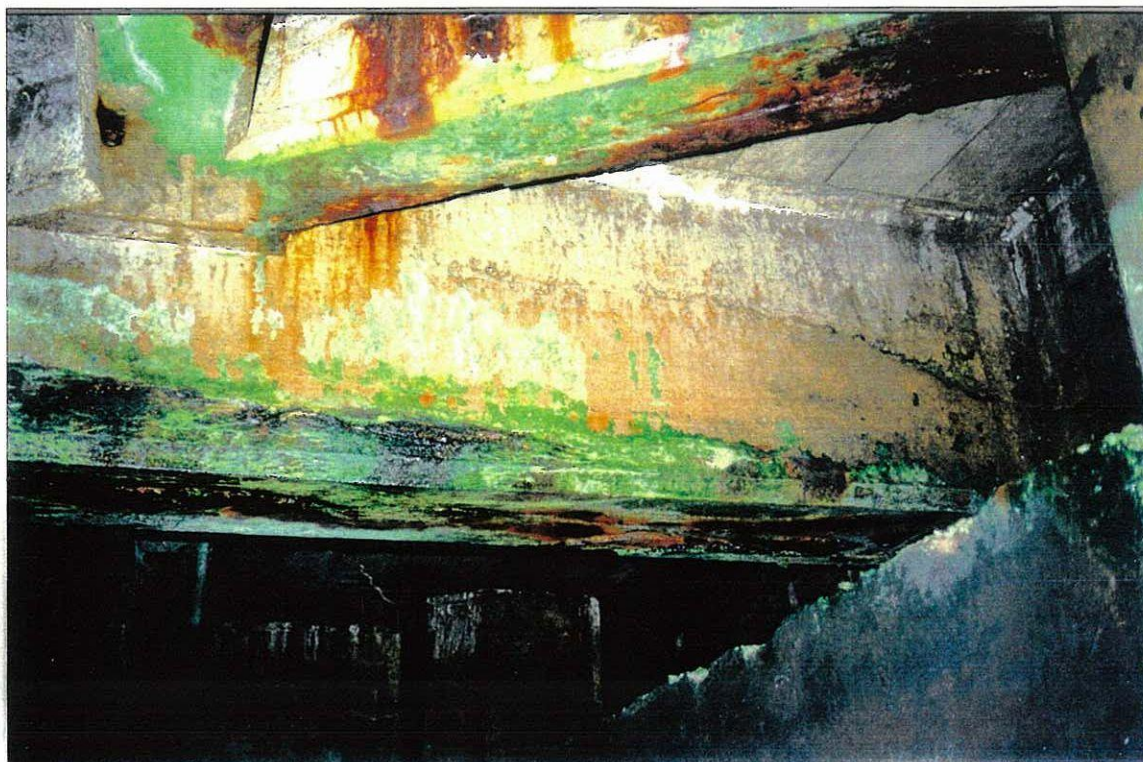
*P.7. - DETERIORATION OF BEAM ELEMENTS*

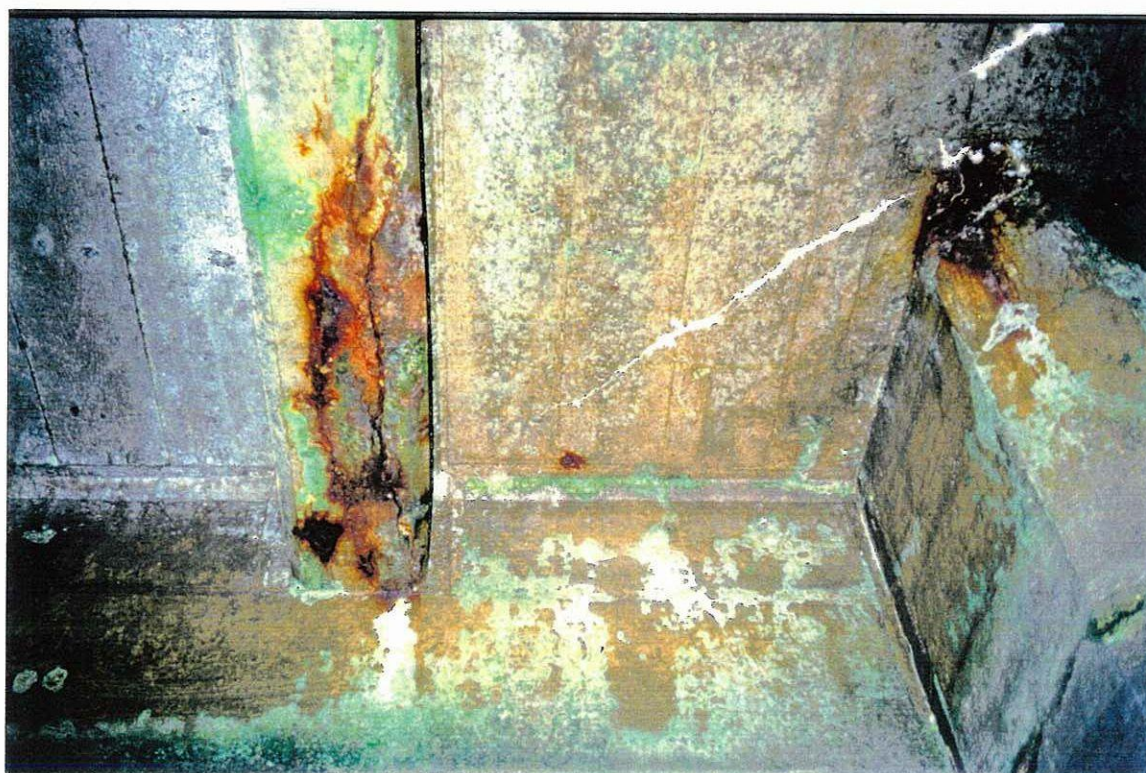
*P.8. - DITTO AS P7*
