# ROSCOMMON COUNTY COUNCIL

## RETAINING STRUCTURE AT QUARRY LANE, BOYLE, CO. ROSCOMMON.

### VISUAL SURVEY REPORT

**JANUARY 2025**

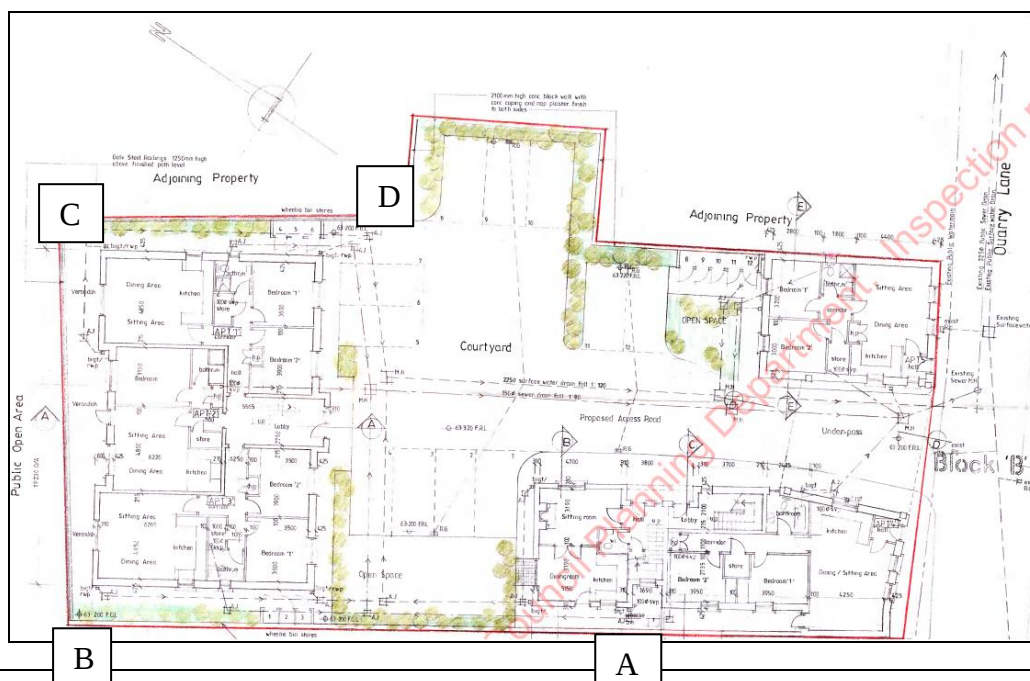
The retaining structure runs from point 'A' to 'B' to 'C' to 'D'.

The height at point 'A' is approximately 1m (retaining). The height at points 'B' and 'C' is approximately 5m (retaining). The height at point 'D' is approximately 1.2m (retaining).

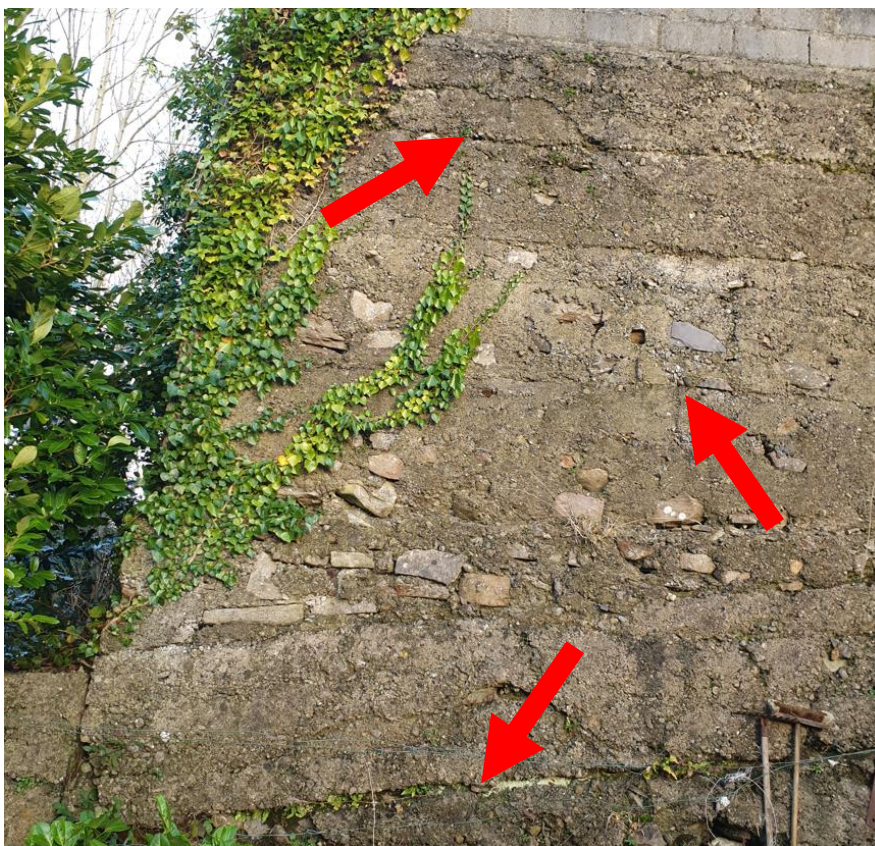
There are horizontal and sloped construction cracks. These cracks developed at locations where sections of the wall were being constructed.

Examples of construction cracks indicated above.

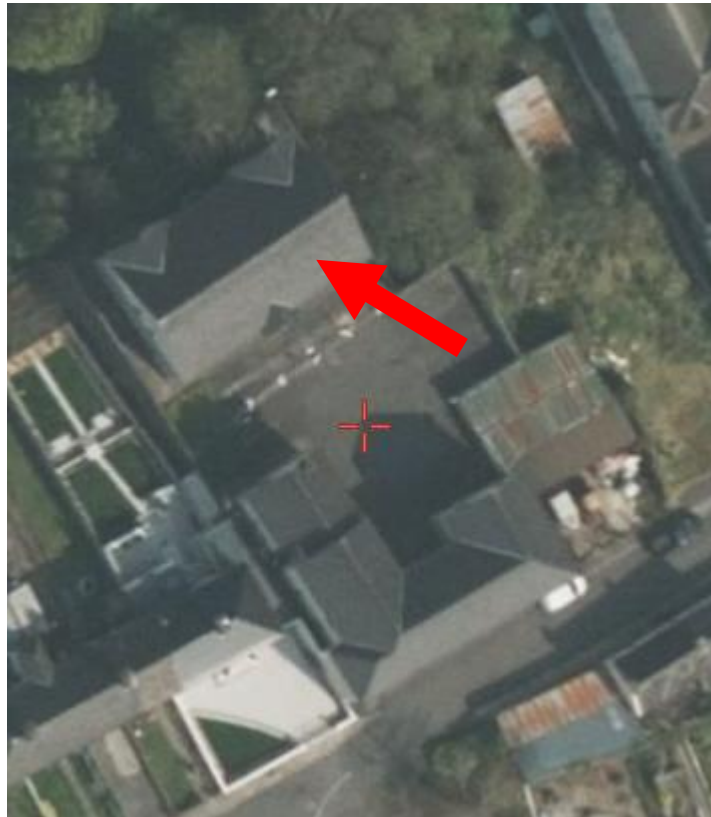
**Photograph 1 Site overview – Note building at northern end of site to be demolished - indicted by red arrow.**

Sequencing of any proposed demolition works, together with preparation of Risk Assessment and method statements (RAMS), incorporating 'safe zones', will need to be developed to ensure that the works do not negatively impact the already compromised retaining structure and provide a safe environment for all workers on site or users of adjacent lands.

Use of long reach excavators is recommended.

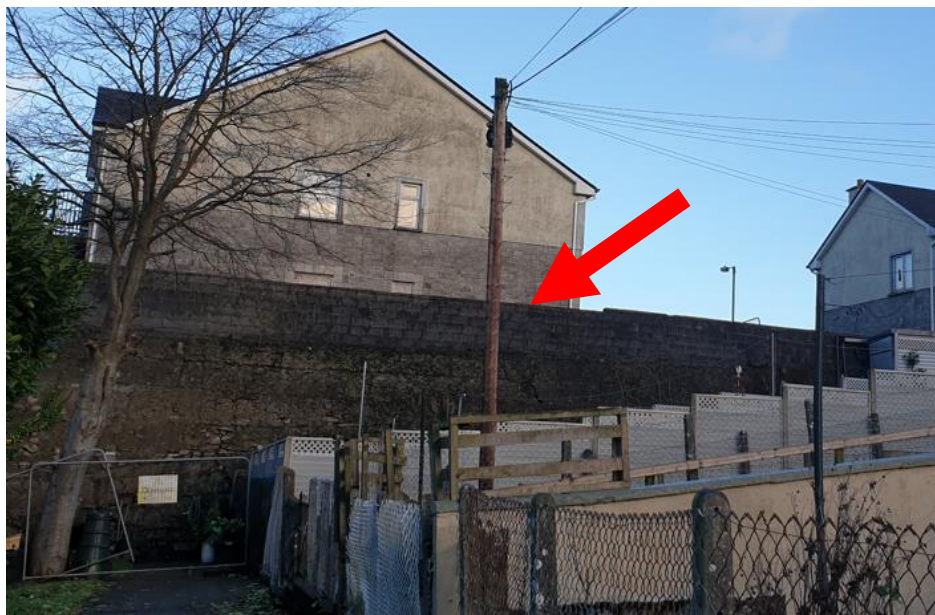
**Photograph 2 West face of structure – Note block built wall over original structure.**

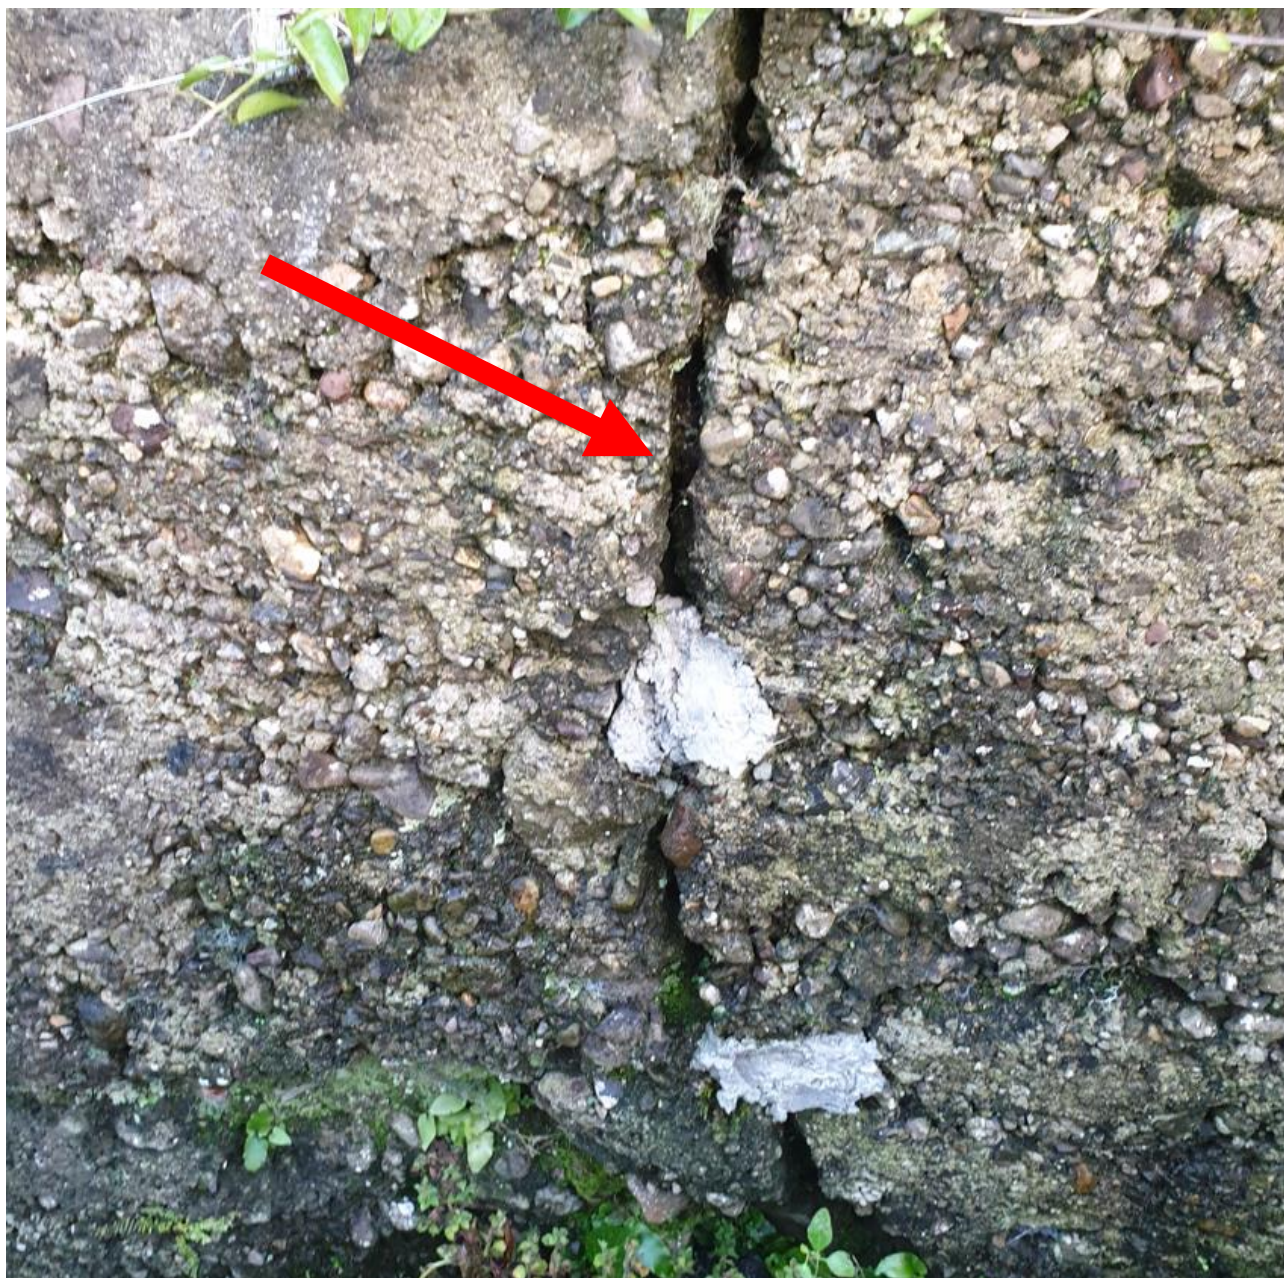
**Photograph 3 West Face of structure. Note cracking to base of wall.**

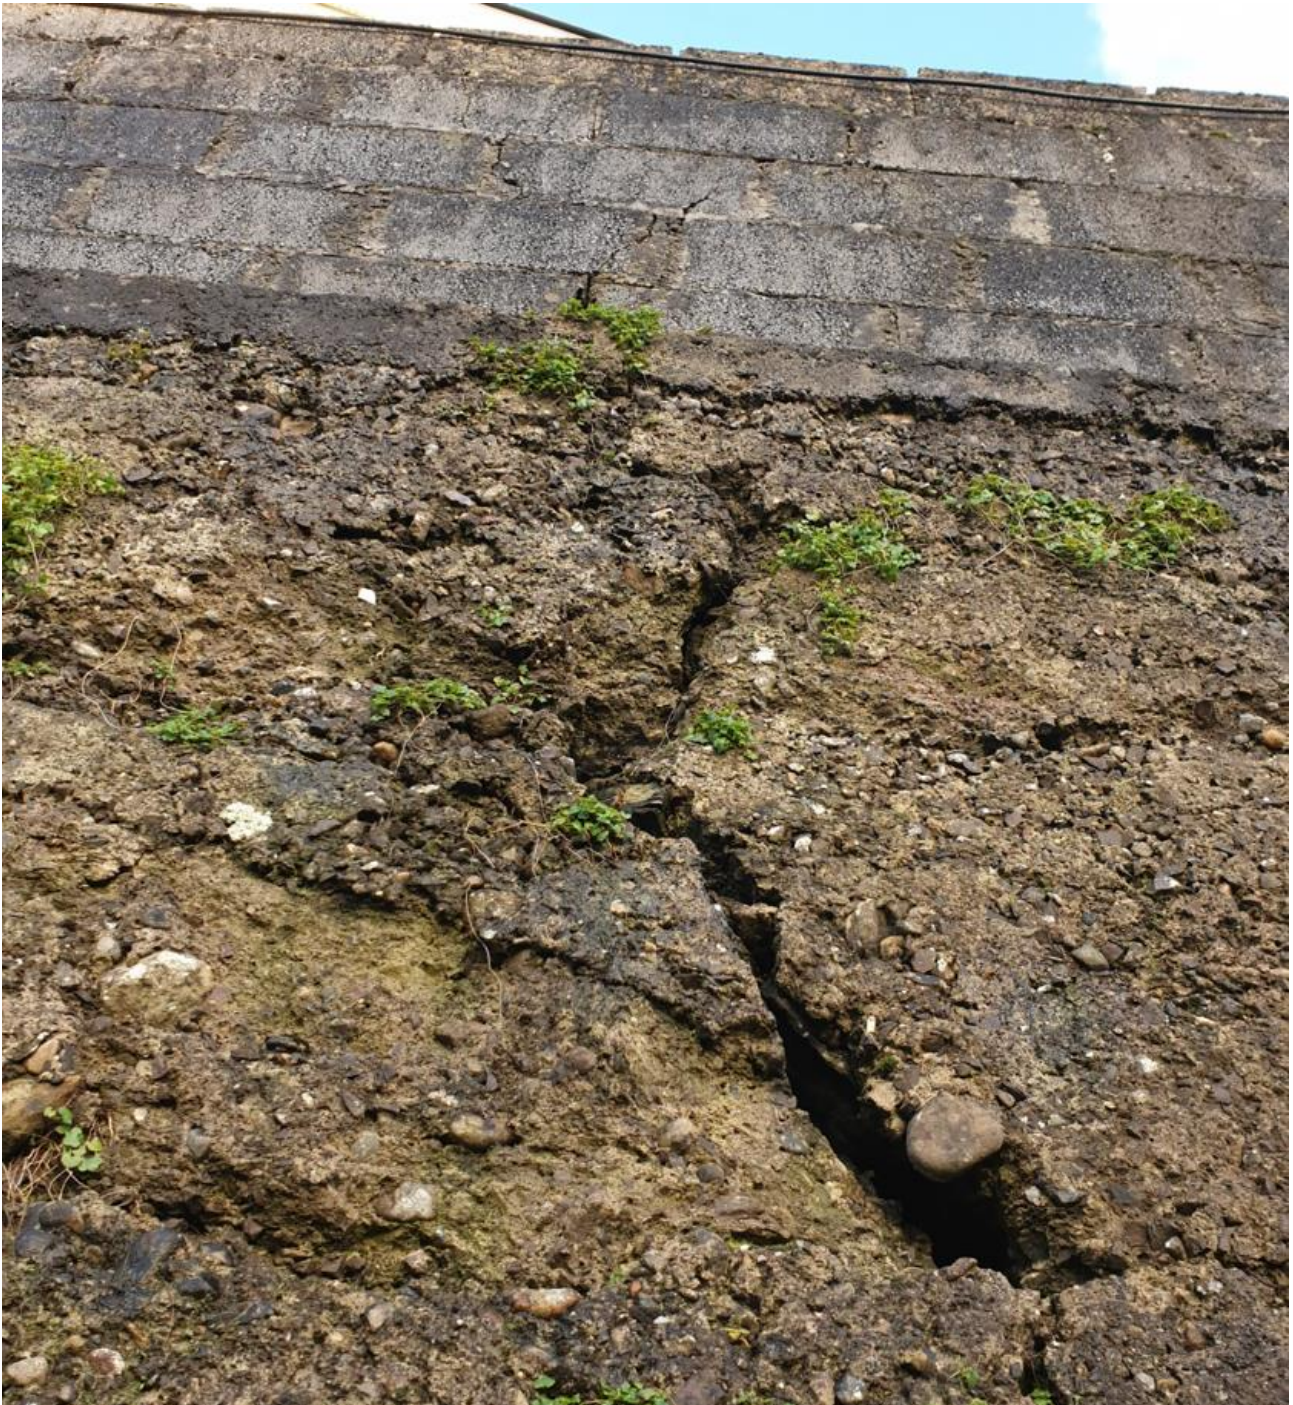
Severe, vertical and stepped cracking was noted to the northern, eastern and western faces of the wall. These cracks are structural in nature and have potentially serious consequences for the overall structural integrity of the wall.

**Photograph 4 West face of structure. Note significant cracking to original wall and to block wall above.**

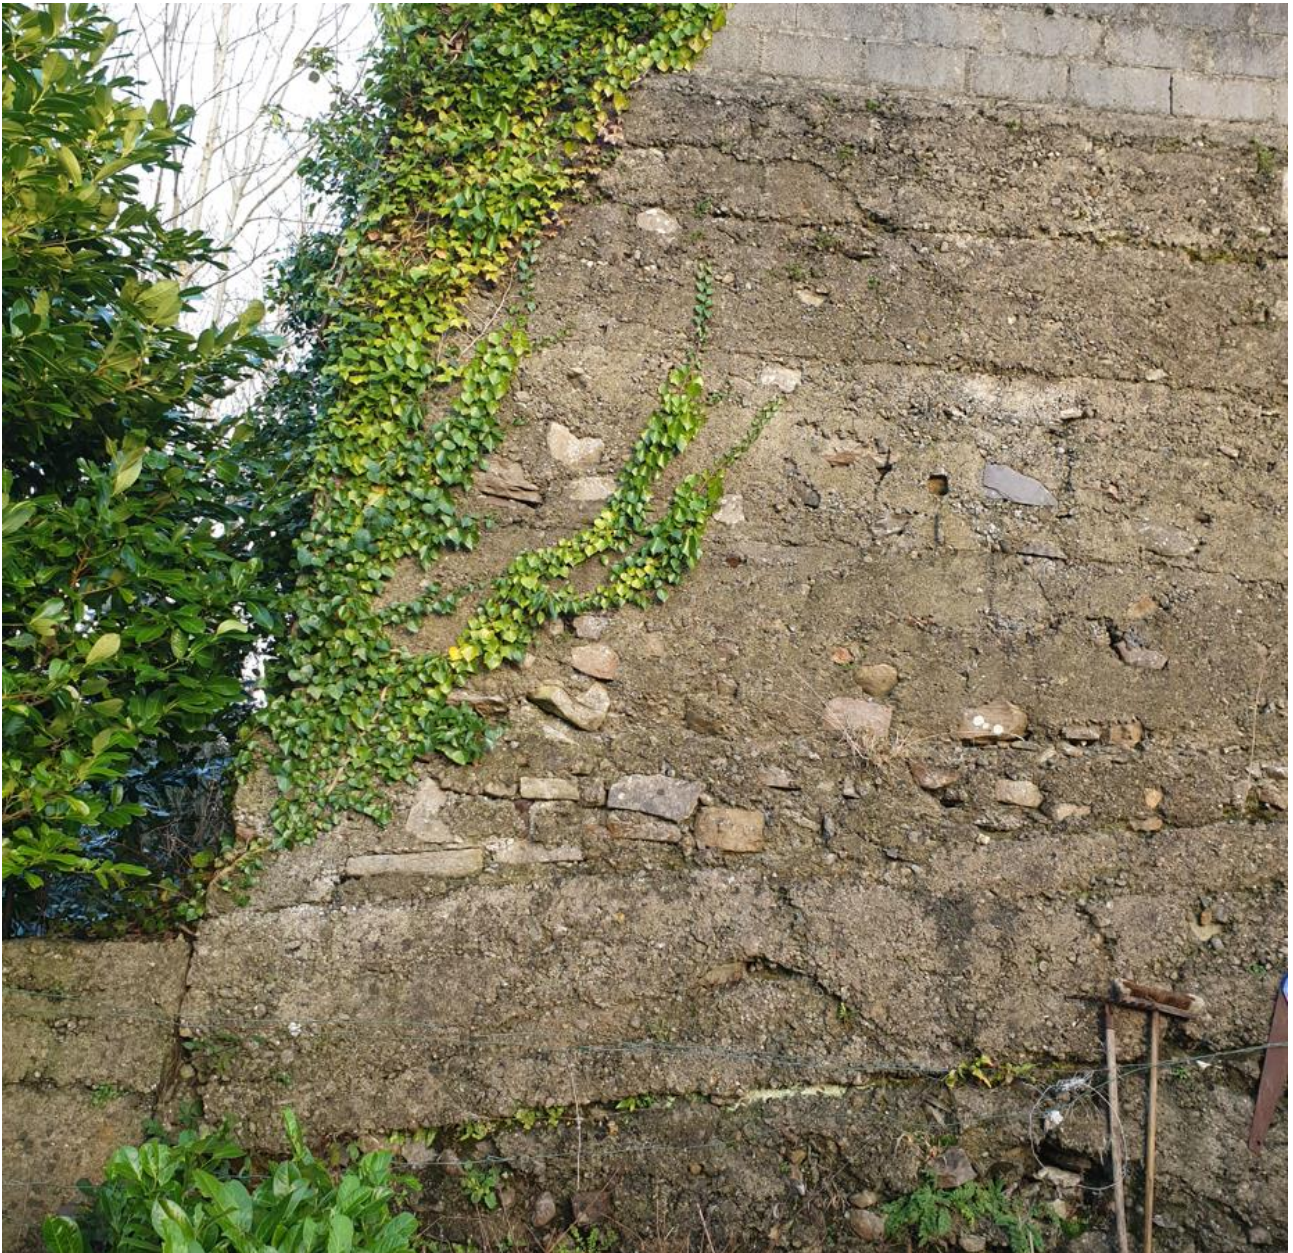
**Photograph 5 West face (northern end of structure). Note general condition, including construction joint cracking.**

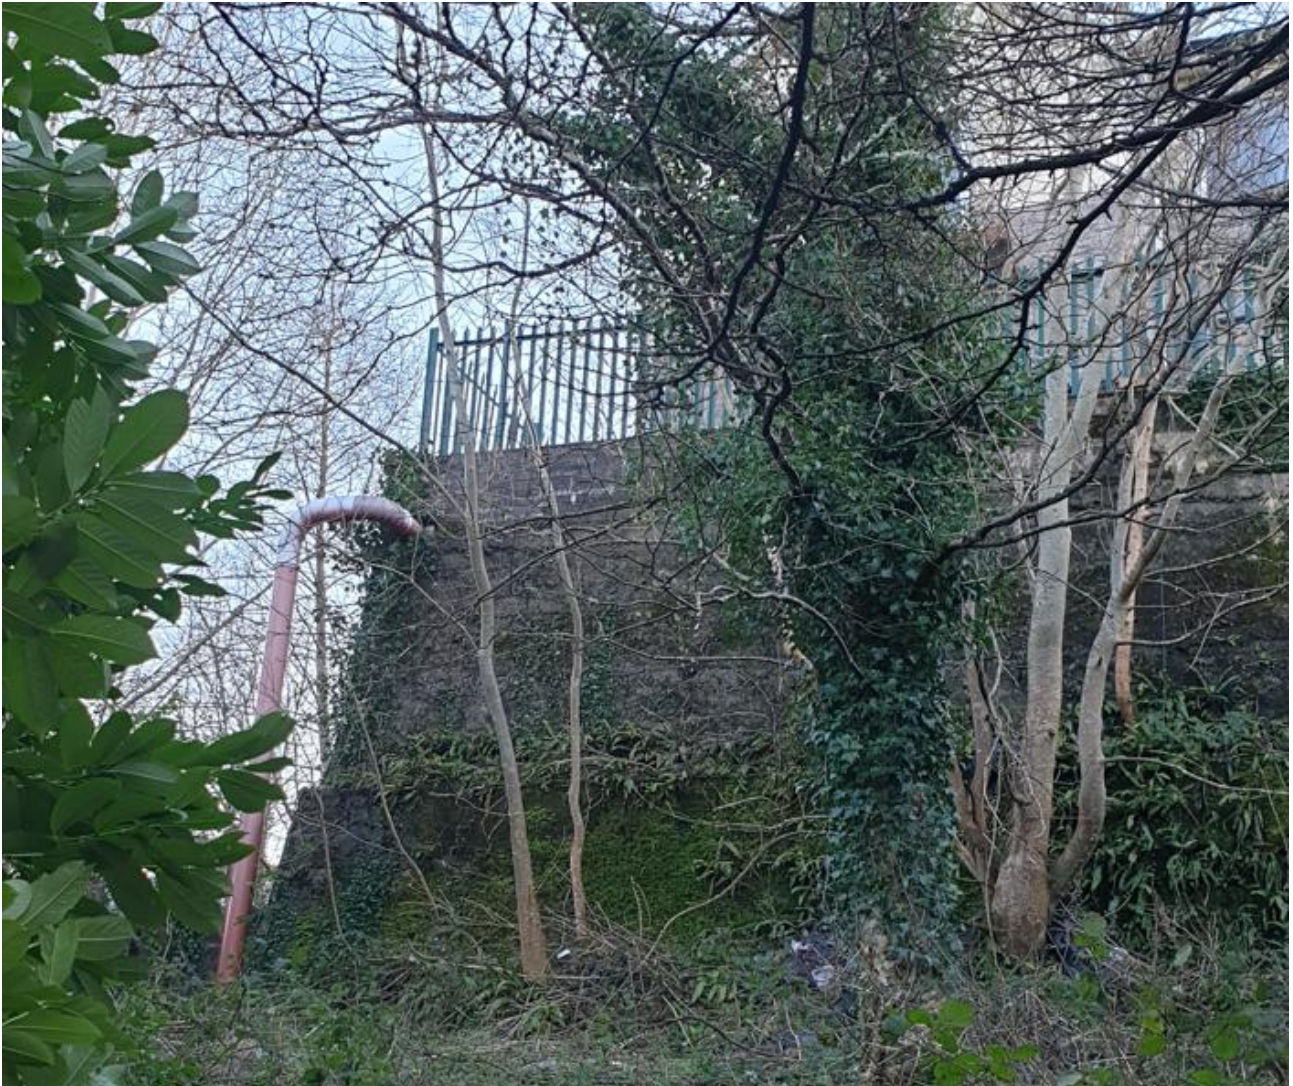
Tree roots and ivy have also penetrated the structure (predominantly on the northern face), further affecting the integrity of the structure.

**Photograph 6 Northern face of structure – Note generally condition of structure including proximity of trees and root infiltration / penetration.**

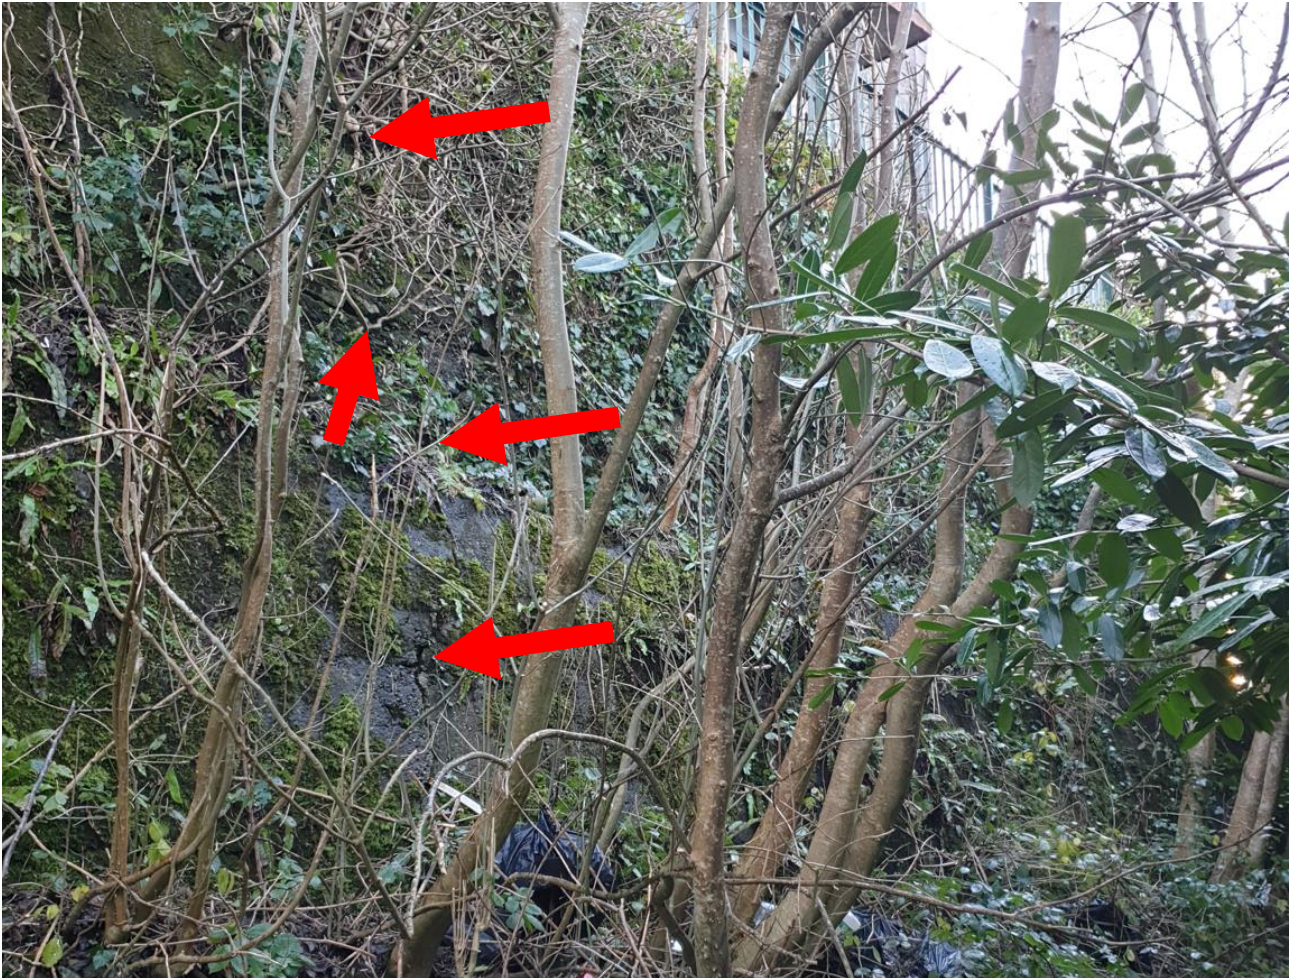
**Photograph 7 Northern face of structure – Note generally condition of structure including proximity of trees and root infiltration / penetration. Location of significant cracking indicated (masked by overgrowth).**

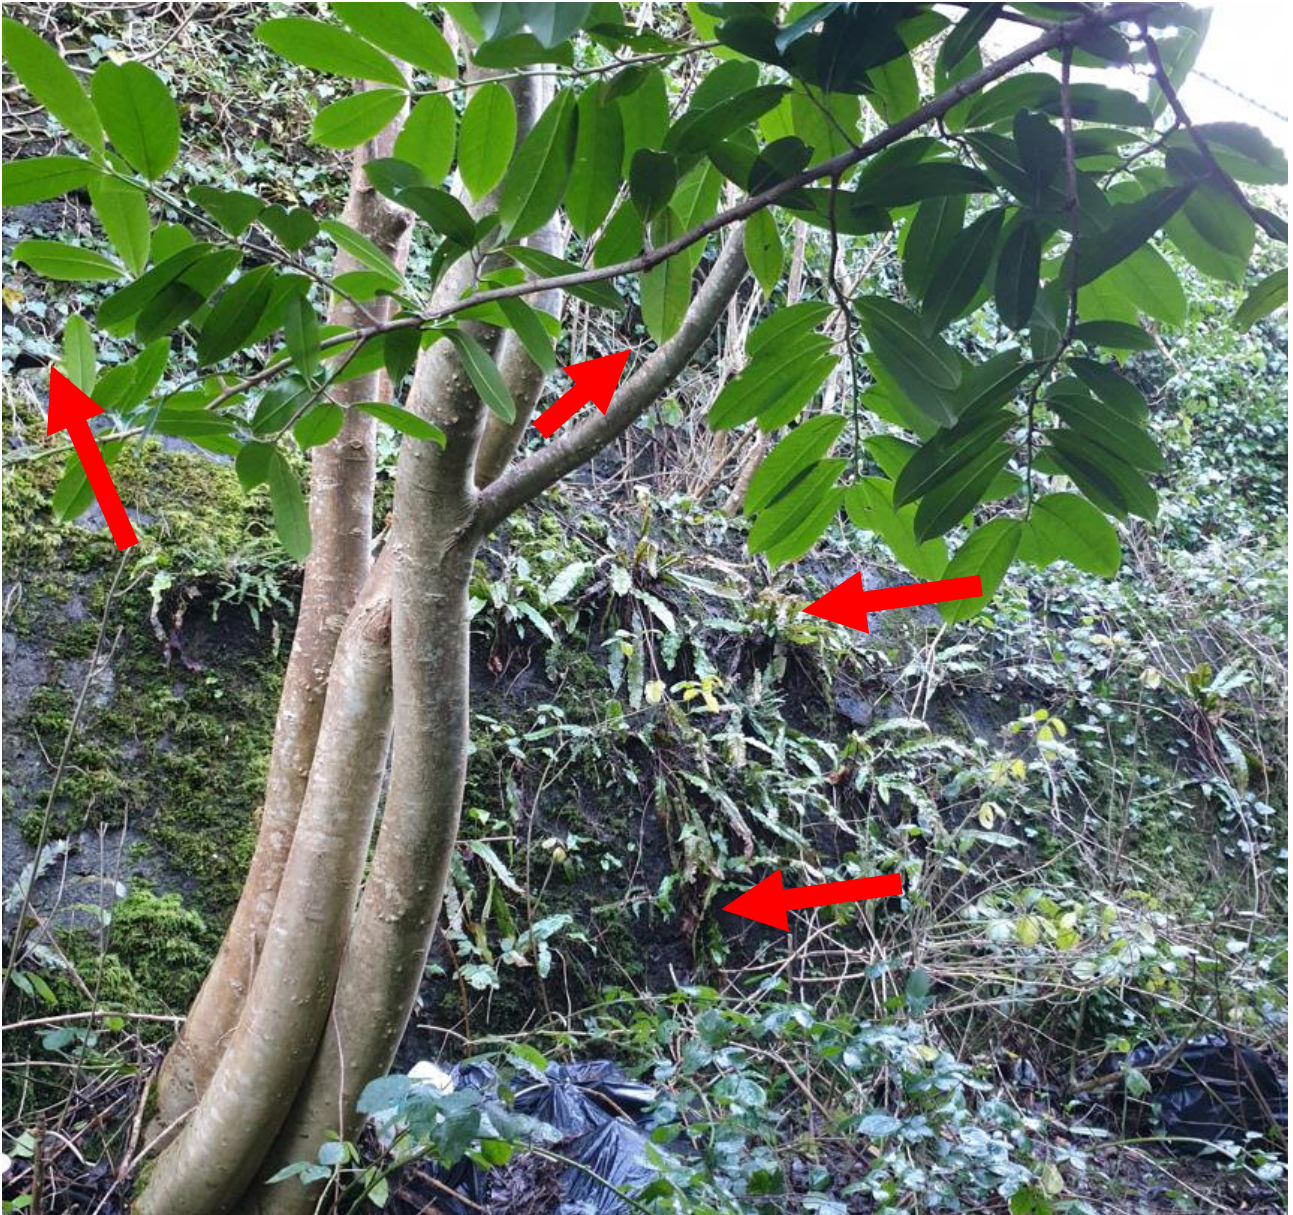
**Photograph 8 Northern face of structure – Note generally condition of structure including proximity of trees and root infiltration / penetration. Location of significant cracking indicated (masked by overgrowth).**

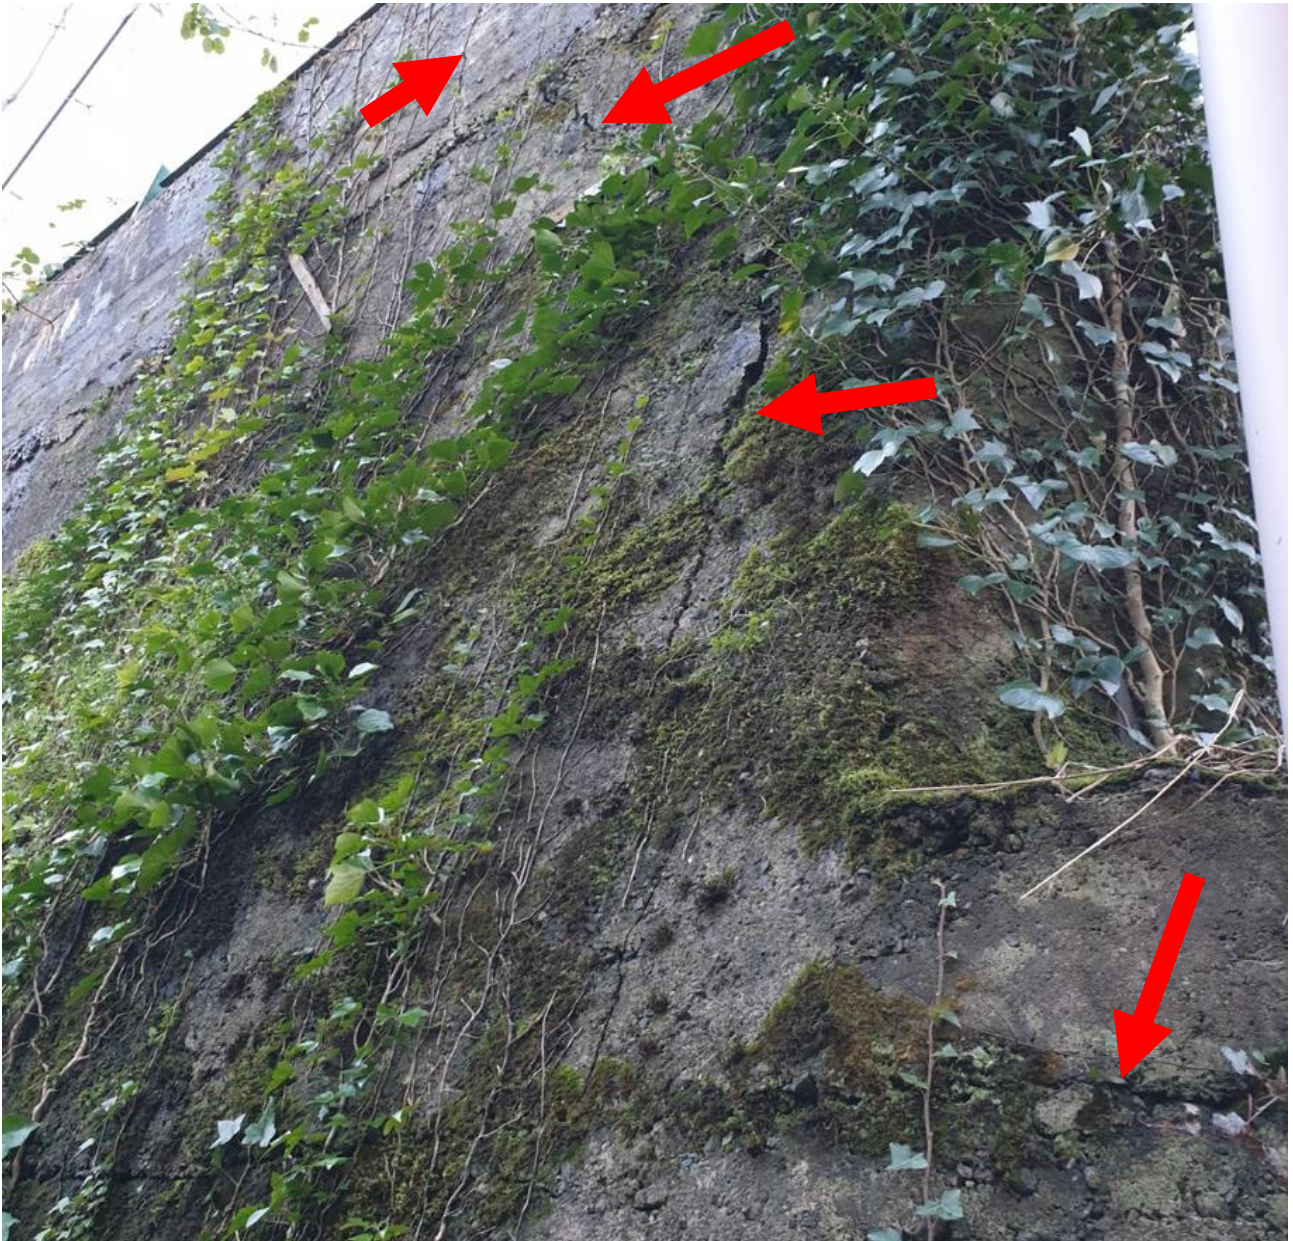
**Photograph 9 Eastern face of structure – Note generally condition of structure including root infiltration / penetration. Location of significant cracking indicated.**

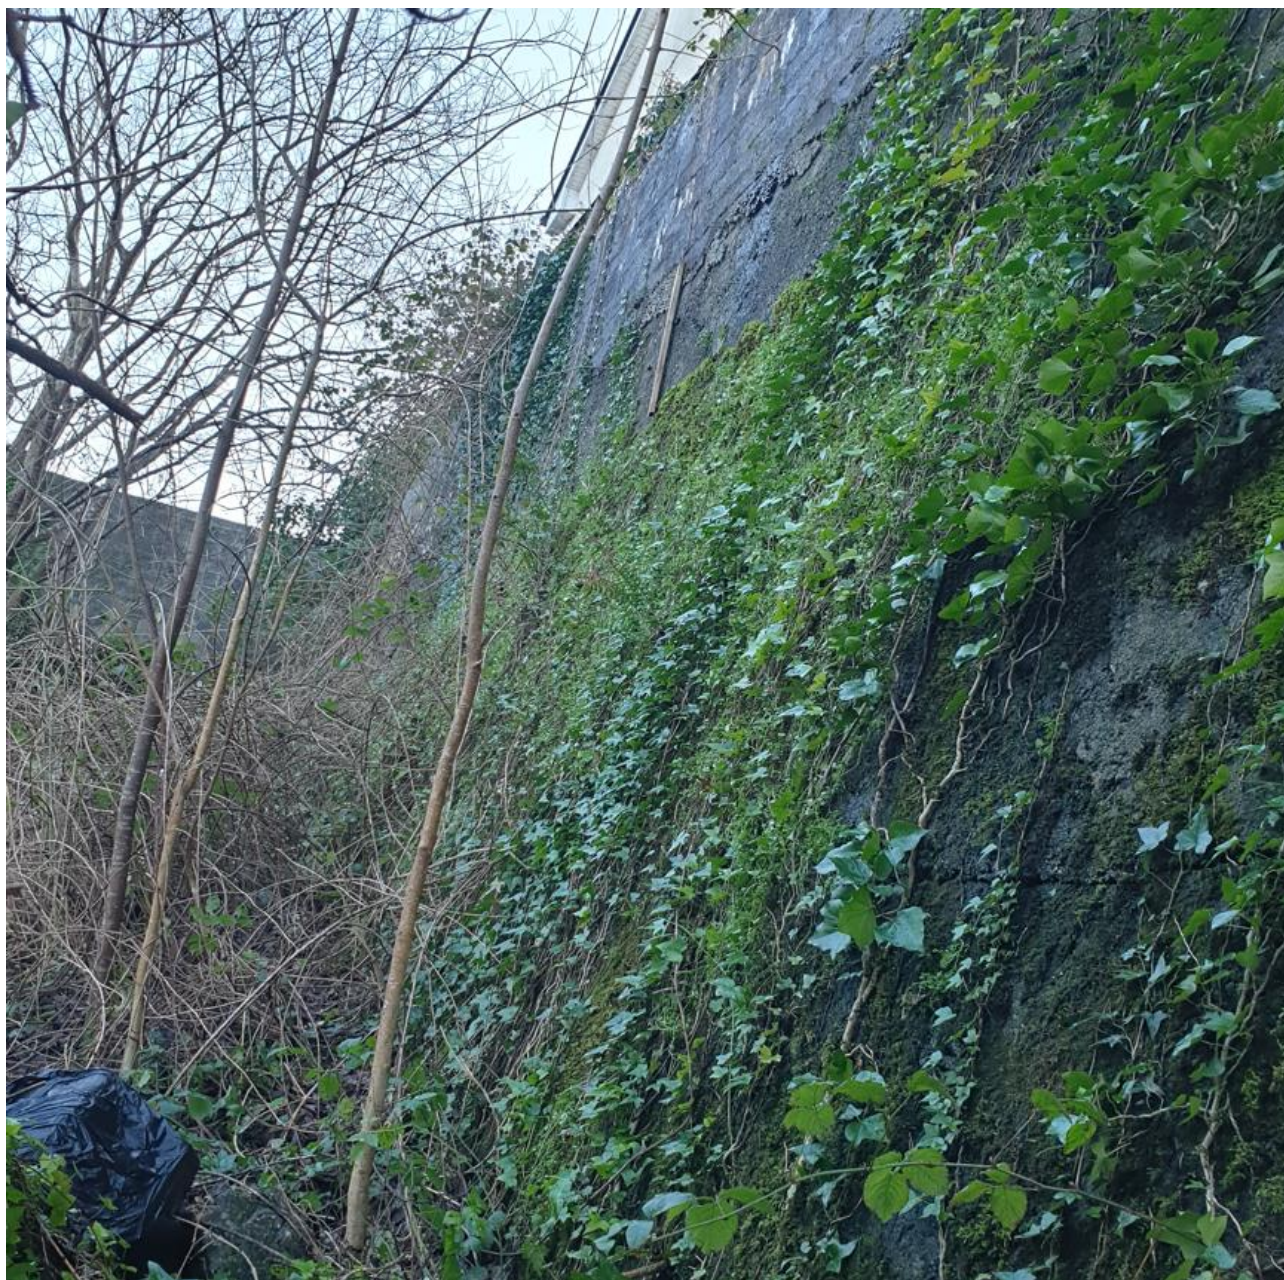
**Photograph 10 Eastern face of structure – Note generally condition of structure.**

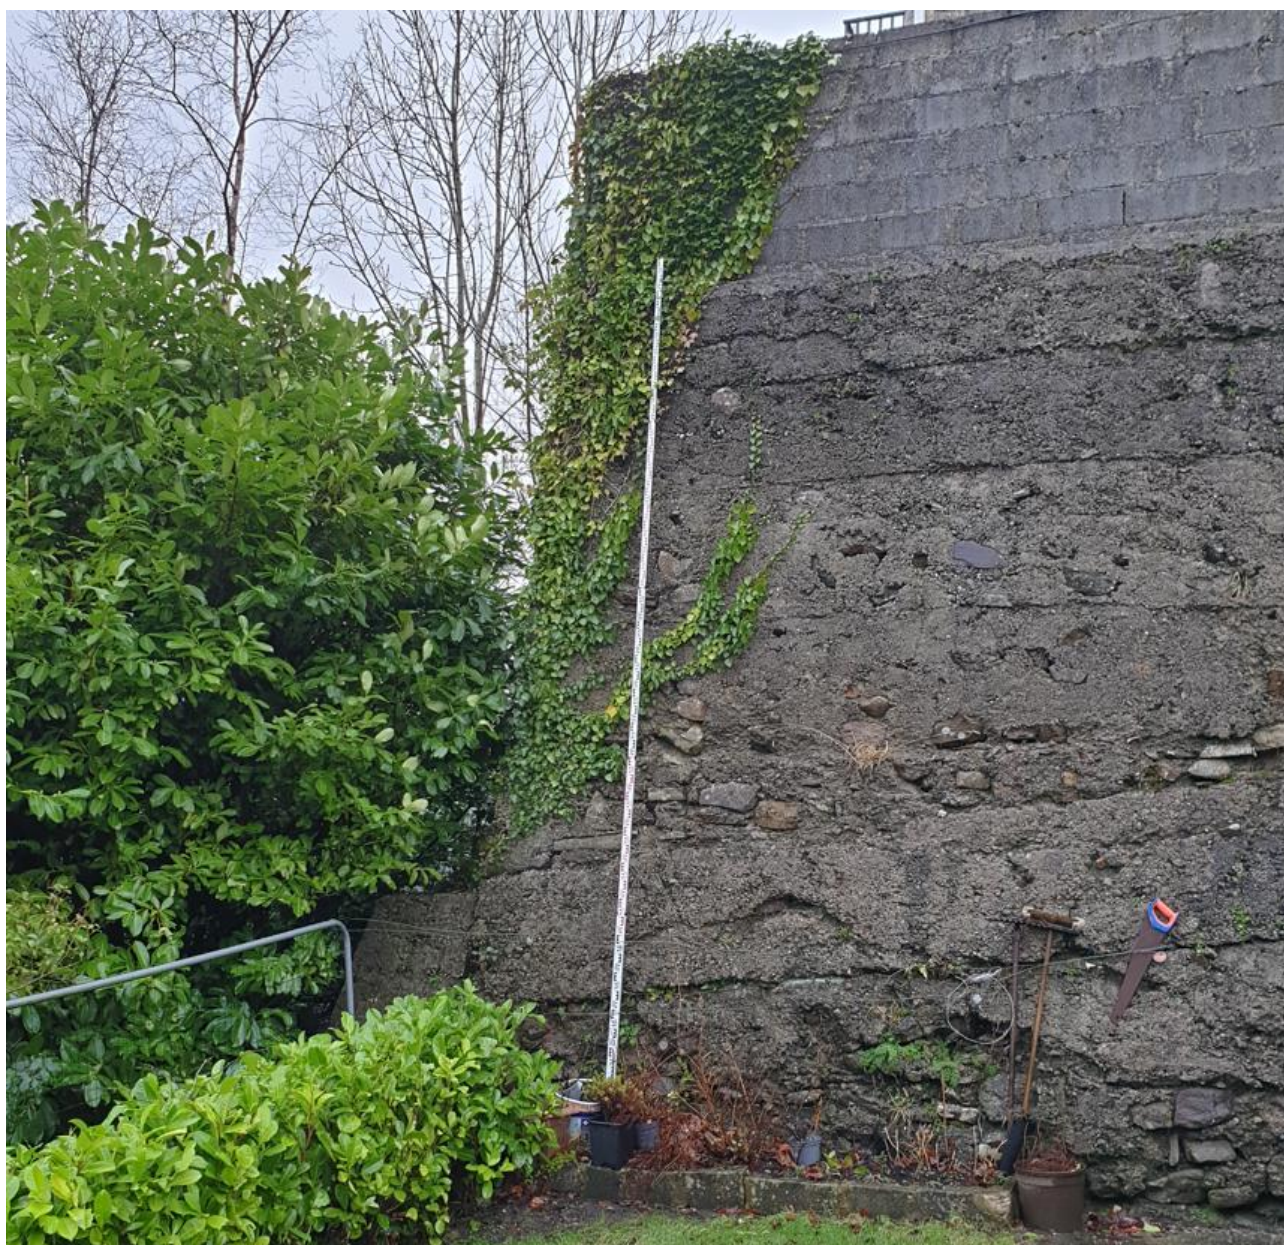
**Photograph 11 North western corner of structure – Note 5m measuring staff.**

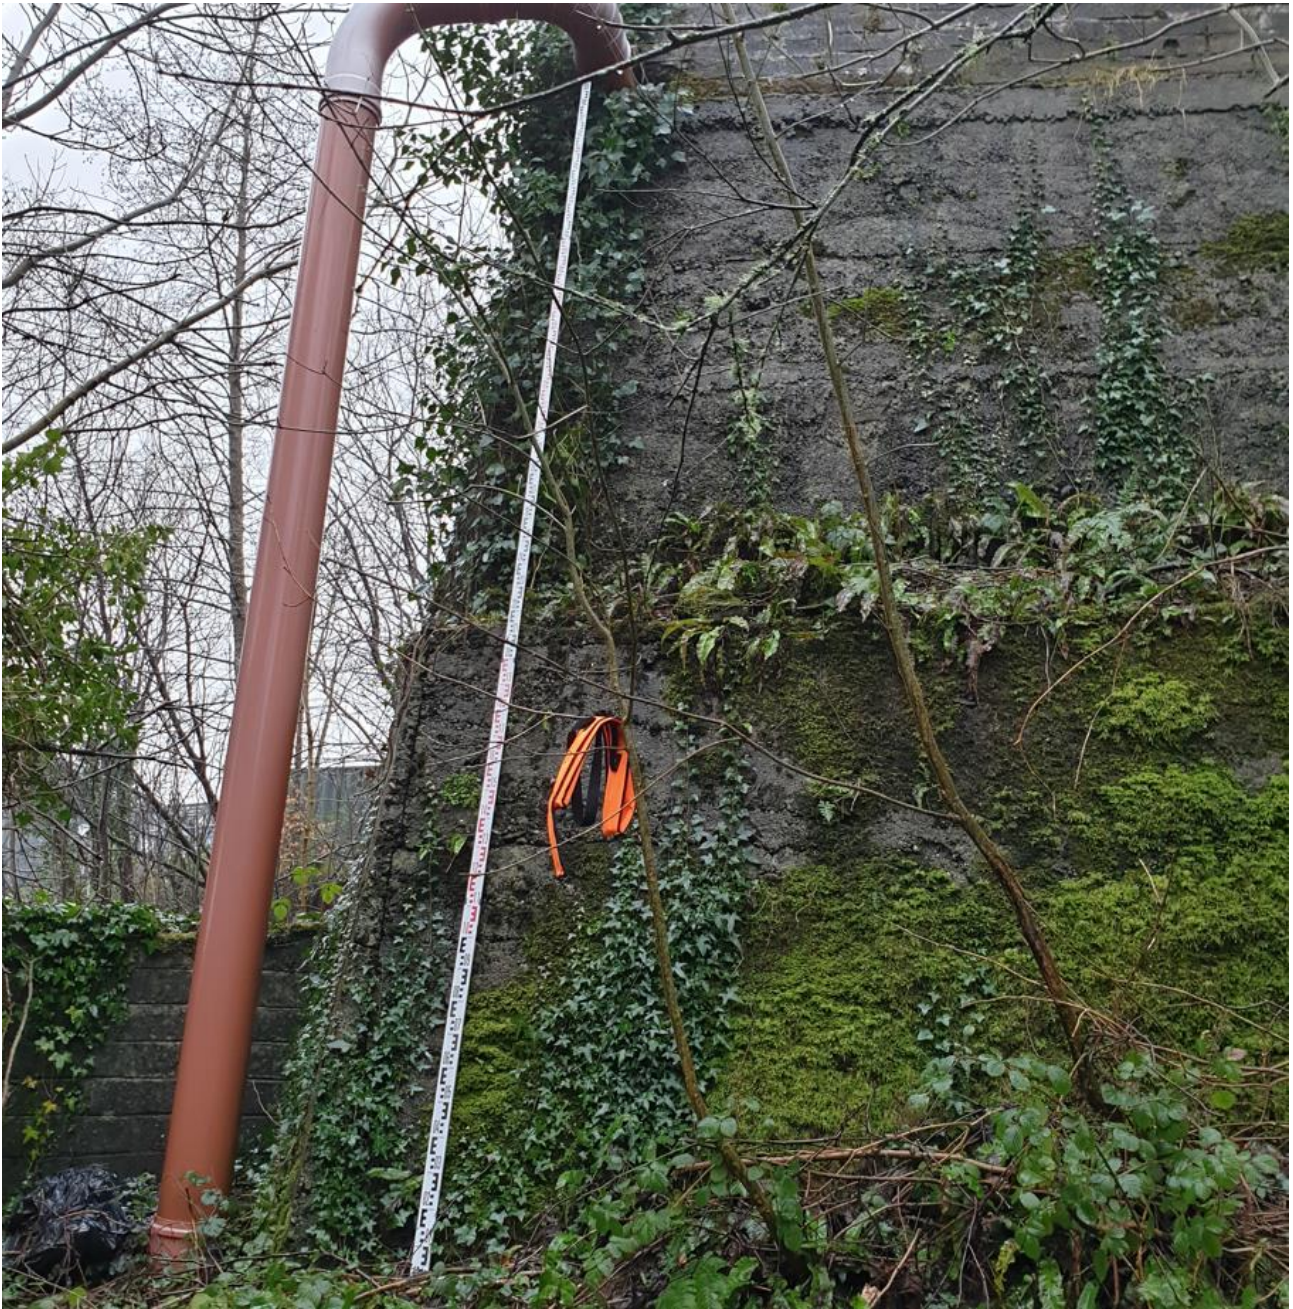
**Photograph 12 North Eastern corner of structure – Note 5m measuring staff.**

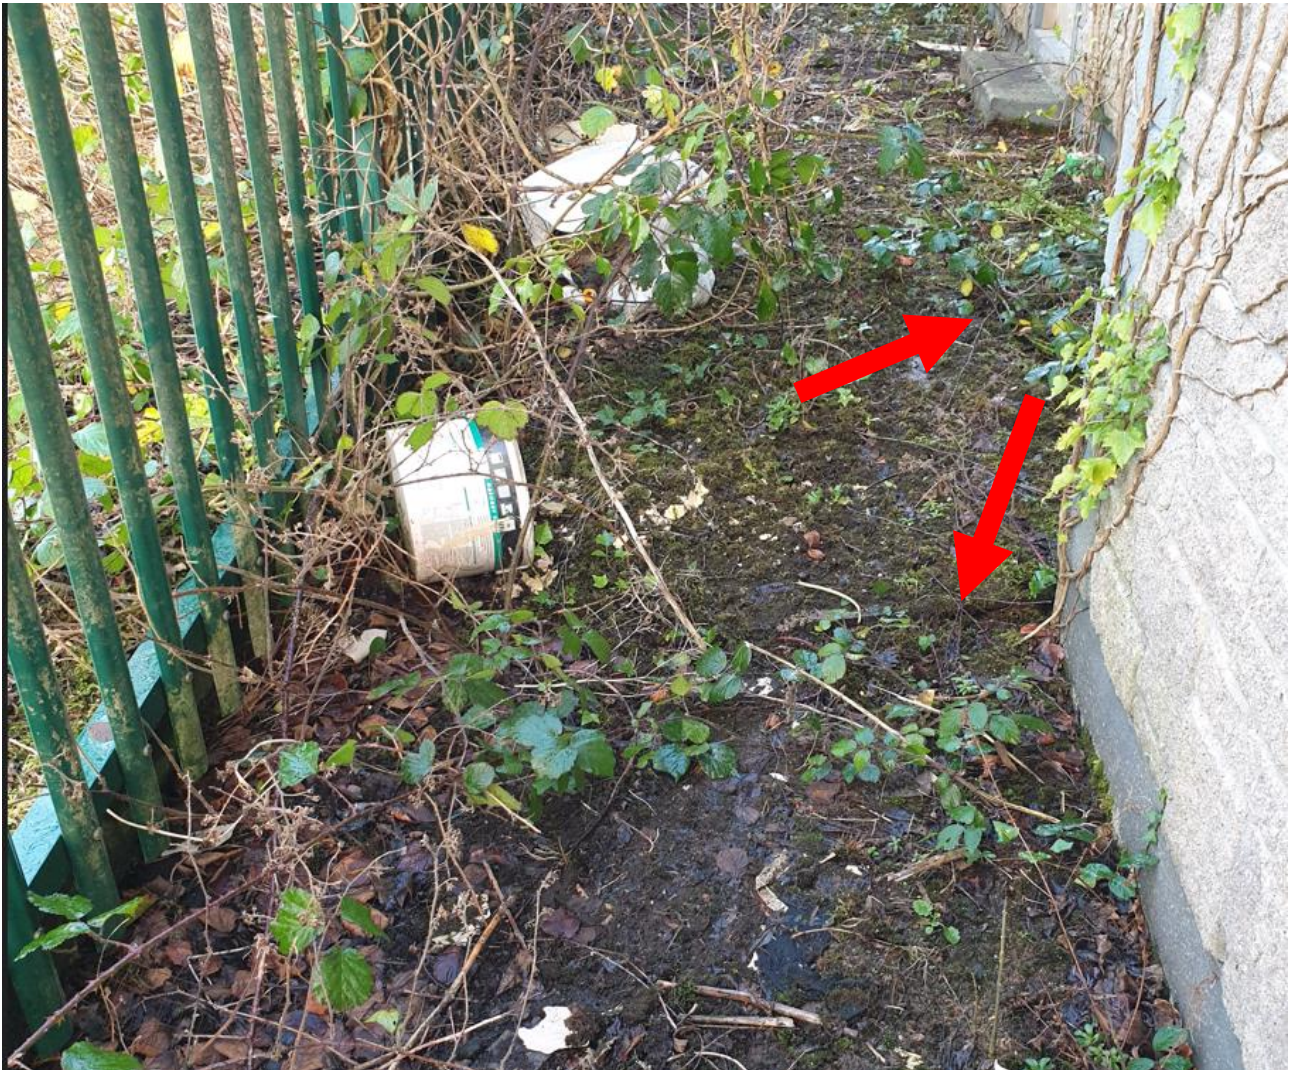
The footpaths around the northern perimeter of the 'Block B' building are severely cracked and significant movement of the footpaths is evident.

**Photograph 13 Footpath to front of northern elevation of 'Block B' building (to be demolished) – Note location of significant cracking (masked by overgrowth).**

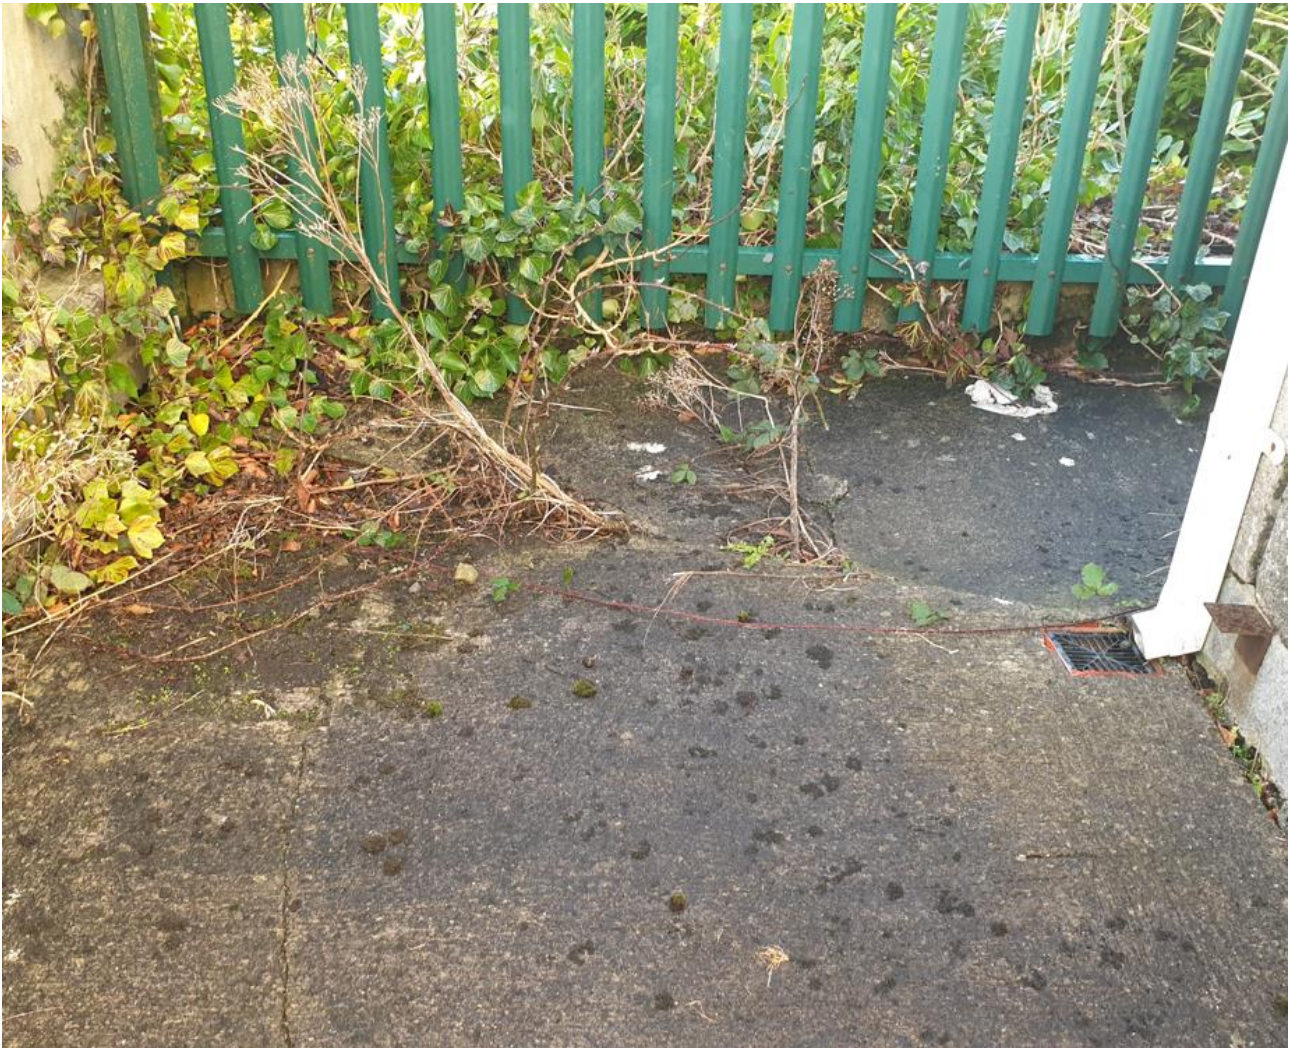
**Photograph 14 Footpath to northwestern corner of 'Block B' building (to be demolished) –**  
**Note significant cracking (masked by overgrowth).**

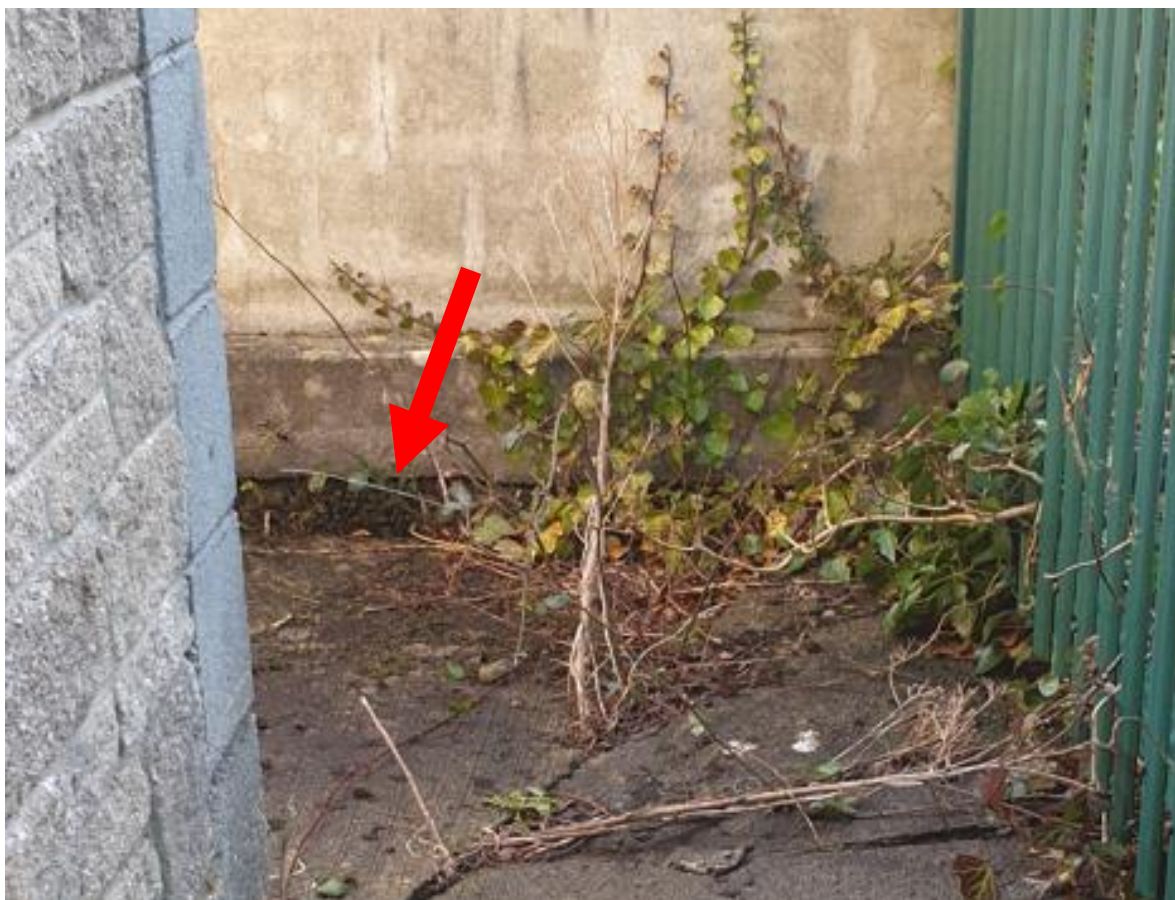
**Photograph 15 Footpath to northwestern corner of 'Block B' building (to be demolished) –**  
**Note exposed wall, indicating significant drop in footpaths.**
