### **SURVEY, SAMPLING AND ASSESSMENT FOR ASBESTOS CONTAINING MATERIALS**

**Collins Barracks**

**Defence Forces**

**Report Date: February 2026**

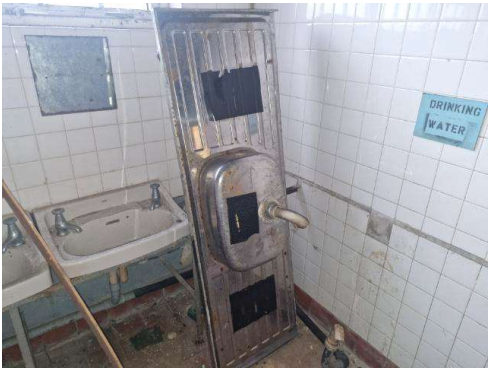
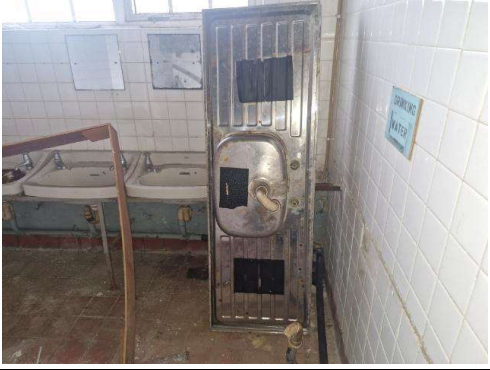
| Block 12 | | | | | | | |
|---|---|---|---|---|---|---|---|
| Ground Floor Toilets 009 - Sink heat pads: Bituminous Product - S004 | 3no | Chrysotile | High Damage | 6 | Remove under controlled conditions | 1 | February 2027 |

| Type | Chrysotile | |
|---|---|---|
| Material | Sink heat pads<br>Bituminous Product | |
| Location | Block 12<br>Ground Floor Toilets 009 | |
| Condition | High Damage | |

| Type | Chrysotile | |
|---|---|---|
| Recommendation | Remove under controlled conditions | |

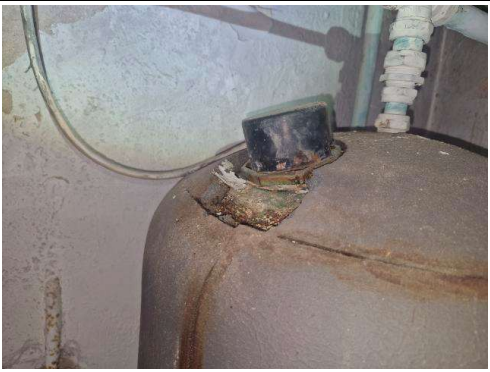
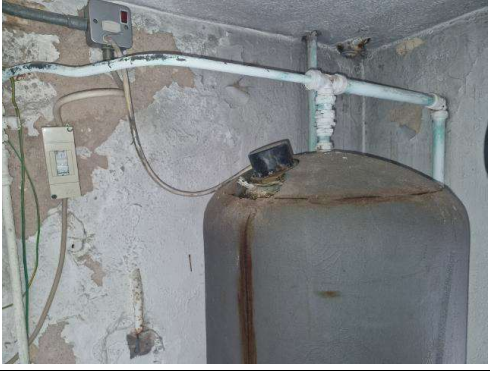
| Block 12 | | | | | | | |
|---|---|---|---|---|---|---|---|
| 1st Floor Toilets 007 - Copper tank thermostat gasket: Gaskets (compressed) - S003 | 1no | Chrysotile | Low Damage | 4 | Remove under controlled conditions | 1 | February 2027 |

| Type | Chrysotile | |
|---|---|---|
| Material | Copper tank thermostat gasket<br>Gaskets (compressed) | |
| Location | Block 12<br>1st Floor Toilets 007 | |
| Condition | Low Damage | |

| Type | Chrysotile | |
|---|---|---|
| Recommendation | Remove under controlled conditions | |

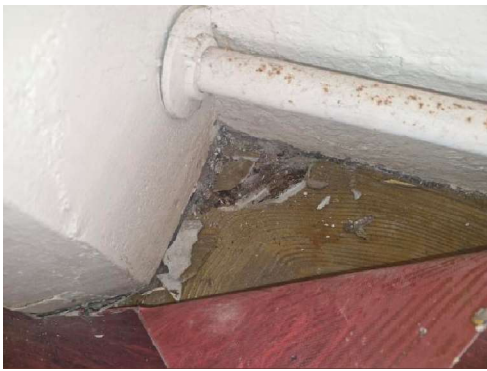
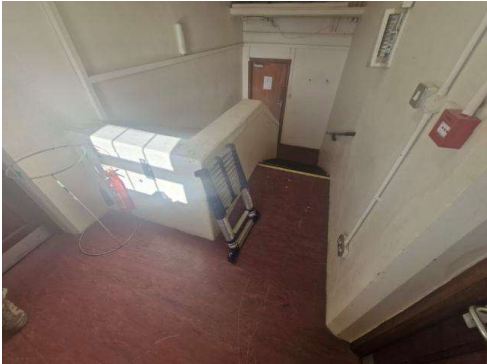
| Block 12 | | | | | | | |
|---|---|---|---|---|---|---|---|
| Ground, 1st & 2nd Floor Staircase 002 - Vinyl floor tiles beneath lino and screed: Vinyl Products - S001 | Non quantifiable | Chrysotile | Low Damage | 3 | Remove under controlled conditions | 1 | February 2027 |

| Type | Chrysotile | |
|---|---|---|
| Material | Vinyl floor tiles beneath lino and screed<br>Vinyl Products | |
| Location | Block 12<br>Ground, 1st & 2nd Floor Staircase 002 | |
| Condition | Low Damage | |

| Type | Chrysotile | |
|---|---|---|
| Recommendation | Remove under controlled conditions | |

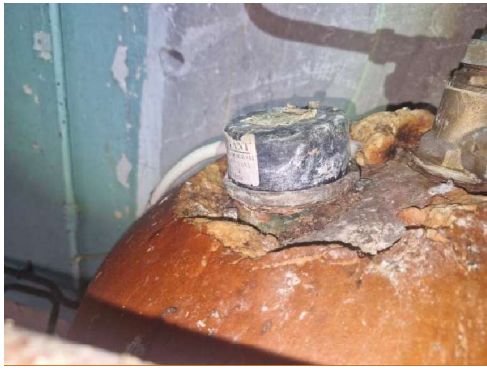
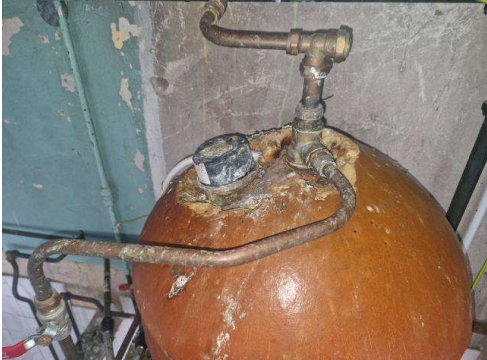
| Block 12 | | | | | | | |
|---|---|---|---|---|---|---|---|
| 2nd Floor Toilets 005 - Copper tank thermostat gasket: Gaskets (compressed) - S002 | 1no | Chrysotile | Low Damage | 4 | Remove under controlled conditions | 1 | February 2027 |

| Type | Chrysotile | |
|---|---|---|
| Material | Copper tank thermostat gasket<br>Gaskets (compressed) | |
| Location | Block 12<br>2nd Floor Toilets 005 | |
| Condition | Low Damage | |

| Type | Chrysotile | |
|---|---|---|
| Recommendation | Remove under controlled conditions | |

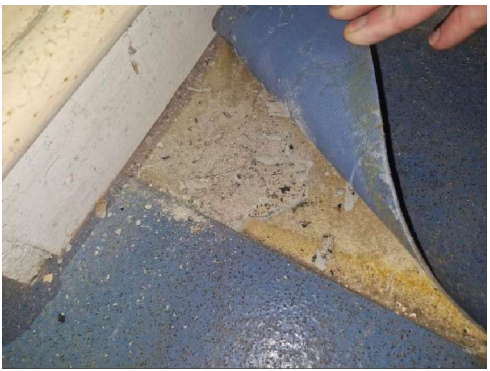
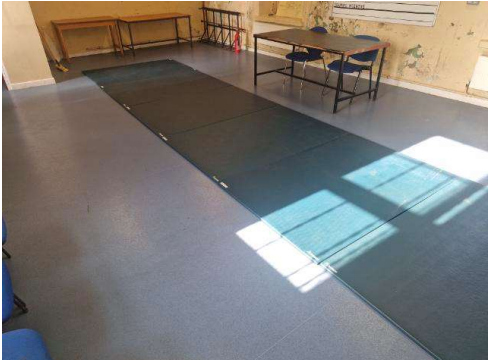
| Block 13 | | | | | | | |
|---|---|---|---|---|---|---|---|
| Ground Floor Section room 1 018 - Mastic beneath lino and screed: Bituminous Product - S007 | Non quantifiable | Chrysotile | Medium Damage | 5 | Remove under controlled conditions | 1 | February 2027 |

| Type | Chrysotile | |
|---|---|---|
| Material | Mastic beneath lino and screed<br>Bituminous Product | |
| Location | Block 13<br>Ground Floor Section room 1 018 | |
| Condition | Medium Damage | |

| Type | Chrysotile | |
|---|---|---|
| Recommendation | Remove under controlled conditions | |

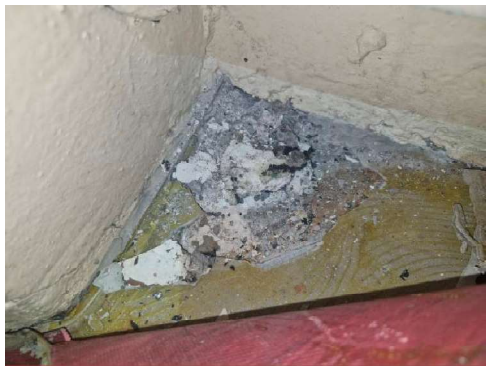
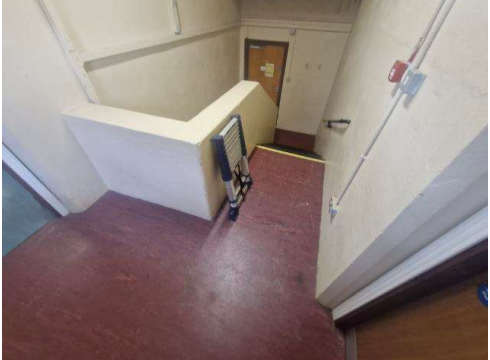
| Location and Use of Material | Quantity (Approx.) | Asbestos Type | Condition | Material Assessment | Recommended Action | Priority Assessment | Next Assessment |
|---|---|---|---|---|---|---|---|
| Ground, 1st & 2nd Floor Staircase 011 - Mastic beneath lino and screed: Bituminous Product - S005 | Non quantifiable | Chrysotile | Medium Damage | 5 | Remove under controlled conditions | 1 | February 2027 |

| Type | Chrysotile | |
|---|---|---|
| Material | Mastic beneath lino and screed<br>Bituminous Product | |
| Location | Block 13<br>Ground, 1st & 2nd Floor Staircase 011 | |
| Condition | Medium Damage | |

| Type | Chrysotile | |
|---|---|---|
| Recommendation | Remove under controlled conditions | |

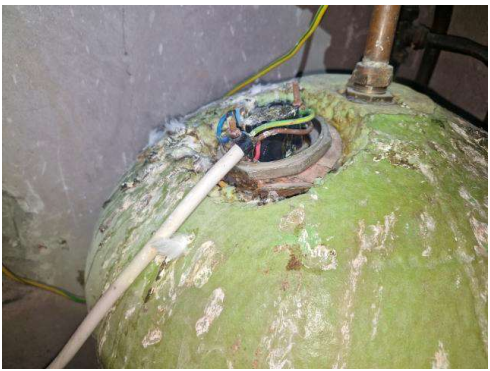
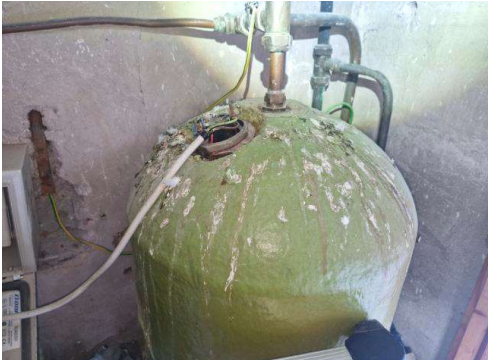
| Location and Use of Material | Quantity (Approx.) | Asbestos Type | Condition | Material Assessment | Recommended Action | Priority Assessment | Next Assessment |
|---|---|---|---|---|---|---|---|
| 2nd Floor Toilets 014 - Copper tank thermostat gasket: Gaskets (compressed) - S006 | 1no | Chrysotile | Medium Damage | 5 | Remove under controlled conditions | 1 | February 2027 |

| Type | Chrysotile | |
|---|---|---|
| Material | Copper tank thermostat gasket<br>Gaskets (compressed) | |
| Location | Block 13<br>2nd Floor Toilets 014 | |
| Condition | Medium Damage | |

| Type | Chrysotile | |
|---|---|---|
| Recommendation | Remove under controlled conditions | |

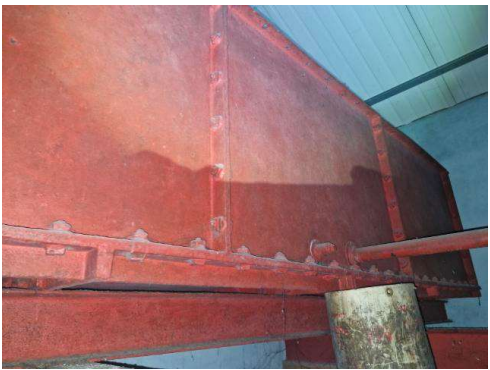
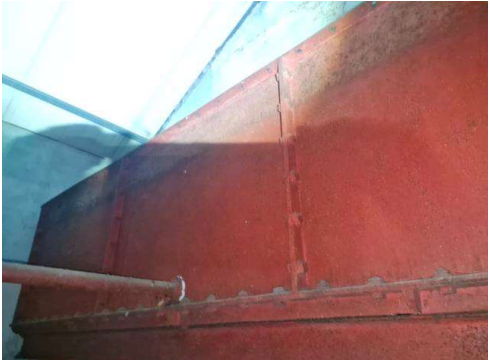
| Location and Use of Material | Quantity (Approx.) | Asbestos Type | Condition | Material Assessment | Recommended Action | Priority Assessment | Next Assessment |
|---|---|---|---|---|---|---|---|
| Ground Floor Medics stores 021 - Water tank seals: Gaskets (rope/woven) - Presumed | Non quantifiable | Chrysotile | Low Damage | 5 | Remove under controlled conditions | 1 | February 2027 |

| Type | Chrysotile | |
|---|---|---|
| Material | Water tank seals<br>Gaskets (rope/woven) | |
| Location | Building 54<br>Ground Floor Medics stores 021 | |
| Condition | Low Damage | |

| Type | Chrysotile | |
|---|---|---|
| Recommendation | Remove under controlled conditions | |

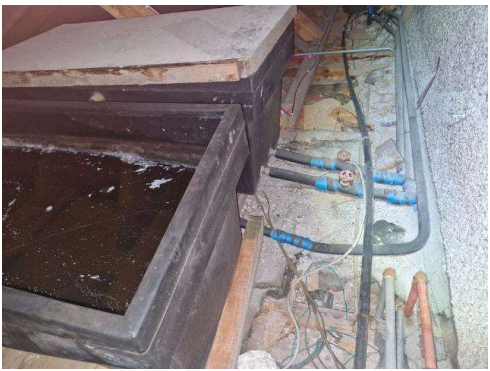
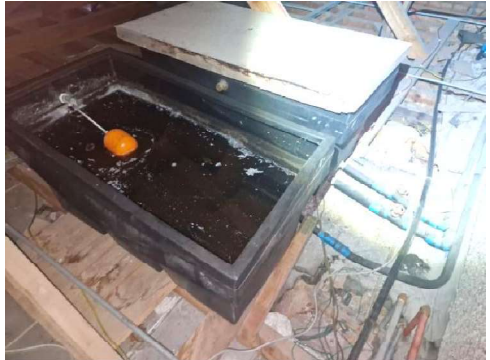
| Location and Use of Material | Quantity (Approx.) | Asbestos Type | Condition | Material Assessment | Recommended Action | Priority Assessment | Next Assessment |
|---|---|---|---|---|---|---|---|
| Ground Floor Locker room attic 024 - Old flat roof felt: Bituminous Product - S008 | Non quantifiable | Chrysotile | High Damage | 6 | Remove under controlled conditions | 1 | February 2027 |

| Type | Chrysotile | |
|---|---|---|
| Material | Old flat roof felt<br>Bituminous Product | |
| Location | Building 54<br>Ground Floor Locker room attic<br>024 | |
| Condition | High Damage | |

| Type | Chrysotile | |
|---|---|---|
| Recommendation | Remove under controlled<br>conditions | |

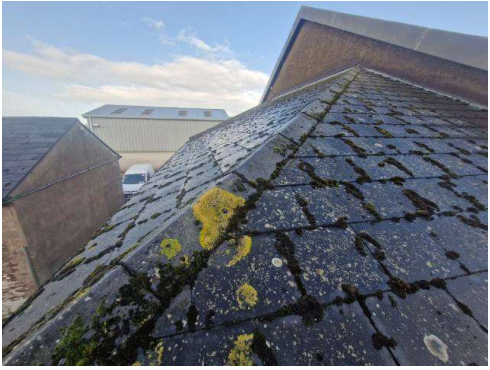
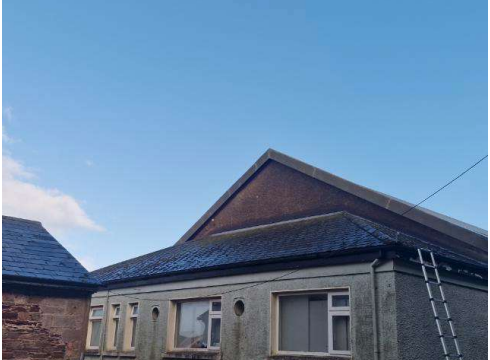
| Location and Use of Material | Quantity (Approx.) | Asbestos Type | Condition | Material Assessment | Recommended Action | Priority Assessment | Next Assessment |
|---|---|---|---|---|---|---|---|
| External Locker room and toilets roof 025 - Slates: Cement Product - S009 | 150m <sup>2</sup> | Chrysotile | Low Damage | 4 | Remove under controlled conditions | 1 | February 2027 |

| Type | Chrysotile | |
|---|---|---|
| Material | Slates<br>Cement Product | |
| Location | Building 54<br>External Locker room and toilets<br>roof 025 | |
| Condition | Low Damage | |

| Type | Chrysotile | |
|---|---|---|
| Recommendation | Remove under controlled<br>conditions | |
