### **SURVEY, SAMPLING AND ASSESSMENT FOR ASBESTOS CONTAINING MATERIALS**

**Renmore Barracks  
Galway**

**Defence Forces**

**Report Date: January 2022**

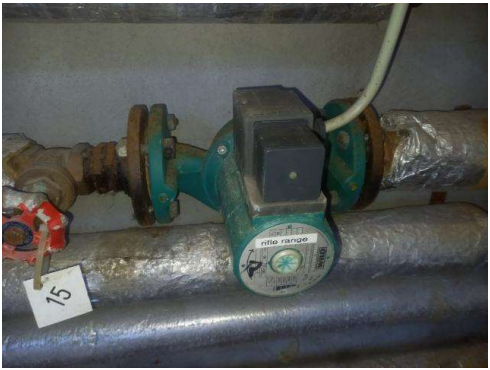
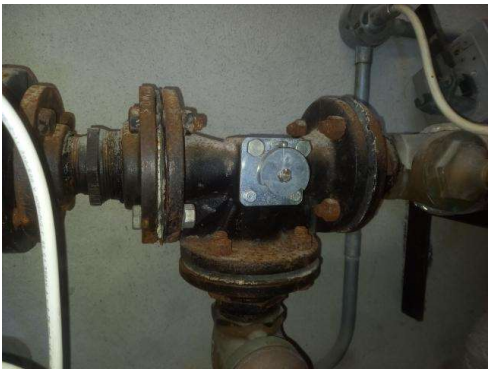
| Locker rooms 1 and 2 | | | | | | | |
|---|---|---|---|---|---|---|---|
| Ground Floor Boiler room 003 - Pump flange gaskets: Gaskets (compressed) - S004 | 5no | Chrysotile | Low Damage | 4 | Remove under controlled conditions | 1 | January 2023 |

| Type | Chrysotile | |
| Material | Pump flange gaskets<br>Gaskets (compressed) | |
| Location | Locker rooms 1 and 2<br>Ground Floor Boiler room 003 | |
| Quantity | 5 no | |
| Sample No. | S004 | |
| Condition | Low Damage | |
| Risk | Very Low | |

| Type | Chrysotile | |
|---|---|---|
| Recommendation | Remove under controlled conditions | |

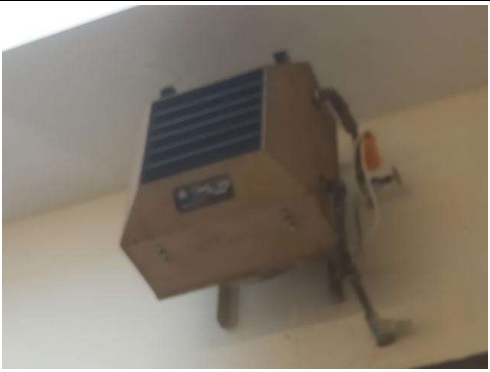
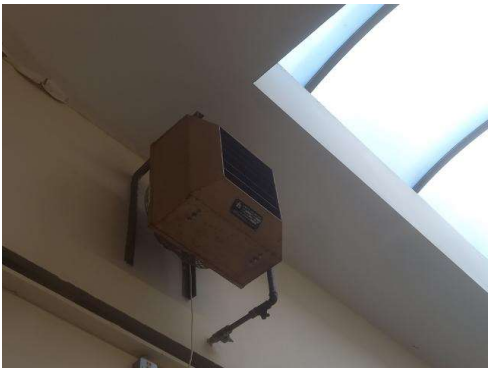
| Locker rooms 1 and 2 | | | | | | | |
|---|---|---|---|---|---|---|---|
| Ground Floor Ladies locker room 004 - Liberty unit heaters: Woven Product - Presumed | 2no | Chrysotile | Good Condition | 4 | Remove under controlled conditions | 1 | January 2023 |

| Type | Chrysotile | |
| Material | Liberty unit heaters<br>Woven Product | |
| Location | Locker rooms 1 and 2<br>Ground Floor Ladies locker room 004 | |
| Quantity | 2 no. | |
| Sample No. | Presumed | |
| Condition | Good Condition | |
| Risk | Very Low | |

| Type | Chrysotile | |
|---|---|---|
| Recommendation | Remove under controlled conditions | |

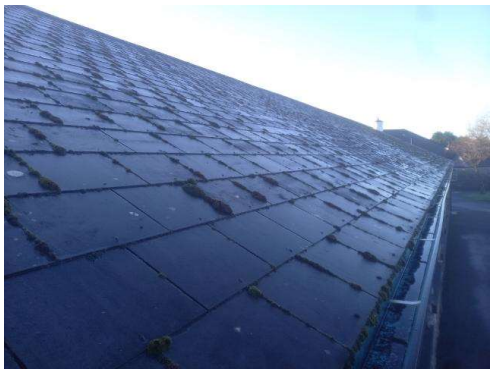
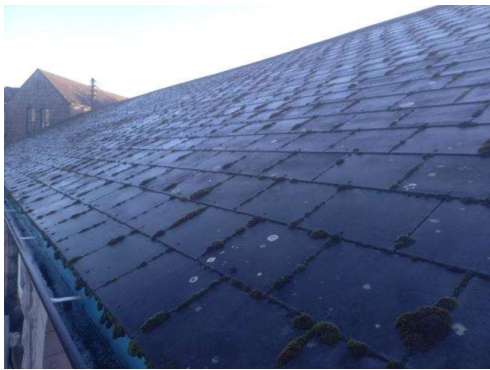
| Locker rooms 1 and 2 | | | | | | | |
|---|---|---|---|---|---|---|---|
| External Roof 001 - Slates: Cement Product - S001 | 770m <sup>2</sup> | Chrysotile | Good Condition | 3 | Remove under controlled conditions | 1 | January 2023 |

| Type | Chrysotile | |
| Material | Slates<br>Cement Product | |
| Location | Locker rooms 1 and 2<br>External Roof 001 | |
| Quantity | 770 m <sup>2</sup> | |
| Sample No. | S001 | |
| Condition | Good Condition | |
| Risk | Very Low | |

| Recommendation | Remove under controlled conditions | |

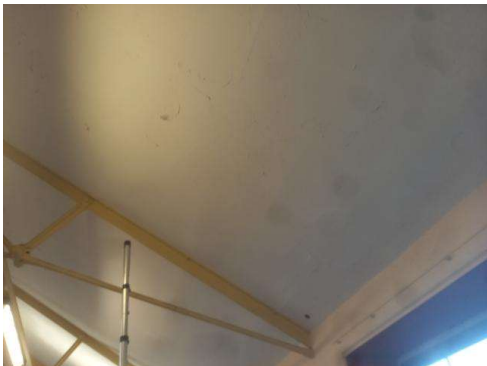
| Type | NAD | |
| Material | Plasterboard | |
| Location | Locker rooms 1 and 2<br>Ground Floor Locker room ceiling 002 | |
| Sample No. | S002 | |

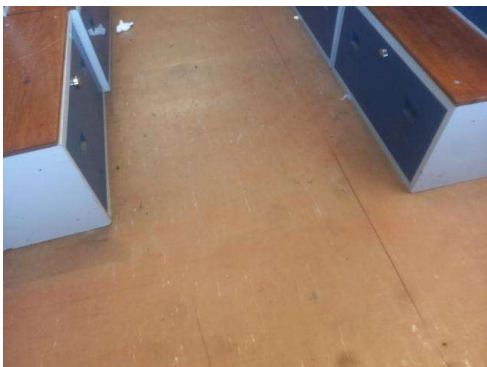
| Type | NAD | |
| Material | Lino | |
| Location | Locker rooms 1 and 2<br>Ground Floor Locker room floor 002 | |
| Sample No. | S003 | |

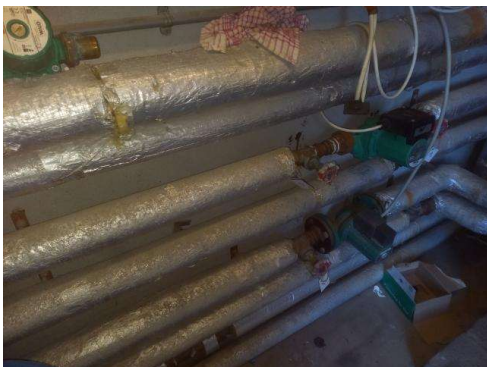
| Type | NAD | |
| Material | Insulation to pipework | |
| Location | Locker rooms 1 and 2<br>Ground Floor Boiler room 003 | |
| Sample No. | No Asbestos Suspected | |

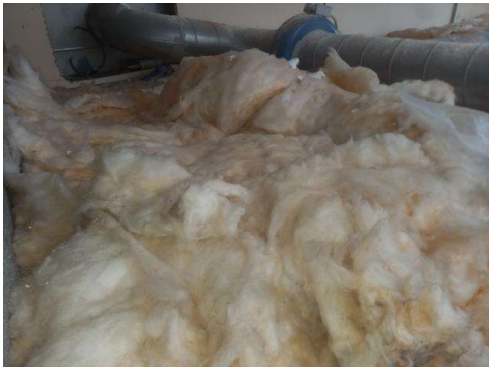
| Type | NAD | |
| Material | Insulation | |
| Location | Locker rooms 1 and 2<br>Ground Floor Ceiling void above lady's shower block 004 | |
| Sample No. | S005 | |

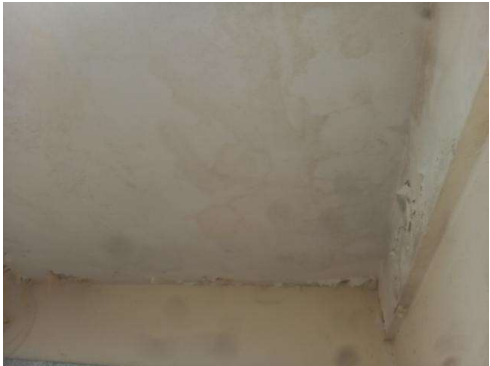
| Type | NAD | |
| Material | Plasterboard | |
| Location | Locker rooms 1 and 2<br>Ground Floor Ceiling lady's locker room 004 | |
| Sample No. | No Asbestos Suspected | |

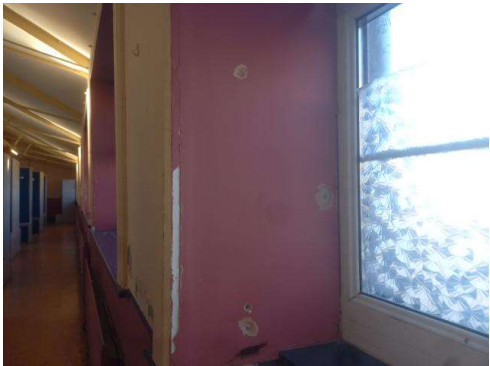
| Type | NAD | |
| Material | Plasterboard to window reveals | |
| Location | Locker rooms 1 and 2<br>Ground Floor Male locker room 004 | |
| Sample No. | No Asbestos Suspected | |
