## Refurbishment Demolition Asbestos Survey

**Site Address:** Stanhope Street Secondary School  
Manor Street  
Stoneybatter  
Dublin 7 , D07 YP03

**Date:** 10/05/2024

**Survey No.:** A-03015

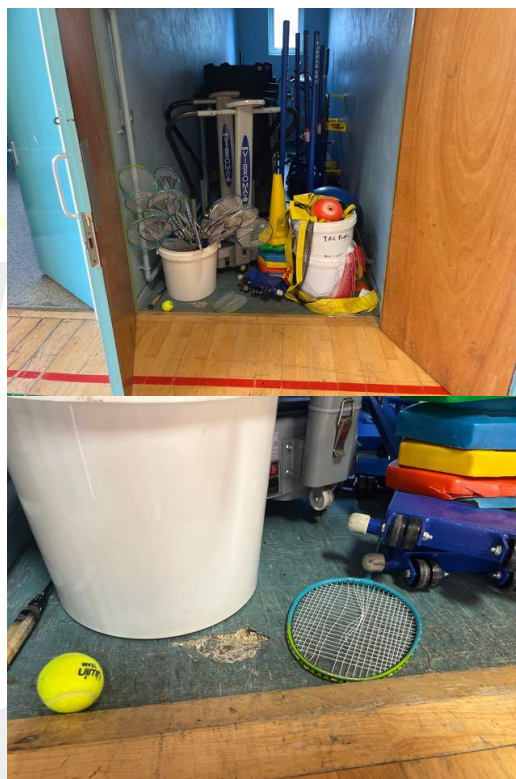
Location Ground Floor Kit Store (001) - Floor

Extent 8 m<sup>2</sup>

| Product type | Vinyl Floor Tiles with Bitumen |
| Extent of damage/deterioration | Low damage |
| Surface treatment | Sealed |
| Asbestos type | Chrysotile |

| <b>Total</b> | <b>4</b> |

Remove if likely to be disturbed by works

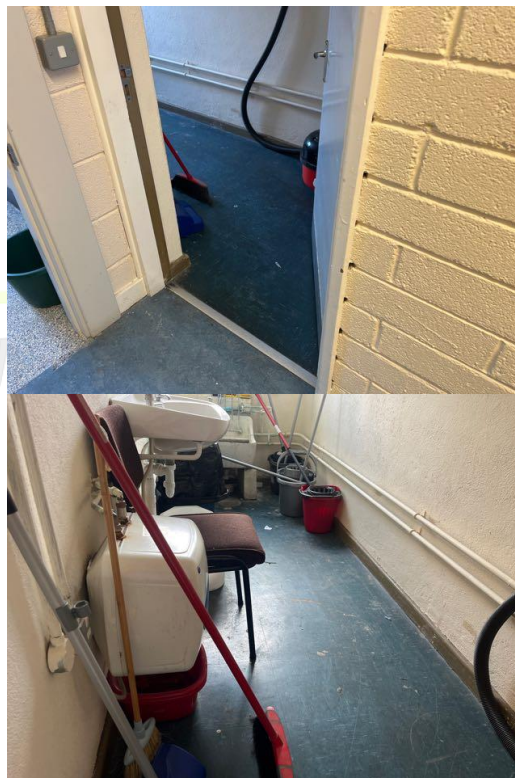
Location Ground Floor Sluice Room (002) -  
Floor  
Sample Range S002  
Extent 20 m<sup>2</sup>

| Vinyl Floor Tiles with Bitumen |
| Low damage |
| Sealed |
| Chrysotile |

| <b>Total</b> | <b>4</b> |

| <b>RECOMMENDATIONS</b> | Remove if likely to be disturbed by works |

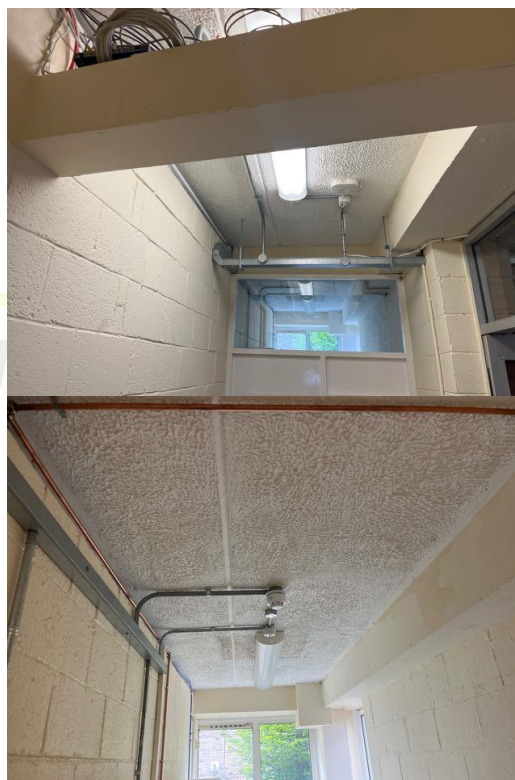
Location Ground Floor Staff Room (003) -  
Ceiling  
Sample Range S003  
Extent 12 m<sup>2</sup>

| Textured Coating |
| Good condition |
| Sealed |
| Chrysotile |

| <b>Total</b> | <b>3</b> |

Remove if likely to be disturbed by works

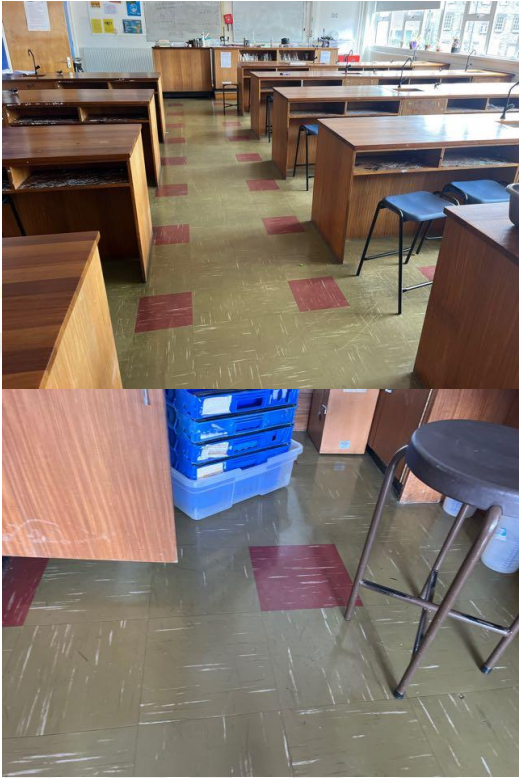
Location 1st Floor Science Lab (004) - Floor  
Sample Range S006  
Extent m<sup>2</sup>

| Product type | Vinyl Floor Tiles with Bitumen |
| Extent of damage/deterioration | Low damage |
| Surface treatment | Composite |
| Asbestos type | Chrysotile |

| Total | 3 |

| RECOMMENDATIONS | Remove if likely to be disturbed by works |

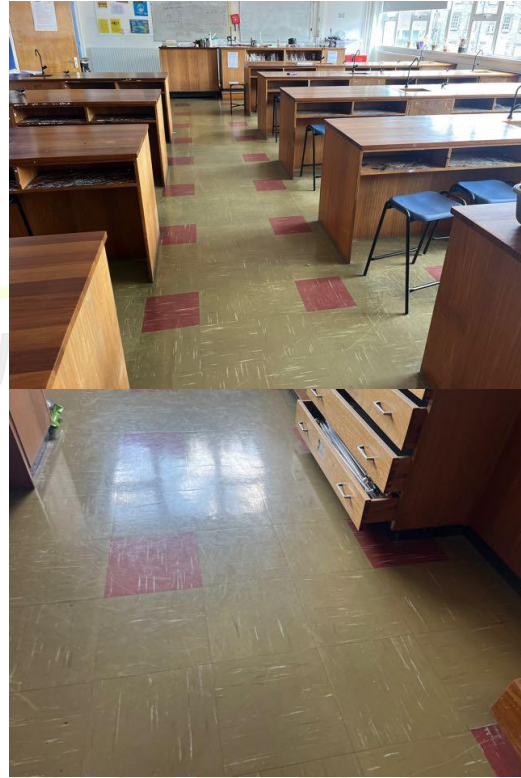
Location 1st Floor Science Lab (004) - Floor  
Sample Range S005  
Extent m<sup>2</sup>

| Product type | Vinyl Floor Tiles with Bitumen |
| Extent of damage/deterioration | Low damage |
| Surface treatment | Composite |
| Asbestos type | Chrysotile |

| <b>Total</b> | <b>3</b> |

| <b>RECOMMENDATIONS</b> | Remove if likely to be disturbed by works |

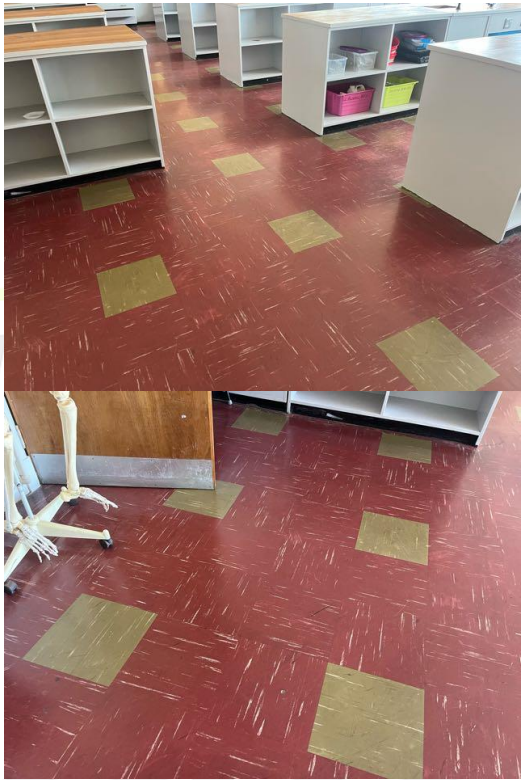
Location 1st Floor Science Lab 2 (005) - Floor  
Sample Range X006  
Extent m<sup>2</sup>

| Product type | Vinyl Floor Tiles with Bitumen |
| Extent of damage/deterioration | Low damage |

| RECOMMENDATIONS | Remove if likely to be disturbed by works |

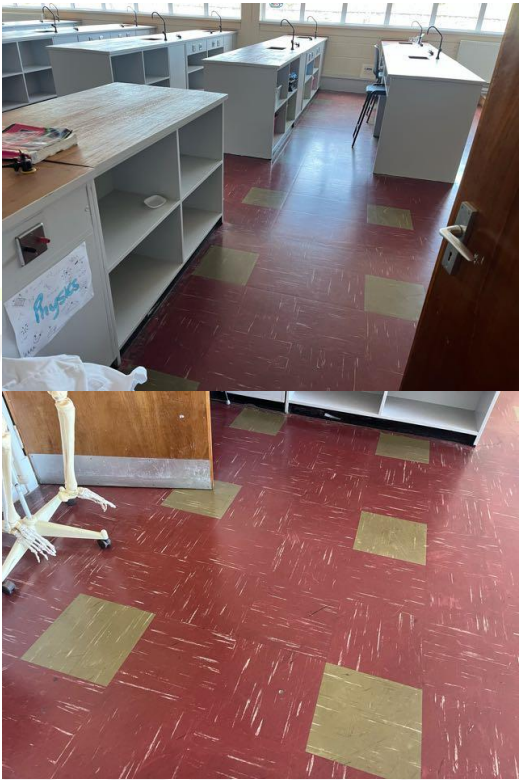
Location 1st Floor Science Lab 2 (005) - Floor  
Sample Range X005  
Extent m<sup>2</sup>

| Product type | Vinyl Floor Tiles with Bitumen |
| Extent of damage/deterioration | Low damage |

| RECOMMENDATIONS | Remove if likely to be disturbed by works |

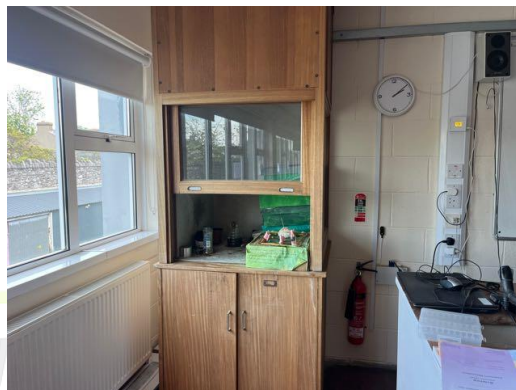
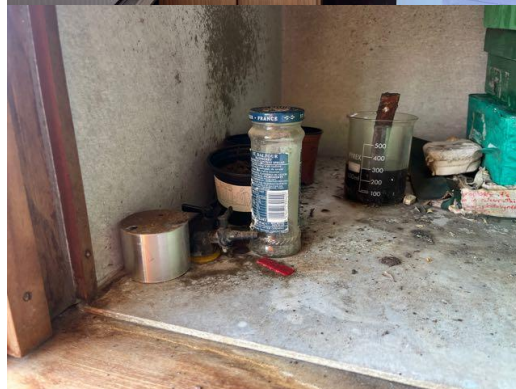
Location 1st Floor Science Lab (005) - Fume  
Cabinet  
Sample Range S007  
Extent 8 m<sup>2</sup>

| Low damage |

| Stanhope Street Secondary School | | | | | | | | |
|---|---|---|---|---|---|---|---|---|
| S007 | 8 | 1st Floor Science Lab (005) - Fume Cabinet - Cement Product | 8m <sup>2</sup> | Chrysotile | Low damage | Low | 5 | Remove if likely to be disturbed by works |

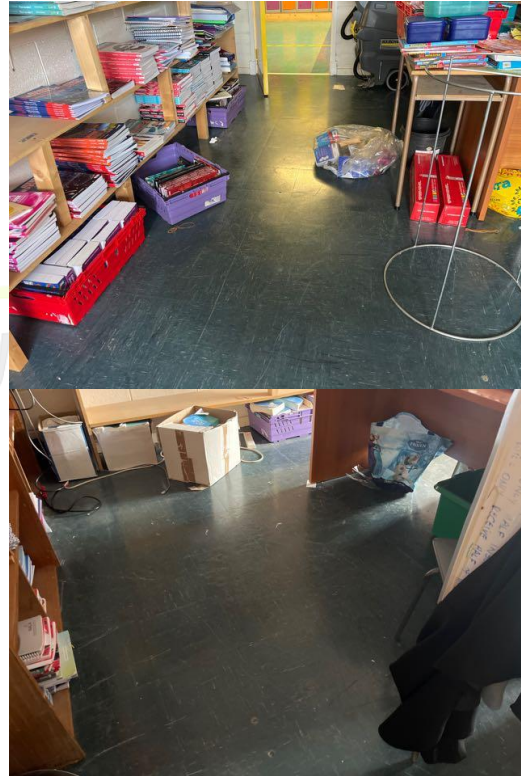
Location 1st Floor Book Store (006) - Floor  
Sample Range S008  
Extent m<sup>2</sup>

| Product type | Vinyl Floor Tiles with Bitumen |
| Extent of damage/deterioration | Low damage |

| <b>RECOMMENDATIONS</b> | Remove if likely to be disturbed by works |

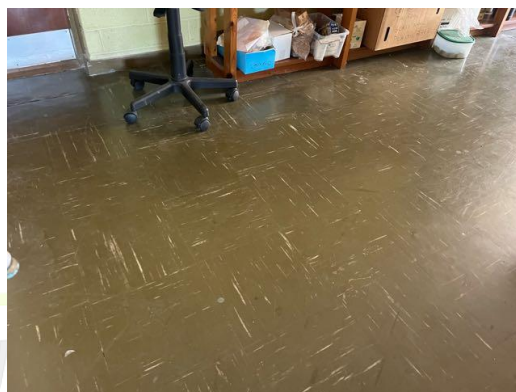
Location 1st Floor Science Prep Room (007) -  
Floor  
Sample Range X001  
Extent 30 m²

| Extent of damage/deterioration | Low damage |

| Stanhope Street Secondary School | | | | | | | | |
|---|---|---|---|---|---|---|---|---|
| X001 | 8 | 1st Floor Science Prep Room (007) - Floor - Vinyl Floor Tiles with Bitumen | 30m <sup>2</sup> | Chrysotile | Low damage | Very Low | 4 | Remove if likely to be disturbed by works |

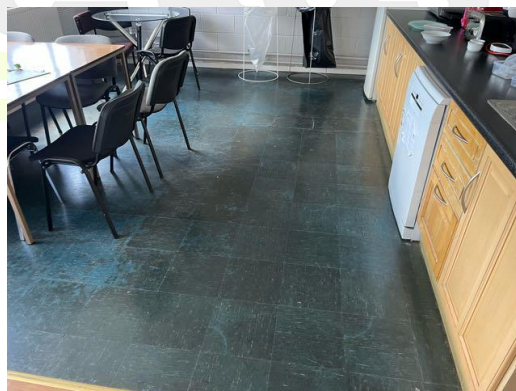
Location 1st Floor Staff Room (008) - Floor  
Sample Range X001  
Extent 15 m²

| Extent of damage/deterioration | Low damage |

| Stanhope Street Secondary School | | | | | | | | |
|---|---|---|---|---|---|---|---|---|
| X001 | 8 | 1st Floor Staff Room (008) - Floor - Vinyl Products | 15m <sup>2</sup> | Chrysotile | Low damage | Very Low | 3 | Remove if likely to be disturbed by works |

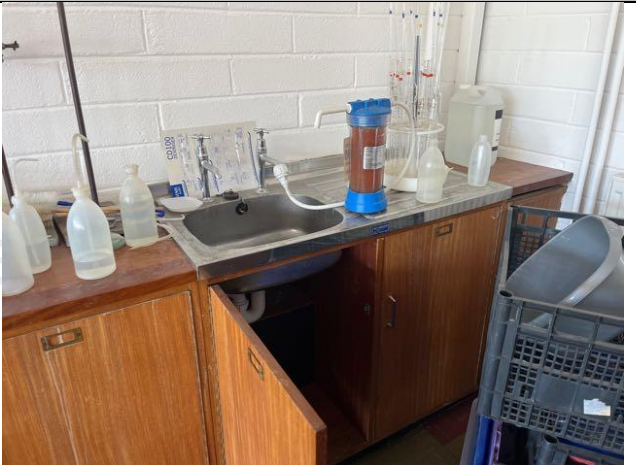
| Stanhope Street Secondary School | | |
|---|---|---|
| S004 | 1st Floor Science Lab (004) - Acoustic sink pad - Bituminous Product | |
