## Water Audit Report

Clonmullen Hall, Edenderry Co. Offaly

| Project: | Water Audit Report<br>Clonmullen Hall, Edenderry,<br>Co. Offaly. |

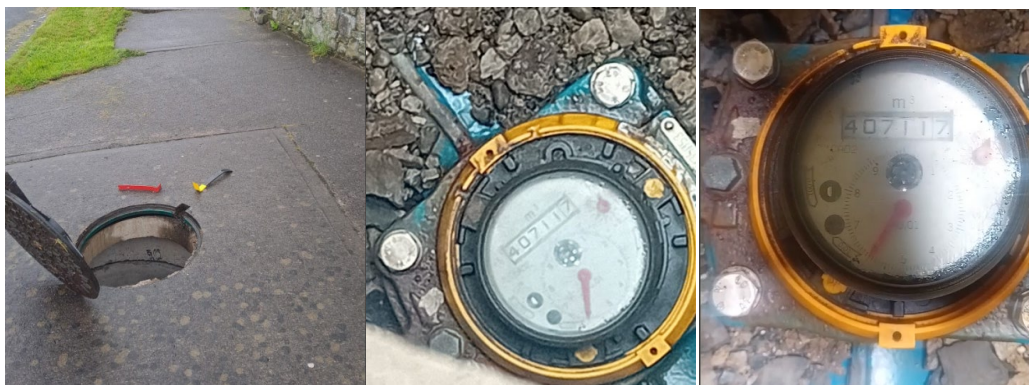
Figure 1 : Elster Main Meter at Entrance of Estate

We can confirm the meter reading on the Elster meter did not change over the duration of the works indicating a faulty meter. Therefore, we could not confirm the usage for the site.

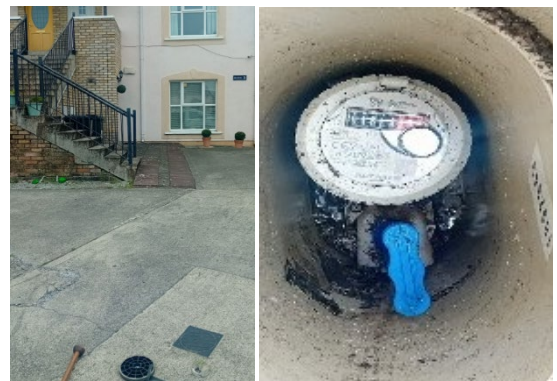
### Leak 1: Customer Side Leak at:

5b Clonmullen Hall, Edenderry, Co. Offaly R45VH31

Leak Rate: 0.6 l/min.

- Continuous usage identified at this meter, Stage 2 customer side leak detection required to pinpoint leak location and access to property.
- Access to home to be arranged for the follow up Stage 2 leak investigation.
- Tracer gas leak detection required on next visit.

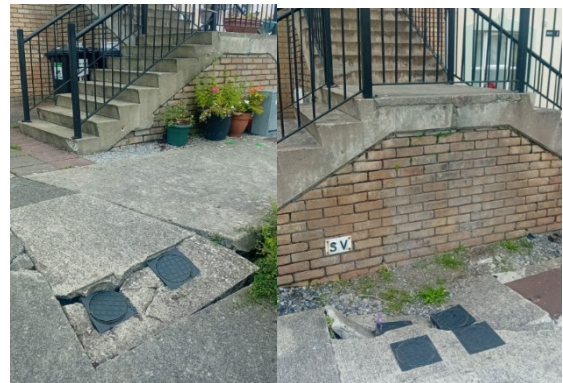
Apartment K3 & K4

- All Boundary Boxes were surveyed/sounded for leaks during the survey.
- Following the house connection survey, we identified 1No. Customer Side Leak within the site as detailed in section 2.
- The concrete plinths for the boundary boxes to apartments K3, K4 & J1, J2 are sinking in place creating a trip hazard which should be rectified.

- The concrete plinths for the boundary boxes to apartments K3, K4 & J1, J2 are sinking in place creating a trip hazard which should be rectified.

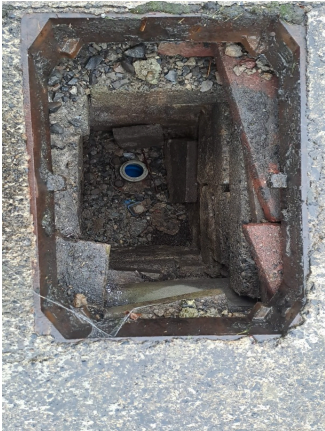
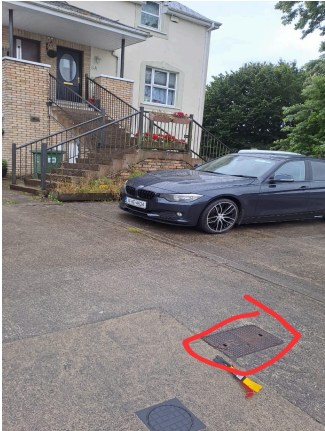
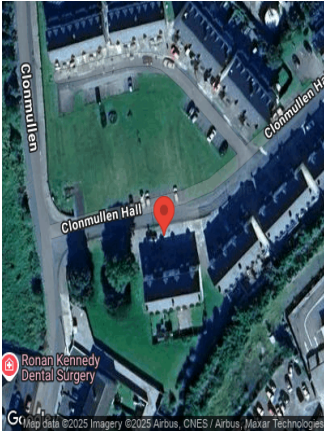
Note: Fire Hydrant FH1 can't be flow test as its missing a spindle for operation and it's too deep to get standpipe.

| Condition Assessment | | | | | | | | | | |
|---|---|---|---|---|---|---|---|---|---|---|
| FH001 | Footpath | Concrete | Good | Fair | Yes | LRT | Missing | No | 770mm | marker post behind the vegetation |

- Install an outlet extension and spindle for Fire Hydrant FH1 to allow access for future operations and the vegetation should be cut back to expose the marker plate.

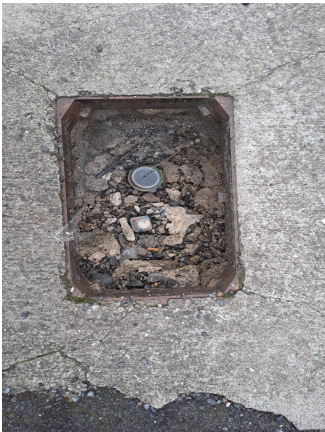
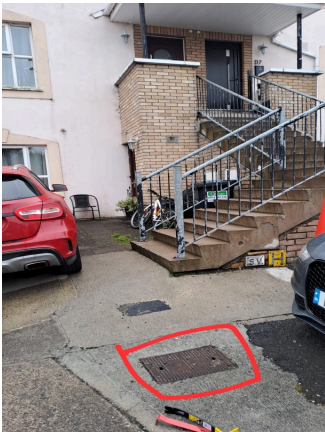
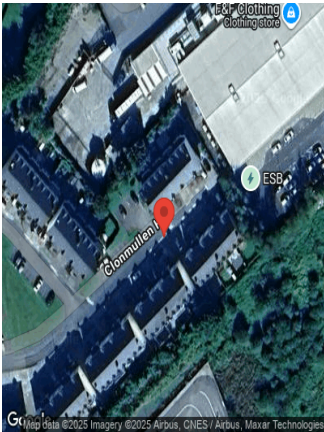
| Condition Assessment | | | | | | | | | | |
|---|---|---|---|---|---|---|---|---|---|---|
| FH002 | Footpath | Concrete | Good | Poor | Yes | LRT | Good | No | 250mm | pit full of debris |

- Maintenance should be carried out for some of the Valves and Hydrants chambers as they are in poor condition and full of debris.
  - The chambers to FH1 and FH2 require cleanouts as the hydrant fitting is buried with only the outlet exposed.

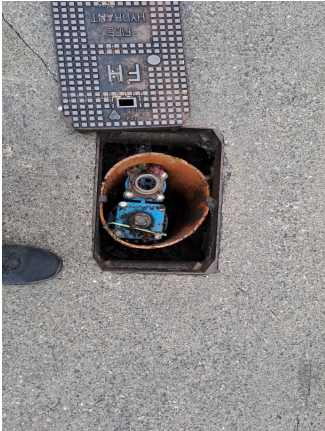
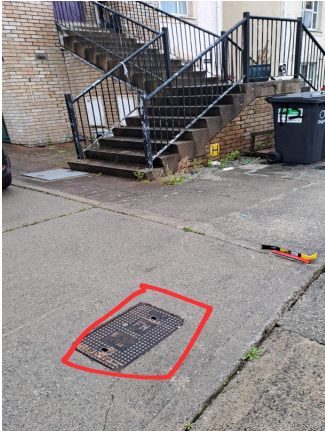
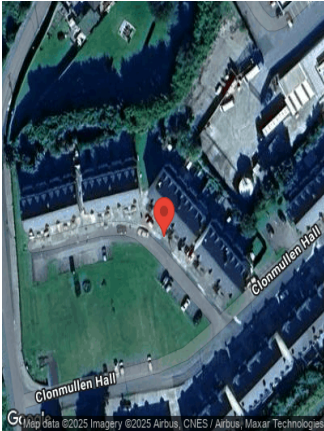
| Condition Assessment | | | | | | | | | | |
|---|---|---|---|---|---|---|---|---|---|---|
| FH003 | Footpath | Concrete | Good | Fair | Yes | LRT | Good | No | 220mm | |

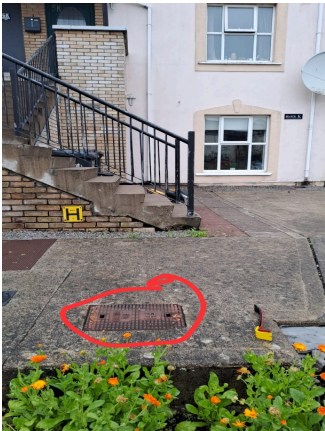
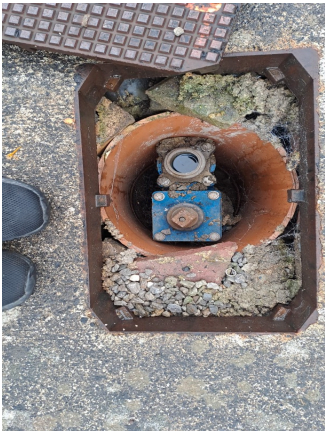
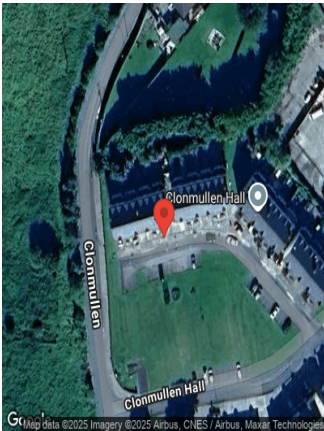
| Condition Assessment | | | | | | | | | | |
|---|---|---|---|---|---|---|---|---|---|---|
| FH004 | Footpath | Concrete | Good | Poor | Yes | LRT | Good | No | 290mm | |

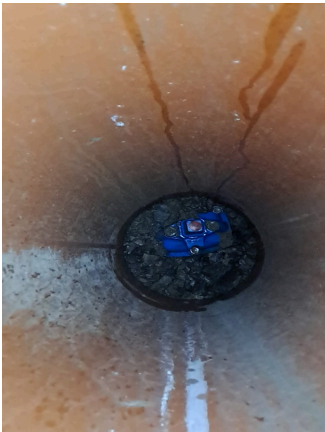
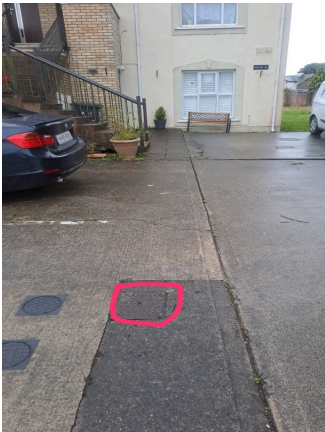
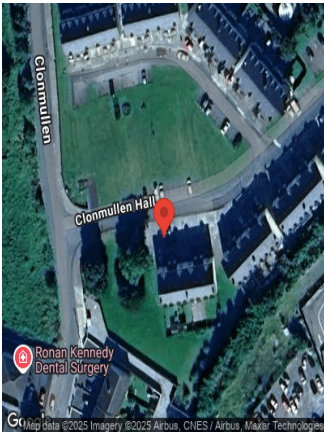
| Condition Assessment | | | | | | | | | | |
|---|---|---|---|---|---|---|---|---|---|---|
| SV001 | Footpath | Concrete | Good | Good | No | Good | Open | Yes | 1300mm | |

- Recommended to install an extension spindle for Sluice Valves exceeding the depth of 700mm for future access.
- Install marker plates for Sluice Valves SV1, SV5 & SV7 to identify the location/details.
