## **26 McCurtain Street, Fermoy, Co. Cork for Cork County Council**

## **CONDITION REPORT**

**February 2026**

**Job No. 26033**

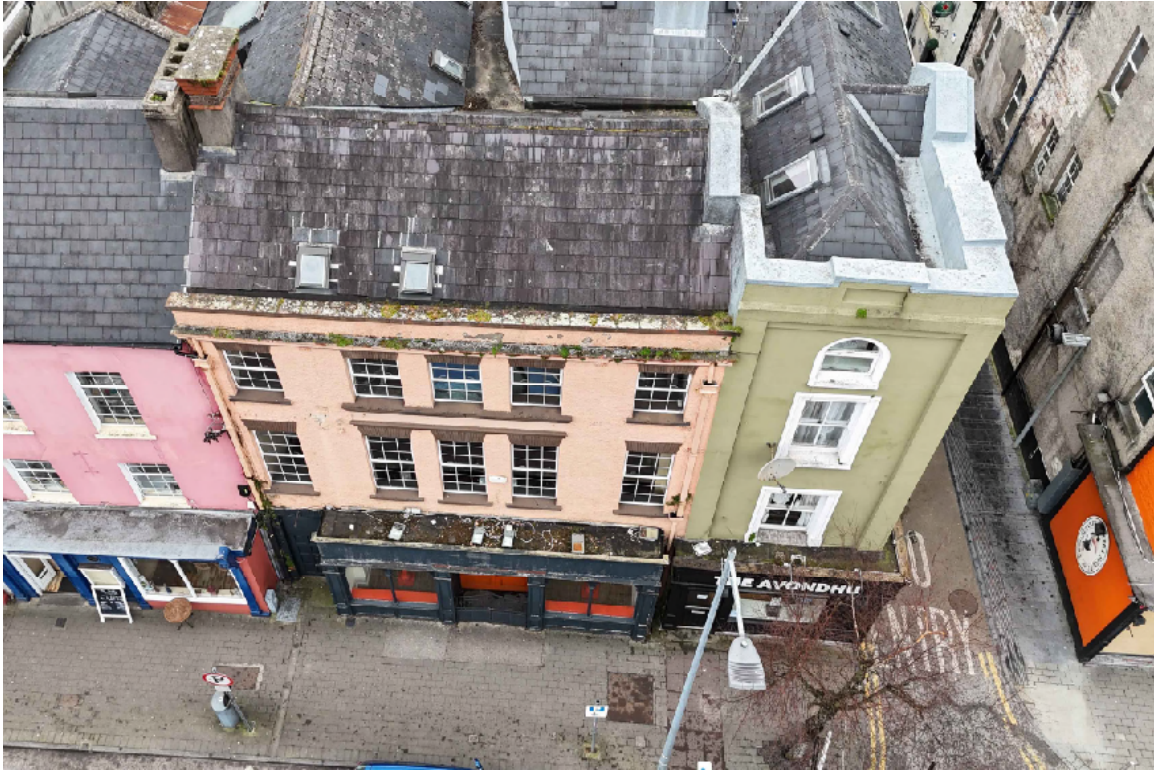
**PHOTOGRAPH 1 - FRONT ROOF SLOPE**

The front and rear slopes of the main roof structure consist of natural slate roof on timber rafters with roof lights cut into the existing roof. Previous repairs have been carried out around the roof lights. Slates have been taped and mastic inserted in the joints to reduce water ingress.

The existing timber rafters are generally in good repair, but allowance must be made for localised repair and splicing of rafter ends. It is recommended that the existing slate roofs be stripped back to the rafters, a new roof membrane, battens and counter battens installed, new lead valleys and complete with ventilation prior to slating the roof slopes. The existing roof lights shall be replaced as they have too reached the end of their useful life.

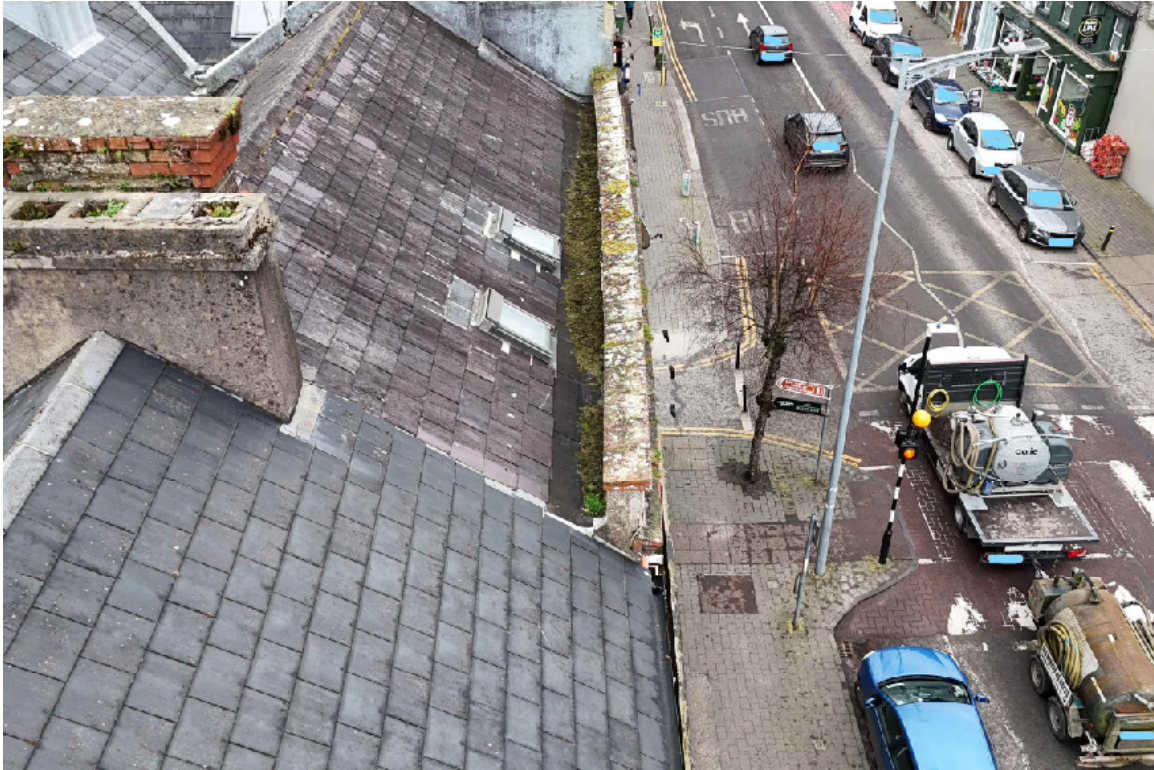
The front parapet has a stone capping, while the gutter behind contains a large volume of moss.

The same process should be applied to the parapet gutter. The parapet capping shall also be removed, new timber build-up underneath and new flashings prior to reinstatement of existing capping.

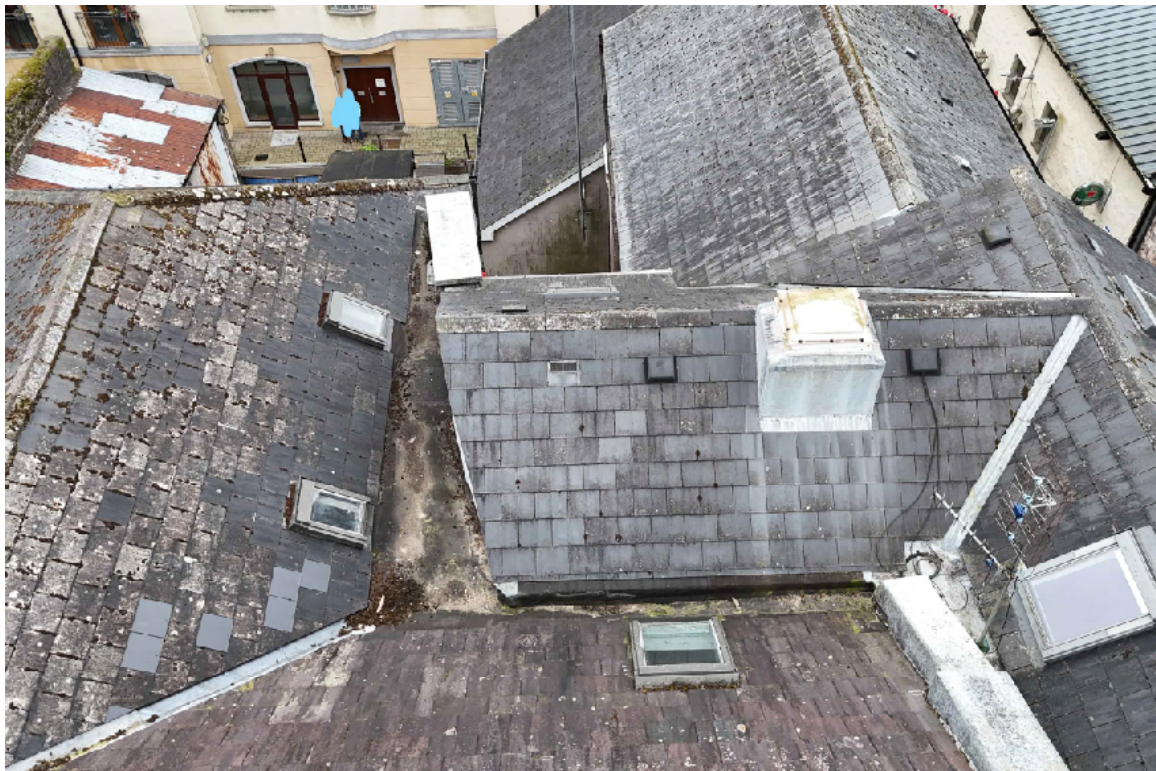
**PHOTOGRAPH 4 - WIDE INTERNAL VALLEY**

There is also a wide flat valley at the junction between the building and the adjoining building to the east. This valley is in very poor condition and leaking.

Water ingress was clearly visible directly beneath the flat valley, underneath the front parapet and beneath the roof of the entrance pop out at the front of the building. The valley is in extremely poor condition where water is visibly running down the walls underneath. The timbers have wet rot, and the entire valley must be stripped back, timbers removed and the valley reconstructed.

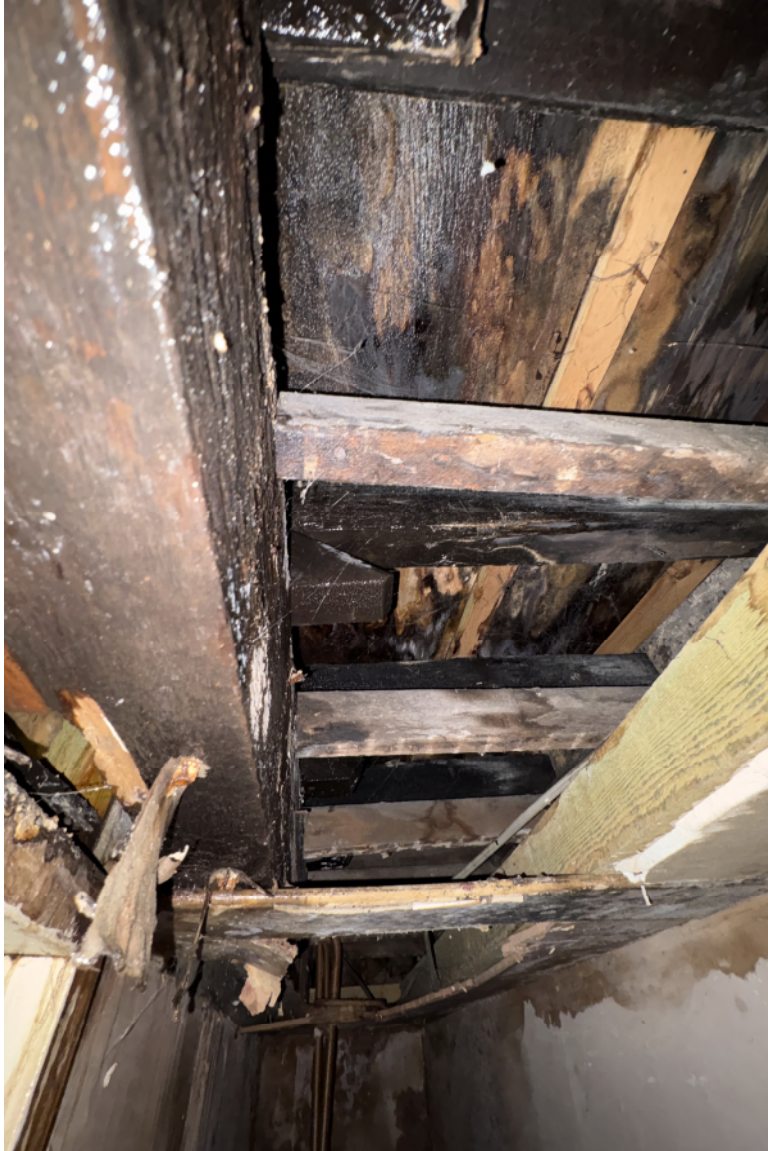
**PHOTOGRAPH 6 - LEAKING VALVE**

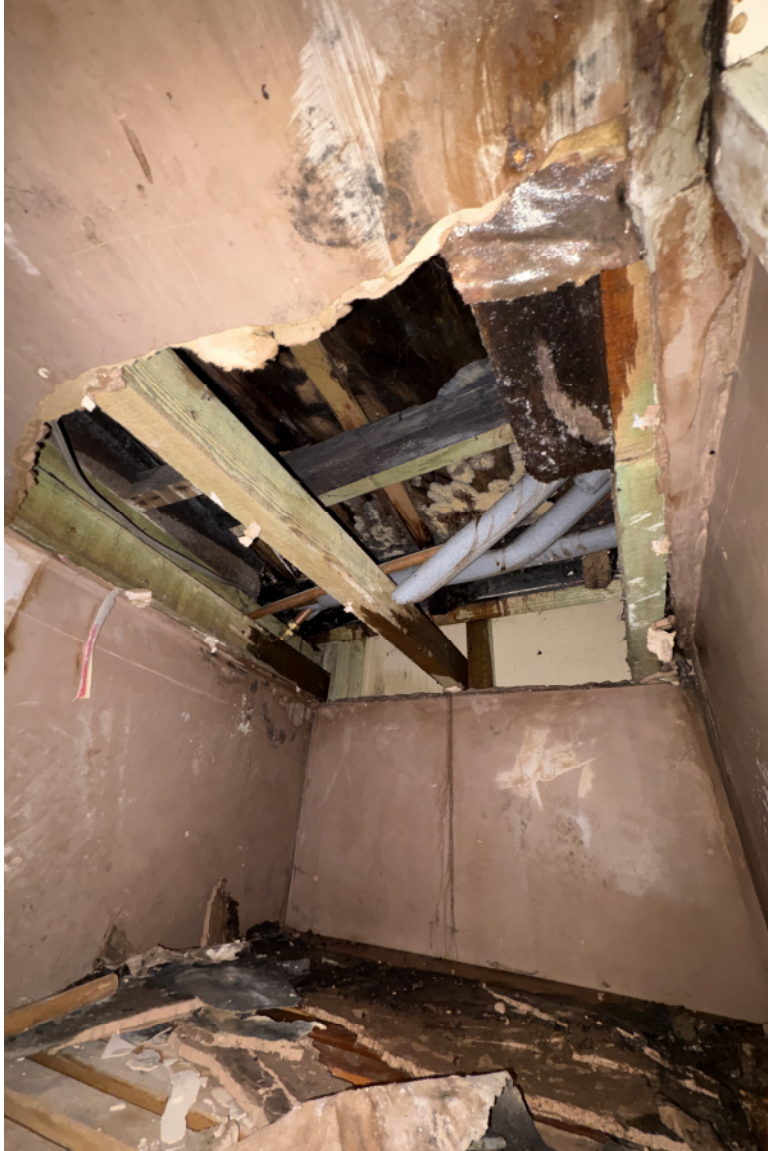
**PHOTOGRAPH 7 - LEAKING VALLEY WITH WET ROT IN TIMBER STRUCTURE**

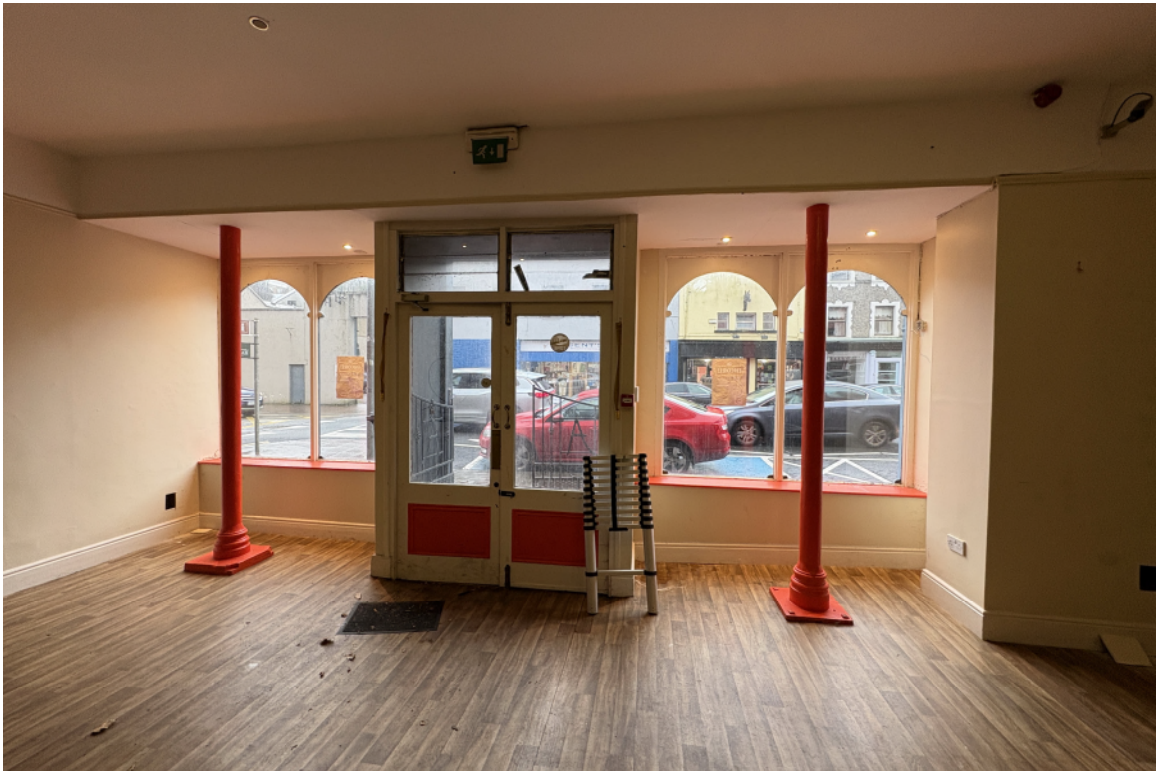
**PHOTOGRAPH 8 - CAST IRON COLUMNS AT GROUND FLOOR**

The single storey entrance pop out at the front of the building has a flat roof with torch on felt covering. This pop out is of timber construction. Cast iron columns support the timber beam under the main front wall of the building. This roof covering also requires immediate replacement.

It must be noted that this will only be phase 1 of the proposed refurbishment of the building. Internal wall linings and floor strengthening (where required) will not form part of this phase of works. It must also be noted that at the time of the survey it was not possible to determine the condition of the beam supporting the front wall of the building. It could not be determined at this time of survey whether the beam was timber or a later replacement of steel but considering the position of two cast iron columns at ground floor level, it is likely that the original timber beams still remain in place.

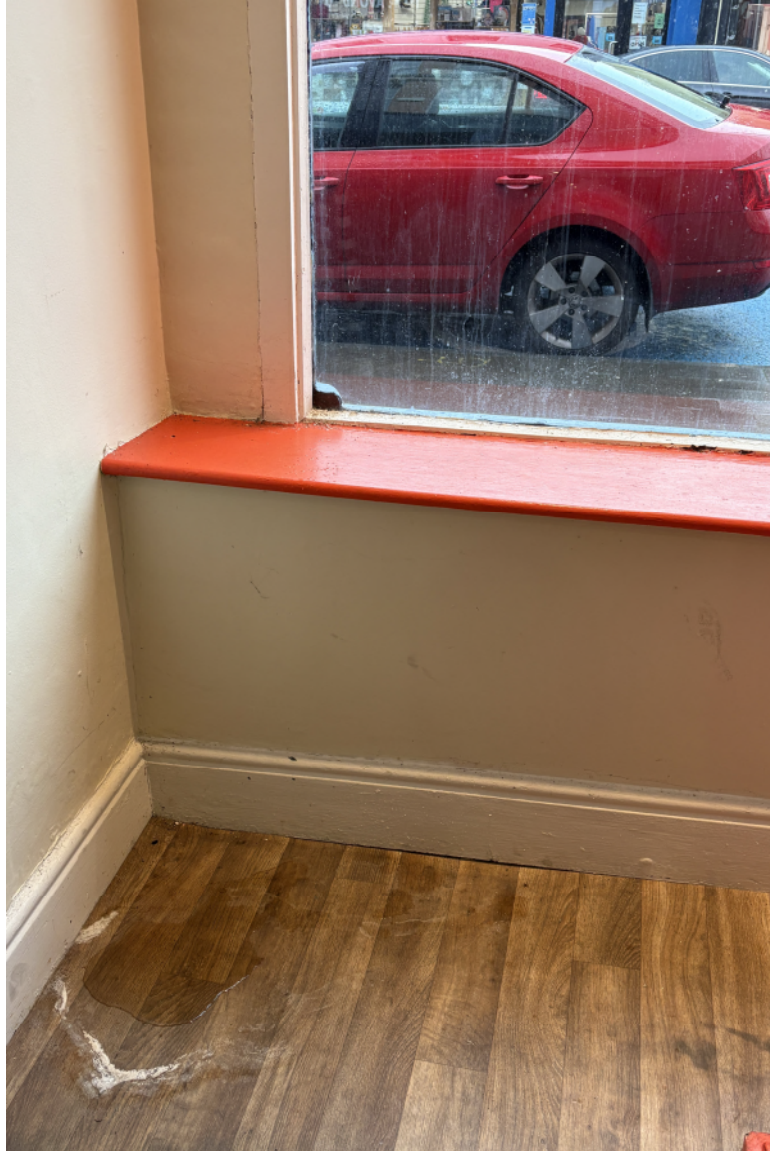
**PHOTOGRAPH 9 - WATER LEAKING FROM POP OUT AT FRONT ENTRANCE**

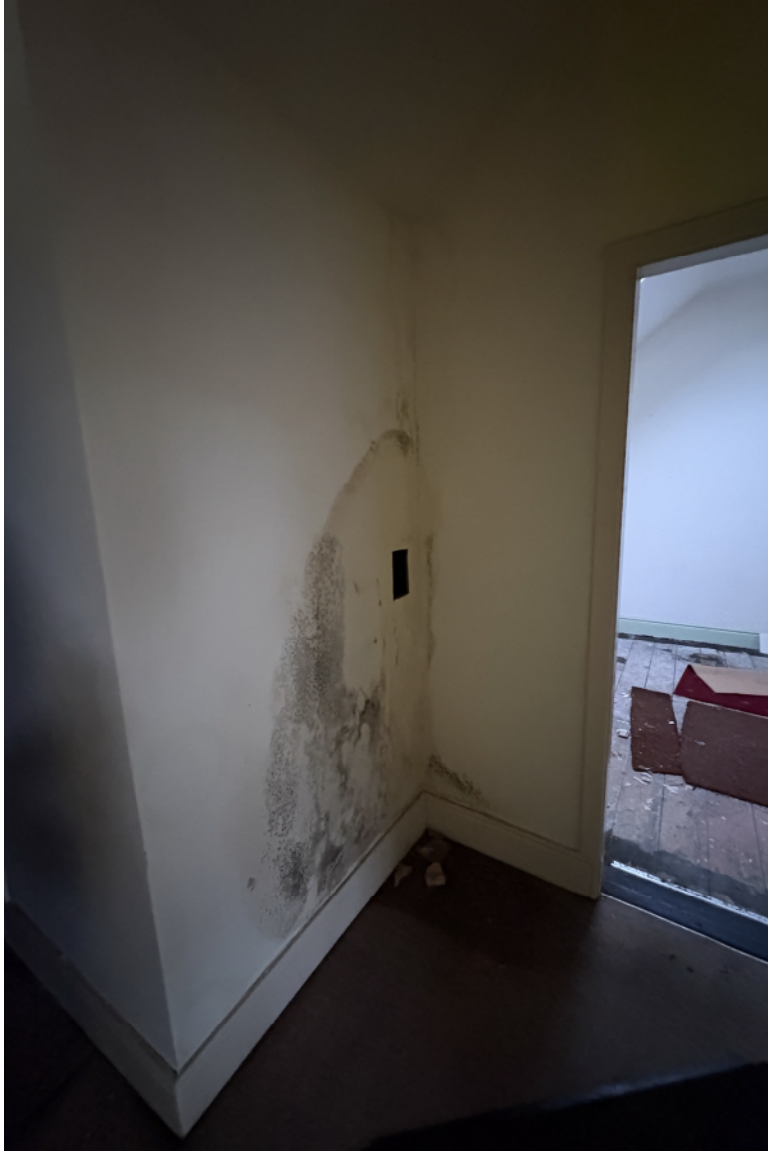
**PHOTOGRAPH 10 - WATER INGRESS THROUGH LININGS BENEATH INTERNAL VALLEY**

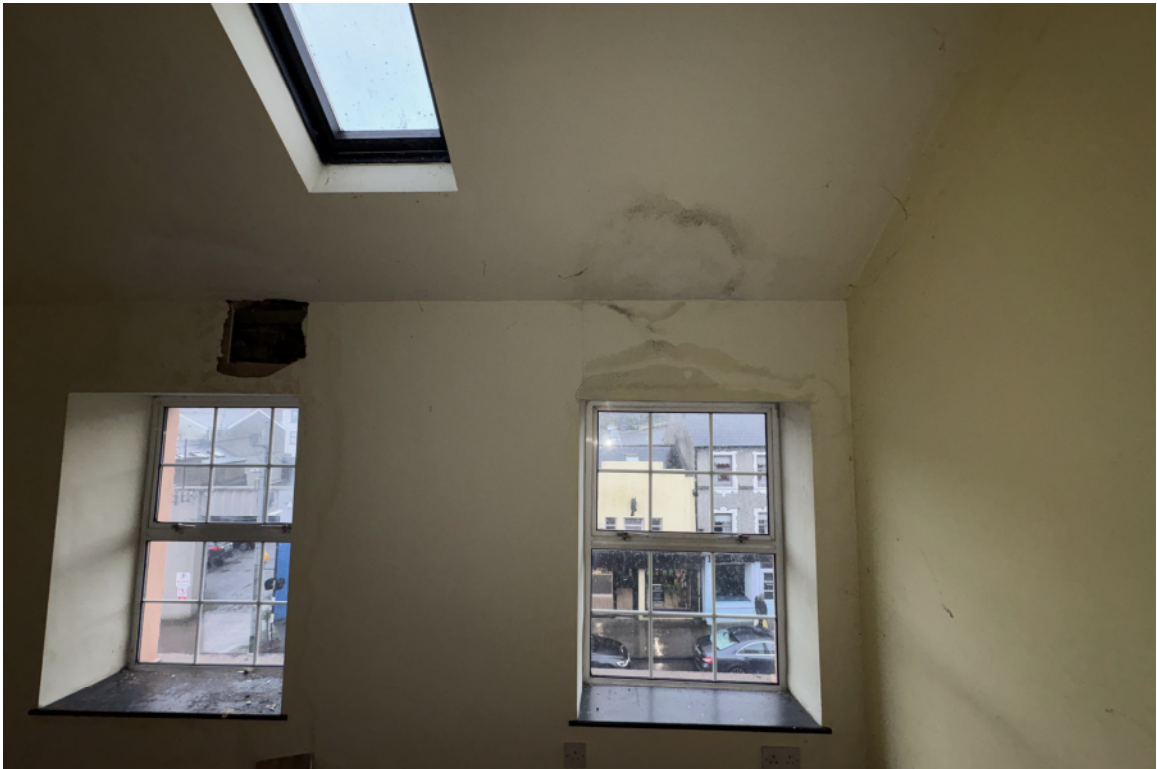
**PHOTOGRAPH 11- WATER INGRESS BEHIND FRONT PARAPET**
