### **SURVEY, SAMPLING AND ASSESSMENT FOR ASBESTOS CONTAINING MATERIALS**

**26 McCurtain Street**

**Fermoy**

**Cork County Council**

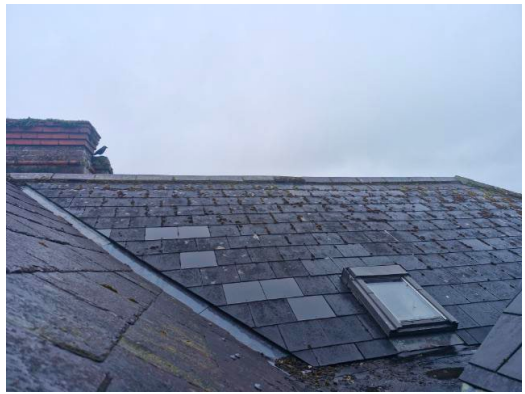
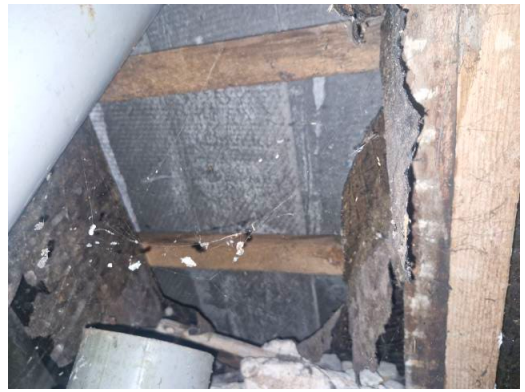
| 26 McCurtain Street | | | | | | | |
|---|---|---|---|---|---|---|---|
| External Adjoining rear extension roof pitches 019 - Slates: Cement Product - S008 | 56m <sup>2</sup> | Chrysotile | Low Damage | 4 | Remove under controlled conditions | 1 | April 2027 |

| Type | Chrysotile | |
| Material | Slates<br>Cement Product | |
| Location | 26 McCurtain Street<br>External Adjoining rear extension<br>roof pitches 019 | |
| Quantity | 56 m <sup>2</sup> | |
| Sample No. | S008 | |
| Condition | Low Damage | |
| Risk | Very Low | |

**Recommendations:** The asbestos containing material will be interfered with as part of the proposed works and should be removed under controlled conditions by a specialist contractor. A management system/plan including routine re-inspections of control measures should be adopted to monitor the material. Site and task specific risk assessments should be carried out ahead of any work in proximity to the material.

| Recommendation | Remove under controlled conditions | |

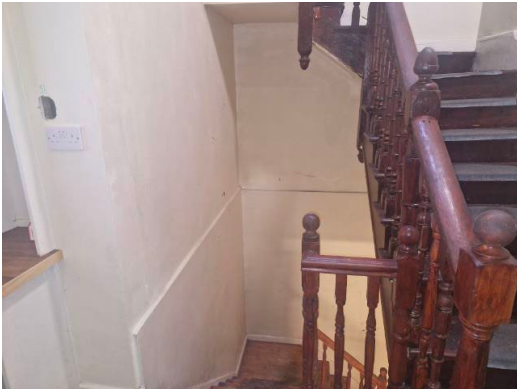
| Type | NAD | |
| Material | Plasterboard ceiling and walls | |
| Location | 26 McCurtain Street<br>Ground Floor Staircase 005 | |

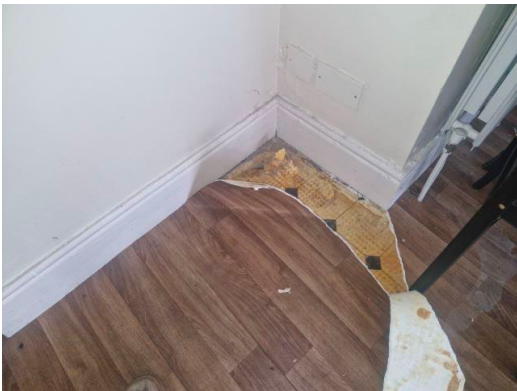
| Type | NAD | |
| Material | Linos | |
| Location | 26 McCurtain Street<br>Ground Floor Retail unit 006 | |
| Sample No. | S001 | |

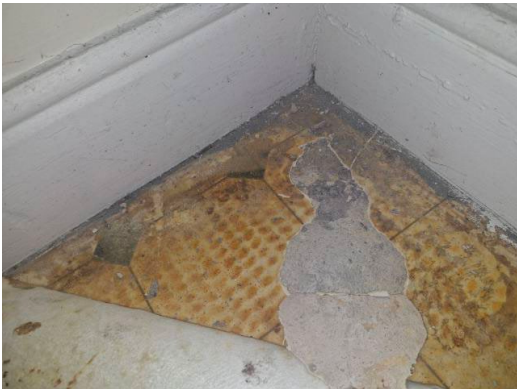
| Type | NAD | |
| Material | Floor screed<br>Cement Product | |
| Location | 26 McCurtain Street<br>Ground Floor Retail unit 006 | |
| Sample No. | S002 | |

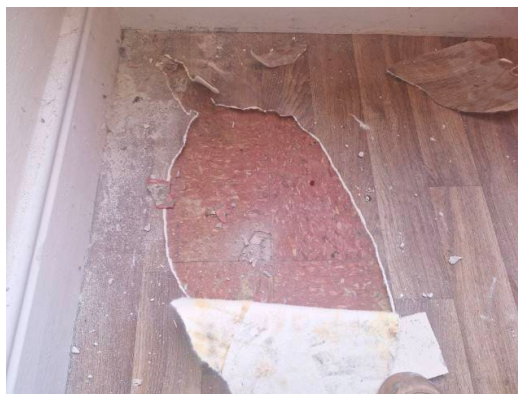
| Type | NAD |
| Material | Vinyl floor tiles beneath lino<br>Vinyl Products |
| Location | 26 McCurtain Street<br>Ground Floor Retail unit 006 |
| Sample No. | S003 |

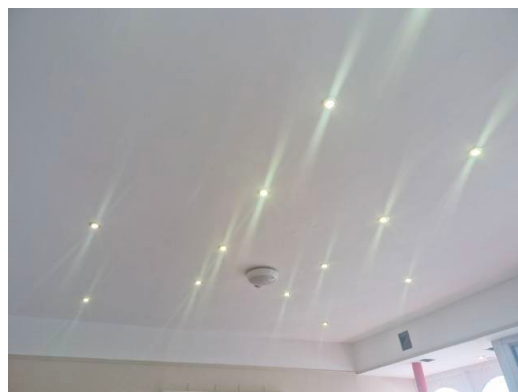
| Type | NAD |
| Material | Plasterboard ceiling |
| Location | 26 McCurtain Street<br>Ground Floor Retail unit 006 |

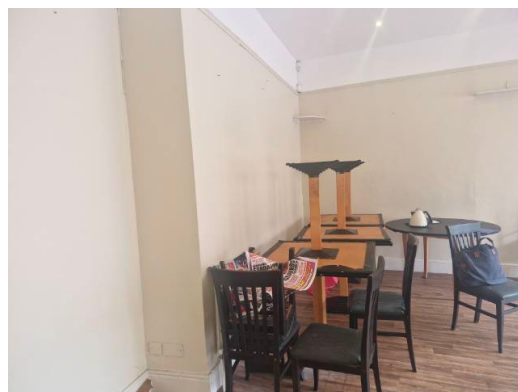
| Type | NAD |
| Material | Plasterboard walls |
| Location | 26 McCurtain Street<br>Ground Floor Retail unit 006 |

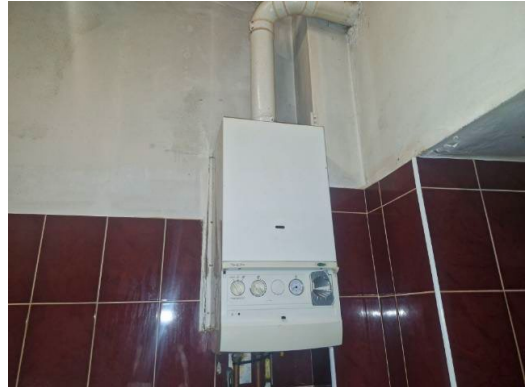
| Type | NAD |
| Material | Boiler unit |
| Location | 26 McCurtain Street<br>Ground Floor Kitchen 007 |

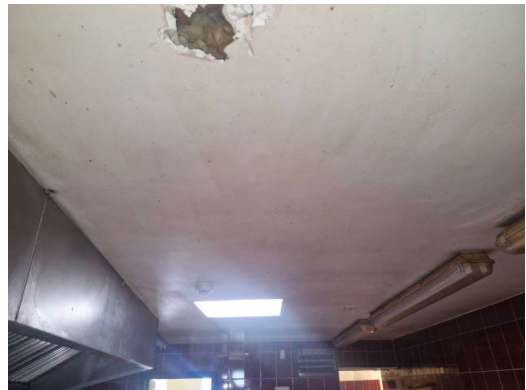
| Type | NAD |
| Material | Plasterboard ceiling |
| Location | 26 McCurtain Street<br>Ground Floor Kitchen 007 |

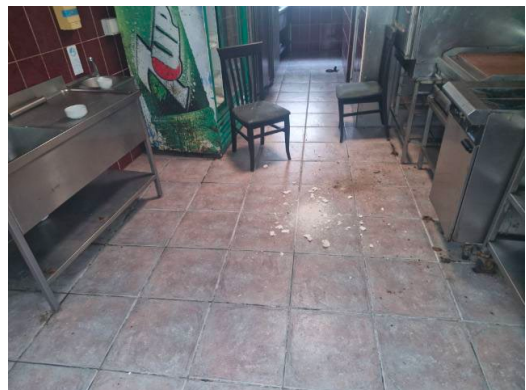
| Type | NAD |
| Material | Ceramic tiles on a concrete floor |
| Location | 26 McCurtain Street<br>Ground Floor Kitchen 007 |

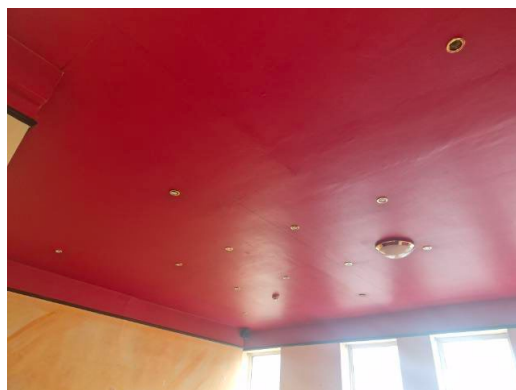
| Type | NAD |
| Material | Plasterboard |
| Location | 26 McCurtain Street<br>1st Floor Ceilings 008 |

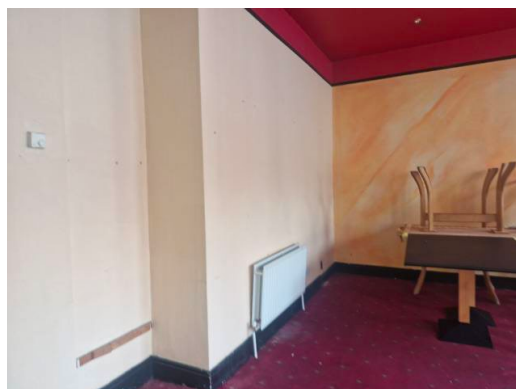
| Type | NAD |
| Material | Plasterboard |
| Location | 26 McCurtain Street<br>1st Floor Walls 009 |

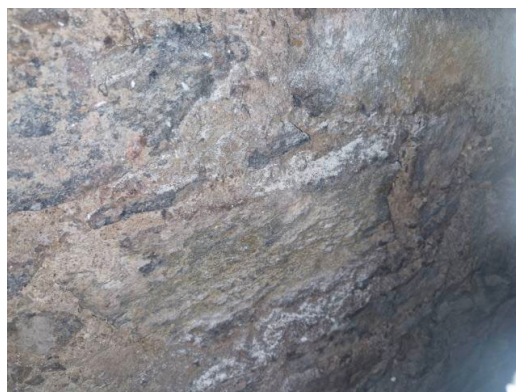
| Type | NAD |
| Material | Stone and mortar |
| Location | 26 McCurtain Street<br>1st Floor Walls 009 |

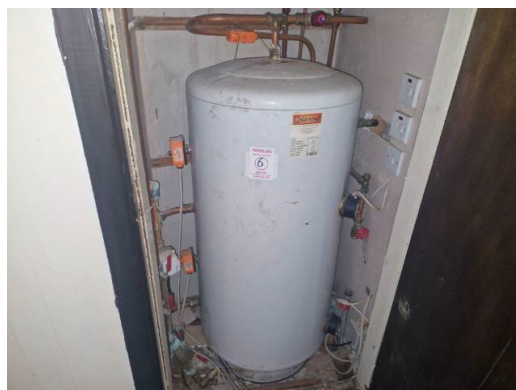
| Type | NAD |
| Material | Water tank |
| Location | 26 McCurtain Street<br>1st Floor Hot press 010 |

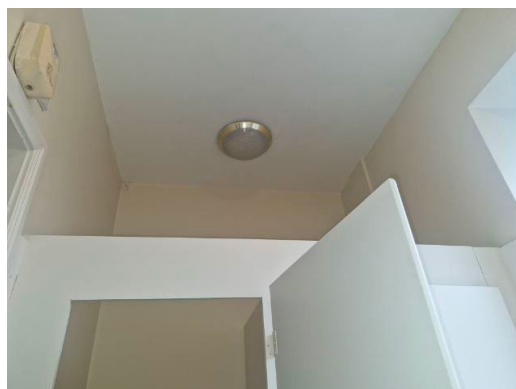
| Type | NAD |
| Material | Plasterboard ceiling and walls |
| Location | 26 McCurtain Street<br>1st Floor Toilets 011 |

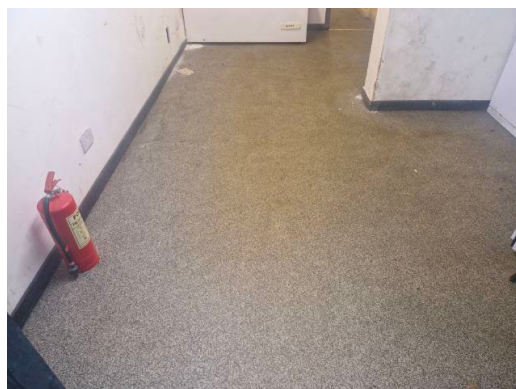
| Type | NAD |
| Material | Lino |
| Location | 26 McCurtain Street<br>Basement Floors 001 |

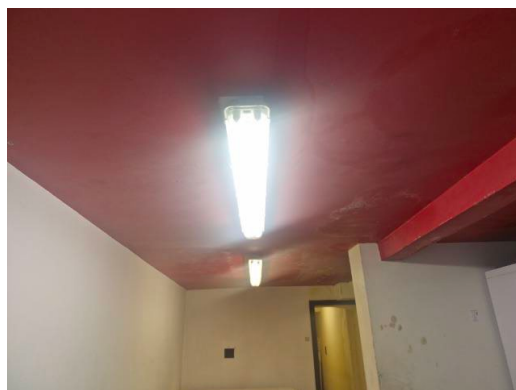
| Type | NAD |
| Material | Plasterboard |
| Location | 26 McCurtain Street<br>Basement Ceilings 002 |

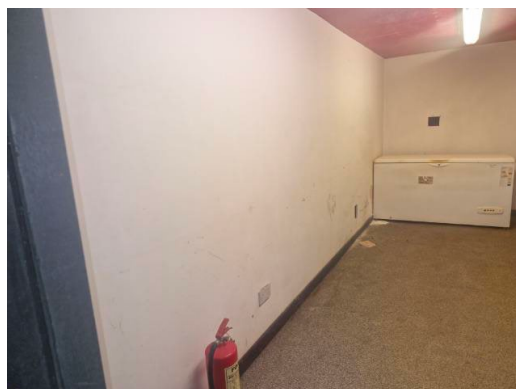
| Type | NAD |
| Material | Plasterboard |
| Location | 26 McCurtain Street<br>Basement Walls 003 |

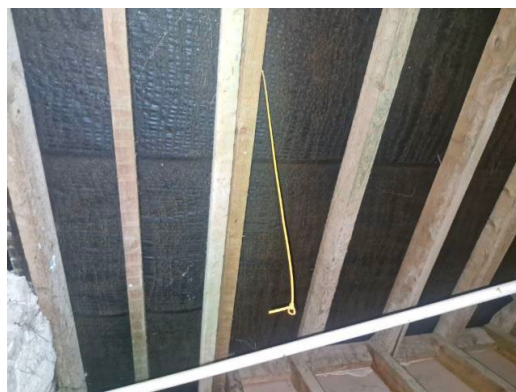
| Type | NAD |
| Material | Roof felt<br>Bituminous Product |
| Location | 26 McCurtain Street<br>2nd Floor Attic 011 |
| Sample No. | S004 |

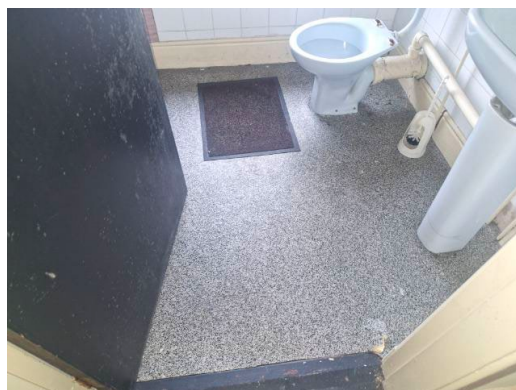
| Type | NAD |
| Material | Three layers of lino |
| Location | 26 McCurtain Street<br>2nd Floor Toilet 012 |
| Sample No. | S005 |

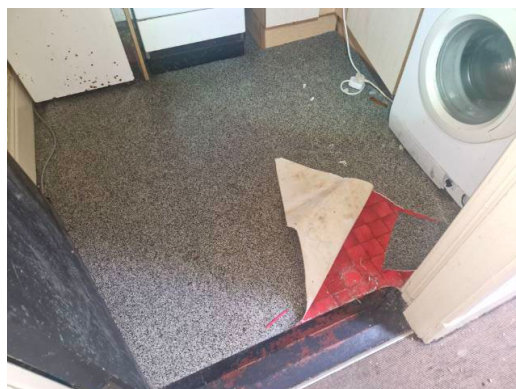
| Type | NAD |
| Material | Two layers of lino |
| Location | 26 McCurtain Street<br>2nd Floor Kitchen 013 |
| Sample No. | S006 |

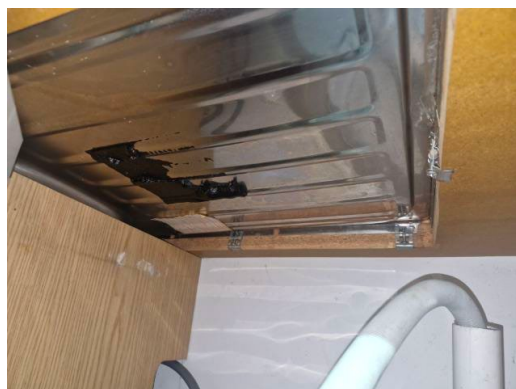
| Type | NAD |
| Material | Sink heat pads<br>Bituminous Product |
| Location | 26 McCurtain Street<br>2nd Floor Kitchen 013 |
| Sample No. | S007 |

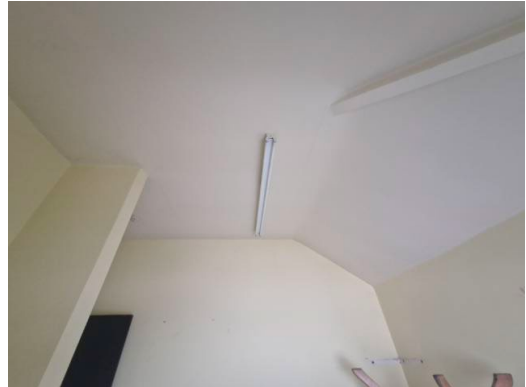
| Type | NAD |
| Material | Plasterboard |
| Location | 26 McCurtain Street<br>2nd Floor Ceilings 013 |

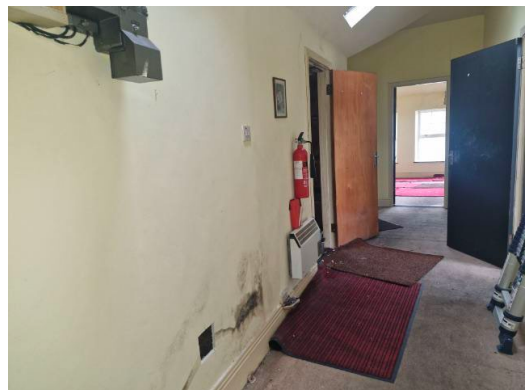
| Type | NAD |
| Material | Plasterboard |
| Location | 26 McCurtain Street<br>2nd Floor Walls 014 |

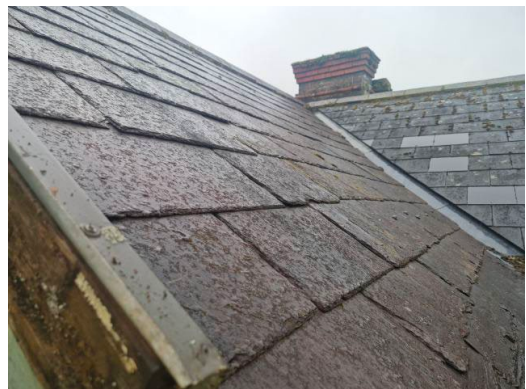
| Type | NAD |
| Material | Natural quarry slates |
| Location | 26 McCurtain Street<br>External Original Road facing<br>roof pitches 018 |

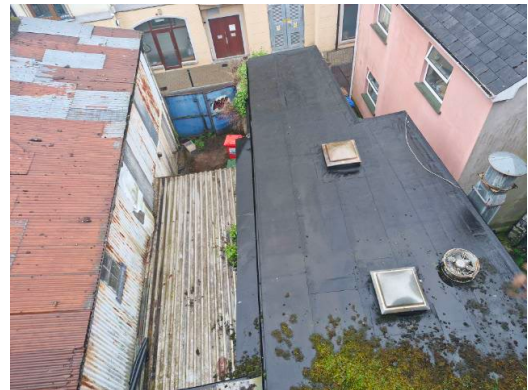
| Type | NAD |
| Material | Felt |
| Location | 26 McCurtain Street<br>External Adjoining rear<br>extension flat roof 019 |
| Sample No. | S009 |
