**TEM**  
**Engineering and Management**

**PROJECT: 26 McCurtain Street Fermoy Condition Report**

**Building Services Condition Report**

**Document Number: 18613 – 100 – R1**

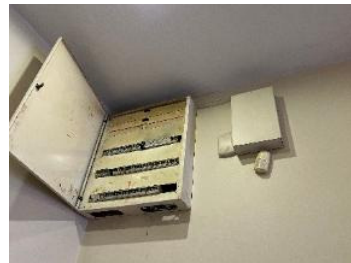
1.1 Main Distribution Board

LV Main Board is located in the plant room. It serves the requirements of the of the entire retail unit. (Refer to Photo 1.1)

The Main Distribution Board is in poor to fair condition with poor labelling. No surge protection was apparent. Access to the board is poor. Flash guards are missing on many of the board sections and live terminals are accessible.

As the boards are in poor condition the following actions are required and recommended:-

| Action | Location/Element | Budget Costs |
|---|---|---|
| (R) | Replace existing Main Distribution Board | €8,000 |

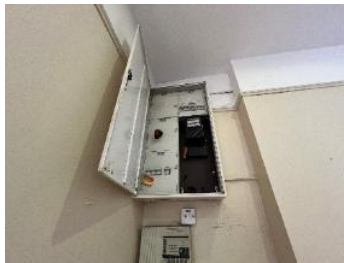
1.2 ESB Meter

The current arrangement for the building is that it is served from the local ESNB network directly into a lucy box and ESB meter and main breaker adjacent to the main entrance to the ground floor retail area. (Refer to Photo 1.2)

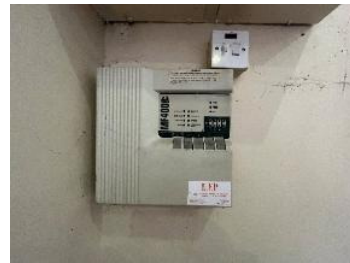
1.3 Fire Alarm Panel

System comprises of a Menvier MF 400 4 zone conventional fire alarm panel within the entrance. (Refer to Photo 1.3). This panel is likely original and from circa the 1980-90's, it would need to be established that the panel is in compliance with the current day regulations. No zone chart was posted at the panel however quarterly inspections are being carried out and this is posted adjacent to the panel. The system is not currently operational. This product is discontinued so the panel or component parts are no longer available.

As replacement parts or devices are no longer available a new system will be required, subject to testing of the cabling, it would be the intention to re-use the existing wiring and where additional devices are required new cabling will be employed.

A new system, panel and devices will be required utilising existing wiring to existing positions with additional devices required to bring the system up to current day standards and the system will need to be tested to the current standards I.S.3218-2024 v4.00 Fire detection and alarm systems for buildings - System design, installation, commissioning, servicing and maintenance and Building Regulations - Technical Guidance Document B - Fire Safety.

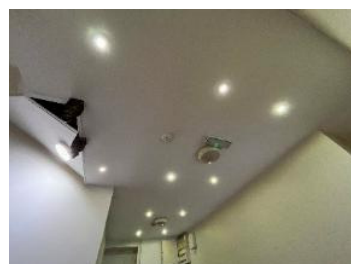
1.10 Lighting

The existing emergency lighting system comprises of fluorescent fittings throughout. Some operational and others not. (Refer to Photo 1.10, 1.37)

The works required here is a new emergency lighting system in accordance with I.S.3217-2023 v4.00 Emergency Lighting.

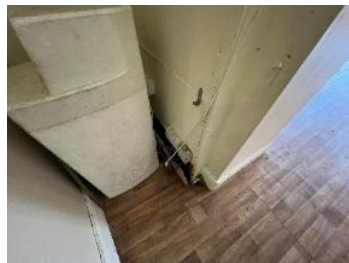
1.16 Sockets

Small Power installation comprises conduit, wall mounted outlets etc., with cabling routed on containment. (Refer to Photo 1.16)

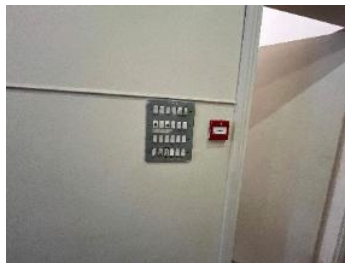
1.17 Switch bank & BGU

Lighting controls consist of Passive Infrared detection, on-off light switch control from local and central switch bank locations. (Refer to Photo 1.17)

Services comprise of automatic smoke detectors, heat detectors, manual call points and electronic sounders. (Refer to Photo 1.17, 1.61, 1.77, 1.78)

The introduction of Lighting controls consisting of additional Passive Infrared detection sensing should be introduced would lend itself to reductions in energy costs.

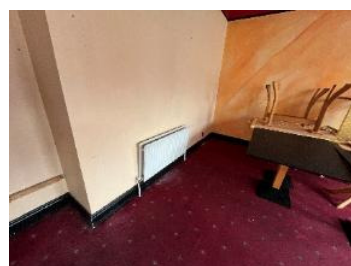
1.41 Radiator

Heating is provided by LPHW radiators (Refer to Photo 1.41) served from gas fired boiler located in the Prep Kitchen with a gas meter located within the rear service yard. It will be intended retaining this heating arrangement for the future needs. This will require the replacement of the gas fired boiler with a new condensing room sealed gas boiler with balanced flue, a slam shut valve at gas service point of entry into the building and should gas appliances be reused all existing gas pipework to be re-tested and certified.

All existing heating pipework to be re-tested for re-use with existing radiators to be replaced for matching modern radiators of equal dimension for ease of connection to the existing pipework. Thermostatic radiator valves will be employed as the exiting pipe arrangement does not lend itself to zoning of the system

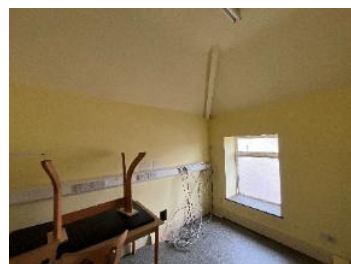
1.72 DADO trunking

These distribution boards serve all the lighting, small power and services requirements etc., throughout the building and the cabling comprises of mainly PVC Singles, NYMJ in dado/on basket/tray and SWA cabling on tray. (Refer to Photo 1.72, 1.76)

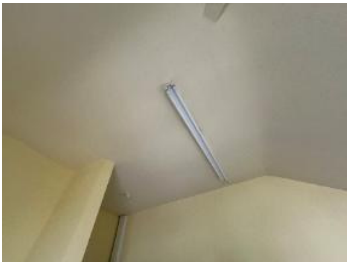
Lighting throughout FOH and BOH is comprised of fluorescent fittings. Lighting comprising of modular recessed, surface, decorative and surface fittings through the retail areas and back of house and ancillary areas. (Refer to Photo 1.5, 1.7, 1.8, 1.9, 1.10, 1.12, 1.26, 1.37, 1.40, 1.43, 1.48, 1.50, 1.51, 1.55, 1.57, 1.59, 1.61, 1.73, 1.75)

All fittings throughout the building are in poor condition and these should be replaced.

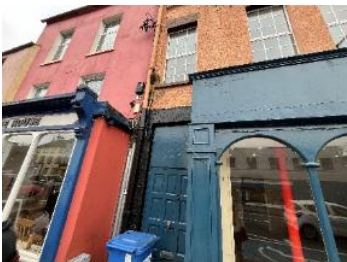
Intruder Alarm Systems exist in the building and will be re-used. (Refer to Photo 1.78)
