# Rossmore Monument Monaghan

## Conservation Report: Condition Survey

| CURRENT ISSUE DATE | RECIPIENT | ISSUE |
|---|---|---|
| JANUARY 2026 | MONAGHAN COUNTY COUNCIL | DRAFT 1 |

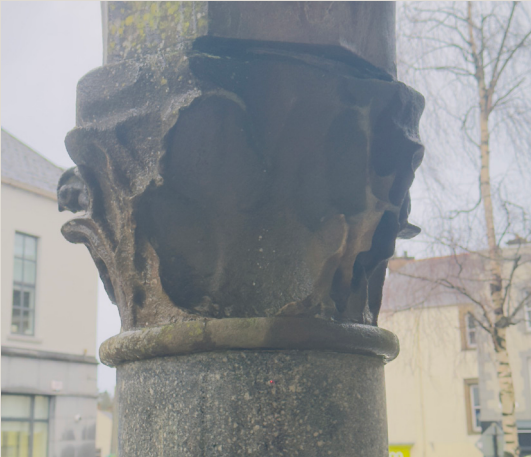
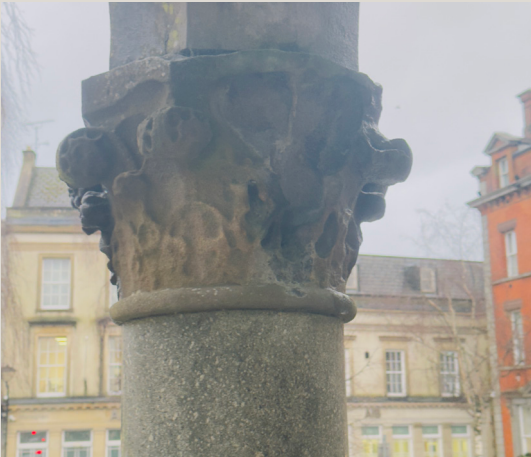
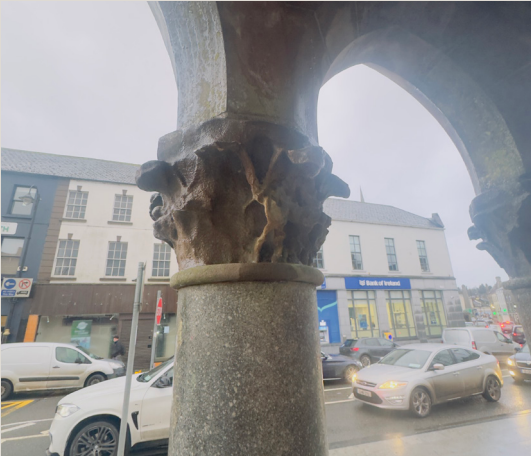
Significant erosion was noted on the sheltered internal faces of the lower capitals. While not currently structurally compromised, these elements are at Medium–High risk of further decay due to prolonged saturation.

| Element | Description | Condition Notes | Symptom Class |
|---|---|---|---|
| Pillar Capitals | 8xno. decoratively carved sandstone foliate capitals each with their own individual design. | <p>Condition varies across the set. The external faces of the capitals are generally in relatively good condition, retaining a high degree of their carved detail and original profile. In contrast, the internal faces of the capitals, orientated towards the fountain, exhibit significant and in some cases severe deterioration.</p> <p>The internal faces of many capitals display advanced surface loss and hollowing, with several showing near-complete erosion of carved detail and localised loss of the stone fabric itself. This pattern of decay is markedly inconsistent with the condition of the more exposed external faces and is not readily attributable to uniform weathering or gradual erosion alone. The scale and character of the material loss suggests the possibility of past mechanical damage or deliberate interference; however, no definitive evidence is available and the precise cause remains uncertain.</p> <p>The internal faces of the capitals exhibiting the most advanced deterioration also appear to be persistently saturated, indicating prolonged moisture retention. It is considered likely that sustained saturation, coupled with limited drying potential, has significantly increased the vulnerability of the sandstone to decay mechanisms, including accelerated surface breakdown and granular disintegration. The disparity in condition between the sheltered internal faces and the more exposed external faces suggests that restricted drying conditions may be a contributory factor, although this cannot be stated conclusively.</p> <p>Of the eight capitals, six exhibit significant loss of carved detail to their internal faces. One capital in particular shows extensive and likely irreversible loss of profile and ornament, such that the legibility of the original foliate carving has been substantially compromised. Remaining areas of intact carving on the affected capitals are now at heightened risk of further erosion if current moisture conditions persist.</p> <p>Further deterioration is evident in the form of carbon staining, together with minor vegetation growth and lichen colonisation, primarily confined to the internal faces of the lower capitals. These deposits are indicative of prolonged damp conditions and limited environmental drying. The presence of biological growth further contributes to surface breakdown and obscuration of carved detail in already weakened areas of stone.</p> <p>The condition of the lower capitals stands in marked contrast to that of the upper capitals, which remain in excellent condition, retaining crisp detailing, sharp profiles, and minimal evidence of moisture-related decay or biological colonisation. This disparity reinforces the conclusion that the deterioration affecting the lower capitals is not solely attributable to exposure or material quality, but is likely influenced by localised environmental factors, including moisture retention, reduced air movement, and limited drying potential at the lower level of the structure.</p> | <div></div> <div>Images</div> <div></div> <div></div> |

- Prior to any intervention, undertake detailed photographic and drawn recording of each capital, noting that each exhibits a unique carved foliate design. Recording should capture surviving profiles, depth of carving, tool marks, and areas of loss, to ensure that the individuality and evidential value of each capital is fully documented.

- Undertake carefully controlled, low-impact cleaning to remove carbon staining, biological growth, and surface soiling from the capitals, with particular care to fragile and hollowed areas. Cleaning methods should be limited to soft-bristle brushing and low-pressure water misting; abrasive techniques and aggressive chemical treatments should be avoided.

- Investigate and, where feasible, address environmental factors contributing to persistent saturation, including limited air movement and restricted drying at the internal faces of the capitals. Interventions should prioritise improving drying potential rather than excluding moisture, avoiding impermeable coatings or water repellents which may exacerbate decay.

- Re-carving or replication of lost foliate detail is not recommended, given the degree of loss, the uniqueness of each capital's carved design, and the risk of conjectural restoration. Intervention should focus on stabilisation and retention of surviving historic fabric rather than reinstatement of lost ornament.

- Where active decay threatens remaining carved detail, minimal, discreet plastic repairs may be considered solely to protect vulnerable edges or undercut areas, carefully profiled to support existing forms without attempting to recreate missing foliage.

- Implement a regular inspection and maintenance regime, with particular attention to moisture retention, surface biological growth, and progression of erosion at the internal faces of the capitals. Monitoring should inform future intervention and ensure that further loss of surviving detail is identified at an early stage.

The carved sandstone foliate capitals are considered to be of medium–high urgency, with early intervention required to stabilise remaining carved detail, address persistent moisture retention, and prevent further irreversible loss of historic fabric.

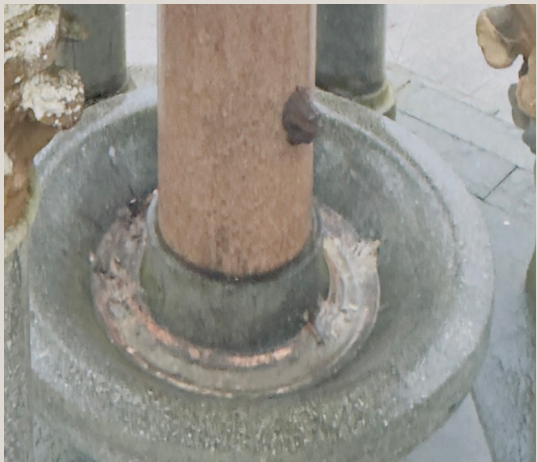
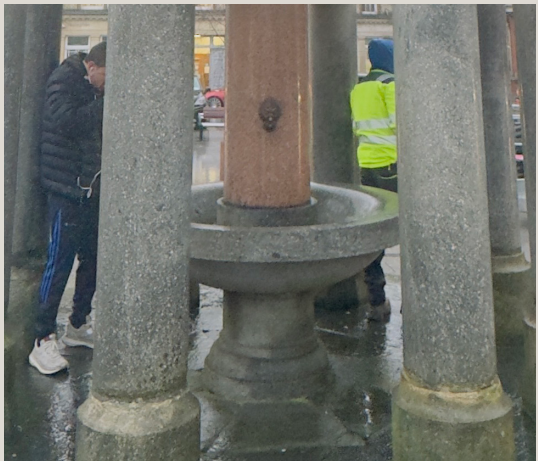
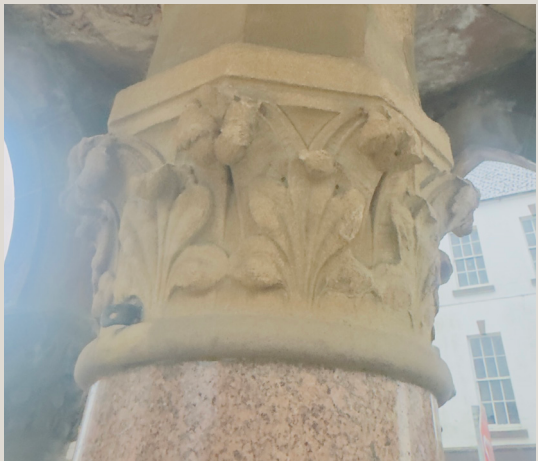
The central fountain column and bowl, though operationally defunct, remain structurally sound with only minor historic staining.

| Central Fountain | <p>The fountain is formed around a central vertical assembly comprising three principal architectural components:</p> <ol style="list-style-type: none"><li>1. a limestone basin,</li><li>2. a pink granite column,</li><li>3. a decoratively carved sandstone foliate capital.</li></ol> | <p>The pink granite column is in excellent condition overall, retaining its surface finish with no evidence of cracking or structural distress. One decorative spout is missing, likely as a result of vandalism or localised removal. Its absence has resulted in localised damage to the column fabric at the point of removal; however, this damage is limited in extent and does not compromise the structural integrity of the column.</p> | |
| | <p>The presence of internal pipework supplying water to the fountain is acknowledged; however, all associated services are concealed within the fabric of the monument and are not externally visible.</p> | | |

- Retain the central pink granite column in its present state, as it is in excellent condition and does not require structural intervention. Any works should be limited to protection and monitoring only.

- Address the missing decorative spout by first recording the area of loss in detail. Consider discreet make-good to the point of removal using a compatible mineral repair mortar, limited strictly to stabilising the damaged area and visually recessing the exposed outlet. Full reinstatement of a replacement spout should not be undertaken unless supported by reliable documentary or physical evidence of the original detail and approved as part of a wider conservation strategy.

- Undertake gentle cleaning of the limestone basin and annular trough to reduce surface staining, using low-impact, non-abrasive methods appropriate to limestone. Cleaning should aim to reduce visual prominence of staining rather than achieve uniform appearance,

- recognising that some staining forms part of the historic use patina. The pink-toned staining within the trough should not be aggressively removed, given the uncertainty of its origin and its superficial nature. Trial cleaning should be undertaken to assess the extent to which staining can be moderated without loss of surface integrity.

- Given that the fountain function is redundant, ensure that all redundant pipework is securely capped, drained, or otherwise made safe internally to prevent accidental water ingress or future leakage, without disturbing historic fabric.

- Avoid reinstating water flow unless there is a clear conservation or interpretive rationale and a fully resolved design that mitigates the risks of moisture accumulation elsewhere within the monument.

The central fountain assembly is considered to be of low urgency, with any remedial works confined to planned maintenance and minor fabric stabilisation rather than immediate intervention.

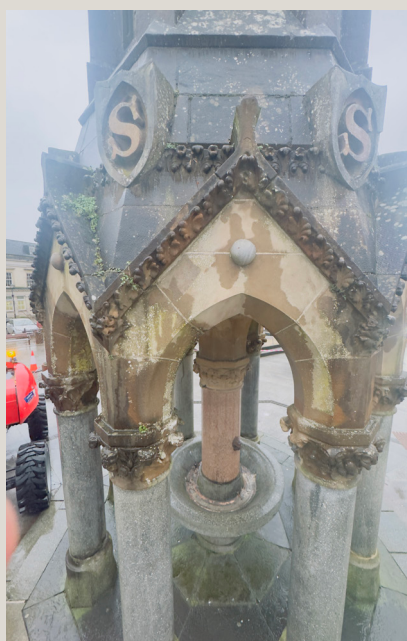
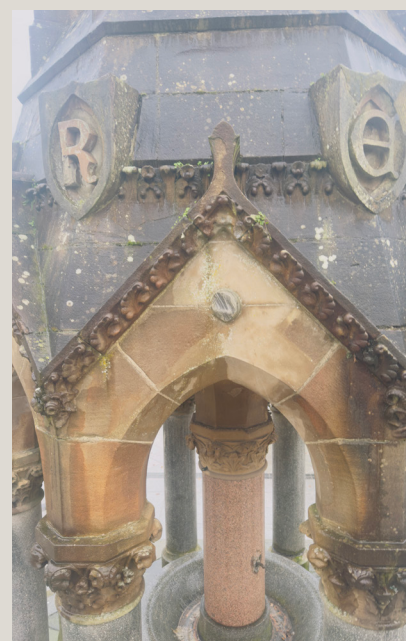
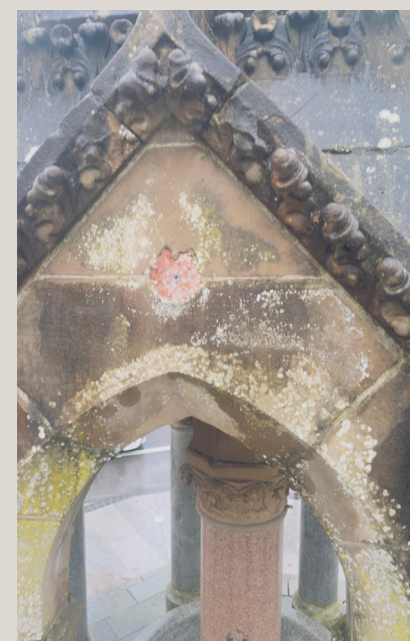
| Element | Description | Condition Notes | Symptom Class |
|---|---|---|---|
| Upper Body of Monument- Mid Section | <p>The upper body of the monument is octagonal in plan, its geometry generated from the points at which adjacent gable ends of the outer arches intersect below. The principal arrises of the octagon align with these intersections, creating a clear and legible transition between the arcade level and the superstructure above.</p> | <p>The upper body of the monument is generally in fairly good condition, retaining its overall form, profile, and legibility. Widespread algae and lichen growth is present, together with limited vegetation growth in isolated locations, indicating prolonged surface dampness.</p> | |
| | <p>At each vertex of the octagon, a projecting limestone shield bears a single deeply carved letter, together spelling R O S S M O R E. The lettering is executed in alternating red and grey marble, inset within the limestone shields and contributing to the polychromatic character of the monument. The upper surfaces of the shields are formed with a later levelled treatment, likely mortar-based, reinforcing the horizontal datum and providing a degree of water shedding.</p> | <p>Evidence suggests that the original stone surfaces of the shields were mechanically keyed to receive the applied facing material, resulting in permanent marking of the historic fabric. This intervention, while visually indistinct from ground level, represents a loss of original surface integrity.</p> | |
| | <p>Together, the two stages and five courses form a coherent and ordered superstructure, in which geometry, inscription, and ornament are integrated directly into the masonry mass.</p> | <p>The foliate-carved sandstone string course remains in good condition, retaining its profile and detailing. Elsewhere, the sandstone exhibits light carbon staining and minor weathering consistent with its exposed urban environment; these effects are not currently considered to be of concern.</p> | |

- Undertake gentle surface cleaning to reduce algae, lichen, and general biological growth using low-pressure, non-abrasive methods appropriate to sandstone and limestone. Cleaning should aim to reduce moisture retention and visual staining rather than achieve uniform appearance.

- Carefully remove minor vegetation growth from joints by hand, ensuring roots are fully extracted to minimise recurrence.
- Inspect all open or depleted mortar joints and carry out localised repointing where required using a compatible lime-based mortar, matched in colour, texture, and permeability to the existing mortar. Repointing should be limited strictly to defective joints and avoid unnecessary disturbance of sound fabric.

- Retain the existing applied facing material around the lettered shields where it is currently sound and performing adequately. No removal or wholesale replacement is recommended at this stage. Any future intervention should be informed by material analysis to confirm composition and long-term compatibility.

- Avoid introducing additional coatings, sealants, or surface treatments to the shields or sandstone courses, as these may interfere with moisture movement and accelerate decay.

- Monitor areas where original stone was mechanically keyed for previous repairs. No remedial action is required at present, but these locations should be recorded and reviewed during future inspections.

- Maintain the foliate-carved string course through routine inspection only; no active intervention is required at this time.
- Implement a cyclical maintenance regime, focusing on biological growth, joint condition, and moisture staining, to ensure early identification of any change in condition.

The upper body of the monument is considered to be of low to medium urgency, with remedial works appropriate as part of a planned programme of maintenance rather than immediate intervention.

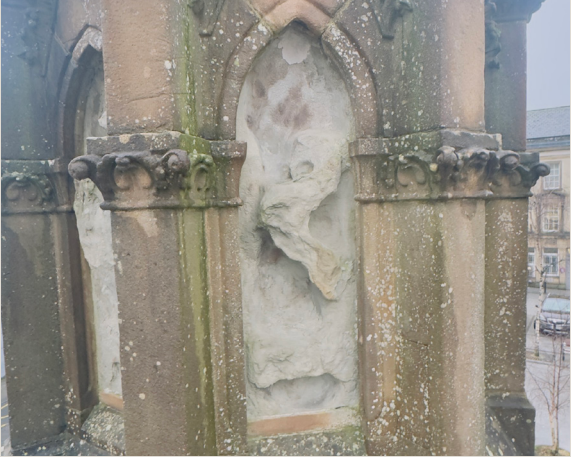
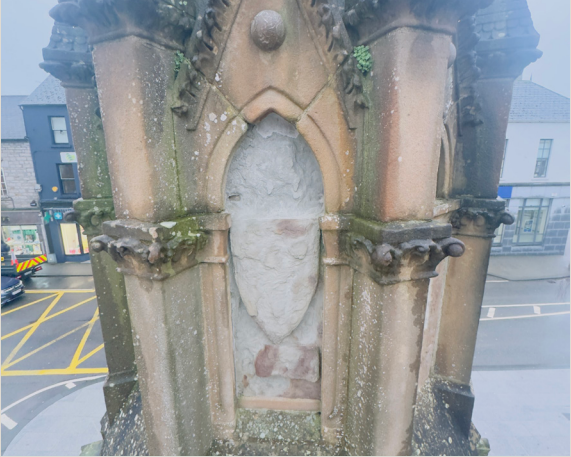
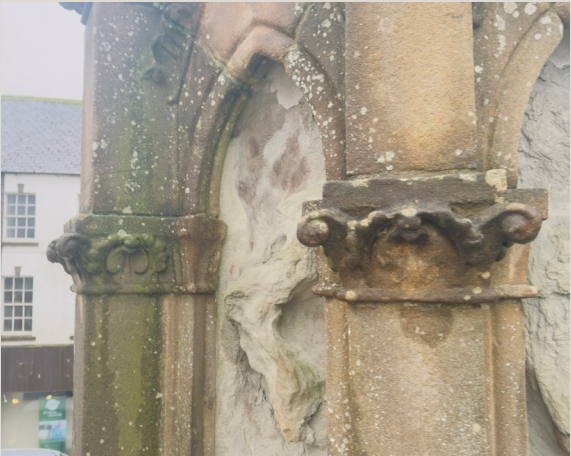
The carved panels within the upper arcade have suffered extensive, irreversible loss of detail. Active delamination and void formation were observed, necessitating urgent specialist intervention to arrest further loss of historic fabric.

- Undertake prompt detailed recording of each heraldic plaque, including high-resolution photography and measured notes, to capture remaining form, voids, and evidence of surface treatments prior to further loss.
- Engage a conservation stone specialist to assess the plaques specifically, distinct from the surrounding sandstone arches and piers, given the advanced and atypical nature of deterioration at this level.

- Investigate potential water ingress pathways at and above the plaque level, including junctions at hood mouldings, crocketed arrises, and upper masonry interfaces, to identify sources of moisture contributing to active decay.
- Where feasible, introduce discreet water-shedding and moisture-management measures above the plaque level, ensuring interventions are minimal, reversible, and do not alter the architectural character of the monument.

The heraldic plaques within the upper arcade are considered to be of high urgency, requiring immediate specialist investigation and stabilisation to arrest ongoing decay and prevent further irreversible loss of historic fabric.
