# Asbestos Refurbishment Survey

Mervue Training Centre, Wellpark Road,  
Galway

S26-184

Higgins Consultancy Ardrahan Ltd

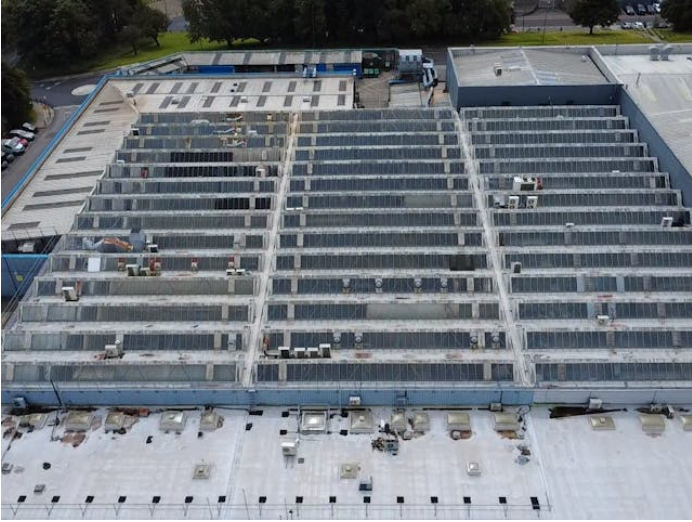
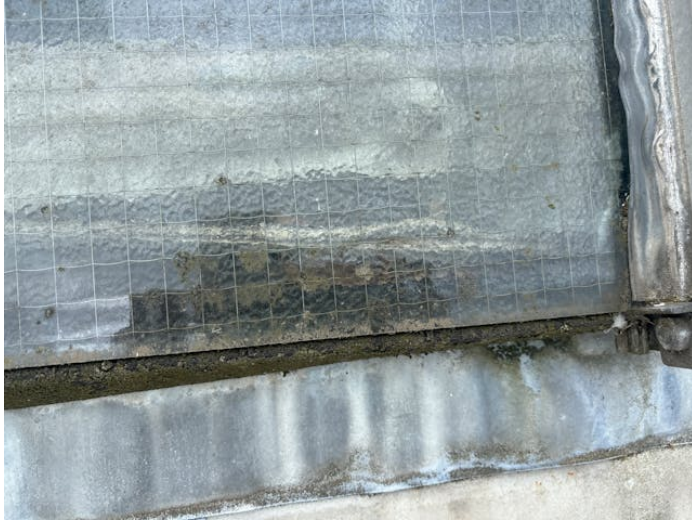
| Material | Textile | Extent | Approx 1350 windows total |
| Strategy / Sample Id | Sample / S101 | Fibre Type | Chrysotile |

| Recommendation | <p>ACM's can be managed in situ.</p> <p>Removal by trained operatives if planned works will involve removal of current glass panels. Internal areas under removal works should be isolated during any removal works and a certificate of reoccupancy obtained before reoccupancy of internal areas.</p> | | |

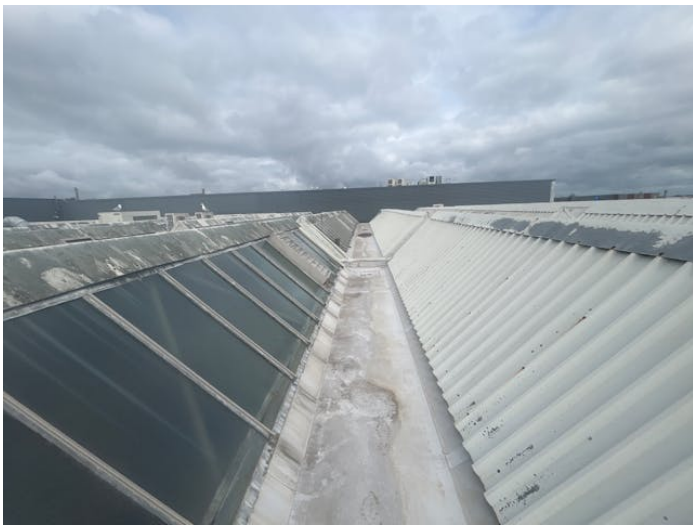
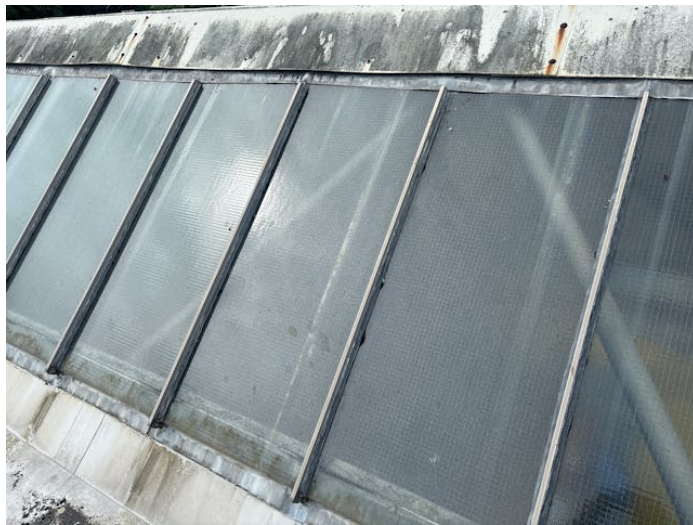
| Location Notes | Non ACM roof felt in walkway areas with metal sheeting on up stands. Glass panel skylights with textile rope seals (sample taken for analysis). Plant machinery on roof has no visible signs of ACM materials externally. Internal operating parts were unable to be inspected due to live units. | | |
| Access / Notes | Limited Access / No access to internal operating parts of plant machinery on roof | | |

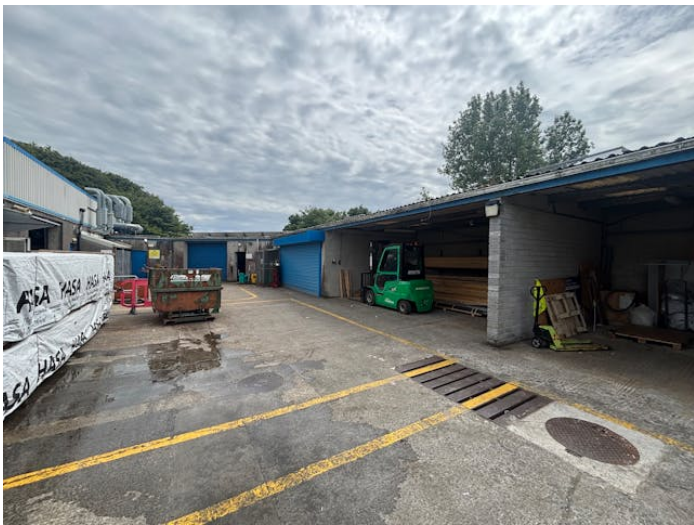
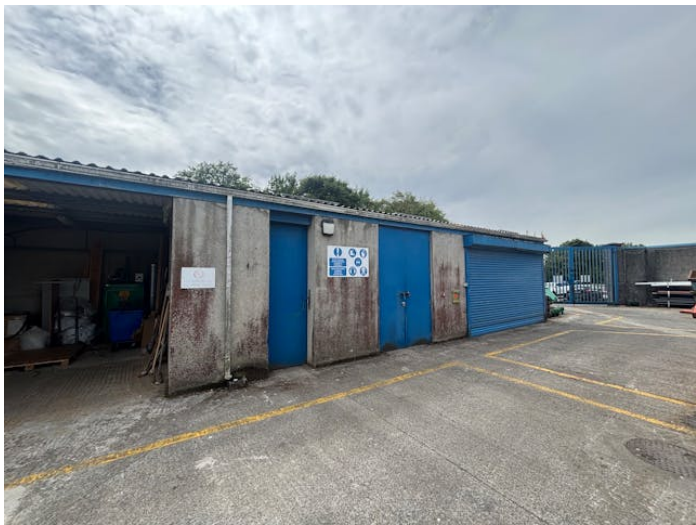
| Location | External Stores | Item | |

| Location Notes | Concrete flooring. Solid walls throughout. Metal roof sheeting. | | |
| General Comments | No ACM's identified. | | |

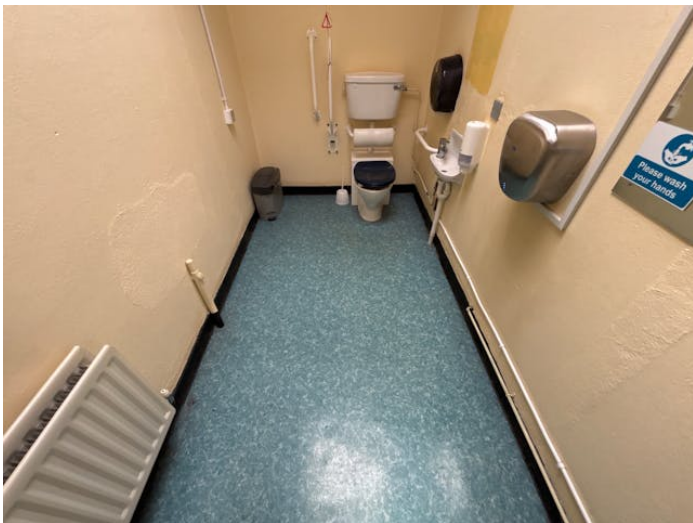
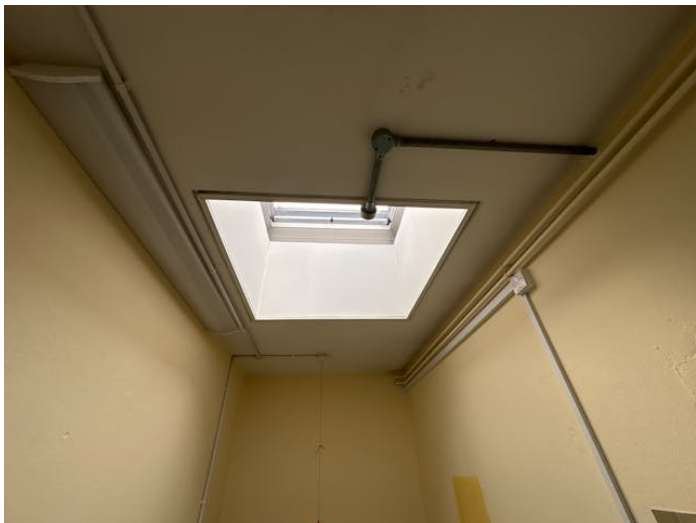
| Location | Bathroom (1114) | Item | |

| Location Notes | Vinyl flooring over ceramic floor tiles. Solid walls throughout. Smooth plaster finish ceilings. | | |
| General Comments | No ACM's identified. | | |

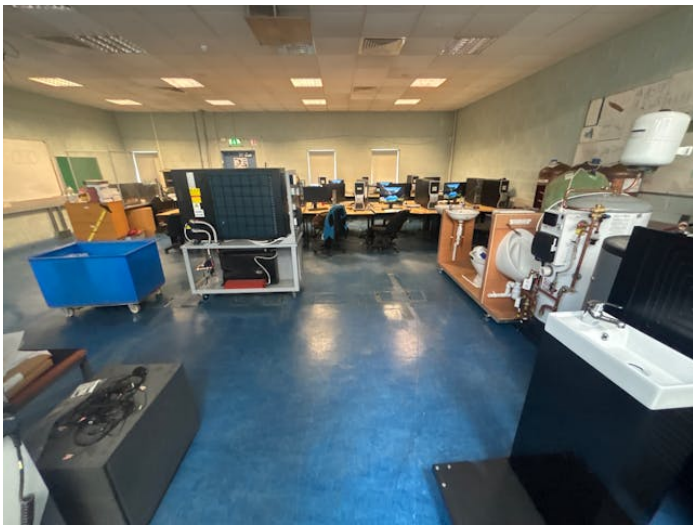
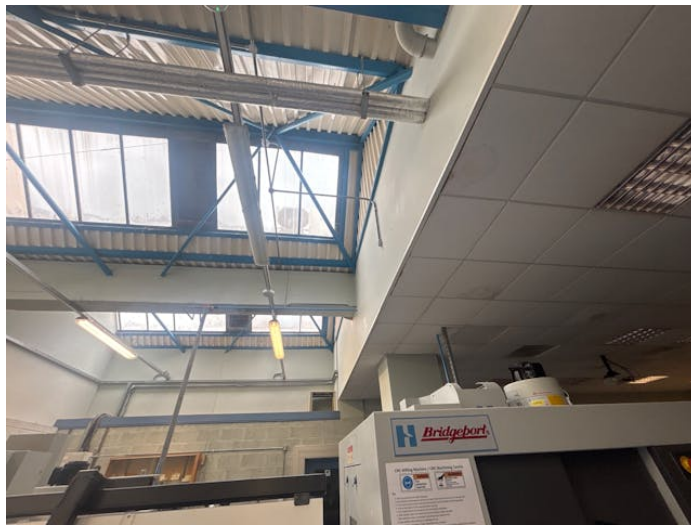
| Location Notes | Vinyl flooring over screed compound floor finish. Solid walls throughout. Metal deck roofing visible internally in areas. Suspended ceiling under metal roof sheeting in rear area of room. | | |
| General Comments | No ACM's identified. | | |

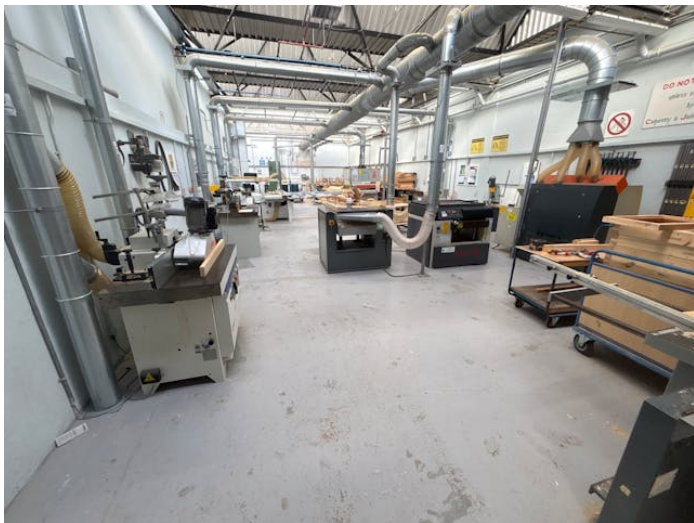
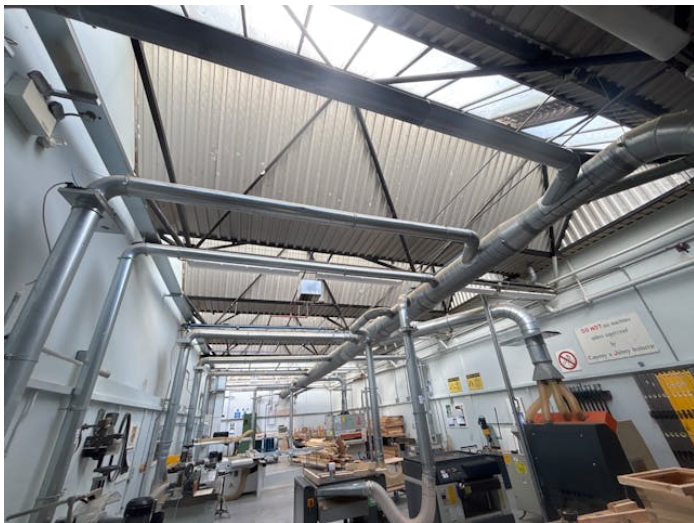
| Location Notes | Exposed concrete subfloor. Solid walls with plasterboard lined stud office walls. Exposed roof decking on ceiling. | | |
| General Comments | No ACM's identified. | | |

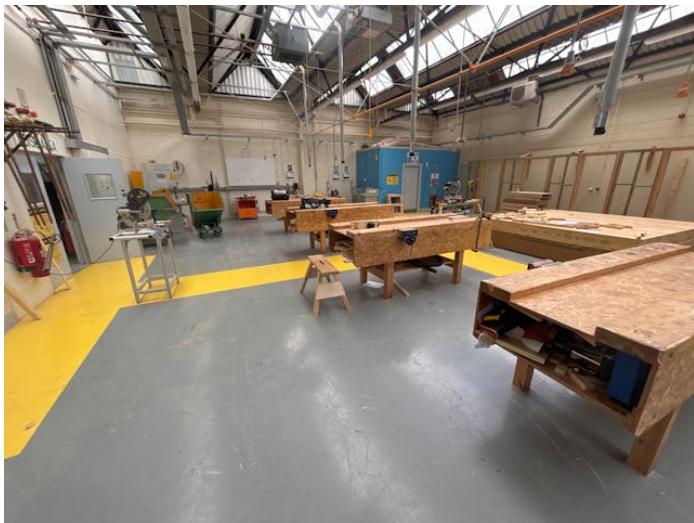
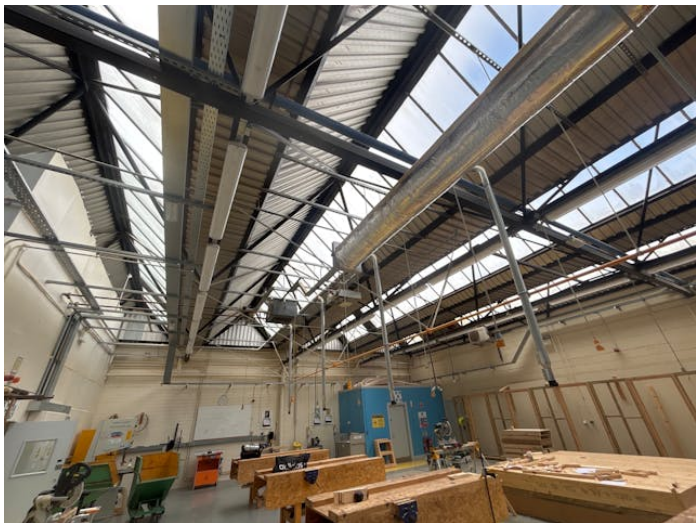
| Location Notes | Exposed concrete subfloor. Solid walls with plasterboard lined stud office walls. Exposed roof decking on ceiling. | | |
| General Comments | No ACM's identified. | | |

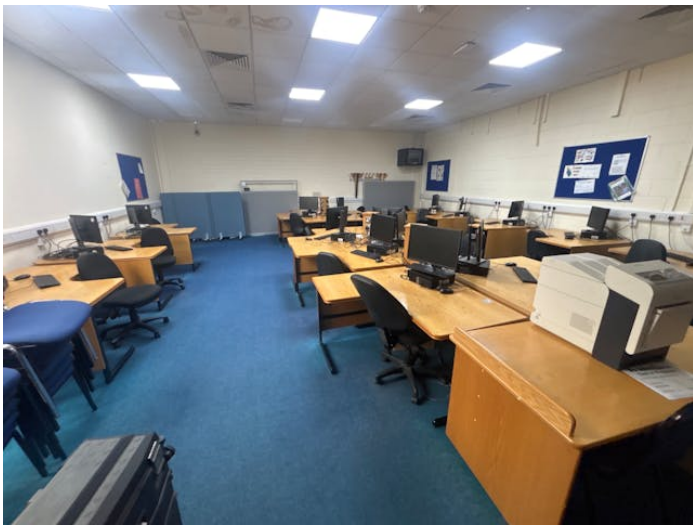
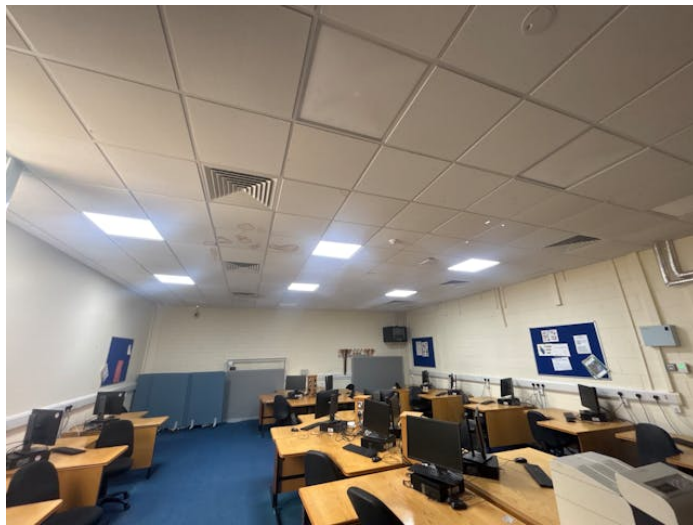
| Location Notes | Carpet flooring over screed compound floor finish. Solid walls throughout. Non ACM suspended ceiling. Metal deck roofing visible in hallway and above suspended ceiling. | | |
| General Comments | No ACM's identified. | | |

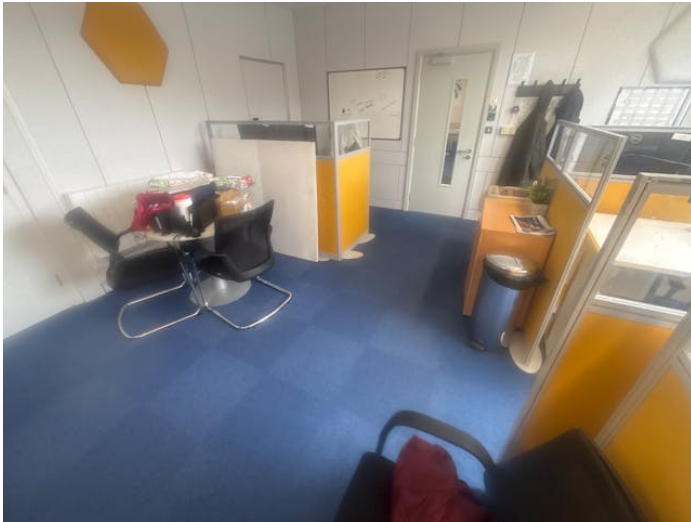
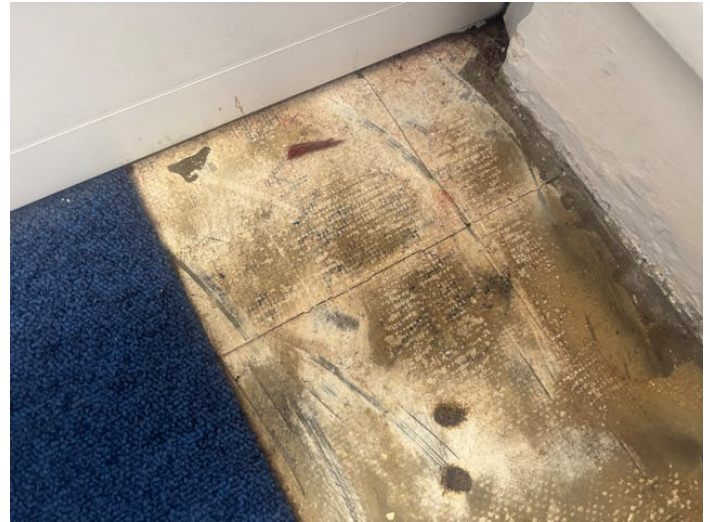
| <b>Location</b> | Course Recruitment (1009) | <b>Item</b> | Vinyl Tiles & Bitumen Adhesive |

| <b>Material</b> | Vinyl Tile & Bitumen Adhesive | <b>Extent</b> | Approx 40 sq.m |

| <b>Strategy / Sample Id</b> | Sample / S103 | <b>Fibre Type</b> | Chrysotile |

| <b>Recommendation</b> | <p>ACM's can be managed in situ.</p> <p>Removal to be carried out by trained operatives and certificate of reoccupation to be obtained if ACM's are to be disturbed</p> | | |

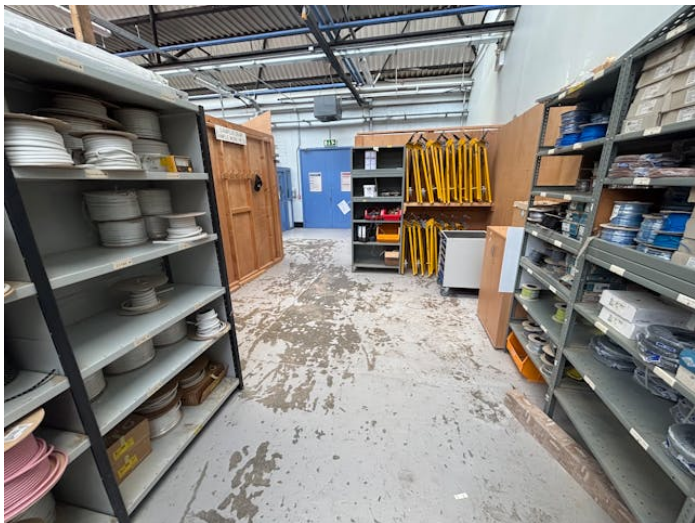
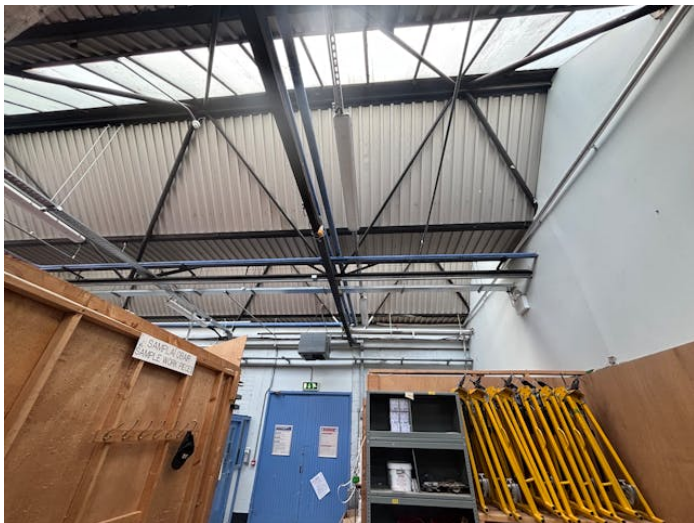
| Location Notes | Exposed concrete subfloor. Solid walls with plasterboard lined stud office walls. Exposed roof decking on ceiling. | | |
| General Comments | No ACM's identified. | | |

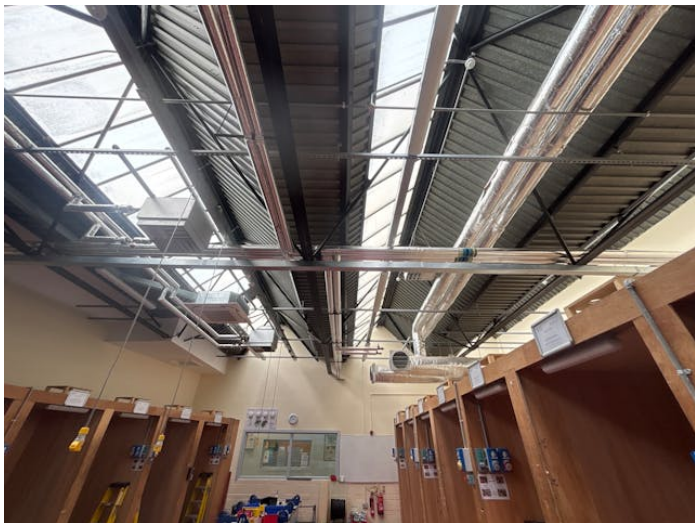
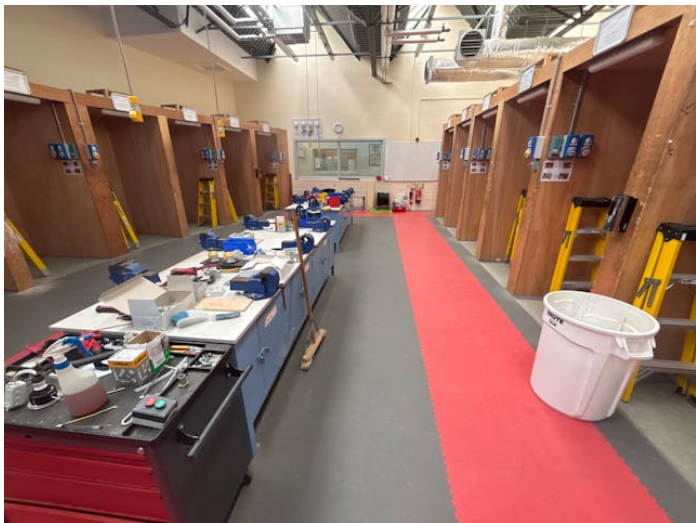
| Location Notes | Vinyl flooring over concrete subfloor. Solid walls with plasterboard lined stud office walls. Exposed roof decking on ceiling. | | |
| General Comments | No ACM's identified. | | |

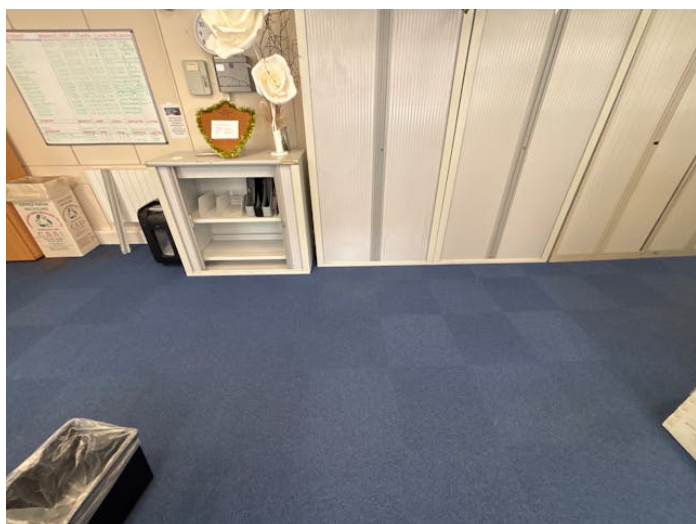
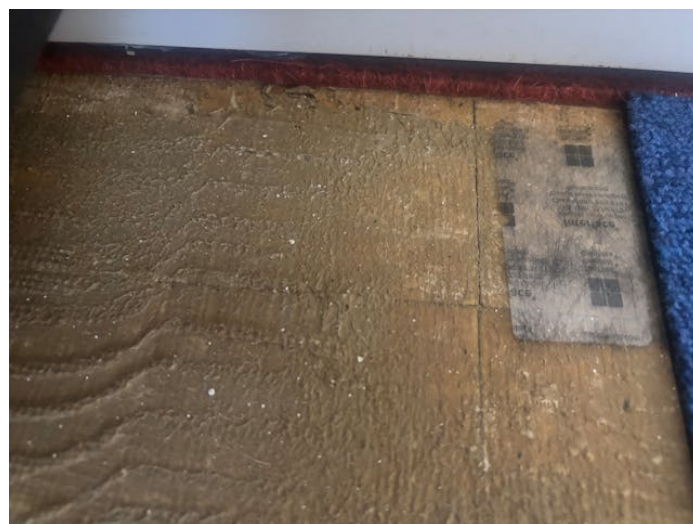
| <b>Location</b> | Finance & Admin (1011) | <b>Item</b> | Vinyl Tiles & Bitumen Adhesive |

| <b>Material</b> | Vinyl Tile & Bitumen Adhesive | <b>Extent</b> | Approx 120 sq.m |

| <b>Strategy / Sample Id</b> | Strongly Presume / S103 | <b>Presumed Fibre Type</b> | Chrysotile |

| <b>Recommendation</b> | <p>ACM's can be managed in situ.</p> <p>Removal to be carried out by trained operatives and certificate of reoccupation to be obtained if ACM's are to be disturbed</p> | | |

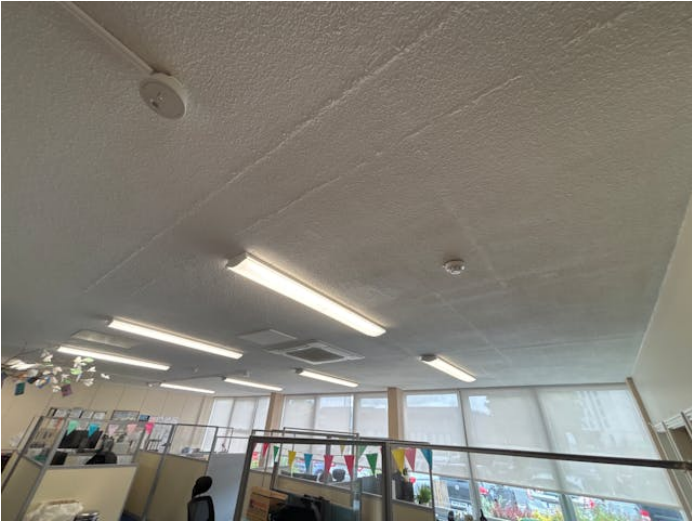
| Location | Finance & Admin (1011) | Item | Texture Coating Decorative Finish |

| Material | Textured Coating | Extent | Approx 120 sq.m |
| Strategy / Sample Id | Sample / S104 | Fibre Type | NADIS |

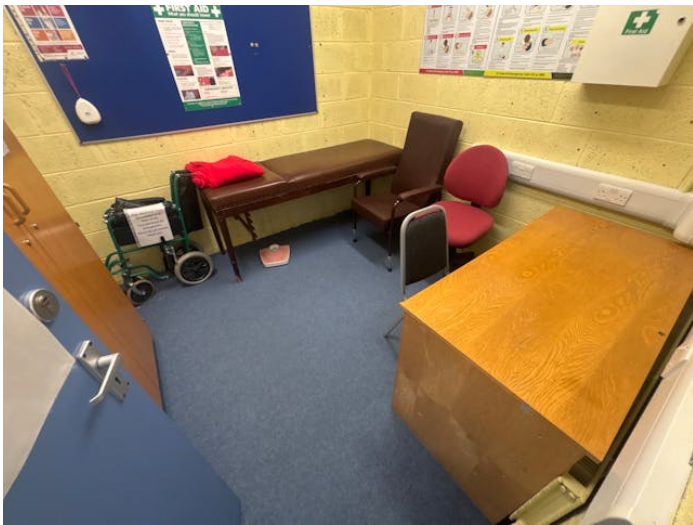
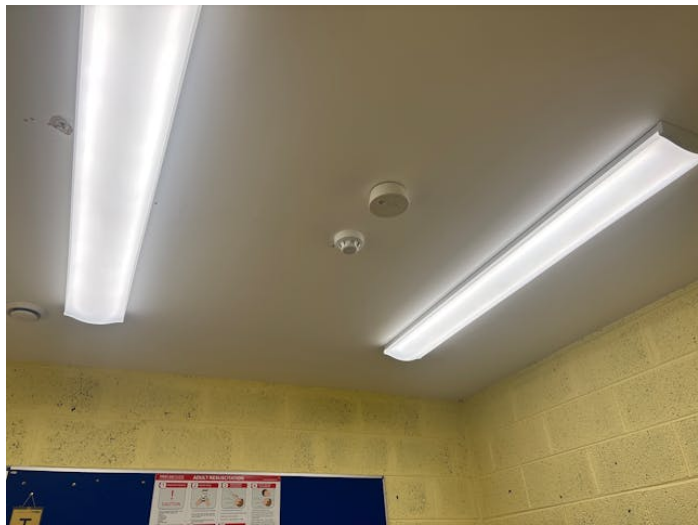
| Location Notes | Carpet flooring over screed compound floor finish. Solid walls throughout. Smooth plasterboard ceilings. Metal deck roofing visible in hallway. | | |
| General Comments | No ACM's identified. | | |

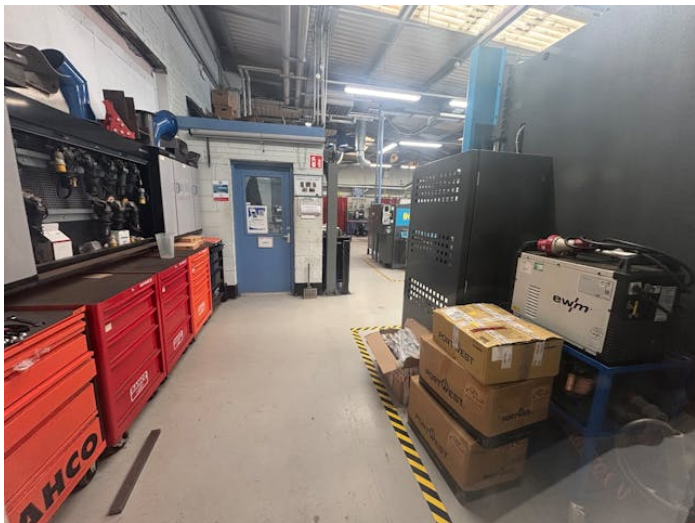
| Location | Metal Workshop (1047) | Item | | | |

| Location Notes | Exposed concrete screed subfloor finish. Solid walls throughout. Exposed metal deck internal ceilings. | | | | |
| General Comments | No ACM's identified. | | | | |

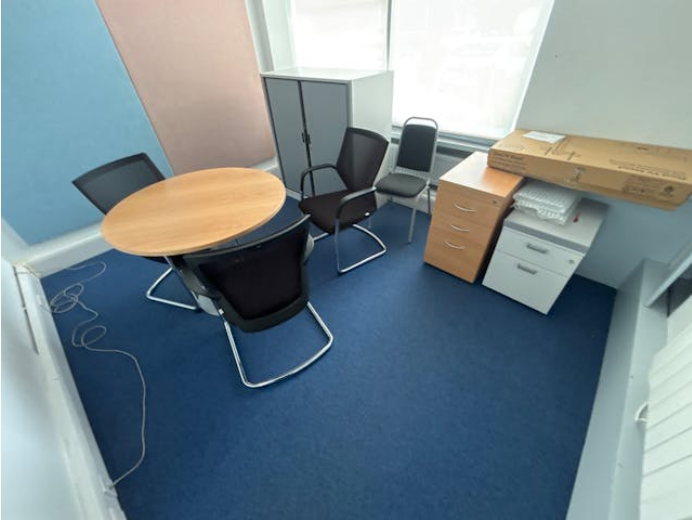
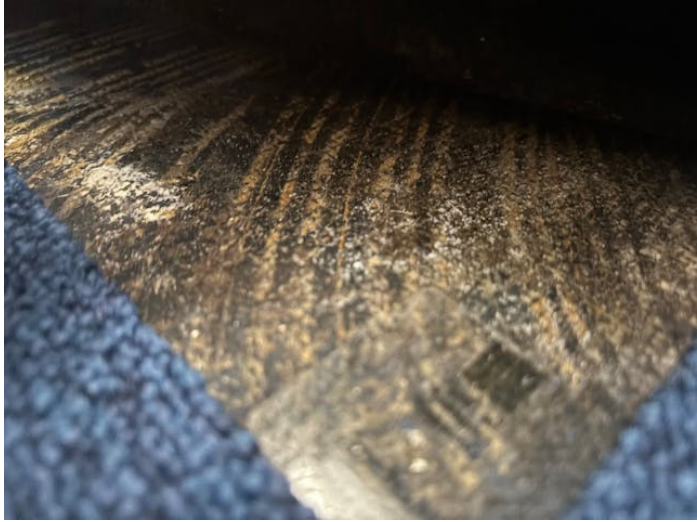
| Material | Bituminous Product | Extent | Approx 12 sq.m |
| Strategy / Sample Id | Strongly Presume / S102 | Presumed Fibre Type | Chrysotile |

| Recommendation | <p>ACM's can be managed in situ.</p> <p>Removal to be carried out by trained operatives and certificate of reoccupation to be obtained if ACM's are to be disturbed</p> | | |

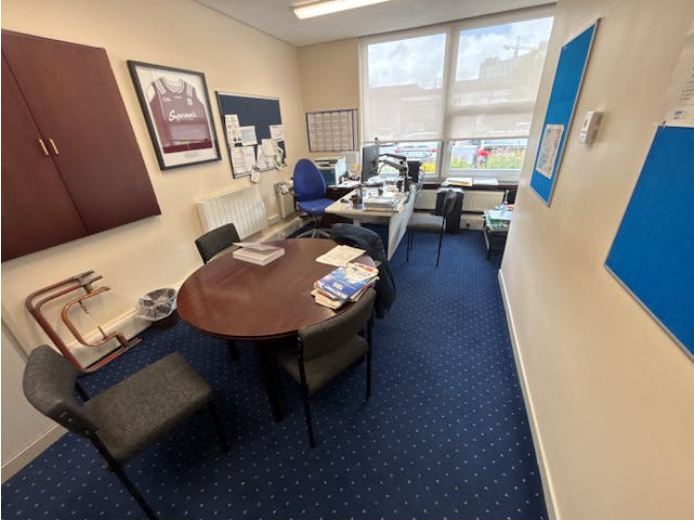
| Location | Office (1119) | Item | Bitumen adhesive |

| Material | Bituminous Product | Extent | Approx 20 sq.m |
| Strategy / Sample Id | Strongly Presume / S102 | Presumed Fibre Type | Chrysotile |

| Recommendation | <p>ACM's can be managed in situ.</p> <p>Removal to be carried out by trained operatives and certificate of reoccupation to be obtained if ACM's are to be disturbed</p> | | |

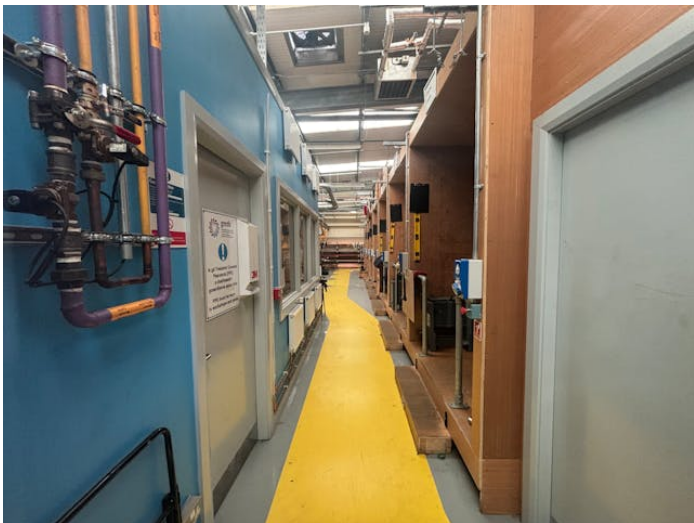
| Location | Plumbing Workshop (1048) | Item | | | |

| Location Notes | Exposed concrete screed subfloor finish. Solid walls throughout. Exposed metal deck internal ceilings. | | | | |
| General Comments | No ACM's identified. | | | | |

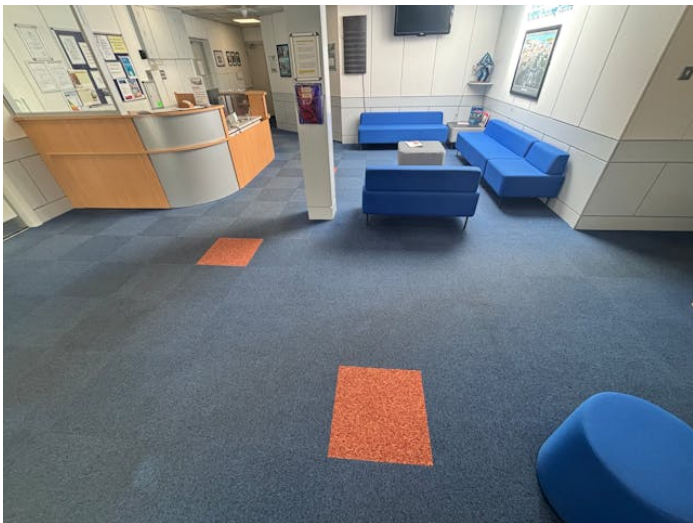
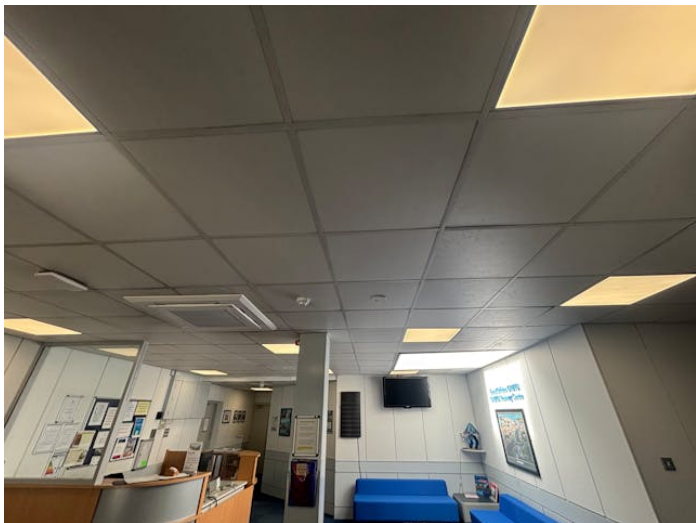
| Location Notes | Carpet floor tiles over levelling screed finish. Bitumen adhesive identified concealed under screed finish (sample taken for analysis). Solid walls throughout. Non ACM suspended ceilings. | | |

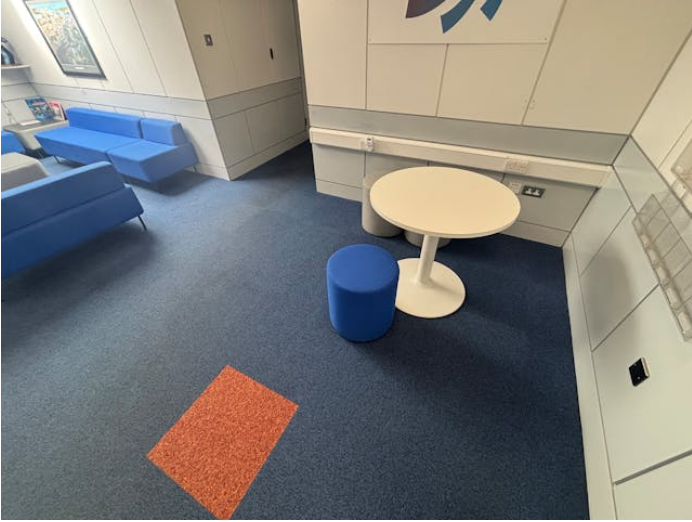
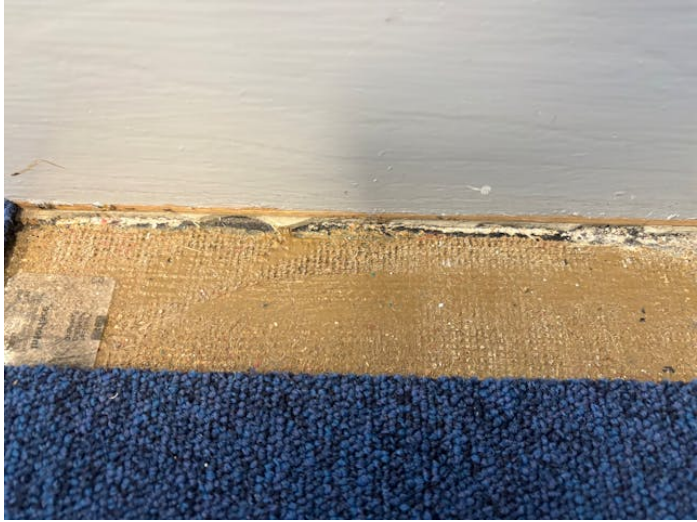
| Material | Bituminous Product | Extent | Approx 60 sq.m |
| Strategy / Sample Id | Sample / S102 | Fibre Type | Chrysotile |

| Recommendation | <p>ACM's can be managed in situ.</p> <p>Further investigation and confirmation of exact locations should be carried out prior to any refurbishment or removal works in the building.</p> | | |

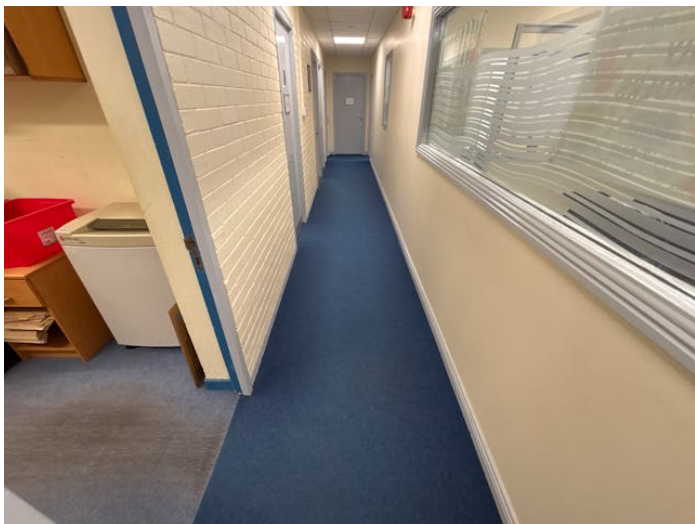
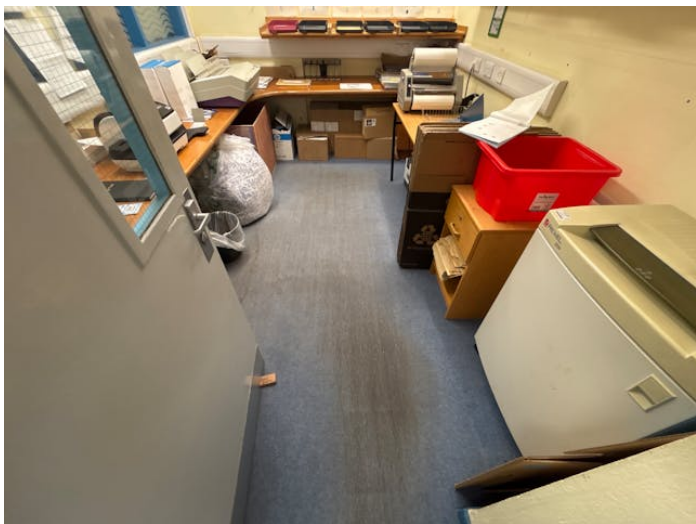
| Material | Bituminous Product | Extent | Approx 60 sq.m |
| Strategy / Sample Id | Strongly Presume / S102 | Presumed Fibre Type | Chrysotile |

| Recommendation | <p>ACM's can be managed in situ.</p> <p>Removal to be carried out by trained operatives and certificate of reoccupation to be obtained if ACM's are to be disturbed</p> | | |

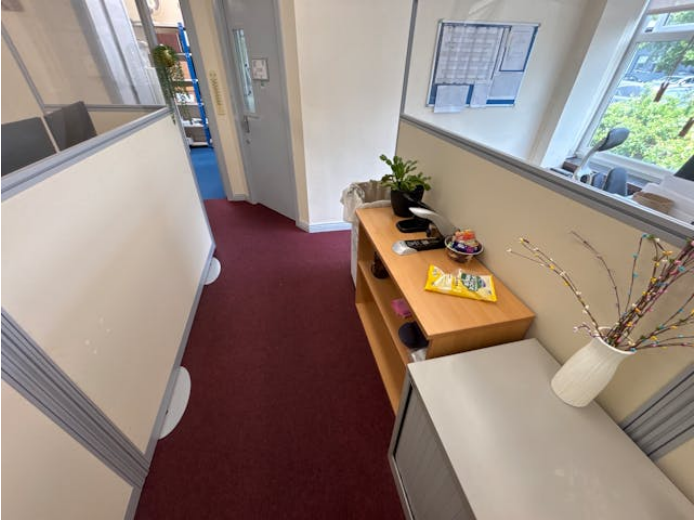
| Location | Training Services (1113) | Item | Bitumen adhesive |

| Material | Bituminous Product | Extent | Approx 50 sq.m |
| Strategy / Sample Id | Strongly Presume / S102 | Presumed Fibre Type | Chrysotile |

| Recommendation | <p>ACM's can be managed in situ.</p> <p>Removal to be carried out by trained operatives and certificate of reoccupation to be obtained if ACM's are to be disturbed</p> | | |

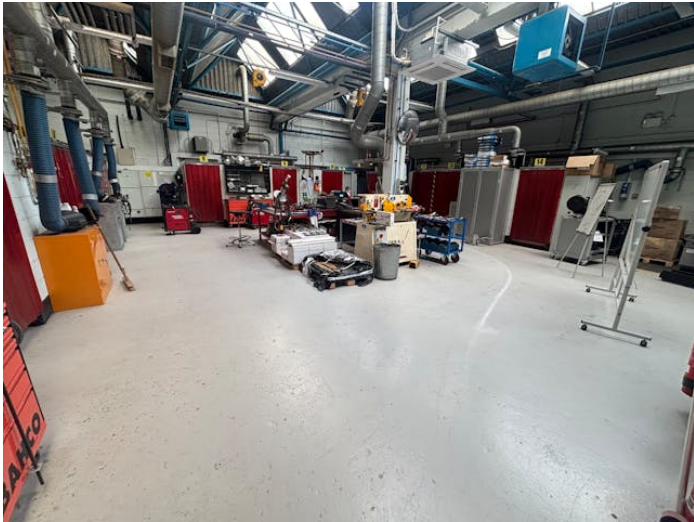
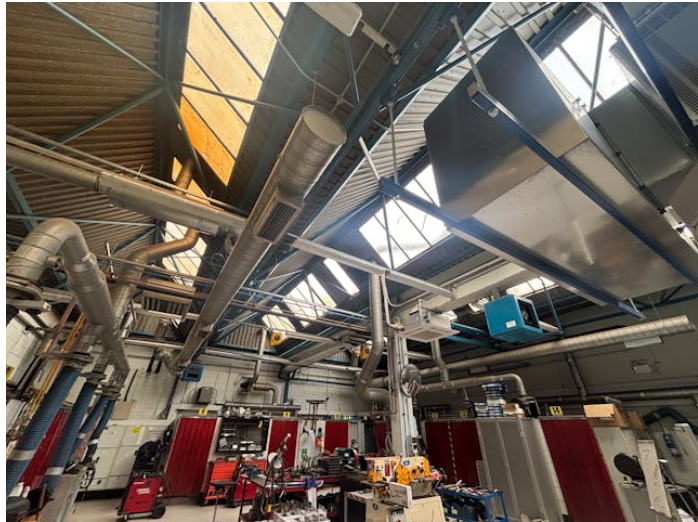
| Location | Welding Workshop (1046) | Item | |

| Location Notes | Exposed concrete screed subfloor finish. Solid walls throughout. Exposed metal deck internal ceilings. | | |
| General Comments | No ACM's identified. | | |

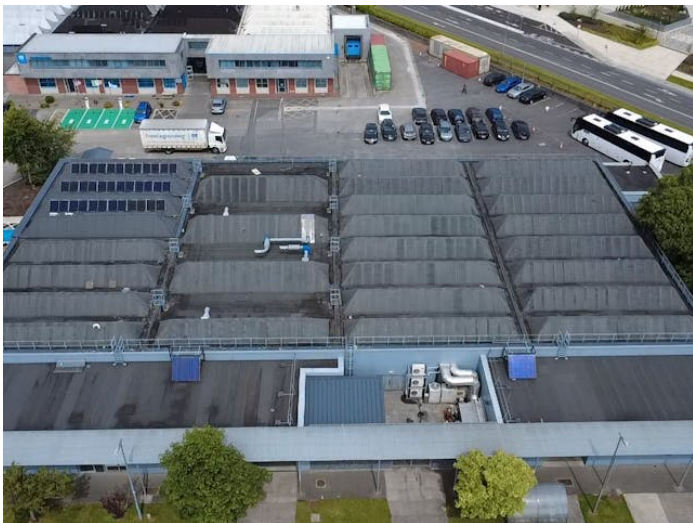
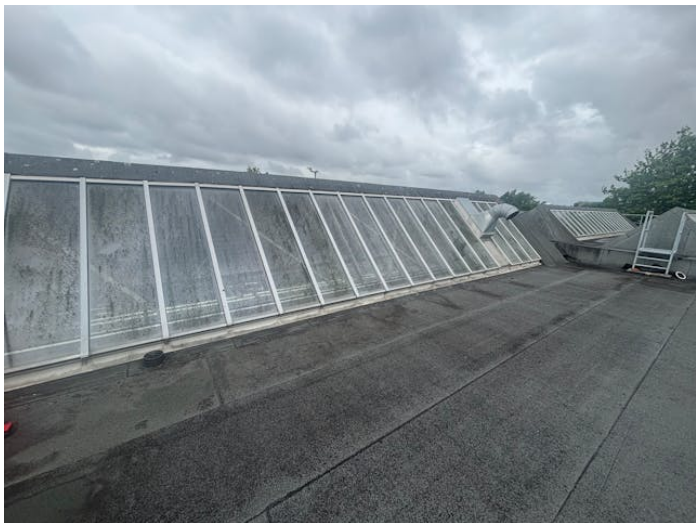
| Location | External Fixtures | Item | |

| Location Notes | Modern Bitumen felt with modern metal frame windows. | | |
| General Comments | No ACM's identified. | | |

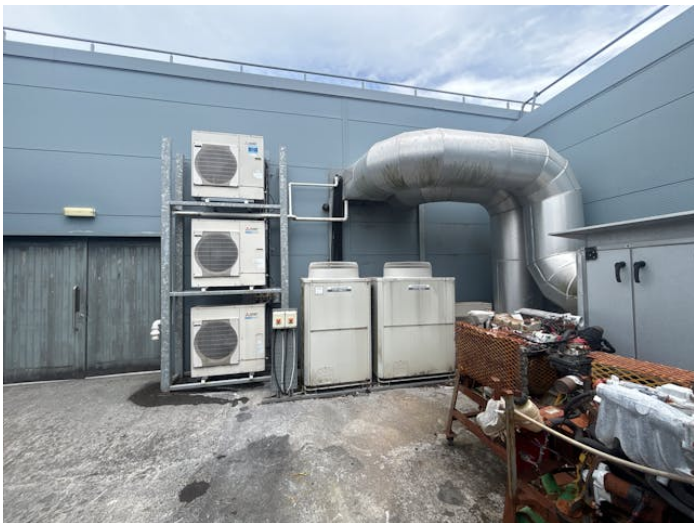
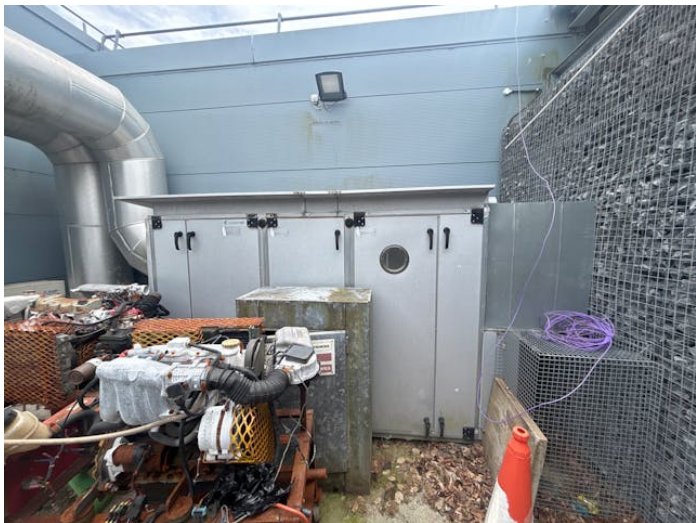
| Location | Yard (2009) | Item | |

| Location Notes | Concrete floors. Modern plant and HVAC systems. | | |
| General Comments | No ACM's identified. | | |

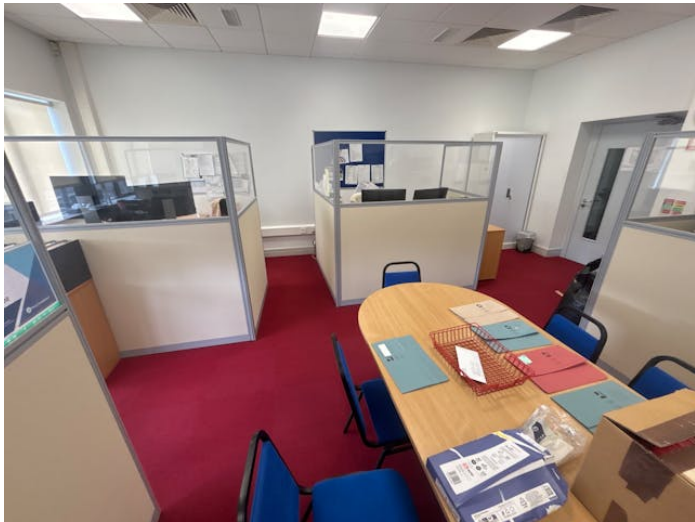
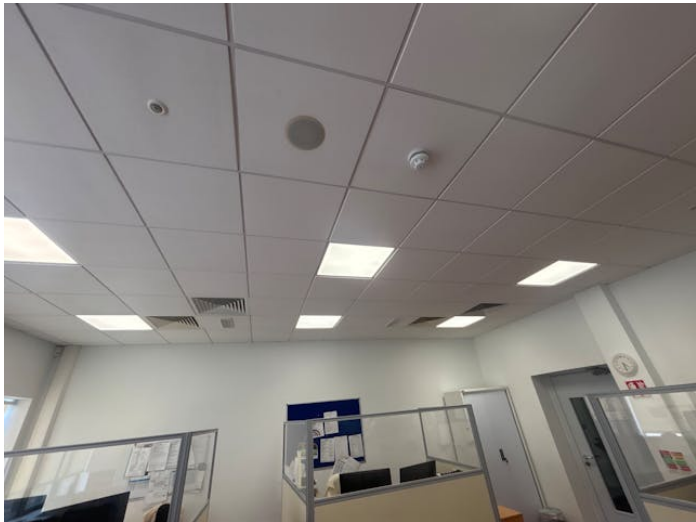
| Location Notes | Carpet flooring over vinyl flooring on levelling screed finish. Solid walls throughout. Non ACM suspended ceilings with metal deck roof structure above. | | |
| General Comments | No ACM's identified. | | |

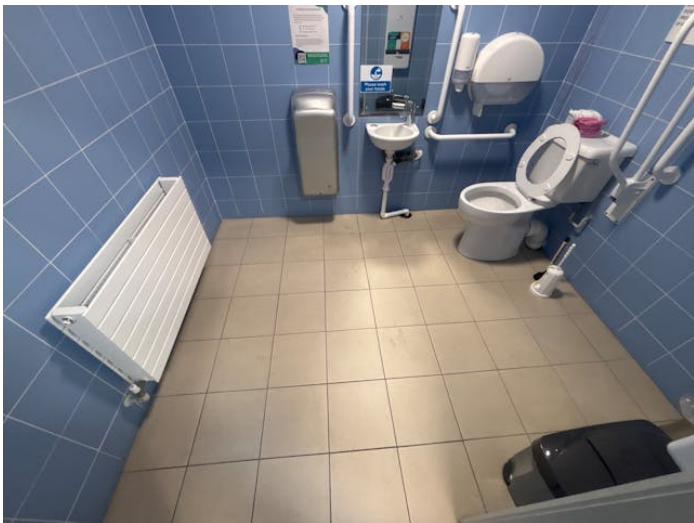
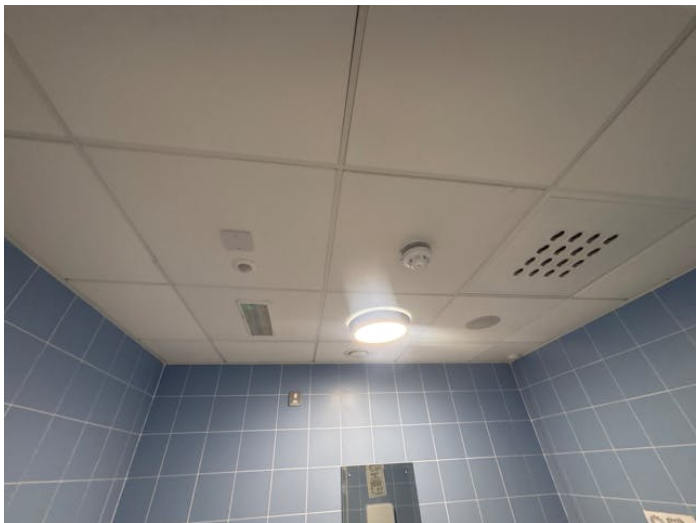
| Location Notes | Ceramic floor and wall tiles. Ceramic finish on plasterboard stud internal walls. Suspended ceilings with non ACM tiles. | | |
| General Comments | No ACM's identified. | | |

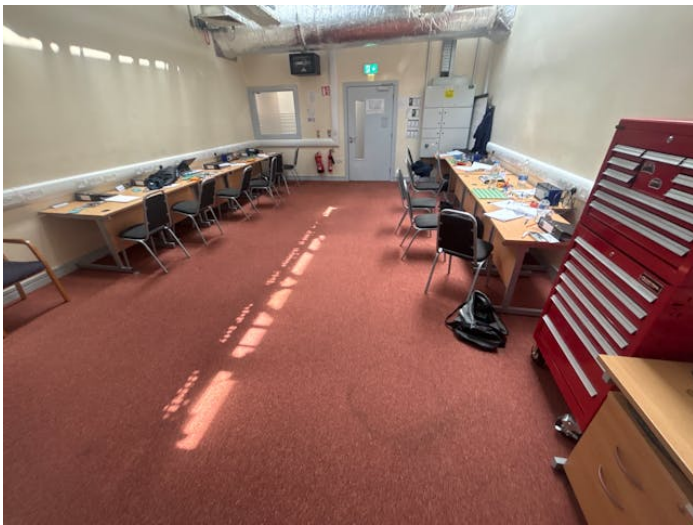
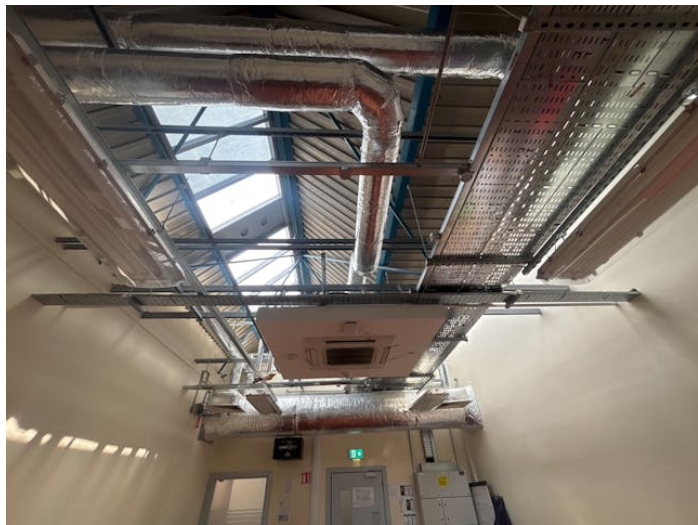
| Location | Classroom (2011) | Item | |

| Location Notes | Carpet floor tiles over painted concrete floors. Metal deck exposed ceilings with modern non ACM windows. | | |
| Access / Notes | Limited Access / No access under current subfloor finish | | |

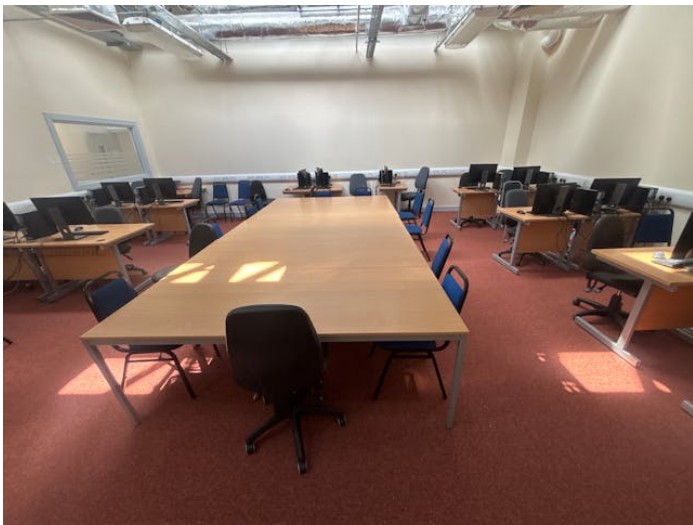
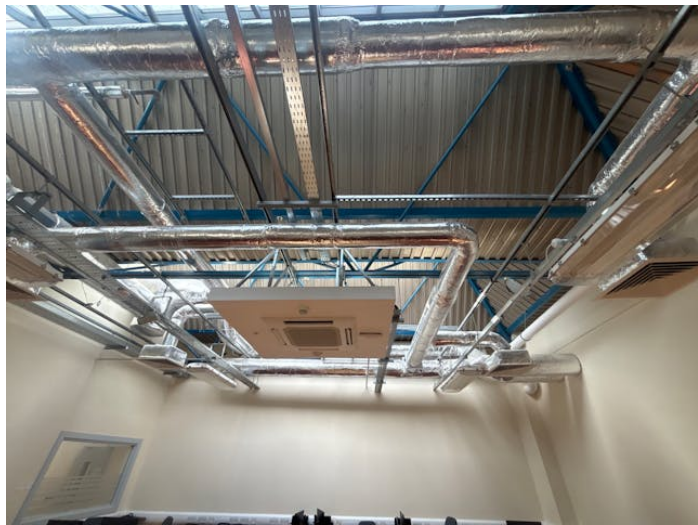
| Location | Classroom (2017) | Item | |

| Location Notes | Carpet floor tiles over painted concrete floors. Metal deck exposed ceilings with modern non ACM windows. | | |
| Access / Notes | Limited Access / No access under current subfloor finish. | | |

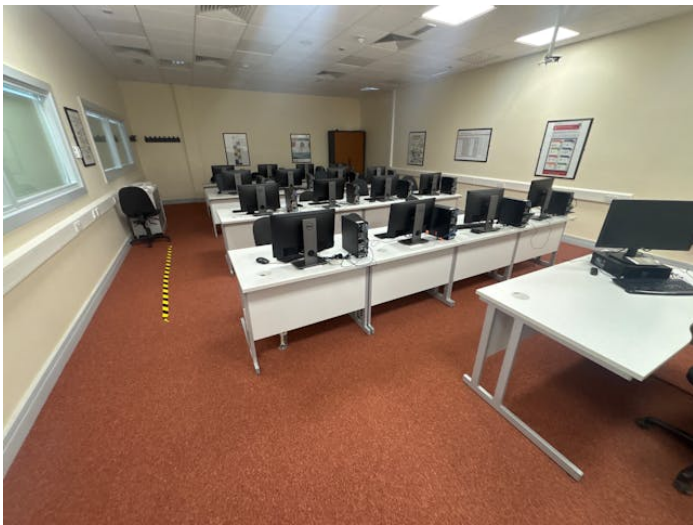
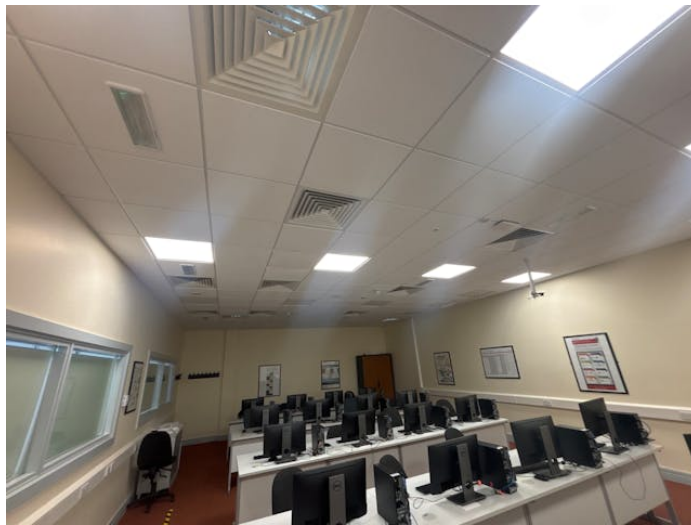
| Location Notes | Carpet flooring over vinyl flooring on levelling screed finish. Plasterboard lined stud internal walls. Non ACM suspended ceilings. | | |
| Access / Notes | Limited Access / No access under current screed floor finish | | |

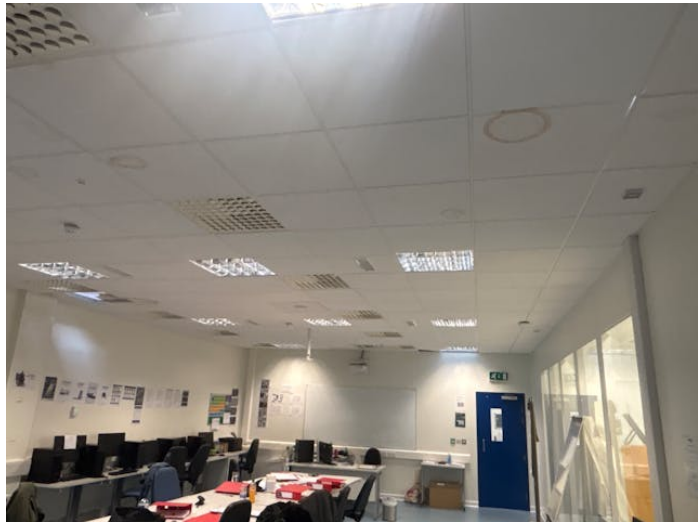
| Location Notes | Vinyl flooring over concrete subfloor finish. Plasterboard lined stud internal walls with non ACM suspended ceilings. | | |
| General Comments | No ACM's identified. | | |
