# Asbestos Refurbishment Survey

Mervue Training Centre, Wellpark Road,  
Galway

S26-184

Higgins Consultancy Ardrahan Ltd

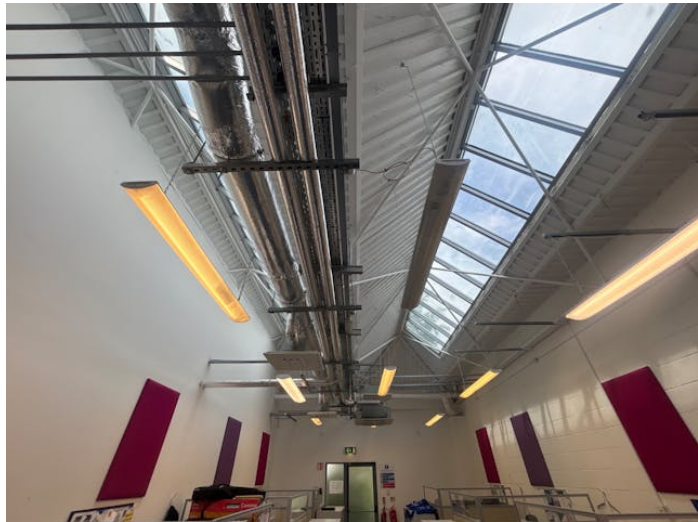
| Location Notes | Carpet flooring over painted concrete subfloors. Plasterboard lined walls with solid external walls. Non ACM suspended ceilings. | | |
| General Comments | No ACM's identified. | | |

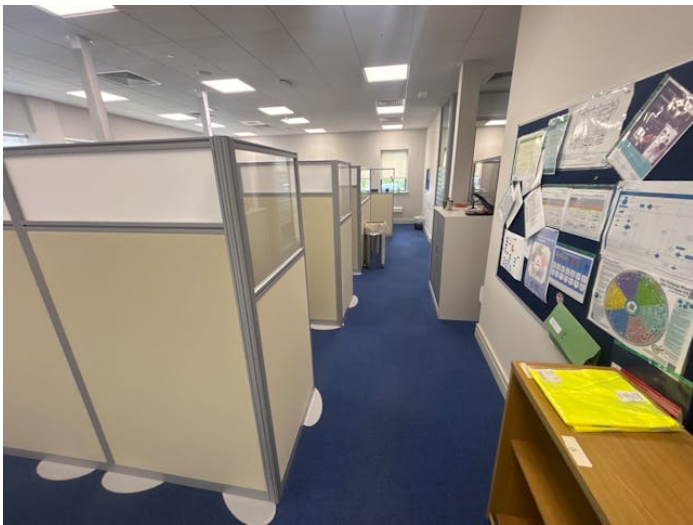
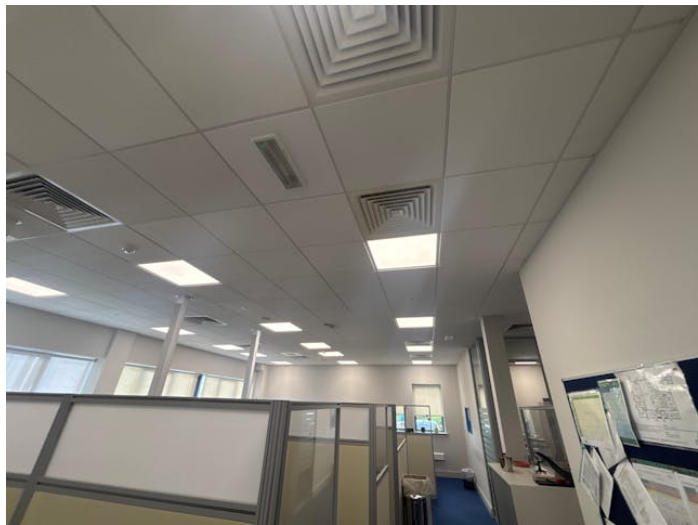
| Location Notes | Carpet flooring over vinyl flooring on concrete subfloors. Plasterboard lined walls with solid external walls. Non ACM suspended ceilings. | | |
| General Comments | No ACM's identified. | | |

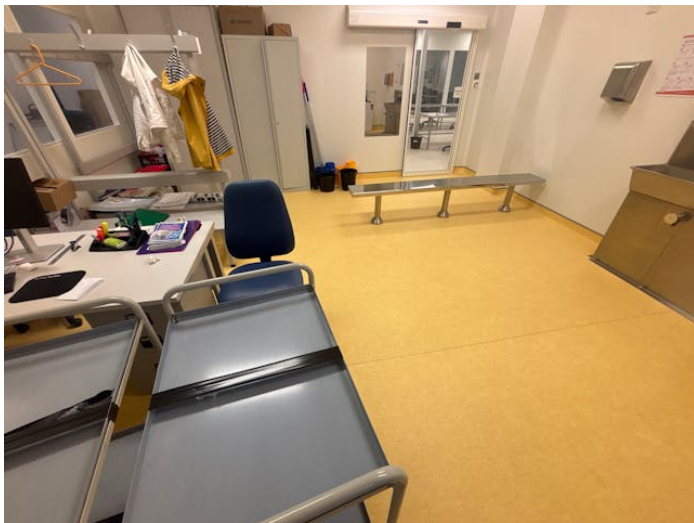
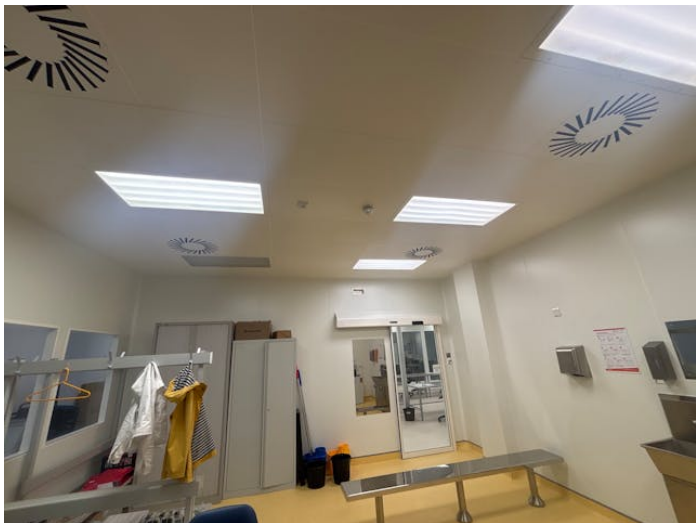
| Location Notes | Vinyl flooring over concrete subfloor finish. Plasterboard lined stud internal walls with non ACM suspended ceilings. | | |
| General Comments | No ACM's identified. | | |

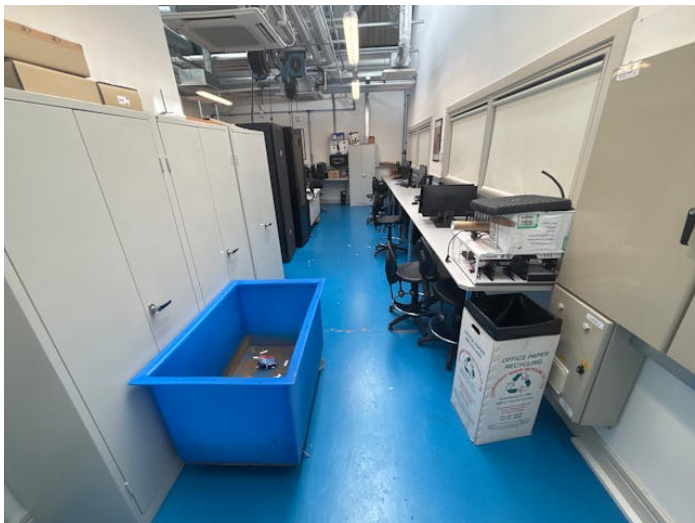
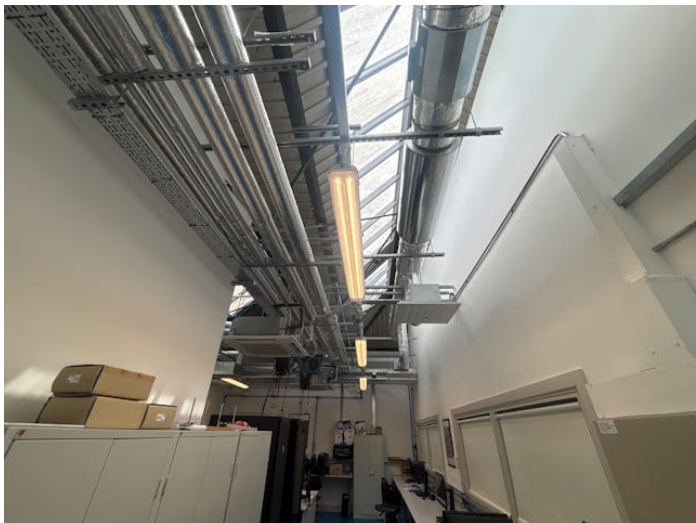
| Location | IT Support Lab (2047) | Item | |

| Location Notes | Painted concrete subfloors. Plasterboard lined stud internal walls. Non ACM suspended ceilings. | | |
| General Comments | No ACM's identified. | | |

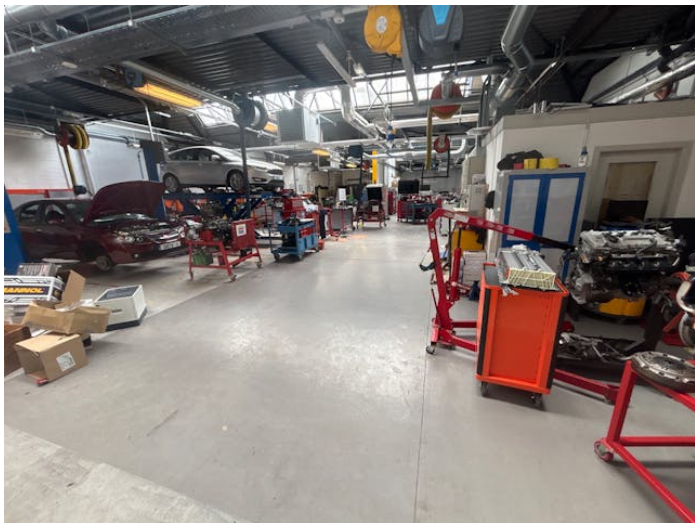
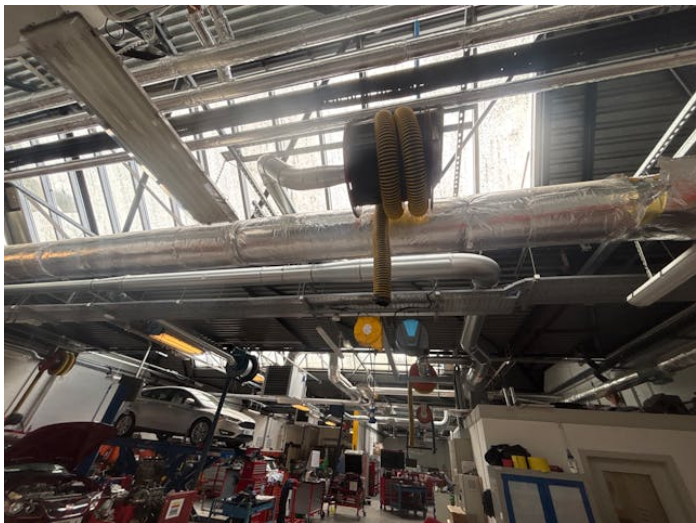
| Location Notes | Exposed concrete subfloors. Solid walls with plasterboard lined stud office walls.<br>Exposed metal roof deck structure. | | |
| General Comments | No ACM's identified. | | |

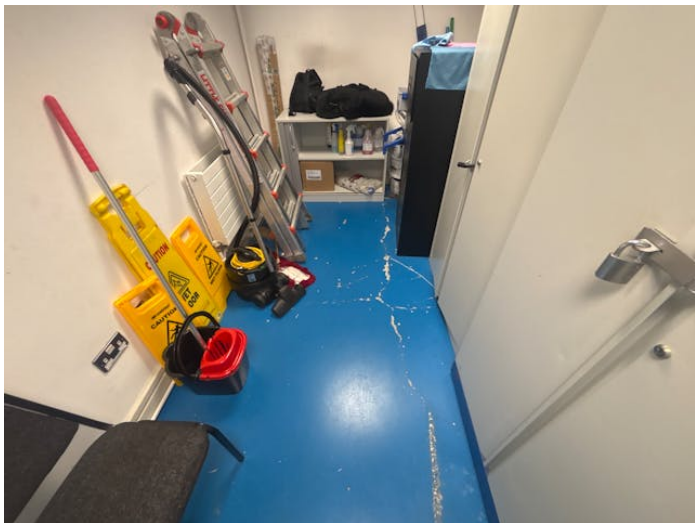
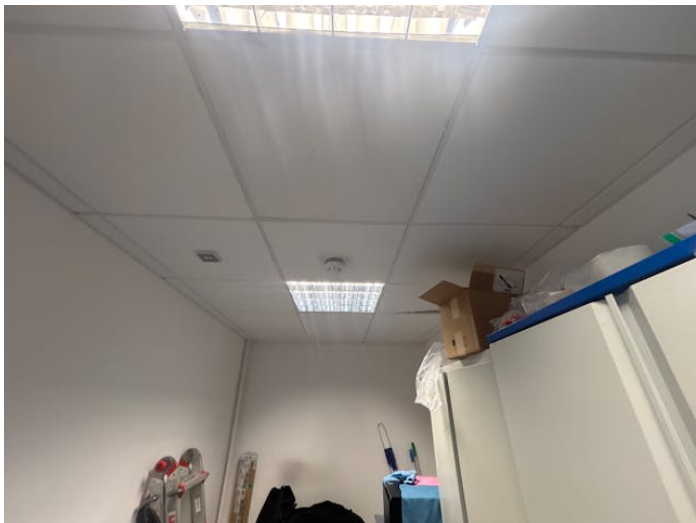
| Location | Store Room (2045) | Item | |

| Location Notes | Painted concrete subfloors. Plasterboard lined stud internal walls. Non ACM suspended ceilings. | | |
| General Comments | No ACM's identified. | | |
