## Refurbishment Demolition Asbestos Survey

**Site Address:** ST KEVINS COLLEGE  
BALLYGALL ROAD  
BALLYGALL  
DUBLIN 11 , D11 VF10

**Survey No.:** A-05733

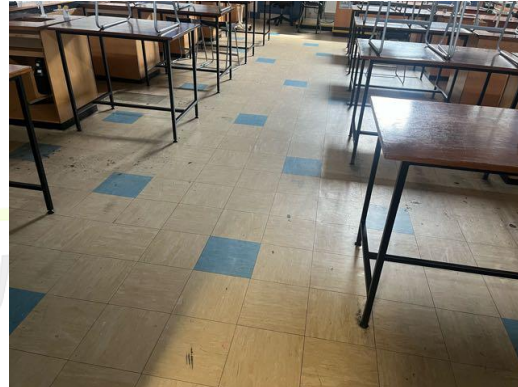
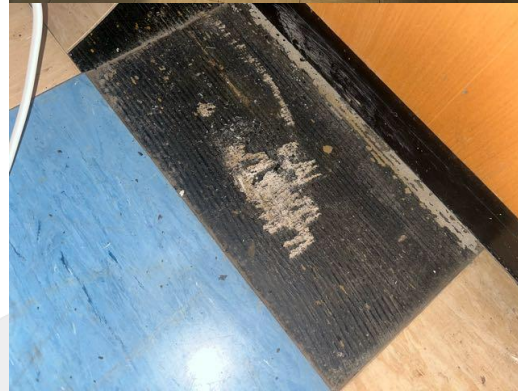
Location Ground Floor Lab 1 (001) - Bitumen  
Sample Range S001  
Extent 45 m<sup>2</sup>

| Product type | Bituminous Product |
| Extent of damage/deterioration | Good condition |

| <b>Total</b> | <b>2</b> |

| ST KEVINS COLLEGE | | | | | | | | |
|---|---|---|---|---|---|---|---|---|
| S001 | 8 | Ground Floor Lab 1 (001) - Bitumen - Bituminous Product | 45m <sup>2</sup> | Chrysotile | Good condition | Very Low | 2 | Remove if likely to be disturbed by works |

Remove if likely to be disturbed by works

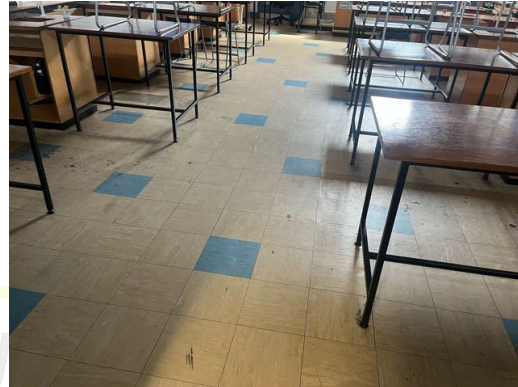
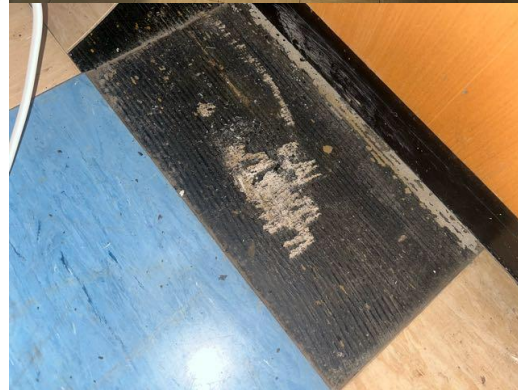
Location Ground Floor Lab 2 (002) - Bitumen  
Sample Range X001  
Extent 45 m²

| Bituminous Product |
| Good condition |

| <b>Total</b> | <b>2</b> |

| ST KEVINS COLLEGE | | | | | | | | |
|---|---|---|---|---|---|---|---|---|
| X001 | 8 | Ground Floor Lab 2 (002) - Bitumen - Bituminous Product | 45m <sup>2</sup> | Chrysotile | Good condition | Very Low | 2 | Remove if likely to be disturbed by works |

Remove if likely to be disturbed by works

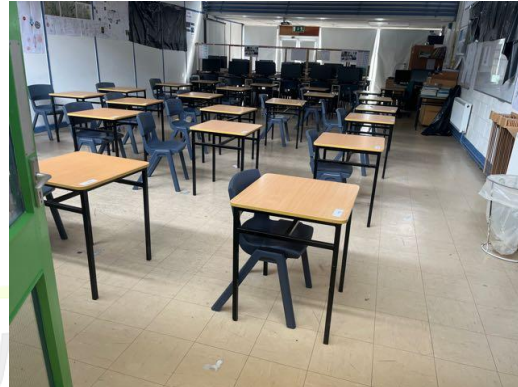
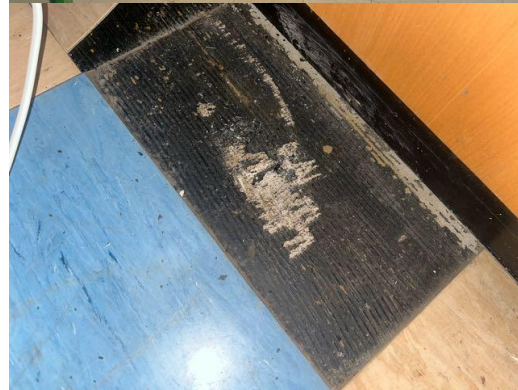
Location Ground Floor DCG Room (003) -  
Sample Range Bitumen  
X001  
Extent 45 m<sup>2</sup>

| Bituminous Product |
| Good condition |

| <b>Total</b> | <b>2</b> |

| ST KEVINS COLLEGE | | | | | | | | |
|---|---|---|---|---|---|---|---|---|
| X001 | 8 | Ground Floor DCG Room (003) - Bitumen - Bituminous Product | 45m <sup>2</sup> | Chrysotile | Good condition | Very Low | 2 | Remove if likely to be disturbed by works |

| <b>RECOMMENDATIONS</b> | Remove if likely to be disturbed by works |

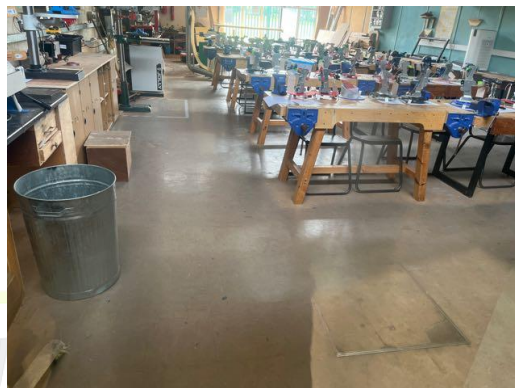
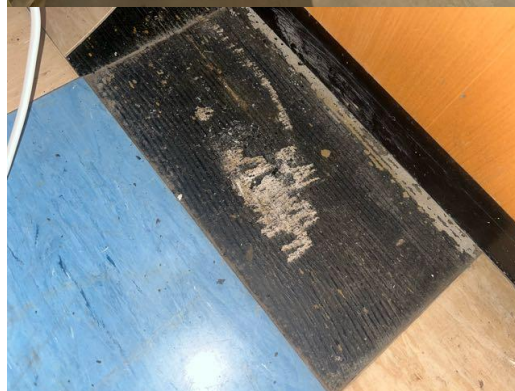
Location Ground Floor Construction room  
(004) - Bitumen  
Sample Range X001  
Extent 45 m<sup>2</sup>

| Bituminous Product |
| Good condition |

| <b>Total</b> | <b>2</b> |

| ST KEVINS COLLEGE | | | | | | | | |
|---|---|---|---|---|---|---|---|---|
| X001 | 8 | Ground Floor Construction room (004) - Bitumen - Bituminous Product | 45m <sup>2</sup> | Chrysotile | Good condition | Very Low | 2 | Remove if likely to be disturbed by works |

Remove if likely to be disturbed by works

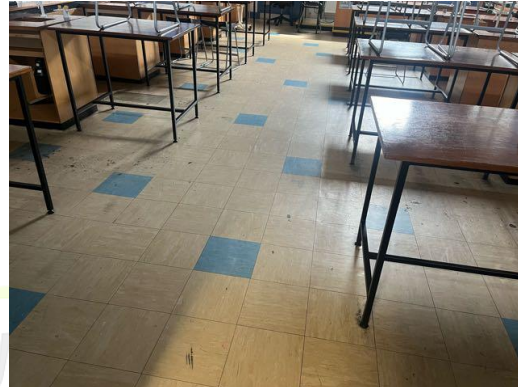
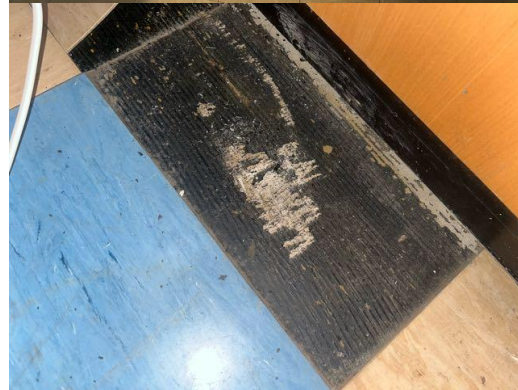
Location Ground Floor Room 13 (005) -  
Sample Range Bitumen  
X001  
Extent 45 m<sup>2</sup>

| Bituminous Product |
| Good condition |

| <b>Total</b> | <b>2</b> |

| ST KEVINS COLLEGE | | | | | | | | |
|---|---|---|---|---|---|---|---|---|
| X001 | 8 | Ground Floor Room 13 (005) - Bitumen - Bituminous Product | 45m <sup>2</sup> | Chrysotile | Good condition | Very Low | 2 | Remove if likely to be disturbed by works |

Remove if likely to be disturbed by works

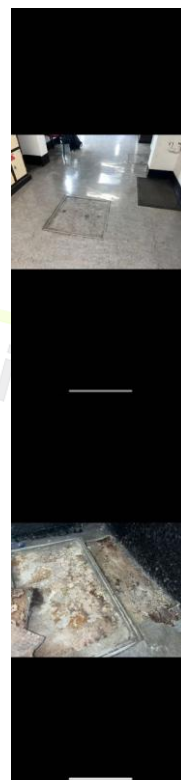
Location Ground Floor Area beside room 3  
(017) - Bitumen  
Sample Range X002  
Extent 10 m<sup>2</sup>

| Bituminous Product |
| Medium damage |

| <b>Total</b> | <b>4</b> |

| ST KEVINS COLLEGE | | | | | | | | |
|---|---|---|---|---|---|---|---|---|
| X002 | 8 | Ground Floor Area beside room 3 (017) - Bitumen - Bituminous Product | 10m <sup>2</sup> | Chrysotile | Medium damage | Very Low | 4 | Remove if likely to be disturbed by works |

Remove if likely to be disturbed by works

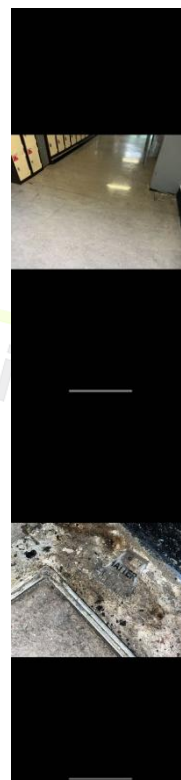
Location Ground Floor Area beside staff room  
(018) - Bitumen  
Sample Range X002  
Extent 10 m²

| Product type | Bituminous Product |
| Extent of damage/deterioration | Medium damage |

| <b>Total</b> | <b>4</b> |

| ST KEVINS COLLEGE | | | | | | | | |
|---|---|---|---|---|---|---|---|---|
| X002 | 8 | Ground Floor Area beside staff room (018) - Bitumen - Bituminous Product | 10m <sup>2</sup> | Chrysotile | Medium damage | Very Low | 4 | Remove if likely to be disturbed by works |

Remove if likely to be disturbed by works

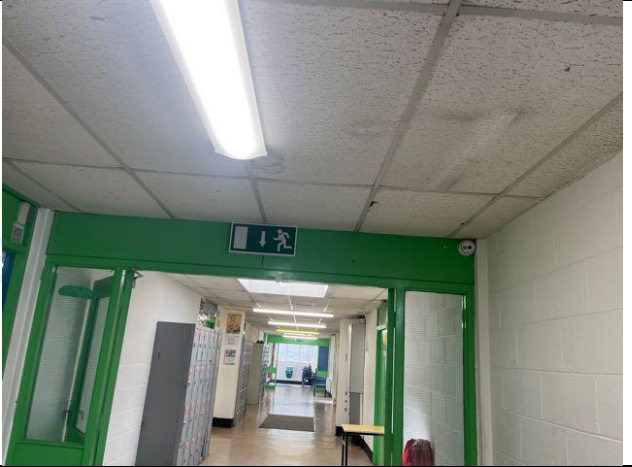
| ST KEVINS COLLEGE | | |
|---|---|---|
| S003 | Ground Floor Hallway (007) - Ceiling tiles - Insulation | |

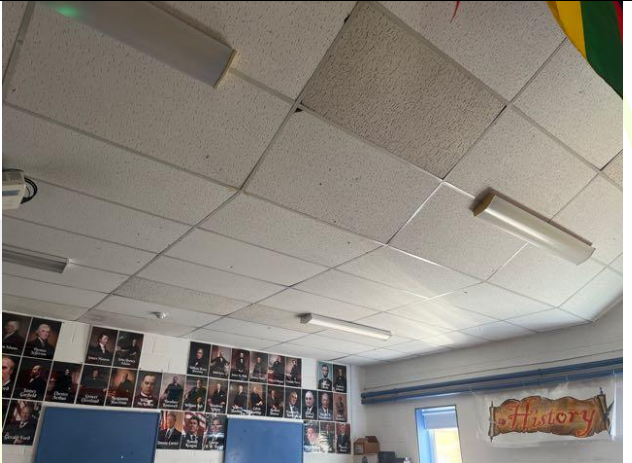
| ST KEVINS COLLEGE | | |
|---|---|---|
| S004 | Ground Floor Classrooms (008) - Ceiling tiles - Insulation | |

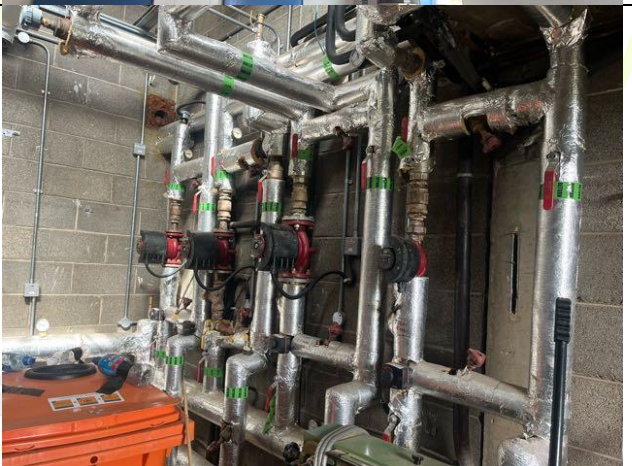
| ST KEVINS COLLEGE | | |
|---|---|---|
| PS001 | Ground Floor Boiler rooms (009) - Boiler rooms - | |

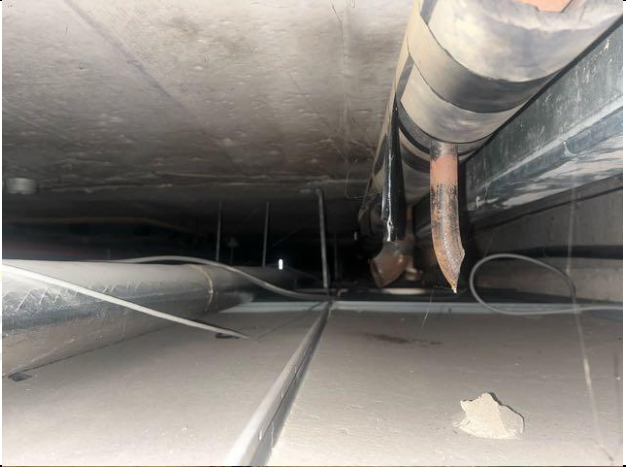
| ST KEVINS COLLEGE | | |
|---|---|---|
| PS002 | Ground Floor Ceiling voids (010) -<br>Ceiling voids - | |

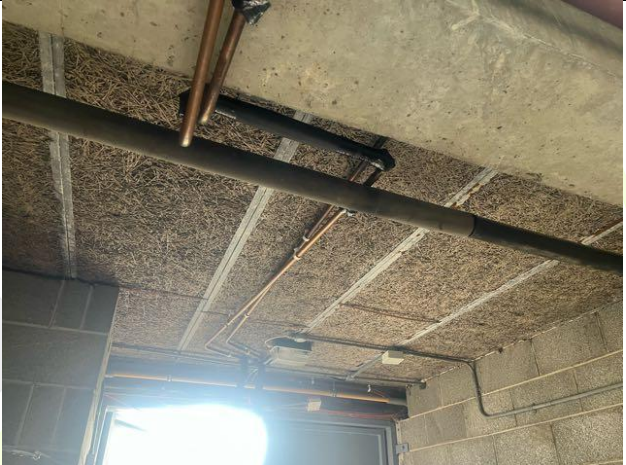
| ST KEVINS COLLEGE | | |
|---|---|---|
| PS003 | Ground Floor Storage rooms (011) -<br>Storage rooms - | |

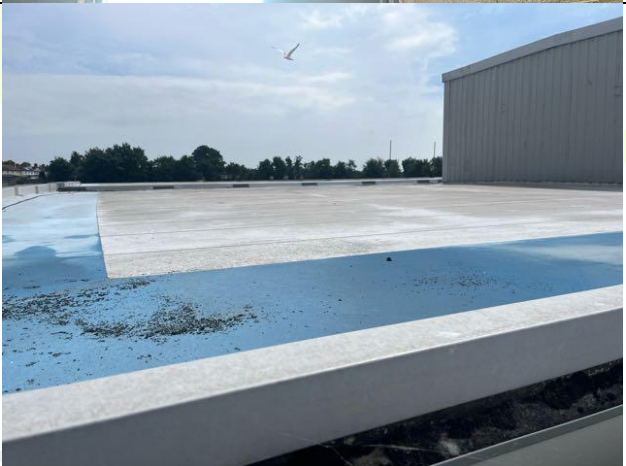
| ST KEVINS COLLEGE | | |
|---|---|---|
| PS004 | Ground Floor Main roof area (012) -<br>Main roof area - | |

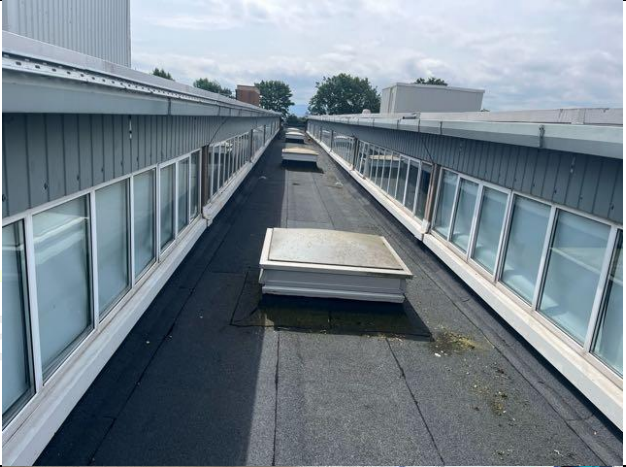
| ST KEVINS COLLEGE | | |
|---|---|---|
| PS005 | Ground Floor Skylights (013) - Skylights - | |

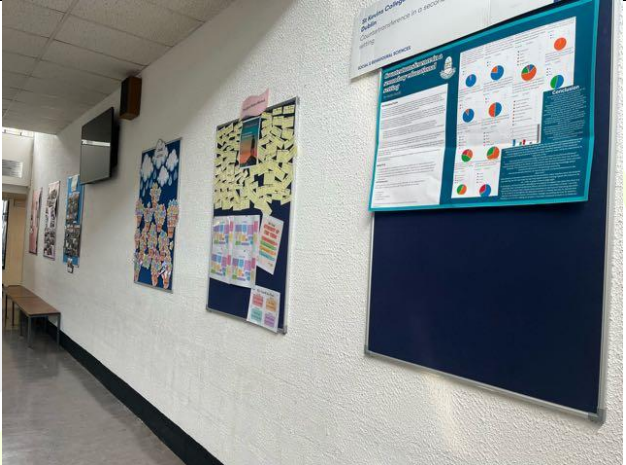
| ST KEVINS COLLEGE | | |
|---|---|---|
| PS006 | Ground Floor Walls (014) - Walls - | |

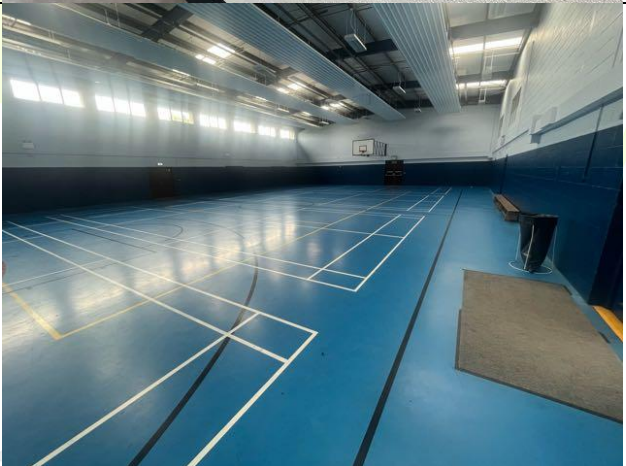
| ST KEVINS COLLEGE | | |
|---|---|---|
| PS007 | Ground Floor Pe hall (015) - Pe hall - | |

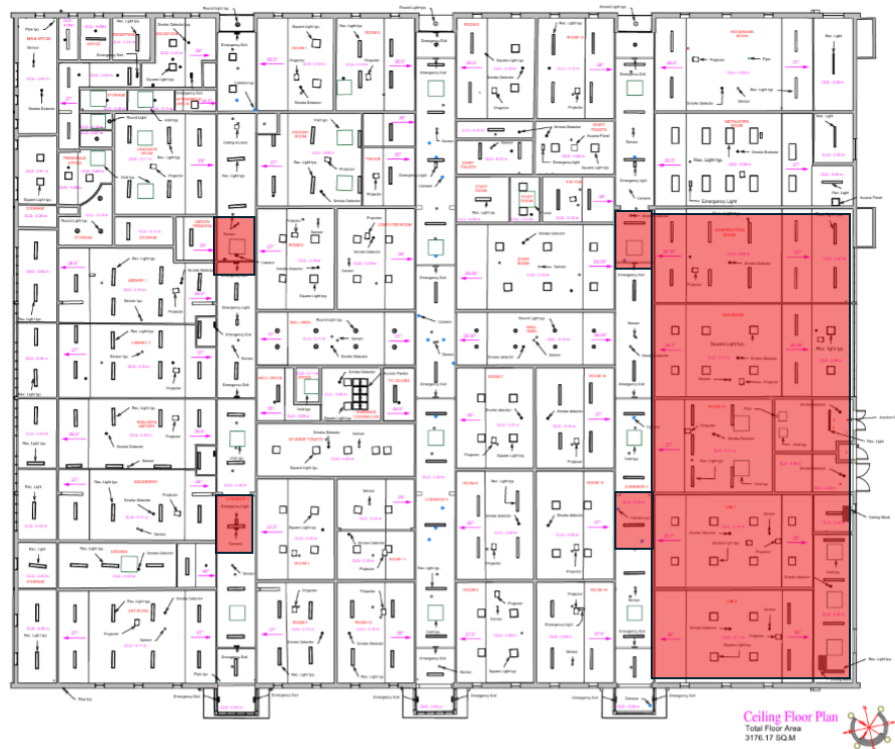
Areas where bitumen adhesive containing asbestos highlighted in red
