## ASBESTOS SURVEY REPORT

(Refurbishment / Demolition Survey)

**Location: Queen of Angels Primary School,  
Blackthorn Drive, Wedgewood, Sandyford, Dublin 16**

**Report No. PE22-434**

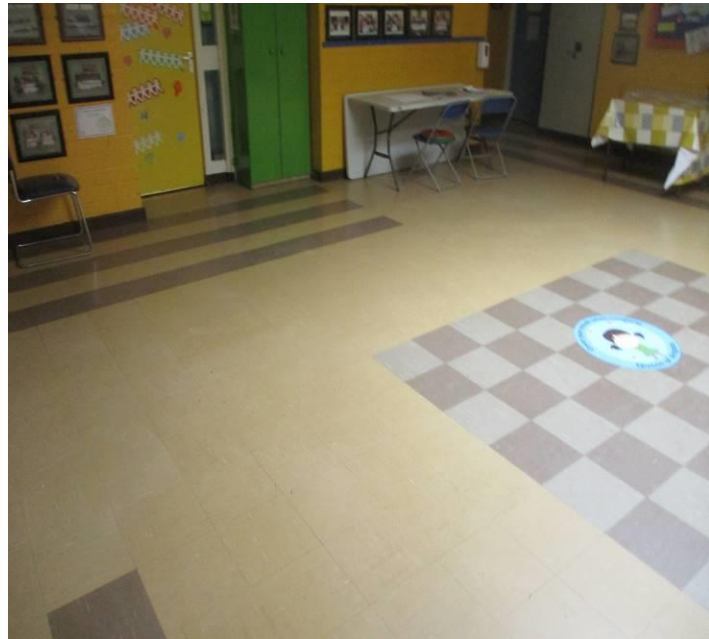
| Location | Floors throughout |
| Extent/<br>Amount | 1,100 m <sup>2</sup> approx. total |

| | MATERIAL ASSESSMENT | | PRIORITY ASSESSMENT |
|---|---|---|---|
| Product type | Floor tiles and bitumen adhesive | Normal occupant activity | N/A |
| Extent of damage | Low | Likelihood of disturbance | N/A |

The floor tiles and bitumen adhesive identified on various areas of the floors throughout Block A - C contain Chrysotile (white) asbestos fibres. Thermoplastic floor tiles usually contain up to 25% asbestos fibres and bitumen adhesive usually contains a small quantity of asbestos fibres, bound into the product matrix

The asbestos containing floor tiles and bitumen adhesive may be left in situ and managed in place. However, if the forthcoming refurbishment works are likely to disturb the floor areas, the asbestos containing floor tiles and adhesive should be removed by an asbestos removal contractor and disposed of as asbestos waste before the works commence

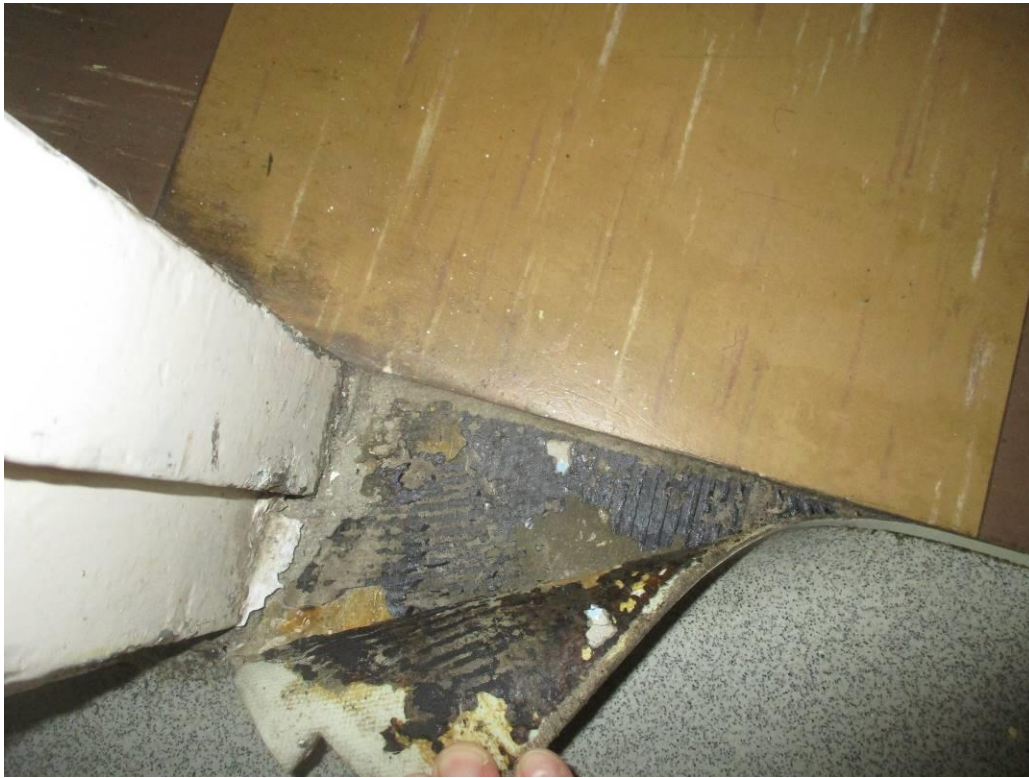
Floor tiles and bitumen adhesive in the classroom entrance and W/C's in Block A

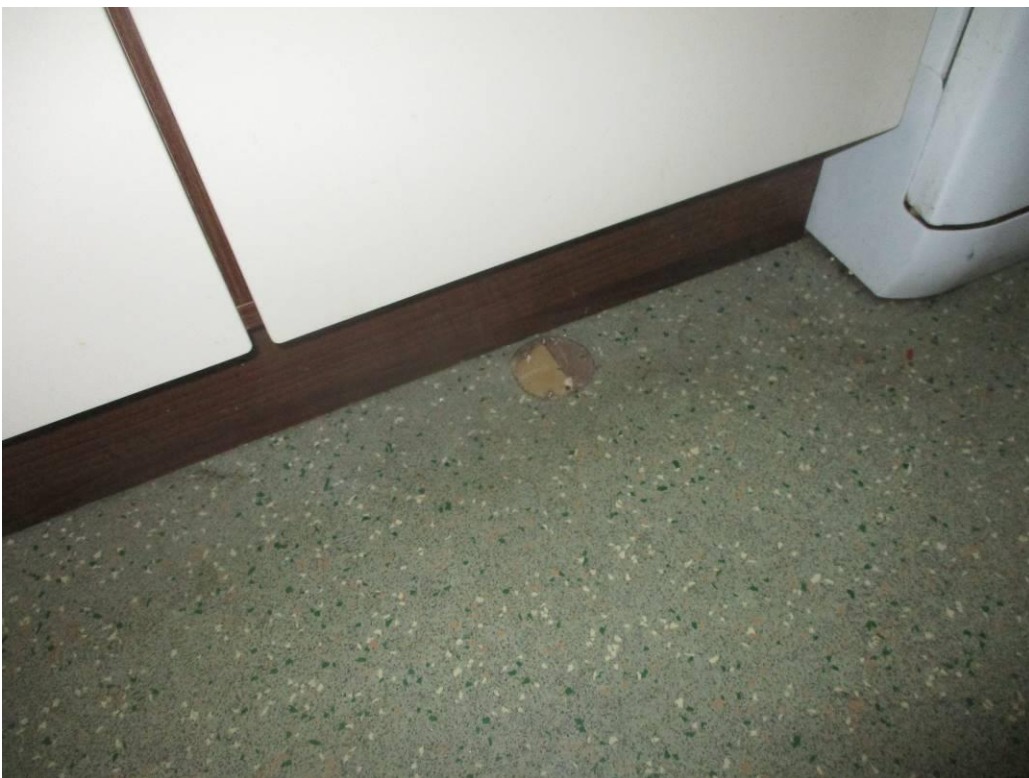
Floor tiles & bitumen adhesive under floor covering beside the sinks in the classrooms in Block A

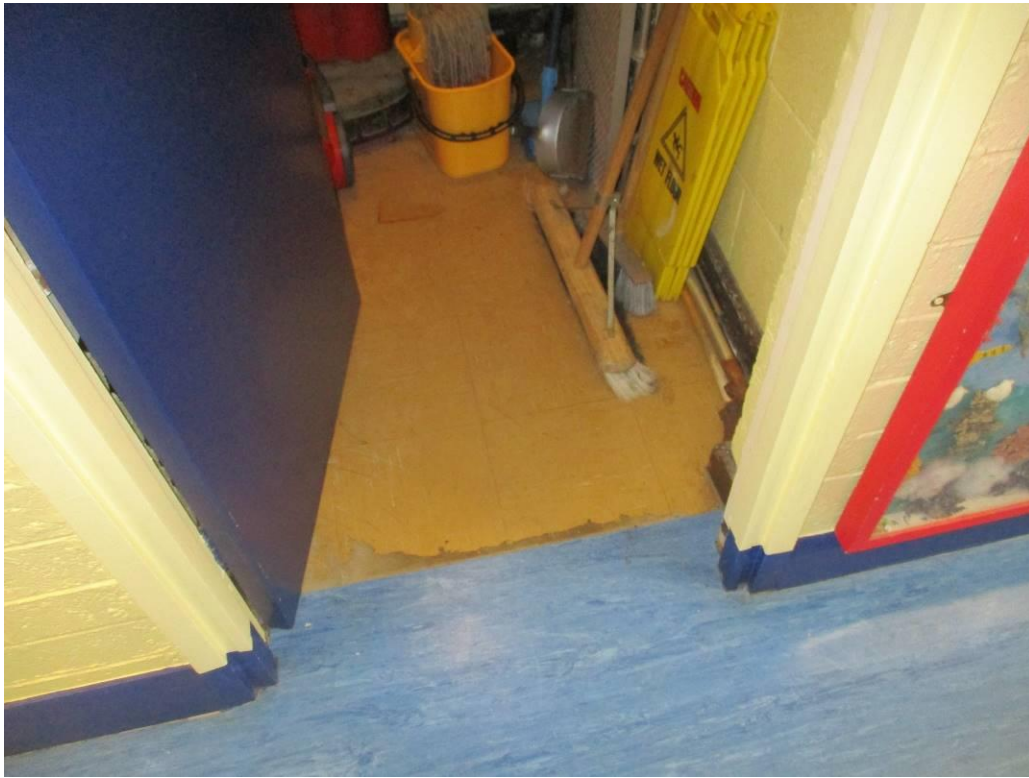
Floor tiles and bitumen adhesive in the cleaners store in Block B

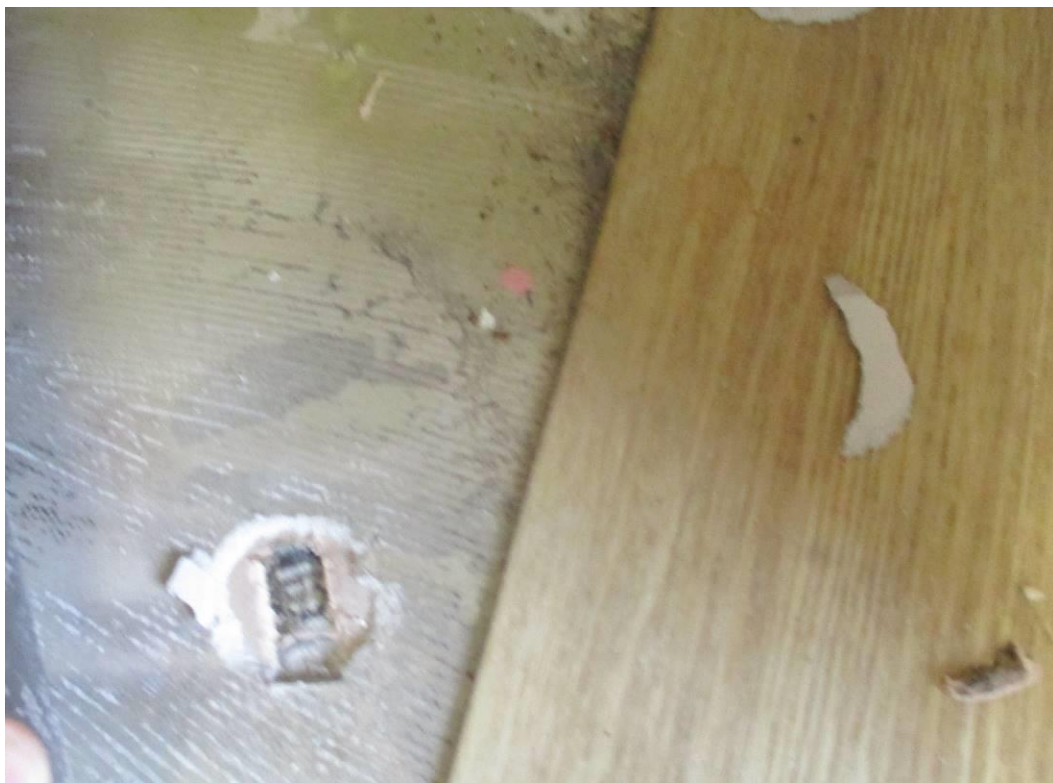
Bitumen adhesive under the flooring and levelling compound in the staff room in Block B

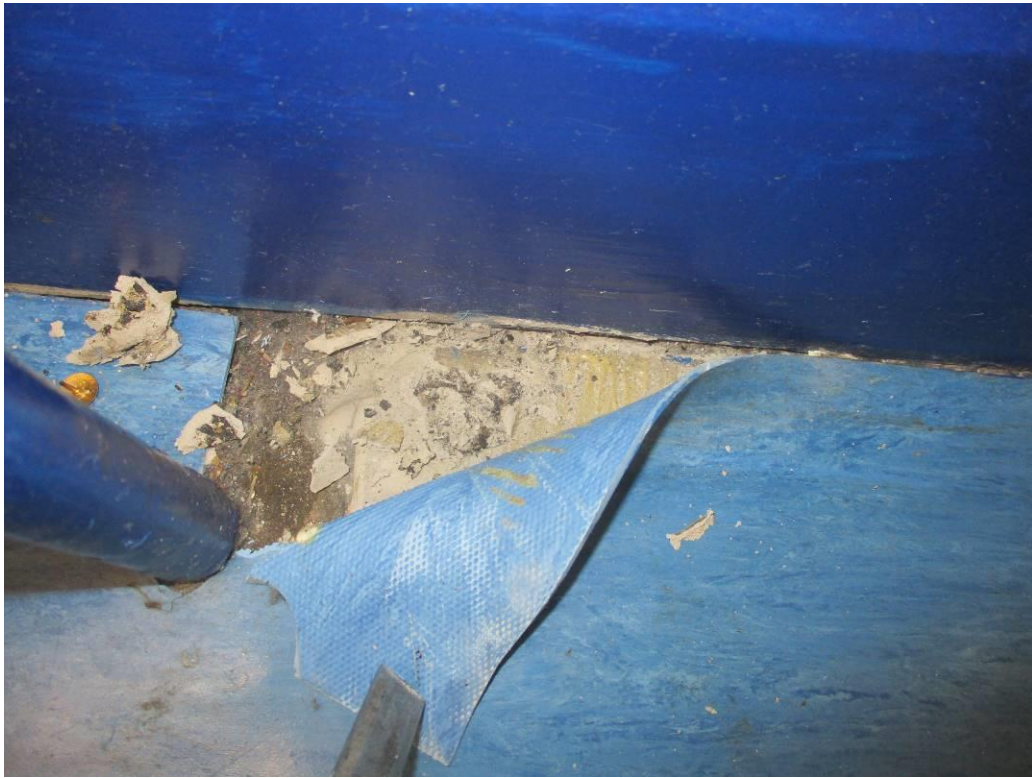
Bitumen adhesive under the flooring in the corridor in Block B

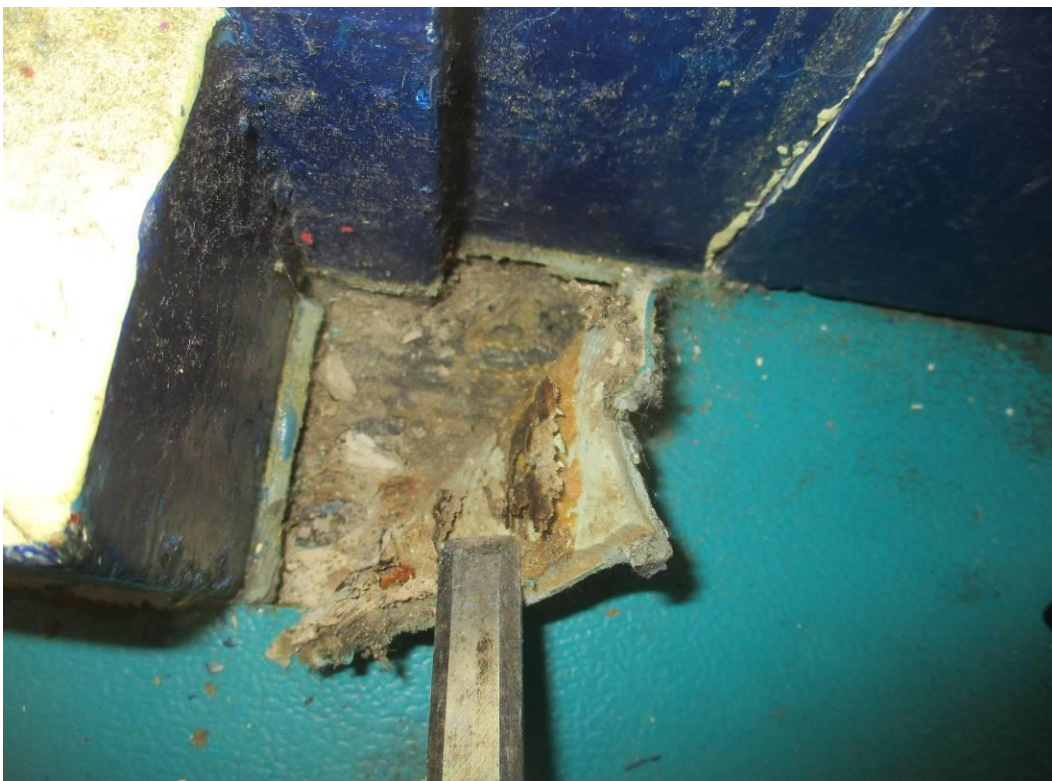
Bitumen adhesive under the flooring in the gym in Block B

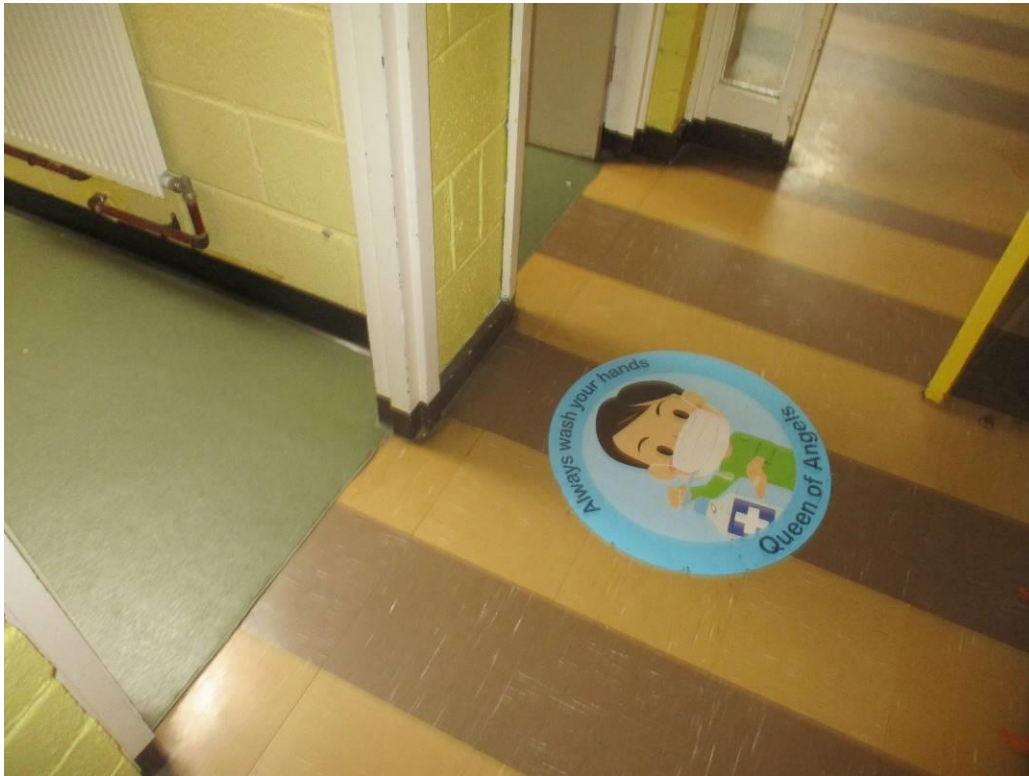
Floor tiles and bitumen adhesive in the classroom entrance and W/C's in Block C

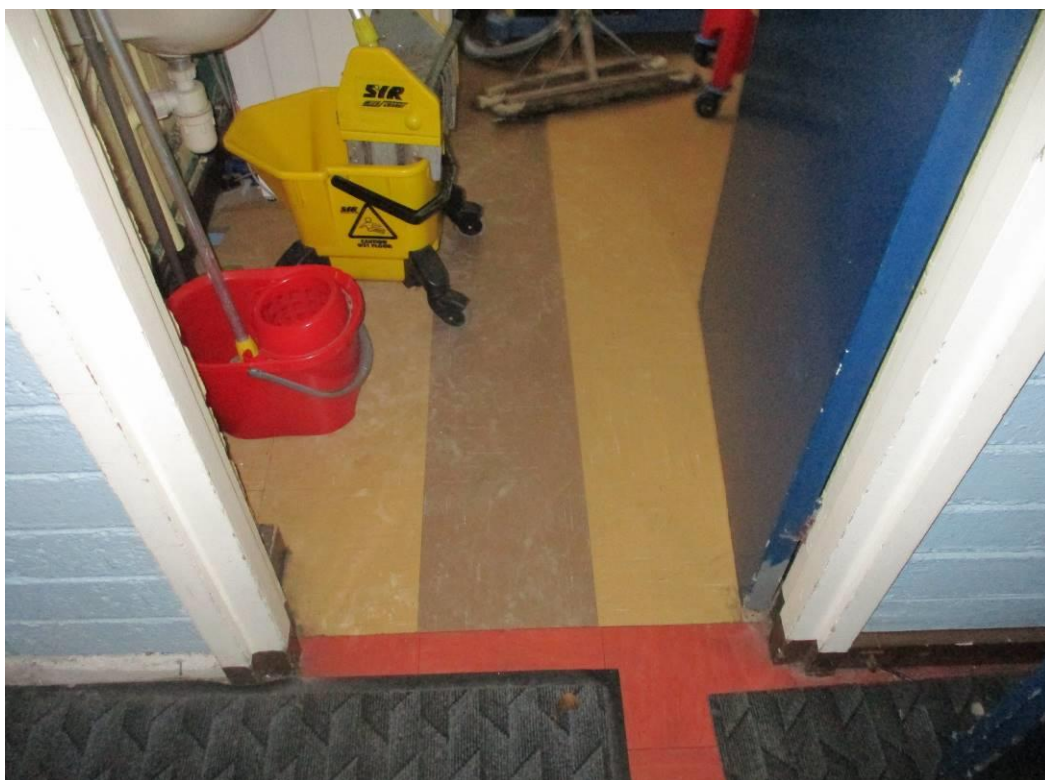
Floor tiles and bitumen adhesive in the cleaners store in Block C

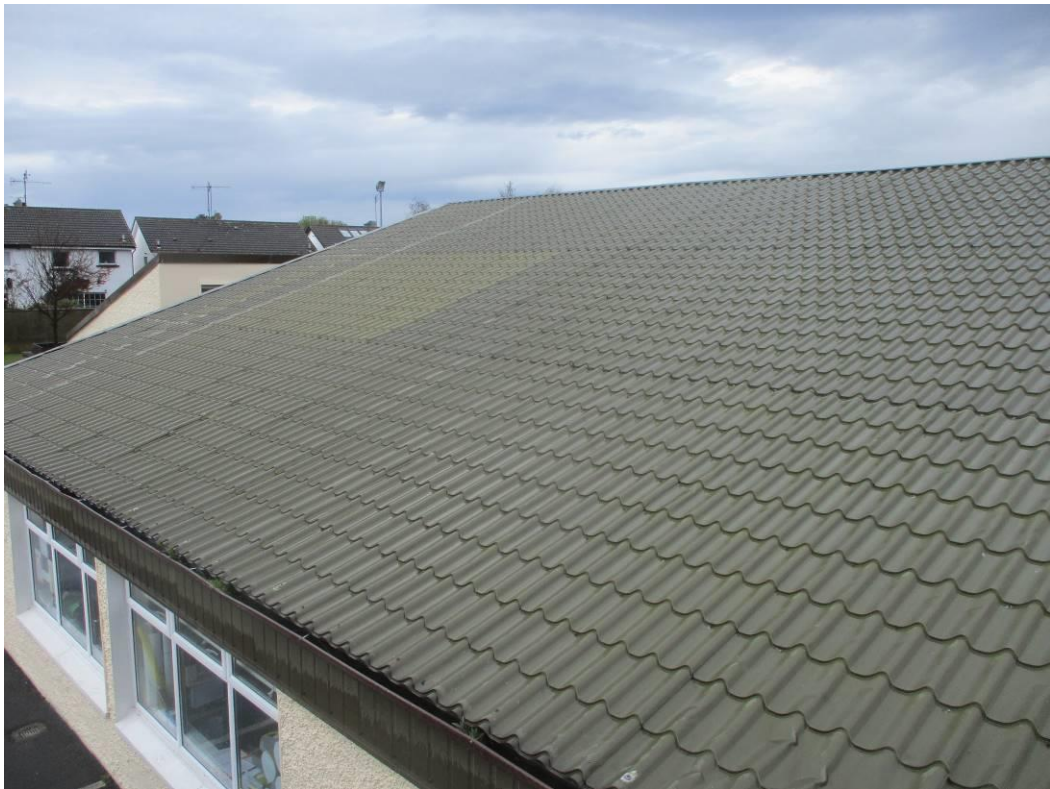
Roof cladding on Block A – C

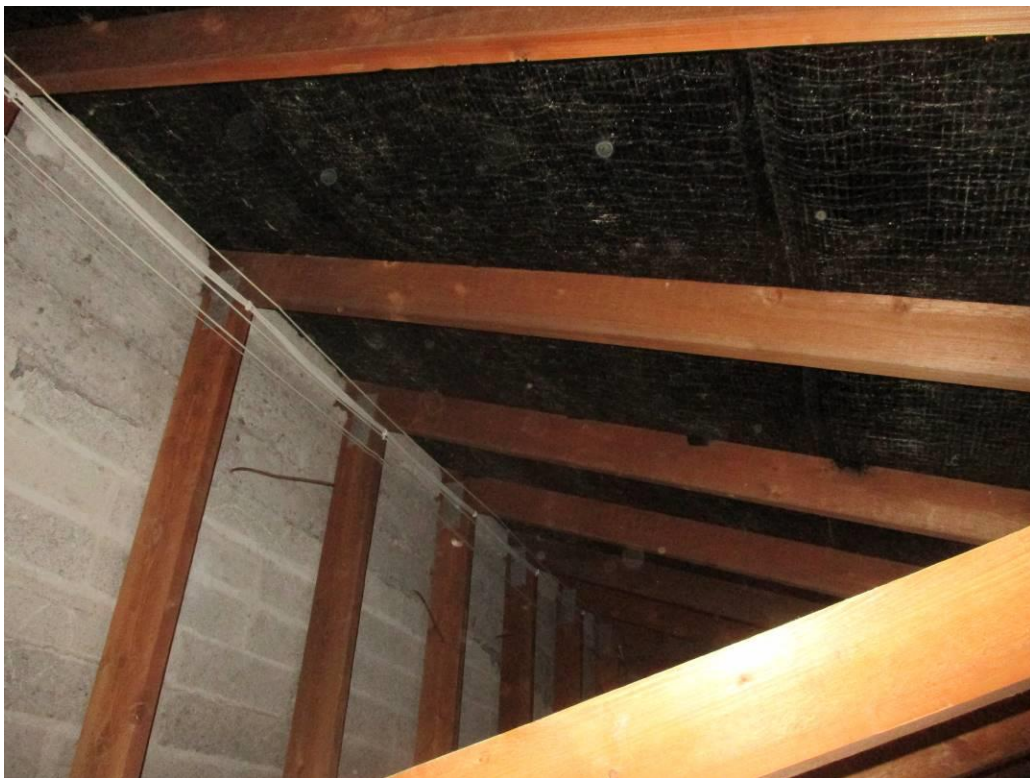
Felt on the roof in Block B

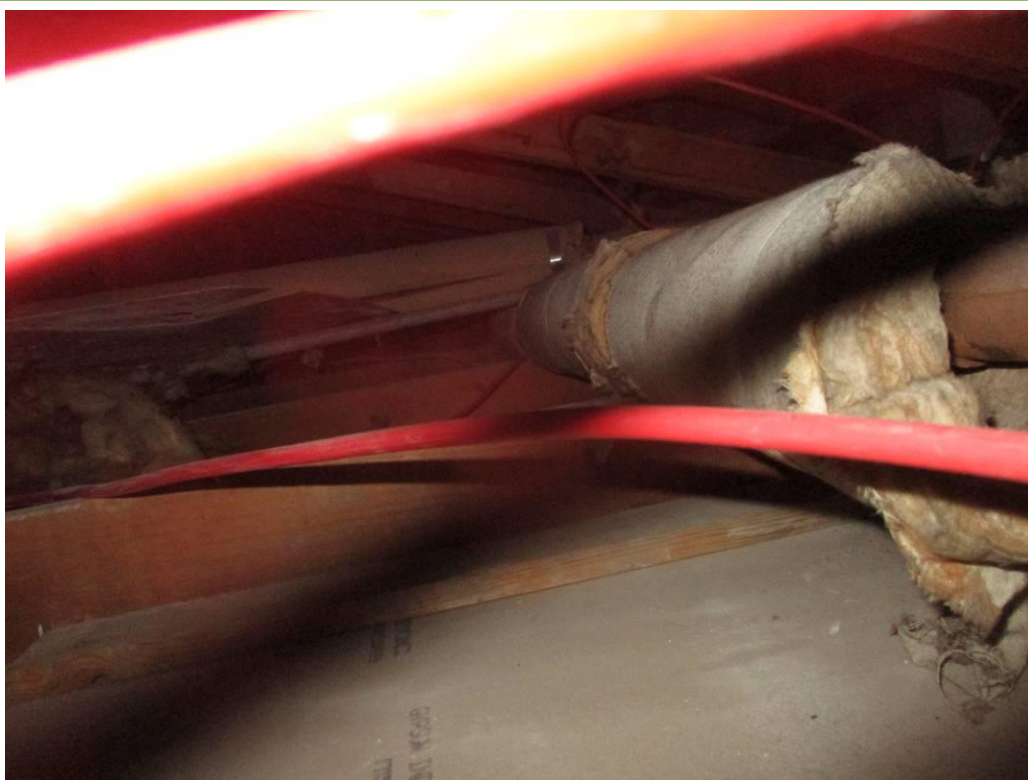
Plasterboard ceiling boards in Block B

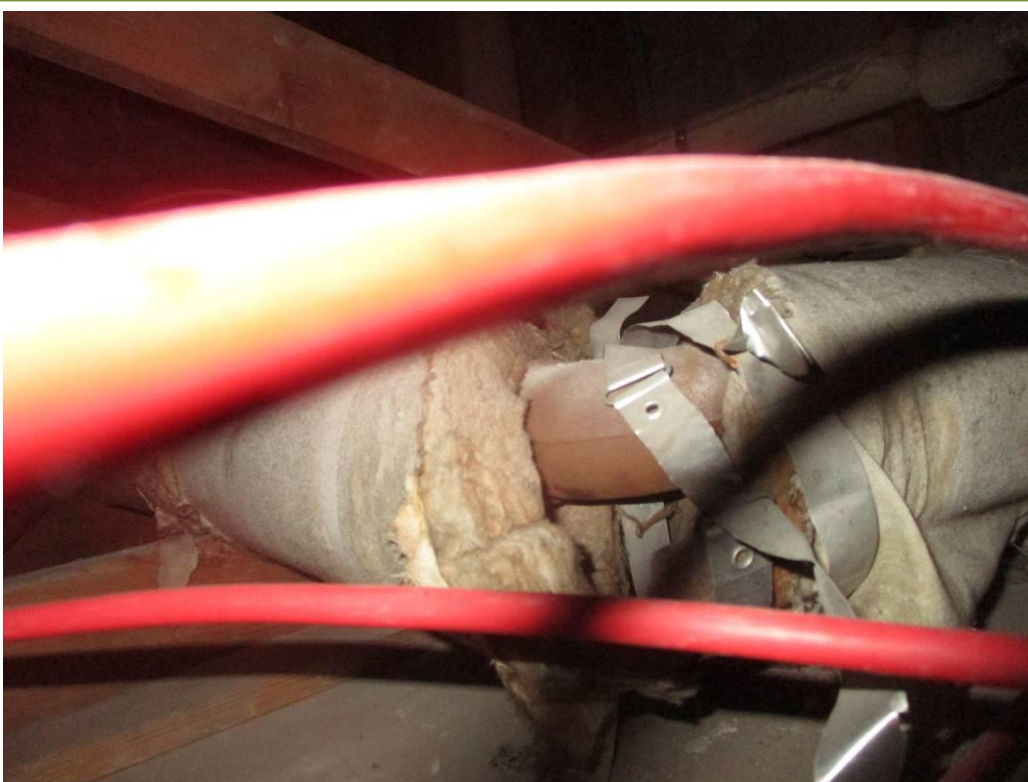
Fiberglass insulation on the pipework in the ceiling void in the boiler room in Block B

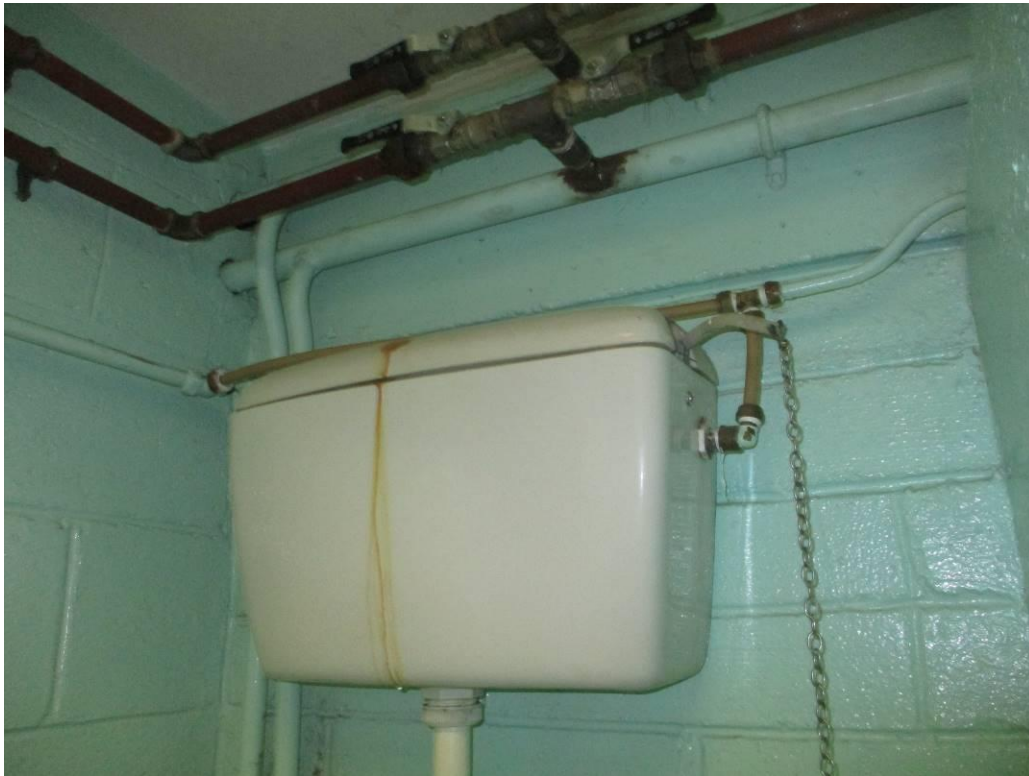
Toilet cisterns in Block A – C

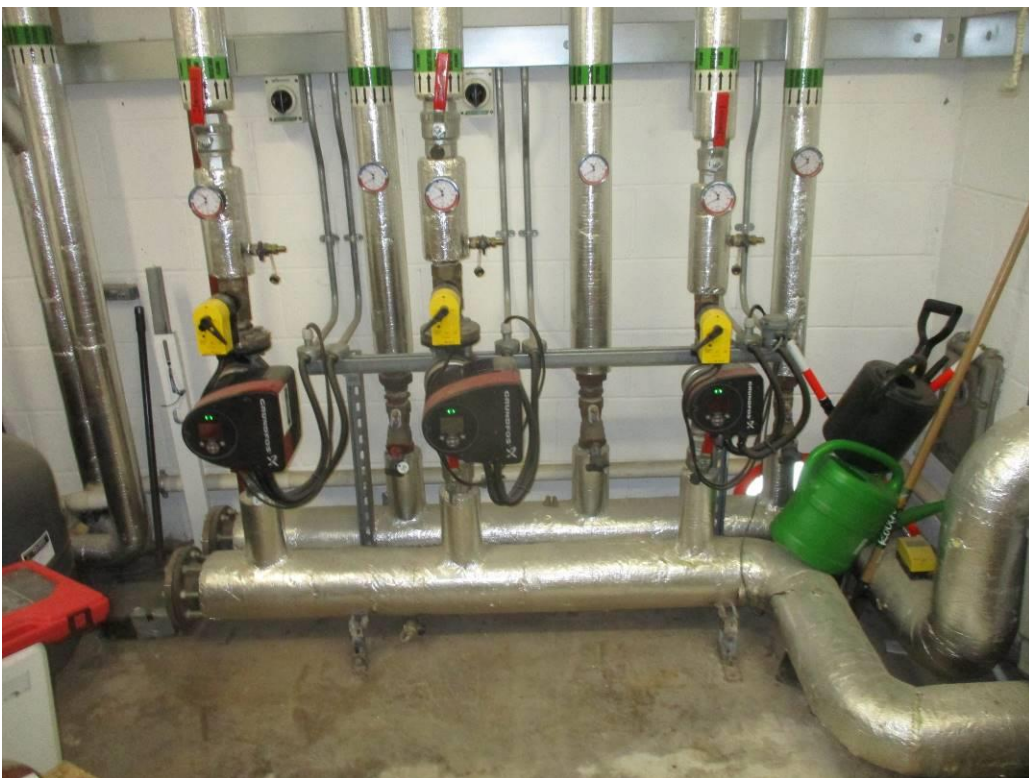
Fiberglass insulation on the pipework and gaskets between flanges in the boiler room in Block B

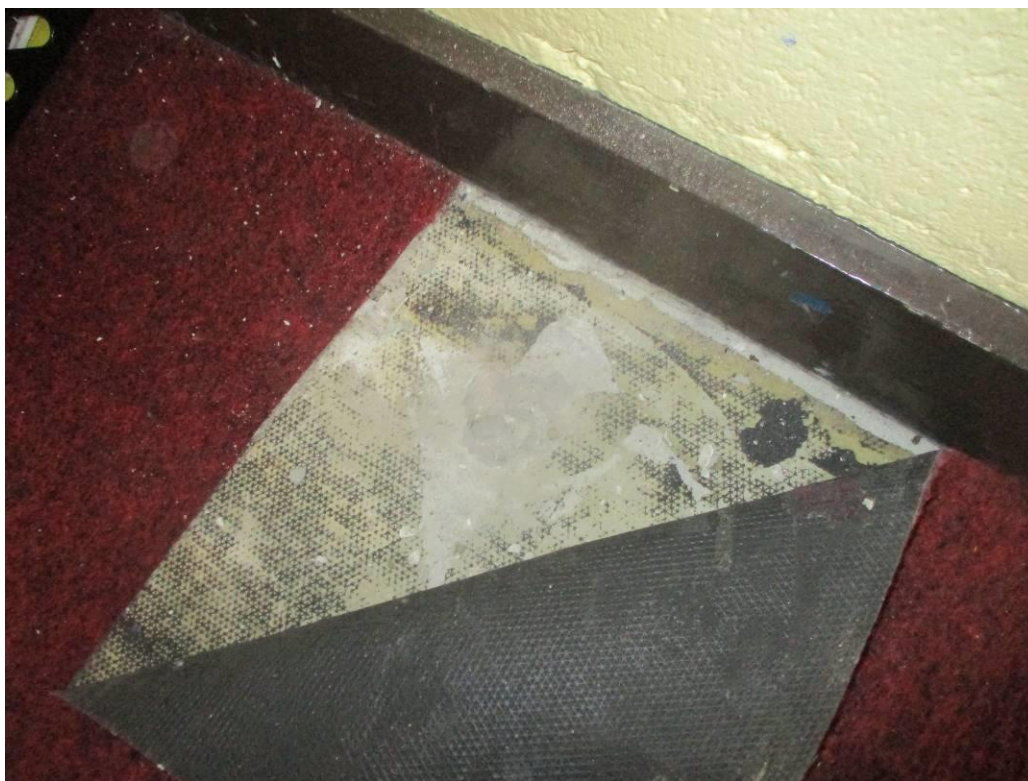
Concrete floors under carpet in the classrooms in Block A – C

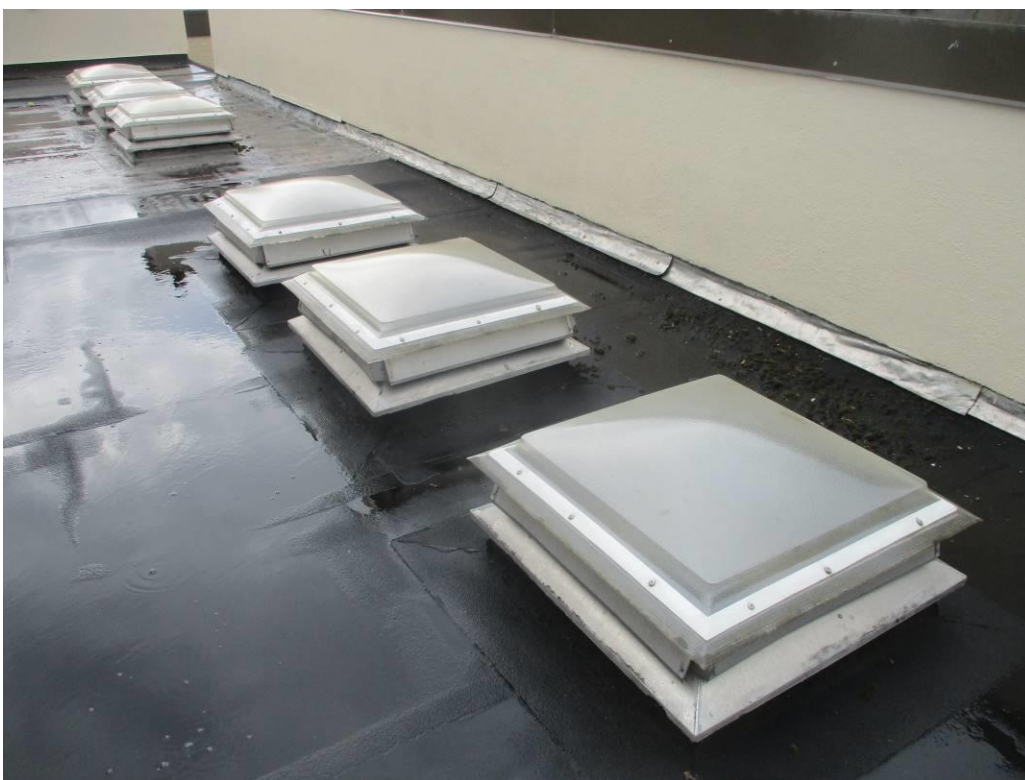
Skylights on the flat roof
