**Report on Inspection of**  
**Residential Building**

**at**  
**13 Market Street, Galway,**  
**Co. Galway**

**for**  
**Galway Simon**

**March 2025**

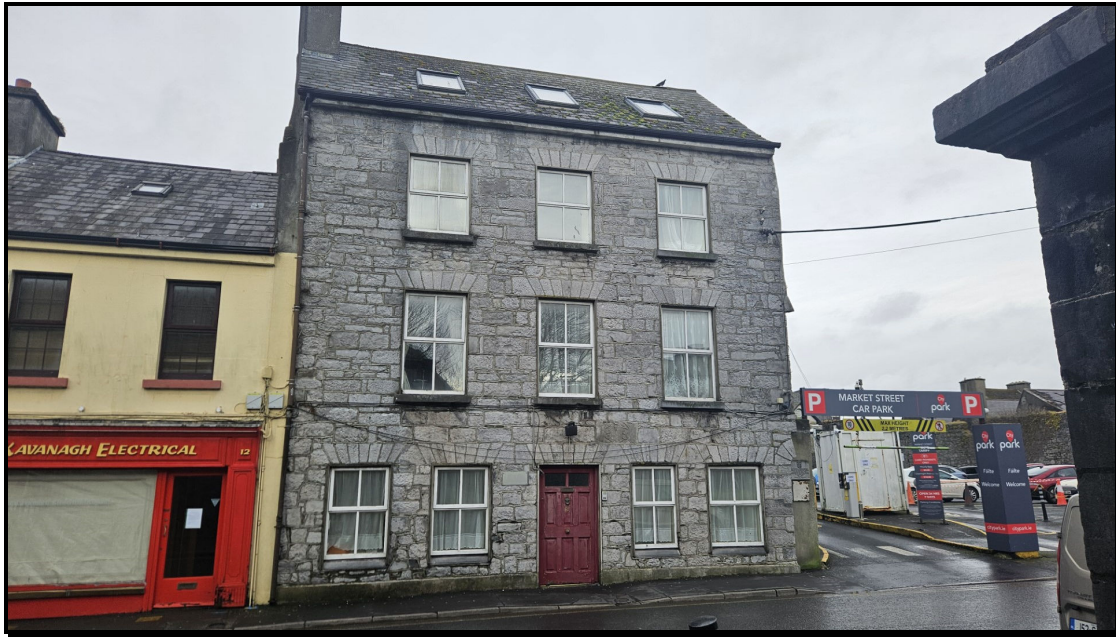
**Photograph 1: Front Elevation of Building**

The property is a four storey end of terrace structure located on the north western side of Market St, in Galway city centre (see photograph 1). It is likely to date from the early to mid-19<sup>th</sup> Century. An historic photograph of the building indicates that the existing street front building was originally constructed with an attached three storey rear annex, most of which has subsequently been demolished (see photograph 2). The remaining original building has been extended to the rear (northwest) by the addition of a single storey extension constructed partly on the footprint of the original rear part of the building. It appears likely that some of the external walls to the original rear building have been retained and the extensions constructed on these original walls.

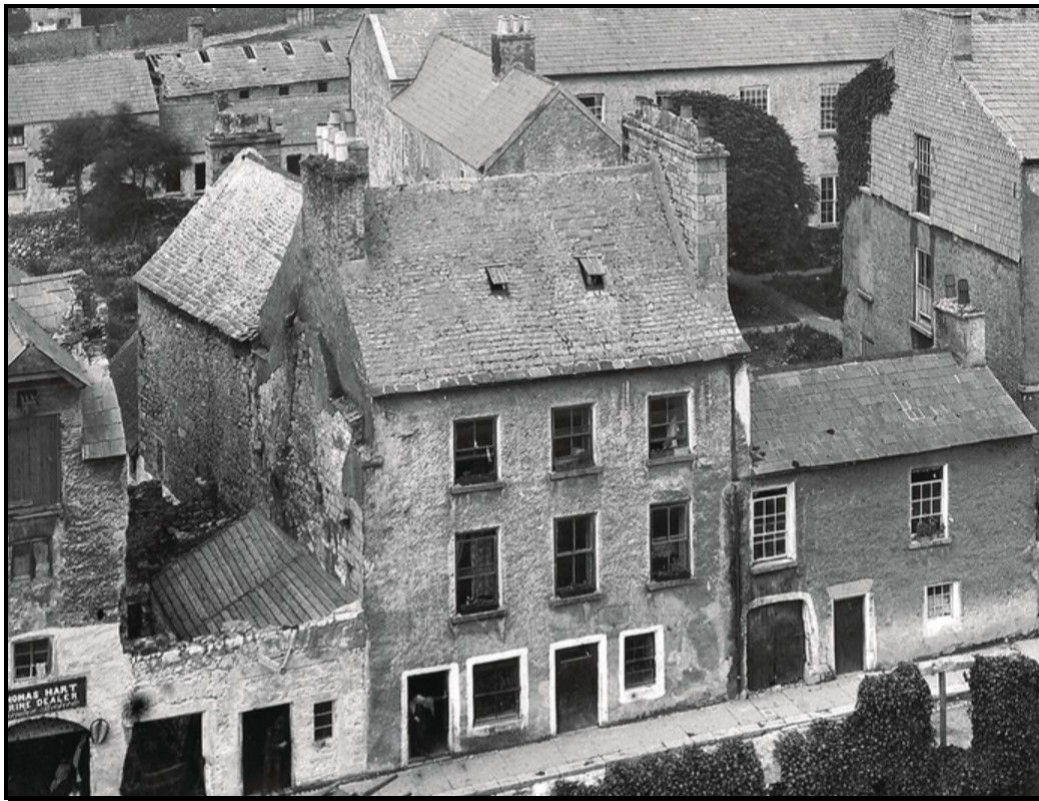
**Photograph 2: Historic photograph of building (dated circa 1880)**

The historic photograph appears to indicate that the building originally contained two adjoining dwellings with two separate front entrance doors, but was subsequently merged into a single property with alterations to the arrangement of doors and windows at ground floor level reflecting these internal alterations.

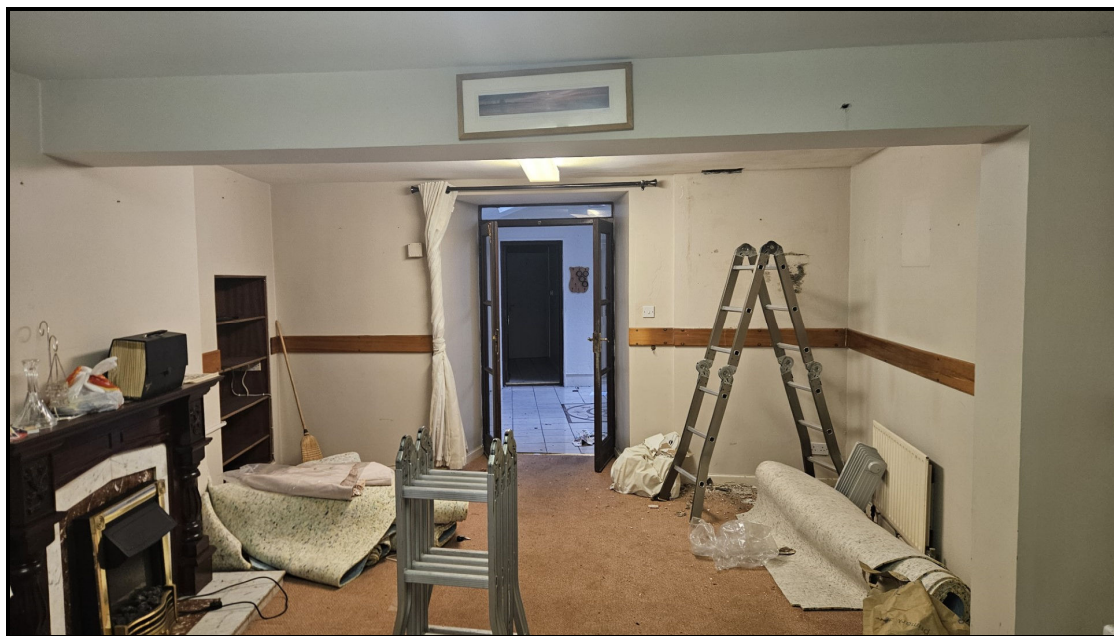
Moisture ingress was noted in numerous locations throughout the ground floor, both in the original building and more extensively in the rear extension. Moisture damage was noted around the front window in room G-1, and also on the rear wall of this room. Copious water ingress is occurring at the junction between the pitched roof over room G-2 in the rear extension and the rear wall of the original building. This is resulting in water damage to the ceilings and walls in room G-2, and is most likely the source of the moisture damage on the inside of the rear wall of the original building. Opening up was carried out to the ceiling at the

rear of room G-1. The bearing ends of the timber floor joists forming the first floor overhead were exposed.

**Photograph 3 – Front room at ground floor level with downstand beam at ceiling level**

While the joists were generally intact, some softening and the timber was observed where the joists are embedded in the rear wall. This is due to the extent of moisture in the wall, which is causing wet rot decay to the timber. Staining on the ceiling over much of the rear of room G-1 would indicate that moisture ingress is occurring over a significant portion of the rear wall, and it is likely that a number of the joist ends have suffered from decay. This would need to be investigated further prior to, or as part of any refurbishment work to determine the extent of the damage to the floor joists and the need for repairs to, or replacement of, the affected floor joists.

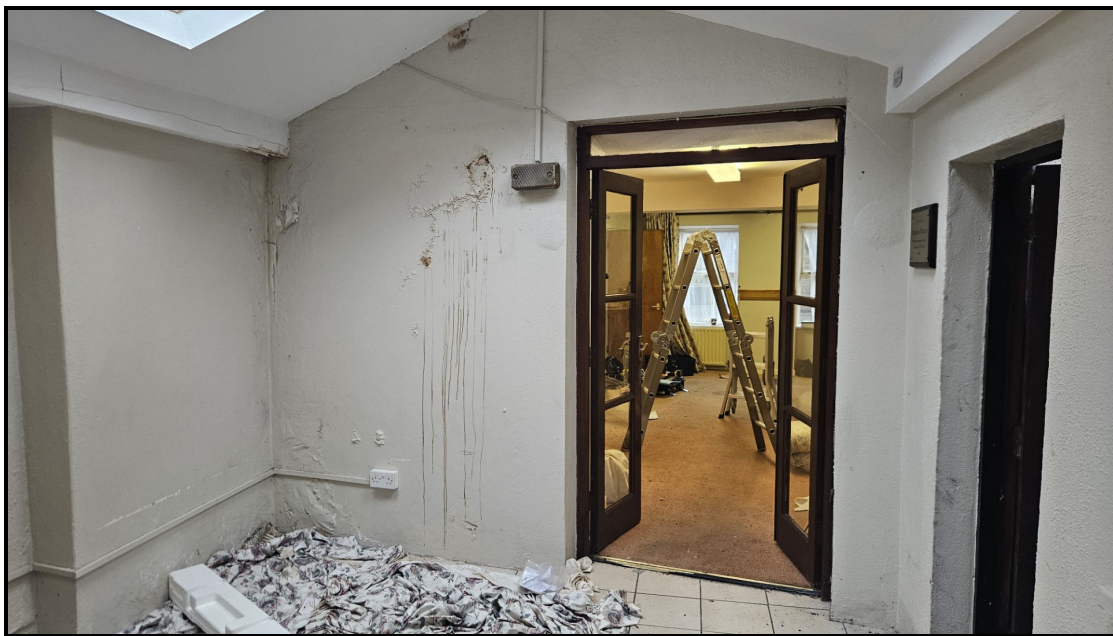
Room G-2 would appear to have originally been an open external area between the original front building and the building containing rooms G-3, G-4 & G-5, which has been roofed over. The building fabric in this room is in very poor condition with water ingress occurring through the roof particularly at the junction between the pitched roof and the rear wall to the original building, and along the valley gutter between the roofs over room G-2 and room G-7 and the stairs (see photograph 4). Rising damp was also observed around the base of the internal walls. This part of the building will either need to be taken down and reconstructed (if required), or extensive repairs would need to be carried out to the roof, walls and floors, and consideration would need to be given to installing an injected type damp proof course around of the base of the masonry walls.

**Photograph 4 – View towards rear wall of original building in room 2 showing water ingress on walls and rising dampness**

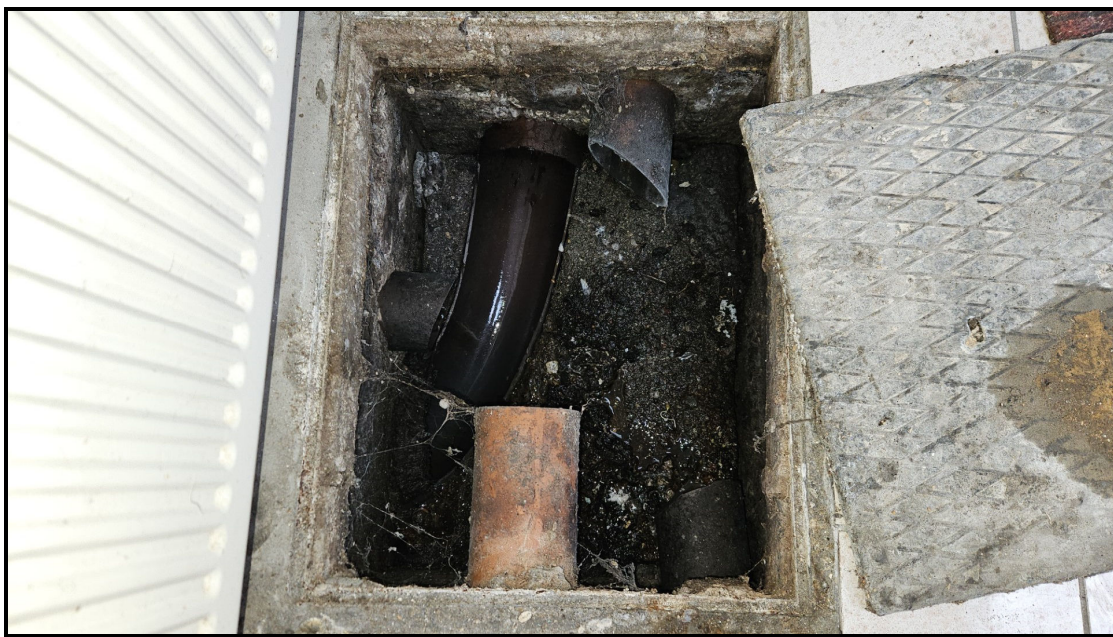
2No. manholes on the foul sewer drainage system are located within the floor of this room, and are covered with matting. The manholes are poorly constructed and are in very poor condition, and the covers are not properly sealed - as required for internal manhole covers - to prevent foul odours or gases from entering the room (see photograph 5). If this area is to form part of the interior of the building in the future, the manholes (as most likely the associated pipework) would need to be removed and reconstructed.

**Photograph 5 – Foul sewer manhole in floor of room 2**

The existing manholes on the foul sewer drainage which are currently located in room G-2 in the single storey part of the building will need to be removed and reconstructed, regardless of whether the accommodation in this part of the building is retained, renovated or removed. A CCTV survey of the existing drainage pipework should be carried out in order to determine its condition and the need for any repairs, remedial works or replacement.

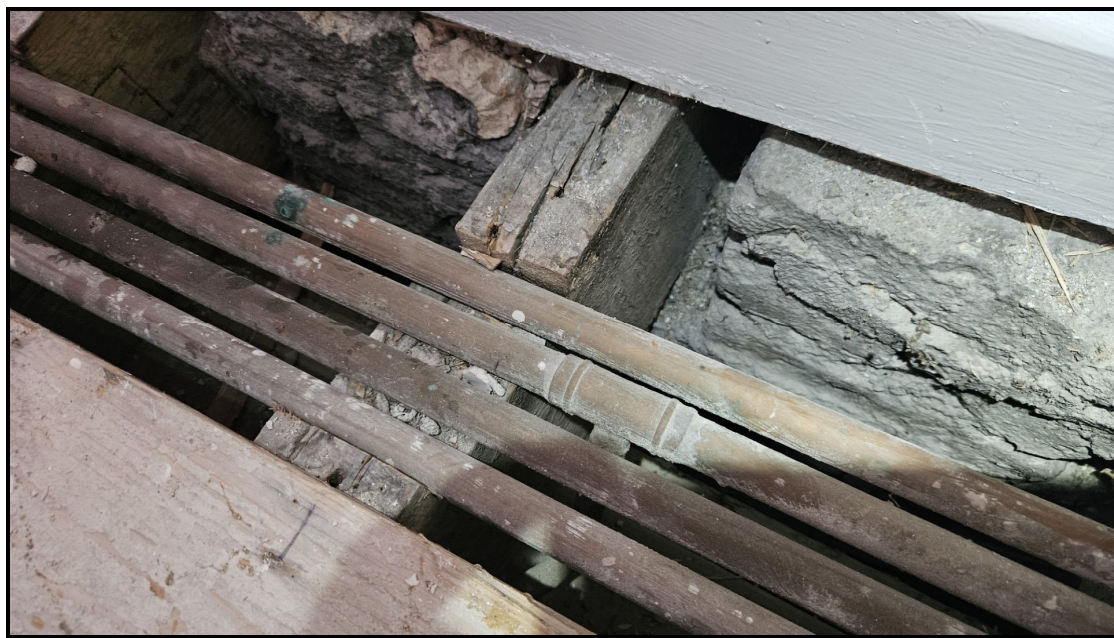
The first floor structure consists of timber decking on timber floor boards which are supported on timber joists spanning between the front and rear walls of the building, and supported on the timber beams over rooms G-1 and G-8 at ground floor level, as noted above. The first floor structure was opened up at 2No. locations within the rooms at first floor level (in addition to the opening up carried out below ceiling level in room G-1 at ground floor as noted above). The floor joists were exposed at their bearing points at the front of room 1-1 and along the rear wall in room 1-4 (see photograph 6). The timber floor joists vary in depth from 210mm to 225mm and vary in width between 50mm and 52mm at the locations which were exposed. Joist centres varied between 360mm and 480mm. No excessive moisture content readings were observed in the masonry walls or in the timber joists at the 2No. locations which were opened up, and no decay was observed in the floor joists. The joists were notched at both of the locations which were opened up, with the notches at these locations measured at 30mm and 35mm, both exceeding the maximum notch depth permitted under current design codes.

**Photograph 6 – View of floor first joists at bearing on external wall**

*Note notching in joists for heating pipes*

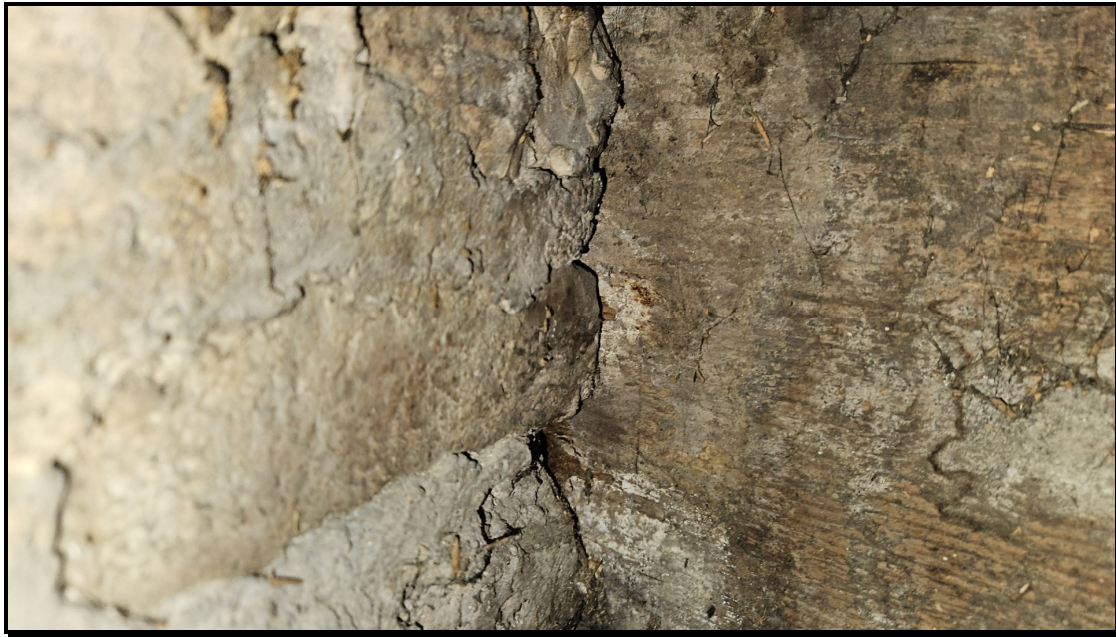
Opening up of the floor structure was carried out against the front wall in room 3-1. The bearing ends of two joists were exposed at this location and one of these joist ends was found to be badly decayed where it was embedded in the front wall due to wet-rot as a result of elevated moisture levels in the masonry (see photograph 7). Again, excessive notching off the joist (up to a depth of 40mm) was observed at this location which significantly exceeds the maximum permitted notch depth for a timber floor joist. An access hatch in the ceiling over room 2-5 at second floor level allowed the bearing end of the adjacent floor joist to be inspected at this location. Significant decay was noted along the bottom edge of the floor joist at its bearing in the external rear wall (see photograph 8). Timber packers were noted between the decayed joist end and the masonry on which it is supported, presumably fitted during an earlier refurbishment of the building in an attempt to remediate the damage cost to the joist end by the localised decay.

**Photograph 7 – Decay at embedded joist end in front masonry wall**

The general condition of the upper floor joists, due to the decay observed at numerous locations throughout the building, is a significant concern in the context of the refurbishment and upgrade of the building, and it is likely that either significant repairs/remedial works will be required to rectify the damage caused by this decay or, depending on the extent of proposed alterations to the internal layout of the building, it may prove more economical to remove and replace the existing timber floor joists.

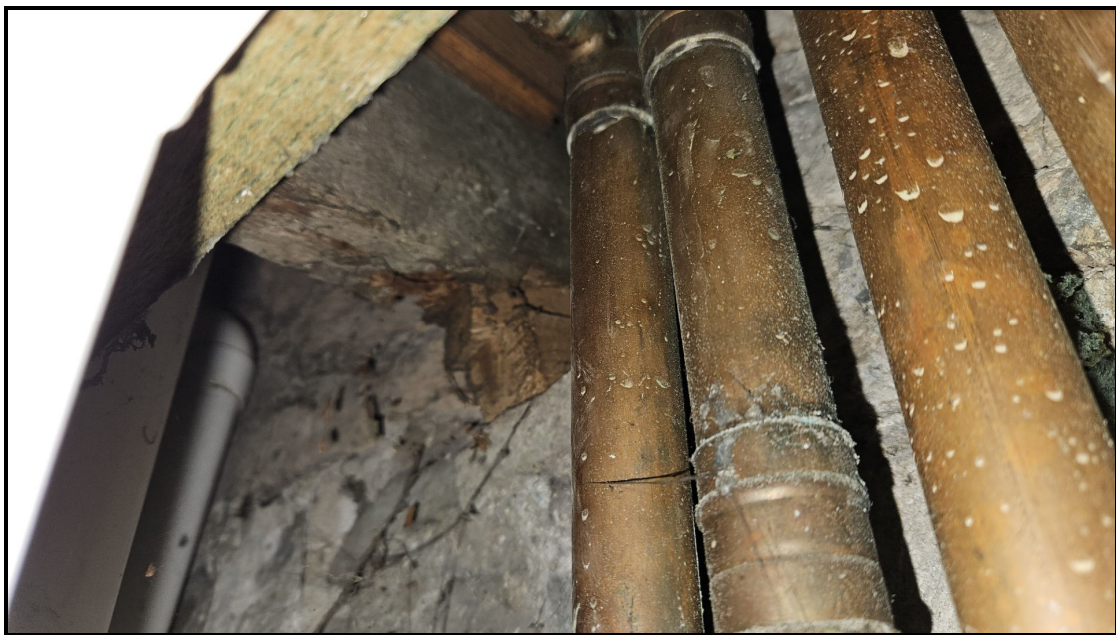
**Photograph 8 – Decay in joists end (beyond pipes) with wedges supporting joist**

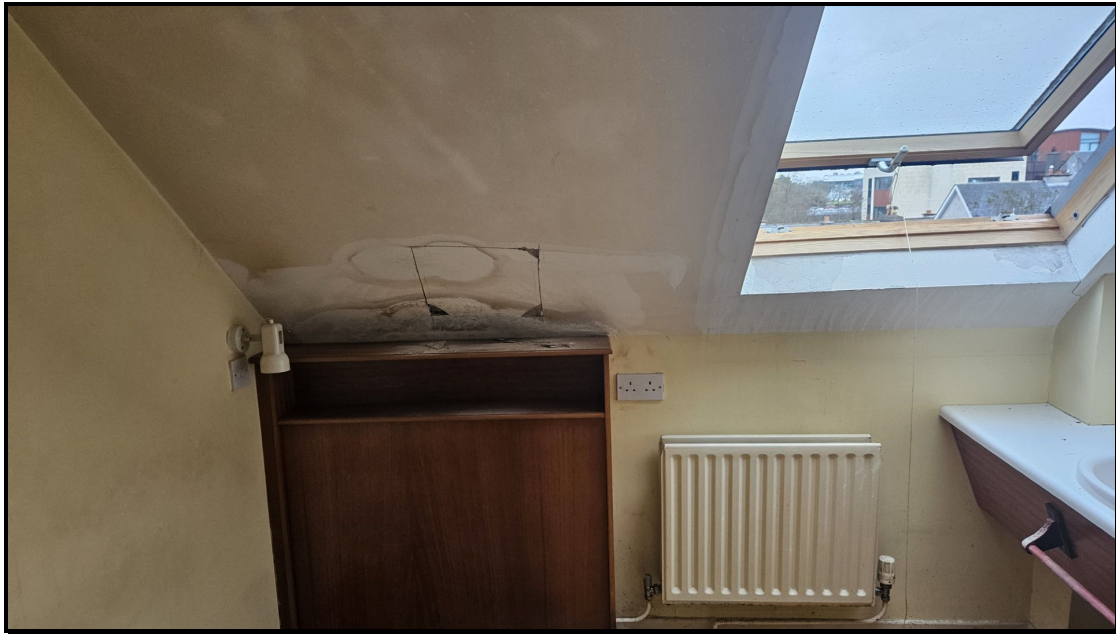
Damage to the sloping ceilings due to water ingress was visible along the rear of room 3-7 close to the rooflight (see photograph 9). Opening up of the sloped ceiling in this area was undertaken in order to assess the condition of the rafters and the roof makeup generally in this area. Significant damage has been caused to the roof construction in this area due to water ingress which appears to be occurring through the slate roof finish adjacent to the velux type roof light on the rear of this sloping roof. The gypsum ceiling slabs were locally removed revealing decayed rafters and slating battens with the roofing felt above the rafters also having failed and broken away (see photograph 10). Fibreglass insulation has been packed

**Photograph 9 – Damage on ceiling/wall at rear due to water ingress**

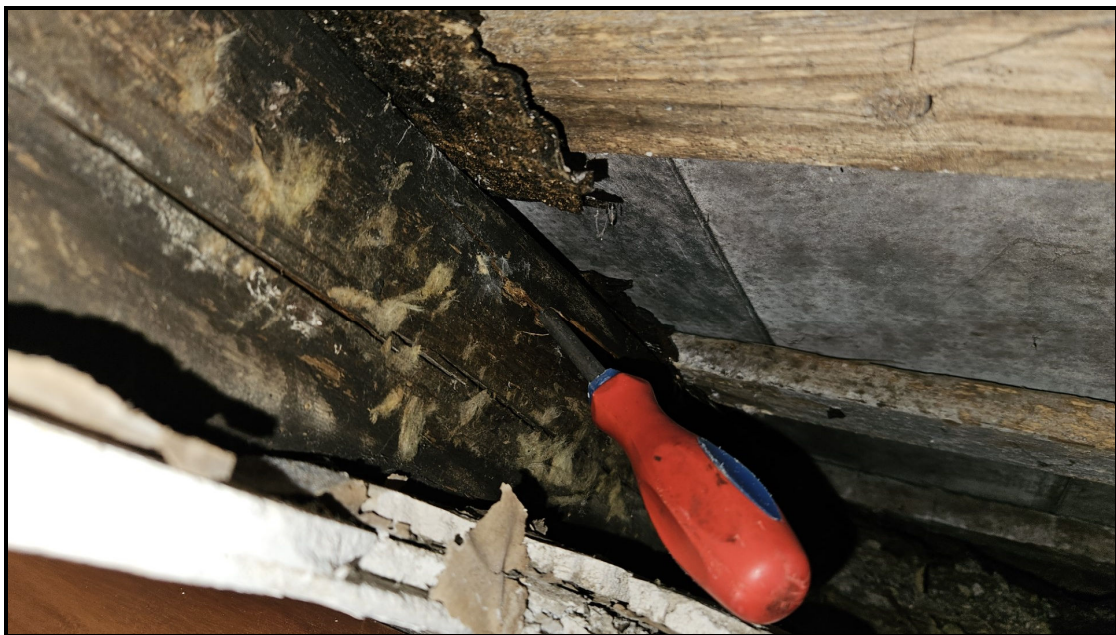
into the voids between the rafters in the roof construction. Both wet rot, and traces of dry-rot mycelium were visible on the rafters where the ceiling was removed (see photograph 11). The extent of this dry-rot infestation will need to be determined by opening up and all affected timber will need to be removed. This area will need to be examined and treated by a specialist, in order to remove all affected timber and to eliminate the dry-rot fungus from any affected wall fabric in this area to prevent it from recurring and/or spreading. Similar evidence of water ingress through the roof coverings was observed at numerous locations throughout the accommodation at third floor level.

**Photograph 10 – Decayed rafter on rear of roof**

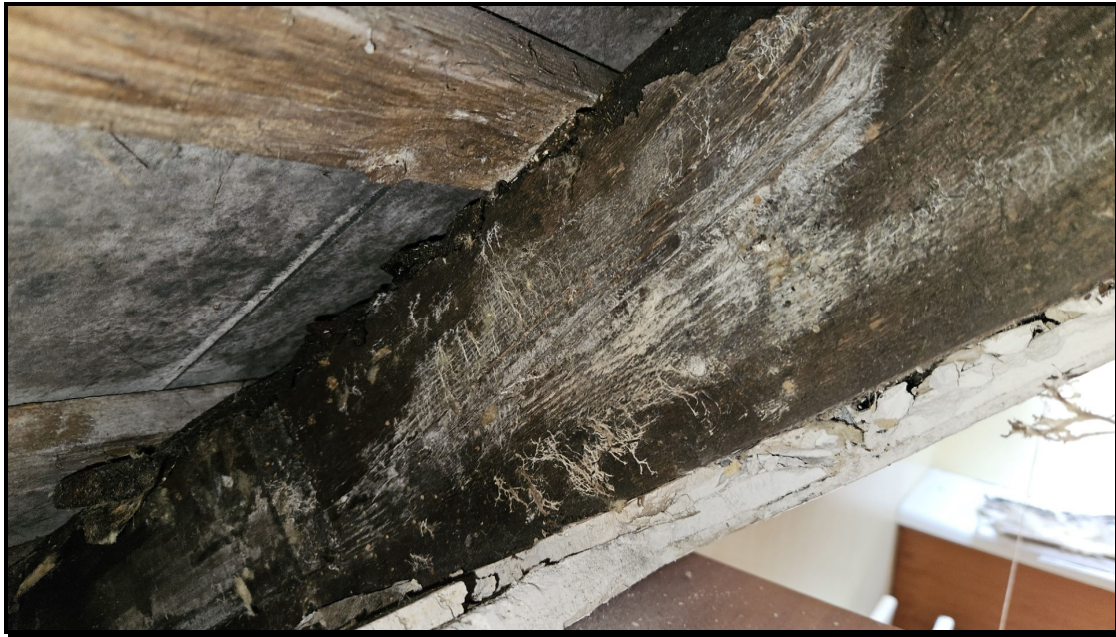
**Photograph 11 – Dry-rot mycelium on rafter at rear of roof**

The existing structure to the main three storey building consists of load bearing external walls, an internal support beam at first floor level and load bearing internal stud walls at the upper floor levels supporting timber joists spanning between the front and rear of the building. While the structure is generally stable at present, with no significant structural distress or cracking apparent on the main external masonry structure, ongoing water ingress through the walls and roof is causing damage and decay to the floor joists at their bearing ends, and this decay has now progressed to a point where it has compromised the structural adequacy of the floors and the roof structure. Without intervention in the short term, the timber elements of the fabric and structure of the building will continue to progressively deteriorate at an increasing rate, and will ultimately reach a point where they are no longer structurally stable. The presence of dry-rot in the roof structure is a significant element in terms of the durability of the building structure and in particular the roof, due to the speed at which it can cause catastrophic damage to the timber elements in which it is present. This dry-rot needs to be eliminated as a matter of urgency.

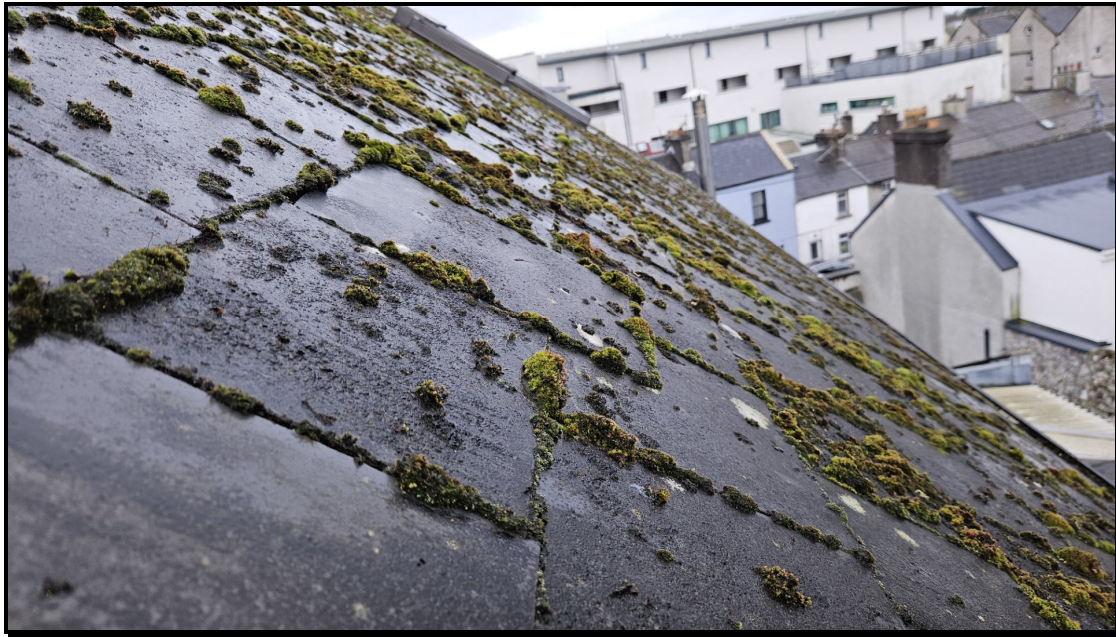
The roof finishes were examined locally around the velux rooflight over room 3-7. A visual inspection of the slates in the vicinity of the rooflight indicated that the slate roof coverings are in poor condition with numerous slipped slates, vegetative growth and extensive surface pitting of the top of the slates (see photograph 12). It is not possible from a visual inspection to determine the exact source of the water ingress that is causing the damage to this part of the roof, however it is likely to be due either to the slipped slates or the issues with the flashings and detailing around the rooflights, or a combination of both. It is likely that similar defects/deterioration to the roof coverings and flashings etc are causing the water ingress that was observed at other locations around the rooms at third floor level. It would appear that the roof coverings are nearing the end of their useful life, and in the context of an extensive refurbishment and upgrade to the building, it is likely that the roof coverings will need to be replaced.

**Photograph 12 – Damaged/pitted and slipped slates on rear of roof**

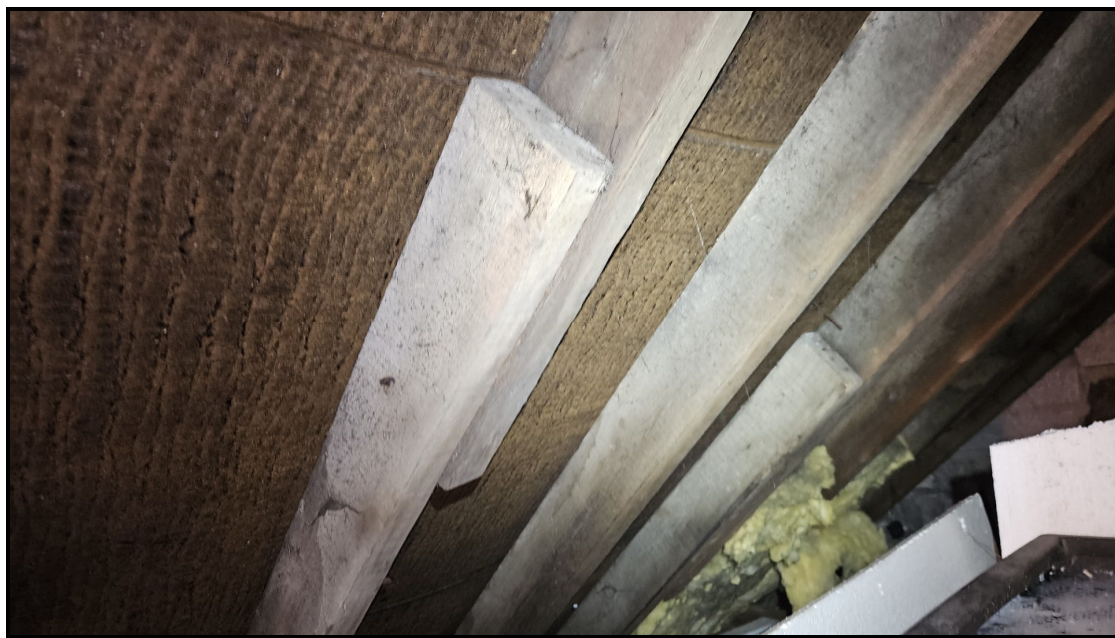
A number of the original timber rafters have also been cut away above ceiling level over the third floor accommodation, with new replacement timbers nailed to the side of the remaining part of the original rafters (see photograph 13). The cutting/replacement of the original rafters was most likely carried out during a previous refurbishment of the building to remove damaged/decayed timbers from historic water ingress. The form of the roof structure relies on continuity of the roof rafters and the integrity of the ceiling joists/ties to provide structural stability to the roof. The cutting and replacement of parts of the rafters has compromised this

stability. It is likely that the extent of cracking observed in the ceilings in the third floor accommodation is partly due to the alterations that have been carried out to the roof structure, most significantly the cutting of the rafters to remediate historic damage and to form the roof light openings. It is likely that the roof structure is now partly relying on the internal stud walls at third floor level to provide support to the roof structure. This will need to be considered prior to the refurbishment of the building, particularly if it is intended to alter the layout of the internal walls. As the roof coverings and internal ceiling finishes will need to be stripped away to facilitate the refurbishment of the building, and the decayed rafters will have to be replaced where wet and dry-rot have occurred as noted above, the cut and lapped rafters should be replaced with new full length timber rafters, properly fixed to the ceiling joists. Where rafters have been cut away to install rooflights, the original rafters on each side of the rooflight openings should be doubled up to restore the integrity of the roof structure.

**Photograph 13 – Cut and lapped rafters above third floor level**

The existing roof structure has been compromised by decay and deterioration, and by the cutting and removal of a number of the original timber rafters. Extensive structural repairs will be required to the roof structure, including the removing and replacing of all timbers affected by the wet rot and dry rot that were observed where the roof was opened up at the rear of the building, treating and eliminating the dry-rot, examining the remaining roof timber and replacing any other areas affected by wet and/or dry rot, in order to restore the structural integrity and capacity of the roof structure.

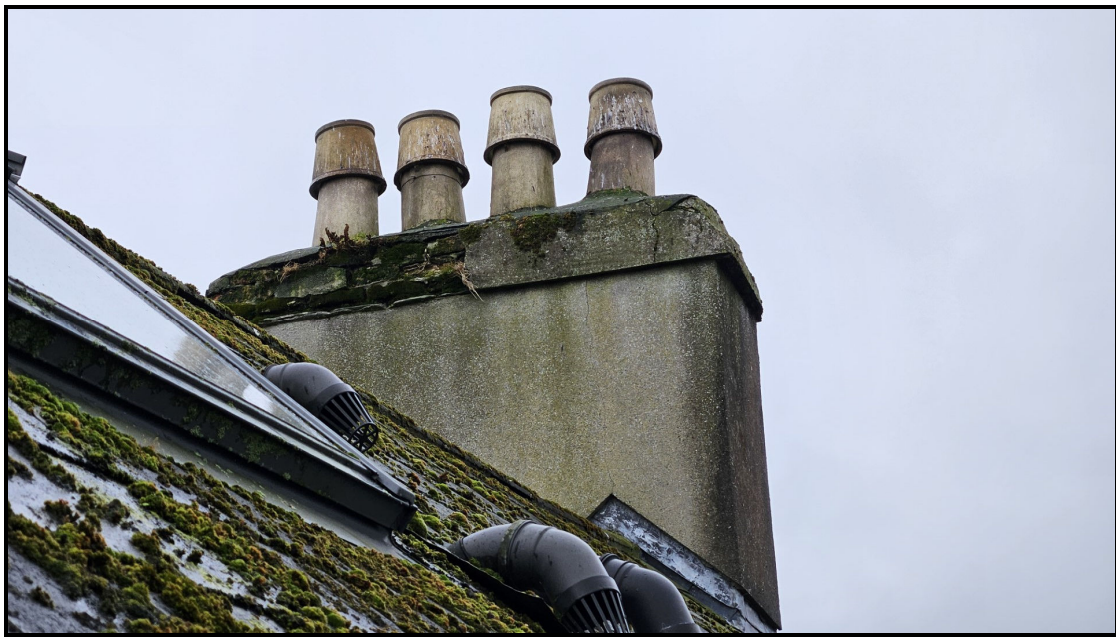
The original chimney that would have been present at the top of the north eastern gable wall has been removed at some point when the building was historically renovated. The chimney on the south western gable remains in place and is finished with what appears to be a sand and cement render. While there is no significant evidence of water ingress into the building through this chimney, the north eastern face of the chimney is visible from the rooflights on the rear of the roof and damage to the chimney capping is evident with loss of the plaster finish and vegetative growth at the top of the chimney (see photograph 14). This chimney should be repaired to prevent further deterioration to the masonry structure and the render finishes, and to mitigate against the risk of future water ingress into the building.

**Photograph 14 – Damage to chimney capping on south western gable wall**
