## Building Condition Survey

13 Market Street,  
Galway  
H91 HN72

**Simon Community**

Date: 20 March 2025

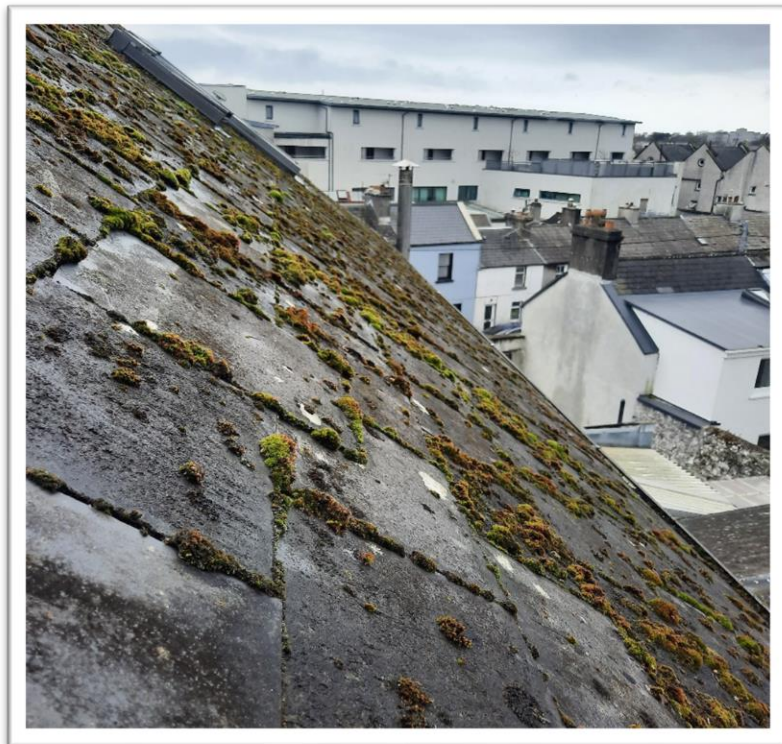
Photo 2 – Moss covering rear roof slope, and slipped slates.

- Recovering of the high-level roof is highly recommended, to secure the long-term lifespan of the building. I.e. new slates, timber battens, breathable underlayment membrane, upgraded thermal insulation, repairs to the chimneys, permanent passive ventilation.

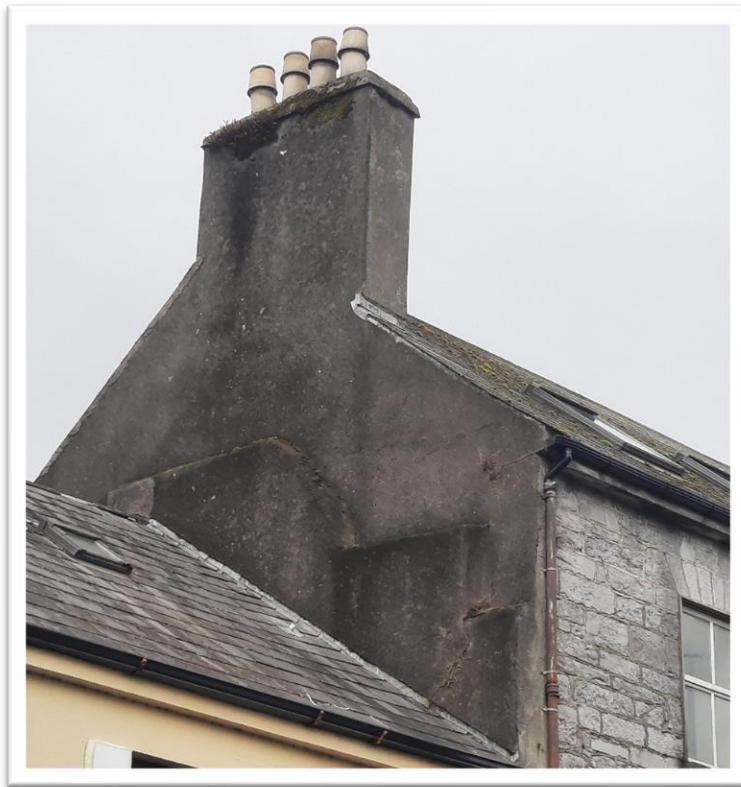
- The external gable wall at No. 12 side is also in poor condition. Some minor patch repairs have been carried out to the gable and as previously mentioned there is moss and vegetative growth visible from a number of cracks along this gable. We anticipate that moisture can easily penetrate here. Whilst it is not visible notably on the interior of the building due to the plasterboard internal linings.

Photo 3 – Party / Gable wall with No. 12 on West / left side. Cracks and vegetation visible

- The side party gable wall will require re-rendering with some stitching repairs to cease movement in the crack and to prevent water penetration in the future.

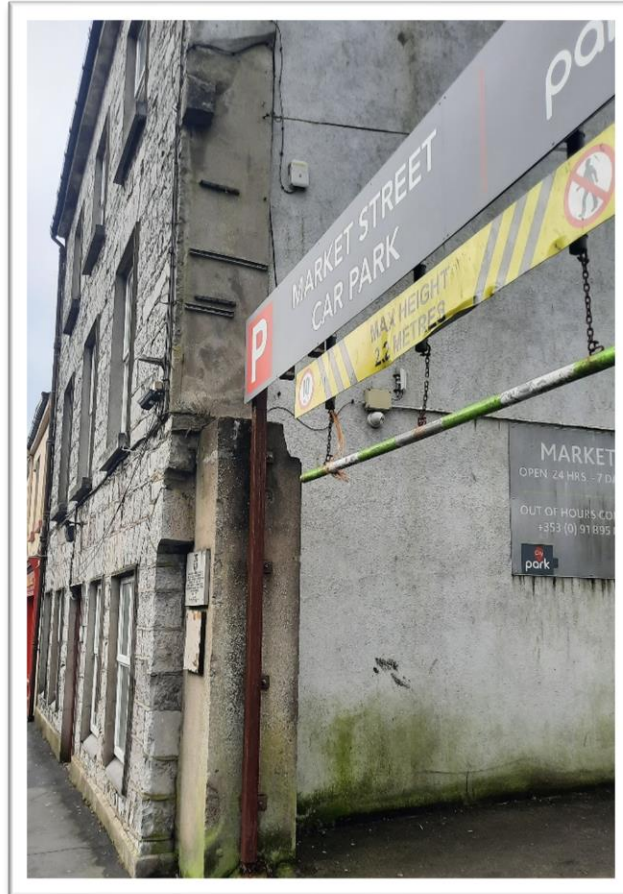
- The undulating nature of the junction of the front wall and the (East) gable wall at the car park leaves this area prone to moisture ingress in the future.

Photo 7 – Undulating external wall surface at the front wall and gable junction. Raised level of footpath in comparison to the internal floor level

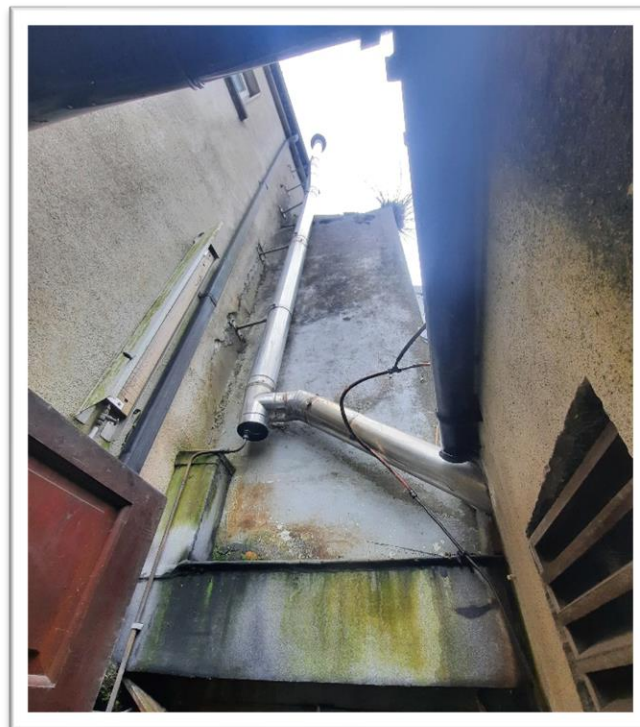
Photo 8 – Externally mounted supply pipes to central heating and stainless steel flue.

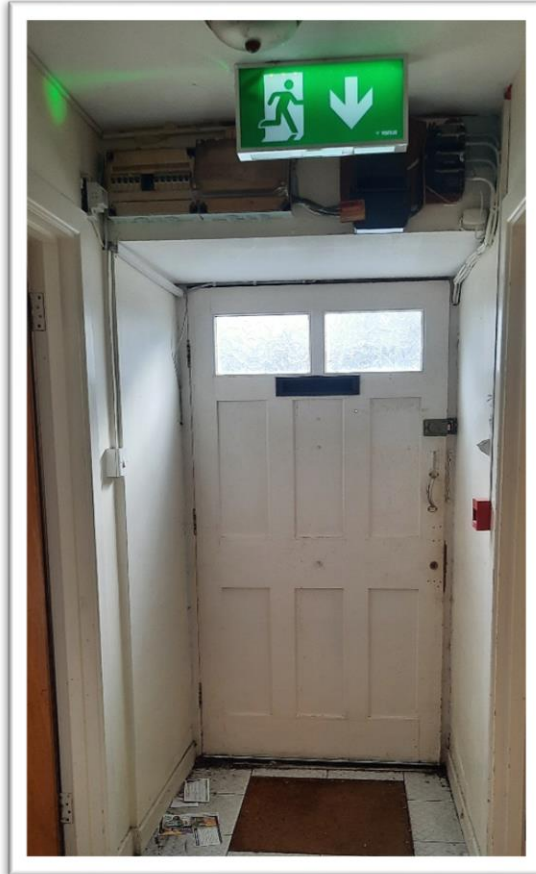
- Firstly, the front door leading to Market Street has a traditional style recessed panel timber door with two upper-level glazing panes. The door is fitted within a timber frame. The door has fallen into a level of disrepair and is stiff to open and close and to lock in position. The decorative condition of the door has also fall into disrepair.

Photo 9 – Front external door and electrical meter and distribution board.

- In the event that this building is likely to be fully renovated and altered for a new purpose group we would strongly recommend that consideration is given to replacing the doors.

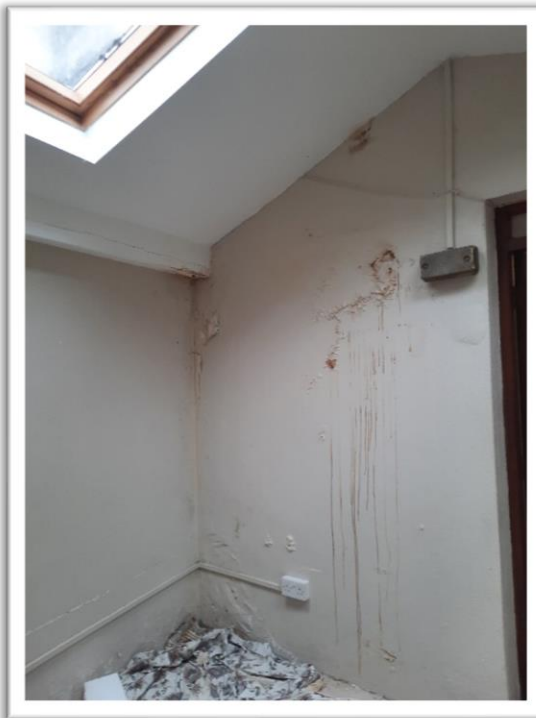
- There is a valley gutter between the roof over the rear living space and that of the kitchen and there is extensive evidence of interior leaks likely linked to a blocked or damaged valley guttering this area.

Photo 10 – Leak damage under valley gutter and in rear wall of atrium room.

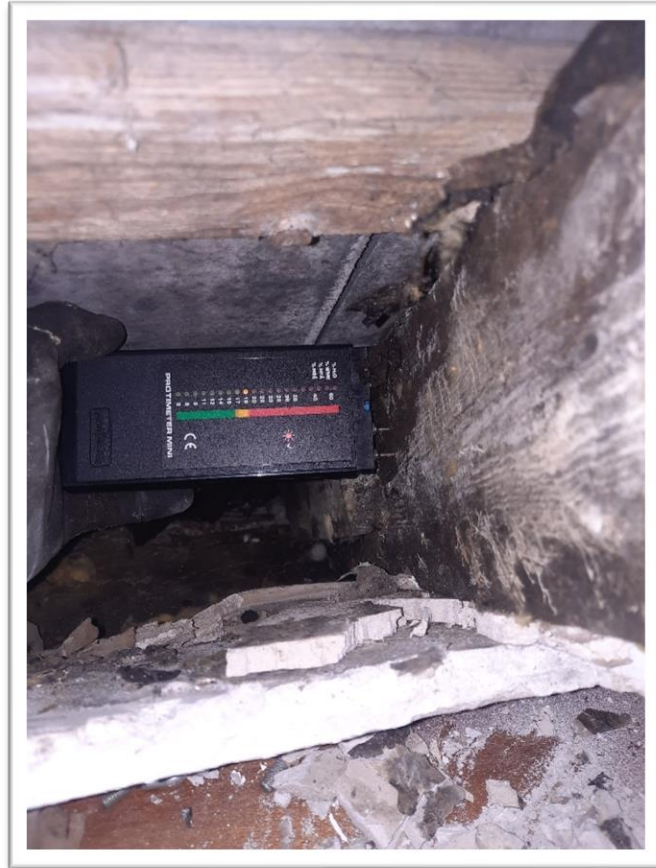
- Rear ceiling damage 3<sup>rd</sup> floor. A small opening section was created here, and we found that significant water ingress has occurred creating damp decay in the timber slate battens and this has led to some decay of the rafters closer to the wall plate. There is evidence of minor dry rot hyphae forming. It should be noted this does not appear to be widespread although treatment would be required for these conditions

Photo 11 – Leak damage to timber rafters and wall plate at roof level.

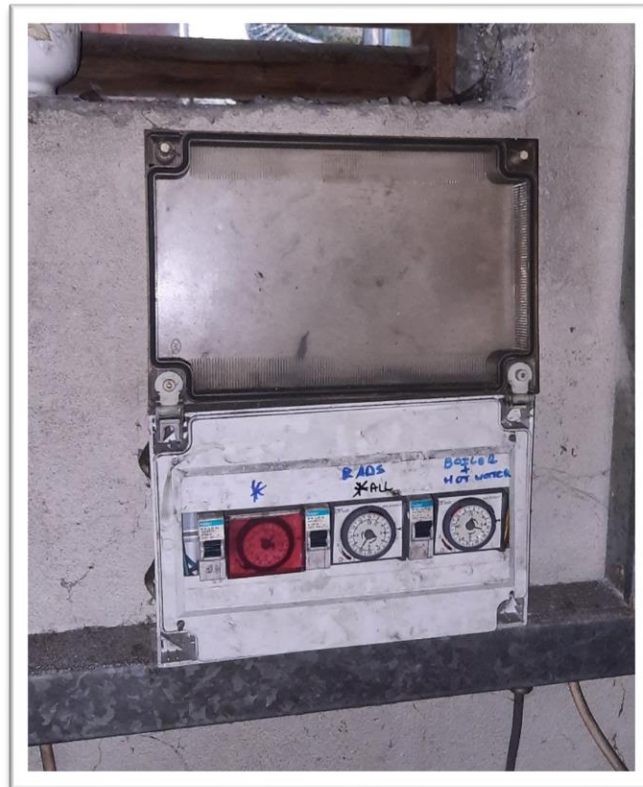
Photo 12 – Outdated heating controls in boiler room.

- New heating system is required. The installation of renewal technology for the provision (or partial provision) of heating and hot water is highly recommended. We recommend a mechanical, electrical and plumbing engineer would design this system.

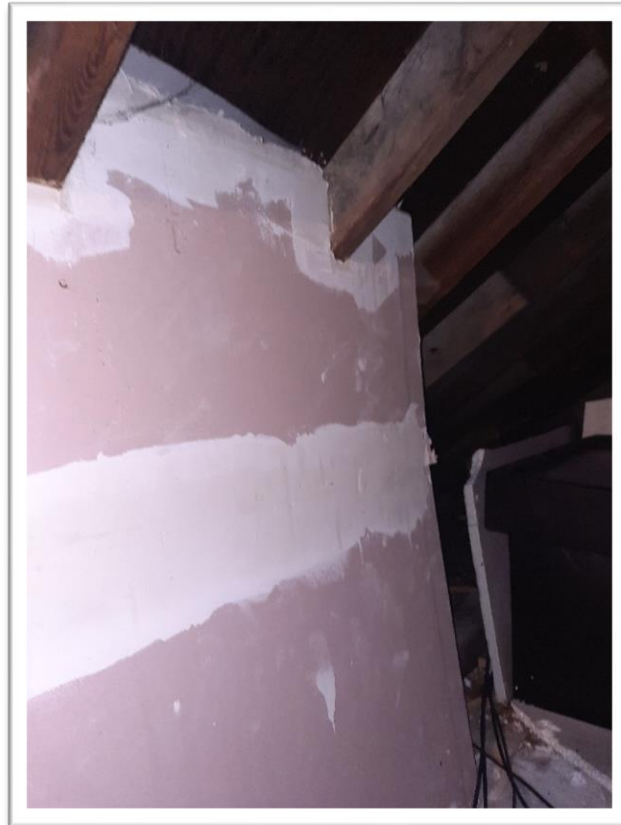
Photo 13 – Fire rated plasterboard partition in attic level is of fair quality.

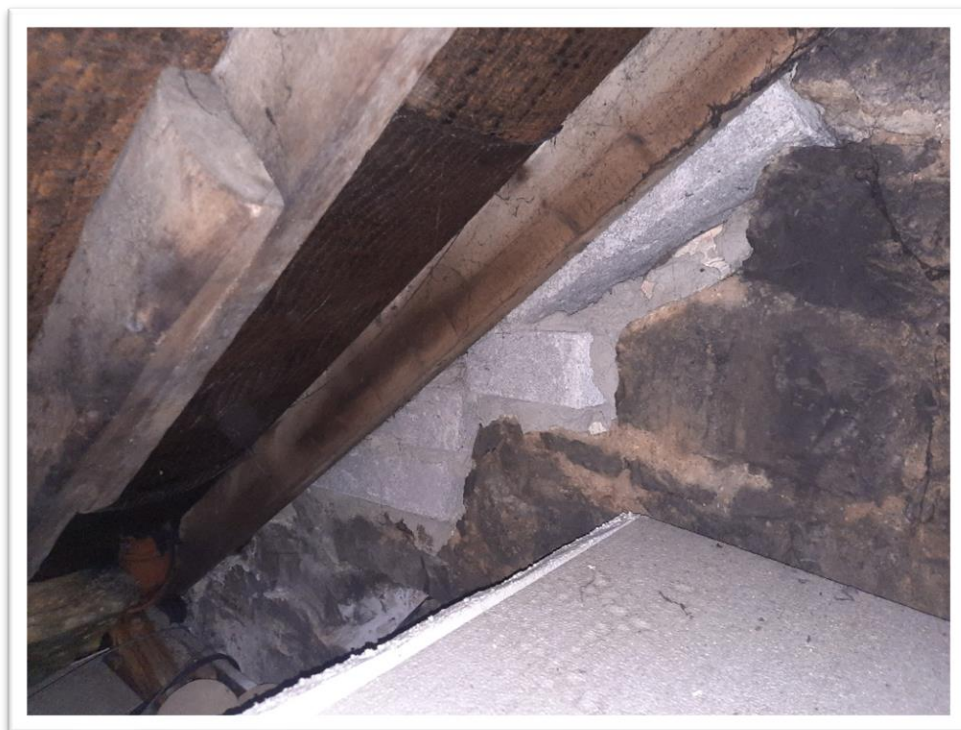
- The gable wall at the car-park side (East) which was formerly a party wall shows signs of some hap-hazard alterations at the top of the gable wall. We anticipate the former chimney has been removed and replaced with some elements of coarsely installed concrete blockwork fitted on top of the rubble stone wall. There is notable elements of staining on the walls suggesting that moisture penetration had previously been a problem.

Photo 14 – Hap-hazard concrete blockwork construction added to RHS gable level in attic.

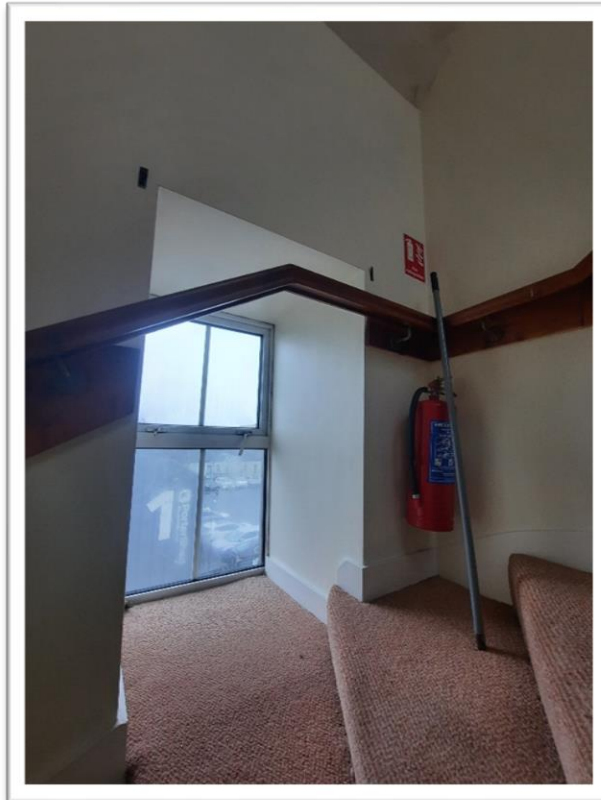
- The existing stairs are of a fair quality which is typical for the type of building. There is high potential for trip hazard with several uneven and tapered steps. Perhaps these could be altered and upgraded as part of renovation works.

Photo 17 – Open area at window along stairwell under the handrail. Tapered Steps to stairs

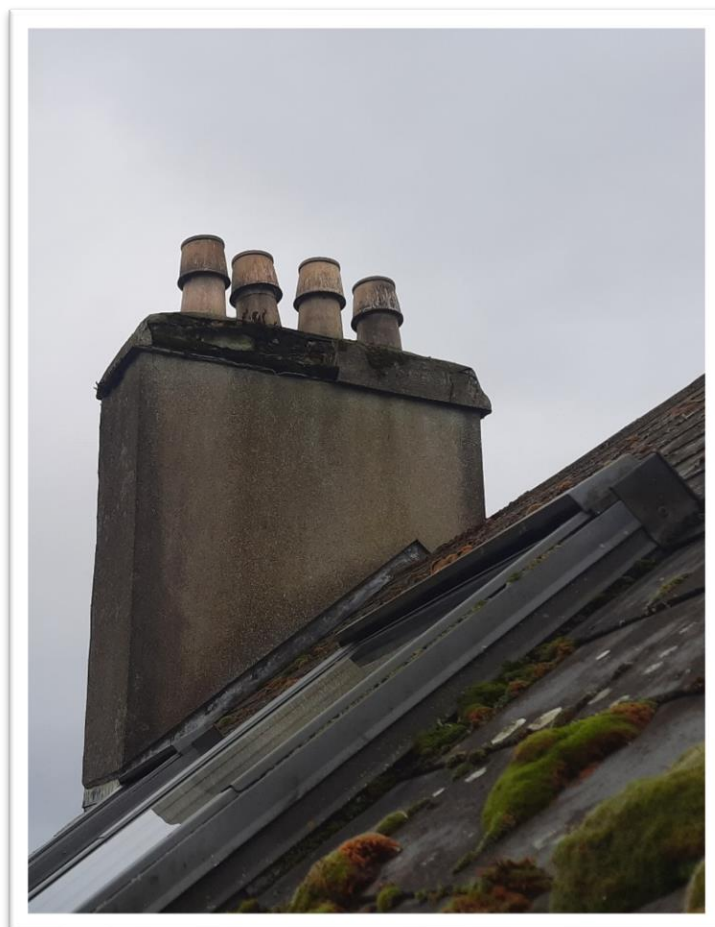
- There is significant moss and vegetative growth visible.
- There are missing sections of render with clear evidence of visible stonework under the chimney cap visible. The chimney is prone to extensive moisture ingress and particularly the evidence of this can be seen within the attic space with significant staining at the party wall.

Photo 20 – Damaged chimney cap

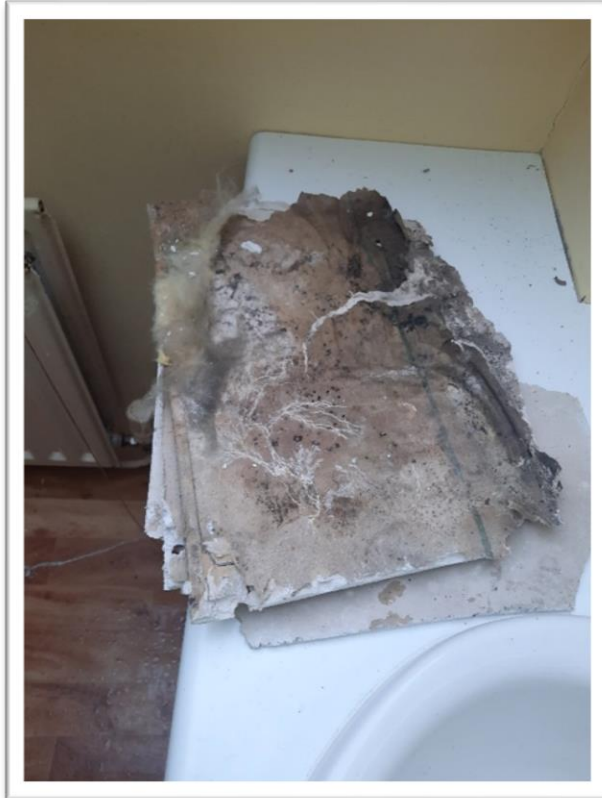
Photo 23 – Dry rot fungal hyphae on the plasterboard 3rd floor ceiling

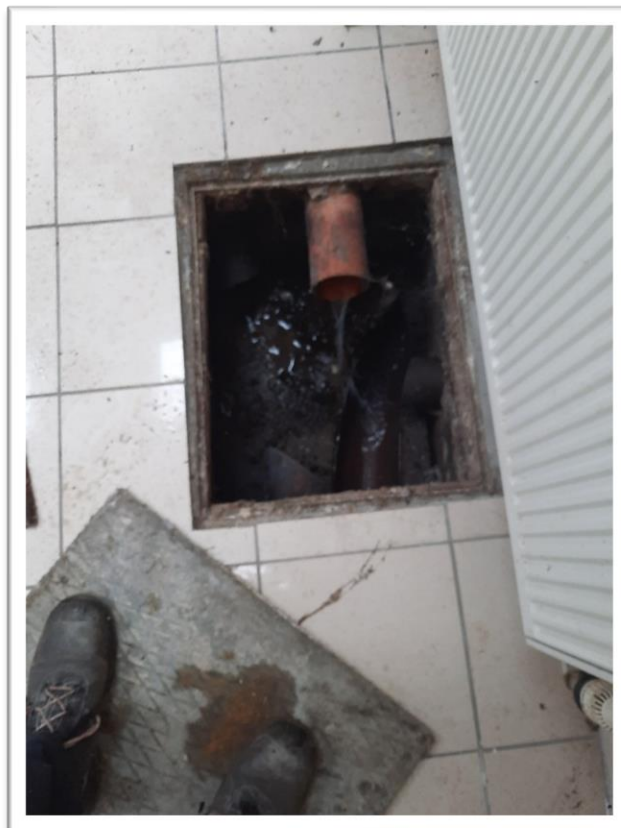
Photo 24 – Ground floor level manhole in rear atrium room.

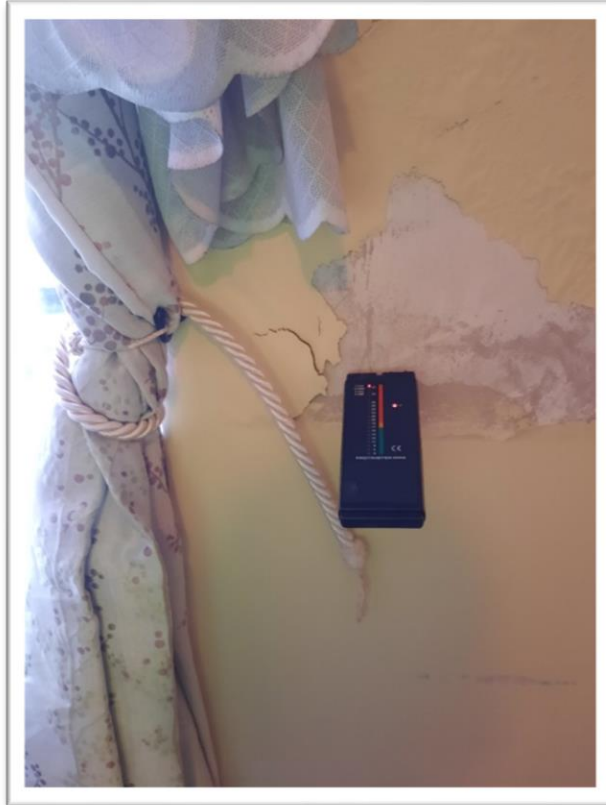
Photo 25 – Blistered and damaged plasterboard internal lining at front wall 1<sup>st</sup> floor LHS

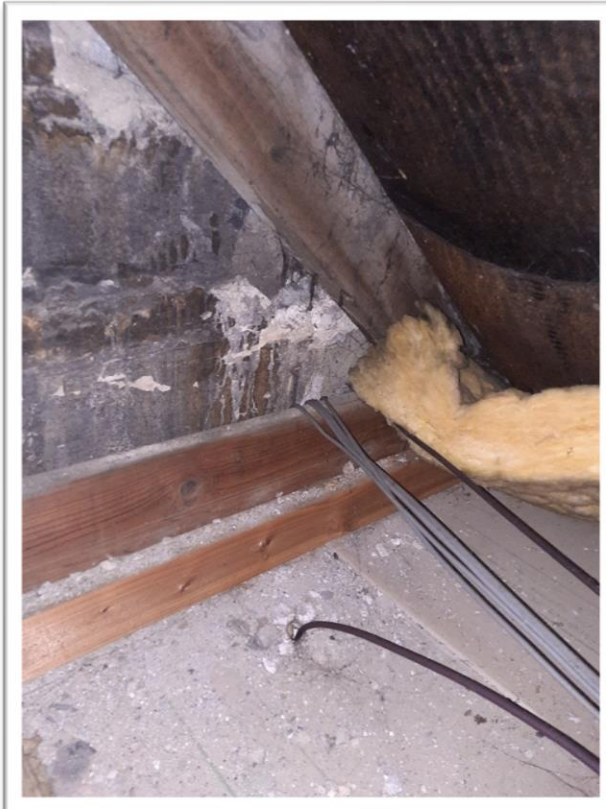
Photo 26 – Missing thermal insulation in the attic ceiling on the horizontal plane. Poorly fitted thermal insulation on sloped section of ceiling. Evidence of damp ingress at gable wall.

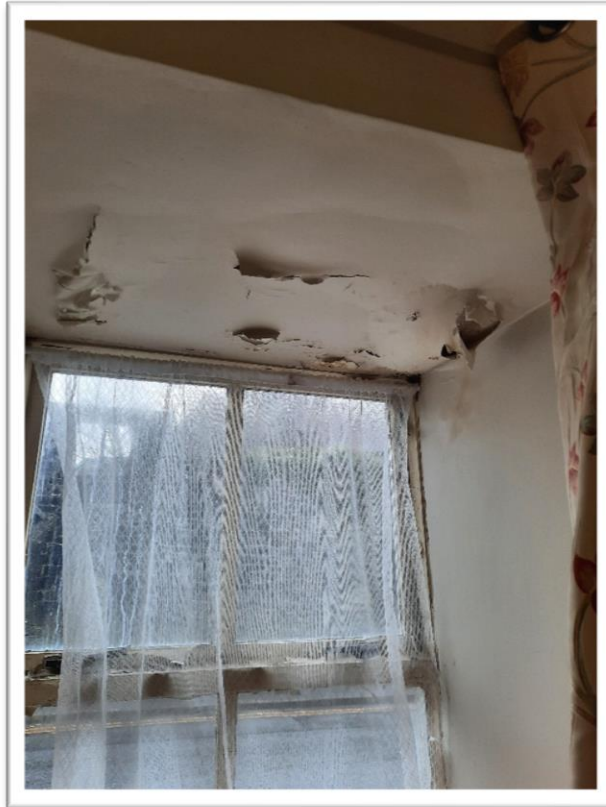
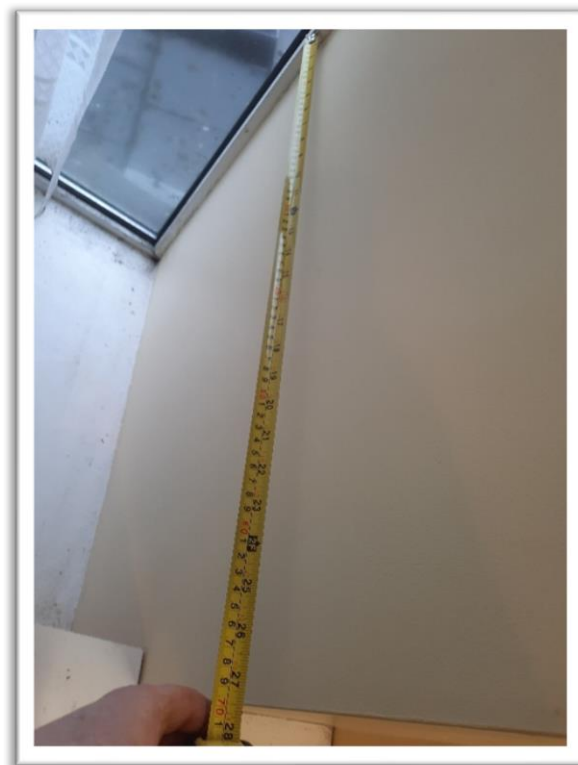
- Lastly at ground floor level we note a significant element of blistering paintwork and plasterwork over the window reveal closest to No. 12 (Left / West) and we found that the likelihood of moisture ingress around the window reveal this has high potential to affect the internal lintels and in turn timber windows.

Photo 27 – Blistered and damaged plasterboard at LHS ground floor window head.

Photo 28 – Blistered and damaged plasterboard at LHS ground floor window head.
