## CONSULTANTS REPORT

This application relates to emergency upgrade of the Electrical Installations in this school which are deficient and have led to a number of serious fire incidents in the school and also the life safety systems and gas safety system which are a combination of various alterations and extensions completed to now obsolete design standards. It is proposed to upgrade the electrical installations in accordance with current Irish Standard IS 10101 National Rules for Electrical Installations, DoEY TGD 003 and 031, Building Regulations and Life Safety Systems Standards IS 3217:2023 Emergency Lighting and IS3218:2024 Fire Detection and Alarm.

The school building comprises a floor area of approx. 4,950m<sup>2</sup> and was constructed on a phased basis between the early 1960s and 2005 approximately as shown in **Figure 1** below.

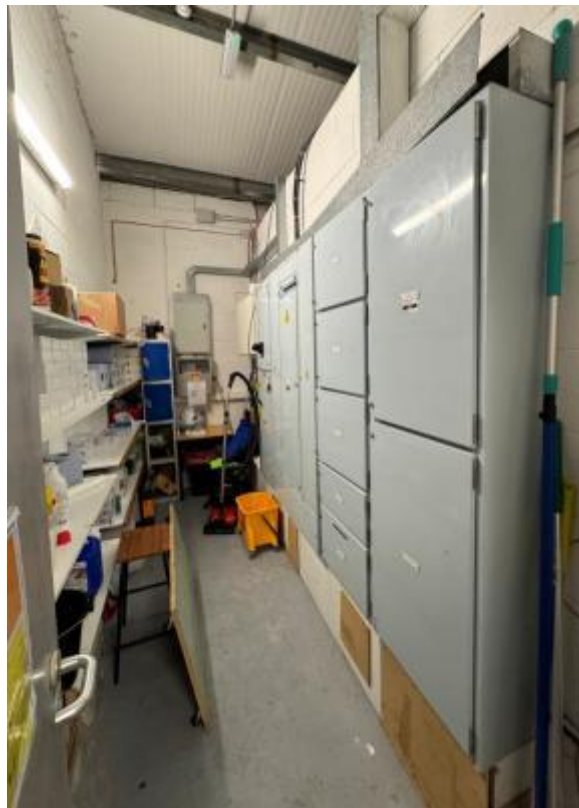
**Figure 2:-** Square D Main Board with ESB CT Meter on back wall adjacent

The Main Board is of Square D manufacture and is rated at 400 Amps while the incoming ESB supply is fused at 125 Amps with 100/5 Amp CT metering connecting to the Main Board as shown below at **Figure 4**. The Main Board dates from the extension constructed in the 1990s and does not comply with current ESB Customer Interface or IS 10101 regulations regarding customer interface standards. The electrical switchroom also doubles as a cleaners store with shelving and storage on the wall opposite the Main Board which reduces the clearance to the front of the board to less than the minimum required clearance of 1200mm and is in breach of regulation. This storage shelving must be removed and relocated to another space

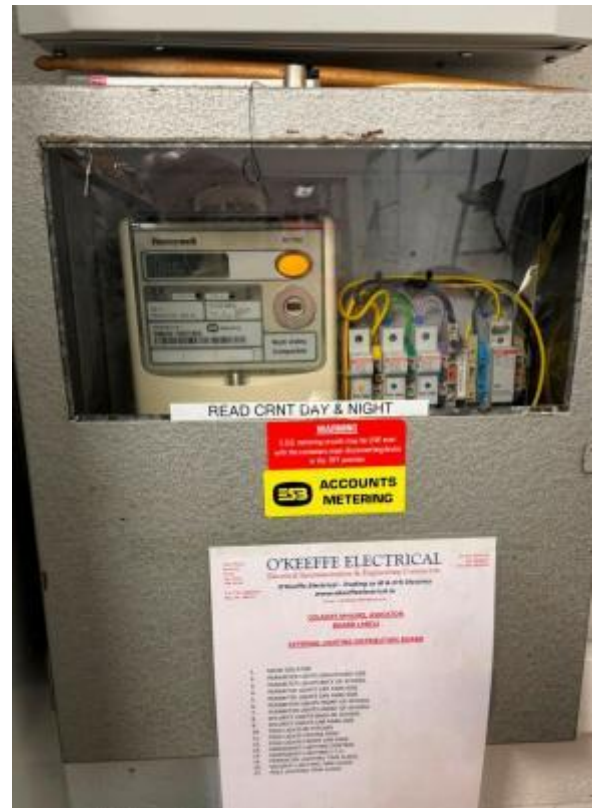
**Figure 3:-** ESB CT Meter Cabinet

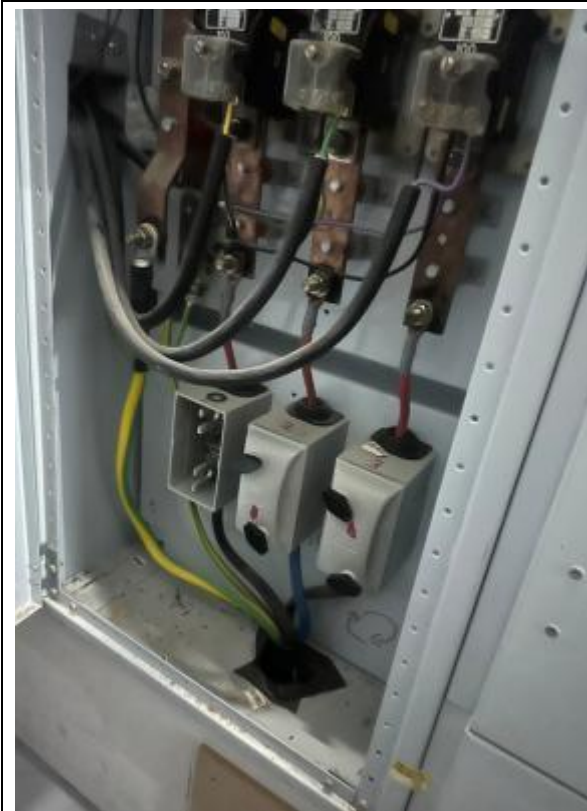
The main incoming ESB fuses are rated at 125 Amps which is lower than the customer's main circuit breaker and some of the sub main feeder breakers on the board. There is therefore no co-ordinated discrimination / selectivity with the current switchgear arrangement. There have been a number of incidents where the main ESB Fuses have blown while the circuit breakers immediately upstream of the fault have not tripped which has resulted in total power failure to the entire school for faults that should have been isolated locally.

**Figure 4:-** Main Board ESB Fuses rated at 125 amps with 100/5 amp CT metering

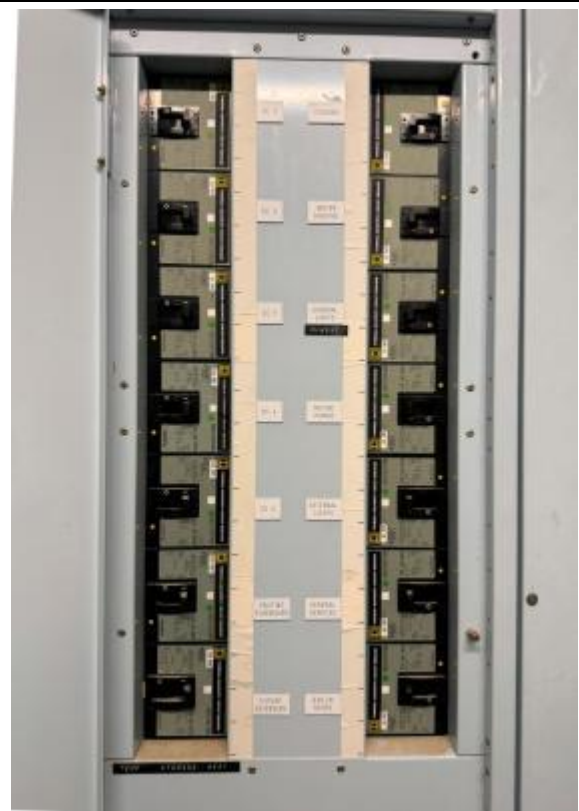
There are fourteen sub main MCCB feeders serving Sub Distribution Boards located around the school with ten rated at 63 Amps, two rated at 100 Amps, one rated at 125 Amps and one rated at 250 Amp which feeds the 2005 extension refer to **Figure 5** below.

**Figure 5:-** Square D Main Board with 14 Nr. TPN sub-feeders rated 63 to 250 Amp

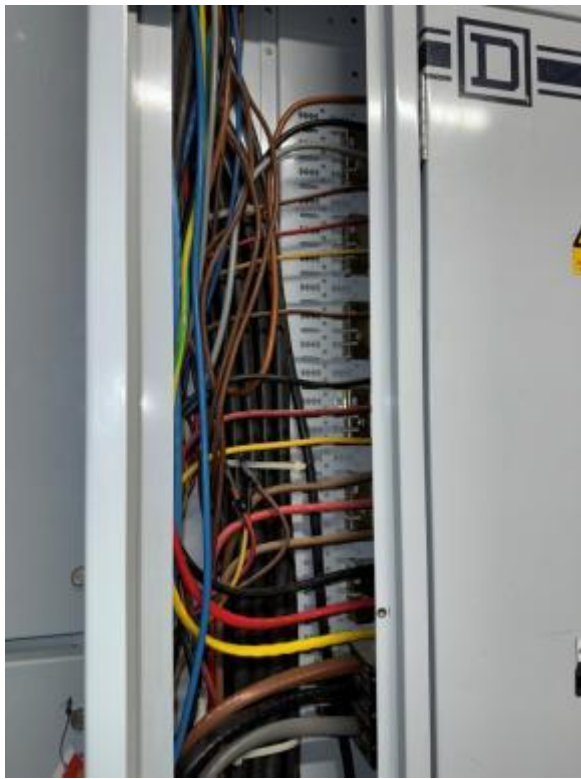
The sub main cables are four core, steel wire armoured type mainly with brown red and yellow phase conductors and blue neutral and with no dedicated protective earth conductor but with the Steel Wire Armour (SWA) acting as the earth. There are however other colour codes present with the older Red, Yellow and Black Phases with Blue neutral present and also the more recent Brown, Black, Grey and Blue neutral also present refer to **Figure 6** below.

**Figure 6:-** Main Board sub main cable duct with mixed colour codes evident

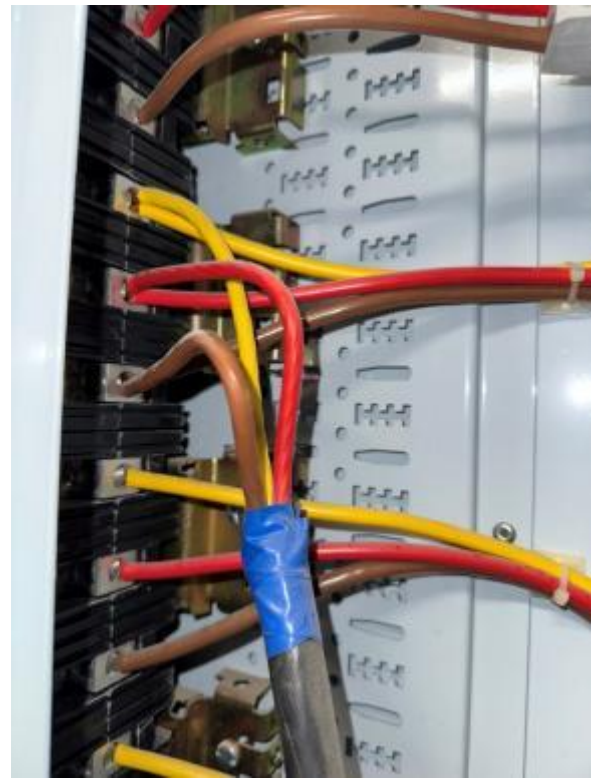
There is one feeder which has two sub main cables connected as shown in **Figure 7** below and appears to be serving two sub boards which is very poor installation practice.

**Figure 7:-** Main Board sub main cable duct with parallel cable connected to one feeder

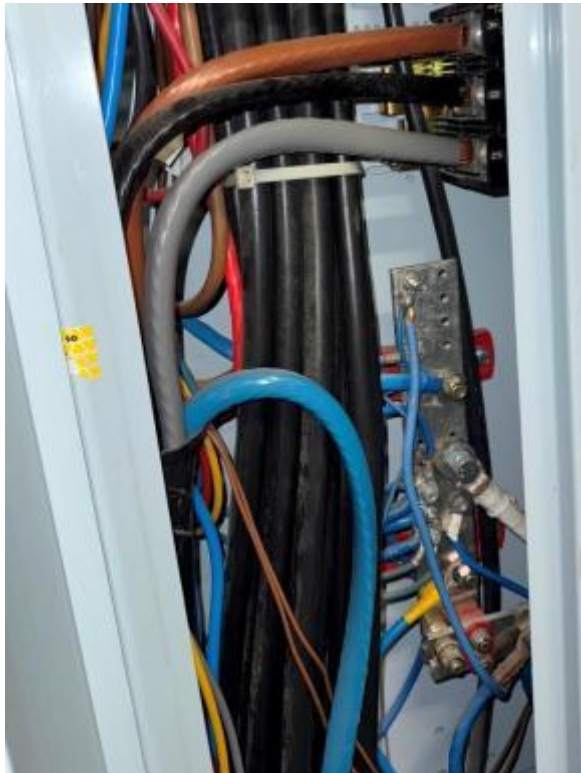
The Main Board has a main neutral bar as shown in **Figure 8** and a main earth bar as shown in **Figure 9** with a neutralising link between the two bars. There are only five earth cables terminated onto the main earth bar with the sub main cables dependant of the Steel Wire Armour (SWA) for connection of the protective earth to Sub Boards

**Figure 8:-** Main Board Main Neutral Bar

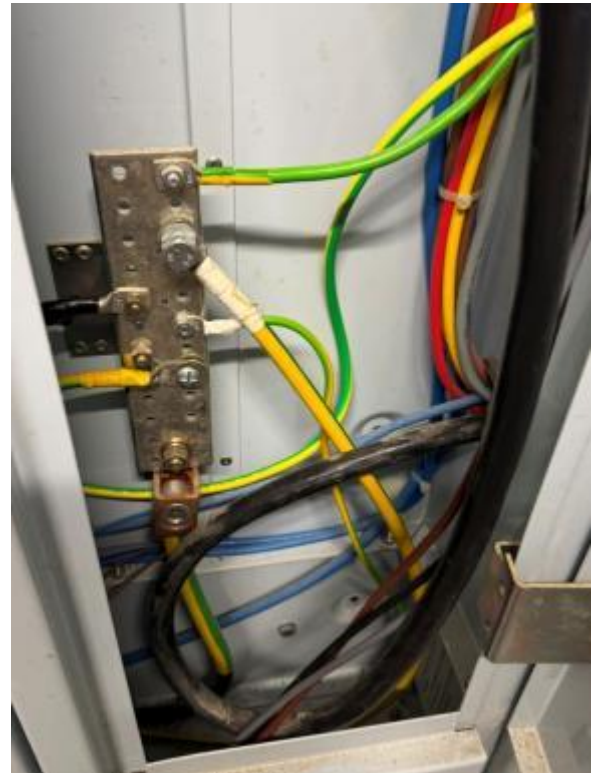
**Figure 9:-** Main Board main Earth Bar

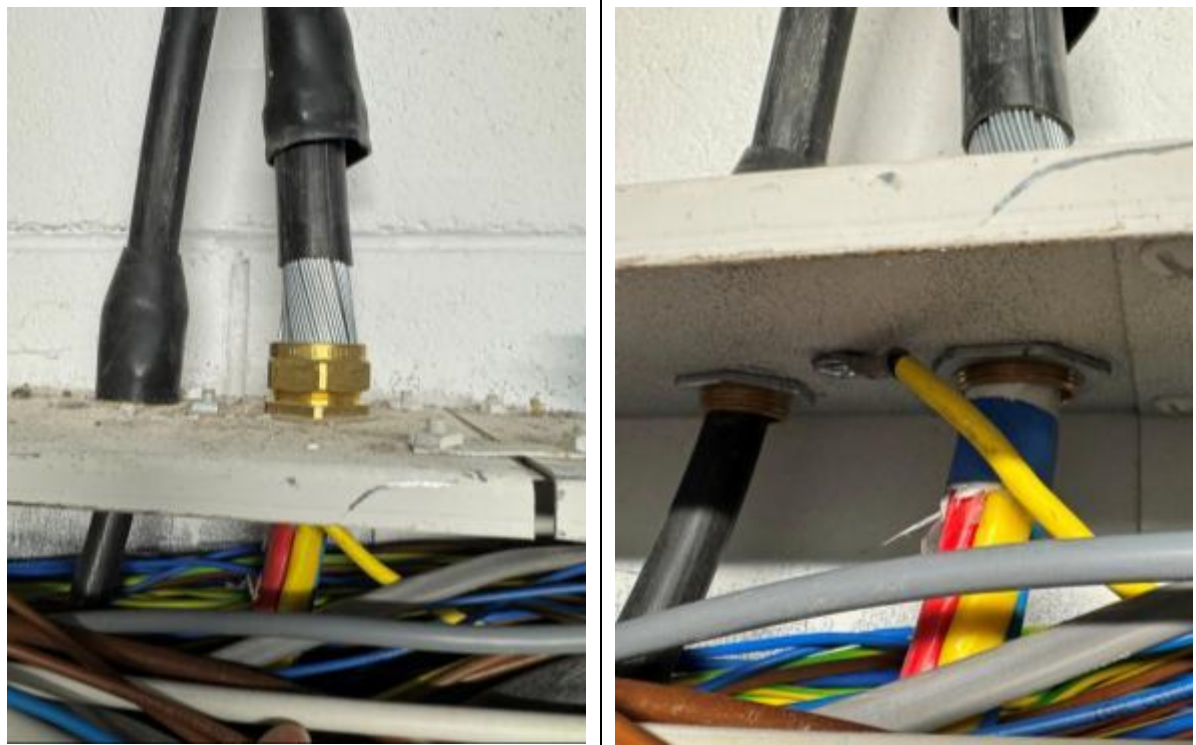
The steel wire armour of the sub mains cables are glanded into the header trunking above the main board with the SWAs providing the protective earth as shown below in **Figure 10** and the header trunking is bonded to the main earth bar however there are no earth tags fitted to connect the gland / SWA directly to the main earth bar. This earthing arrangement with the SWA and trunking providing the protective earth to the sub boards is not compliant with the current edition of IS-10101:2020+A1:2024 which requires dedicated earth conductors.

**Figure 10:-** Sub main SWA cables glanded onto the main header trunking over the main board with a earth conductor link from the trunking to the main earth bar

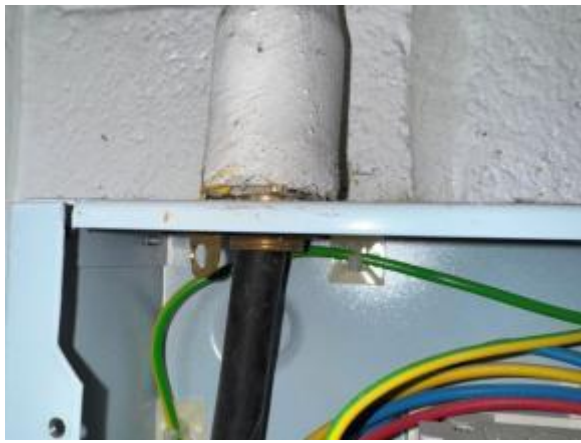
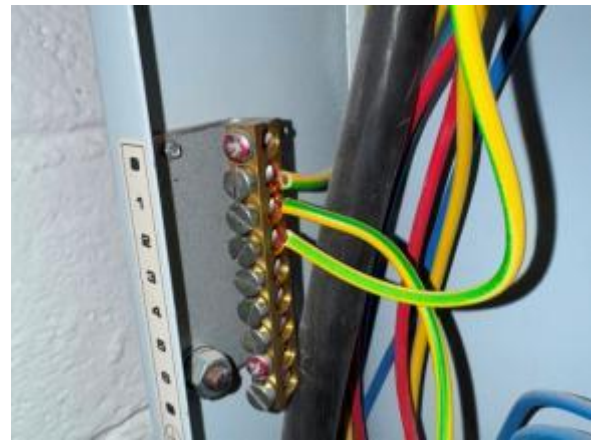
At the sub board the SWA cables are generally glanded directly to the sub boards mild steel frame, which are a painted sheet metal construction, and the earth bar terminal is bolted onto the panel frame as shown in **Figure 11** below. Over time the earth continuity can degrade and be lost due to corrosion of these mild steel connections as evidenced by the recently completed Periodic Inspections in the Metalwork / Engineering Room and Science Lab.

**Figure 11:-** Sub main SWA cables glanded onto the sub board metal cabinet (photo on the left) and the earth bar is fixed to the cabinet (photo on the right)

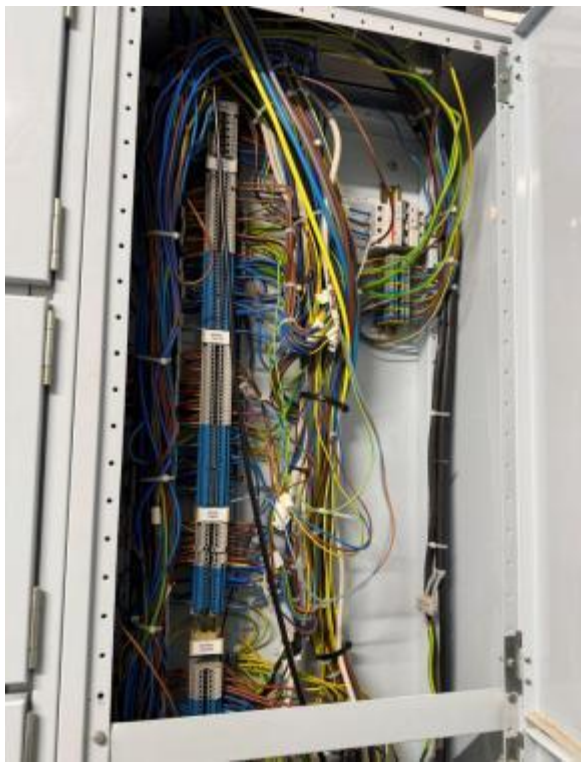
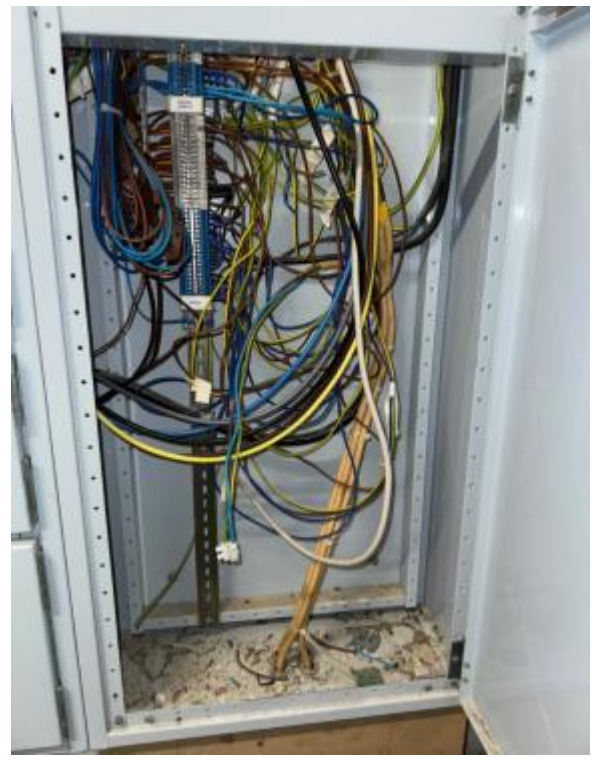
This earthing arrangement is also used for the Main Board Equipment Power, General Service and Lighting Board final circuits as shown in **Figure 12:-** Terminal sections of the Main Board General service and lighting boards

**Figure 12:-** Terminal sections of the Main Board General service and lighting boards

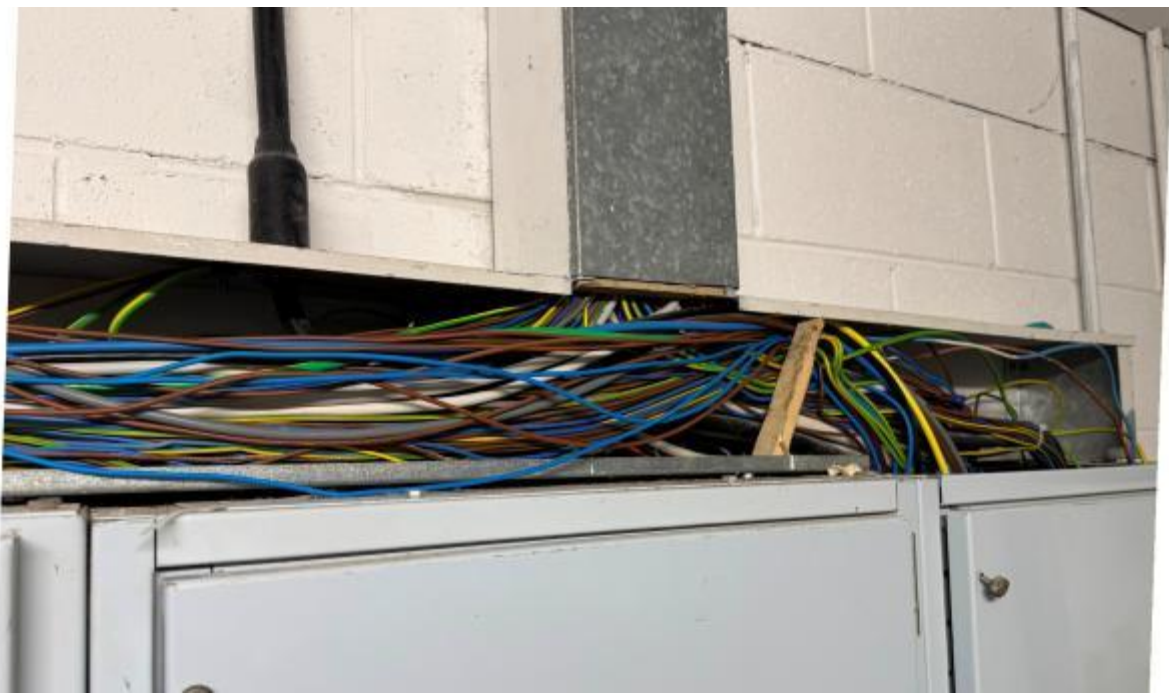
The existing main header trunking at the Main Board is over filled with cables as shown in which would need to be de-rated due to overheating which is a potential fire risk particularly in an installation with deficient earthing.

**Figure 13:-** Header Trunking at the Main Board is overfilled with non-compliant space factor

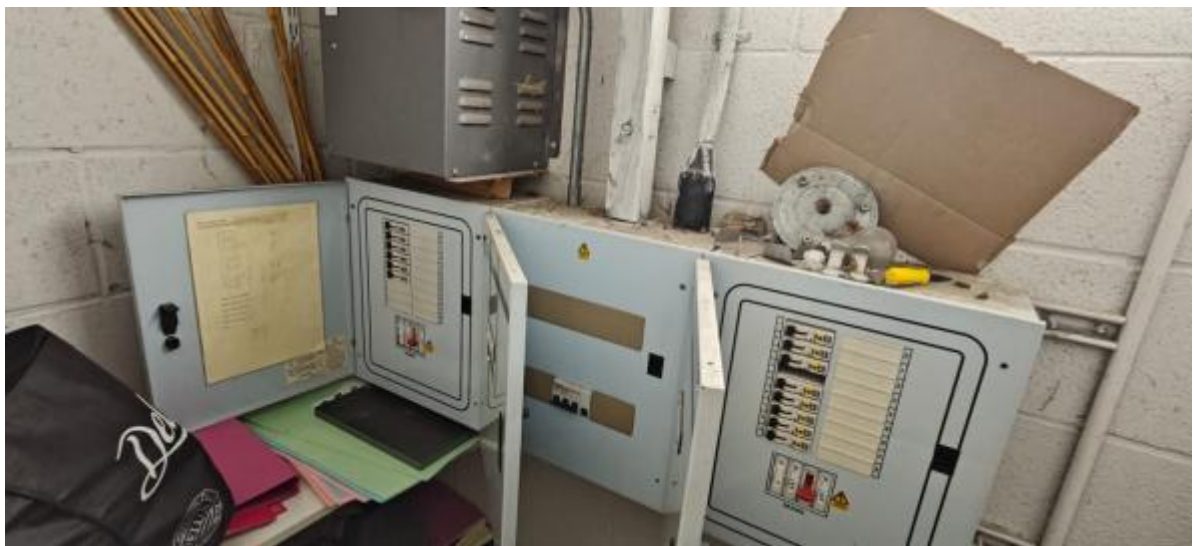
Sub distribution boards are located in the practical classrooms throughout the 1960s and 1990s building and are generally Square D TPN type boards as shown **Figure 14** below.

**Figure 14:-** Square D Sub Board in the Home Economics Classroom with SWA cable glanded at the top in the centre which connects to a 63 Amp incomer MCB in the centre panel which serves an 18 way MCB board fitted with six MCBs for fixed equipment in the LHS Panel and also an 18 way RCD board on the RHS serving the socket circuits via an isolating transformer mounted above the Board at the left hand side.

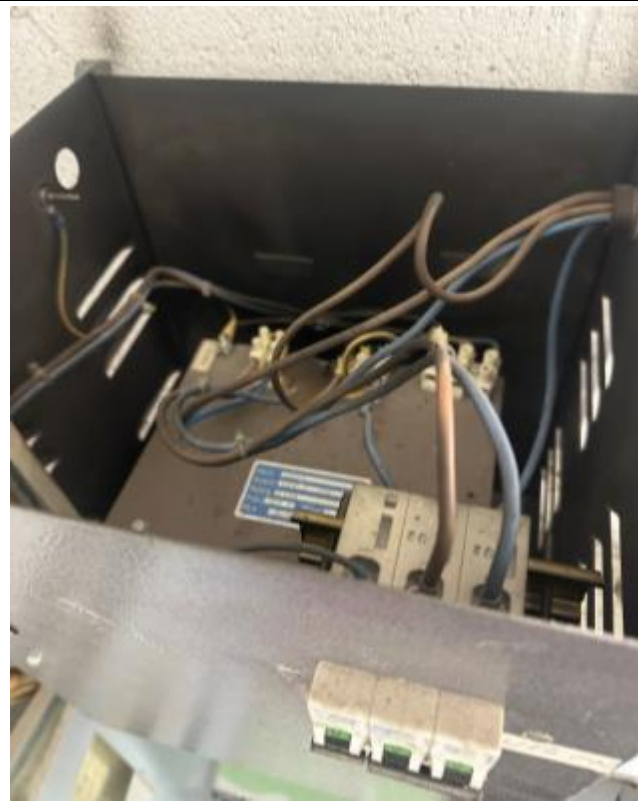
On January 21<sup>st</sup> there was a fire incident at the Home Economics Sub Board caused by a fault on the safety isolating transformer serving the socket circuits, shown in **Figure 15** which resulted in one of the ESB fuses blowing and loss of power to 1/3<sup>rd</sup> of the school. Neither the local Sub Board MCB protective device nor the Main Board MCCB Feeder operated to isolate the upstream fault resulting in the ESB fuse blowing and general loss of power to the school. The failure of the upstream protective switchgear to operate is likely as a result of loss of earth continuity to the sub board and transformer primary side.

The Home Economics Board has now been switched off pending completion of emergency remedial works and only the lighting is operational in the classroom. As a result of the fault the school cannot deliver the home economics practical curriculum and have lost valuable teaching time due to the resulting power outage to other areas of the school.

**Figure 15:- Failed Home Economics Room Sub Board Safety Isolating Trasformer.**

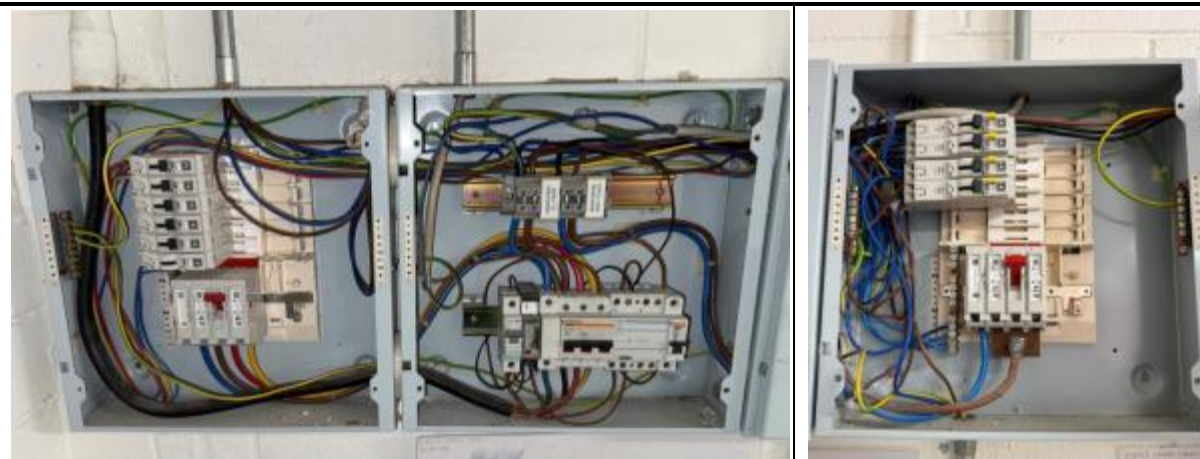
The Arts and Crafts Sub Board with covers removed is shown in **Figure 16** below. The arrangement is typical of all Practical Classroom Sub Boards. The incoming SWA cable is glanded at the top left-hand side and connects to a 63 Amp MCB incomer in the centre section which serves a 12 way MCB board fitted with six 25 Amp MCBs for fixed equipment in the LHS Panel and a 12 way RCD board fitted with six 25 Amp RCDs in the RHS Panel serving the socket circuits via a safety isolating transformer.

**Figure 16:-** Square D Sub Board in the Arts & Crafts Classroom

We recommend completing a full replacement upgrade to the power supply and distribution system throughout the 1960s and 1990s school building areas.

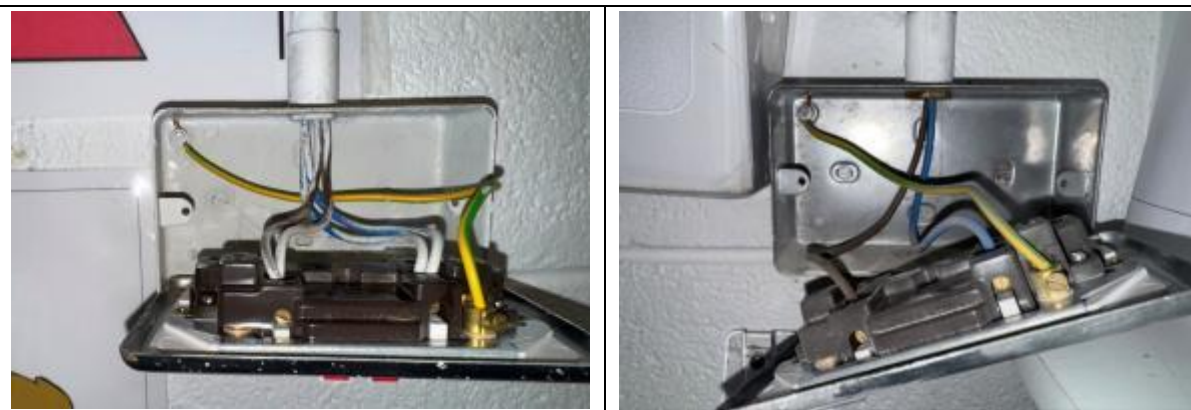
The cable colour code in use in these 1990 installations is brown phase and blue neutral with the containment acting as protective earth – refer to socket outlets shown in **Figure 17** below.

**Figure 17:-** General service socket in 1990s extension with brown phase and blue neutral and the mild steel containment alone providing the protective earth

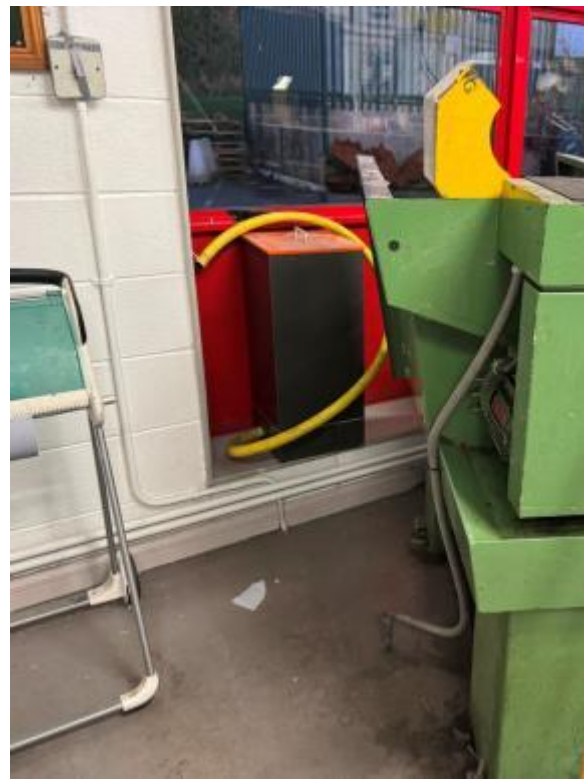
There are damaged cables running in a kopex flexible conduit to the lathe and the local isolator is taped off with “DO NOT USE” written on the tape as shown in **Figure 18** to **Figure 20** below.

**Figure 18:-** Old style local isolating switch in Engineering Room serving the lathe with DO NOT USE tape due to damaged wiring

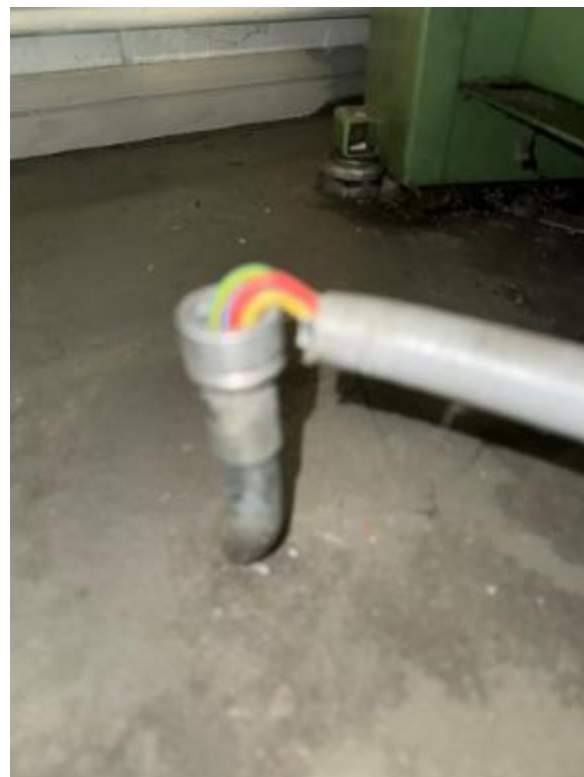
**Figure 20:-** Engineering Room local isolator taped off but isolator switched on and in service

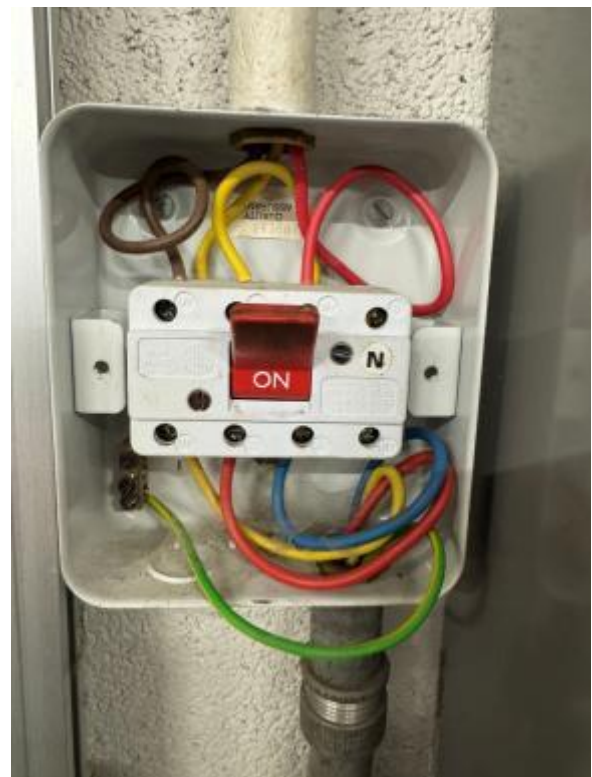
The circuits serving the fixed equipment are wired in three phase with the mild steel conduit providing the protective earth and there are no neutral conductors provided as shown in **Figure**

21 below. As a result, modern equipment with display screens which are being procured by the school and which require a neutral cannot be placed in service until the system is upgraded.

**Figure 21:-** Engineering Room Three Phase Isolator with no neutral and conduit as protective earth

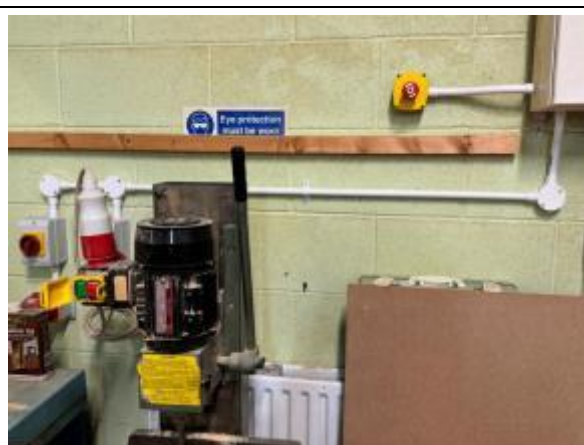
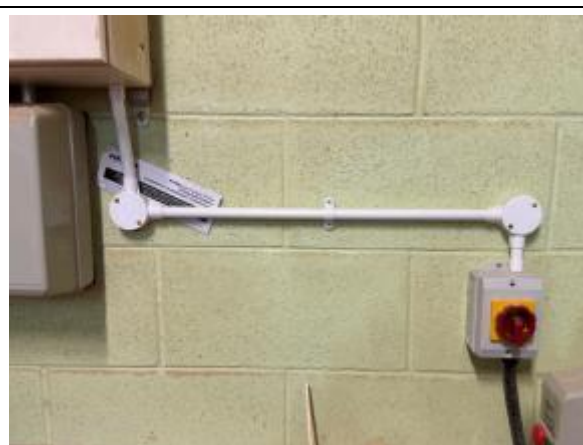
**Figure 22:-** Recent additions wired in PVC conduit serving fixed equipment.

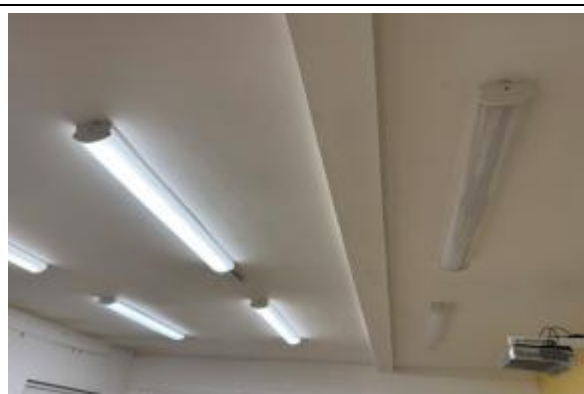
**Figure 23:-** Lighting has been upgraded to LED through the school

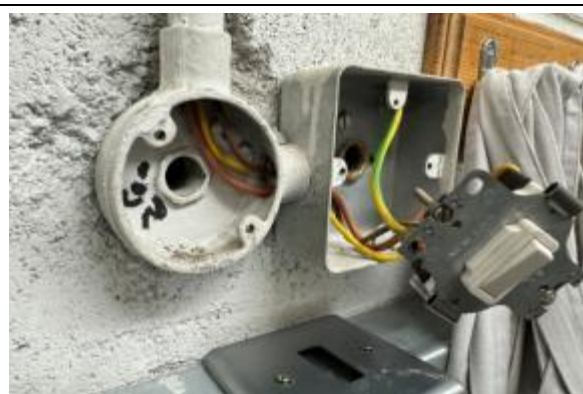
The lighting and emergency lighting was upgraded to LED fittings throughout the school under an SEAI energy efficiency project completed circa 2018. The school report that these LED fittings has been failing with multiple units not working as evident in the classroom shown below at **Figure 23** with two failed fittings. The replacement LED fittings were the lowest cost option tendered at the time and are clearly a budget product which has a short service life. The replacement fitting were all connected to the original wiring installation which was retained throughout and the new LED lighting system is dependent on the original mild steel containment for the protective earth as shown in **Figure 24** below.

**Figure 24:-** No earth conductor to the Light circuits which depend on the mild steel conduit for the protective earth

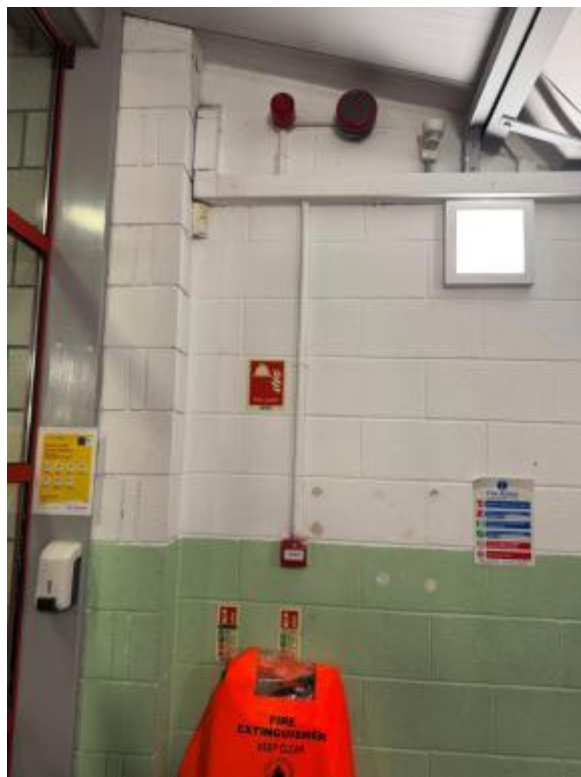
The original emergency lighting would have been designed to a now obsolete standard, probably the 1989 edition and is not compliant with the current IS 3217:2023 standard and additional

emergency lighting is required to achieve compliance particularly at points of emphasis, such as manual call points / firefighting posts as shown in **Figure 25** and on escape routes, open areas and for system integrity.

**Figure 25:-** Points of emphasis are not adequately covered by emergency lighting

We therefore recommend a full replacement upgrade of the lighting and emergency lighting throughout the entire school to include new LED fittings with automatic daylight and absence detection energy saving controls as part of the proposed electrical upgrade works.

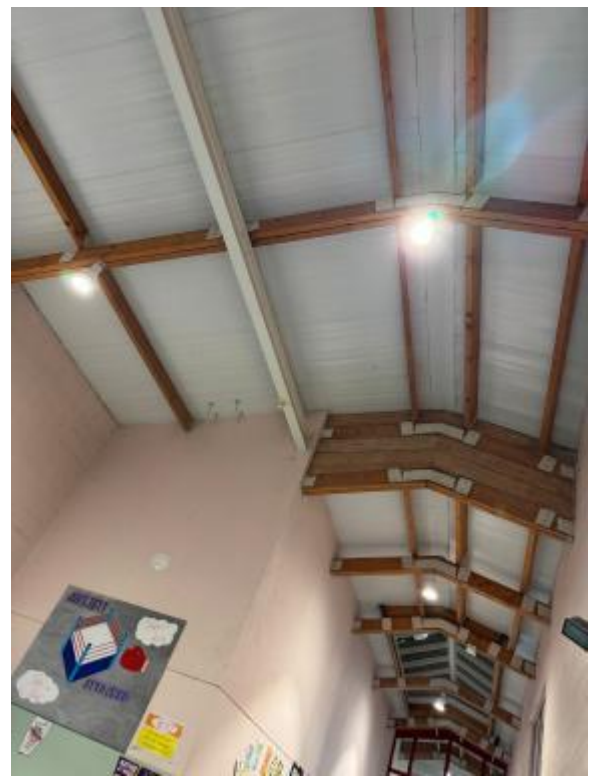
Additional emergency light fittings will be required to achieve full compliance. We also note that provision of emergency lighting does not comply with the current IS3217:2023 standard particularly with regard to points of emphasis and escape route illuminance as in the main double height circulation space shown in **Figure 26** below and additional emergency light fittings are required to achieve compliance with the 2023 edition of the standard.

**Figure 26:-** Escape routes emergency lighting is not compliant with current standard

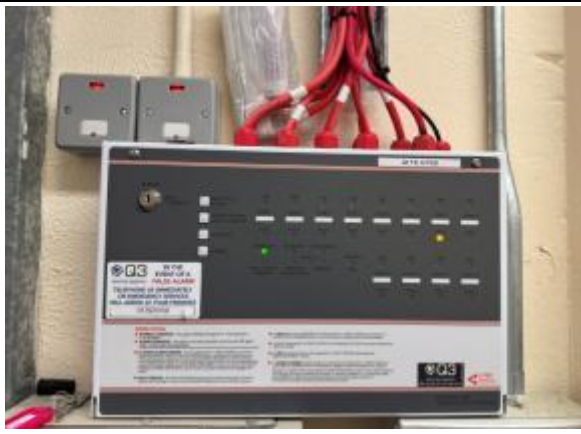
The Fire Detection and Alarm system comprises a 12 zone conventional control panel shown in **Figure 27** below which is the original 1960 & 1990s system which has been extended to provide protection to the 2005 extensions and is now passed end of service life and requires replacement upgrade.

**Figure 27:-** Existing 12 zone conventional C-Tec Fire Alarm Panel in fault on zone 7

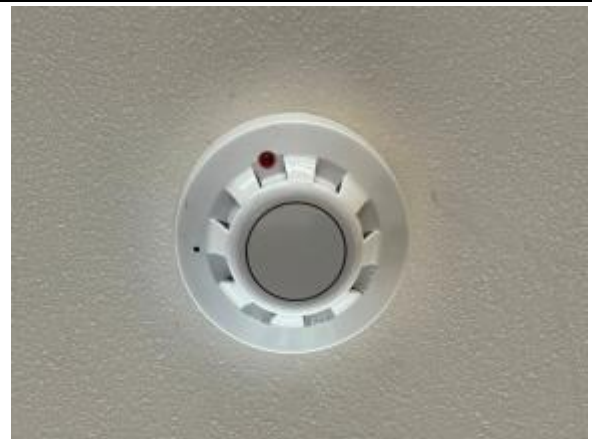
**Figure 28:-** Existing system is not L3 with some classrooms and escapes unprotected.

The category of protection does not appear to be type L3 as required by current building regulations as there are some rooms adjacent to escape corridors without automatic smoke detection refer as shown below in **Figure 29** and the main double height circulation corridor in the original 1960s / 1990s school has sections with no visible smoke detection as shown in **Figure 30** and current detector spacing does not meet requirements for type L3.

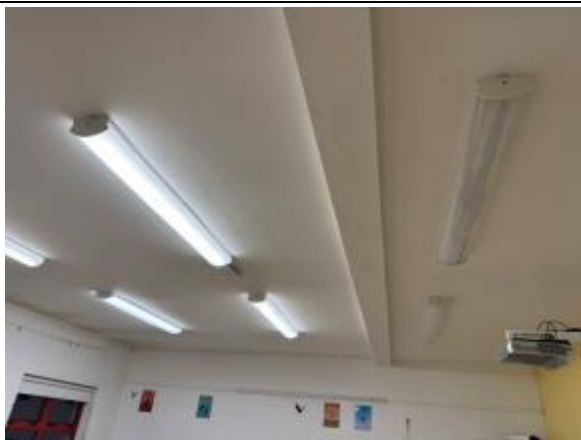
**Figure 29:-** Mainstream cClassroom with no automatic smoke detection fitted

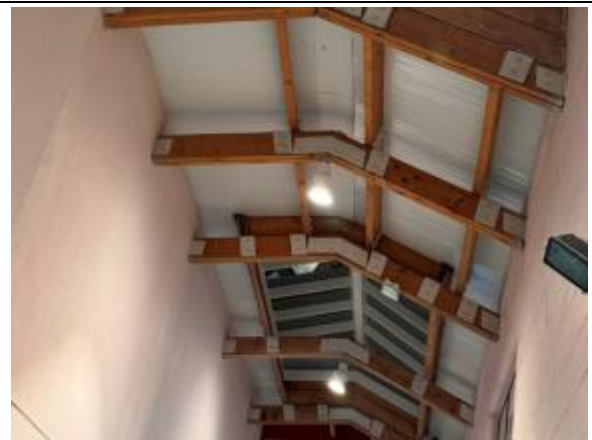
**Figure 30:-** Main double height corridor with inadequate automatic smoke detection.

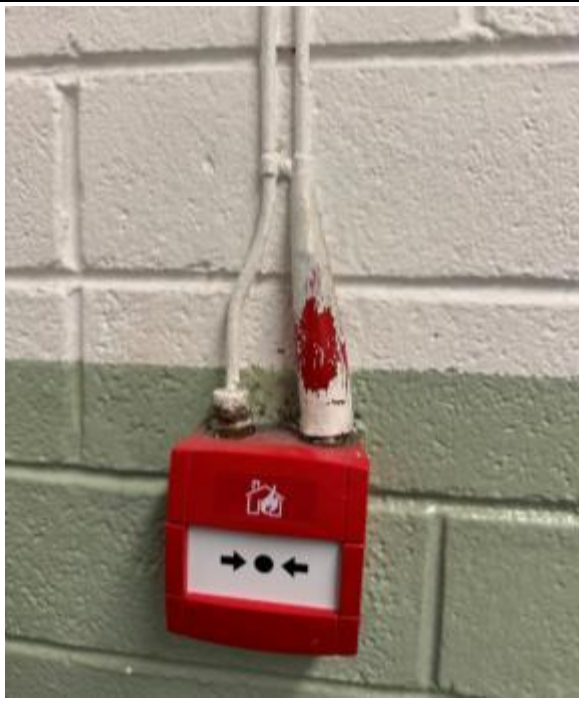
The fire alarm cable installations are a mixture of MICC in the original school as shown in **Figure 31** and **Figure 32** below with later alterations and extensions wired in Firetuf.

**Figure 31:-** Fire alarm call point wired in MICC Cable in the original building

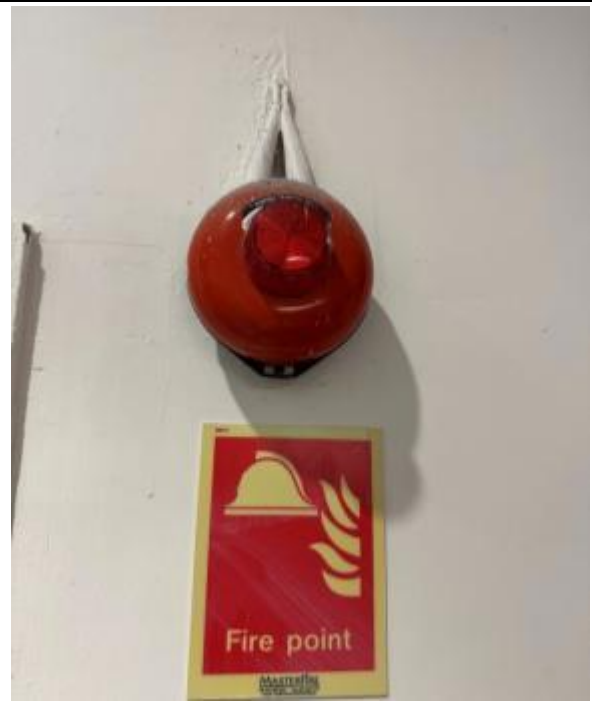
**Figure 32:-** Fire Alarm sounder and strobe wired in MICC Cable in the original building

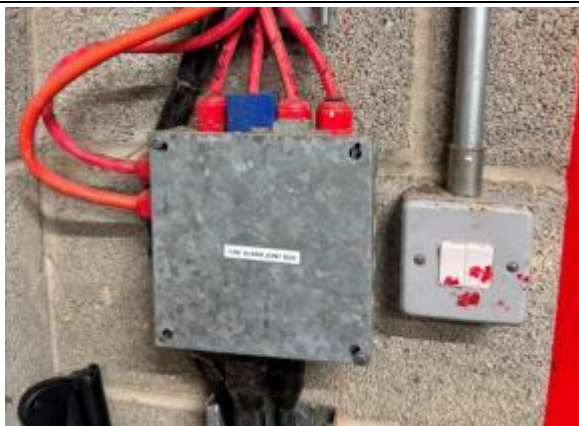
The 2005 extension fire alarm is wired back to the control panel in SWA cable run underground externally with link boxes at either end as shown below in **Figure 33** below. The 2005 extension is wired in red Firetuf which is run in shared trays and trunkings with the other services as shown in **Figure 34** and **Figure 35** and loosely above the suspended ceilings as shown in **Figure 36**.

**Figure 33:-** Fire Alarm cables to the 2005 extension run via U/G SWA to joint box

These are considered substandard non-compliant cable installations under the current Fire Alarm standard IS3218:2024 and we therefore recommend a full upgrade to new type L3 addressable fire detection and alarm system with automatic detection fitted to all escape routes and adjacent rooms with new fire rated fire alarm cable run on fully segregated containment with fire rated fixings in full compliance with the current IS 3218:2024 standard.

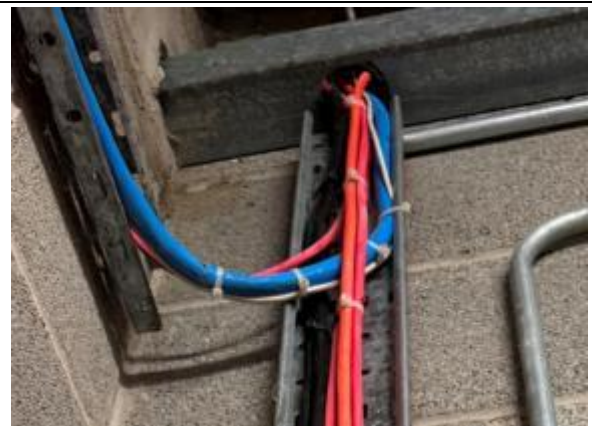
**Figure 34:-** Fire Alarm cables share tray with other services in the 2005 extension

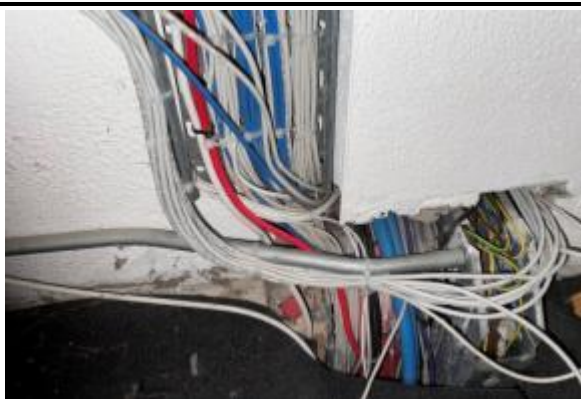
**Figure 35:-** Fire Alarm cables share tray with other services in the 2005 extension

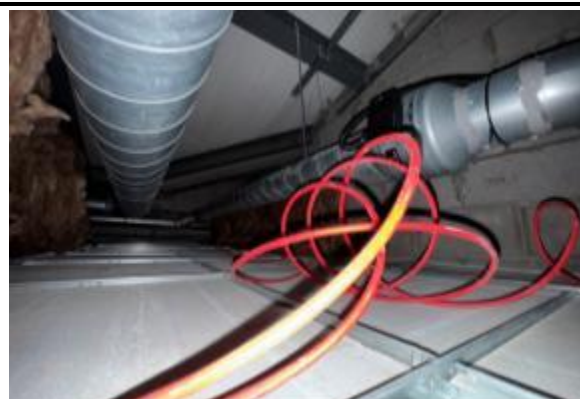
**Figure 36:-** Fire Alarm cables share tray with other services in the 2005 extension

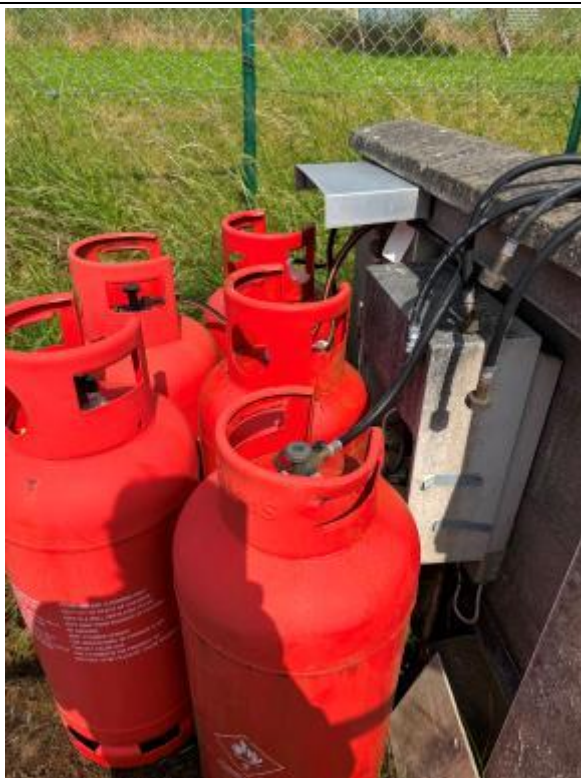
The existing Master gas pressure proving system has failed and the school have no gas services to the practical classrooms including Home Economics, Engineering and Science Labs. The practical rooms are supplied with LPG which is stored in 34kg bottles located in an external compound as shown in **Figure 37**. The system is fitted with an automatic changeover arrangement as shown in **Figure 38** and there is a spare bottle kept on site.

**Figure 37:-** Five 34kg LPG gas bottles for practical classrooms gas services

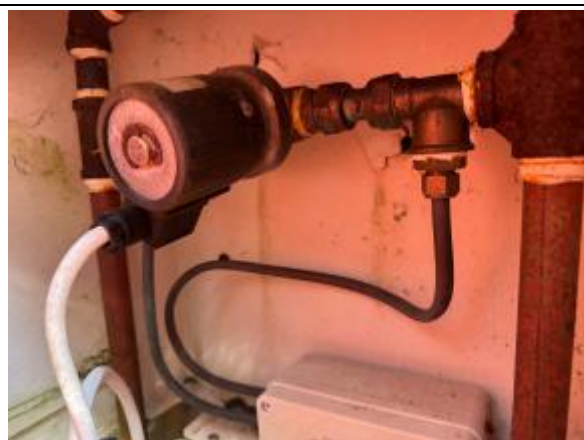
The master pressure proving slam shut valve as shown in **Figure 39**, is controlled by a pressure proving control panel Medem model GPPS-L, as shown in **Figure 40**, located in the admin office. This system has failed and is no longer serviceable and requires replacement as the external slam shut valve and pipework is showing advanced corrosion and the control panel is now an obsolete model.

**Figure 39:-** Five 34kg LPG gas bottles or practical classrooms gas services

We recommend a full upgrade of the gas safety pressure proving systems and associated electrical installations as part of the electrical upgrade. The existing gas pipework and distribution system will require integrity testing and certification and will require to be painted yellow and the final connections to all gas appliances should all be renewed as part of the proposed gas upgrade

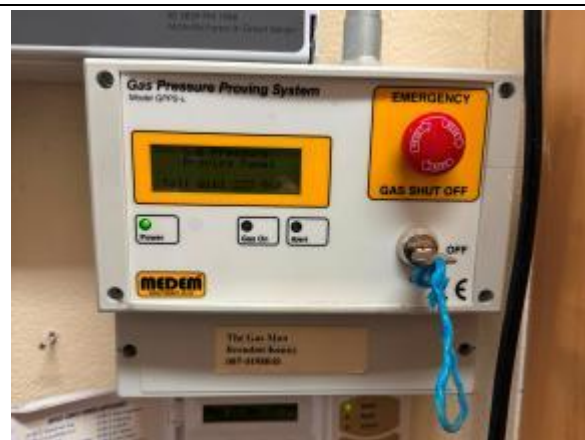
**Figure 40:-** Master Pressure Proving Control Panel is now an obsolete unit

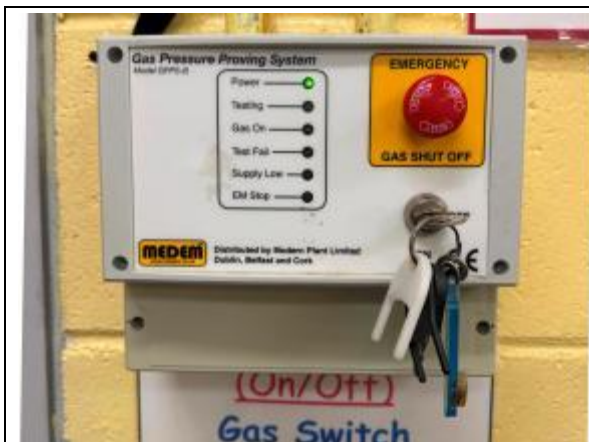
Each of the individual practical classrooms are fitted with a local slam shut valve and pressure proving control panel Medem Model GPPS-B as shown in **Figure 41** below which are also an obsolete model which have passed end of recommended service life. Final appliance connections to gas equipment such as the Home economics cookers shown in **Figure 42** are at end of service life and require full replacement upgrade.

**Figure 41:-** Five 34kg LPG gas bottles or practical classrooms gas services

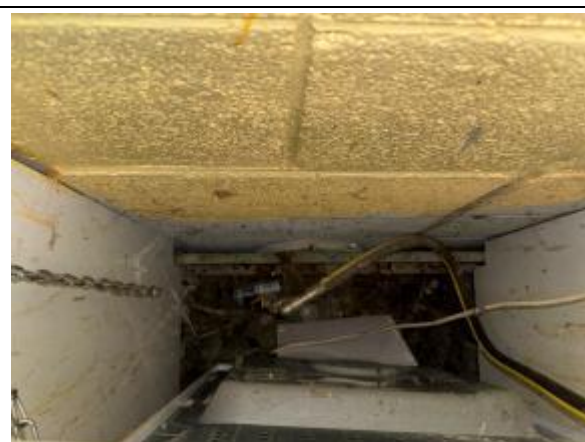
**Figure 42:-** Gas service connection to gas cooker in the Home Economics Room
