# **Asbestos Survey**

**Baltinglass OETC,  
Weaver's Square,  
Baltinglass East,  
Baltinglass,  
Co. Wicklow.**

| Project N°<br>and<br>Revision N° | Report Status | Surveyor | Report Author | Approved by | Issue Date |
|---|---|---|---|---|---|
| A-04426<br>(Revision 1) | Issued | Daragh Gogarty | Jordan Costello | <br>Daragh Gogarty | 08/09/2026 |

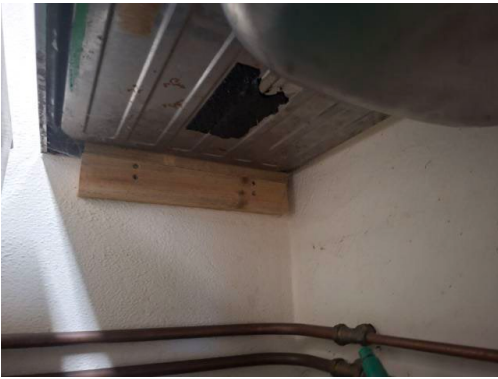
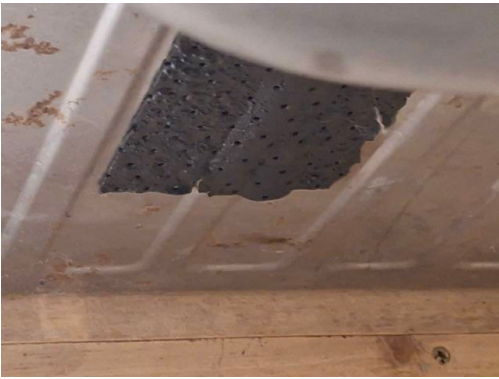
| Baltinglass OETC | | | | | | |
|---|---|---|---|---|---|---|
| S1 | Ground Floor | Laundry, 0-011 | Sink – Bitumen Sink Pad | Chrysotile | 1 no | Remove if affected by project. Label & manage & review every 12 months |

| PRODUCT TYPE: | Bitumen Sink Pad | | | ACCESSIBILITY: | Easy | | |
| FOUND IN: | Sink | | | | | | |

| Refurbishment Survey: | | Baltinglass OETC | Surveyor(s): | | Daragh Gogarty | Survey Date: | | 27/08/26 to 28/08/26 |
|---|---|---|---|---|---|---|---|---|
| Ground Floor | S1 | Laundry 0-011 – Sink (Bitumen Sink Pad) | Chrysotile | Medium Damage | Easy | 1 no | 4 | Remove if affected by refurbishment works. If managed - Label & manage & review every 12 months |

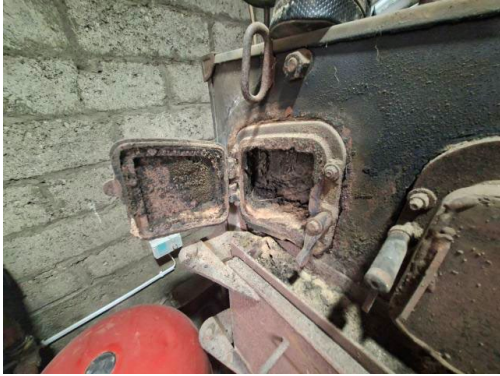
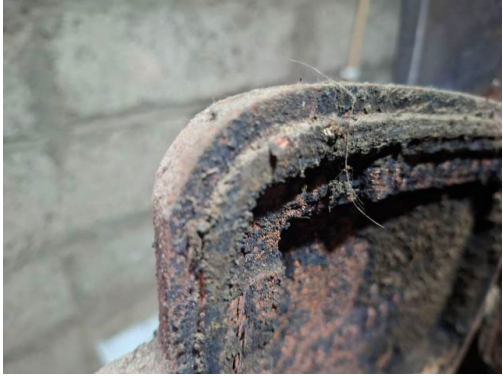
| Baltinglass OETC | | | | | | |
|---|---|---|---|---|---|---|
| S2 | External | Boiler House 2, 99-002 | Boiler – Rope | Chrysotile | 3 no | Remove if affected by project. Label & manage & review every 12 months |

| PRODUCT TYPE: | Rope | ACCESSIBILITY: | Medium | | | | |
| FOUND IN: | Boiler | | | | | | |

| Refurbishment Survey: | | Baltinglass OETC | Surveyor(s): | | Daragh Gogarty | Survey Date: | | 27/08/26 to 28/08/26 |
|---|---|---|---|---|---|---|---|---|
| External | S2 | Boiler House 2 99-002 – Boiler (Rope) | Chrysotile | High Damage | Medium | 3 no | 5 | Remove if affected by refurbishment works. If managed - Label & manage & review every 12 months |

The old boiler within Boiler House 2 should be treated as containing asbestos internally. Appropriate asbestos controls should therefore be established before the boiler is dismantled, opened or removed.

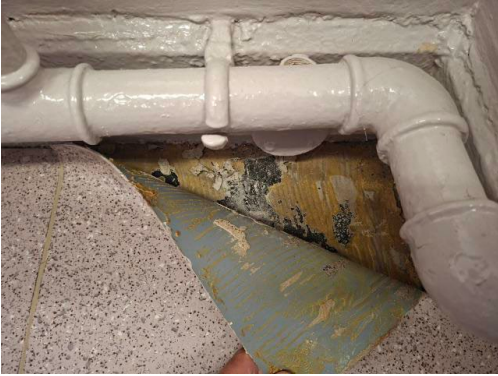
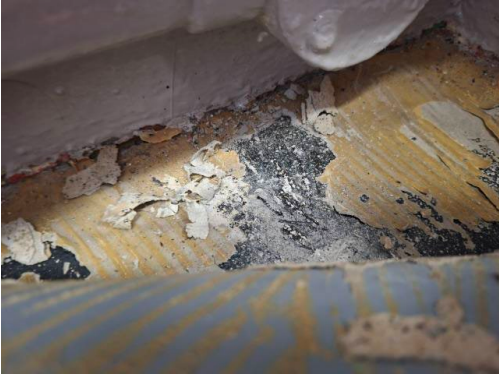
| Baltinglass OETC | | | | | | |
|---|---|---|---|---|---|---|
| S3 | 1st Floor | Canteen, 1-004 | Floor – Bitumen Adhesive | Chrysotile | 50 approx m <sup>2</sup> | Remove if affected by project. Label & manage & review every 12 months |

| PRODUCT TYPE: | Bitumen Adhesive | | ACCESSIBILITY: | Medium | | | | |
| FOUND IN: | Floor | | | | | | | |

| Refurbishment Survey: | | Baltinglass OETC | Surveyor(s): | | Daragh Gogarty | Survey Date: | | 27/08/26 to 28/08/26 |
|---|---|---|---|---|---|---|---|---|
| 1st Floor | S3 | Canteen 1-004 – Floor (Bitumen Adhesive) | Chrysotile | Medium Damage | Medium | 50 approx m² | 4 | Remove if affected by refurbishment works. If managed - Label & manage & review every 12 months |

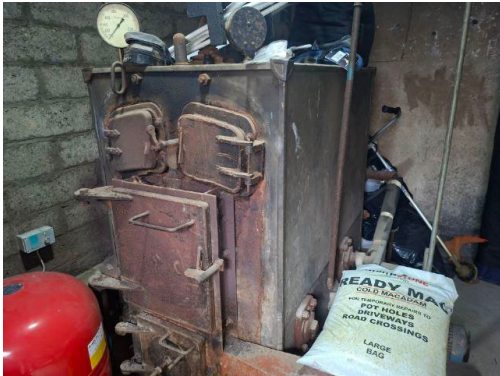
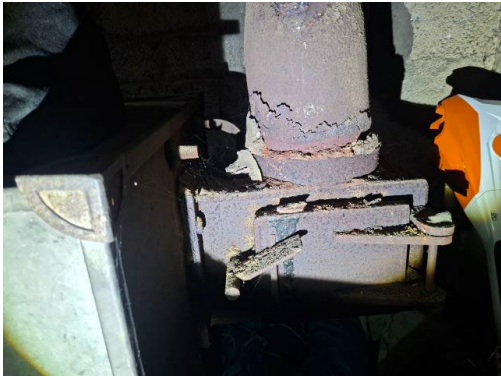
| Baltinglass OETC | | | | | | |
|---|---|---|---|---|---|---|
| P | External | Boiler House 2, 99-002 | Boiler – Rope | Chrysotile | N/A no | Remove if affected by project. Label & manage & review every 12 months |

| PRODUCT TYPE: | Rope | ACCESSIBILITY: | Medium | | | | |
| FOUND IN: | Boiler | | | | | | |

| Refurbishment Survey: | | Baltinglass OETC | Surveyor(s): | | Daragh Gogarty | Survey Date: | | 27/08/26 to 28/08/26 |
|---|---|---|---|---|---|---|---|---|
| External | Presumed | Boiler House 2 99-002 – Boiler (Rope) | Chrysotile | Medium Damage | Medium | N/A no | 4 | Remove if affected by refurbishment works. If managed - Label & manage & review every 12 months |

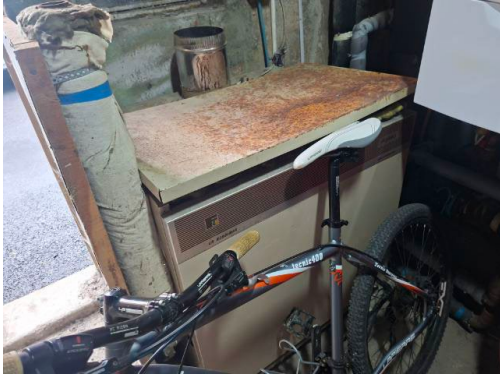
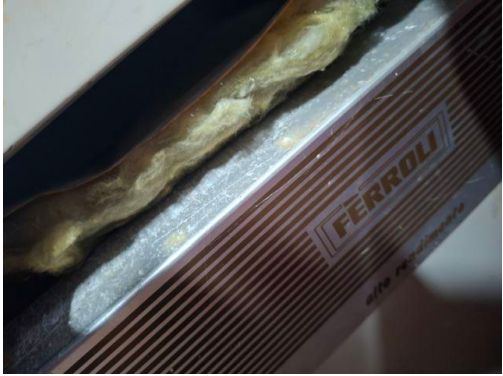
| Baltinglass OETC | | | | | | |
|---|---|---|---|---|---|---|
| P | External | Boiler House 2, 99-002 | Boiler – Board | Chrysotile | N/A no | Remove if affected by project. Label & manage & review every 12 months |

| PRODUCT TYPE: | Board | ACCESSIBILITY: | Medium |
| FOUND IN: | Boiler | | |

| Refurbishment Survey: | | Baltinglass OETC | Surveyor(s): | | Daragh Gogarty | Survey Date: | | 27/08/26 to 28/08/26 |
|---|---|---|---|---|---|---|---|---|
| External | Presumed | Boiler House 2 99-002 – Boiler (Board) | Chrysotile | Medium Damage | Medium | N/A no | 4 | Remove if affected by refurbishment works. If managed - Label & manage & review every 12 months |
