**Refurbishment & Demolition**  
**Asbestos Survey**  
(including Sampling and Analysis)

**for**  
***KWETB Kildare Office***

**at**  
**Blessington FETC,**  
**Blessington,**  
**Co. Wicklow,**  
**W91 HDH9.**

| Project N°<br>and<br>Revision N° | Report Status | Surveyor | Report Author | Approved by | Issue Date |
|---|---|---|---|---|---|
| A-04399<br>(Revision 1) | Issued | Daragh Gogarty | Jordan Costello | <br>Daragh Gogarty | 28/08/2026 |

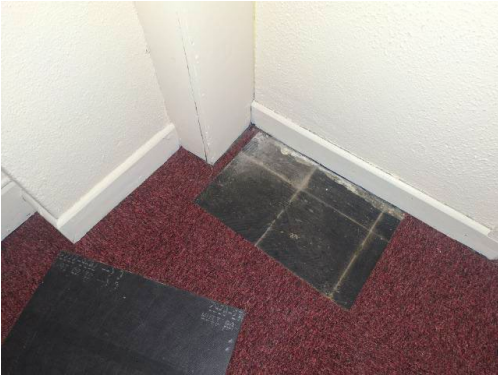
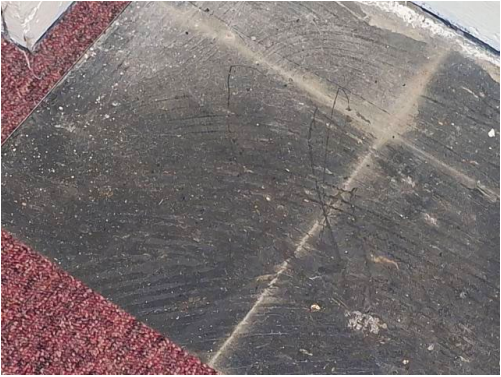
**S2 – IT Room 2, Area 0-011:** Chrysotile asbestos-containing bitumen adhesive. Material Risk Assessment Score: 4.

| PRODUCT TYPE: | Bitumen Adhesive | | | ACCESSIBILITY: | Easy | | |
| FOUND IN: | Floor | | | | | | |

| Area Surveyed | Sample Number | Location and Use of Material | Asbestos Type | Condition | Accessibility | Extent | Material Risk Assessment Score | Recommended Action |
|---|---|---|---|---|---|---|---|---|
| Ground Floor | S2 | IT Room 2 0-011 – Floor (Bitumen Adhesive) | Chrysotile | Medium Damage | Easy | N/A m <sup>2</sup> | 4 | Label & manage & review every 12 months |

**S2 – Bitumen Adhesive:** Where the floor or underlying adhesive will be affected by the proposed refurbishment works, the ACM should be appropriately removed or made safe before those works commence. Where unaffected, the material may remain in situ and should be managed.

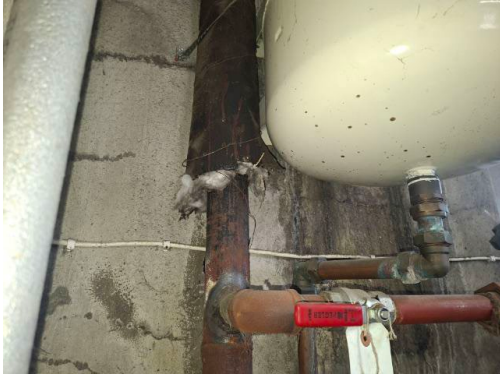
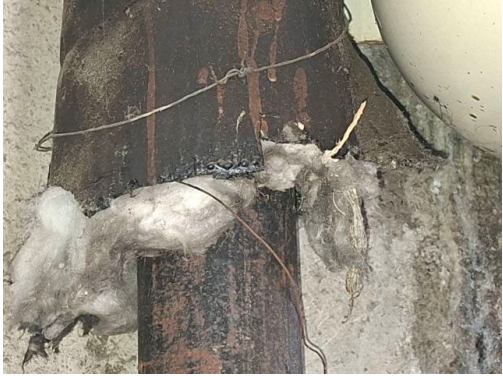
**S3 – External Boiler Room, Area 99-003:** Chrysotile asbestos-containing insulation material to metal pipework/services. The material was recorded as being in **high-damage condition and readily accessible**, with a Material Risk Assessment Score of 8.

| PRODUCT TYPE: | Insulated pipework / services | | ACCESSIBILITY: | Easy | | | |
| FOUND IN: | Pipework Textile | | | | | | |

| Area Surveyed | Sample Number | Location and Use of Material | Asbestos Type | Condition | Accessibility | Extent | Material Risk Assessment Score | Recommended Action |
|---|---|---|---|---|---|---|---|---|
| External | S3 | Boiler Room 99-003 – Pipework (Insulated pipework / services) | Chrysotile | High Damage | Easy | N/A m <sup>2</sup> | 8 | Restrict Access<br>Label & manage & review every 12 months |

**S3 – Boiler Room Pipework Insulation:** Due to the high-damage condition of the material, access to the isolated boiler room should be restricted to authorised personnel and disturbance prevented. The material may remain managed in situ while unaffected by the proposed works. Its condition should be monitored and, before any future work affecting the pipework or insulation, the ACM should be appropriately addressed by a competent asbestos removal contractor.

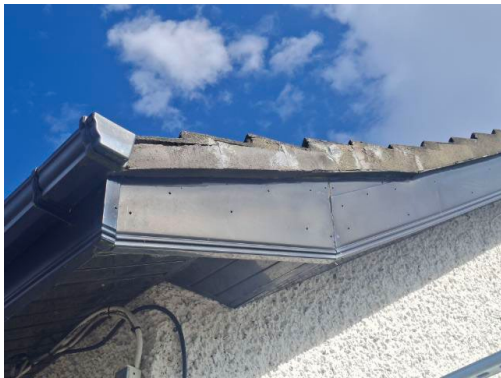
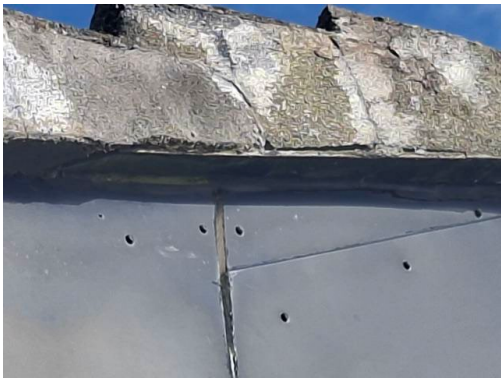
**Main Roof, Area 99-001:** Cement slate under cloaking – **presumed asbestos-containing**.

| PRODUCT TYPE: | Cement Slate | ACCESSIBILITY: | Medium | | | | |
| FOUND IN: | Roof | | | | | | |

| Area Surveyed | Sample Number | Location and Use of Material | Asbestos Type | Condition | Accessibility | Extent | Material Risk Assessment Score | Recommended Action |
|---|---|---|---|---|---|---|---|---|
| External | Presumed | Main Roof 99-001 – Roof (Cement Slate) | Chrysotile, Amosite, Crocidolite | Low Damage | Medium | N/A m <sup>2</sup> | 5 | Label & manage & review every 12 months |

**Main Roof Under cloaking:** The suspect cement slate under cloaking should continue to be treated as asbestos-containing unless representative sampling demonstrates otherwise. Where the proposed works may disturb the material, it should be appropriately addressed prior to commencement.

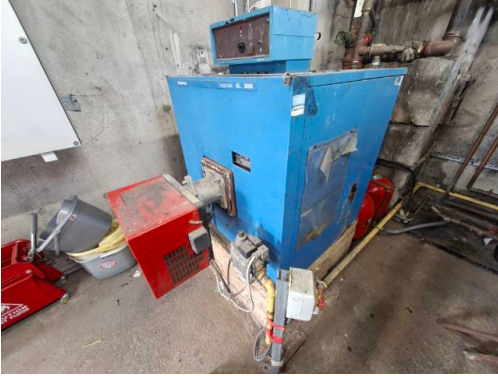
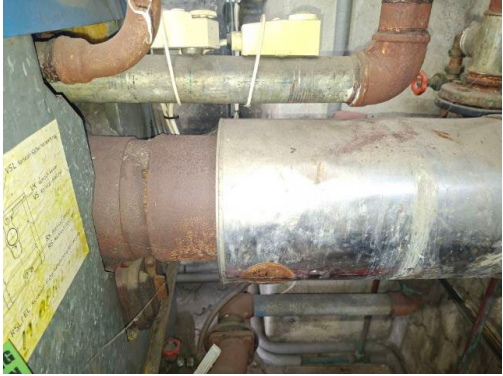
**Boiler/Rear Metal Flue, Area 99-003:** Internal insulation – **presumed asbestos-containing**. The boiler was live and the material was not subject to intrusive inspection.

| PRODUCT TYPE: | Boiler Insulation | | ACCESSIBILITY: | Easy | | |
| FOUND IN: | Boiler | | | | | |

| Area Surveyed | Sample Number | Location and Use of Material | Asbestos Type | Condition | Accessibility | Extent | Material Risk Assessment Score | Recommended Action |
|---|---|---|---|---|---|---|---|---|
| External | Presumed | Boiler Room 99-003 – Boiler (Boiler Insulation) | Amosite | Low Damage | Easy | 1 no | 4 | Label & manage & review every 12 months |

**Boiler/Rear Metal Flue:** Suspect internal insulation should remain presumed asbestos-containing. No disturbance should take place until further investigation has been undertaken where works are proposed to the boiler, flue or associated components.

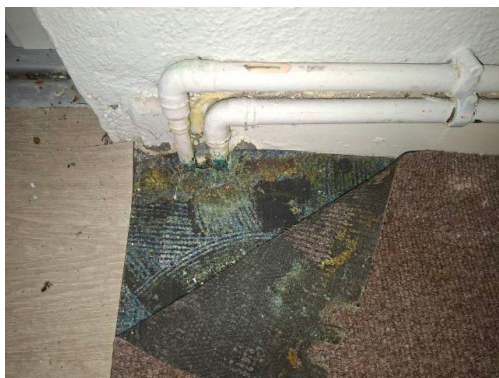
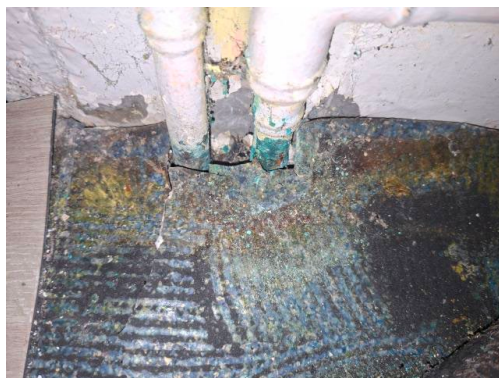
| ROOM NAME / NO.: | 0-005 | SAMPLE REF NO.: | S1 |

| PRODUCT TYPE: | Vinyl Floor Covering & Adhesive | | ACCESSIBILITY: Medium |
| FOUND IN: | Floor | | |
