# **Refurbishment & Demolition Asbestos Survey** (including Sampling and Analysis)

**for  
Kildare FETC  
at  
Kildare FETC,  
Bothar na gCorp,  
Kildare Town,  
Co. Kildare.**

Project Number: A-04403

Revision 1 Issued on: 14/08/2026

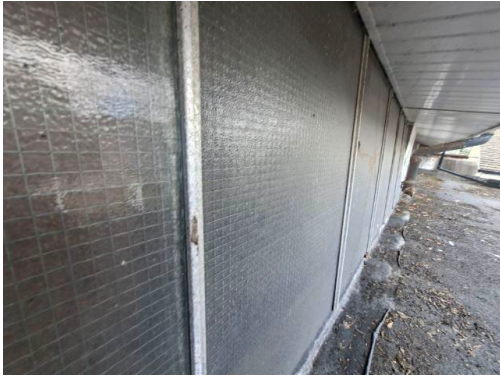
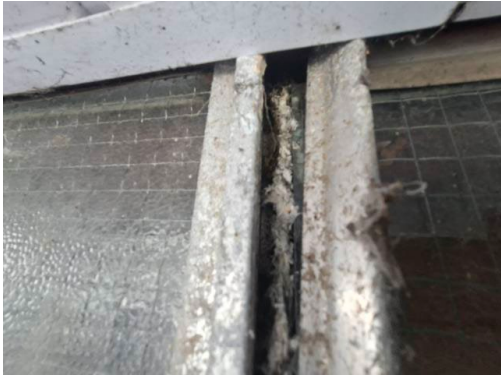
#### **S3 – External – High-Level Metal Mesh Windows, Area 99-003**

Rope seals – **Chrysotile asbestos detected**

The surveyor recorded similar rope seals to high-level metal mesh windows associated with the **Boiler House, main office block north wing and toilet block west wing**.

Chrysotile asbestos was confirmed within rope seals associated with high-level metal mesh windows.

| PRODUCT TYPE: | Rope | ACCESSIBILITY: | Medium | | | | |
| FOUND IN: | Windows | | | | | | |

| Area Surveyed | Sample Number | Location and Use of Material | Asbestos Type | Condition | Accessibility | Extent | Material Risk Assessment Score | Recommended Action |
|---|---|---|---|---|---|---|---|---|
| External | S3 | High Line Metal Mesh Windows 99-003 – Windows (Rope) | Chrysotile | Medium Damage | Medium | N/A m <sup>2</sup> | 5 | Remove if affected by refurbishment works or label & manage & review every 12 months if not affected |

| Kildare FETC | | | | | | |
|---|---|---|---|---|---|---|
| S3 | External | High Line Metal Mesh Windows, 99-003 | Windows – Rope | Chrysotile | N/A m <sup>2</sup> | Remove if affected by refurbishment works or label & manage & review every 12 months if not affected |

The confirmed chrysotile-containing S3 rope seals should be appropriately addressed prior to window replacement works which will disturb them. The surveyor recorded similar rope seals at the Boiler House, main office block north wing and toilet block west wing; the extent of the material should therefore be established as part of planning the window replacement works.

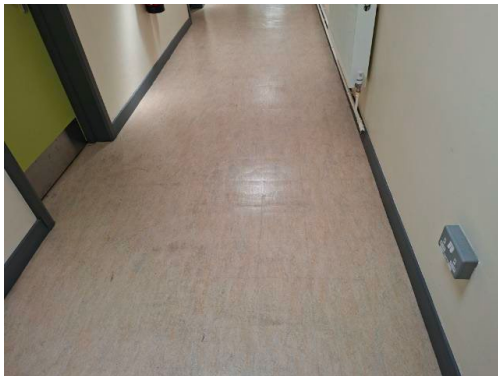
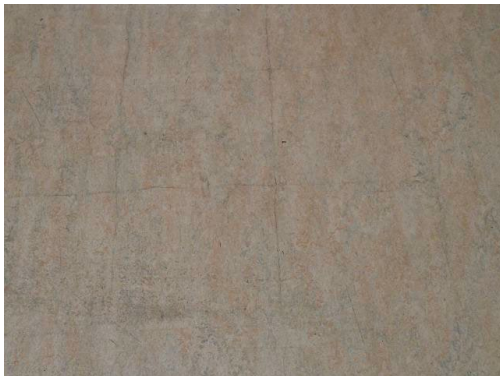
Residual floor tile markings and bitumen adhesive were identified beneath retained modern floor finishes. Intrusive inspection was limited and further investigation is required where future refurbishment works will affect the floors to quantify.

| PRODUCT TYPE: | | Bitumen Adhesive | | | | ACCESSIBILITY: | | Difficult | |
| FOUND IN: | | Floor | | | | | | | |

| Area Surveyed | Sample Number | Location and Use of Material | Asbestos Type | Condition | Accessibility | Extent | Material Risk Assessment Score | Recommended Action |
|---|---|---|---|---|---|---|---|---|
| Ground Floor | Presumed | Corridor 2 0-003 – Floor (Bitumen Adhesive) | Chrysotile | Medium Damage | Difficult | N/A m <sup>2</sup> | 4 | Label & manage & review every 12 months |

| Kildare FETC | | | | | | |
|---|---|---|---|---|---|---|
| P | Ground Floor | Corridor 2, 0-003 | Floor – | Chrysotile | N/A m <sup>2</sup> | Label & manage & review every 12 months |

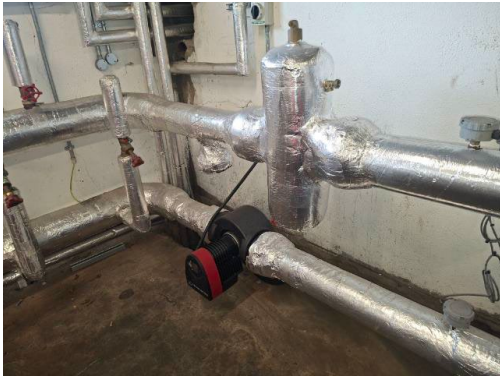
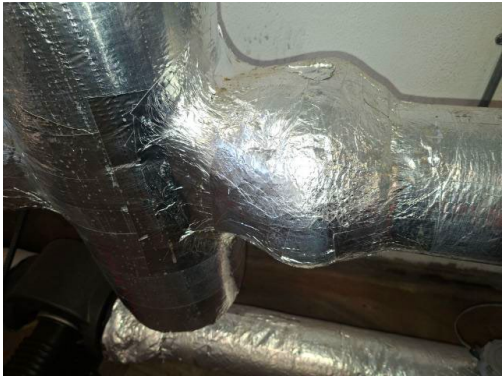
Compressed gaskets associated with boiler-house pipework were presumed asbestos-containing. Inspection was limited due to the boiler being live.

| PRODUCT TYPE: | Gaskets (compressed) | | ACCESSIBILITY: | Medium | | | |
| FOUND IN: | Pipework | | | | | | |

| Area Surveyed | Sample Number | Location and Use of Material | Asbestos Type | Condition | Accessibility | Extent | Material Risk Assessment Score | Recommended Action |
|---|---|---|---|---|---|---|---|---|
| External | Presumed | Boiler House 99-005 – Pipework (Gaskets (compressed)) | Chrysotile | Low Damage | Medium | N/A m <sup>2</sup> | 3 | Label & manage & review every 12 months |

| Kildare FETC | | | | | | |
|---|---|---|---|---|---|---|
| P | External | Boiler House, 99-005 | Pipework - Gaskets (compressed) | Chrysotile | N/A m <sup>2</sup> | Label & manage & review every 12 months |

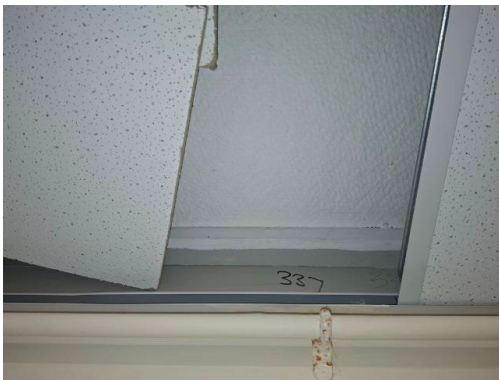
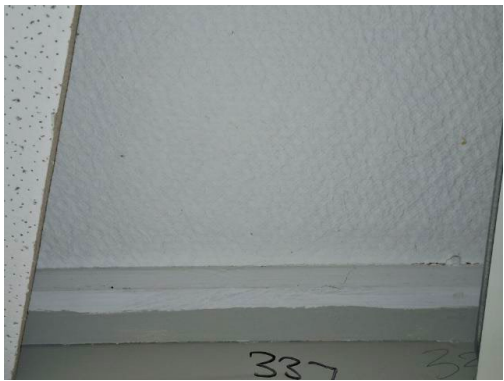
| ROOM NAME / NO.: | 0-002 | SAMPLE REF NO.: | S7 |

| PRODUCT TYPE: | Board | ACCESSIBILITY: | Medium |
| FOUND IN: | Ceilings | | |

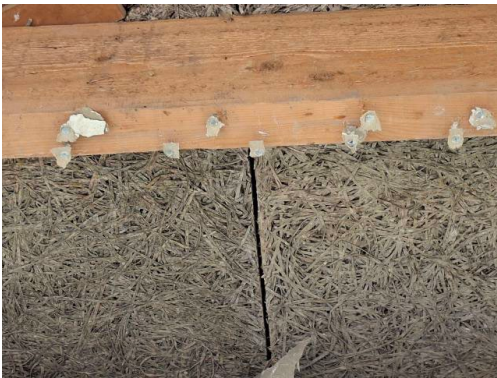
| ROOM NAME / NO.: | 0-005 | SAMPLE REF NO.: | S8 |

| PRODUCT TYPE: | Board | ACCESSIBILITY: | Difficult |
| FOUND IN: | Ceiling/Internal Roof | | |

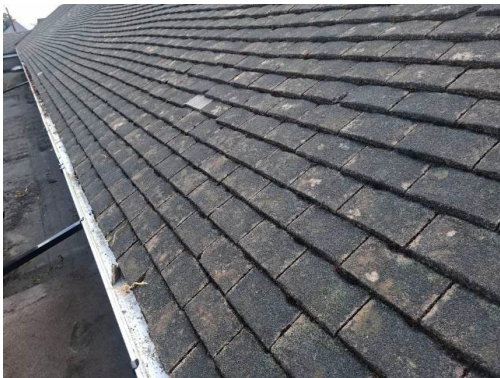
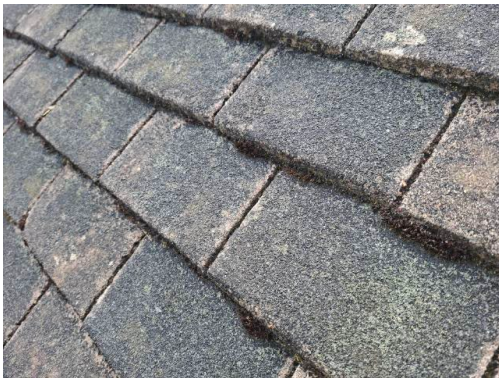
| ROOM NAME / NO.: | 99-001 | SAMPLE REF NO.: | S1 |

| PRODUCT TYPE: | Cement Slate | ACCESSIBILITY: | Difficult |
| FOUND IN: | Roof | | |

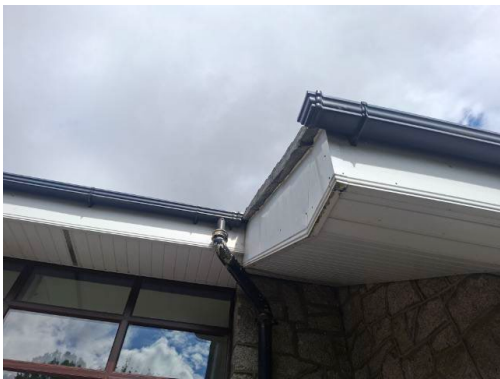
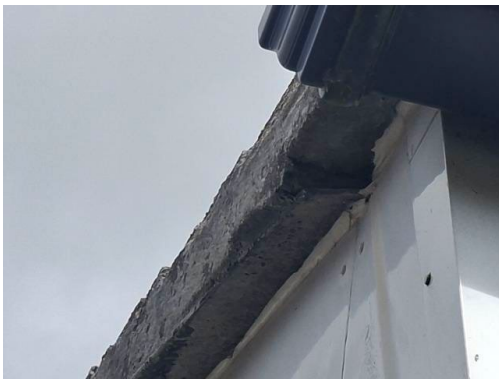
| ROOM NAME / NO.: | 99-001 | SAMPLE REF NO.: | S2 |

| PRODUCT TYPE: | Cement Slate | ACCESSIBILITY: | Medium |
| FOUND IN: | Roof | | |

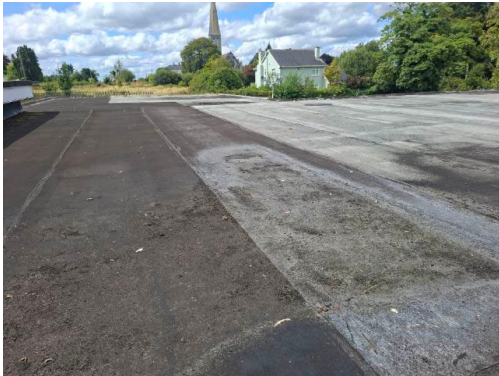
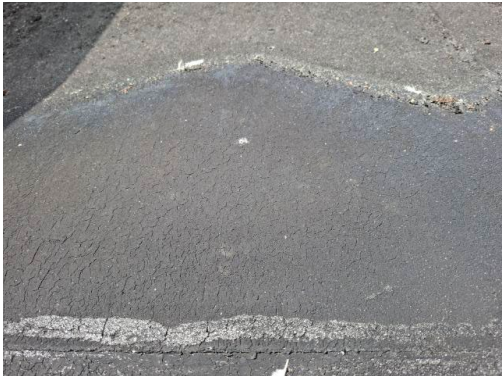
| ROOM NAME / NO.: | 99-004 | SAMPLE REF NO.: | S4 |

| PRODUCT TYPE: | Flat, bitumen felt lined | ACCESSIBILITY: | Easy |
| FOUND IN: | Roof | | |

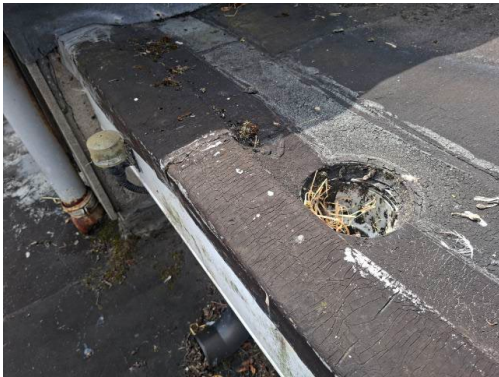
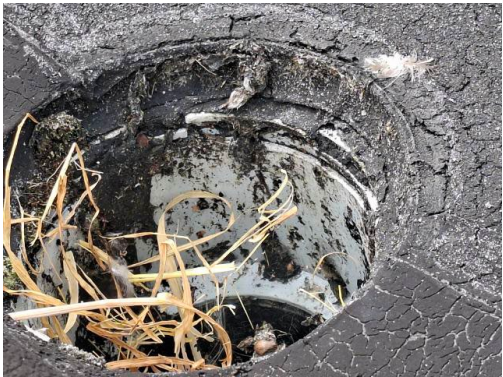
| ROOM NAME / NO.: | 99-004 | SAMPLE REF NO.: | S5 |

| PRODUCT TYPE: | Flat, bitumen felt lined | ACCESSIBILITY: | Easy |
| FOUND IN: | Roof | | |

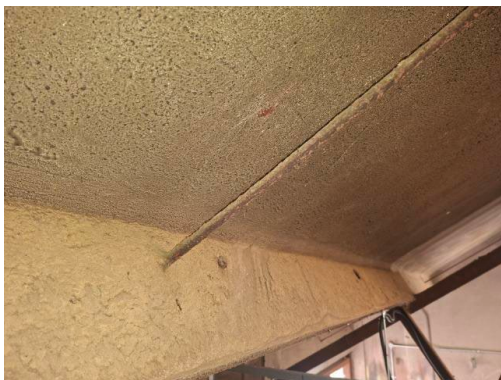
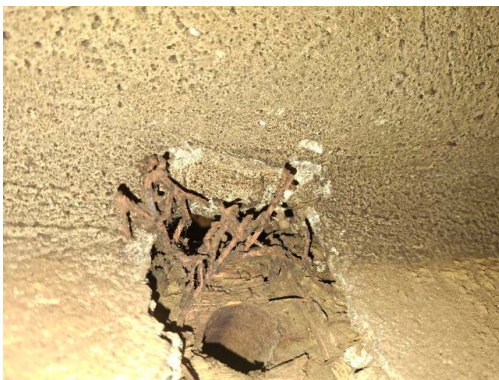
| ROOM NAME / NO.: | 99-005 | SAMPLE REF NO.: | S6 |

| PRODUCT TYPE: | Board | ACCESSIBILITY: | Difficult |
| FOUND IN: | Ceiling | | |
