# **DMA ARCHITECTS**

## **CONDITION REPORT**

Client: Marillac Housing Association  
Property: Templemore Road, Roscrea, Co. Tipperary  
Date of Inspection: 08 February 2024  
Folio: TY35006  
Eircode: E53EC67  
Document Ref: DMA-CR-2024-001 Rev 1

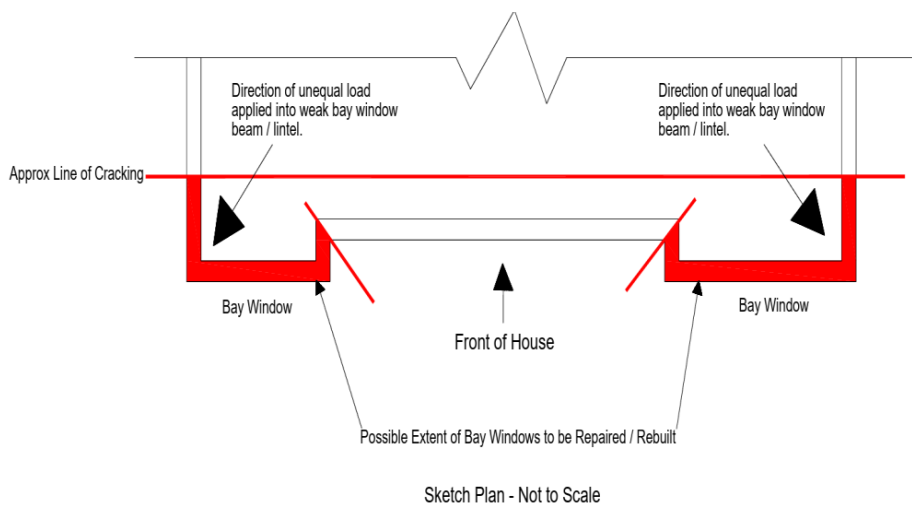
*Sketch Plan (Not to Scale) — direction of forces acting on the bay window lintels.*

- 4.13.1** As described in the room-by-room assessments above, cracking is most pronounced in rooms on the front elevation, and is attributable to movement and structural weakness within the roof.
- 4.13.2** All cracks were assessed in accordance with BRE Digest 251 ('Assessment of Damage in Low-Rise Buildings'). Crack widths range from Category 01 (0.2–2 mm, defined as Fine – not usually structurally serious) to Category 02 (2–5 mm, defined as Moderate – likely to have structural significance, occurring at points of weakness). The majority are Category 01.
- 4.13.3** The two front bay windows represent the weakest points of the building envelope. Roof spreading has transferred lateral loads onto the bay window lintels, structurally compromising them.
- 4.13.4** The sketch below illustrates the direction of forces acting on the bay window lintels.

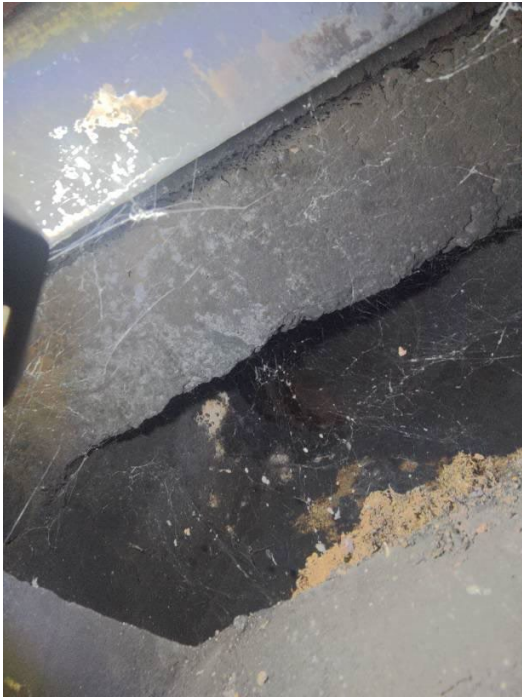
**Photo 008 — Damaged**

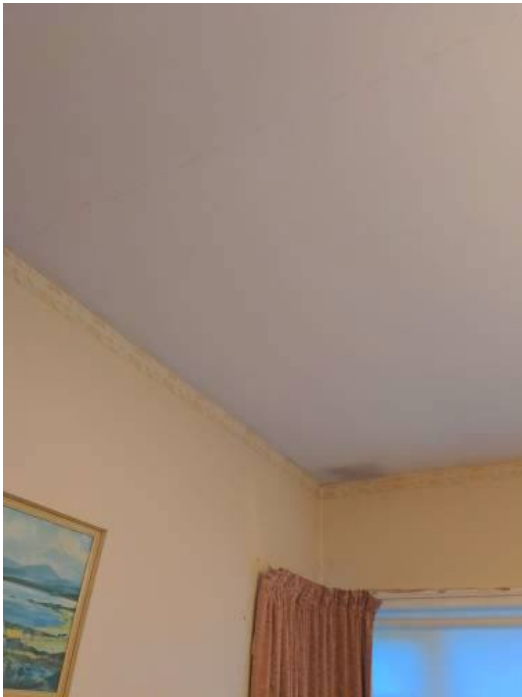
- 4.2.1** The room is in satisfactory visual condition. Structural issues are noted below. [\[Ref photo 02\]](#)
- 4.2.2** The open fire surround and hearth are safe and secure. The fire backing is damaged and requires repair. An internal flue inspection was not carried out; however, the chimney is visibly lined with clay flue pots. Minor thermal cracking observed in the chimney breast is not considered structurally significant. [\[Ref photos 07, 08 & 09\]](#)
- 4.2.3** Cracking is present in the ceiling and in the vicinity of the bay window. See Section 4.13 for the probable cause. [\[Ref photos 10, 11, 12 & 13\]](#)

**Photo 010 — Cracking**

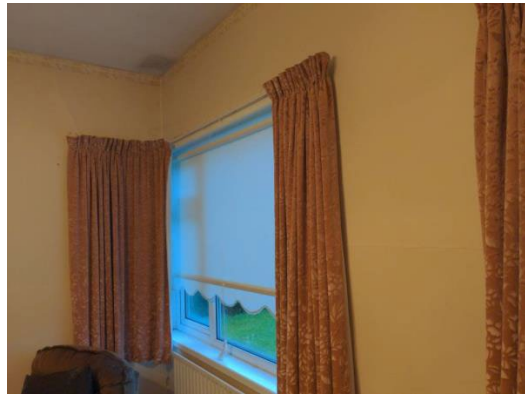
**Photo 011 — Cracking**

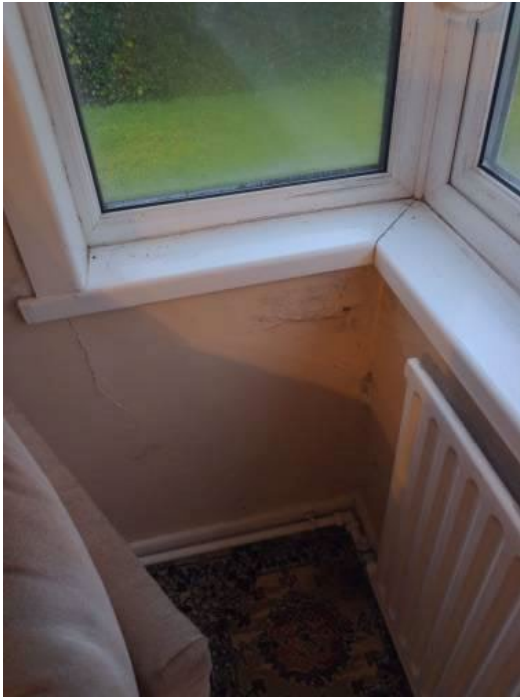
**Photo 012 — Cracking**

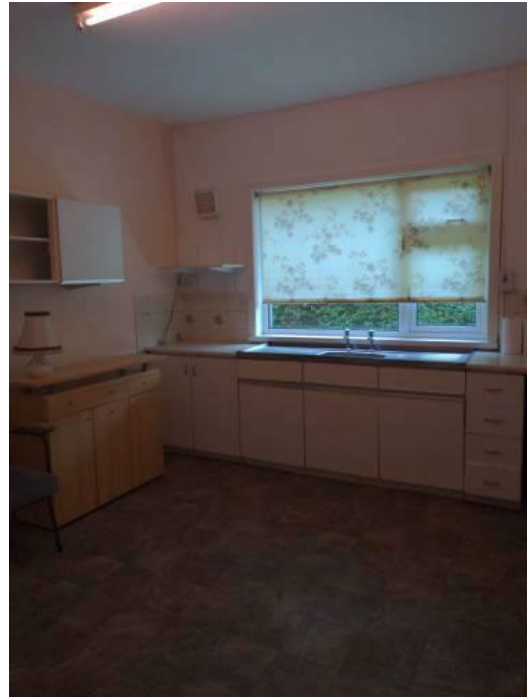
**Photo 013 — Cracking**

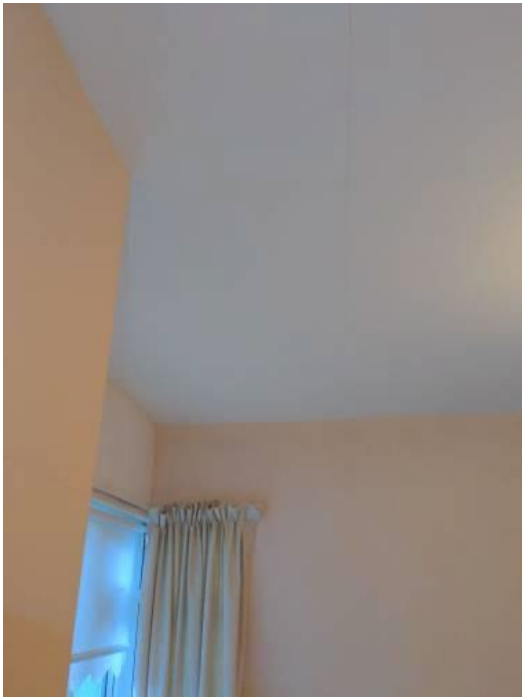
- 4.7.1 The room is in satisfactory visual condition. Structural issues are noted below. [\[Ref photo 42\]](#)
- 4.7.2 Cracking is present in the ceiling and around the bay window. See Section 4.13 for the probable cause. [\[Ref photos 46, 47, 48, 49, 50 & 51\]](#)
- 4.7.3 Built-in wardrobes are in functional condition. [\[Ref photo 52\]](#)

**Photo 046 — Cracking from the bay window**

- 5.1.4.4** Additional struts to be installed beneath purlins.
- 5.1.5 Bay Windows:** Subject to further investigation and detailed structural design, full rebuilding of both front bay windows incorporating structural steelwork and replacement lintels is likely to be necessary. Associated internal making-good works will also be required.

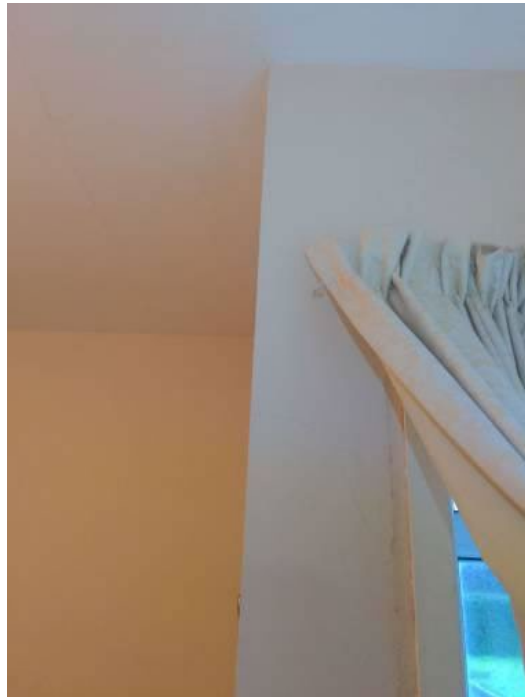
**Photo 047 — Cracking in line with front window**

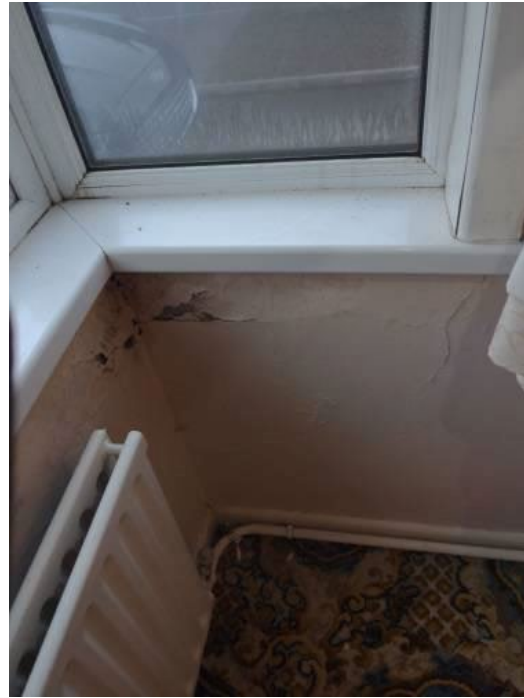
**Photo 049 — Cracking**

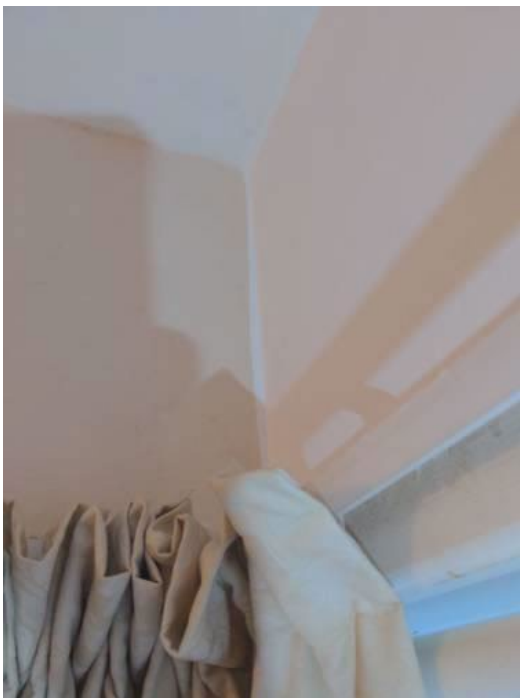
**Photo 050 — Cracking**

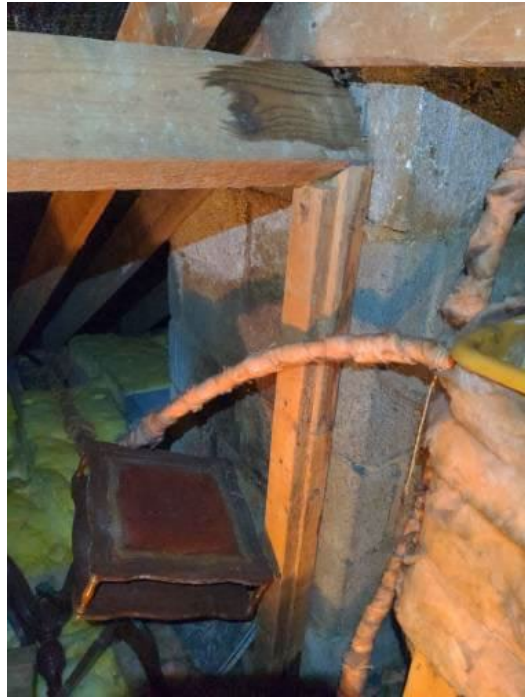
- 4.12.7 The cold water storage tank and associated pipework in the attic are inadequately insulated and uncovered. [\[Ref photo 90\]](#)
- 4.12.8 Both chimneys appear structurally sound; however, evidence of active water penetration around both chimney bases was observed from within the attic. [\[Ref photos 91, 92 & 96\]](#)

Photo 091 — Flashing and or cracked clay flue pot

- 5.1.3 Chimney Repairs:** Both chimneys exhibit active water penetration. The root cause (cracked flue pot, defective flashing or failed capping) must be identified and remedied by a competent tradesperson. If chimneys are no longer required, they should at minimum be reduced to below roof level and the opening sealed. [\[Ref photos 34, 91, 92 & 96\]](#)

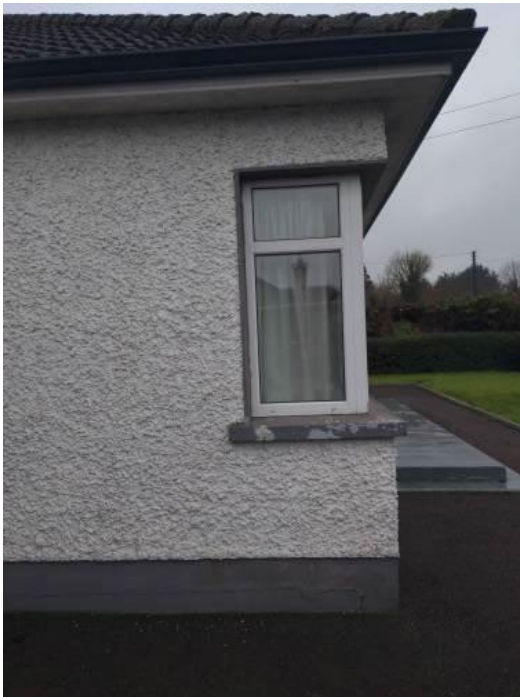
- 4.15.3** The front elevation is in good condition with minor fine cracking in places. [\[Ref photos 102, 105 & 106\]](#)
- 4.15.4** The concrete path to the front of the dwelling exhibits significant cracking and is obstructing the sub-floor ventilation opening serving the suspended timber floor in the adjacent bedroom. [\[Ref photo 104\]](#)

**Photo 106 — Fine cracking**
