# DMA ARCHITECTS

## CONDITION REPORT

### Building Survey & Assessment

| Property | 8 Willmount Estate, Janesboro, Limerick |

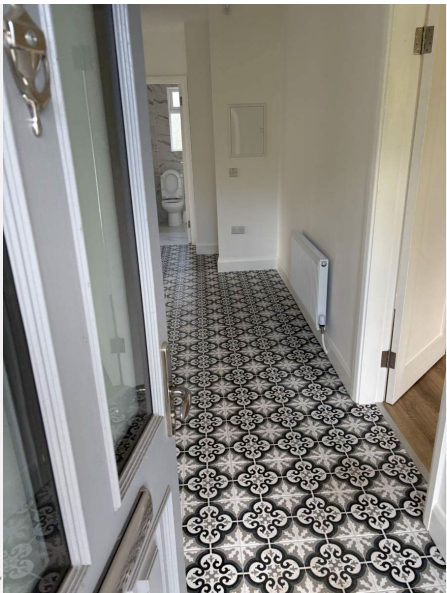
[ PHOTO 004 — Existing internal door and frame

- Fire safety: existing internal doors are recorded as non-fire-rated; replacement fire-rated doors and frames, a fire-rated attic hatch, ceiling fire-protection measures and party-wall fire stopping are proposed.

- Removal of existing non-fire-rated internal doors and frames; widening of openings and installation of fire-rated doors, frames and ironmongery.
- Replacement of attic access with a fire-rated hatch and proprietary access ladder.

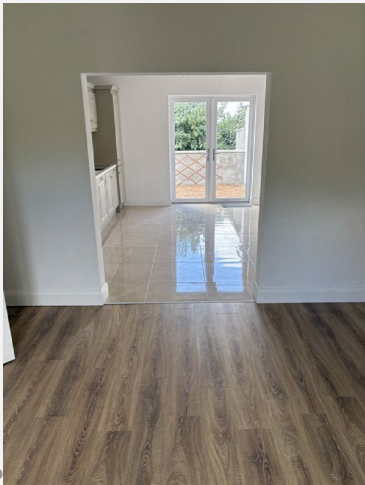
[ INSERT PHOTO 005 — Existing floor finish

- 4.3.1 The project information provides for removal of all existing floor finishes. No specific structural defect to the underlying floor construction is recorded.
- 4.3.2 New floor finishes are specifically identified to wet-room areas. Final finishes should be slip resistant, durable and appropriate for community residential use.
- 4.3.3 Any changes in floor level arising from removal and replacement of finishes should be coordinated to maintain level circulation and avoid trip hazards.

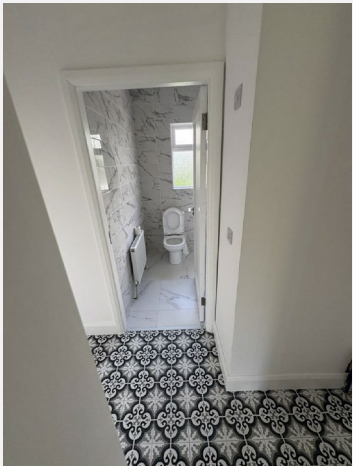
[ INSERT PHOTO 006 — Existing bathroom / shower accommodation

- 4.4.1 The existing main bathroom is proposed to be removed as part of the adaptation works.
- 4.4.2 A new wet room is proposed within the rear extension. Detailed design should address level access, falls, waterproofing, sanitary fittings, grab-rail provision where required, mechanical extract ventilation and safe transfer/turning space.
- 4.4.3 Existing water and waste services should be surveyed to confirm capacity and suitable connection points before construction.

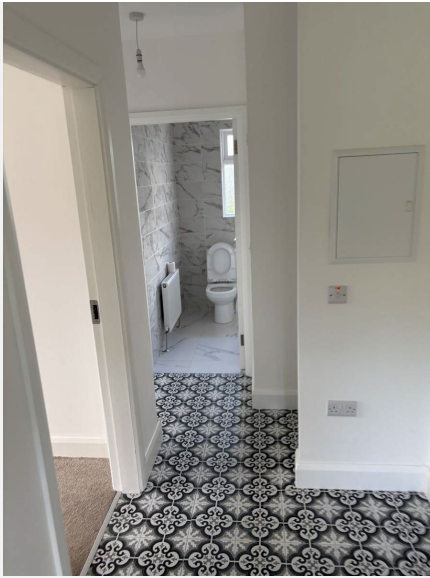
Photo 007 — Hall / proposed connection to rear extension

4.11.2 Access to the extension is proposed by forming a connection from the existing hallway through the area of the existing shower/bathroom accommodation.

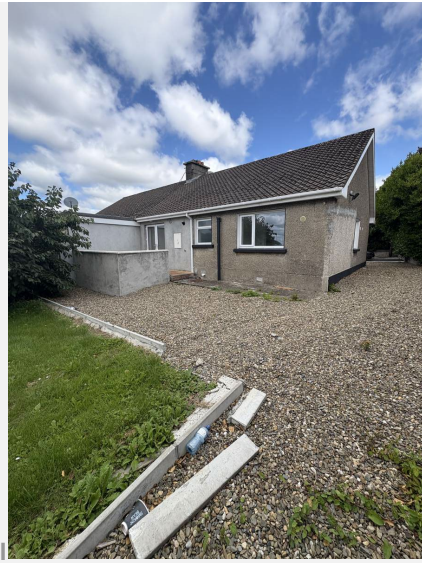
Photo 008 — Rear elevation / proposed extension area

4.11.1 A rear extension of approximately 40 m<sup>2</sup> is proposed to accommodate an additional bedroom, new wet room and utility room.

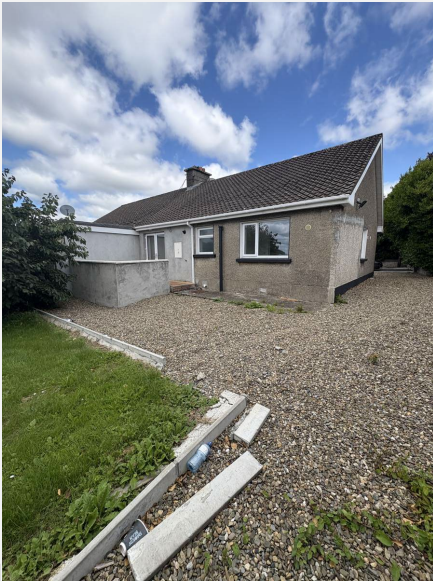
Photo 009 — Rear patio / garden access

4.13.1 The existing patio area is proposed to be adapted to facilitate level access from the kitchen to the garden.

4.13.2 Finished levels should be coordinated with damp-proof courses, drainage falls and threshold detailing so that accessibility improvements do not create moisture-ingress risks.

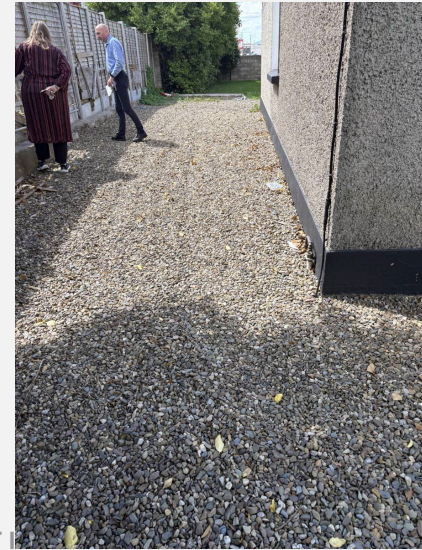
Photo 010 — Existing driveway / side access

4.12.2 New tarmac surfacing is proposed to the side and rear driveway areas.

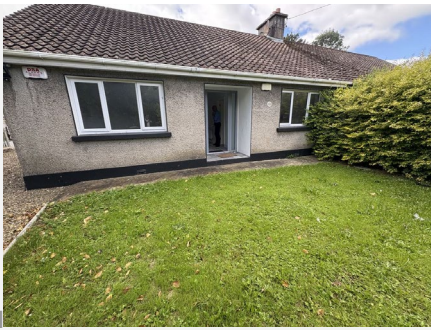
Photo 011 — Front garden / proposed parking area

4.12.1 New parking is proposed within the front garden together with a new ramp to the front entrance and handrails.

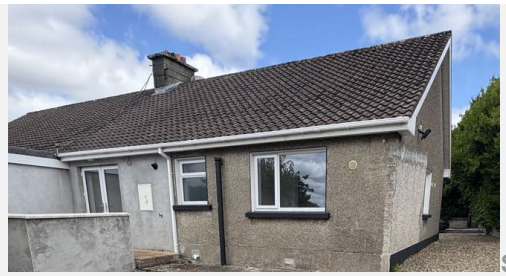
Photo 012 — Existing drainage / rainwater arrangements

4.14.1 External drainage diversion/adaptation works are proposed. The exact existing drainage layout is not established in the supplied material.

4.14.3 Existing foul and surface-water systems should be surveyed prior to detailed design. Where soakaways are proposed, ground suitability, separation distances and discharge arrangements should be confirmed.

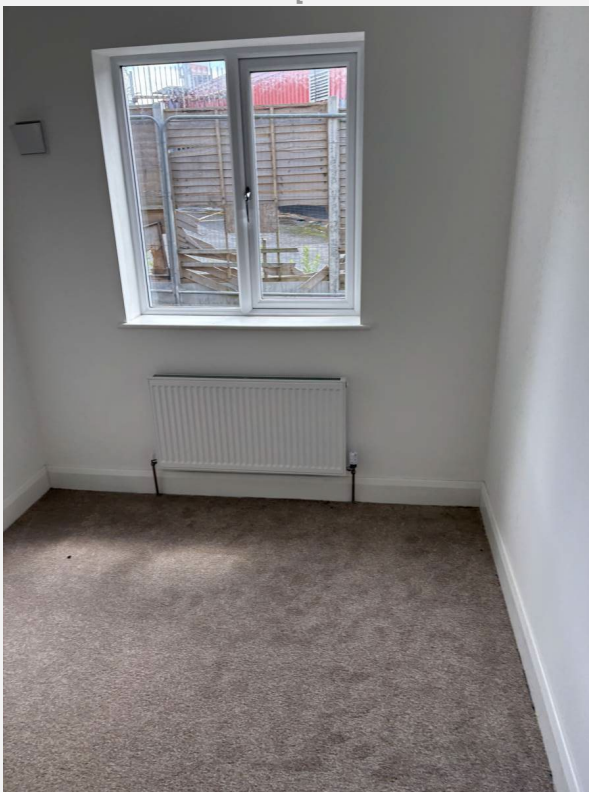
Photo 013 — Party wall / attic area

- 4.7.1 Fire stopping is proposed at the dwelling party wall.
- 4.7.2 The continuity of the separating wall should be inspected within the attic and at all service penetrations. Any gaps or discontinuities should be sealed using tested fire-stopping systems appropriate to the construction.
- 4.7.3 This report does not constitute a fire safety assessment. The final fire strategy should be coordinated with the proposed community residential use and relevant statutory requirements.

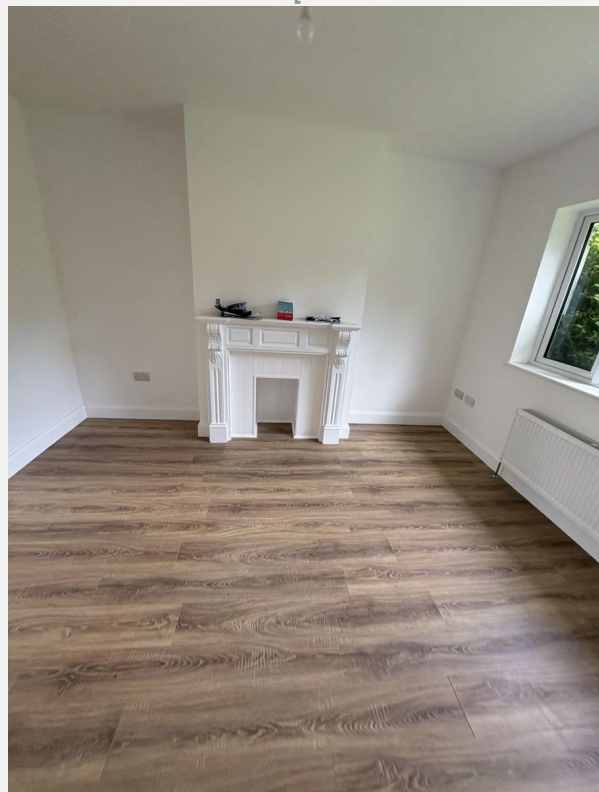
Photo 014 — Existing attic hatch / ceiling

- 4.6.1 The existing attic hatch is proposed to be replaced with a fire-rated hatch incorporating a proprietary access ladder.
- 4.6.2 A fire-rated coating system is proposed to existing ceilings. The existing ceiling substrate, joints, service penetrations and compatibility with the selected proprietary coating should be checked before specification.
- 4.6.3 Where ceilings are opened during works, concealed fire stopping, wiring and insulation should be inspected and upgraded as required.

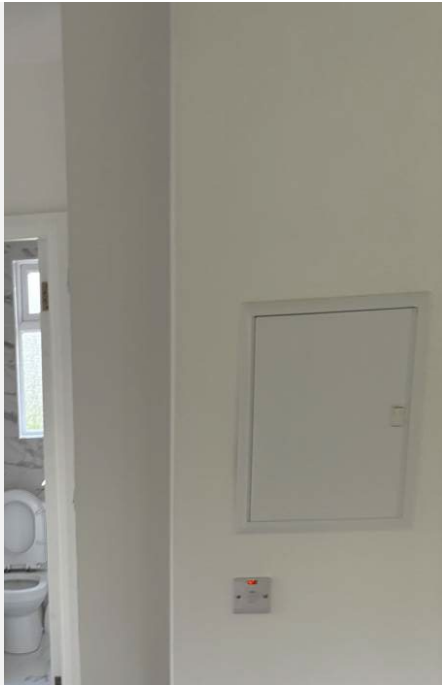
**Photo 015 — Electrical installation / distribution equipment**

4.9.3 No conclusion should therefore be drawn from this report as to the safety, capacity or regulatory compliance of the existing electrical installation. A registered electrical contractor should undertake the appropriate periodic inspection and testing, with remedial works incorporated into the final scope.

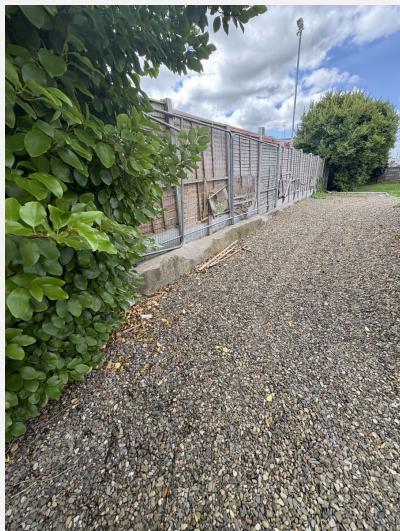
**Photo 017 — Rear boundary**

4.15.1 The boundary with the neighbouring property is to be left untouched, made good only where affected by the works. A new block-on-flat boundary wall, 2000mm in height, is proposed to the opposite site boundary, replacing the existing timber fence and concrete posts.

4.15.2 The precise legal boundary position is outside the scope of this report and should be verified before boundary construction is undertaken.

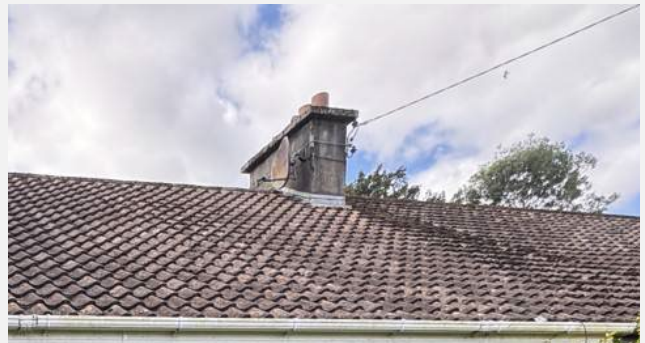
**Photo 018 — Chimney / capping**

4.16.2 The supplied information does not identify the reason for replacement or record wider chimney defects. The chimney, flashings, flue and capping should be visually inspected at close range when safe access is available.

4.16.1 Replacement of the chimney cap is proposed.
