# ASBESTOS MANAGEMENT SURVEY REPORT

KGH Main Building

Tralee

| <b>Document Title</b> | Asbestos Management Survey Report |

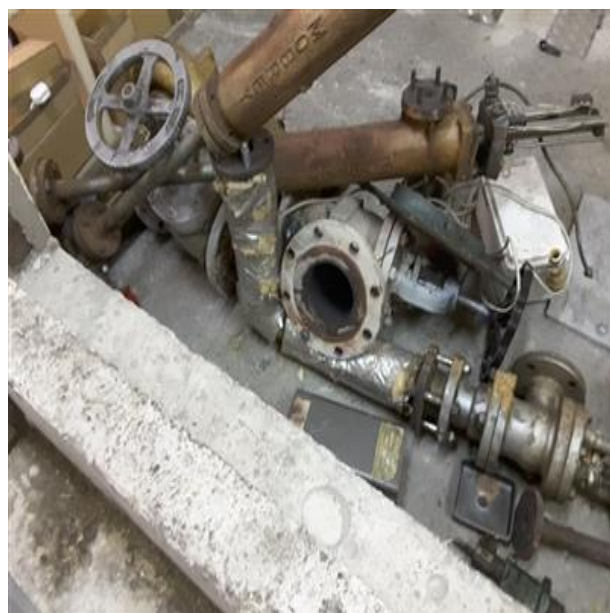
9

Priority 1 : Urgent Action Required Remove ACM's.

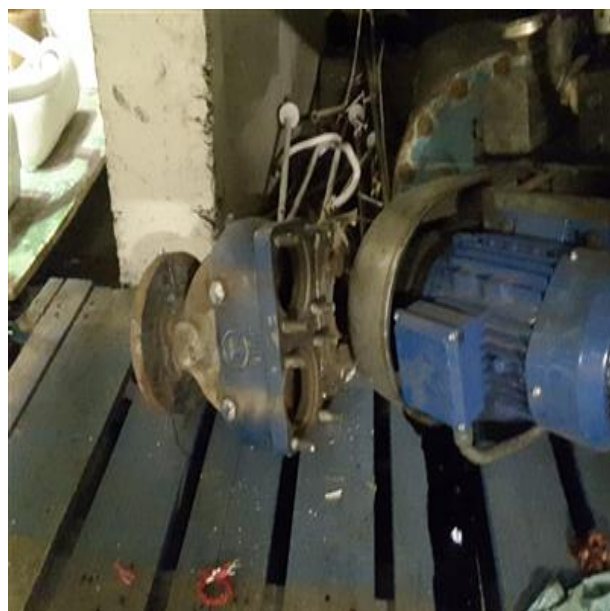
9

Priority 1 : Urgent Action Required Remove ACM's.

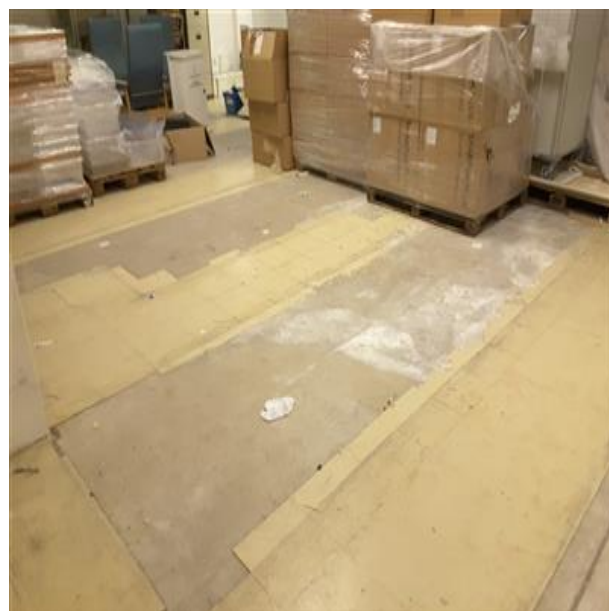
9

Priority 2: Remedial Work Required

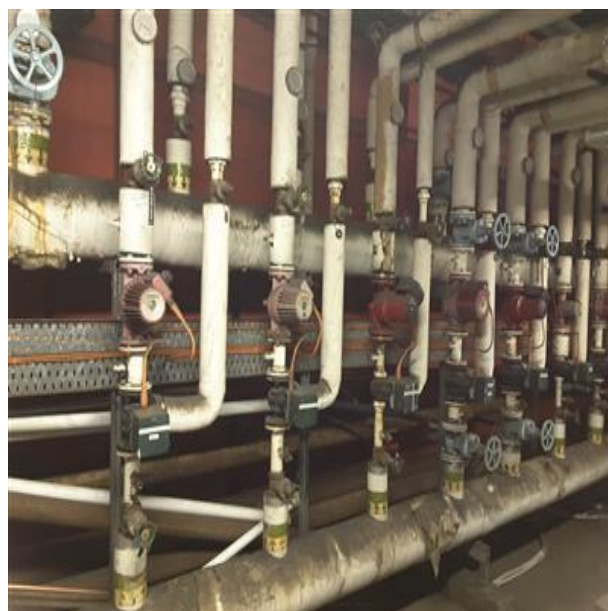
6

Priority 3: Manage in Place & Monitor Periodically.

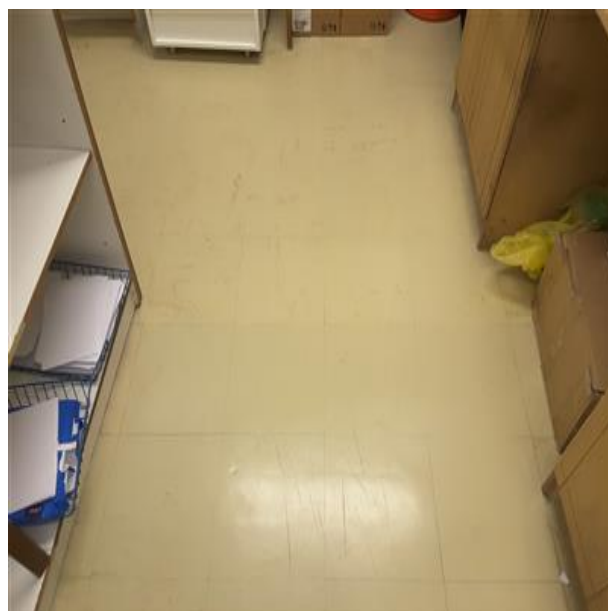
6

Priority 3: Manage in Place & Monitor Periodically.

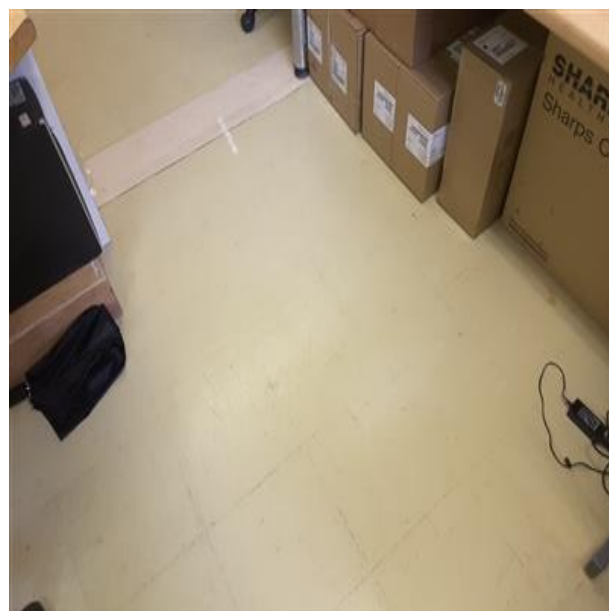
6

Priority 3: Manage in Place & Monitor Periodically.

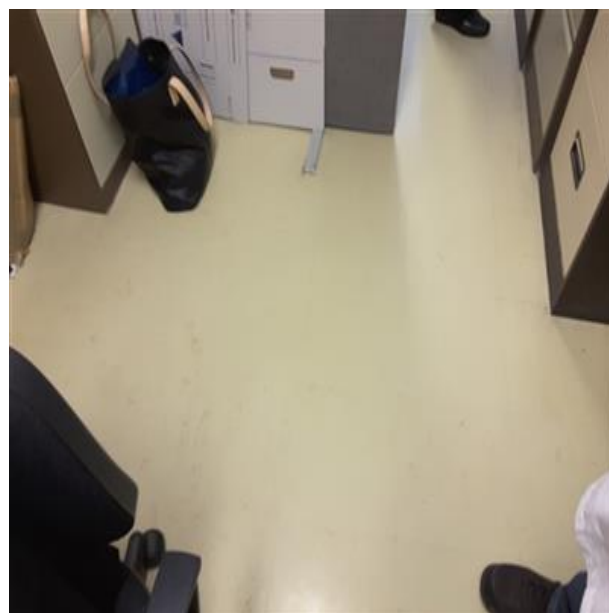
6

Priority 3: Manage in Place & Monitor Periodically.

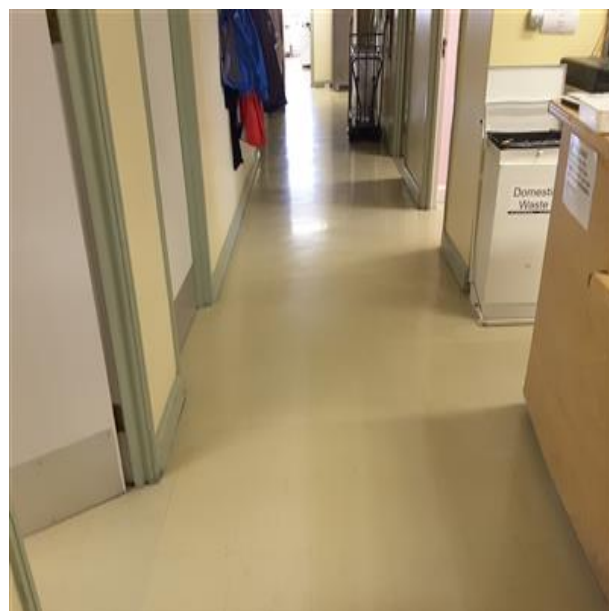
6

Priority 3: Manage in Place & Monitor Periodically.

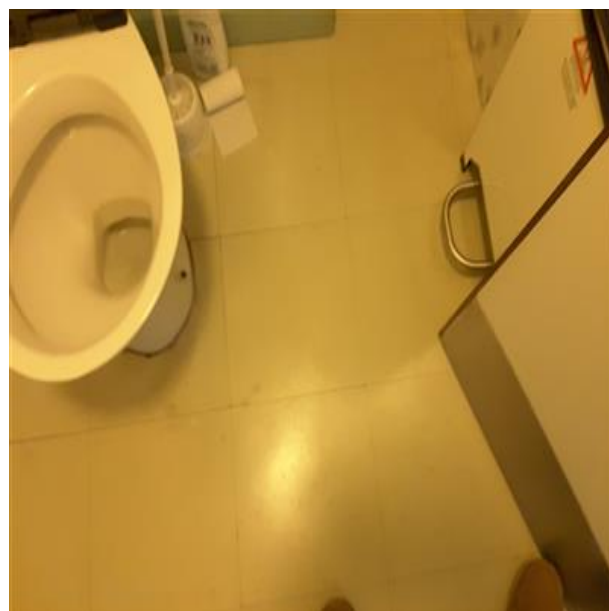
6

Priority 3: Manage in Place & Monitor Periodically.

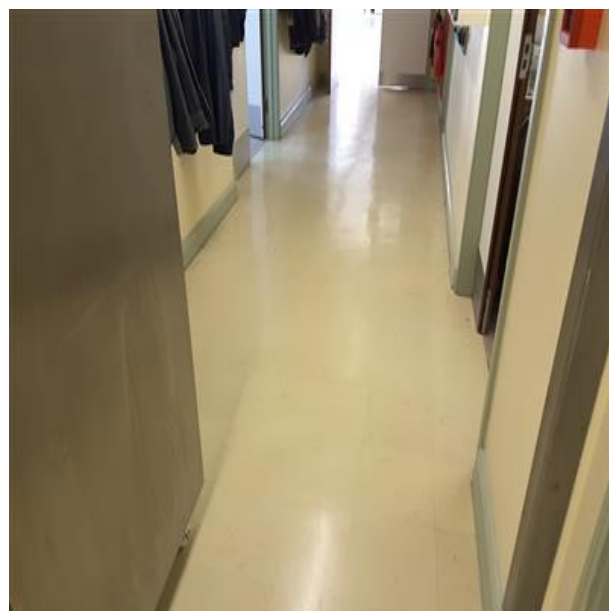
6

Priority 3: Manage in Place & Monitor Periodically.

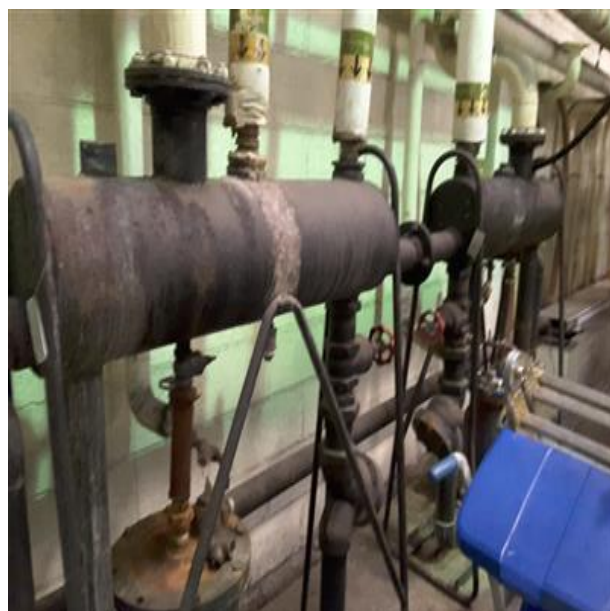
5

Priority 3: Manage in Place & Monitor Periodically.

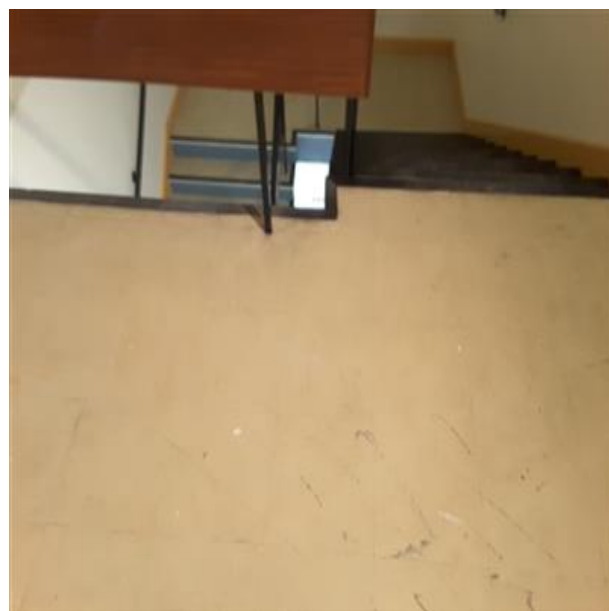
5

Priority 3: Manage in Place & Monitor Periodically.

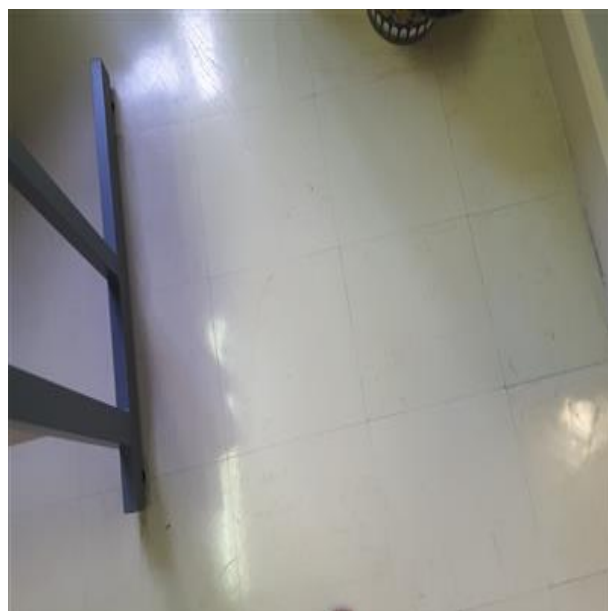
5

Priority 3: Manage in Place & Monitor Periodically.

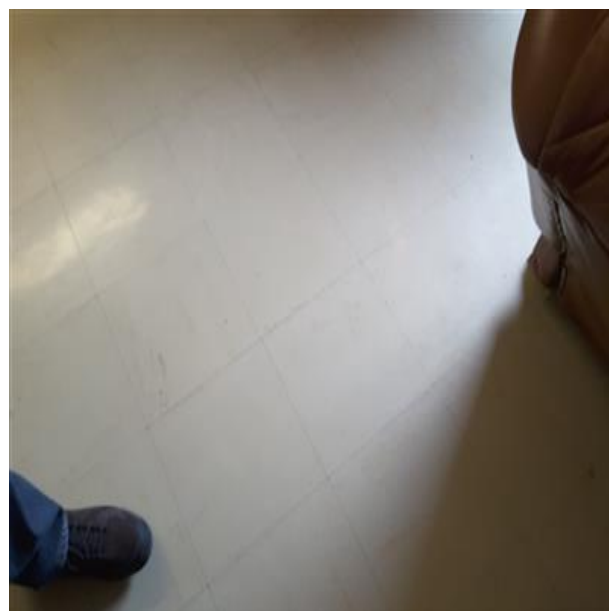
5

Priority 3: Manage in Place & Monitor Periodically.

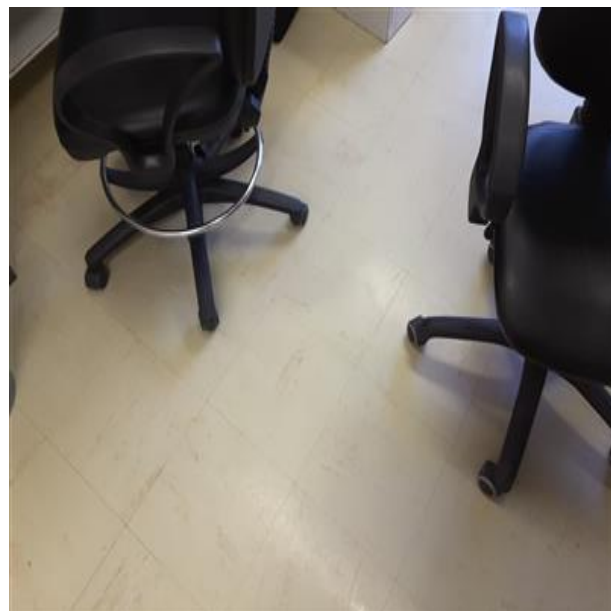
5

Priority 3: Manage in Place & Monitor Periodically.

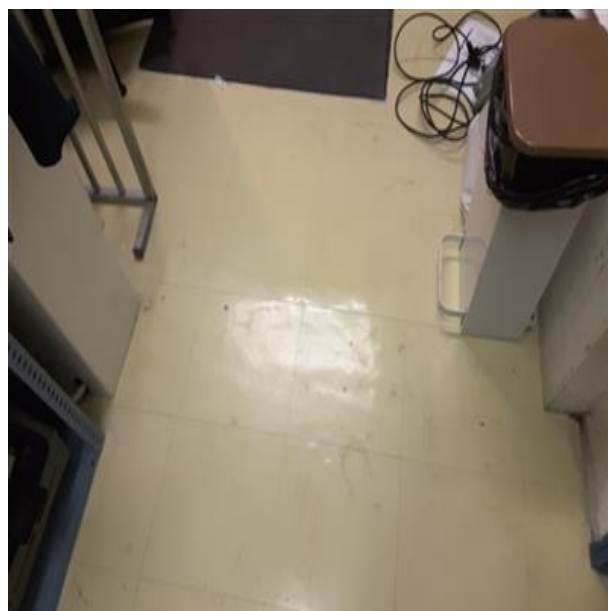
5

Priority 3: Manage in Place & Monitor Periodically.

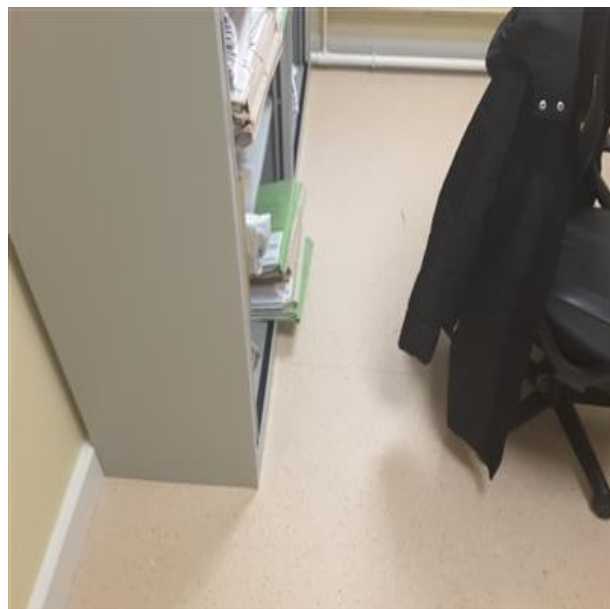
5

Priority 3: Manage in Place & Monitor Periodically.

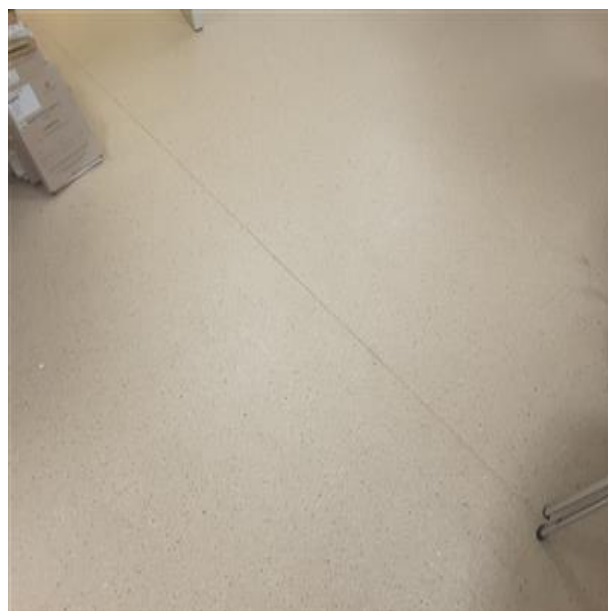
5

Priority 3: Manage in Place & Monitor Periodically.

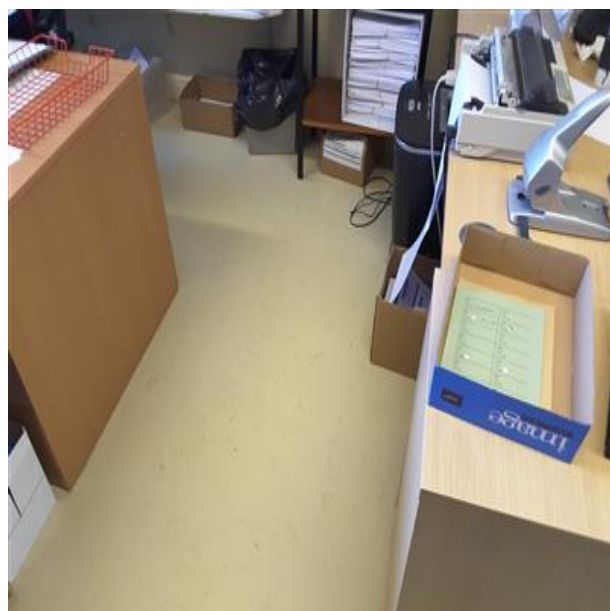
5

Priority 3: Manage in Place & Monitor Periodically.

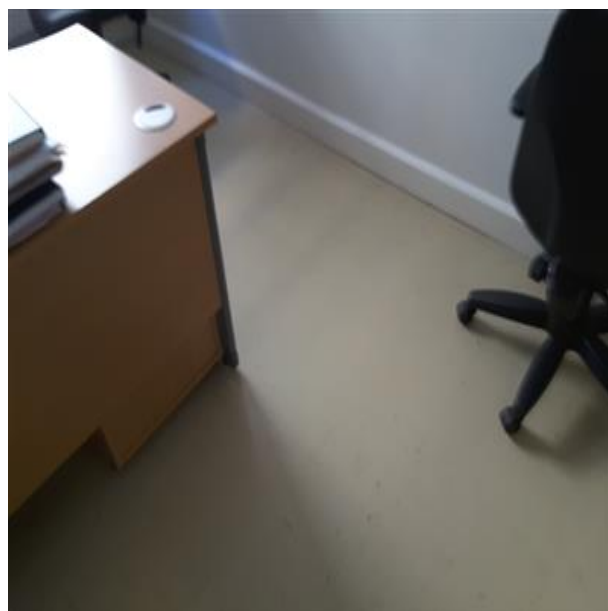
5

Priority 3: Manage in Place & Monitor Periodically.

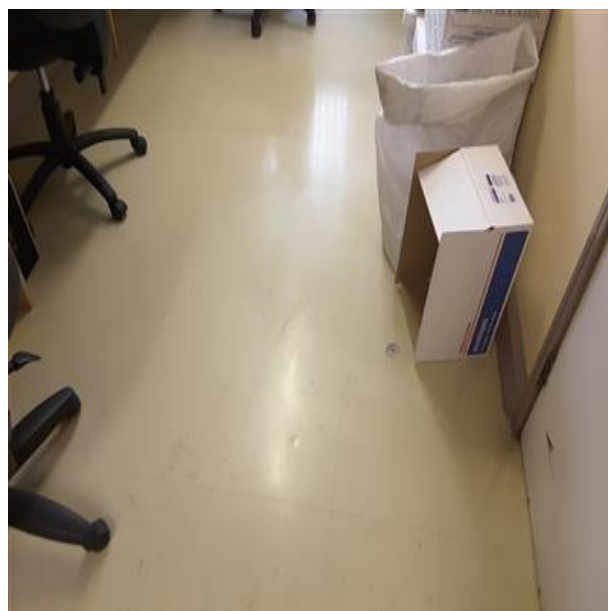
5

Priority 3: Manage in Place & Monitor Periodically.

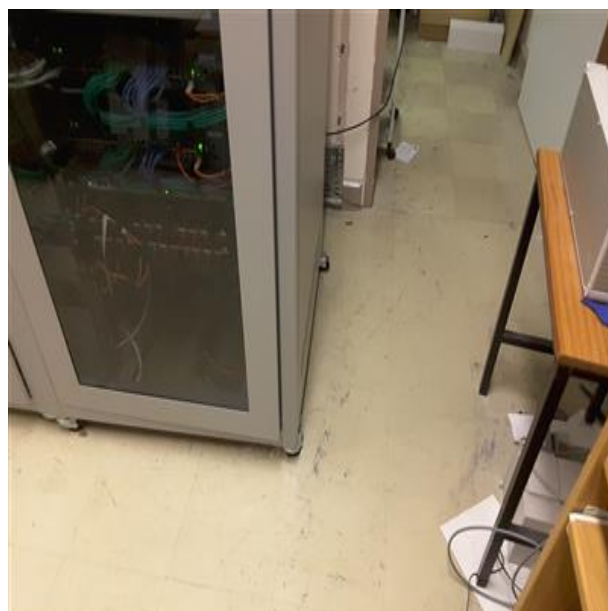
5

Priority 3: Manage in Place & Monitor Periodically.

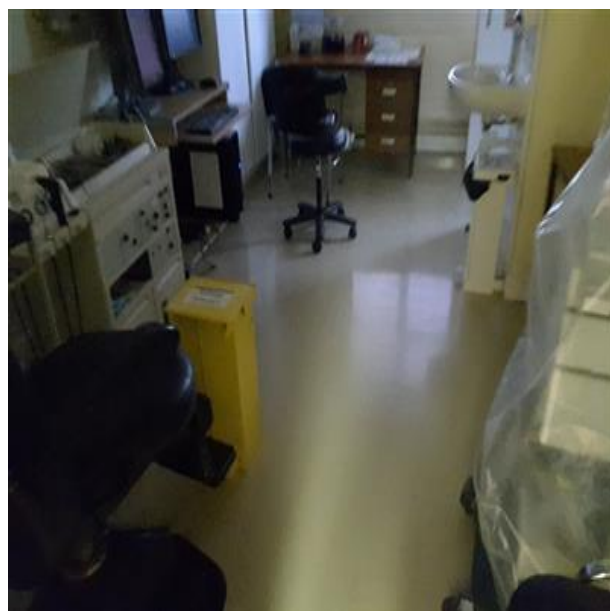
5

Priority 3: Manage in Place & Monitor Periodically.

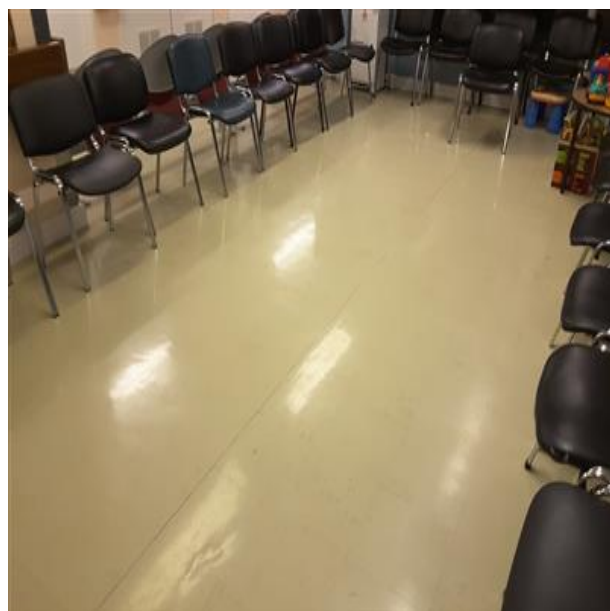
5

Priority 3: Manage in Place & Monitor Periodically.

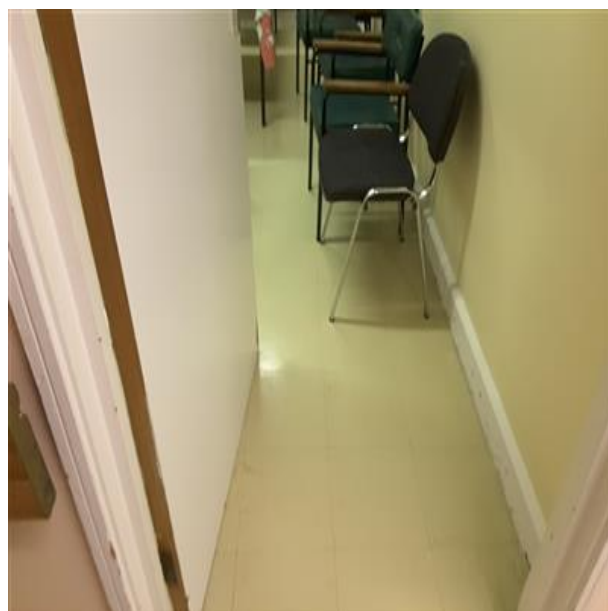
5

Priority 3: Manage in Place & Monitor Periodically.

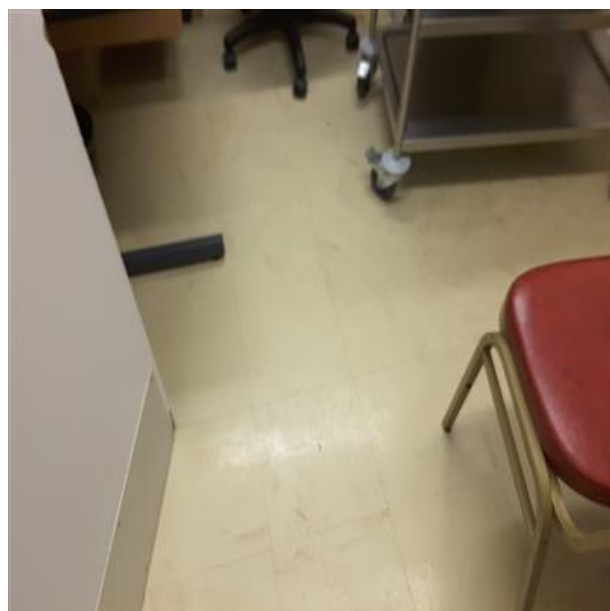
Material and Priority Assessment Score: 5

Priority 3: Manage in Place & Monitor Periodically.

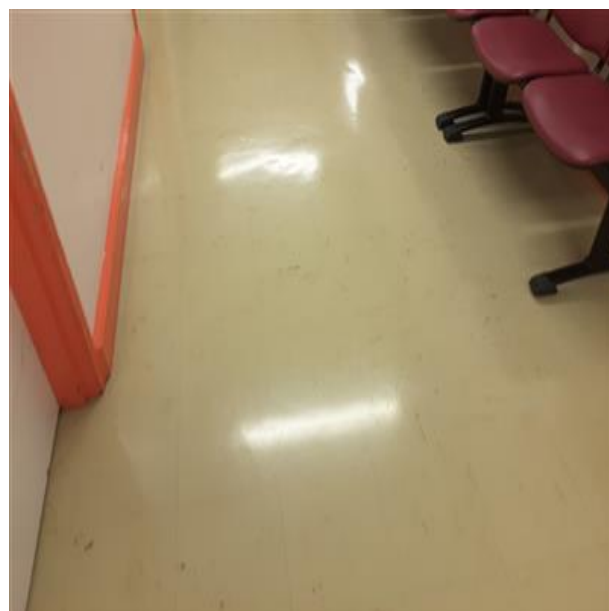
5

Priority 3: Manage in Place & Monitor Periodically.

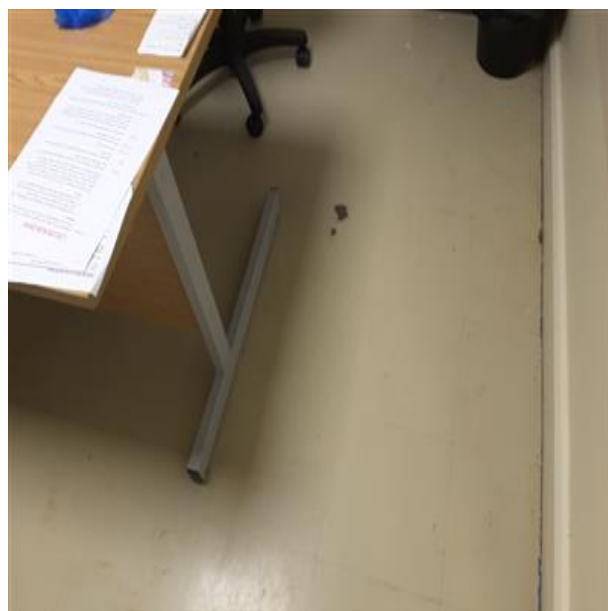
5

Priority 3: Manage in Place & Monitor Periodically.

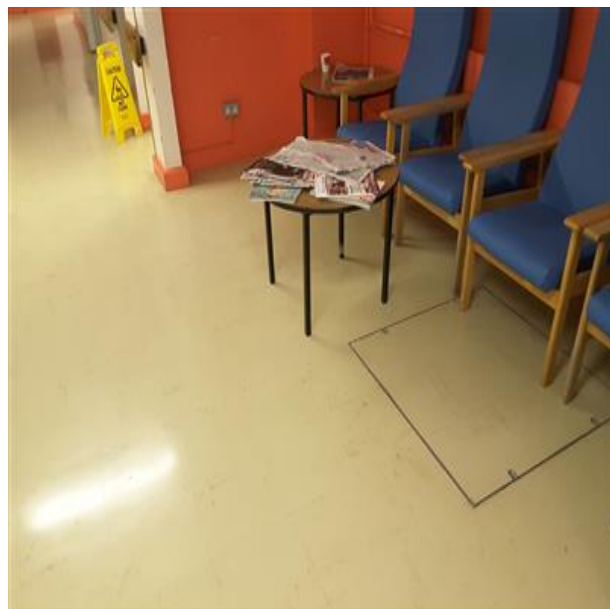
5

Priority 3: Manage in Place & Monitor Periodically.

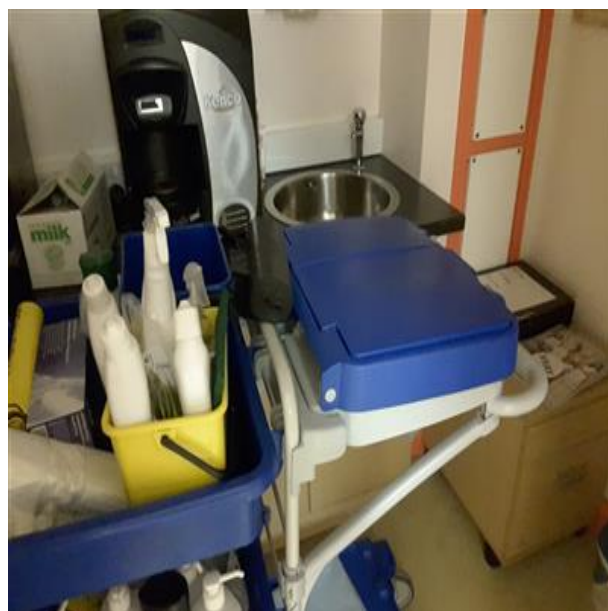
5

Priority 3: Manage in Place & Monitor Periodically.

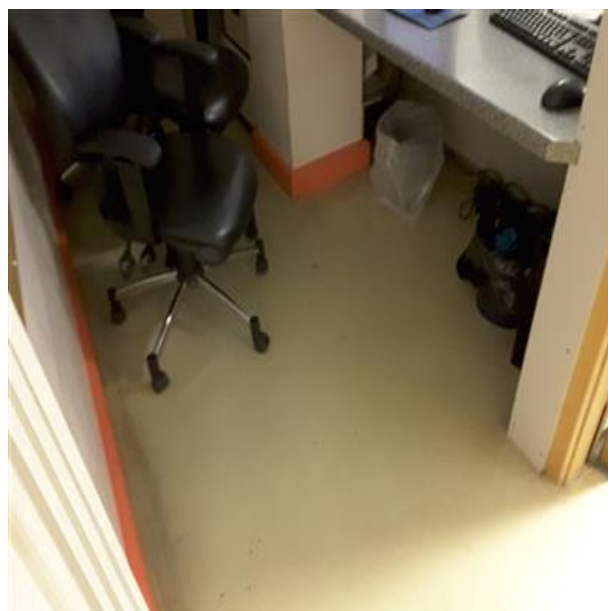
5

Priority 3: Manage in Place & Monitor Periodically.

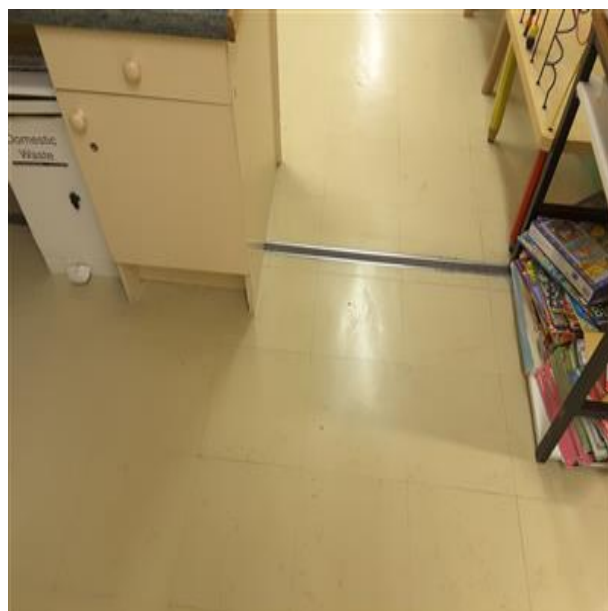
5

Priority 3: Manage in Place & Monitor Periodically.

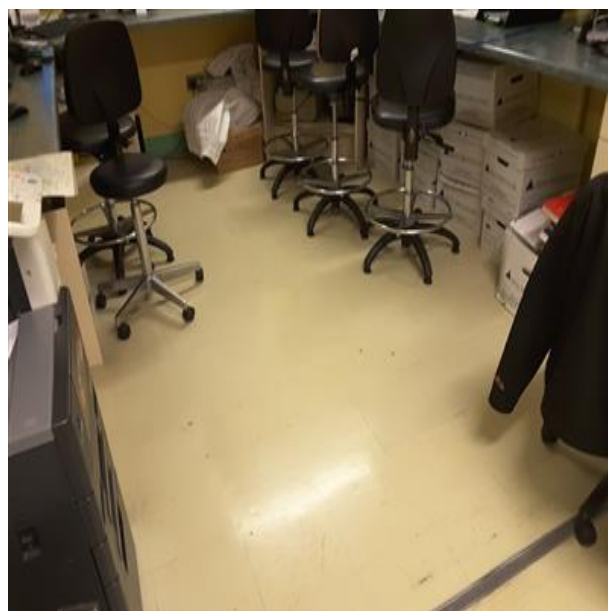
5

Priority 3: Manage in Place & Monitor Periodically.

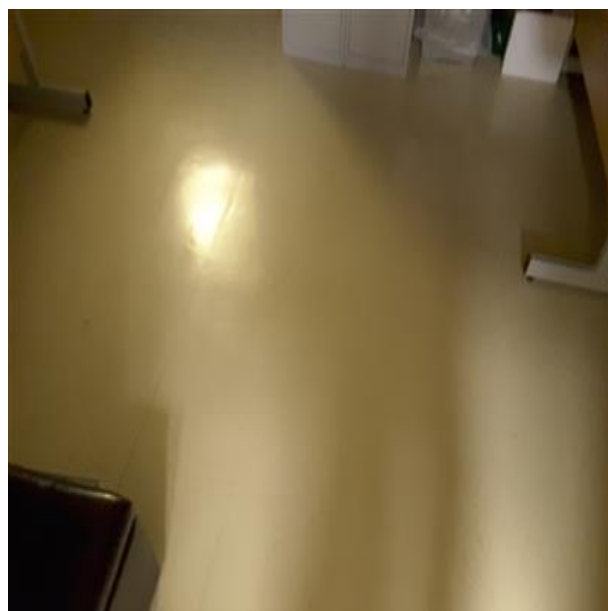
5

Priority 3: Manage in Place & Monitor Periodically.

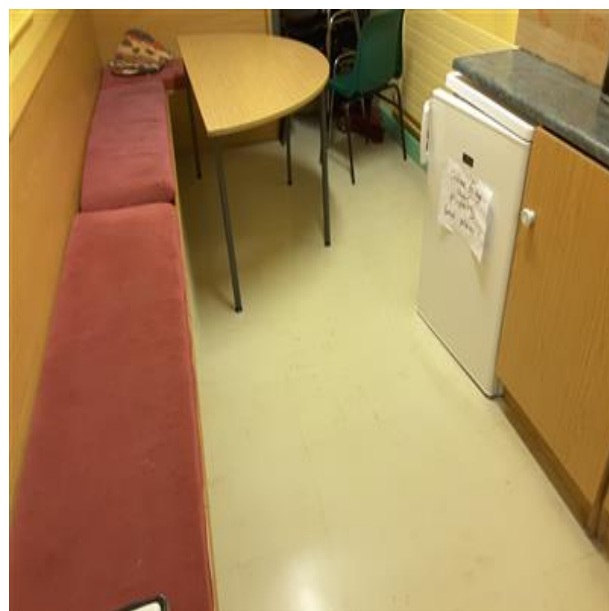
5

Priority 3: Manage in Place & Monitor Periodically.

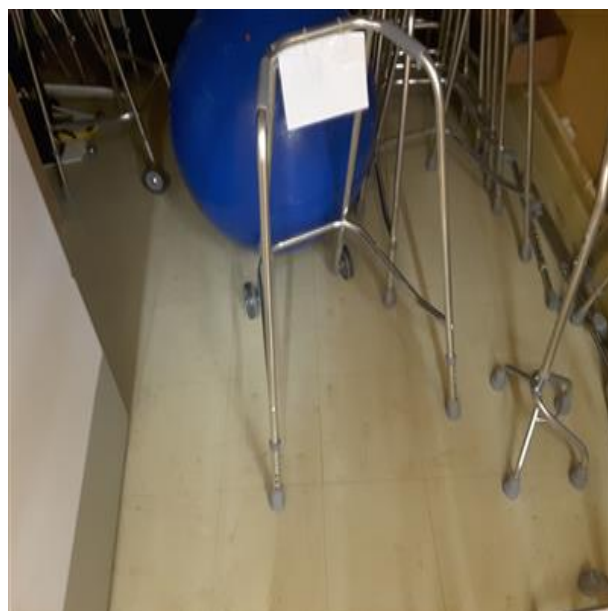
5

Priority 3: Manage in Place & Monitor Periodically.

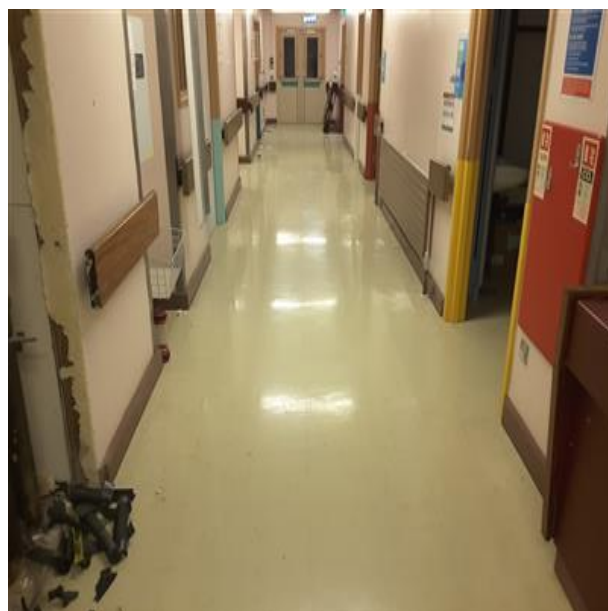
5

Priority 3: Manage in Place & Monitor Periodically.

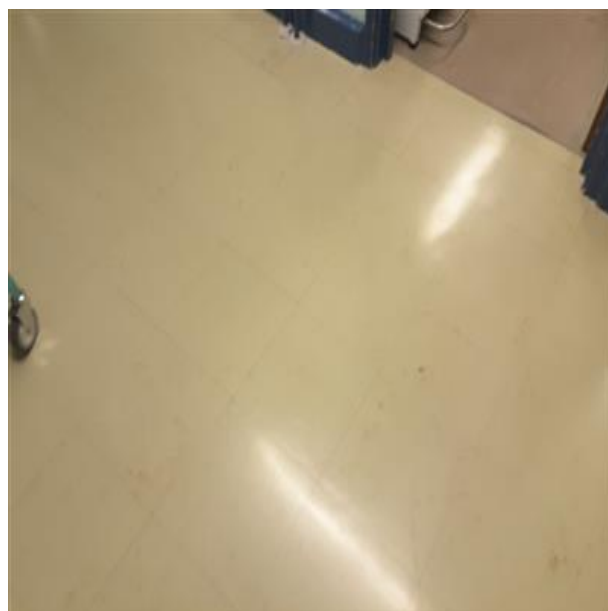
| <b>Material and Priority Assessment Score:</b> | <b>5</b> |

Priority 3: Manage in Place & Monitor Periodically.

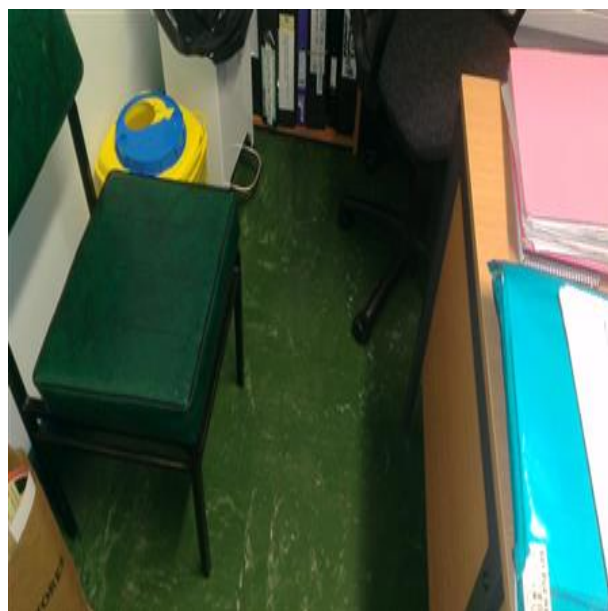
5

Priority 3: Manage in Place & Monitor Periodically.

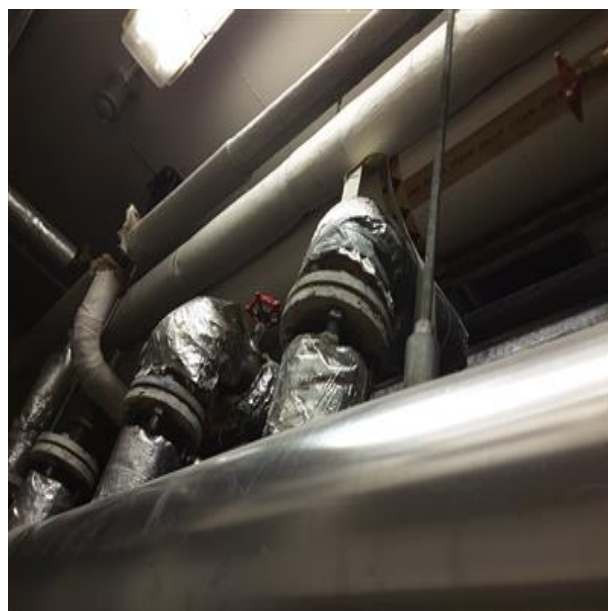
4

Priority 3: Manage in Place & Monitor Periodically.

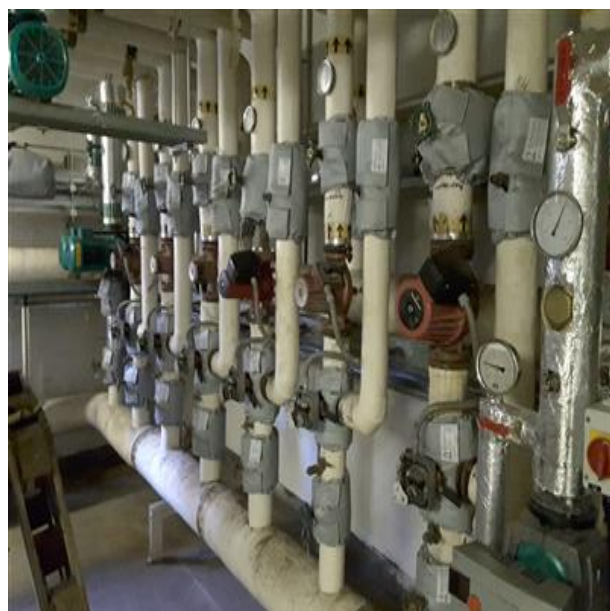
4

Priority 3: Manage in Place & Monitor Periodically.

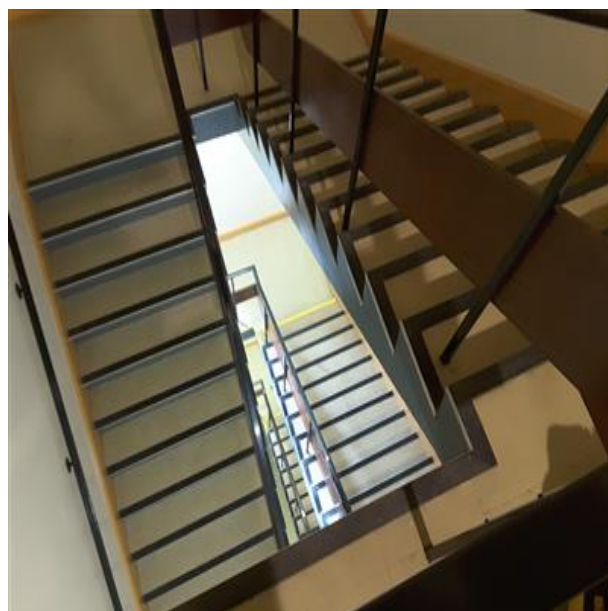
4

Priority 3: Manage in Place & Monitor Periodically.

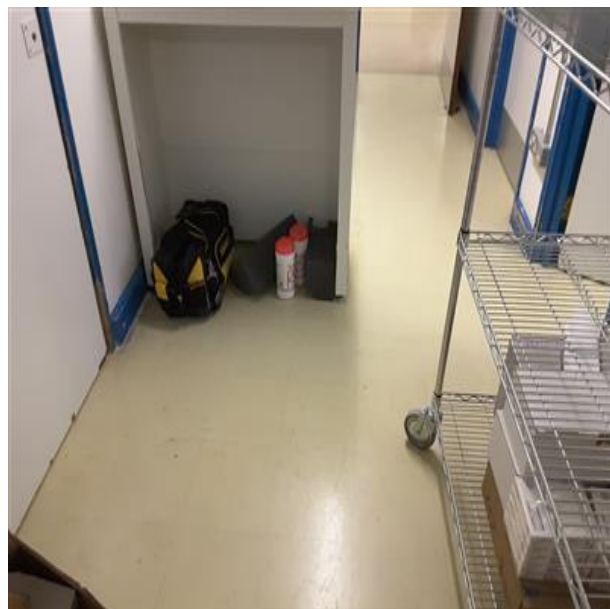
4

Priority 3: Manage in Place & Monitor Periodically.

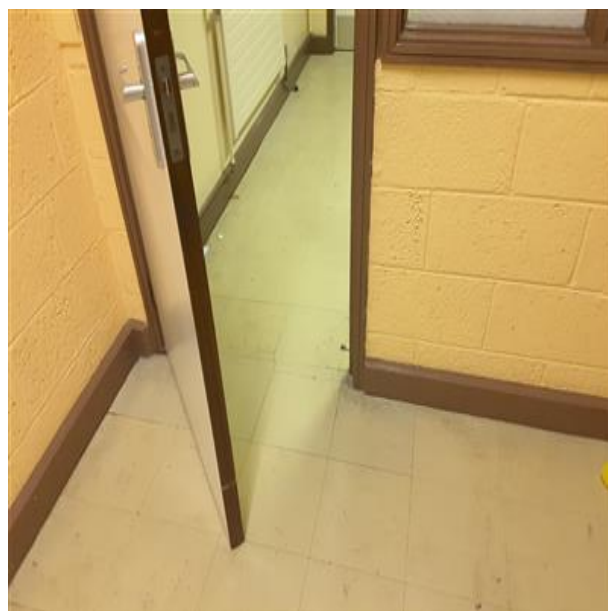
4

Priority 3: Manage in Place & Monitor Periodically.

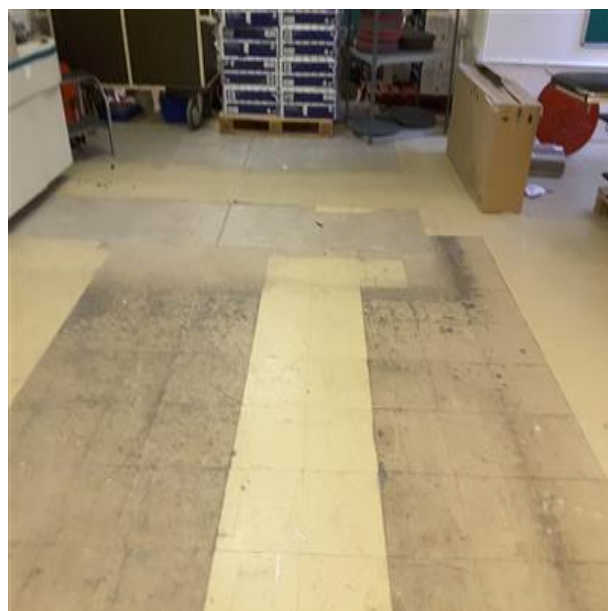
4

Priority 3: Manage in Place & Monitor Periodically.

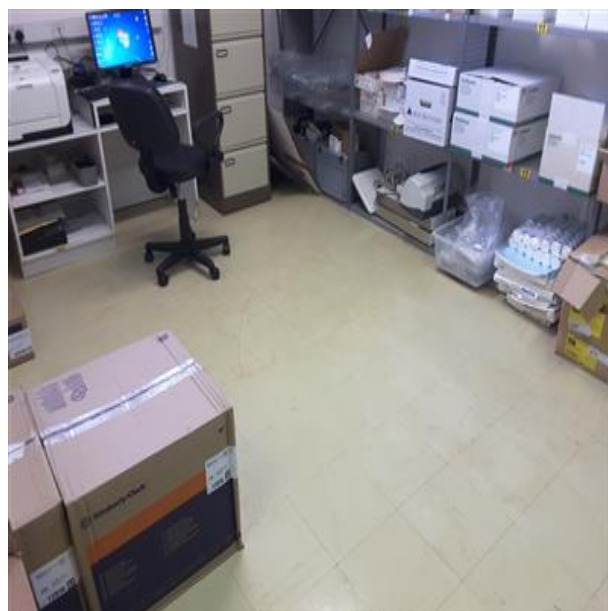
4

Priority 3: Manage in Place & Monitor Periodically.

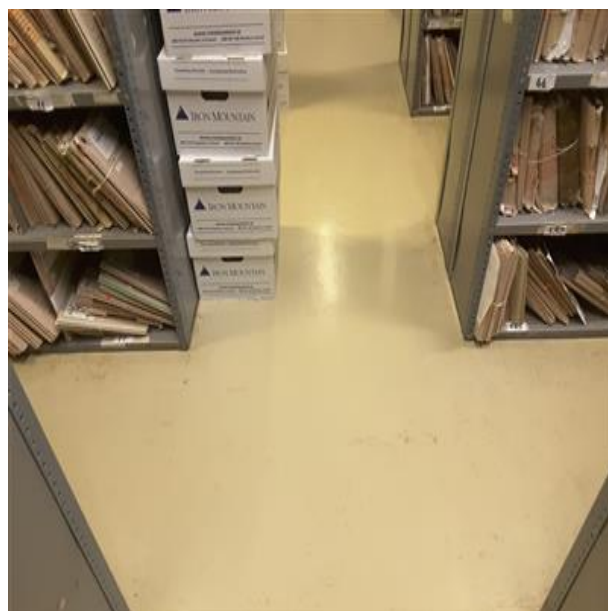
4

Priority 3: Manage in Place & Monitor Periodically.

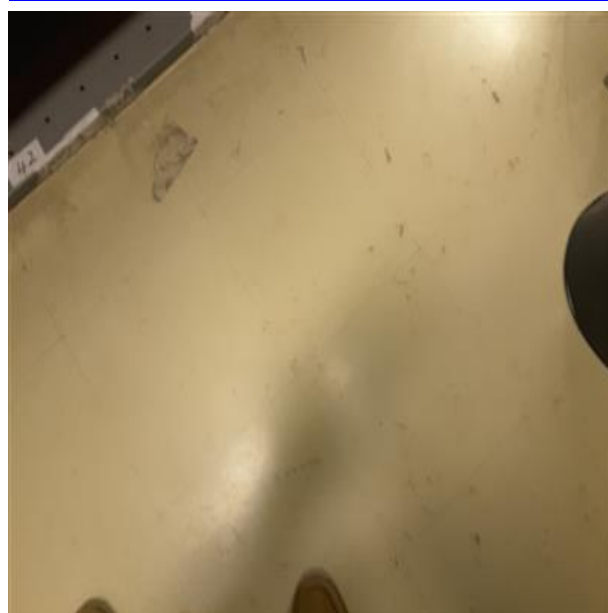
4

Priority 3: Manage in Place & Monitor Periodically.

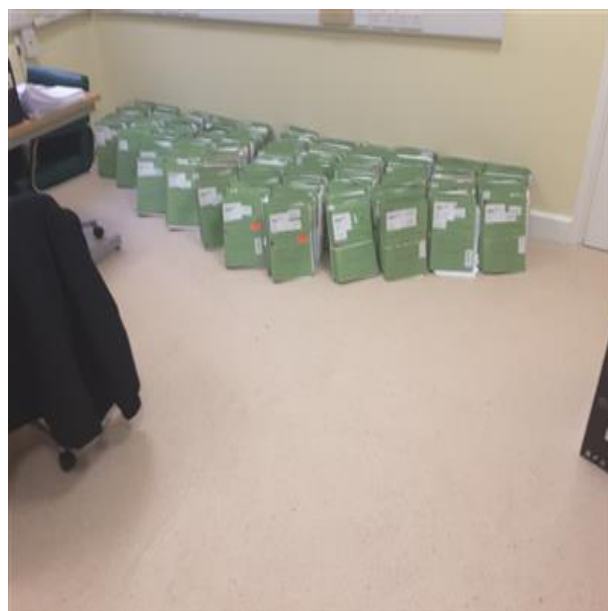
4

Priority 3: Manage in Place & Monitor Periodically.

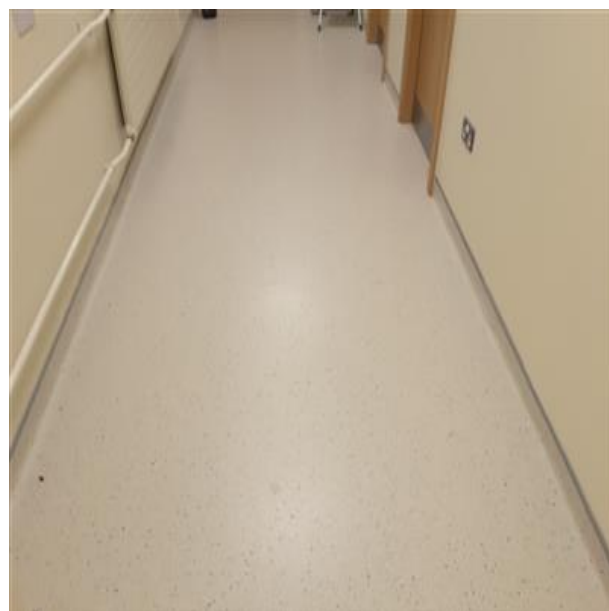
4

Priority 3: Manage in Place & Monitor Periodically.

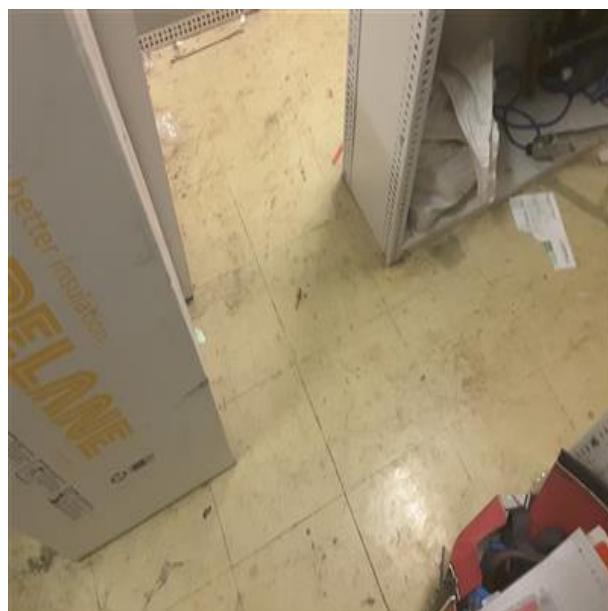
4

Priority 3: Manage in Place & Monitor Periodically.

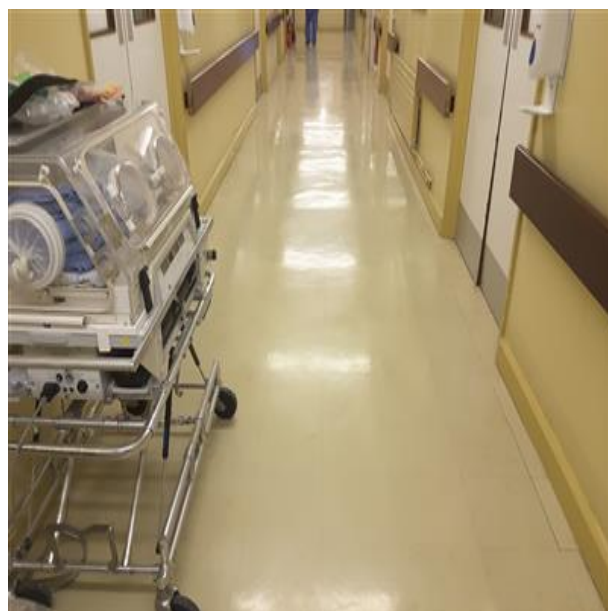
4

Priority 3: Manage in Place & Monitor Periodically.

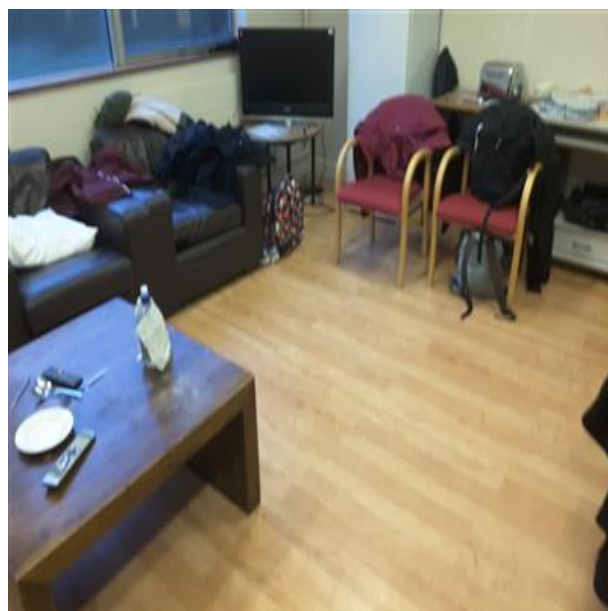
4

Priority 3: Manage in Place & Monitor Periodically.

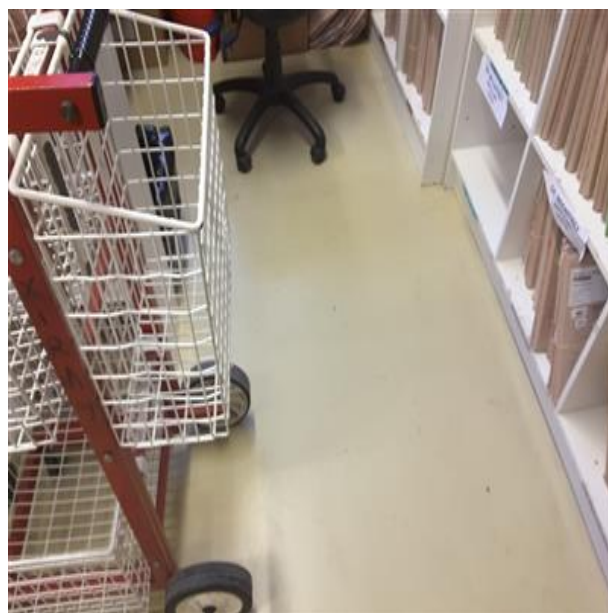
4

Priority 3: Manage in Place & Monitor Periodically.

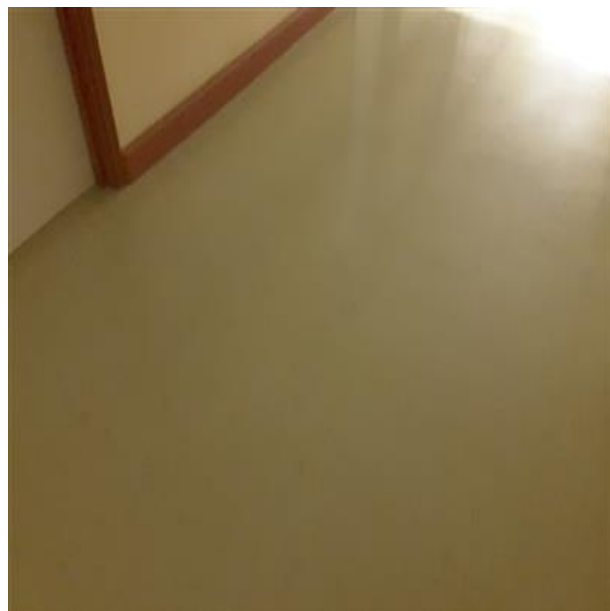
4

Priority 3: Manage in Place & Monitor Periodically.

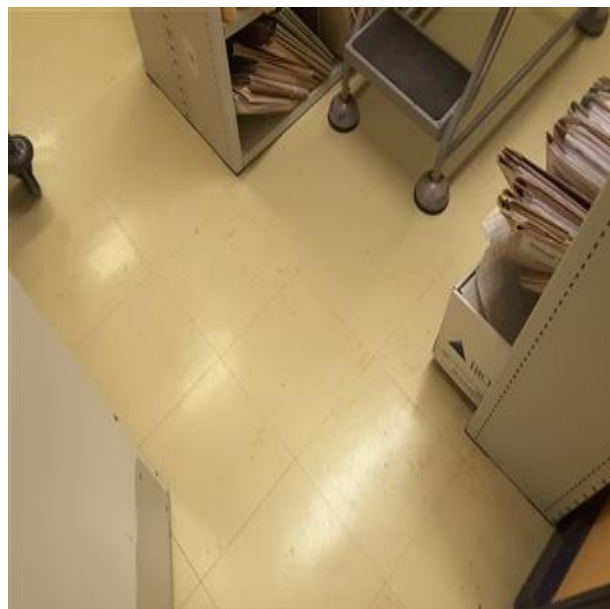
4

Priority 3: Manage in Place & Monitor Periodically.

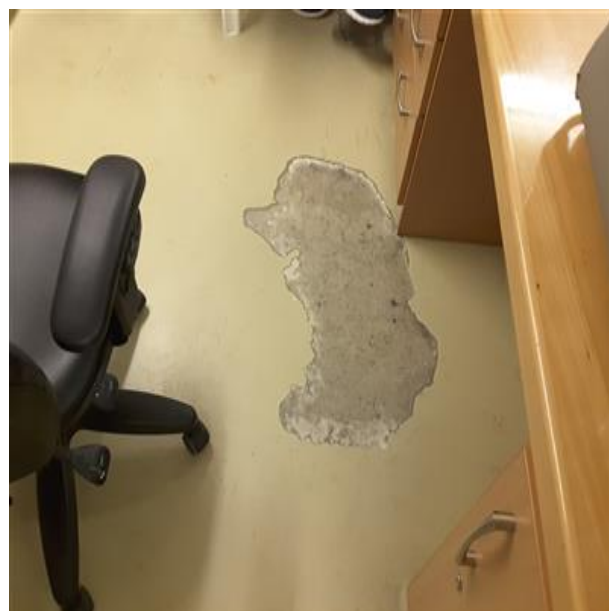
4

Priority 3: Manage in Place & Monitor Periodically.

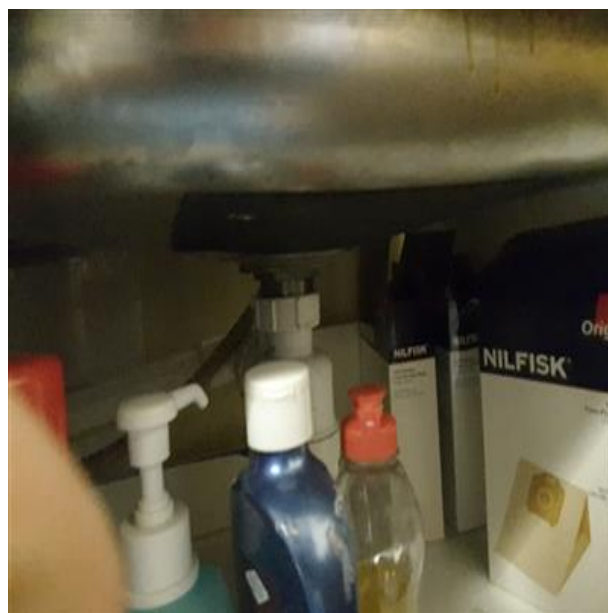
3

Priority 3: Manage in Place & Monitor Periodically.
