# BUILDING CONDITION ASSESSMENT REPORT

**Fairhill Lodge, Dungloe, Co. Donegal**

**7<sup>th</sup> June 2025**

Project Title: Assessment of Fairhill Lodge, Dungloe, Co. Donegal

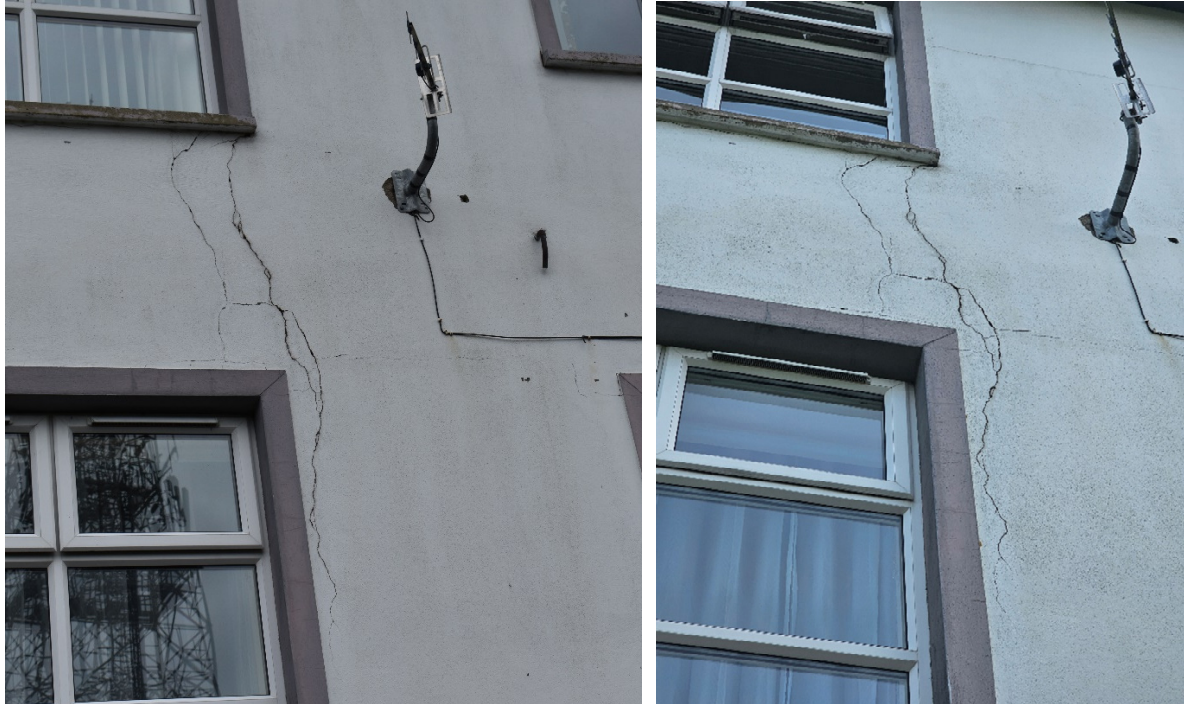
RHS Elevation – Vertical crack present above the window. (Pictures – Left: 2021, Right: 2025)

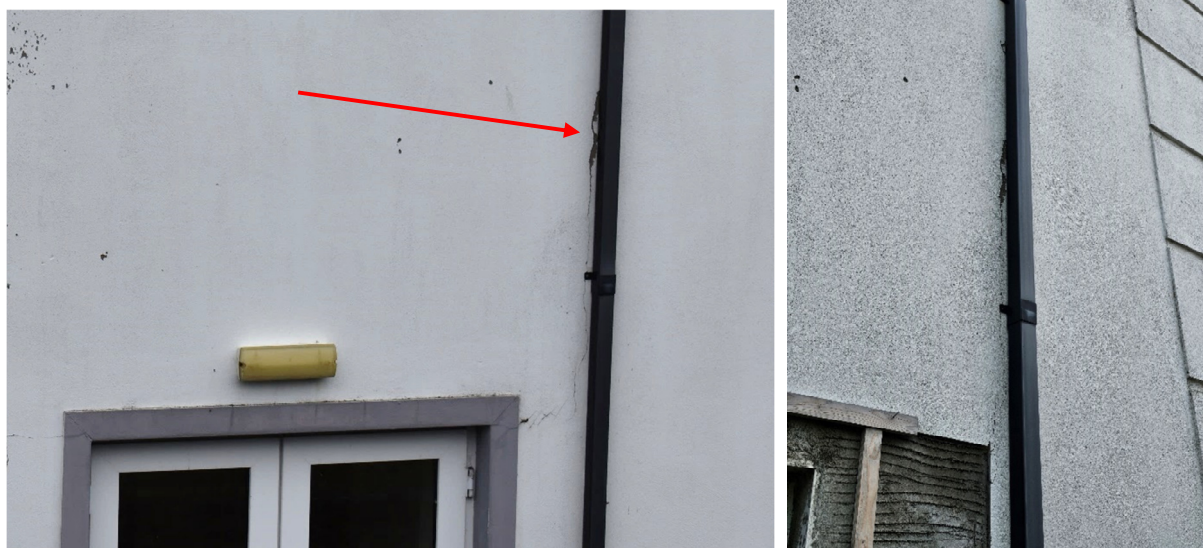
RHS Elevation – Vertical crack present behind rainwater down pipe. (Pictures – Left: 2021, Right: 2025)

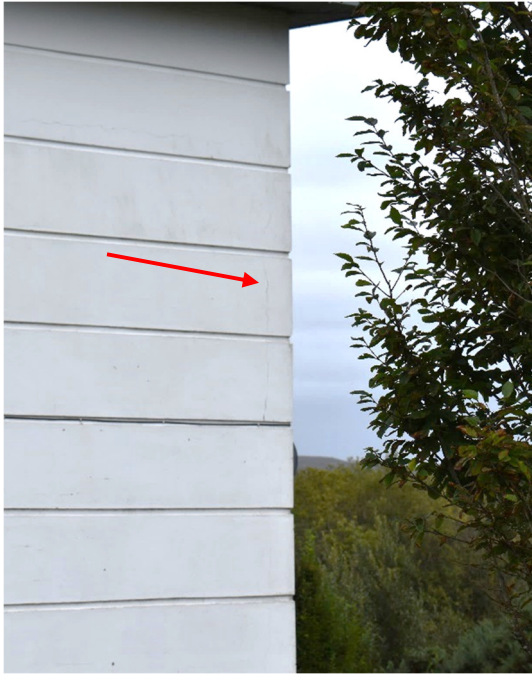
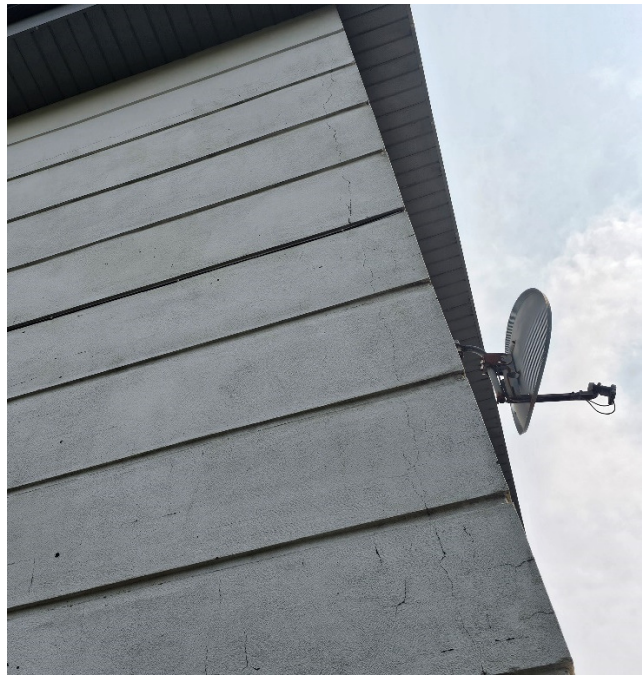
RHS Elevation – Vertical crack present near the corner of the elevation. (Pictures – Left: 2021, Right: 2025)

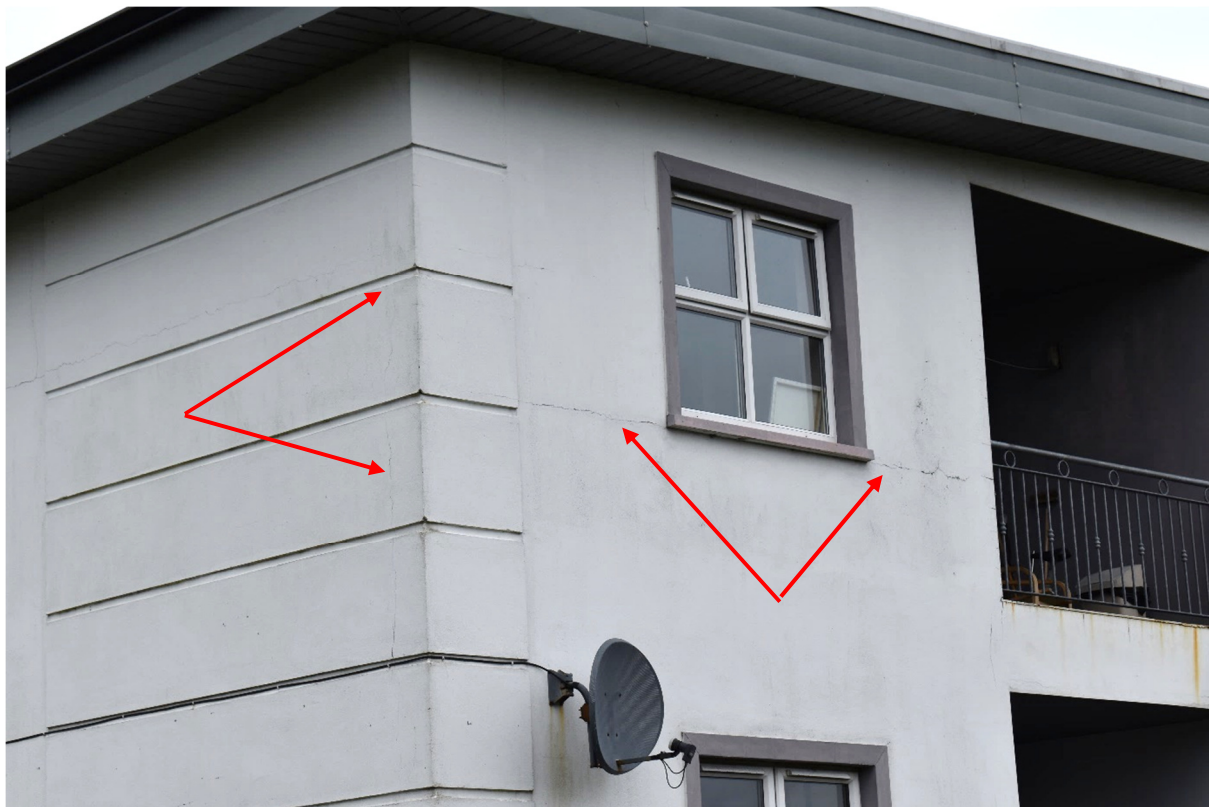
Rear Elevation – Vertical crack present near the corner of the elevation. Horizontal crack near the window sill. (Picture: 2021)

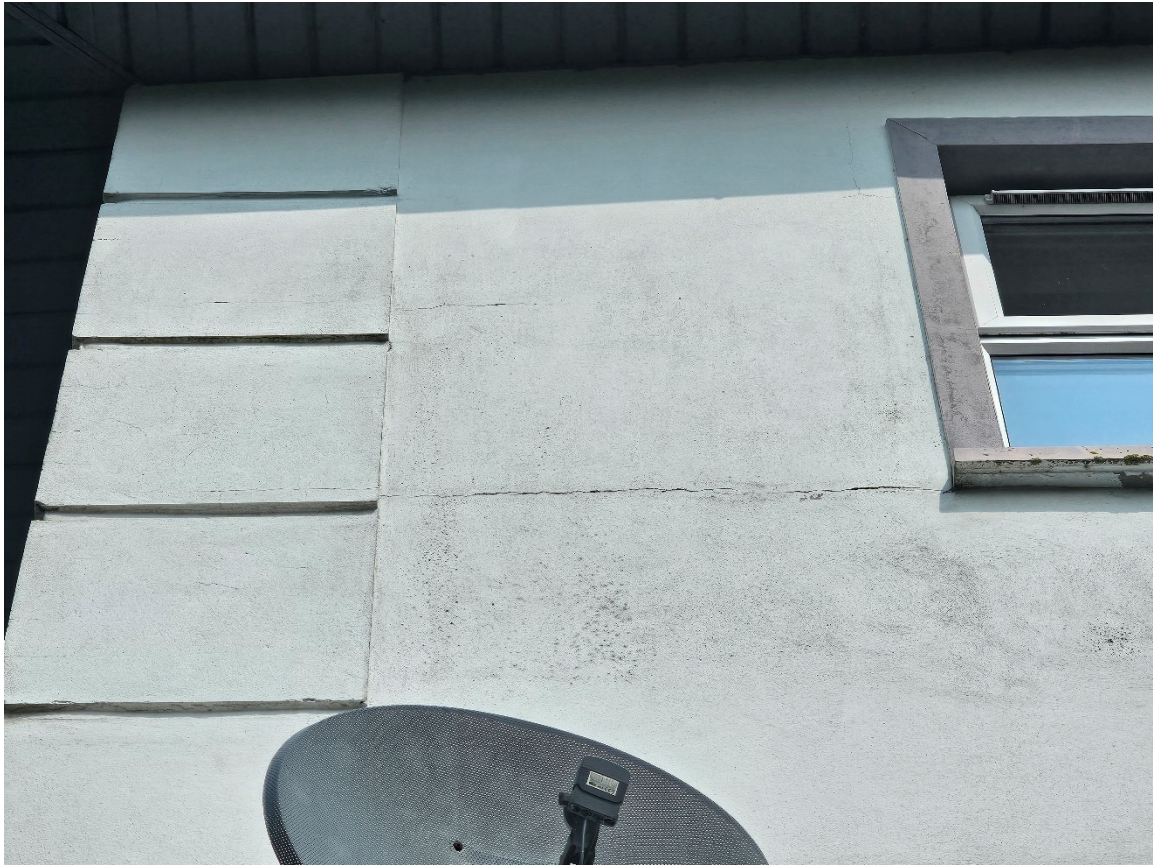
Rear Elevation – Horizontal crack near the window cill. (Picture: 2025)

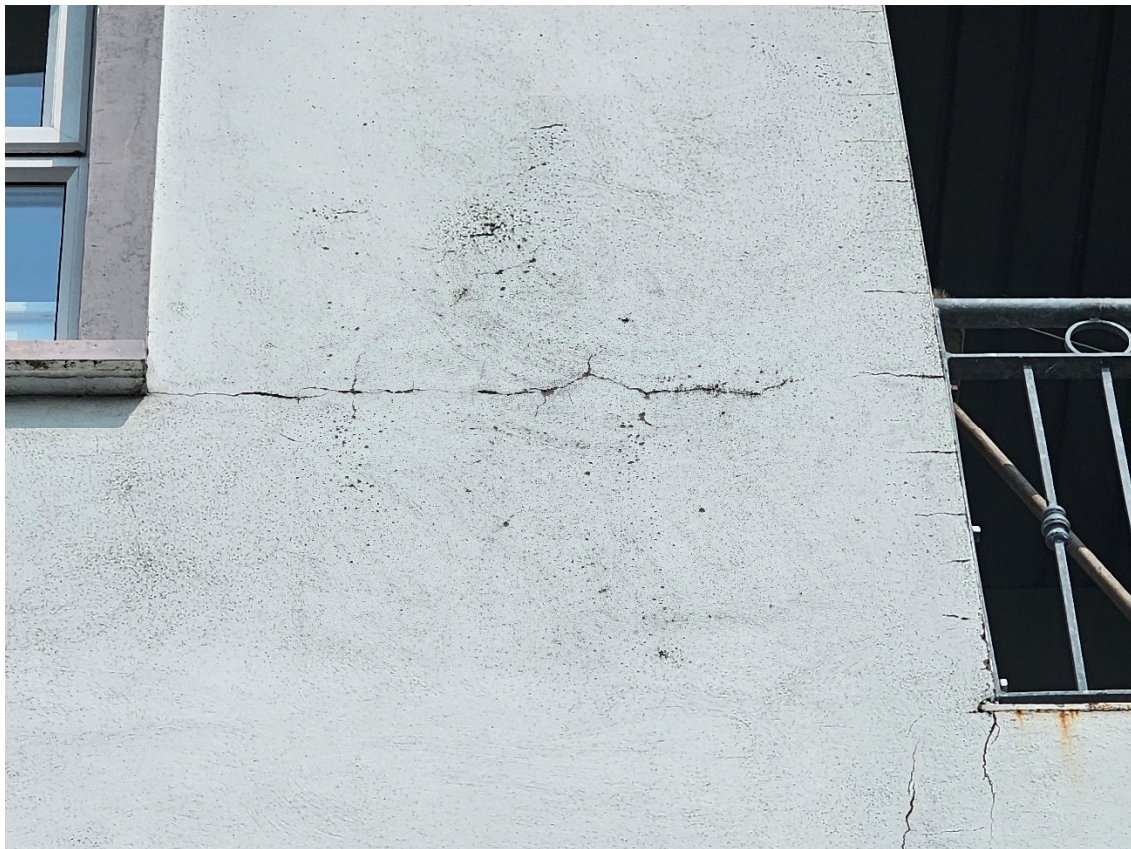
Rear Elevation – Horizontal crack near the window cill. (Picture: 2025)

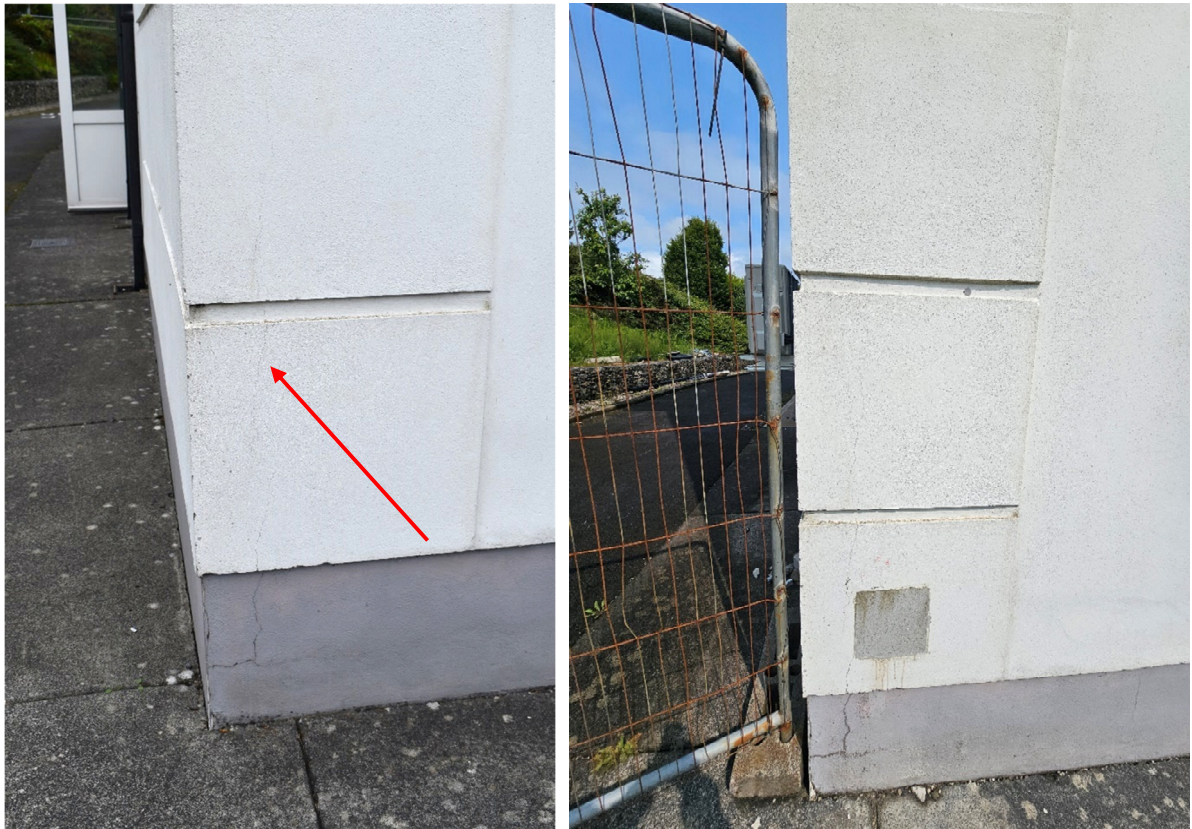
Rear Elevation – Vertical crack present near the corner of the elevation. (Pictures – Left: 2021, Right: 2025)

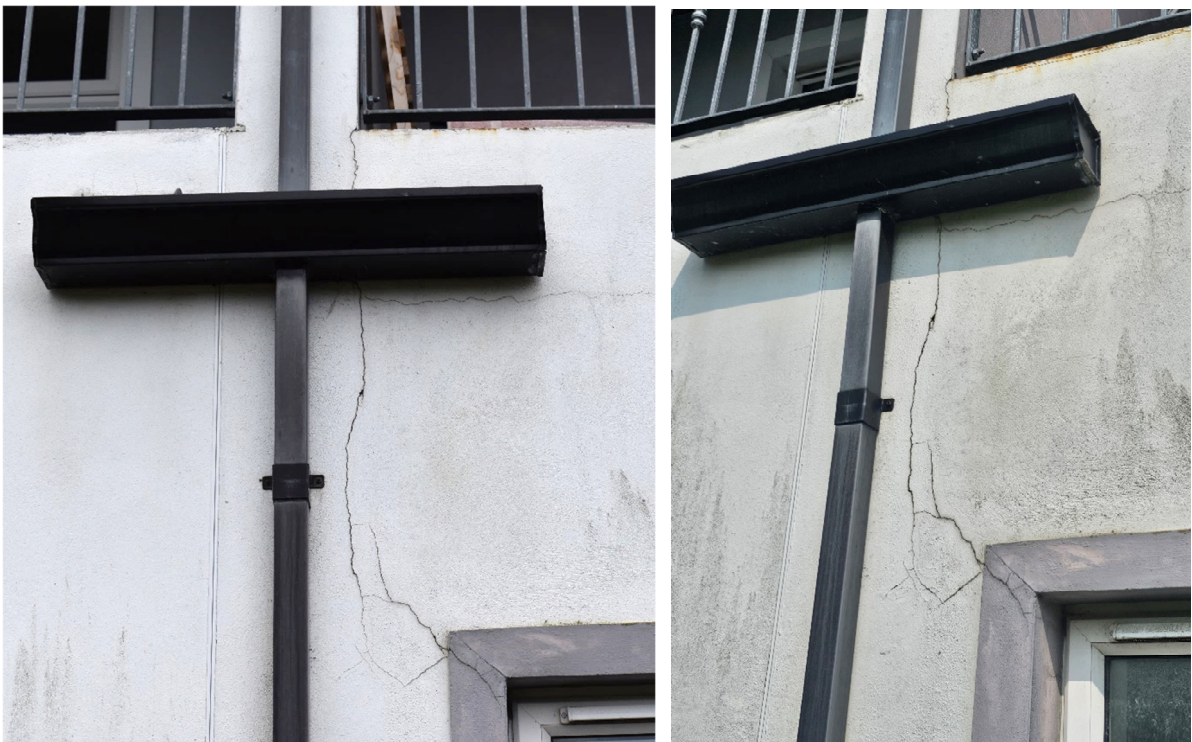
Rear Elevation – Vertical crack present above the door opening and pattern like cracking can be seen in the above photo. (Pictures – Left: 2021, Right: 2025)

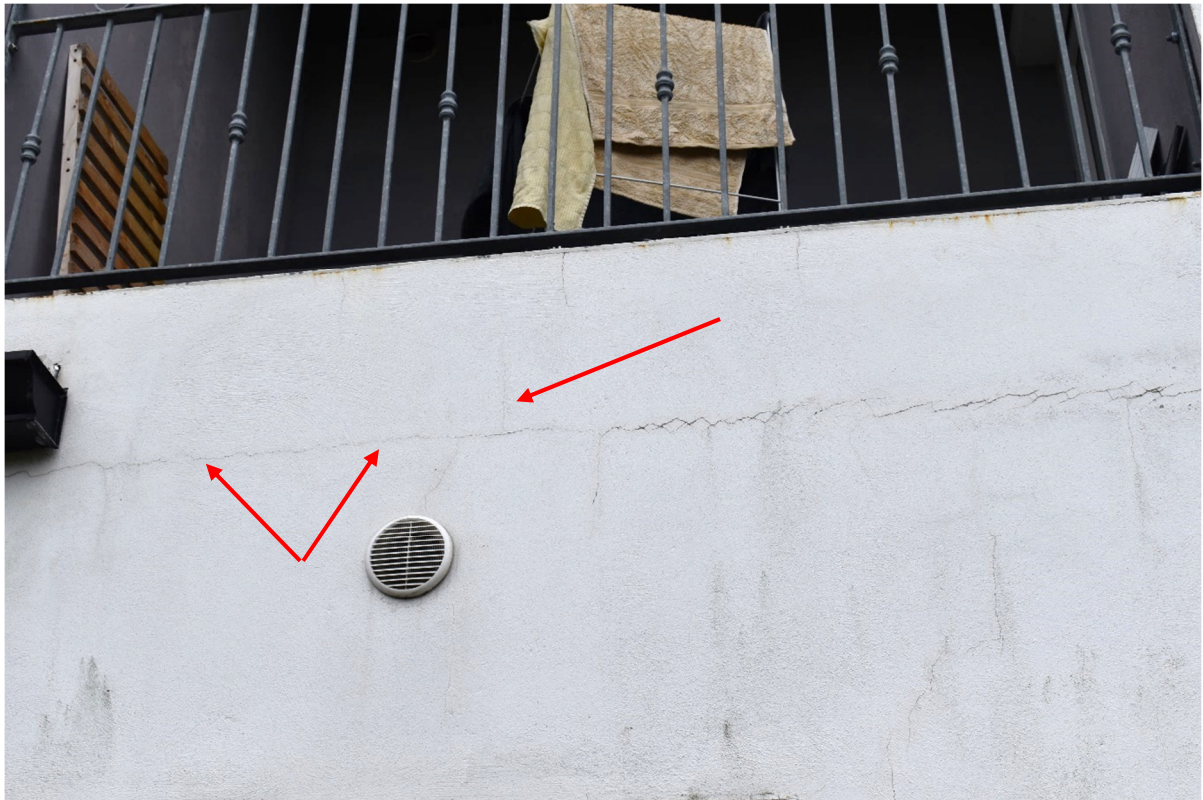
Rear Elevation – Pattern like cracks can be seen in the above photo. (Picture – 2021)

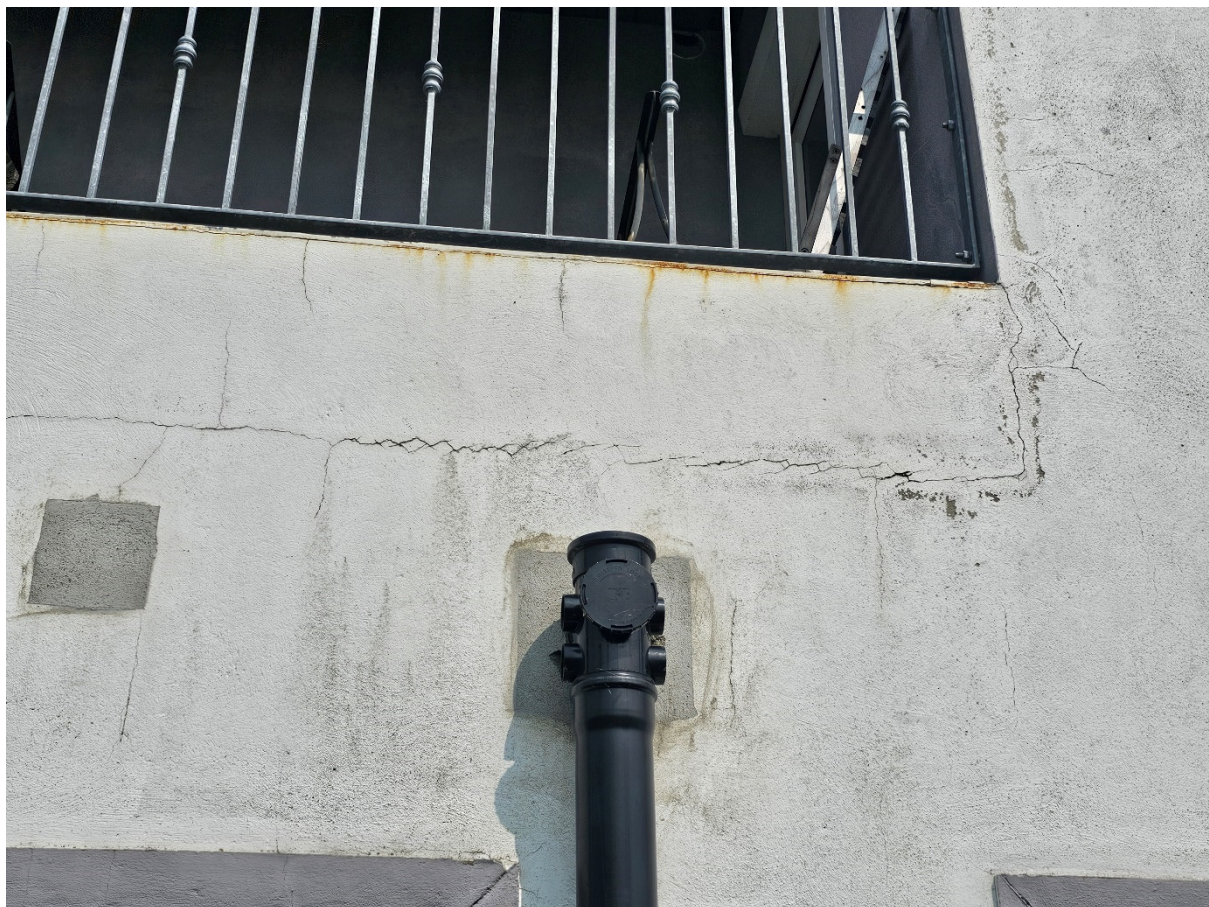
Rear Elevation – Pattern like cracks can be seen in the above photo. (Picture – 2025)

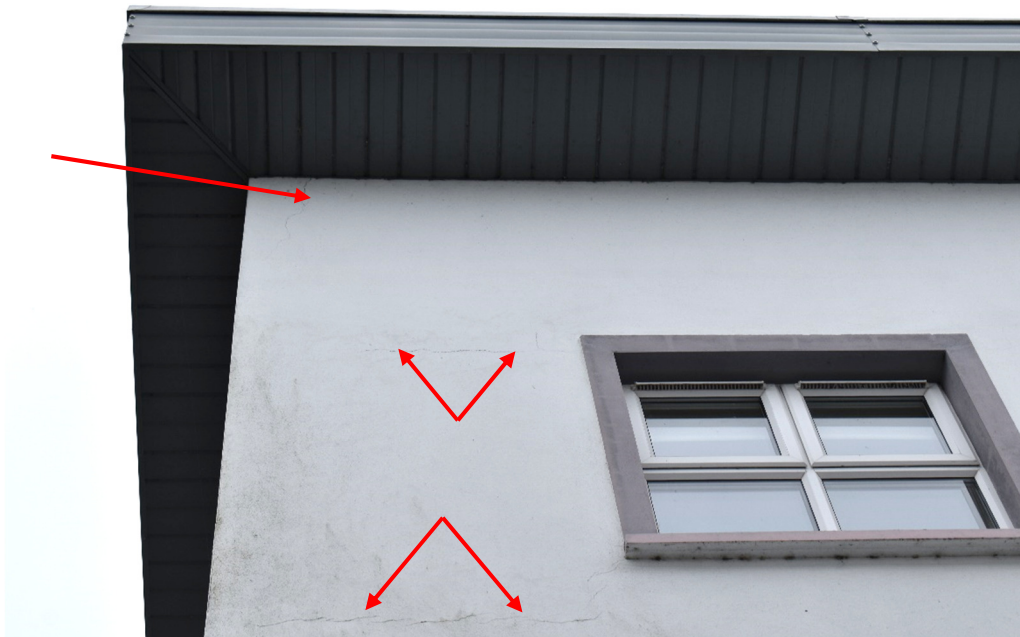
Rear Elevation – Horizontal crack from the window head and cill level can be seen in the above photo. A vertical crack near the corner of the elevation can be seen in the above photo also. (Picture – 2021)

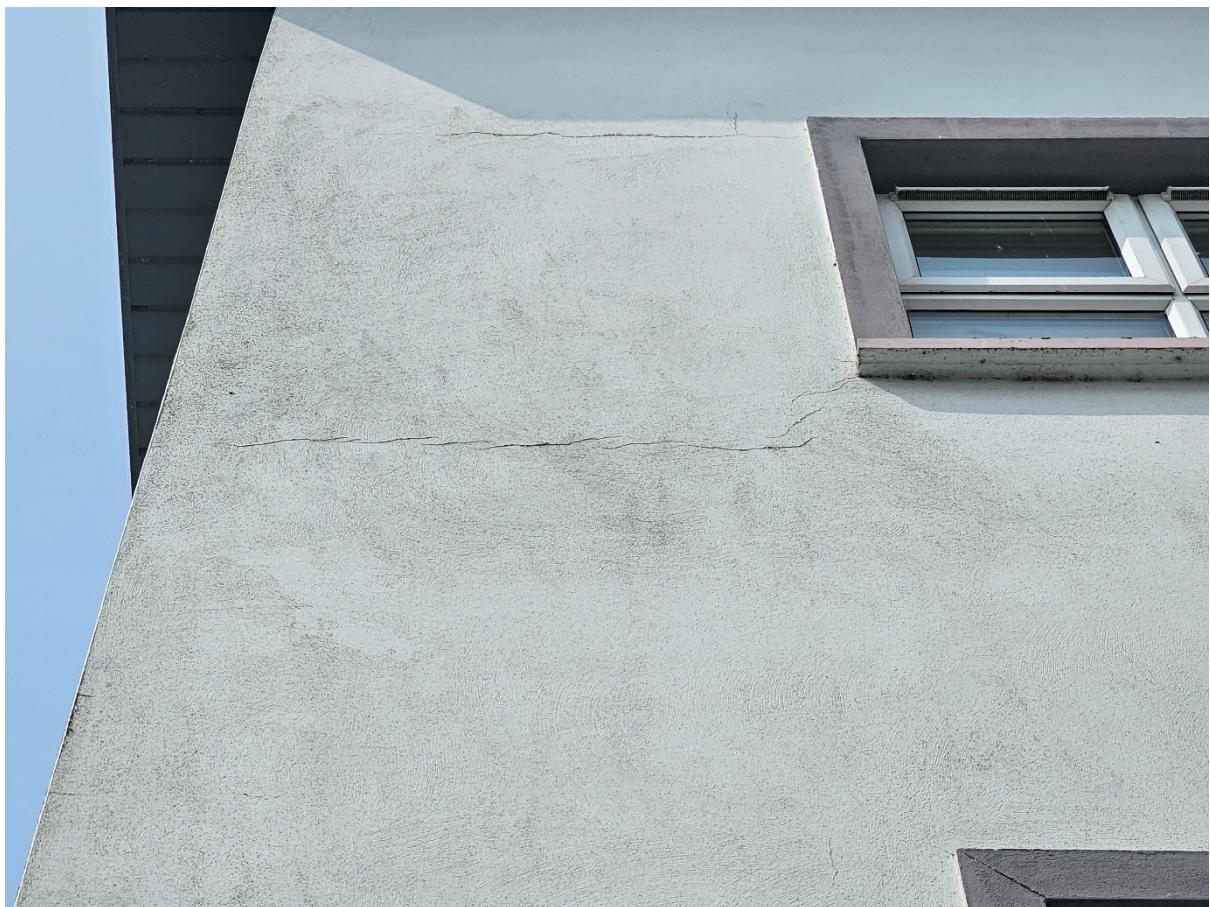
Rear Elevation – Horizontal crack from the window head and cill level can be seen in the above photo. (Picture – 2025)

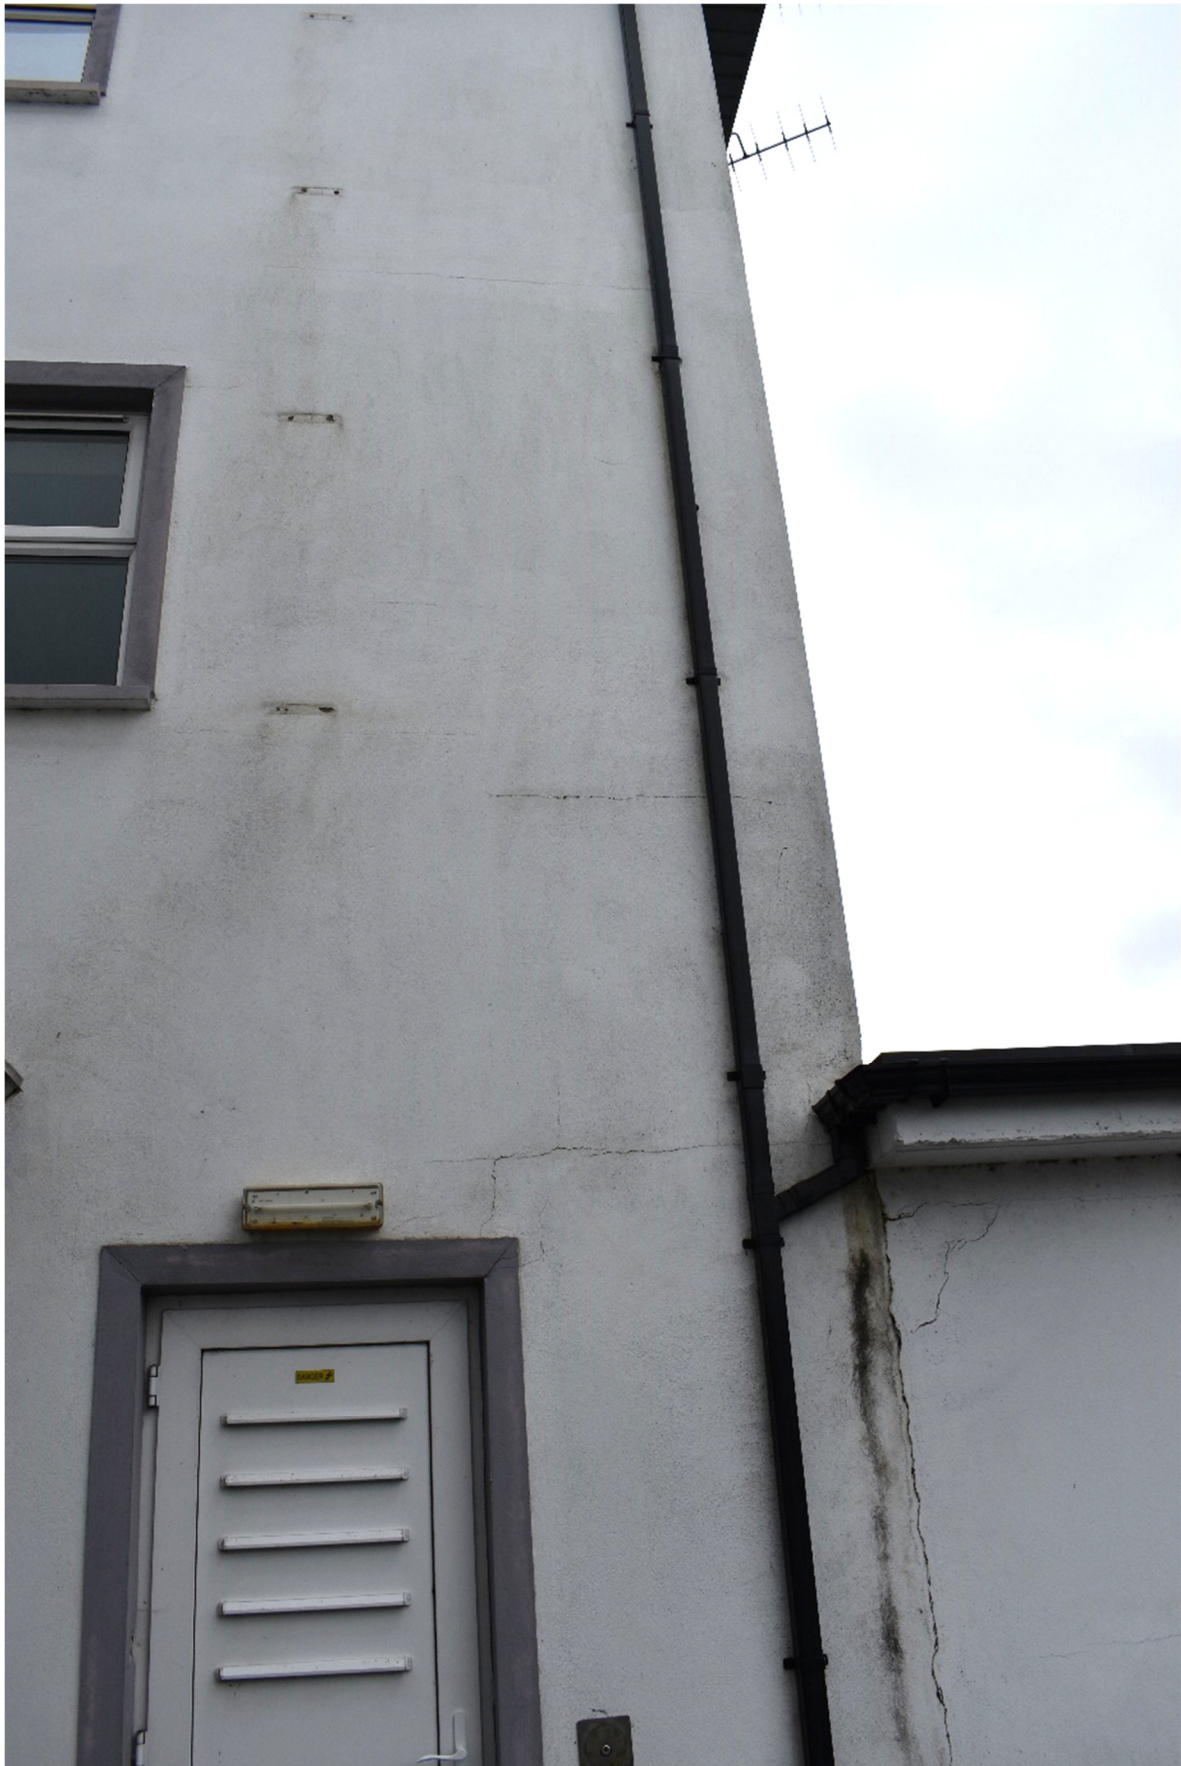
Rear Elevation – A series of horizontal crack from the window head and cill level can be seen in the above photo. A vertical crack near the corner of the elevation can be seen in the above photo also. (Picture – 2021)

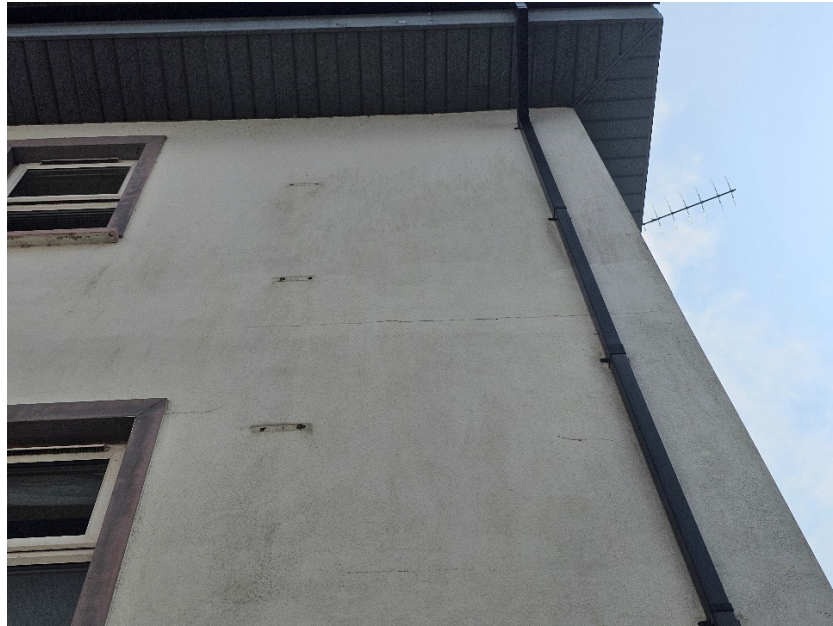
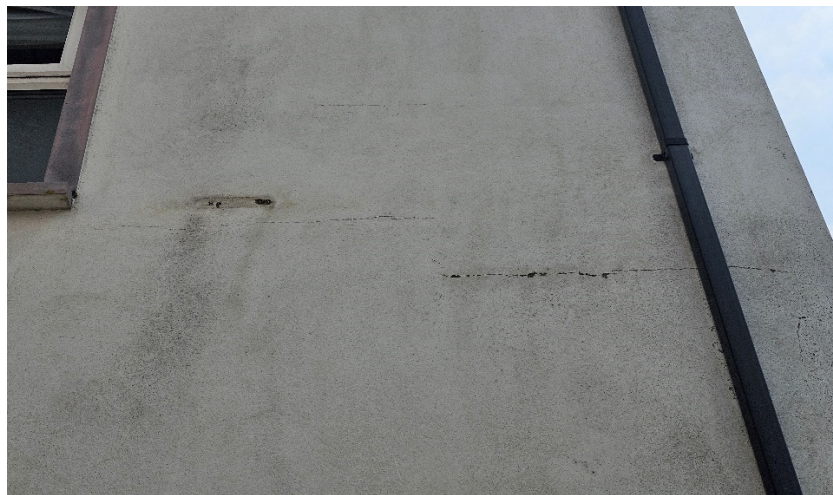
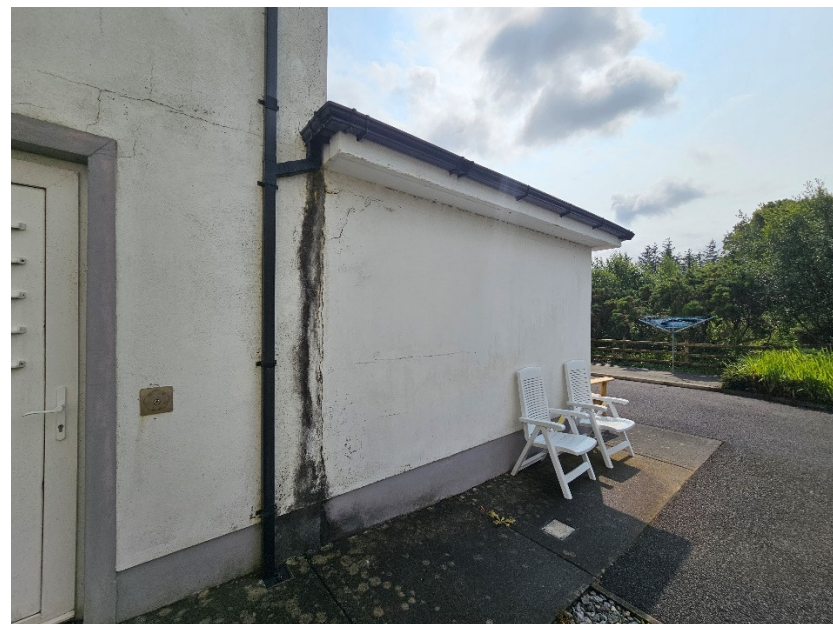
Rear Elevation – A series of horizontal crack from the window head and sill level can be seen in the above photos. A vertical crack near the corner of the elevation can be seen in the above photo also. (Pictures – 2025)

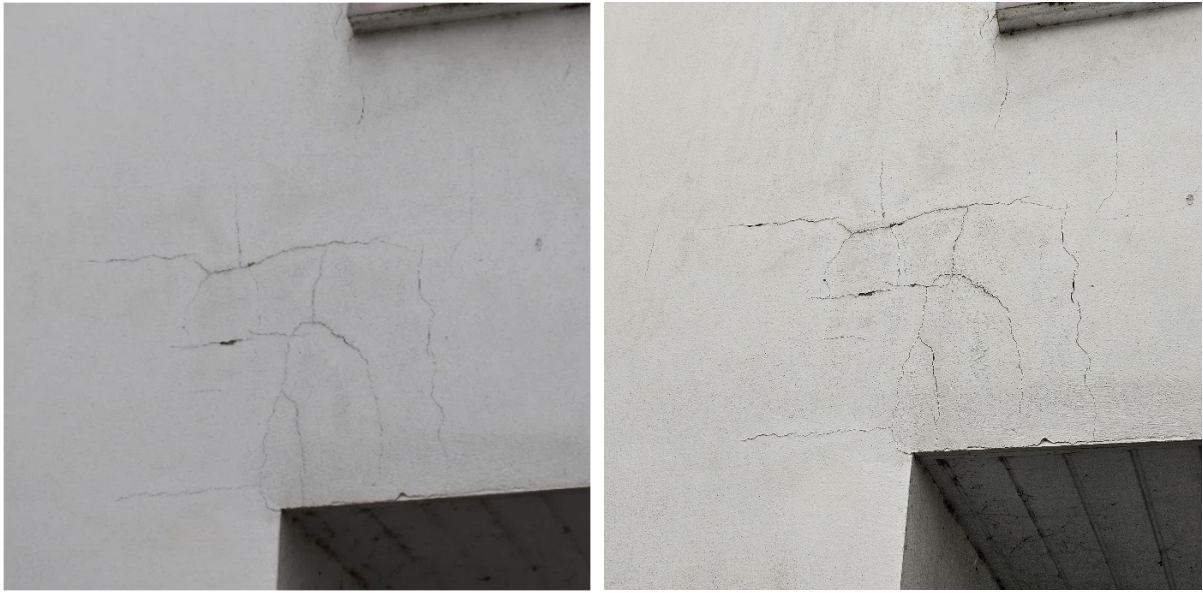
Rear Elevation – Web like cracks can be seen on the elevation in the above photo. (Pictures – Left: 2021, Right: 2025)

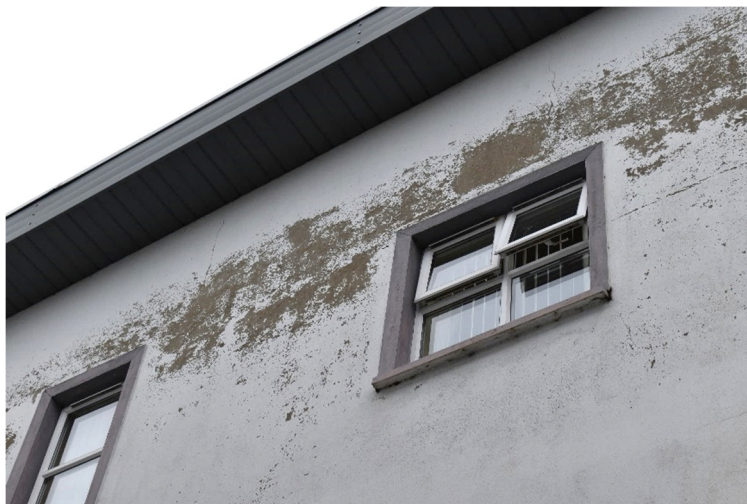
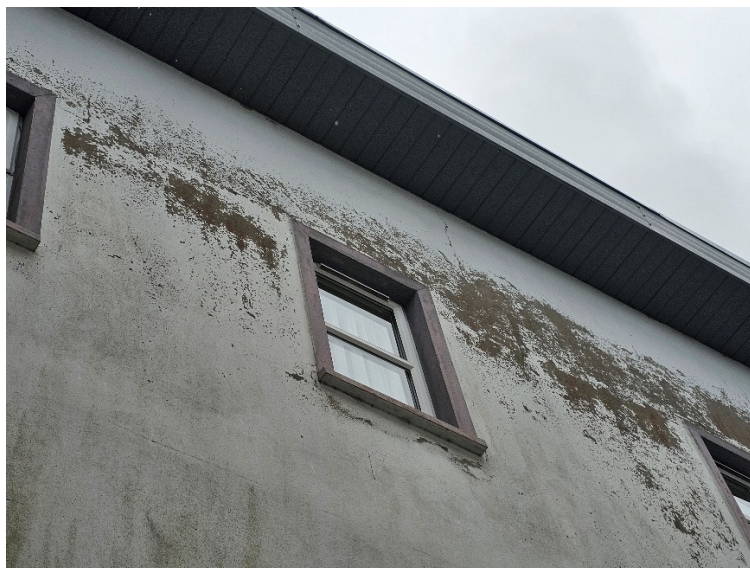
Rear Elevation – Example of flaking paint present on the external wall. (Pictures – Top: 2021, Bottom: 2025)

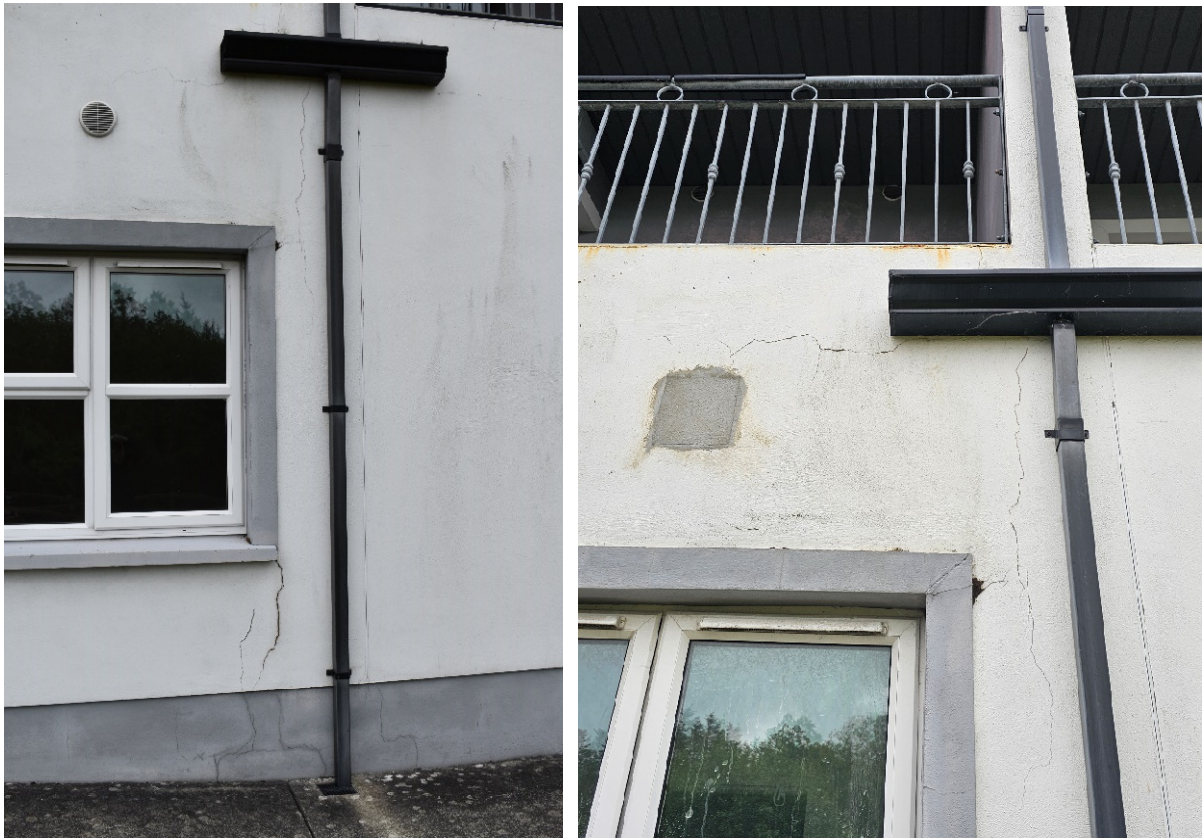
Rear Elevation – Cracking present above and below the window in the above photo. (Pictures – Left: 2021, Right: 2025)

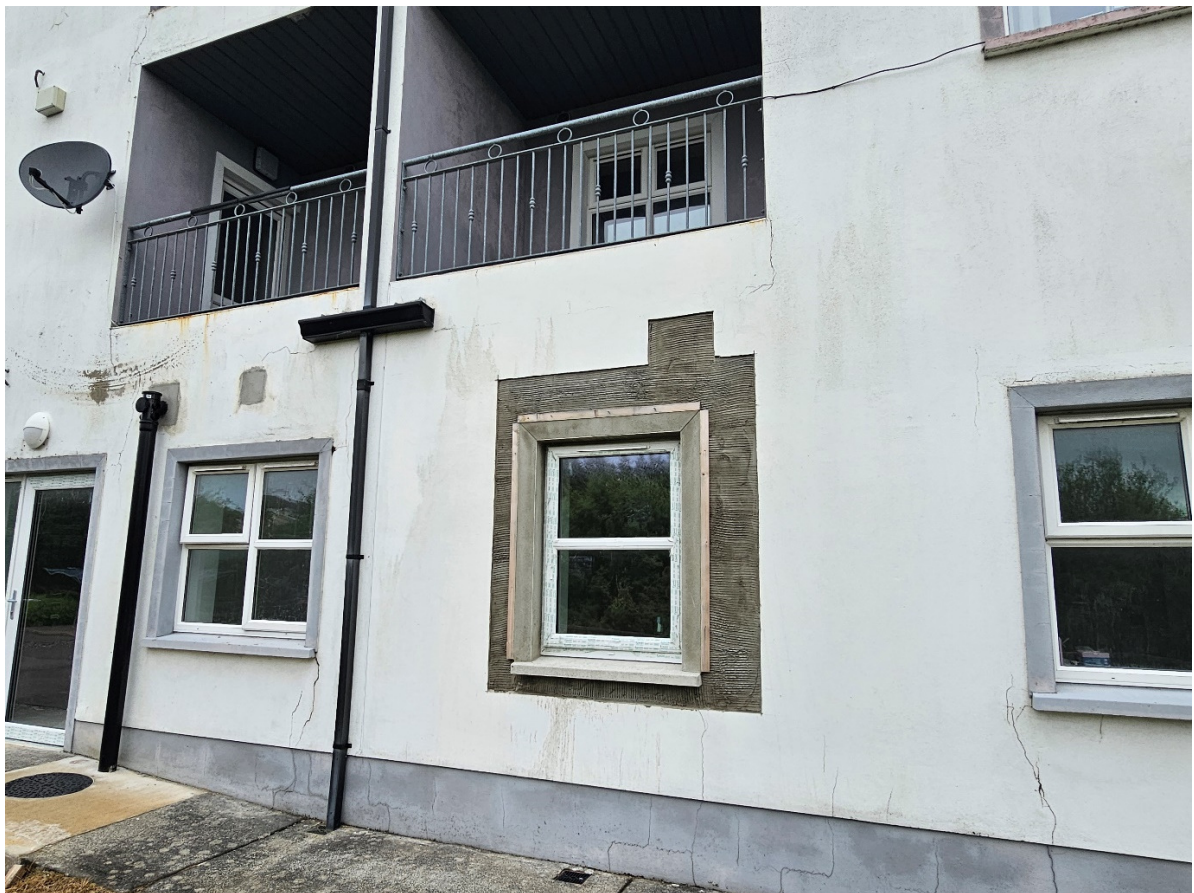
Rear Elevation – Cracking present throughout (Picture – 2025)

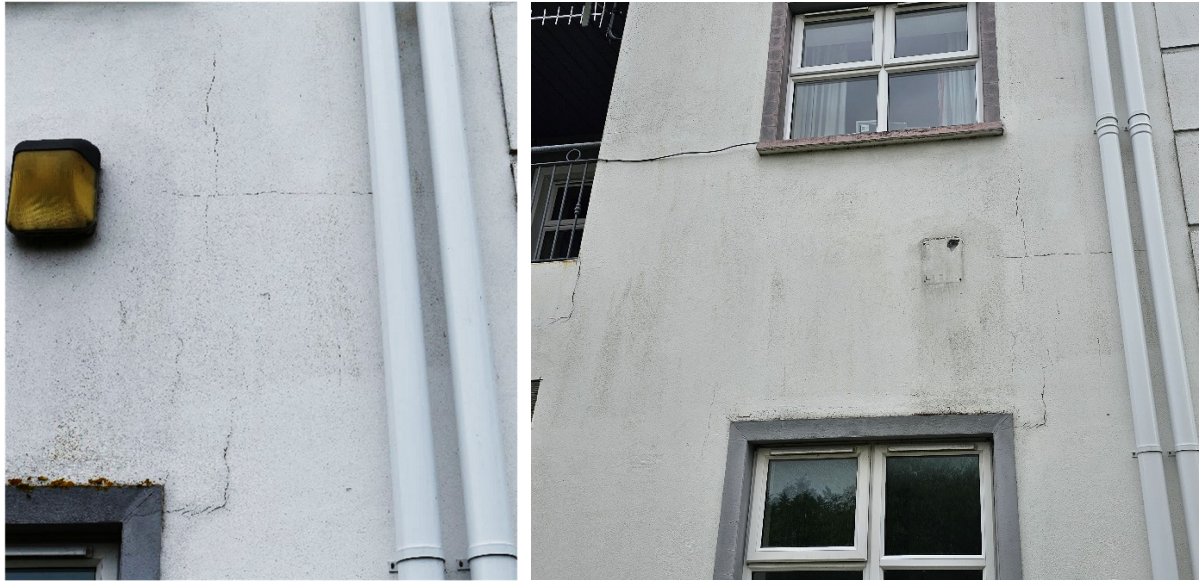
Rear Elevation – Pattern like cracks can be seen on the elevation in the above photo. (Pictures – Left: 2021, Right: 2025)

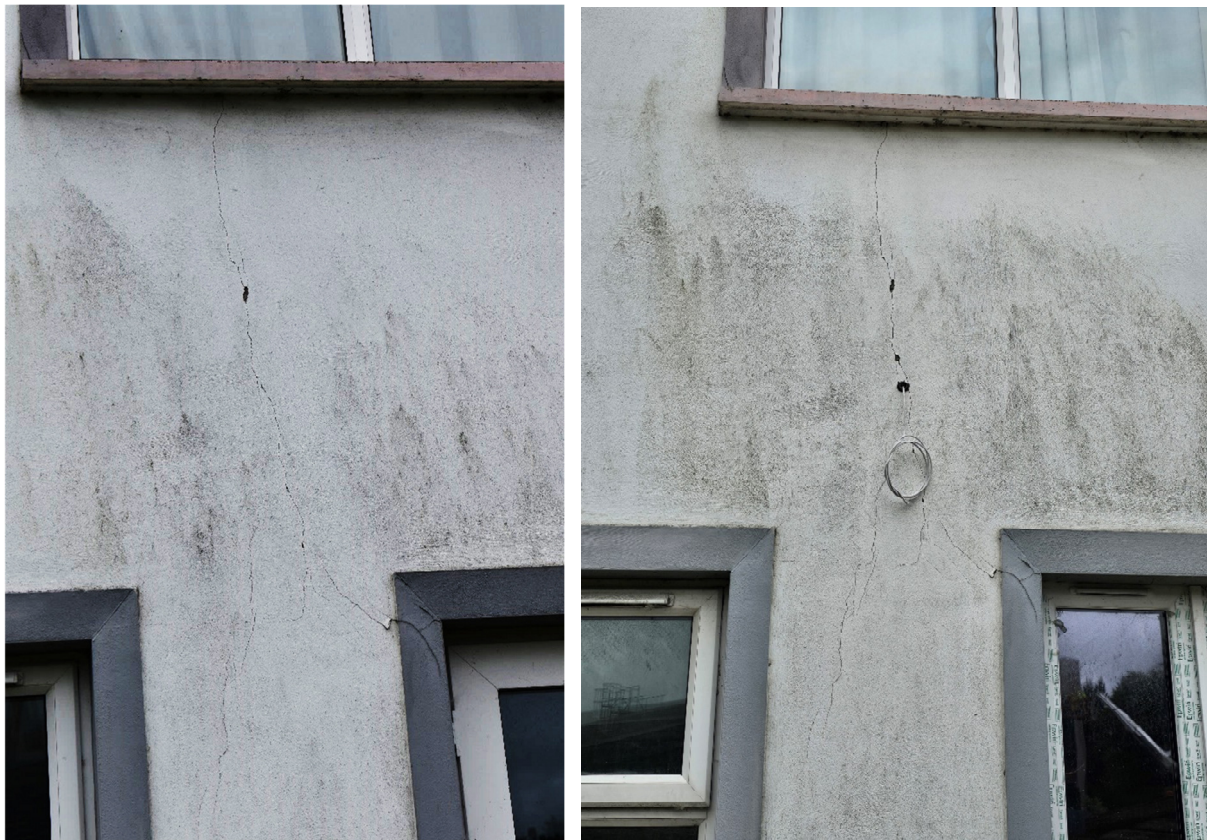
LHS Elevation – Web like cracks present near the window heads. (Pictures – Left: 2021, Right: 2025)

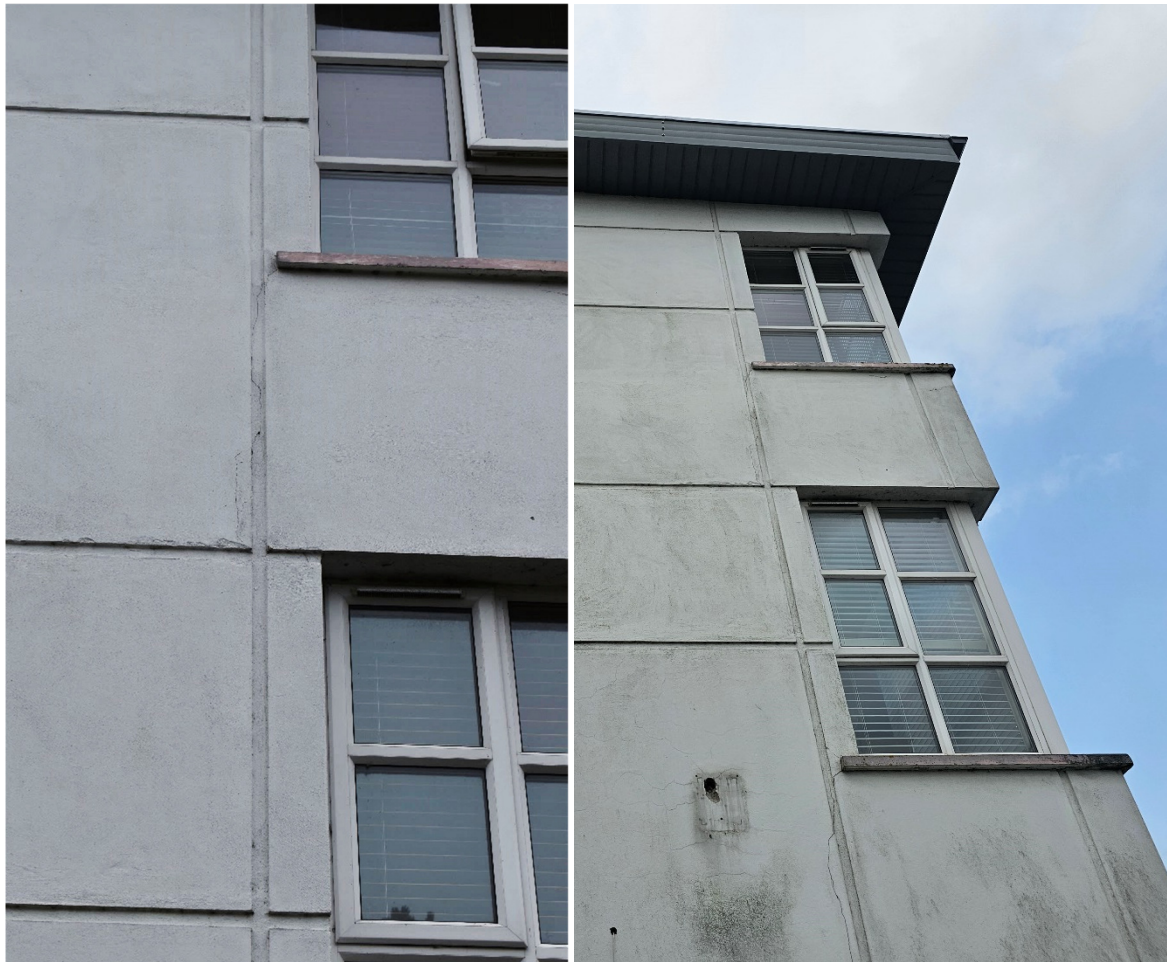
LHS Elevation – Vertical crack present near below the window cill in the above photo. (Pictures – Left: 2021, Right: 2025)

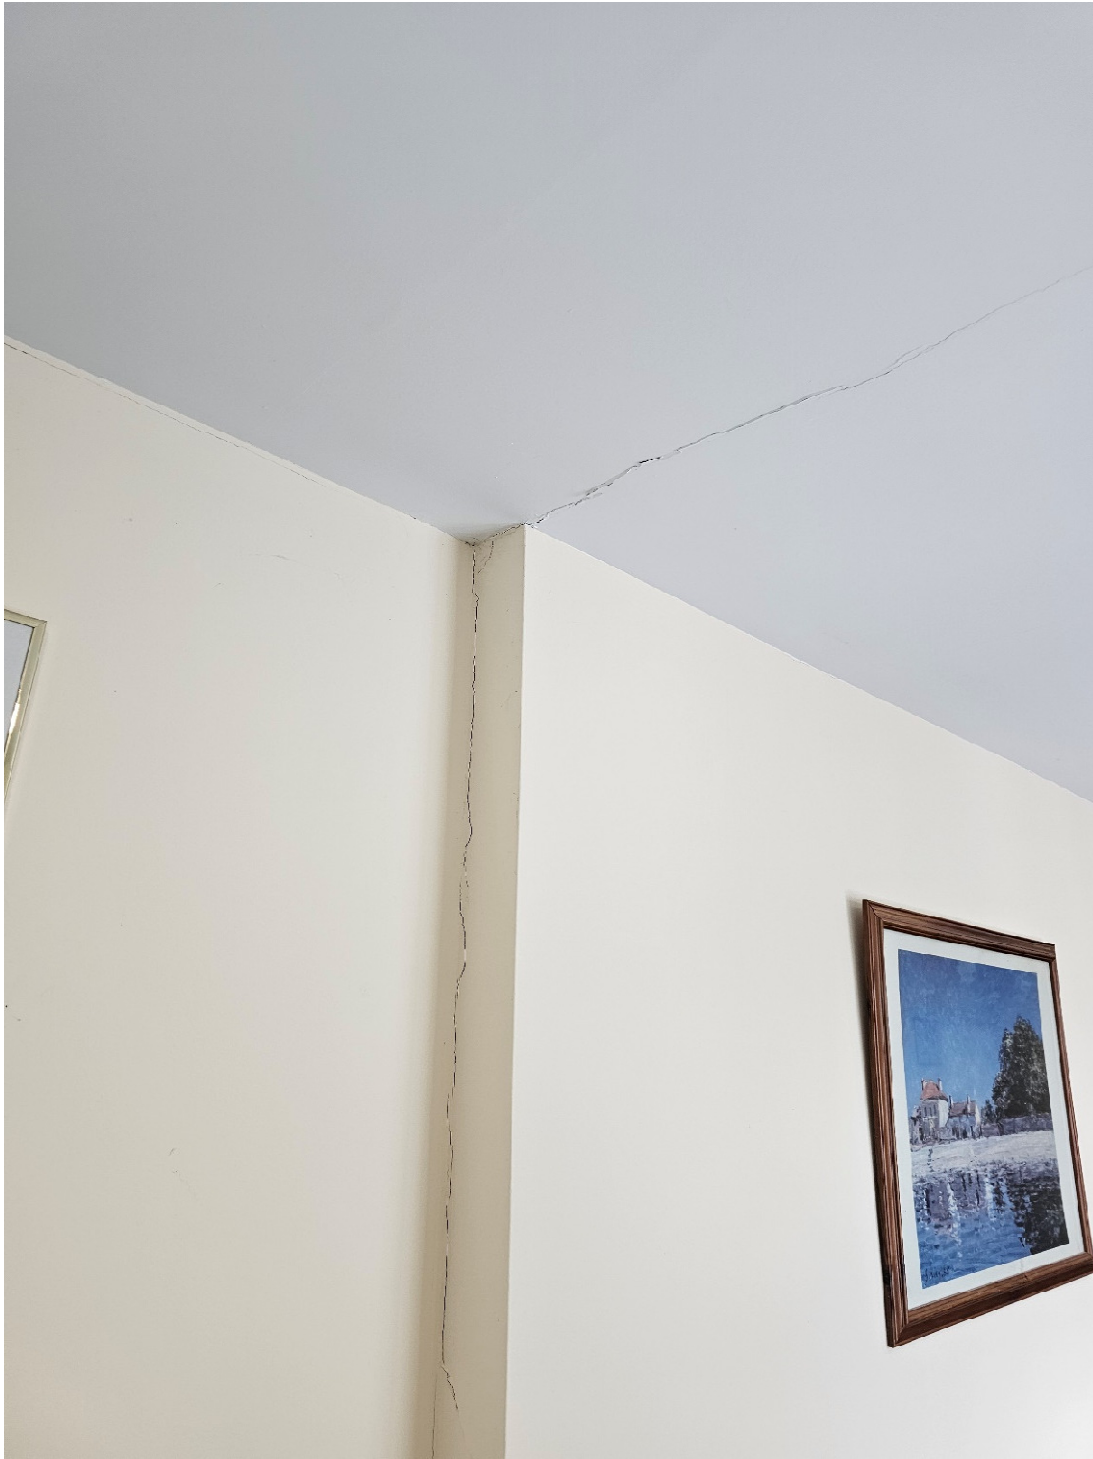
Second Floor – Cracking is present vertically on the wall and continues across the ceiling (2025)
