# BUILDING CONDITION ASSESSMENT REPORT

**Fairhill Lodge, Dungloe, Co. Donegal**

**7<sup>th</sup> June 2025**

Project Title: Assessment of Fairhill Lodge, Dungloe, Co. Donegal

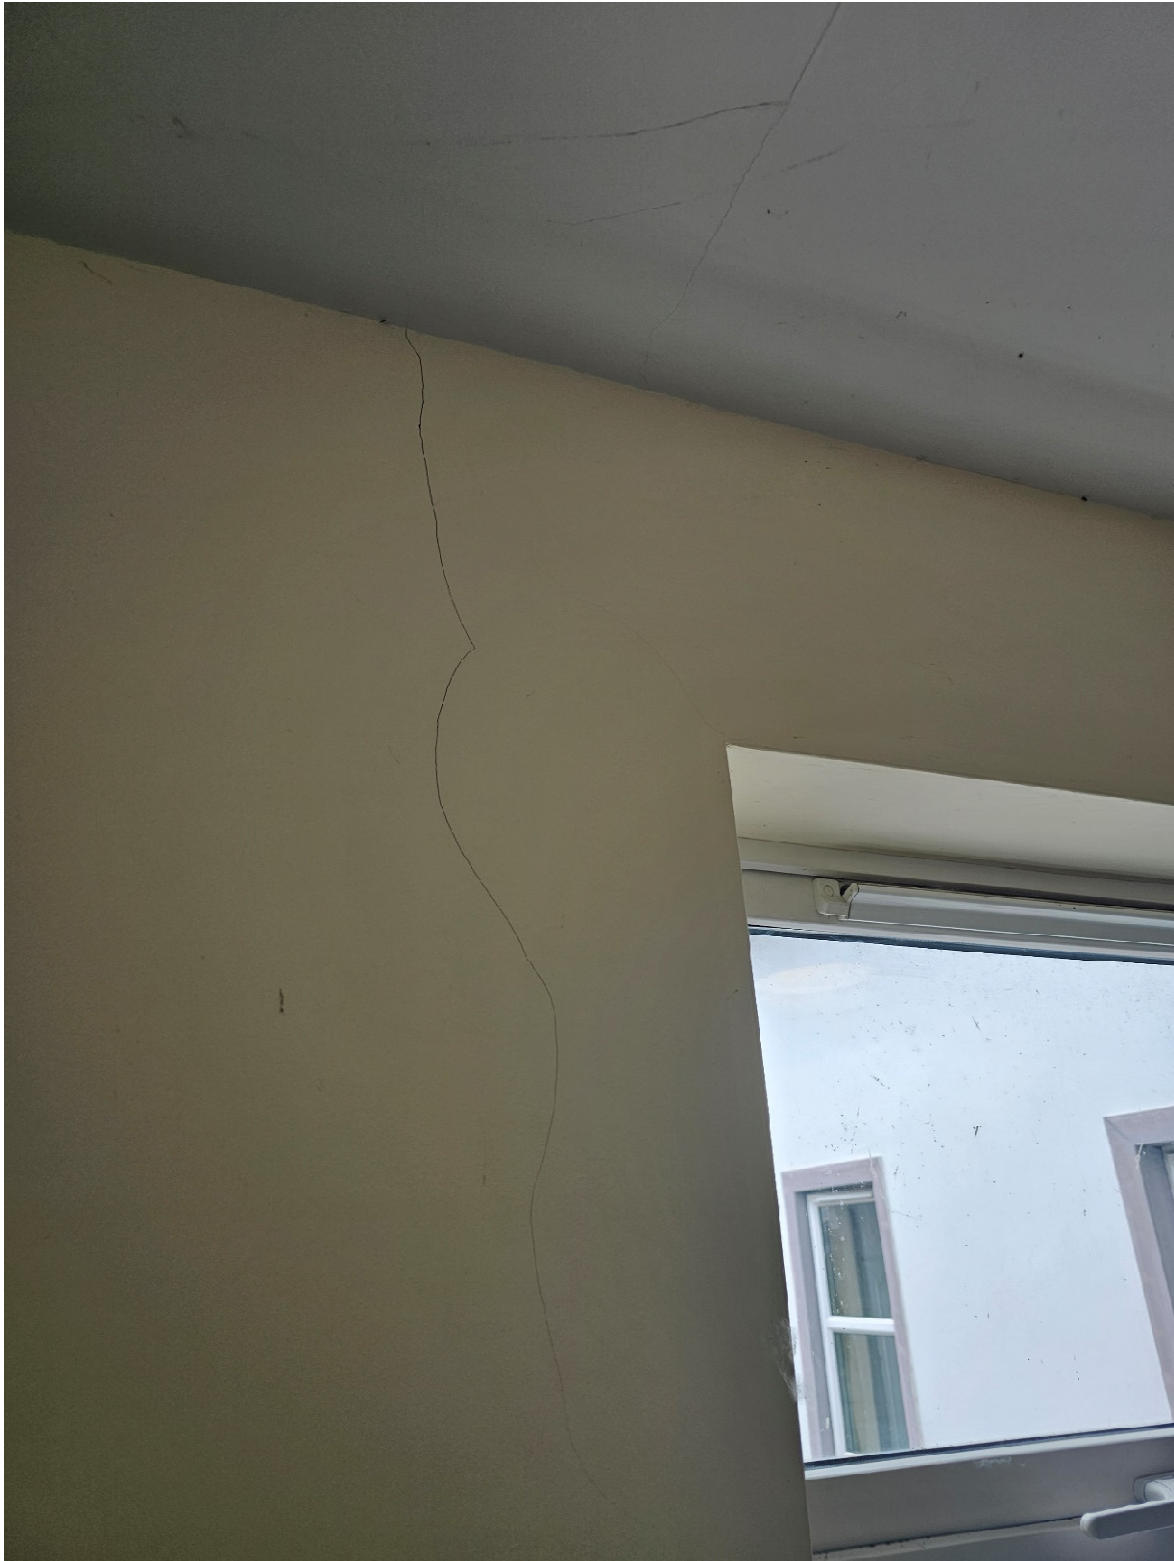
Second Floor – Cracking is present on the wall and ceiling in the above photo. (2025)

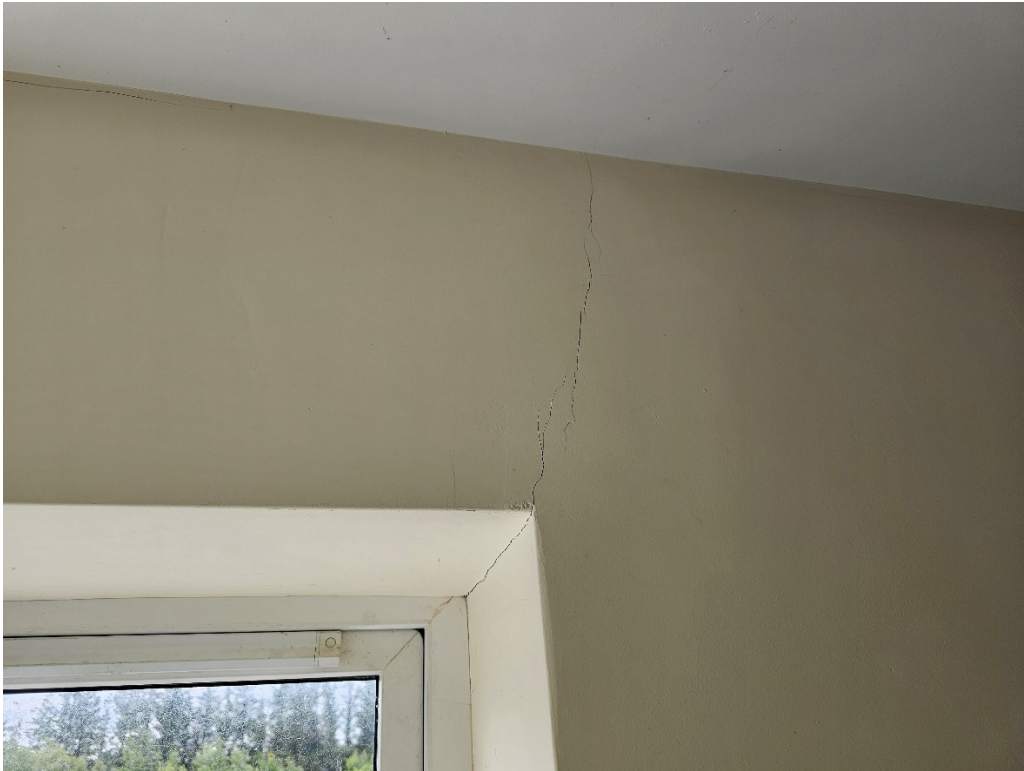
First Floor – Cracking is present at the head of the window in the games room. (2025)

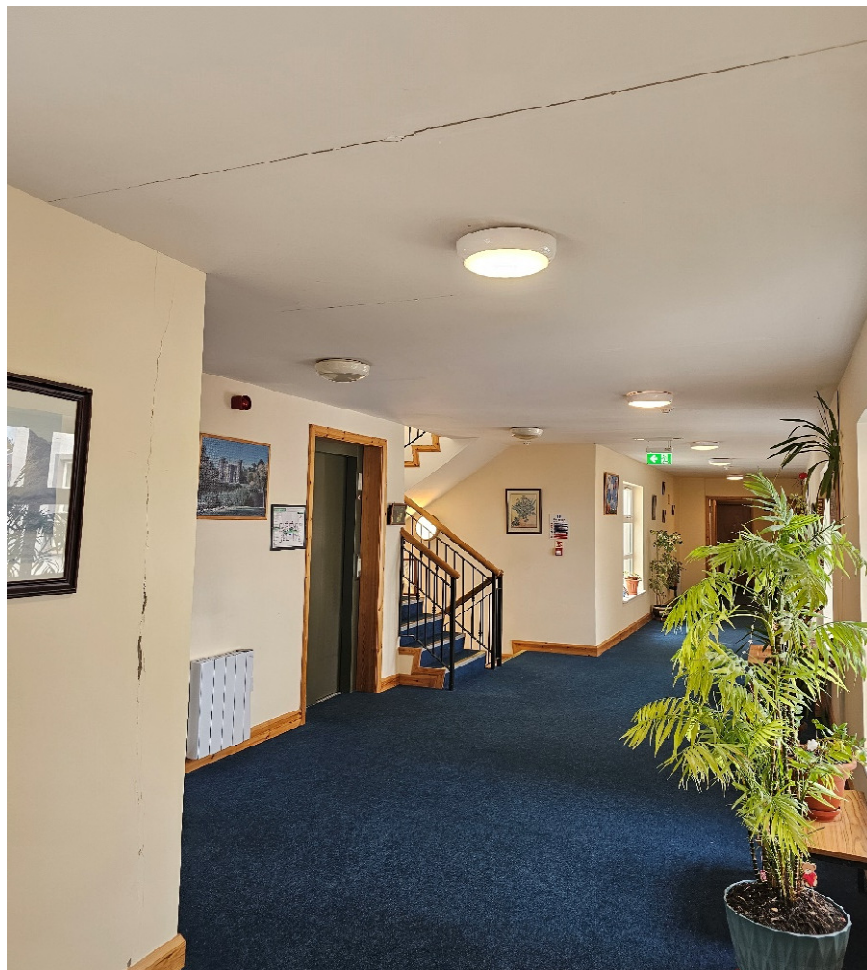
First Floor – Large vertical crack can be seen outside the games room with multiple ceiling cracks throughout. (2025)

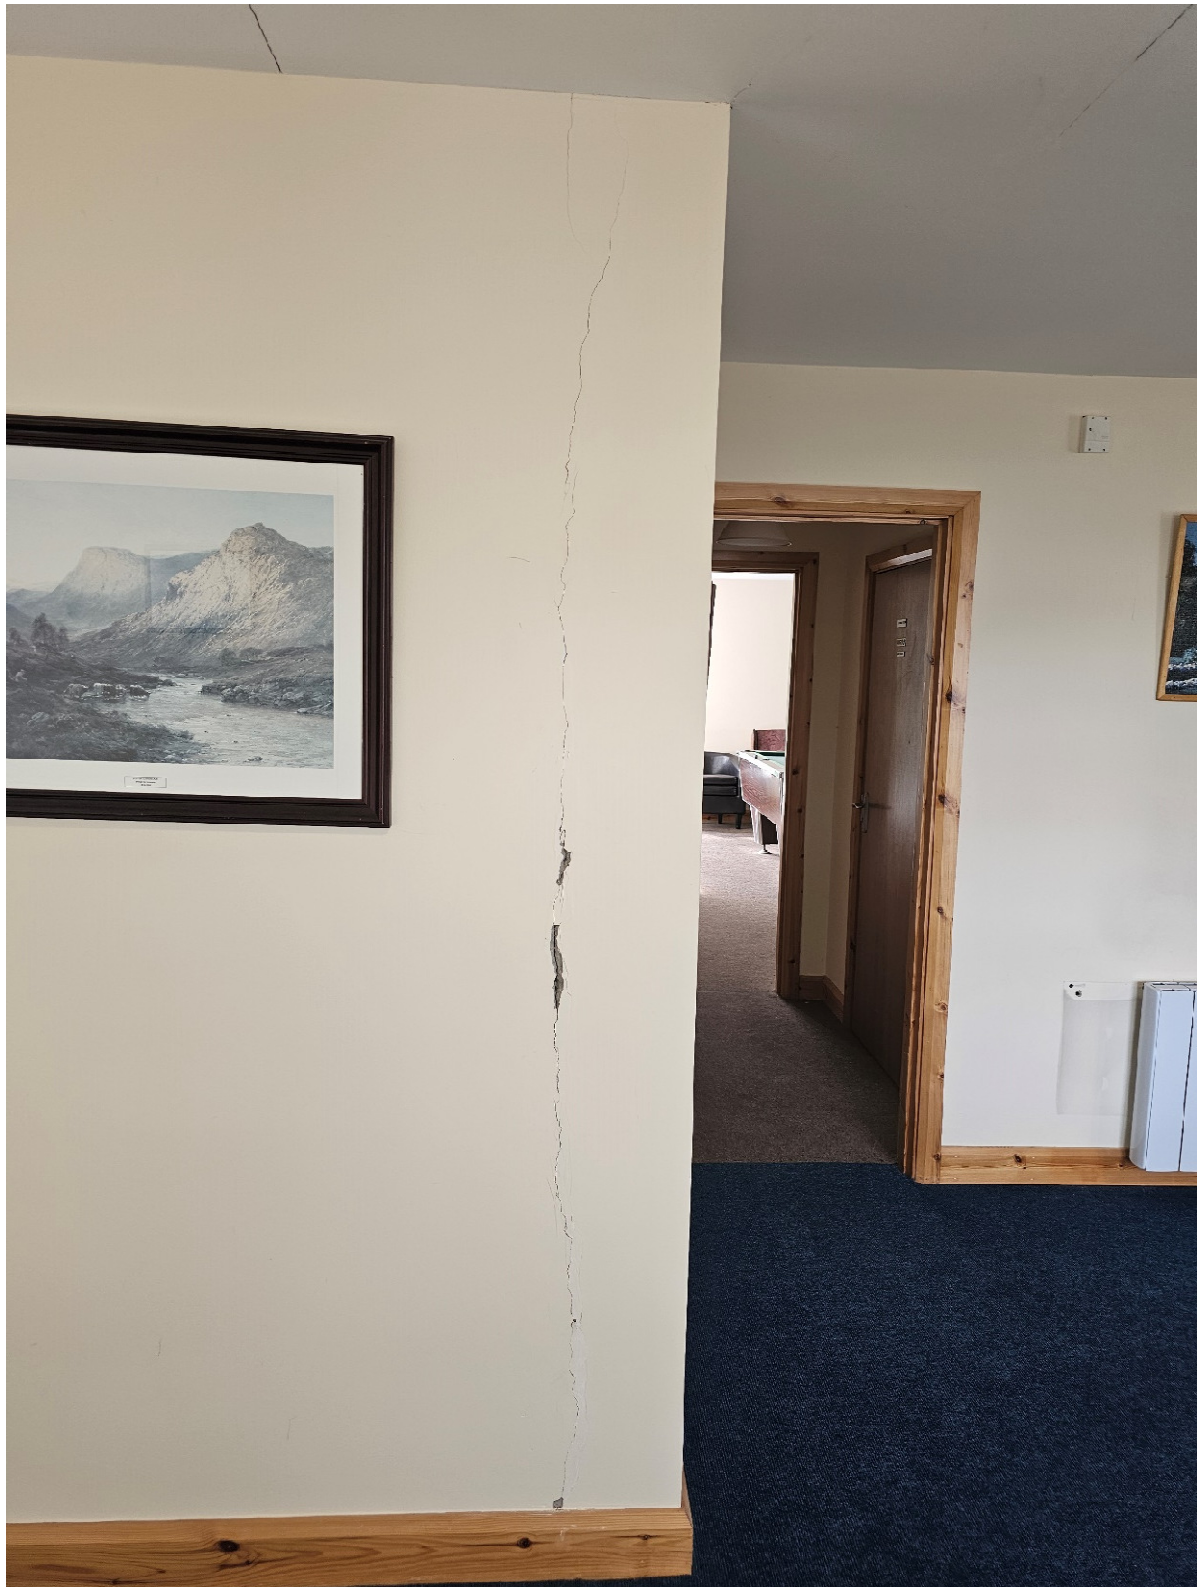
First Floor – Large vertical crack can be seen outside the games room. (2025)

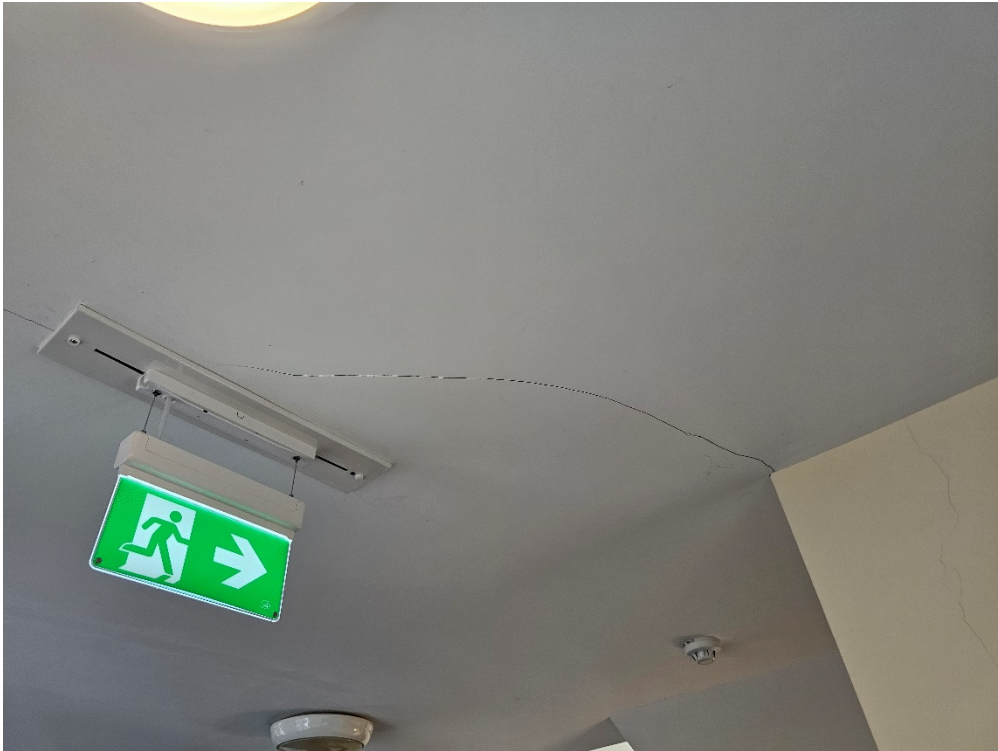
First Floor – Ceiling cracks can be seen throughout. (2025)

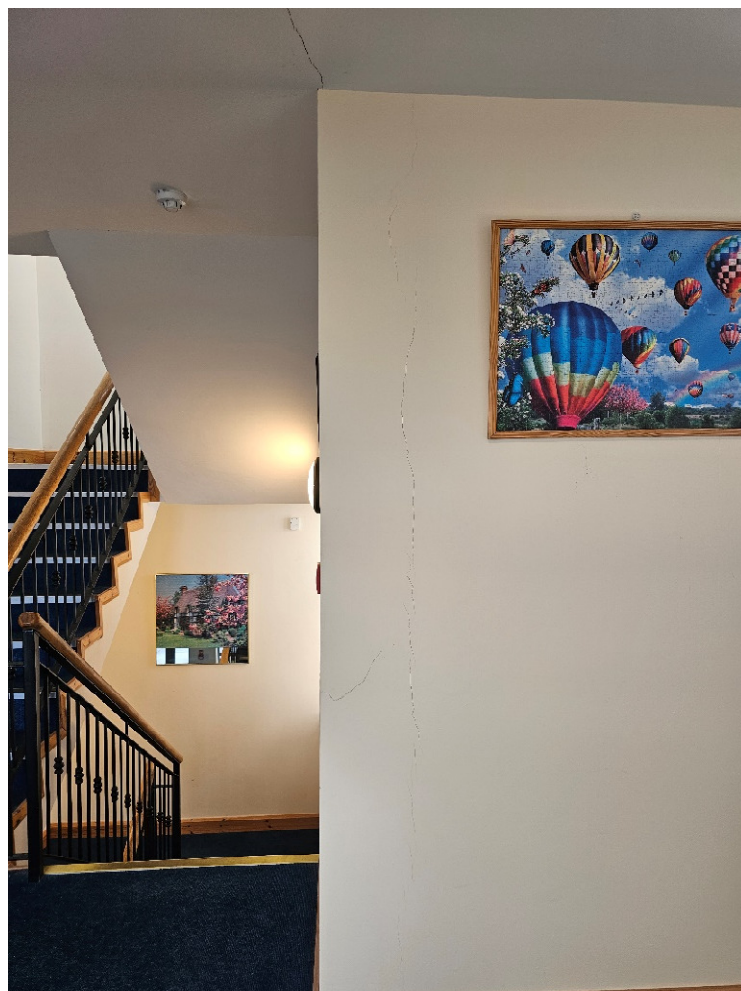
First Floor – Vertical crack can be seen on the wall beside the stairwell. (2025)
